ASIS GIP Report

NPS Guardwall/Rail Inventory Program Assateague Island National Seashore

**Federal Highway Administration
Eastern Federal Lands Highway Division
Road Inventory Program (RIP)**

**Data Collection Date: November 2010
Report Date: November 2015**

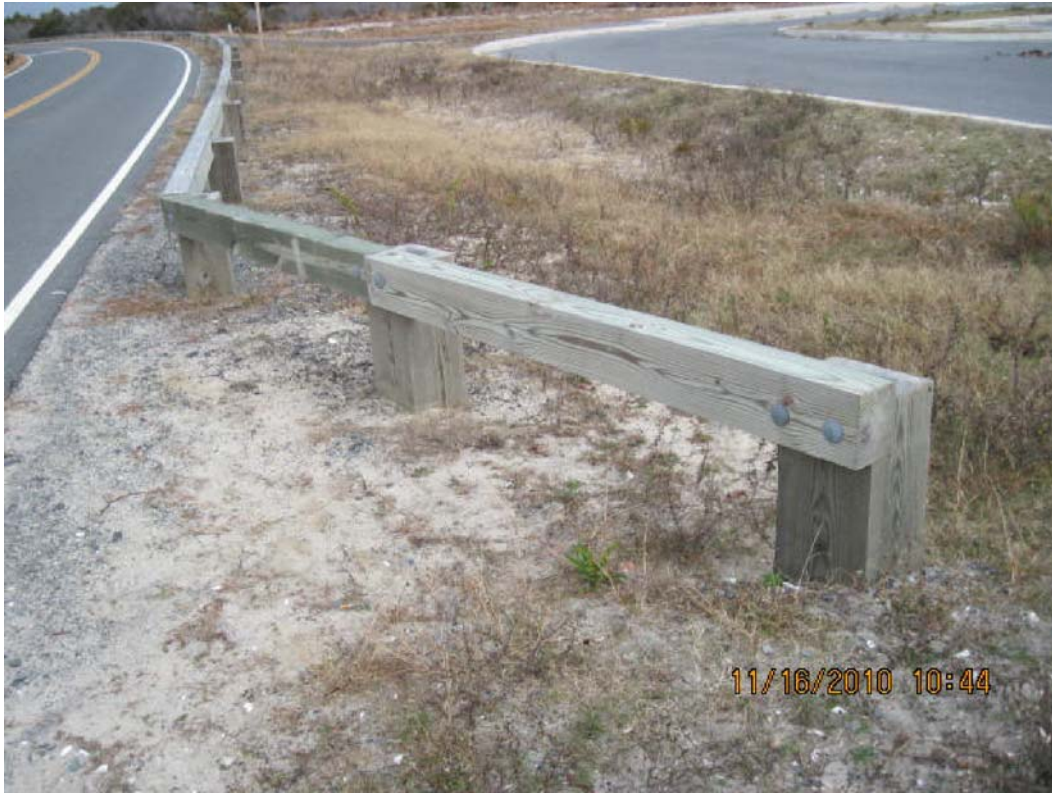
ASIS_0010ZZ_0.168_L_1.jpg

Barrier ID:	ASIS-0010ZZ-0.168-L				
Route Name:	BAYBERRY DRIVE				
Inspection Date:	11/16/2010	Barrier Rating:	42.50		
Barrier Description					
Type:	OTHER: TIMBER RAIL ON TIMBER POSTS	Barrier Function:	TRAFFIC		
Barrier Material:	LOG/TIMBER/WOOD	Post Material:	WOOD		
Blockout Type:	N/A	Length (ft.):	10784		
Speed Limit (MPH):	30	Placement with Respect to Road:	BOTH INSIDE AND OUTSIDE		
Hazard Behind Barrier:	LOW				
Barrier Crashworthiness					
Appropriate Test Level:	TL-1	Barrier Test Level:	NCW	Is Barrier Crashworthy?:	NO
Beg. End Trtmt Type:	NONE	Is Beg. End Trtmt Crashworthy?:	N/A	Approach Transition Type:	NONE
Ending End Trtmt Type:	NONE	Ending End Trtmt Crashworthy?:	N/A		
Average Measurements					
Design Height (In.):	20	Width (In.):	0.0	Post Spacing (In.):	121.8
Height (In.):	22.0	Lateral Offset (In.):	39.5	Road Grade (%):	0.10
Physical Condition					
Barrier	Alignment and Height:	Alignment deflection was less than 6 in. The entire barrier was 1/2 in below or exceeded design height (20 in) by up to 3 1/2 ins.

Breaking and Cracking:	10 (10 ft) rails showed signs of impacts.			
	Missing Elements:	Bolts were loose and missing sporadically throughout barrier.			
	Corrosion and Weathering:	100 rails were observed to have rotting of between 5% and 50% of cross section. 100 posts were observed to have rotting of between 5% and 50% of cross section. No erosion observed.			
End Treatments	Alignment and Height:				
	Breaking and Cracking:				
	Missing Elements:				
	Corrosion and Weathering:

Repair Action:	REPAIR	FMSS Work Type:	DEFERRED MAINTENANCE	Repair Cost:	\$49693
Brief Workorder:	Replace 1100 feet of rail 100 posts and missing bolts throughout.				
Workorder:	Replace Post at \$100- per -Each for 100 Post(s) = \$10000. Replace 100 posts due to rotting. Replace Rail at \$25- per -Lin. Ft. for 1100 LF = \$27500. Replace 1100 ft (10 ft rails) due to impacts and rotting. Labor at \$60- per -Hour for 5 Hrs = \$300. Replace missing bolts Low Speed Traffic Control at \$1475- per -Day for 5 Day(s) = \$7375.

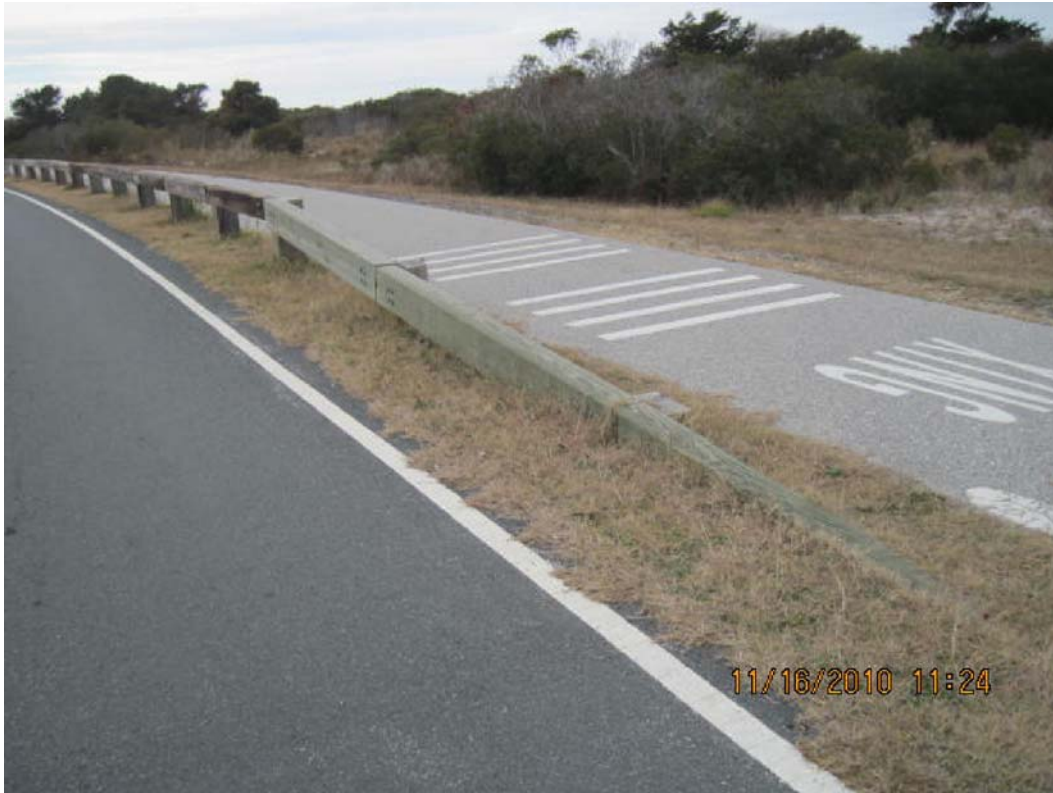
ASIS_0010ZZ_1.964_R_1.jpg

Barrier ID:	ASIS-0010ZZ-1.964-R				
Route Name:	BAYBERRY DRIVE				
Inspection Date:	11/16/2010	Barrier Rating:	38.40		
Barrier Description					
Type:	OTHER: TIMBER RAIL ON TIMBER POSTS	Barrier Function:	TRAFFIC		
Barrier Material:	LOG/TIMBER/WOOD	Post Material:	WOOD		
Blockout Type:	N/A	Length (ft.):	1288		
Speed Limit (MPH):	30	Placement with Respect to Road:	BOTH INSIDE AND OUTSIDE		
Hazard Behind Barrier:	LOW				
Barrier Crashworthiness					
Appropriate Test Level:	TL-1	Barrier Test Level:	NCW	Is Barrier Crashworthy?:	NO
Beg. End Trtmt Type:	OTHER: TIMBER FLARED	Is Beg. End Trtmt Crashworthy?:	NO	Approach Transition Type:	NONE
Ending End Trtmt Type:	NONE	Ending End Trtmt Crashworthy?:	N/A		
Average Measurements					
Design Height (In.):	20	Width (In.):	0.0	Post Spacing (In.):	119.6
Height (In.):	25.1	Lateral Offset (In.):	36.0	Road Grade (%):	0.20
Physical Condition					
Barrier	Alignment and Height:	No deflections observed in alignment. Entire barrier exceeds 20 in design height by 4.5 to 6 in.

Breaking and Cracking:	No impact related breaking or cracking observed.			
	Missing Elements:	No elements were observed to be missing.			
	Corrosion and Weathering:	19 rails and 3 posts were observed to have rotting and cracking between 5% and 50% of cross section. No erosion around posts observed.			
End Treatments	Alignment and Height:	Alignment acceptable. Height within 1-in. of 20-in. design height.			
	Breaking and Cracking:	No impact related breaking or cracking observed.			
	Missing Elements:	No elements were observed to be missing.			
	Corrosion and Weathering:	No loss of cross section or erosion around posts observed.

Repair Action:	REPAIR	FMSS Work Type:	DEFERRED MAINTENANCE	Repair Cost:	\$7178
Brief Workorder:	Replace 190 feet of rail and 3 posts.				
Workorder:	Replace Rail at \$25- per -Lin. Ft. for 190 LF = \$4750. Replace 19 rails. Replace Post at \$100- per -Each for 3 Post(s) = \$300. Replace 3 posts. Low Speed Traffic Control at \$1475- per -Day for 1 Day(s) = \$1475.

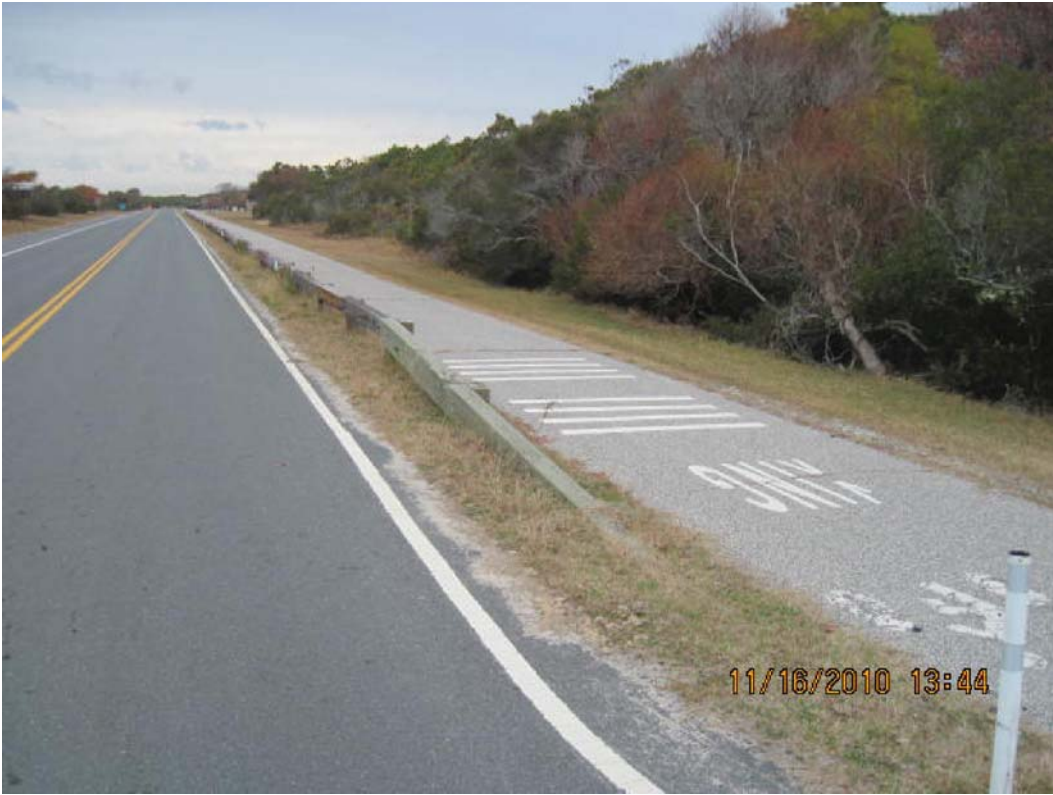
ASIS_0010ZZ_2.250_R_1.jpg

Barrier ID:	ASIS-0010ZZ-2.250-R				
Route Name:	BAYBERRY DRIVE				
Inspection Date:	11/16/2010	Barrier Rating:	27.00		
Barrier Description					
Type:	OTHER: TIMBER RAIL ON TIMBER POSTS	Barrier Function:	TRAFFIC		
Barrier Material:	LOG/TIMBER/WOOD	Post Material:	WOOD		
Blockout Type:	N/A	Length (ft.):	590		
Speed Limit (MPH):	30	Placement with Respect to Road:	TANGENT		
Hazard Behind Barrier:	LOW				
Barrier Crashworthiness					
Appropriate Test Level:	TL-1	Barrier Test Level:	NCW	Is Barrier Crashworthy?:	NO
Beg. End Trtmt Type:	OTHER: TIMBER FLARED	Is Beg. End Trtmt Crashworthy?:	NO	Approach Transition Type:	NONE
Ending End Trtmt Type:	NONE	Ending End Trtmt Crashworthy?:	N/A		
Average Measurements					
Design Height (In.):	20	Width (In.):	0.0	Post Spacing (In.):	103.0
Height (In.):	21.7	Lateral Offset (In.):	46.7	Road Grade (%):	0.20
Physical Condition					
Barrier	Alignment and Height:	No deflections greater than 6 in were observed in the alignment. The barrier height was equal to or greater than the 20 in design height by up to 2 in for the entire length of the barrier.

Breaking and Cracking:	No impact related breaking or cracking observed.			
	Missing Elements:	No elements were observed to be missing.			
	Corrosion and Weathering:	6 rails and 2 posts were severely weathered/rotted. No erosion was observed.			
End Treatments	Alignment and Height:	Alignment acceptable. Height within 1-in. of 20-in. design height.			
	Breaking and Cracking:	No impact related breaking or cracking was observed.			
	Missing Elements:	No elements were observed to be missing.			
	Corrosion and Weathering:	No loss of cross section or erosion around posts observed.

Repair Action:	REPAIR	FMSS Work Type:	DEFERRED MAINTENANCE	Repair Cost:	\$3493
Brief Workorder:	Replace 60 feet of rail and 2 posts.				
Workorder:	Replace Rail at \$25- per -Lin. Ft. for 60 LF = \$1500. Replace 6 rotted/damaged rails. Replace Post at \$100- per -Each for 2 Post(s) = \$200. Replace 2 rotted/damaged posts. Low Speed Traffic Control at \$1475- per -Day for 1 Day(s) = \$1475.

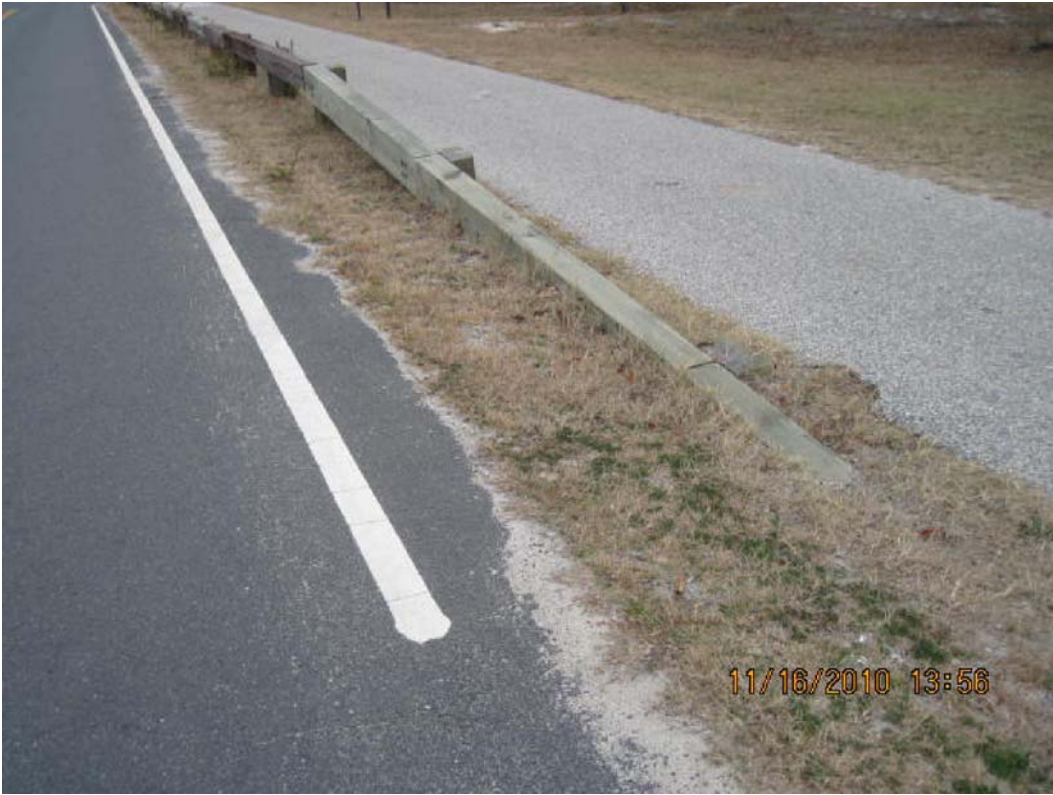
ASIS_0010ZZ_2.315_R_1.jpg

Barrier ID:	ASIS-0010ZZ-2.315-R				
Route Name:	BAYBERRY DRIVE				
Inspection Date:	11/16/2010	Barrier Rating:	19.70		
Barrier Description					
Type:	OTHER: TIMBER RAIL ON TIMBER POSTS	Barrier Function:	TRAFFIC		
Barrier Material:	LOG/TIMBER/WOOD	Post Material:	WOOD		
Blockout Type:	N/A	Length (ft.):	154		
Speed Limit (MPH):	30	Placement with Respect to Road:	TANGENT		
Hazard Behind Barrier:	LOW				
Barrier Crashworthiness					
Appropriate Test Level:	TL-1	Barrier Test Level:	NCW	Is Barrier Crashworthy?:	NO
Beg. End Trtmt Type:	OTHER: TIMBER FLARED	Is Beg. End Trtmt Crashworthy?:	NO	Approach Transition Type:	NONE
Ending End Trtmt Type:	NONE	Ending End Trtmt Crashworthy?:	N/A		
Average Measurements					
Design Height (In.):	20	Width (In.):	0.0	Post Spacing (In.):	119.0
Height (In.):	20.8	Lateral Offset (In.):	37.5	Road Grade (%):	0.20
Physical Condition					
Barrier	Alignment and Height:	Alignment deflection was less than 6 in. The entire barrier exceeded design height (20 in) by 1.5 to 2 in.

Breaking and Cracking:	No impact related breaking or cracking observed.			
	Missing Elements:	No elements were observed to be missing.			
	Corrosion and Weathering:	2 rails and 2 posts were rotting and had cross section loss between 5% and 50%. No erosion was observed.			
End Treatments	Alignment and Height:	Alignment acceptable. Height within 1-in. of 20-in. design height.			
	Breaking and Cracking:	No impact related breaking/cracking observed.			
	Missing Elements:	No elements were observed to be missing.			
	Corrosion and Weathering:	No loss of cross section or erosion around posts observed.

Repair Action:	REPAIR	FMSS Work Type:	DEFERRED MAINTENANCE	Repair Cost:	\$2393
Brief Workorder:	Replace 2 posts and 20 feet of rail				
Workorder:	Replace Post at \$100- per -Each for 2 Post(s) = \$200. Replace 2 posts due to rotting. Replace Rail at \$25- per -Lin. Ft. for 20 LF = \$500. Replace 2 rails due to rotting. Low Speed Traffic Control at \$1475- per -Day for 1 Day(s) = \$1475.

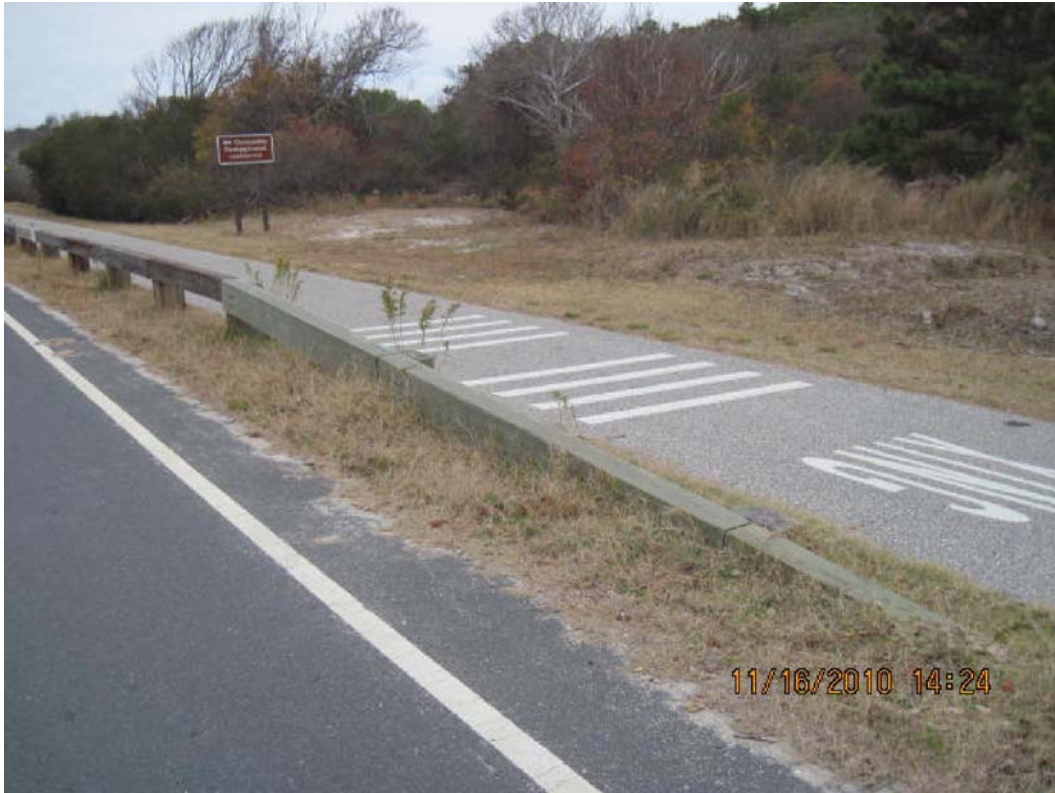
ASIS_0010ZZ_2.492_R_1.jpg

Barrier ID:	ASIS-0010ZZ-2.492-R				
Route Name:	BAYBERRY DRIVE				
Inspection Date:	11/16/2010	Barrier Rating:	19.70		
Barrier Description					
Type:	OTHER: TIMBER RAIL ON TIMBER POSTS	Barrier Function:	TRAFFIC		
Barrier Material:	LOG/TIMBER/WOOD	Post Material:	WOOD		
Blockout Type:	N/A	Length (ft.):	288		
Speed Limit (MPH):	30	Placement with Respect to Road:	TANGENT		
Hazard Behind Barrier:	LOW				
Barrier Crashworthiness					
Appropriate Test Level:	TL-1	Barrier Test Level:	NCW	Is Barrier Crashworthy?:	NO
Beg. End Trtmt Type:	OTHER: TIMBER FLARED	Is Beg. End Trtmt Crashworthy?:	NO	Approach Transition Type:	NONE
Ending End Trtmt Type:	NONE	Ending End Trtmt Crashworthy?:	N/A		
Average Measurements					
Design Height (In.):	20	Width (In.):	0.0	Post Spacing (In.):	102.1
Height (In.):	20.7	Lateral Offset (In.):	48.5	Road Grade (%):	0.70
Physical Condition					
Barrier	Alignment and Height:	No deflections observed in alignment. Entire barrier is 1 in or less below or exceeds 20 in design height by up to 2 in.

Breaking and Cracking:	No impact related breaking or cracking observed.			
	Missing Elements:	No elements were observed to be missing.			
	Corrosion and Weathering:	4 rails and 1 post were observed to have rotting and cracking for a loss of about 30% to 50% of cross section. No erosion around posts observed.			
End Treatments	Alignment and Height:	Alignment acceptable. Height within 1-in. of 20-in. design height.			
	Breaking and Cracking:	No impact related breaking or cracking observed.			
	Missing Elements:	No elements were observed to be missing.			
	Corrosion and Weathering:	No loss of cross section or erosion around posts observed.

Repair Action:	REPAIR	FMSS Work Type:	DEFERRED MAINTENANCE	Repair Cost:	\$2833
Brief Workorder:	Replace 40 feet of rail and 1 post.				
Workorder:	Replace Rail at \$25- per -Lin. Ft. for 40 LF = \$1000. Replace 4 rails. Replace Post at \$100- per -Each for 1 Post(s) = \$100. Replace 1 post. Low Speed Traffic Control at \$1475- per -Day for 1 Day(s) = \$1475.

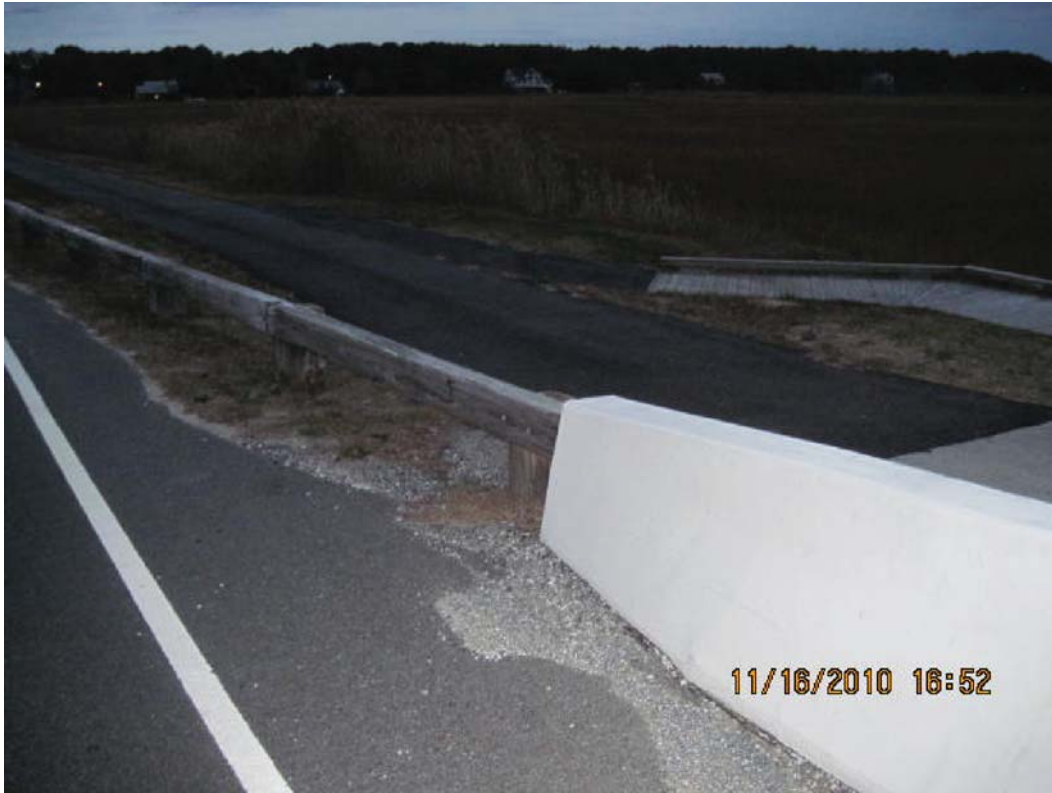
ASIS_0012_0.037_L_1.jpg

Barrier ID:	ASIS-0012-0.037-L				
Route Name:	MADDOX BOULEVARD				
Inspection Date:	11/16/2010	Barrier Rating:	28.00		
Barrier Description					
Type:	OTHER: TIMBER RAIL ON TIMBER POSTS	Barrier Function:	TRAFFIC		
Barrier Material:	LOG/TIMBER/WOOD	Post Material:	WOOD		
Blockout Type:	N/A	Length (ft.):	704		
Speed Limit (MPH):	25	Placement with Respect to Road:	TANGENT		
Hazard Behind Barrier:	MEDIUM				
Barrier Crashworthiness					
Appropriate Test Level:	TL-1	Barrier Test Level:	NCW	Is Barrier Crashworthy?:	NO
Beg. End Trtmt Type:	NONE	Is Beg. End Trtmt Crashworthy?:	N/A	Approach Transition Type:	NONE
Ending End Trtmt Type:	NONE	Ending End Trtmt Crashworthy?:	N/A		
Average Measurements					
Design Height (In.):	20	Width (In.):	0.0	Post Spacing (In.):	120.3
Height (In.):	19.3	Lateral Offset (In.):	23.5	Road Grade (%):	0.50
Physical Condition					
Barrier	Alignment and Height:	No deflections greater than 6 in were observed in the alignment. The height was within 1 in of the 20 in design height for 604 ft between 1 and 3 in below the design height for 60 ft and more than 3 in below for 40 ft.

Breaking and Cracking:	No impact related breaking or cracking observed.			
	Missing Elements:	No elements were observed to be missing.			
	Corrosion and Weathering:	Less than 5 percent of the cross section has been lost due to weathering. No erosion was observed throughout.			
End Treatments	Alignment and Height:	NA			
	Breaking and Cracking:	NA			
	Missing Elements:	NA			
	Corrosion and Weathering:	NA

Repair Action:	REPAIR	FMSS Work Type:	DEFERRED MAINTENANCE	Repair Cost:	\$2723
Brief Workorder:	Raise 100 feet of guardrail up to the 20 inch design height.				
Workorder:	Adjust Guardrail at \$10- per -Lin. Ft. for 100 LF = \$1000. Raise 100 feet of guardrail to 20 inch design height. Low Speed Traffic Control at \$1475- per -Day for 1 Day(s) = \$1475.

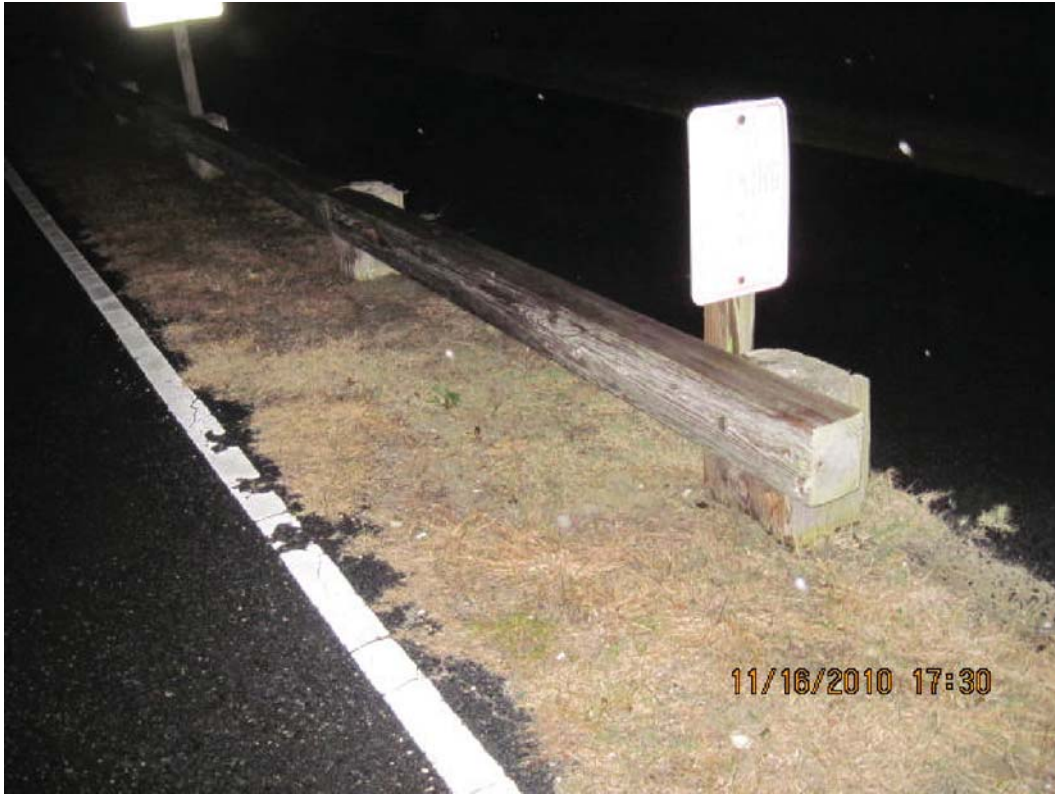
ASIS_0012_0.037_R_1.jpg

Barrier ID:	ASIS-0012-0.037-R				
Route Name:	MADDOX BOULEVARD				
Inspection Date:	11/16/2010	Barrier Rating:	25.20		
Barrier Description					
Type:	OTHER: TIMBER RAIL ON TIMBER POSTS	Barrier Function:	TRAFFIC		
Barrier Material:	LOG/TIMBER/WOOD	Post Material:	WOOD		
Blockout Type:	N/A	Length (ft.):	704		
Speed Limit (MPH):	25	Placement with Respect to Road:	TANGENT		
Hazard Behind Barrier:	MEDIUM				
Barrier Crashworthiness					
Appropriate Test Level:	TL-1	Barrier Test Level:	NCW	Is Barrier Crashworthy?:	NO
Beg. End Trtmt Type:	NONE	Is Beg. End Trtmt Crashworthy?:	N/A	Approach Transition Type:	NONE
Ending End Trtmt Type:	NONE	Ending End Trtmt Crashworthy?:	N/A		
Average Measurements					
Design Height (In.):	20	Width (In.):	0.0	Post Spacing (In.):	120.0
Height (In.):	19.0	Lateral Offset (In.):	44.2	Road Grade (%):	0.10
Physical Condition					
Barrier	Alignment and Height:	No deflections greater than 6 in were observed in the alignment. The height was within 1 in of the 20 in design height for 624 ft and between 1 and 3 in below the design height for 80 ft.

Breaking and Cracking:	No impact related breaking or cracking observed.			
	Missing Elements:	No elements were observed to be missing.			
	Corrosion and Weathering:	2 rails and 7 posts were damaged/rotted due to weathering. Erosion around the posts should be monitored.			
End Treatments	Alignment and Height:	NA			
	Breaking and Cracking:	NA			
	Missing Elements:	NA			
	Corrosion and Weathering:	NA

Repair Action:	REPAIR	FMSS Work Type:	DEFERRED MAINTENANCE	Repair Cost:	\$3823
Brief Workorder:	Raise 80 ft of guardrail up to the 20 inch design height and replace 20 feet of rail and 7 posts.				
Workorder:	Adjust Guardrail at \$10- per -Lin. Ft. for 80 LF = \$800. Raise 80 feet of guardrail to 20 inch design height. Replace Rail at \$25- per -Lin. Ft. for 20 LF = \$500. Replace 2 rotted rails. Replace Post at \$100- per -Each for 7 Post(s) = \$700. Replace 7 rotted posts. Low Speed Traffic Control at \$1475- per -Day for 1 Day(s) = \$1475.

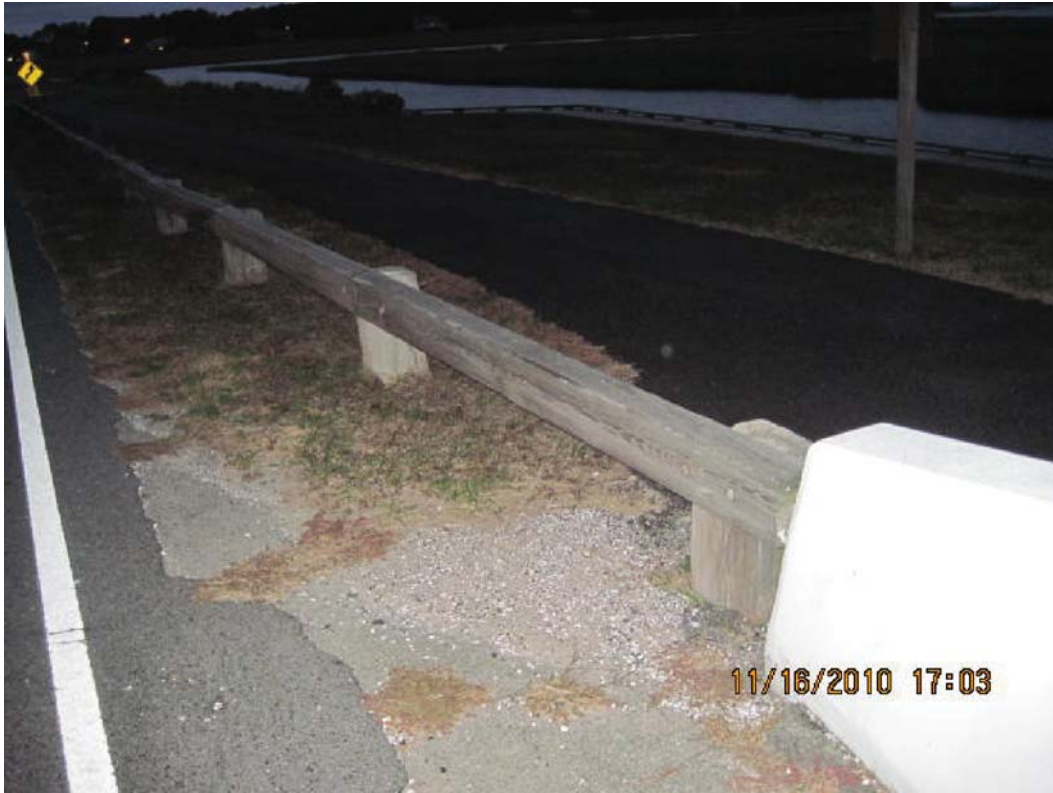
ASIS_0012_0.187_L_1.jpg

Barrier ID:	ASIS-0012-0.187-L				
Route Name:	MADDOX BOULEVARD				
Inspection Date:	11/16/2010	Barrier Rating:	32.70		
Barrier Description					
Type:	OTHER: TIMBER RAIL ON TIMBER POSTS	Barrier Function:	TRAFFIC		
Barrier Material:	LOG/TIMBER/WOOD	Post Material:	WOOD		
Blockout Type:	N/A	Length (ft.):	606		
Speed Limit (MPH):	25	Placement with Respect to Road:	OUTSIDE OF CURVE		
Hazard Behind Barrier:	HIGH				
Barrier Crashworthiness					
Appropriate Test Level:	TL-1	Barrier Test Level:	NCW	Is Barrier Crashworthy?:	NO
Beg. End Trtmt Type:	NONE	Is Beg. End Trtmt Crashworthy?:	N/A	Approach Transition Type:	NONE
Ending End Trtmt Type:	NONE	Ending End Trtmt Crashworthy?:	N/A		
Average Measurements					
Design Height (In.):	20	Width (In.):	0.0	Post Spacing (In.):	120.4
Height (In.):	20.6	Lateral Offset (In.):	59.2	Road Grade (%):	1.00
Physical Condition					
Barrier	Alignment and Height:	Alignment deflection was less than 6 in. 150 ft of the barrier was between 1 and 3 in below design height (20 in) while the remaining length ranged between 1in. below to 3in. above the design height.

Breaking and Cracking:	No impact related breaking or cracking observed.			
	Missing Elements:	10 bolts were loose or missing.			
	Corrosion and Weathering:	5 rails were observed to have rotting. 5% to 50% of cross section was lost. No erosion observed.			
End Treatments	Alignment and Height:				
	Breaking and Cracking:				
	Missing Elements:				
	Corrosion and Weathering:

Repair Action:	REPAIR	FMSS Work Type:	DEFERRED MAINTENANCE	Repair Cost:	\$4912
Brief Workorder:	Raise 150 ft of the barrier up to the 20 inch design height and replace 50 feet of rail and missing bolts.				
Workorder:	Adjust Guardrail at \$10- per -Lin. Ft. for 150 LF = \$1500. Raise 150 ft of barrier to 20 inch design height. Replace Rail at \$25- per -Lin. Ft. for 50 LF = \$1250. Replace 5 rails due to rotting Labor at \$60- per -Hour for 4 Hrs = \$240. Replace missing bolts Low Speed Traffic Control at \$1475- per -Day for 1 Day(s) = \$1475.

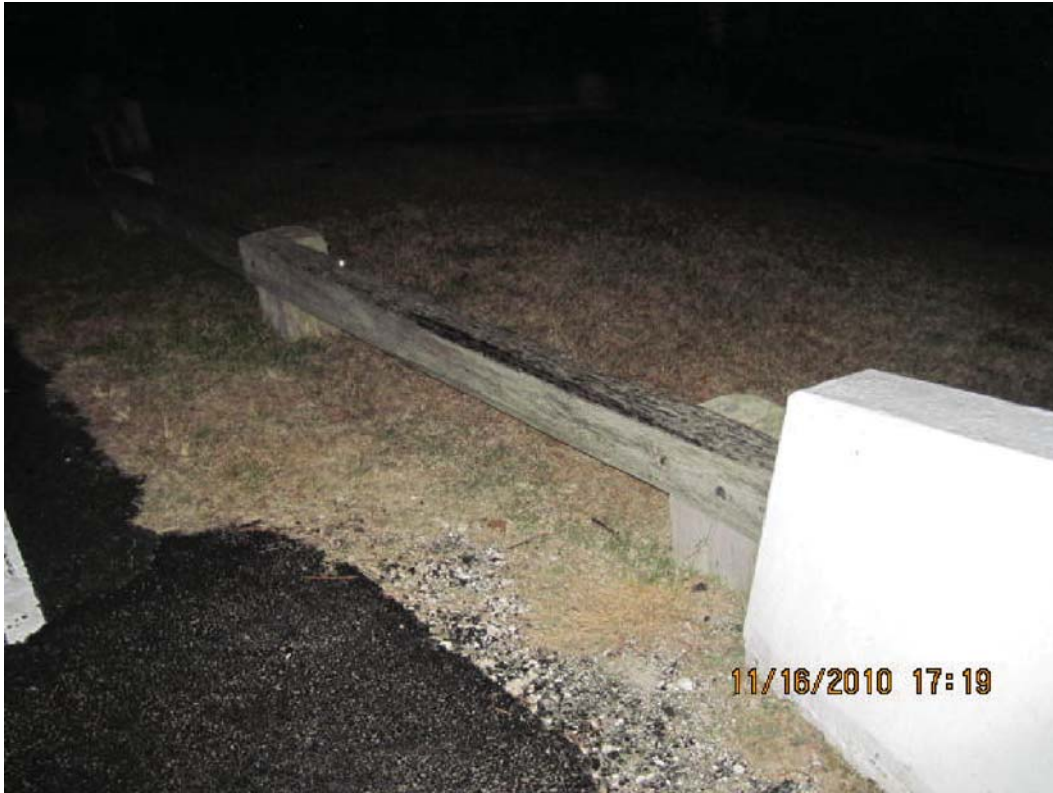
ASIS_0012_0.187_R_1.jpg

Barrier ID:	ASIS-0012-0.187-R				
Route Name:	MADDOX BOULEVARD				
Inspection Date:	11/16/2010	Barrier Rating:	24.10		
Barrier Description					
Type:	OTHER: TIMBER RAIL ON TIMBER POSTS	Barrier Function:	TRAFFIC		
Barrier Material:	LOG/TIMBER/WOOD	Post Material:	WOOD		
Blockout Type:	N/A	Length (ft.):	612		
Speed Limit (MPH):	25	Placement with Respect to Road:	TANGENT		
Hazard Behind Barrier:	HIGH				
Barrier Crashworthiness					
Appropriate Test Level:	TL-1	Barrier Test Level:	NCW	Is Barrier Crashworthy?:	NO
Beg. End Trtmt Type:	NONE	Is Beg. End Trtmt Crashworthy?:	N/A	Approach Transition Type:	NONE
Ending End Trtmt Type:	NONE	Ending End Trtmt Crashworthy?:	N/A		
Average Measurements					
Design Height (In.):	20	Width (In.):	0.0	Post Spacing (In.):	118.8
Height (In.):	20.2	Lateral Offset (In.):	52.9	Road Grade (%):	0.90
Physical Condition					
Barrier	Alignment and Height:	No deflections observed in alignment. 120 ft of barrier is 1 to 3 in below 20 in design height. 492 ft of barrier is 1 in or less below or exceeds 20 in design height up to 2 in.

Breaking and Cracking:	3 rails were cracked due to an impact loading.			
	Missing Elements:	There were 7 nut/bolt assemblies observed to have missing elements.			
	Corrosion and Weathering:	6 posts were observed to have rotting due to weathering causing a loss of 15% to 50% of cross section.			
End Treatments	Alignment and Height:				
	Breaking and Cracking:				
	Missing Elements:				
	Corrosion and Weathering:

Repair Action:	REPAIR	FMSS Work Type:	DEFERRED MAINTENANCE	Repair Cost:	\$4560
Brief Workorder:	Raise 120 feet of barrier up to the 20 inch design height and replace 30 feet of rail 6 posts and 7 nut/bolt assemblies.				
Workorder:	Adjust Guardrail at \$10- per -Lin. Ft. for 120 LF = \$1200. Raise 120 feet of rail to 20 inch design height. Replace Rail at \$25- per -Lin. Ft. for 30 LF = \$750. Replace 3 rails. Replace Post at \$100- per -Each for 6 Post(s) = \$600. Replace 6 posts. Labor at \$60- per -Hour for 2 Hrs = \$120. Labor to replace 7 nut/bolt assemblies. Low Speed Traffic Control at \$1475- per -Day for 1 Day(s) = \$1475.

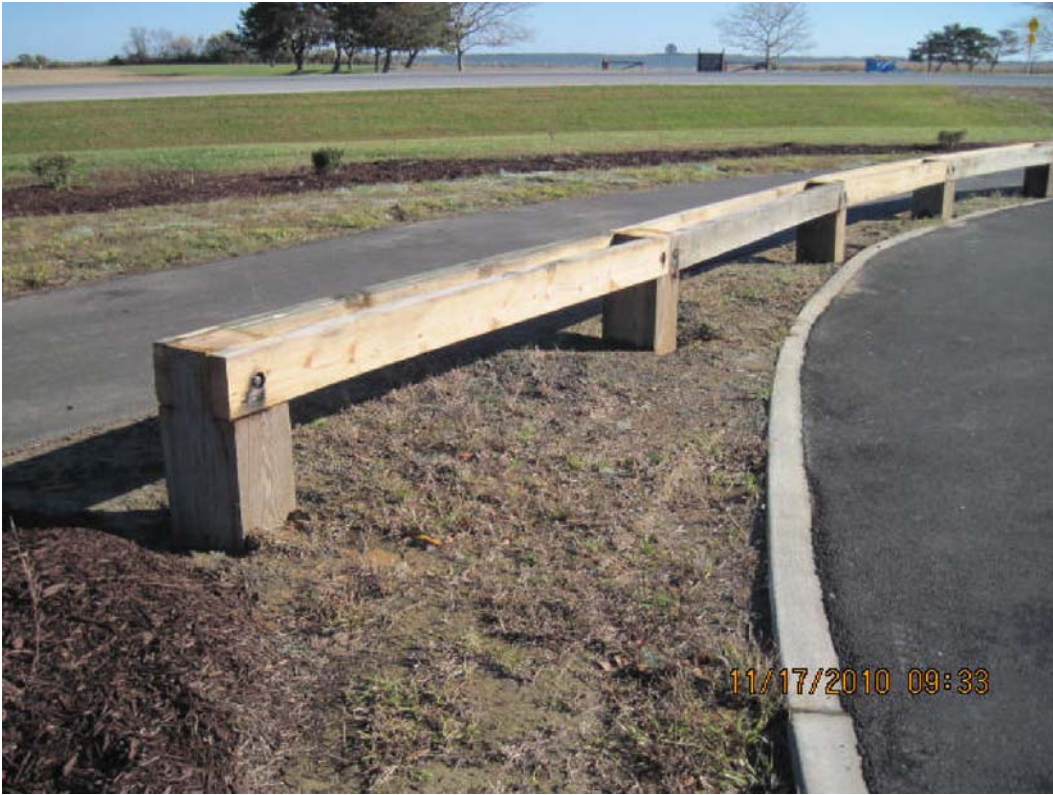
ASIS_0903_0.000_P1_1.jpg

Barrier ID:	ASIS-0903-0.000-P1				
Route Name:	VISITOR CENTER ACCESS PARKING				
Inspection Date:	11/16/2010	Barrier Rating:	5.50		
Barrier Description					
Type:	OTHER: TIMBER RAIL DOUBLE FACE ON TIMBER	Barrier Function:	NON-TRAFFIC		
Barrier Material:	LOG/TIMBER/WOOD	Post Material:	WOOD		
Blockout Type:	N/A	Length (ft.):	336		
Speed Limit (MPH):	15	Placement with Respect to Road:	NON-TRAFFIC BARRIER		
Hazard Behind Barrier:	LOW				
Barrier Crashworthiness					
Appropriate Test Level:	TL-1	Barrier Test Level:	N/A	Is Barrier Crashworthy?:	N/A
Beg. End Trtmt Type:	NONE	Is Beg. End Trtmt Crashworthy?:	N/A	Approach Transition Type:	NONE
Ending End Trtmt Type:	NONE	Ending End Trtmt Crashworthy?:	N/A		
Average Measurements					
Design Height (In.):	20	Width (In.):	0.0	Post Spacing (In.):	0.0
Height (In.):	23.2	Lateral Offset (In.):	0.0	Road Grade (%):	0.00
Physical Condition					
Barrier	Alignment and Height:	Alignment deflection was less than 6 in. The entire barrier exceeded design height (20 in) by 2 to 4 in.

Breaking and Cracking:	No impact related breaking or cracking observed.			
	Missing Elements:	No elements were observed to be missing.			
	Corrosion and Weathering:	No loss of cross section observed. Monitor erosion at base of posts.			
End Treatments	Alignment and Height:				
	Breaking and Cracking:				
	Missing Elements:				
	Corrosion and Weathering:

Repair Action:	MONITOR	FMSS Work Type:	DEFERRED MAINTENANCE	Repair Cost:	\$0
Brief Workorder:	Monitor erosion at the base of posts.				
Workorder:
