**NPS Guardwall/Rail Inventory Program
Bighorn Canyon National Recreation Area**

**Federal Lands Highway
Road Inventory Program**

**Federal Highway Administration
Eastern Federal Lands Highway Division
Road Inventory Program (RIP)**

**Data Collection Date: August 2010
Report Date: December 2015**

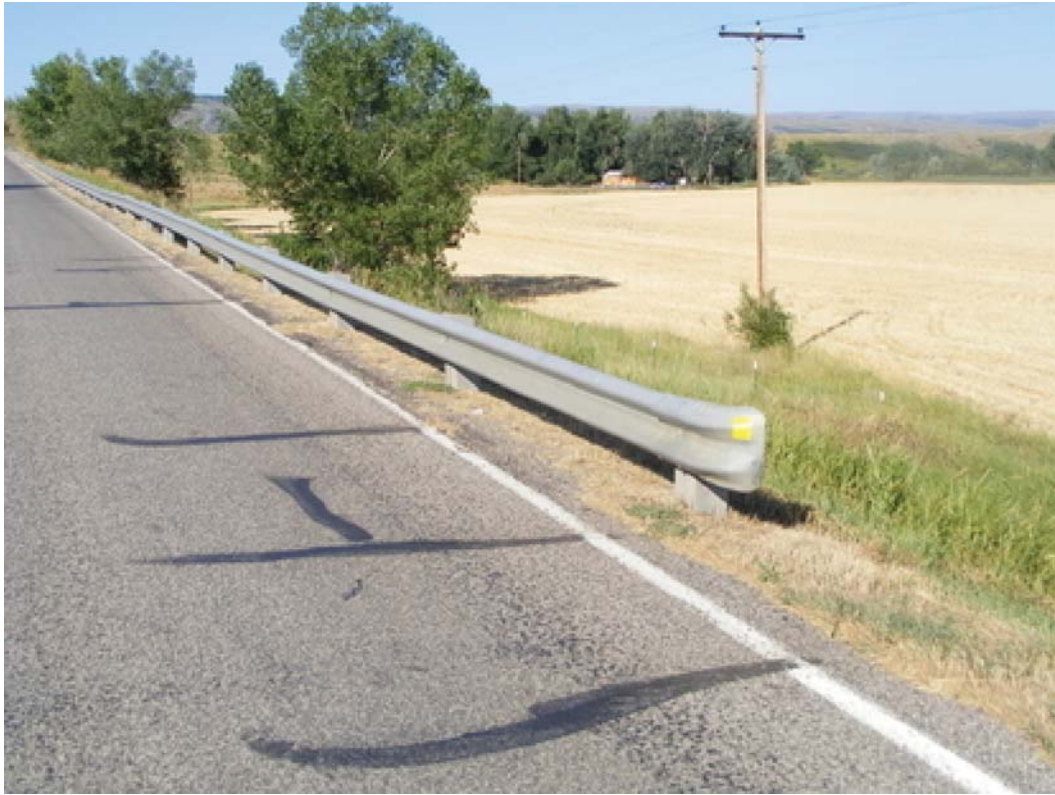
BICA_0010_0.266_R_1.JPG

Barrier ID:	BICA-0010-0.266-R				
Route Name:	FORT SMITH ACCESS ROAD				
Inspection Date:	02/08/2010	Barrier Rating:	71.10		
Barrier Description					
Type:	W-BEAM WEAK POST	Barrier Function:	TRAFFIC		
Barrier Material:	GALVANIZED STEEL	Post Material:	OTHER: CONCRETE		
Blockout Type:	N/A	Length (ft.):	830		
Speed Limit (MPH):	55	Placement with Respect to Road:	TANGENT		
Hazard Behind Barrier:	HIGH				
Barrier Crashworthiness					
Appropriate Test Level:	TL-3	Barrier Test Level:	TL-2	Is Barrier Crashworthy?:	NO
Beg. End Trtmt Type:	NONE	Is Beg. End Trtmt Crashworthy?:	N/A	Approach Transition Type:	NONE
Ending End Trtmt Type:	NONE	Ending End Trtmt Crashworthy?:	N/A		
Average Measurements					
Design Height (In.):	27	Width (In.):	0.0	Post Spacing (In.):	150.0
Height (In.):	21.2	Lateral Offset (In.):	22.2	Road Grade (%):	2.30
Physical Condition					
Barrier	Alignment and Height:	The barrier alignment is off by more than 6 in for 48 ft. Entire barrier is between 4-8in. below the 27-in design height.

Breaking and Cracking:	No breaking or cracking of barrier.			
	Missing Elements:	No missing barrier items.			
	Corrosion and Weathering:	No major weathering of barrier.			
End Treatments	Alignment and Height:				
	Breaking and Cracking:				
	Missing Elements:				
	Corrosion and Weathering:

Repair Action:	REPLACE	FMSS Work Type:	CAPITAL IMPROVEMENT	Repair Cost:	\$67155
Brief Workorder:	Replace barrier with W-beam strong post guardrail and two W-beam tangent end treatments.				
Workorder:	Remove Guardrail at \$10- per -Lin. Ft. for 830-ft = \$8300. Remove 830-ft guardrail. W-Beam Strong Post at \$35- per -Lin. Ft. for 770-ft = \$26950. Install 770-ft of W-beam strong post. W-beam tangent 350 compliant at \$3500- per -Each for 2 Unit(s) = \$7000. Install 2 W-beam tangent end treatments. High Speed Traffic Control at \$2350- per -Day for 8 Day(s) = \$18800. 4 days removal 4 days installation.

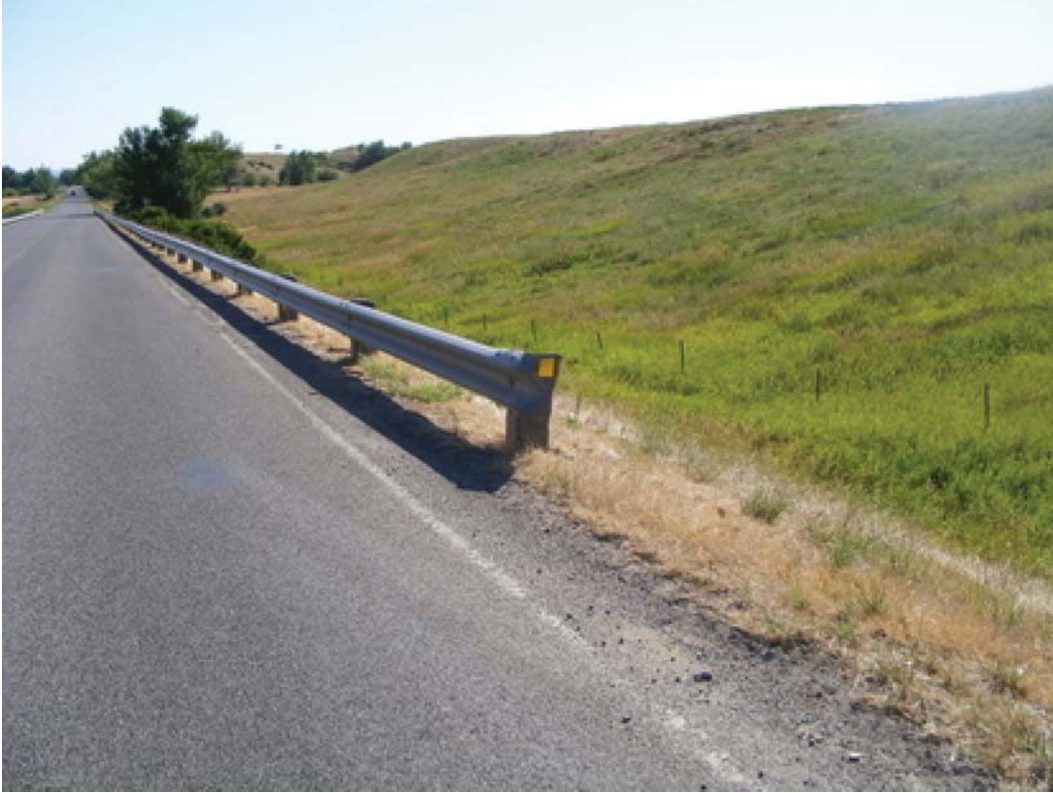
BICA_0010_0.267_L_1.JPG

Barrier ID:	BICA-0010-0.267-L				
Route Name:	FORT SMITH ACCESS ROAD				
Inspection Date:	02/08/2010	Barrier Rating:	59.40		
Barrier Description					
Type:	W-BEAM WEAK POST	Barrier Function:	TRAFFIC		
Barrier Material:	GALVANIZED STEEL	Post Material:	OTHER: CONCRETE		
Blockout Type:	N/A	Length (ft.):	617		
Speed Limit (MPH):	55	Placement with Respect to Road:	TANGENT		
Hazard Behind Barrier:	MEDIUM				
Barrier Crashworthiness					
Appropriate Test Level:	TL-3	Barrier Test Level:	TL-2	Is Barrier Crashworthy?:	NO
Beg. End Trtmt Type:	NONE	Is Beg. End Trtmt Crashworthy?:	N/A	Approach Transition Type:	NONE
Ending End Trtmt Type:	NONE	Ending End Trtmt Crashworthy?:	N/A		
Average Measurements					
Design Height (In.):	27	Width (In.):	0.0	Post Spacing (In.):	150.0
Height (In.):	20.0	Lateral Offset (In.):	28.7	Road Grade (%):	2.60
Physical Condition					
Barrier	Alignment and Height:	Alignment of barrier is acceptable except for one 13 ft segment of impacted rail. Entire barrier is between 6-9in. below the 27-in design height.

Breaking and Cracking:	Bent spoon on approach end and trailing end of barrier. 3 broken posts. 41 ft of bent rail. One loose bolt.			
	Missing Elements:	5 missing bolts on trailing end of barrier.			
	Corrosion and Weathering:	Concrete posts are spalling on top ends. No corrosion of galvanized rails on barrier. Moderate erosion of soil around posts at 100 ft from approach end due to roadway runoff.			
End Treatments	Alignment and Height:				
	Breaking and Cracking:				
	Missing Elements:				
	Corrosion and Weathering:

Repair Action:	REPLACE	FMSS Work Type:	CAPITAL IMPROVEMENT	Repair Cost:	\$45667
Brief Workorder:	Replace barrier with W-beam Strong Post guardrail and 2 W-beam Tangent/non-flared end treatments.				
Workorder:	Remove Guardrail at \$10- per -Lin. Ft. for 617 LF = \$6170. Remove 617 feet of W-beam guardrail. W-Beam Strong Post at \$35- per -Lin. Ft. for 557 LF = \$19495. Install 557 feet of W-beam strong post guardrail. W-beam tangent 350 compliant at \$3500- per -Each for 2 Unit(s) = \$7000. Install 2 W-beam tangent 350 compliant end treatments. Low Speed Traffic Control at \$1475- per -Day for 6 Day(s) = \$8850. 3 days removal 3 days installation.
