**GIP Report**

**NPS Guardwall/Rail Inventory Program  
Big South Fork National River and Recreation Area**

**Federal Highway Administration  
Eastern Federal Lands Highway Division  
Road Inventory Program (RIP)**

**Data Collection Date: October 2010  
Report Date: November 2015**

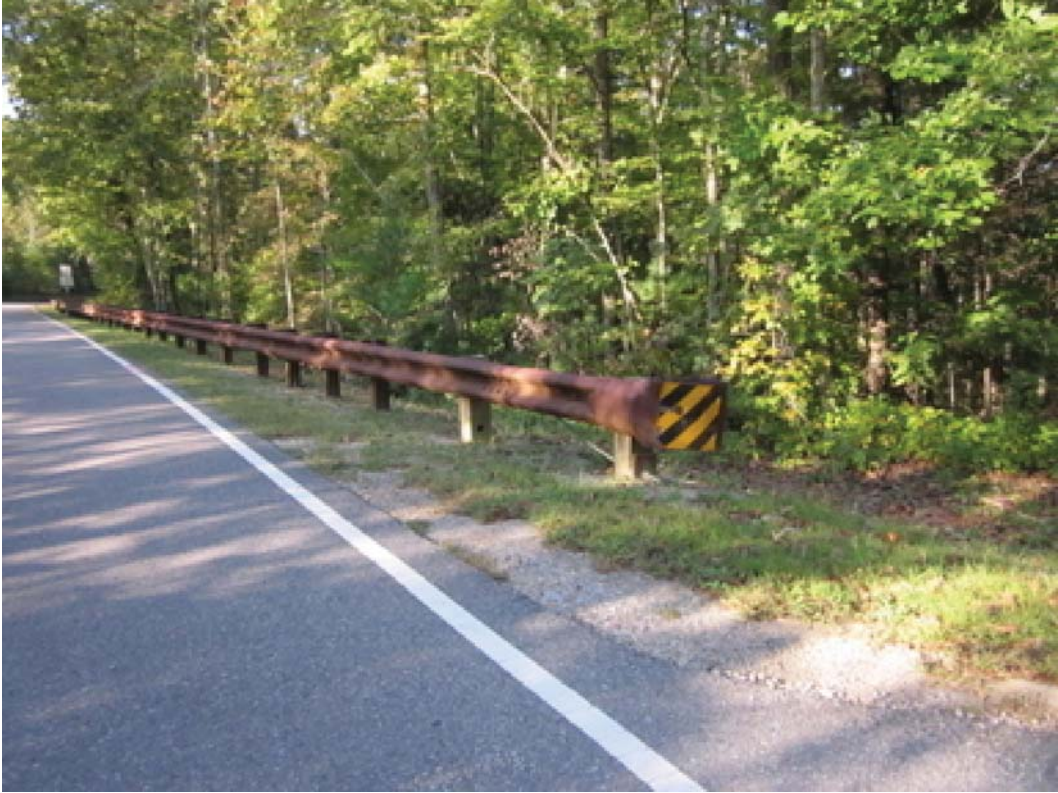
BISO\_0010\_0.040\_R\_1.JPG

| <b>Hazard Behind Barrier:</b> | MEDIUM | | | | |
| | <b>Breaking and Cracking:</b> | No breaking or cracking observed. | | | |
| | <b>Missing Elements:</b> | No missing elements observed. | | | |
| | <b>Corrosion and Weathering:</b> | No corrosion or weathering observed. | | | |

| <b>Repair Action:</b> | REPAIR | <b>FMSS Work Type:</b> | DEFERRED MAINTENANCE | <b>Repair Cost:</b> | \$10731 |

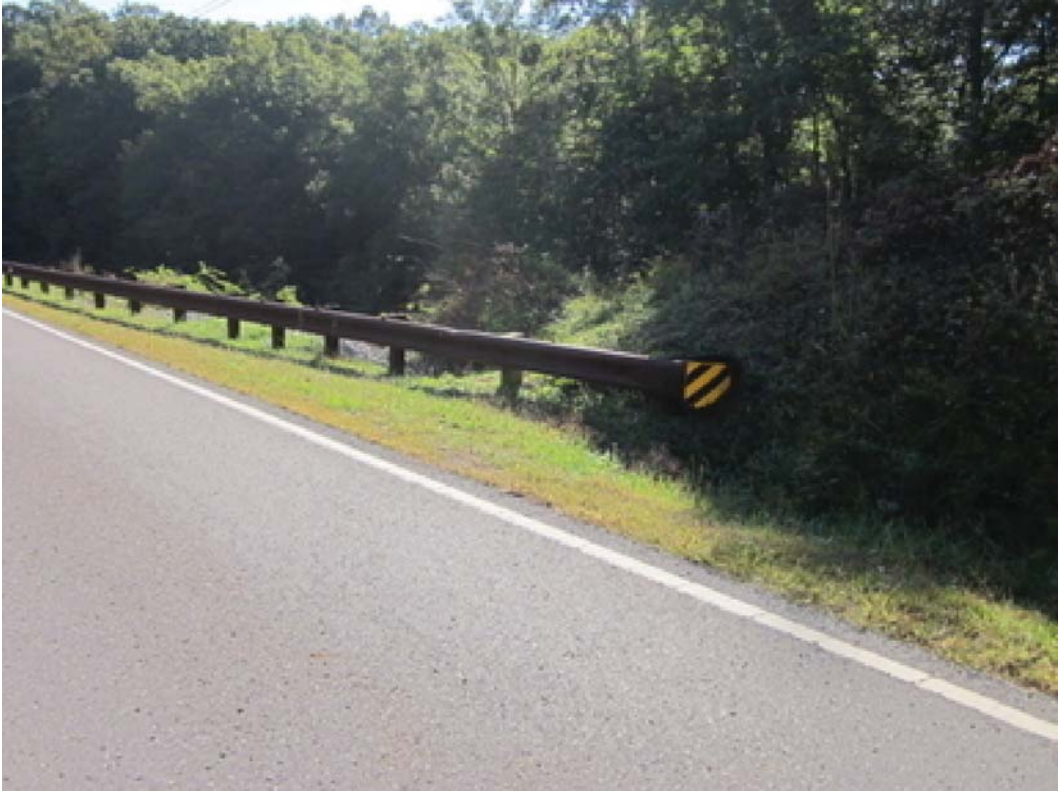
BISO\_0010\_0.202\_L\_1.JPG

| <b>Hazard Behind Barrier:</b> | HIGH | | | | |
| | <b>Breaking and Cracking:</b> | No breaking or cracking observed. | | | |
| | <b>Missing Elements:</b> | No missing elements observed. | | | |
| | <b>Corrosion and Weathering:</b> | No corrosion or weathering observed. | | | |

| <b>Repair Action:</b> | NO ACTION | <b>FMSS Work Type:</b> | N/A | <b>Repair Cost:</b> | \$0 |

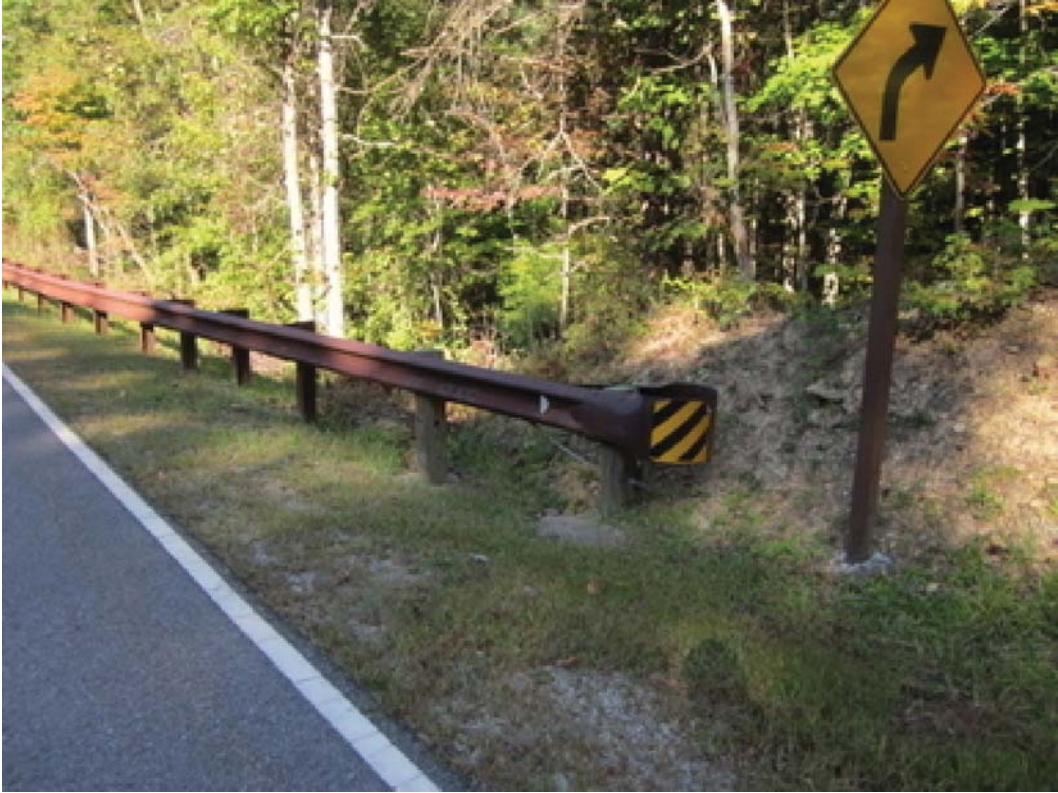
BISO\_0010\_0.204\_R\_1.JPG

| <b>Hazard Behind Barrier:</b> | HIGH | | | | |
| | <b>Breaking and Cracking:</b> | No breaking or cracking observed. | | | |
| | <b>Missing Elements:</b> | No missing elements observed. | | | |
| | <b>Corrosion and Weathering:</b> | No corrosion or weathering observed. | | | |

| <b>Repair Action:</b> | NO ACTION | <b>FMSS Work Type:</b> | N/A | <b>Repair Cost:</b> | \$0 |

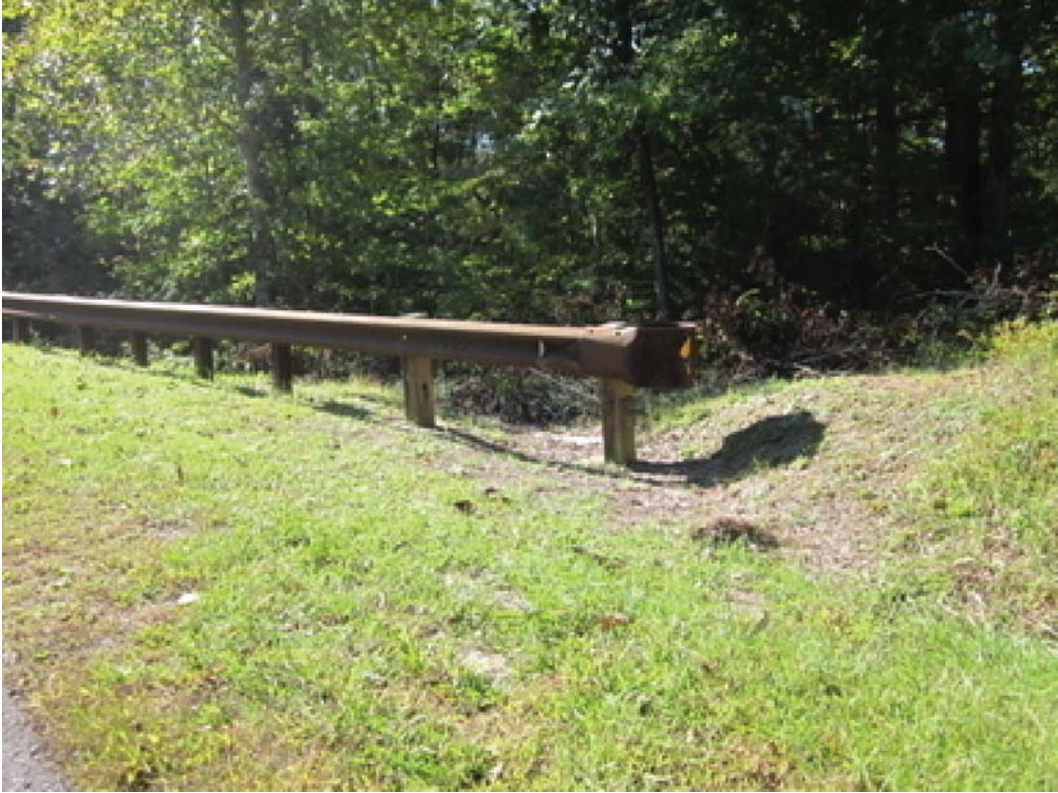
BISO\_0010\_0.353\_L\_1.JPG

| <b>Hazard Behind Barrier:</b> | MEDIUM | | | | |
| | <b>Breaking and Cracking:</b> | No breaking or cracking observed. | | | |
| | <b>Missing Elements:</b> | No missing elements observed. | | | |
| | <b>Corrosion and Weathering:</b> | No corrosion or weathering observed. | | | |

| <b>Repair Action:</b> | NO ACTION | <b>FMSS Work Type:</b> | N/A | <b>Repair Cost:</b> | \$0 |

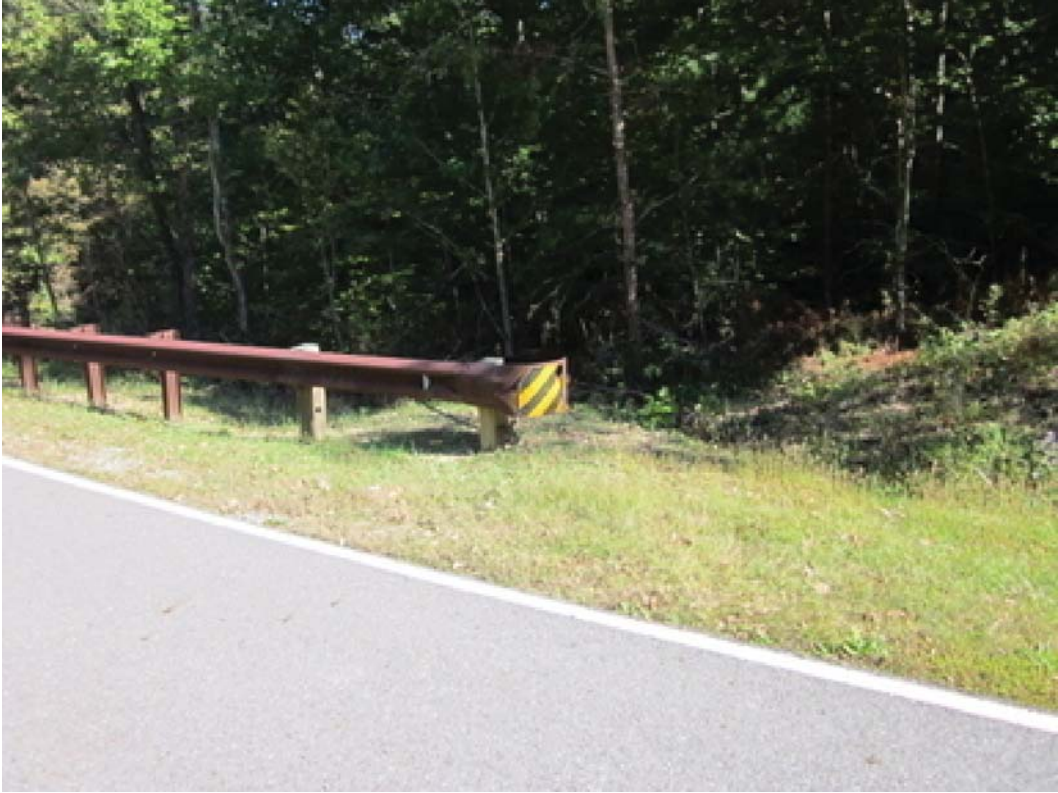
BISO\_0010\_0.395\_R\_1.JPG

| <b>Hazard Behind Barrier:</b> | HIGH | | | | |
| | <b>Breaking and Cracking:</b> | No breaking or cracking observed. | | | |
| | <b>Missing Elements:</b> | No missing elements observed. | | | |
| | <b>Corrosion and Weathering:</b> | No corrosion or weathering observed. | | | |

| <b>Repair Action:</b> | REPAIR | <b>FMSS Work Type:</b> | DEFERRED MAINTENANCE | <b>Repair Cost:</b> | \$2690 |

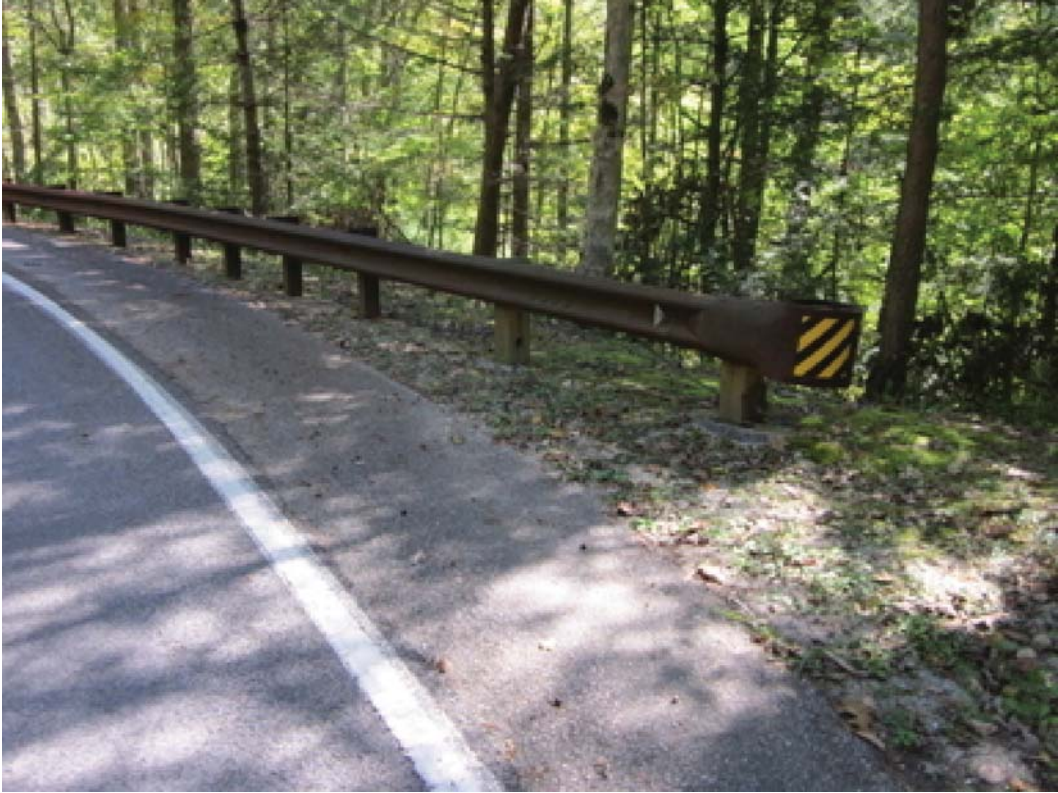
BISO\_0010\_1.144\_L\_1.JPG

| <b>Hazard Behind Barrier:</b> | HIGH | | | | |
| | <b>Breaking and Cracking:</b> | No breaking or cracking observed. | | | |
| | <b>Missing Elements:</b> | No missing elements observed. | | | |
| | <b>Corrosion and Weathering:</b> | No corrosion or weathering observed. | | | |

| <b>Repair Action:</b> | REPAIR | <b>FMSS Work Type:</b> | DEFERRED MAINTENANCE | <b>Repair Cost:</b> | \$7667 |

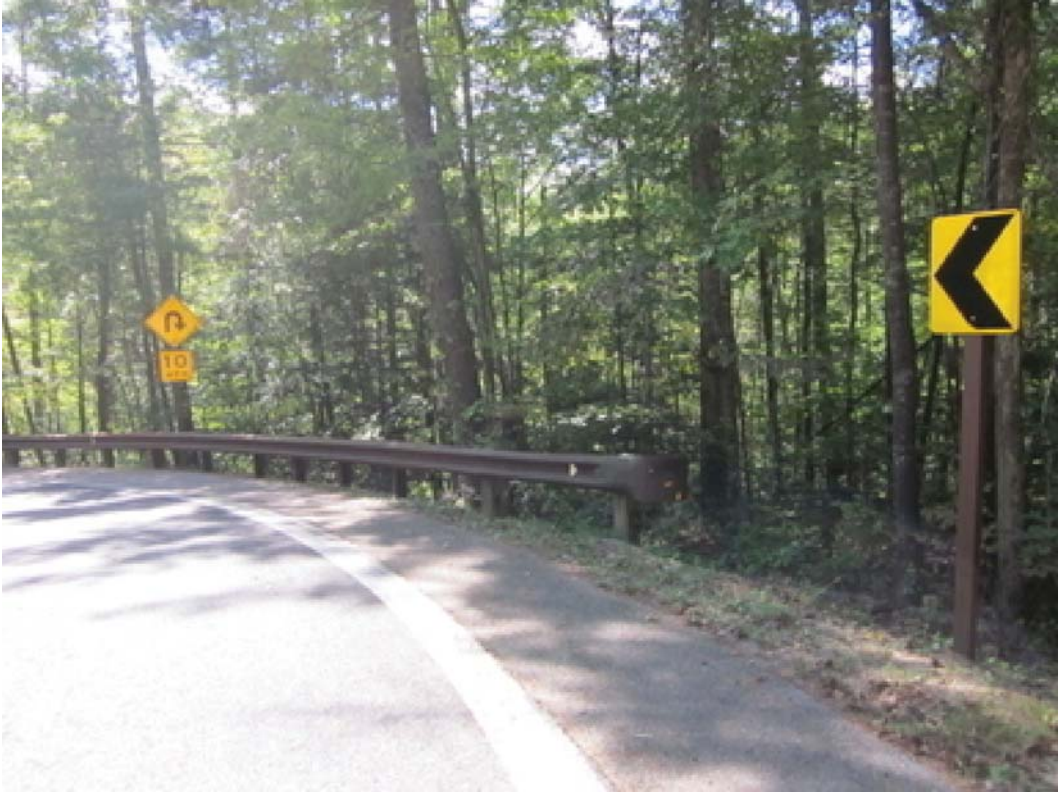
BISO\_0010\_1.345\_R\_1.JPG

| <b>Hazard Behind Barrier:</b> | MEDIUM | | | | |
| | <b>Breaking and Cracking:</b> | No breaking or cracking observed. | | | |
| | <b>Missing Elements:</b> | No missing elements observed. | | | |
| | <b>Corrosion and Weathering:</b> | No corrosion or weathering observed. | | | |
