BRCA GIP Report

NPS Guardwall/Rail Inventory Program Bryce Canyon National Park

**Federal Lands Highway
Road Inventory Program**

Data Collection Date: April 2010
Report Date: November 2015

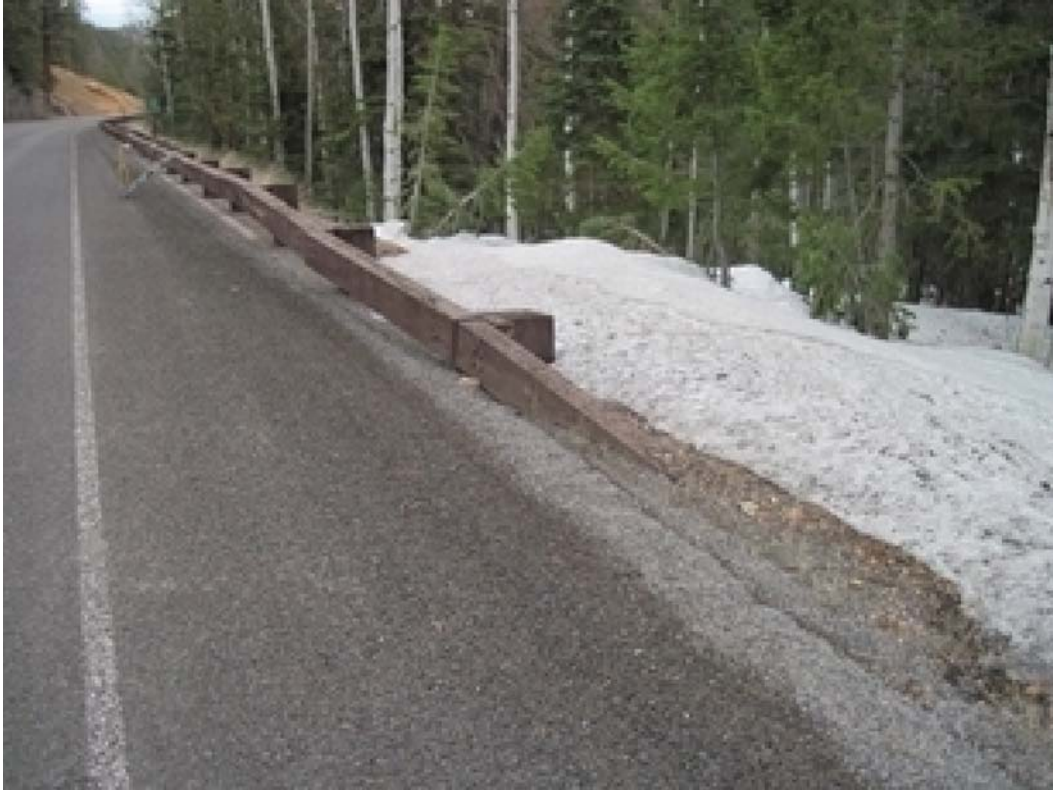
BRCA_0010_6.875_L_1.jpg

Barrier ID:	BRCA-0010-6.875-L				
Route Name:	MAIN PARK ROAD				
Inspection Date:	04/20/2010	Barrier Rating:	45.50		
Barrier Description					
Type:	STEEL-BACKED TIMBER WITH BLOCKOUT	Barrier Function:	TRAFFIC		
Barrier Material:	STEEL-BACKED TIMBER/LOG	Post Material:	WOOD		
Blockout Type:	WOOD	Length (ft.):	1185		
Speed Limit (MPH):	45	Placement with Respect to Road:	BOTH INSIDE AND OUTSIDE		
Hazard Behind Barrier:	HIGH				
Barrier Crashworthiness					
Appropriate Test Level:	TL-2	Barrier Test Level:	TL-3	Is Barrier Crashworthy?:	YES
Beg. End Trtmt Type:	SBT/LOG FLARED	Is Beg. End Trtmt Crashworthy?:	NO	Approach Transition Type:	NONE
Ending End Trtmt Type:	SBT/LOG FLARED	Ending End Trtmt Crashworthy?:	NO		
Average Measurements					
Design Height (In.):	27	Width (In.):	0.0	Post Spacing (In.):	118.0
Height (In.):	26.2	Lateral Offset (In.):	64.5	Road Grade (%):	5.90
Physical Condition					
Barrier	Alignment and Height:	Alignment is acceptable. Height is 1.5in to 2.5" below the 27" design height for 200 LF.

Breaking and Cracking:	Approximately 60 LF of barrier has been badly scraped by snow removal equipment.			
	Missing Elements:	No missing elements observed.			
	Corrosion and Weathering:	20 LF of rail is badly cracked and warped from weathering. A significant amount of gravel build-up is at the base of the barrier.			
End Treatments	Alignment and Height:	Alignment is acceptable. Height is within 1in of the 27" design height.			
	Breaking and Cracking:	No breaking or cracking observed.			
	Missing Elements:	No missing elements observed.			
	Corrosion and Weathering:	There is a significant amount of gravel build-up at the base of the barrier.

Repair Action:	REPAIR	FMSS Work Type:	DEFERRED MAINTENANCE	Repair Cost:	\$8195
Brief Workorder:	Raise 200 L.F. of barrier to 27 inch design height and replace 80-ft. of rail sections and remove the gravel buildup.				
Workorder:	Adjust Guardrail at \$10- per -Lin. Ft. for 200 LF = \$2000. Raise 200 ft. of barrier up to 27-in. design height. Replace Rail at \$25- per -Lin. Ft. for 80 LF = \$2000. Replace the damaged rail sections. Loader at \$125- per -Hour for 4 Hrs = \$500. Remove gravel build-up. Low Speed Traffic Control at \$1475- per -Day for 2 Day(s) = \$2950. 1 day to raise rail; 1 day remove gravel and repair hardware.

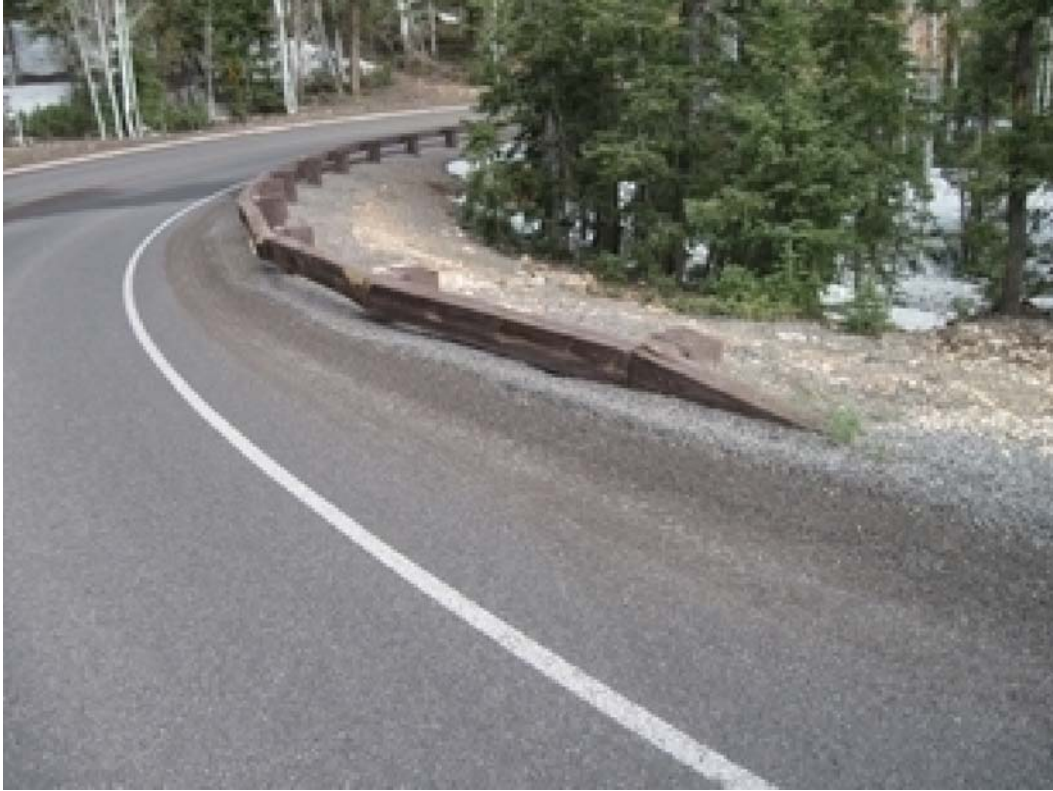
BRCA_0010_7.178_L_1.jpg

Barrier ID:	BRCA-0010-7.178-L				
Route Name:	MAIN PARK ROAD				
Inspection Date:	04/20/2010	Barrier Rating:	34.20		
Barrier Description					
Type:	STEEL-BACKED TIMBER WITH BLOCKOUT	Barrier Function:	TRAFFIC		
Barrier Material:	STEEL-BACKED TIMBER/LOG	Post Material:	WOOD		
Blockout Type:	WOOD	Length (ft.):	174		
Speed Limit (MPH):	45	Placement with Respect to Road:	INSIDE OF CURVE		
Hazard Behind Barrier:	LOW				
Barrier Crashworthiness					
Appropriate Test Level:	TL-2	Barrier Test Level:	TL-3	Is Barrier Crashworthy?:	YES
Beg. End Trtmt Type:	SBT/LOG FLARED	Is Beg. End Trtmt Crashworthy?:	NO	Approach Transition Type:	NONE
Ending End Trtmt Type:	SBT/LOG FLARED	Ending End Trtmt Crashworthy?:	NO		
Average Measurements					
Design Height (In.):	27	Width (In.):	0.0	Post Spacing (In.):	117.0
Height (In.):	25.2	Lateral Offset (In.):	67.6	Road Grade (%):	6.30
Physical Condition					
Barrier	Alignment and Height:	Alignment is acceptable. 100 ft. of barrier is 1in - 2" below the 27" design height.

Breaking and Cracking:	There is breaking and cracking of 6 wood rails (60 ft) from snow removal operations.			
	Missing Elements:	No missing elements observed.			
	Corrosion and Weathering:	There is gravel build-up in the curb flow line over entire length of barrier (174 ft).			
End Treatments	Alignment and Height:	Alignment is acceptable. Height is 1.5in to 2.5" below the 27" design height.			
	Breaking and Cracking:	One wood rail on the approach end treatment shows serious breaking/cracking.			
	Missing Elements:	No missing elements observed.			
	Corrosion and Weathering:	There is gravel build-up in the curb flow line.

Repair Action:	REPAIR	FMSS Work Type:	DEFERRED MAINTENANCE	Repair Cost:	\$6298
Brief Workorder:	Raise 100 L.F. of barrier to 27" design height replace the damaged barrier components and remove gravel build-up				
Workorder:	Adjust Guardrail at \$10- per -Lin. Ft. for 100 LF = \$1000. Raise 100 ft. of barrier up to 27-in. design height. Steel-Backed Timber w/ Blockout at \$50- per -Lin. Ft. for 60 LF = \$3000. Replace damaged sections. Loader at \$125- per -Hour for 2 Hrs = \$250. Remove gravel build-up. Low Speed Traffic Control at \$1475- per -Day for 1 Day(s) = \$1475.

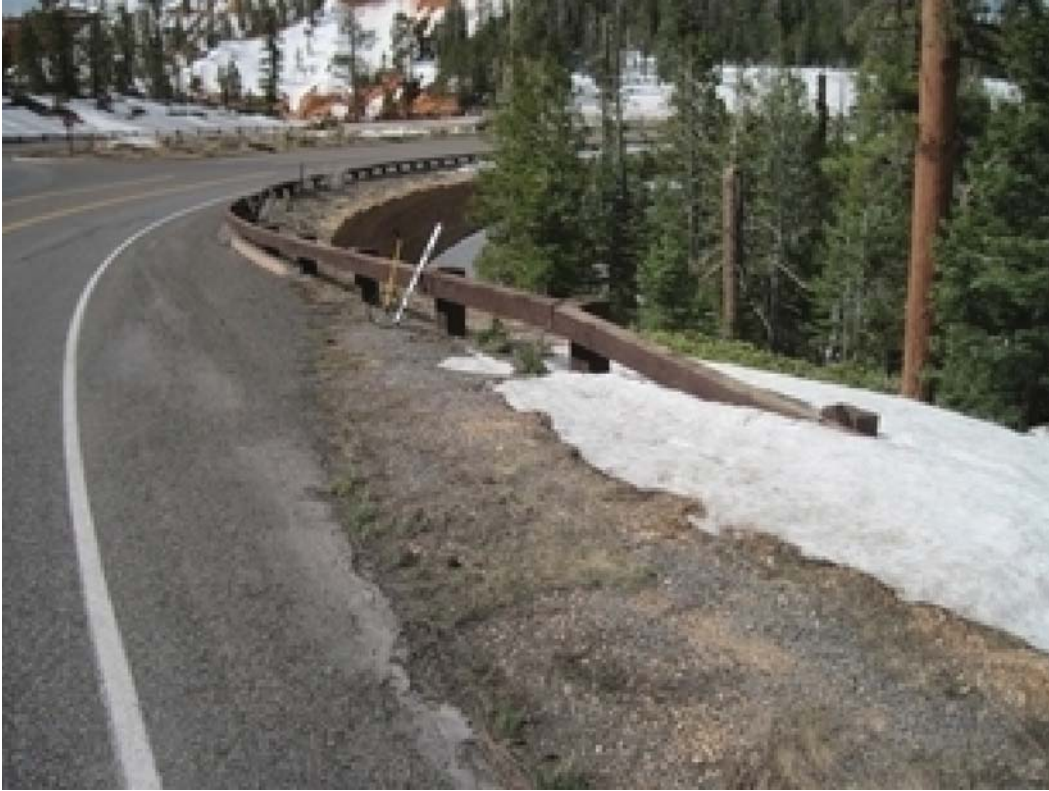
BRCA_0010_12.410_R_1.jpg

Barrier ID:	BRCA-0010-12.410-R				
Route Name:	MAIN PARK ROAD				
Inspection Date:	04/20/2010	Barrier Rating:	34.20		
Barrier Description					
Type:	STEEL-BACKED TIMBER WITH BLOCKOUT	Barrier Function:	TRAFFIC		
Barrier Material:	STEEL-BACKED TIMBER/LOG	Post Material:	WOOD		
Blockout Type:	WOOD	Length (ft.):	570		
Speed Limit (MPH):	35	Placement with Respect to Road:	INSIDE OF CURVE		
Hazard Behind Barrier:	HIGH				
Barrier Crashworthiness					
Appropriate Test Level:	TL-2	Barrier Test Level:	TL-3	Is Barrier Crashworthy?:	YES
Beg. End Trtmt Type:	SBT/LOG FLARED	Is Beg. End Trtmt Crashworthy?:	NO	Approach Transition Type:	NONE
Ending End Trtmt Type:	SBT/LOG FLARED	Ending End Trtmt Crashworthy?:	NO		
Average Measurements					
Design Height (In.):	27	Width (In.):	0.0	Post Spacing (In.):	119.6
Height (In.):	25.2	Lateral Offset (In.):	88.3	Road Grade (%):	3.10
Physical Condition					
Barrier	Alignment and Height:	The alignment had less than 6in of deflection. Height is 1" to 2.5" below the 27" design height for 400 ft and is less than 1" below the design height for 170 ft.

Breaking and Cracking:	There are 3 rail segments (10-ft each) that are badly scraped by snow removal equipment. There is 1 broken block and 2 broken bolts. One 30 ft. section of rail is badly broken.			
	Missing Elements:	No missing elements observed.			
	Corrosion and Weathering:	There is gravel build-up next to the guardrail.			
End Treatments	Alignment and Height:	Alignment is acceptable. Height is within 1in of the 27" design height.			
	Breaking and Cracking:	No breaking or cracking observed.			
	Missing Elements:	No missing elements observed.			
	Corrosion and Weathering:	There is a significant amount of gravel build-up at the base of the barrier.

Repair Action:	REPAIR	FMSS Work Type:	DEFERRED MAINTENANCE	Repair Cost:	\$11099
Brief Workorder:	Raise 400 L.F. of barrier to 27" design height replace 30' of damaged rail replace 30' of badly scraped rail pieces replace 1 block and 2 bolts remove gravel with loader.				
Workorder:	<p>Adjust Guardrail at \$10- per -Lin. Ft. for 400 LF = \$4000. Raise 400 ft. of barrier up to 27-in. design height.</p> <p>Remove Guardrail at \$10- per -Lin. Ft. for 30 LF = \$300. Remove 30 ft badly damaged section.</p> <p>Steel-Backed Timber w/ Blockout at \$50- per -Lin. Ft. for 30 LF = \$1500. Replace 30 ft badly damaged section.</p> <p>Replace Block at \$30- per -Each for 1 Block(s) = \$30. Replace 1 broken block.</p> <p>Replace Rail at \$25- per -Lin. Ft. for 30 LF = \$750. Replace 30 ft of badly scraped rail.</p> <p>Labor at \$60- per -Hour for 1 Hrs = \$60. Replace 2 broken bolts.</p> <p>Loader at \$125- per -Hour for 4 Hrs = \$500. Remove gravel build-up next to rail.</p> <p>Low Speed Traffic Control at \$1475- per -Day for 2 Day(s) = \$2950.</p>

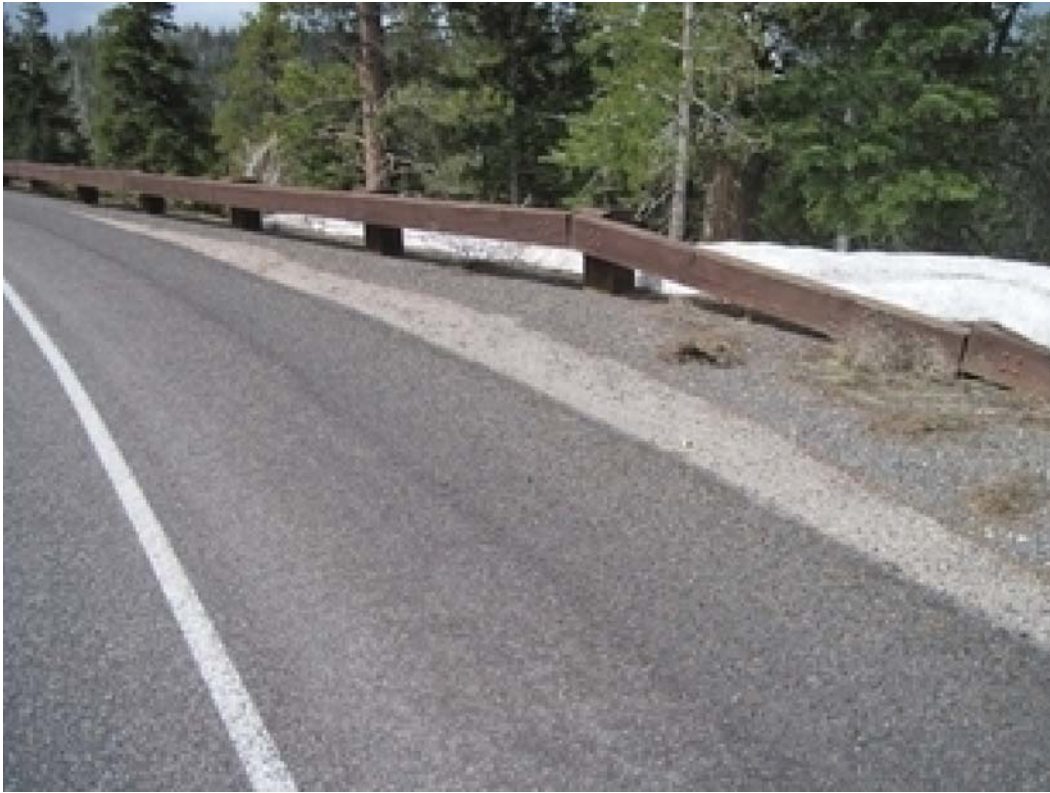
BRCA_0010_12.769_R_1.jpg

Barrier ID:	BRCA-0010-12.769-R				
Route Name:	MAIN PARK ROAD				
Inspection Date:	04/20/2010	Barrier Rating:	35.70		
Barrier Description					
Type:	STEEL-BACKED TIMBER WITH BLOCKOUT	Barrier Function:	TRAFFIC		
Barrier Material:	STEEL-BACKED TIMBER/LOG	Post Material:	WOOD		
Blockout Type:	WOOD	Length (ft.):	452		
Speed Limit (MPH):	35	Placement with Respect to Road:	OUTSIDE OF CURVE		
Hazard Behind Barrier:	HIGH				
Barrier Crashworthiness					
Appropriate Test Level:	TL-2	Barrier Test Level:	TL-3	Is Barrier Crashworthy?:	YES
Beg. End Trtmt Type:	SBT/LOG FLARED	Is Beg. End Trtmt Crashworthy?:	NO	Approach Transition Type:	NONE
Ending End Trtmt Type:	SBT/LOG FLARED	Ending End Trtmt Crashworthy?:	NO		
Average Measurements					
Design Height (In.):	27	Width (In.):	0.0	Post Spacing (In.):	119.8
Height (In.):	25.7	Lateral Offset (In.):	83.6	Road Grade (%):	1.60
Physical Condition					
Barrier	Alignment and Height:	Alignment is acceptable. Height is 1.5in to 2" below the 27" design height for 350 ft.

Breaking and Cracking:	10 LF of barrier is damaged due to scraping. 10 LF of damaged barrier has created a snag point. One block is cracked in half.			
	Missing Elements:	No missing elements observed.			
	Corrosion and Weathering:	There is significant build-up of gravel along the barrier.			
End Treatments	Alignment and Height:	Alignment is acceptable. Height is between 1.5in to 2" below the 27" design height.			
	Breaking and Cracking:	There are 2 broken blocks.			
	Missing Elements:	No missing elements observed.			
	Corrosion and Weathering:	There is a significant amount of gravel build-up at the base of the barrier.

Repair Action:	REPAIR	FMSS Work Type:	DEFERRED MAINTENANCE	Repair Cost:	\$8019
Brief Workorder:	Raise 350 L.F. of barrier to 27" design height replace damaged barrier items and remove gravel build-up.				
Workorder:	Adjust Guardrail at \$10- per -Lin. Ft. for 350 LF = \$3500. Raise 350 ft. of barrier up to 27-in. design height. Replace Block at \$30- per -Each for 3 Block(s) = \$90. Replace the damaged blocks. Replace Rail at \$25- per -Lin. Ft. for 20 LF = \$500. Replace the scraped rail and fix the snag point. Loader at \$125- per -Hour for 2 Hrs = \$250. Remove the gravel build-up. Low Speed Traffic Control at \$1475- per -Day for 2 Day(s) = \$2950.

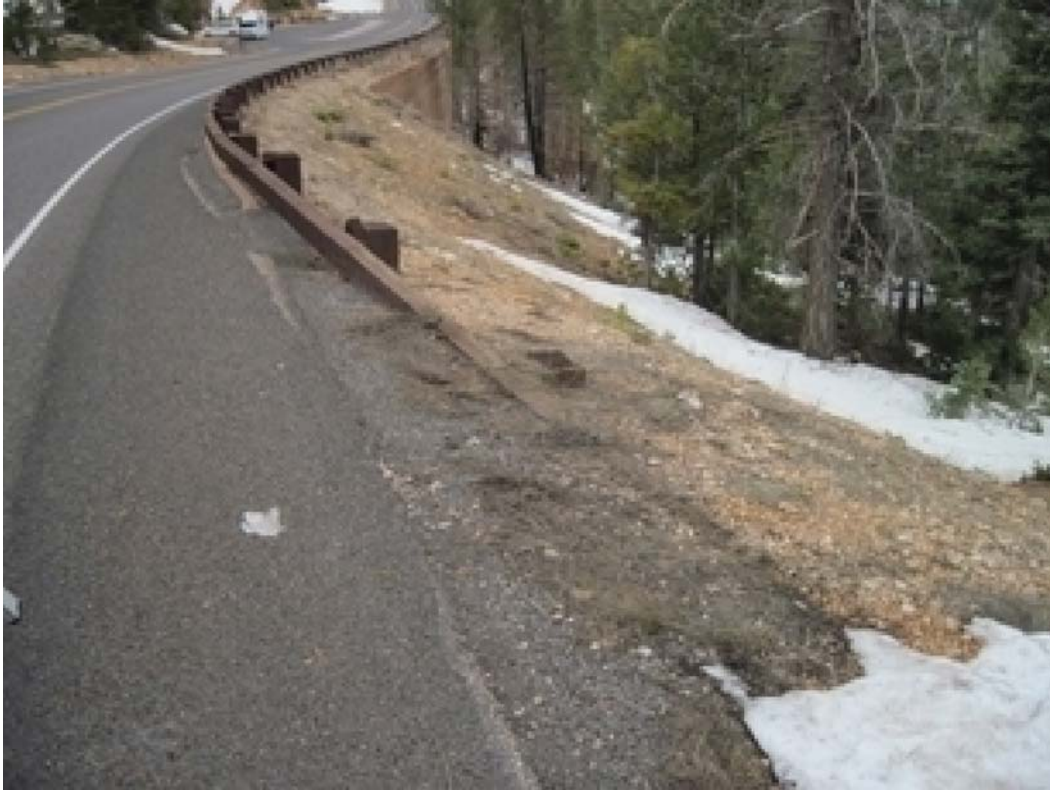
BRCA_0010_13.820_R_1.jpg

Barrier ID:	BRCA-0010-13.820-R				
Route Name:	MAIN PARK ROAD				
Inspection Date:	04/20/2010	Barrier Rating:	42.70		
Barrier Description					
Type:	STEEL-BACKED TIMBER WITH BLOCKOUT	Barrier Function:	TRAFFIC		
Barrier Material:	STEEL-BACKED TIMBER/LOG	Post Material:	WOOD		
Blockout Type:	WOOD	Length (ft.):	1400		
Speed Limit (MPH):	35	Placement with Respect to Road:	BOTH INSIDE AND OUTSIDE		
Hazard Behind Barrier:	HIGH				
Barrier Crashworthiness					
Appropriate Test Level:	TL-2	Barrier Test Level:	TL-3	Is Barrier Crashworthy?:	YES
Beg. End Trtmt Type:	SBT/LOG FLARED	Is Beg. End Trtmt Crashworthy?:	NO	Approach Transition Type:	NONE
Ending End Trtmt Type:	SBT/LOG FLARED	Ending End Trtmt Crashworthy?:	NO		
Average Measurements					
Design Height (In.):	27	Width (In.):	0.0	Post Spacing (In.):	119.9
Height (In.):	24.2	Lateral Offset (In.):	59.0	Road Grade (%):	0.70
Physical Condition					
Barrier	Alignment and Height:	Alignment is acceptable. 1300 L.F. of barrier is 2in to 3" below the 27" design height and 100' is 4" below the 27" design height.

Breaking and Cracking:	Nine wood rails (10-ft each) and 5 blockouts are exhibiting breaking and cracking.			
	Missing Elements:	No missing elements observed.			
	Corrosion and Weathering:	There is gravel build-up along the curb flow line and under the barrier.			
End Treatments	Alignment and Height:	Alignment is acceptable. Height is 3in below the 27" design height.			
	Breaking and Cracking:	No breaking or cracking observed.			
	Missing Elements:	No missing elements observed.			
	Corrosion and Weathering:	There is gravel build-up along the curb flow line and under the barrier.

Repair Action:	REPAIR	FMSS Work Type:	DEFERRED MAINTENANCE	Repair Cost:	\$29948
Brief Workorder:	Raise 1400 L.F. of barrier to 27" design height replace 90 L.F. of barrier replace 5 blocks.				
Workorder:	Adjust Guardrail at \$10- per -Lin. Ft. for 1400 LF = \$14000. Adjust barrier height. Raise 1400 ft. of barrier up to 27-in. design height. Replace Block at \$30- per -Each for 5 Block(s) = \$150. Replace damaged blocks. Replace Rail at \$25- per -Lin. Ft. for 90 LF = \$2250. Replaced damaged SBT rails. Loader at \$125- per -Hour for 4 Hrs = \$500. Remove gravel built up under barrier. Low Speed Traffic Control at \$1475- per -Day for 7 Day(s) = \$10325. 6 days to raise barrier; 1 day for remaining work.

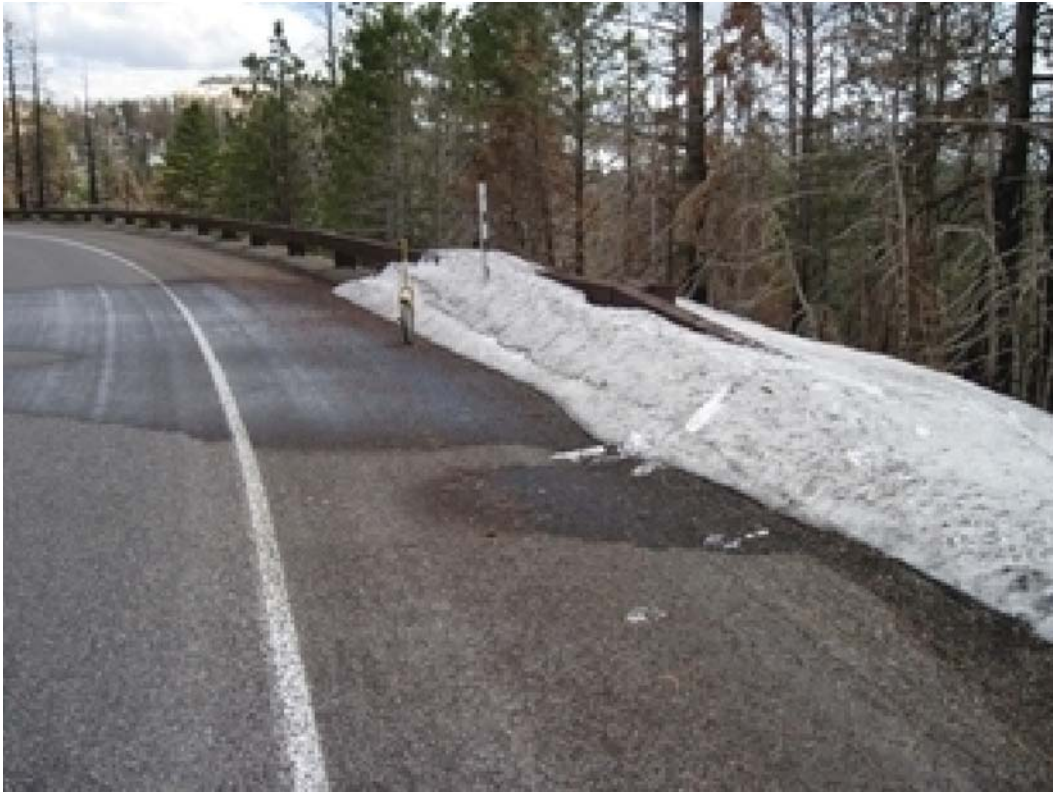
BRCA_0010_16.657_R_1.jpg

Barrier ID:	BRCA-0010-16.657-R				
Route Name:	MAIN PARK ROAD				
Inspection Date:	04/20/2010	Barrier Rating:	31.20		
Barrier Description					
Type:	STEEL-BACKED TIMBER WITH BLOCKOUT	Barrier Function:	TRAFFIC		
Barrier Material:	STEEL-BACKED TIMBER/LOG	Post Material:	WOOD		
Blockout Type:	WOOD	Length (ft.):	370		
Speed Limit (MPH):	35	Placement with Respect to Road:	OUTSIDE OF CURVE		
Hazard Behind Barrier:	HIGH				
Barrier Crashworthiness					
Appropriate Test Level:	TL-2	Barrier Test Level:	TL-3	Is Barrier Crashworthy?:	YES
Beg. End Trtmt Type:	SBT/LOG FLARED	Is Beg. End Trtmt Crashworthy?:	NO	Approach Transition Type:	NONE
Ending End Trtmt Type:	SBT/LOG FLARED	Ending End Trtmt Crashworthy?:	NO		
Average Measurements					
Design Height (In.):	27	Width (In.):	0.0	Post Spacing (In.):	121.0
Height (In.):	26.7	Lateral Offset (In.):	86.0	Road Grade (%):	4.70
Physical Condition					
Barrier	Alignment and Height:	The alignment had less than 6in of deflection. The height is less than 1" from the 27" design height for the entire length.

Breaking and Cracking:	There are 12 broken blocks and 1 broken post. There are 6 (10ft) rail pieces that are badly scraped by snow removal equipment. There are 2 broken bolts.			
	Missing Elements:	No missing elements observed.			
	Corrosion and Weathering:	There is gravel build-up next to the guardrail.			
End Treatments	Alignment and Height:	Alignment is acceptable. Height is within 1-in of 27-in.design height.			
	Breaking and Cracking:	No breaking or cracking observed.			
	Missing Elements:	No missing elements observed.			
	Corrosion and Weathering:	There is gravel build-up next to the guardrail.

Repair Action:	REPAIR	FMSS Work Type:	DEFERRED MAINTENANCE	Repair Cost:	\$4257
Brief Workorder:	Replace 12 broken blocks 1 broken post 2 broken bolts 6 damaged rail pieces. Remove gravel build-up next to the guardrail.				
Workorder:	Replace Block at \$30- per -Each for 12 Block(s) = \$360. Replace 12 broken blocks. Replace Post at \$100- per -Each for 1 Post(s) = \$100. Replace 1 broken post. Replace Rail at \$25- per -Lin. Ft. for 60 LF = \$1500. Replace 6(10ft) damaged rail pieces. Labor at \$60- per -Hour for 1 Hrs = \$60. Replace 2 broken bolts. Loader at \$125- per -Hour for 3 Hrs = \$375. Remove gravel build-up next to guardrail. Low Speed Traffic Control at \$1475- per -Day for 1 Day(s) = \$1475.

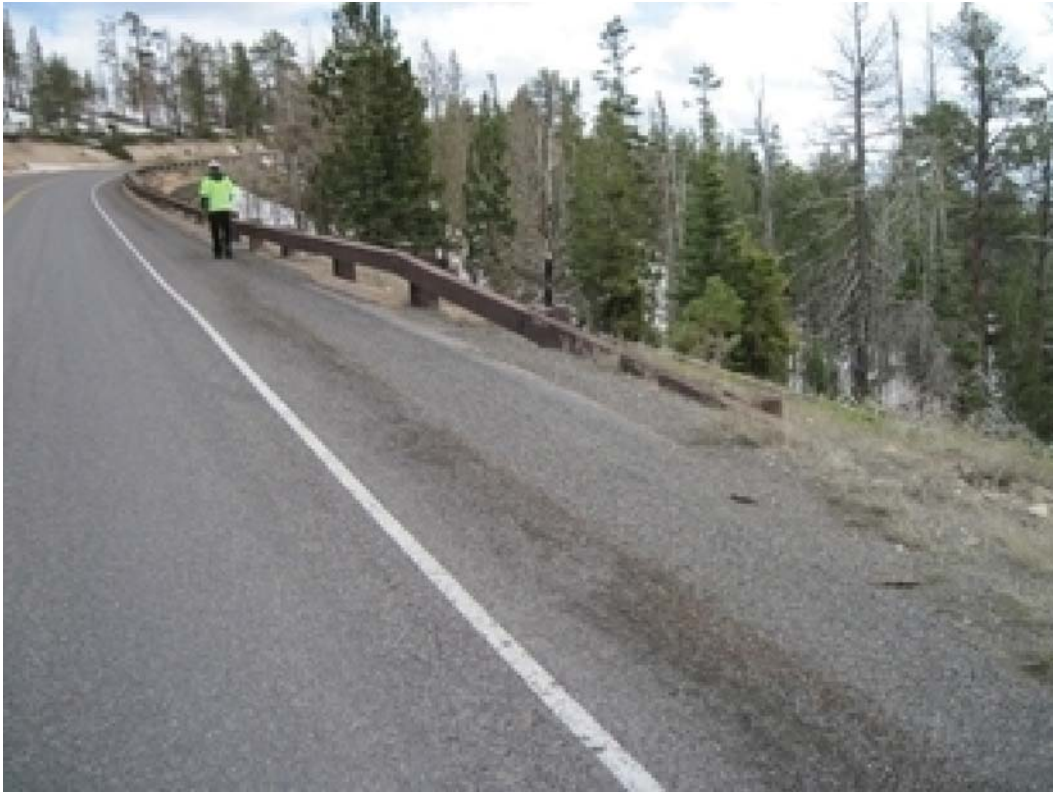
BRCA_0010_17.271_R_1.jpg

Barrier ID:	BRCA-0010-17.271-R				
Route Name:	MAIN PARK ROAD				
Inspection Date:	04/20/2010	Barrier Rating:	30.00		
Barrier Description					
Type:	STEEL-BACKED TIMBER WITH BLOCKOUT	Barrier Function:	TRAFFIC		
Barrier Material:	STEEL-BACKED TIMBER/LOG	Post Material:	WOOD		
Blockout Type:	WOOD	Length (ft.):	525		
Speed Limit (MPH):	35	Placement with Respect to Road:	INSIDE OF CURVE		
Hazard Behind Barrier:	HIGH				
Barrier Crashworthiness					
Appropriate Test Level:	TL-2	Barrier Test Level:	TL-3	Is Barrier Crashworthy?:	YES
Beg. End Trtmt Type:	SBT/LOG FLARED	Is Beg. End Trtmt Crashworthy?:	NO	Approach Transition Type:	NONE
Ending End Trtmt Type:	SBT/LOG FLARED	Ending End Trtmt Crashworthy?:	NO		
Average Measurements					
Design Height (In.):	27	Width (In.):	0.0	Post Spacing (In.):	119.3
Height (In.):	25.7	Lateral Offset (In.):	62.7	Road Grade (%):	6.60
Physical Condition					
Barrier	Alignment and Height:	There are two locations where the alignment between the rail section is misaligned and creates a snag point. The height of the first 150 LF of the barrier is 2.5in below the 27" design height.

Breaking and Cracking:	There are 9 cracked blocks 3 broken blocks 1 cracked post, and 10 Lf of cracked rail.			
	Missing Elements:	No missing elements observed.			
	Corrosion and Weathering:	No corrosion or weathering observed.			
End Treatments	Alignment and Height:	Alignment is acceptable. 50-ft. of the beginning end treatment is 3in below the 27" design height.			
	Breaking and Cracking:	There is 1 broken block in the beginning end treatment.			
	Missing Elements:	No missing elements observed.			
	Corrosion and Weathering:	No corrosion or weathering observed.

Repair Action:	REPAIR	FMSS Work Type:	DEFERRED MAINTENANCE	Repair Cost:	\$5841
Brief Workorder:	Raise 150 L.F. of barrier to 27" design height replace damaged barrier items and remedy the two snap points on the barrier.				
Workorder:	<p>Adjust Guardrail at \$10- per -Lin. Ft. for 150 LF = \$1500. Raise 150 ft. of barrier up to 27-in. design height.</p> <p>Replace Block at \$30- per -Each for 13 Block(s) = \$390. Replace all of the damaged blocks.</p> <p>Replace Post at \$100- per -Each for 1 Post(s) = \$100. Replace the cracked post.</p> <p>Replace Rail at \$25- per -Lin. Ft. for 10 LF = \$250. Replace the 10 LF of damaged rail.</p> <p>Labor at \$60- per -Hour for 2 Hrs = \$120. Remedy the two snag points.</p> <p>Low Speed Traffic Control at \$1475- per -Day for 2 Day(s) = \$2950. 1 day to raise the rail; 1 day all other work.</p>
