CANY GIP Report

NPS Guardwall/Rail Inventory Program Canyonlands National Park

**Federal Lands Highway
Road Inventory Program**

**Data Collection Date: April 2010
Report Date: November 2015**

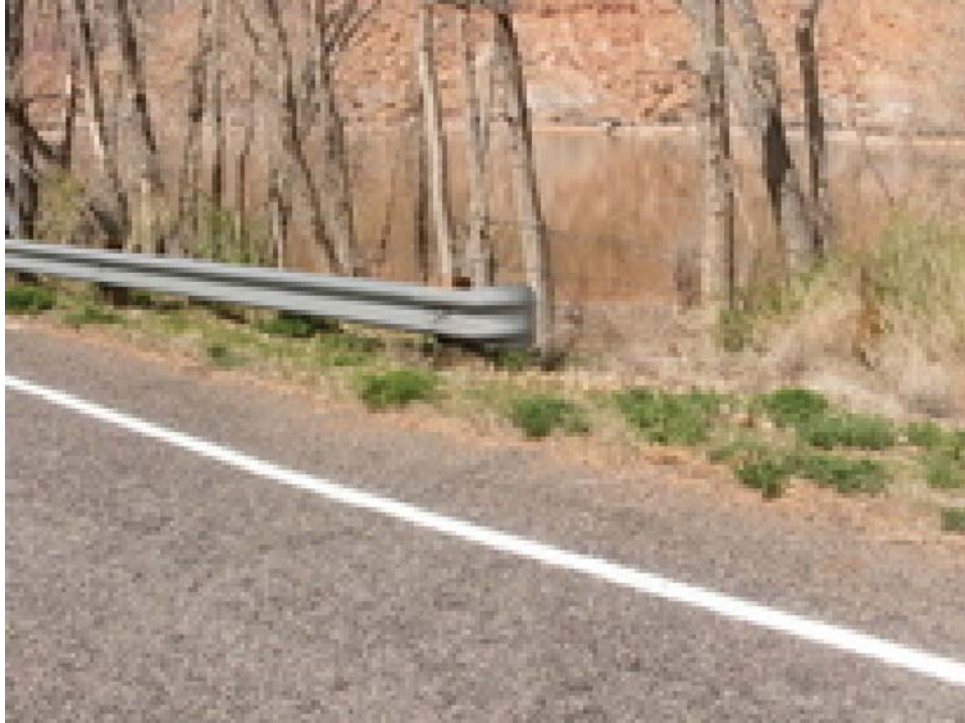
CANY_0010_0.709_R_1.JPG

Barrier ID:	CANY-0010-0.709-R				
Route Name:	NEEDLES ACCESS ROAD				
Inspection Date:	04/13/2010	Barrier Rating:	66.50		
Barrier Description					
Type:	W-BEAM WEAK POST	Barrier Function:	TRAFFIC		
Barrier Material:	GALVANIZED STEEL	Post Material:	WOOD		
Blockout Type:	N/A	Length (ft.):	862		
Speed Limit (MPH):	55	Placement with Respect to Road:	INSIDE OF CURVE		
Hazard Behind Barrier:	MEDIUM				
Barrier Crashworthiness					
Appropriate Test Level:	TL-3	Barrier Test Level:	TL-2	Is Barrier Crashworthy?:	NO
Beg. End Trtmt Type:	NONE	Is Beg. End Trtmt Crashworthy?:	N/A	Approach Transition Type:	NONE
Ending End Trtmt Type:	NONE	Ending End Trtmt Crashworthy?:	N/A		
Average Measurements					
Design Height (In.):	27	Width (In.):	0.0	Post Spacing (In.):	150.6
Height (In.):	21.3	Lateral Offset (In.):	62.0	Road Grade (%):	0.20
Physical Condition					
Barrier	Alignment and Height:	Barrier is leaning outward for about 150 lf (only about 3in). Remaining barrier is in alignment. Height of barrier is 3-8in below 27-in. design height for entire length.

Breaking and Cracking:	Four loose bolts. No breaking or cracking of barrier elements. No evidence of impact.			
	Missing Elements:	Two missing bolts. No missing posts or rails.			
	Corrosion and Weathering:	Animal trail along back of rail resulting in loss of burial depth on posts. Minimal corrosion. Minor weathering of wood posts.			
End Treatments	Alignment and Height:	End terminal consists of steel spoon section. Height is more than 5-in below 27-in. design height and is not crashworthy.			
	Breaking and Cracking:				
	Missing Elements:				
	Corrosion and Weathering:

Repair Action:	REPAIR	FMSS Work Type:	DEFERRED MAINTENANCE	Repair Cost:	\$20075
Brief Workorder:	Raise 862ft. of barrier to 27-in. design height.				
Workorder:	Adjust Guardrail at \$10- per -Lin. Ft. for 862 LF = \$8620. Raise 862ft. of barrier to 27-in. design height. Structural Backfill at \$50- per -Cu. Yd. for 1 CY = \$50. Add backfill to eroded area around one post. Labor at \$60- per -Hour for 3 Hrs = \$180. Dig drainage to divert water around eroded area. High Speed Traffic Control at \$2350- per -Day for 4 Day(s) = \$9400.

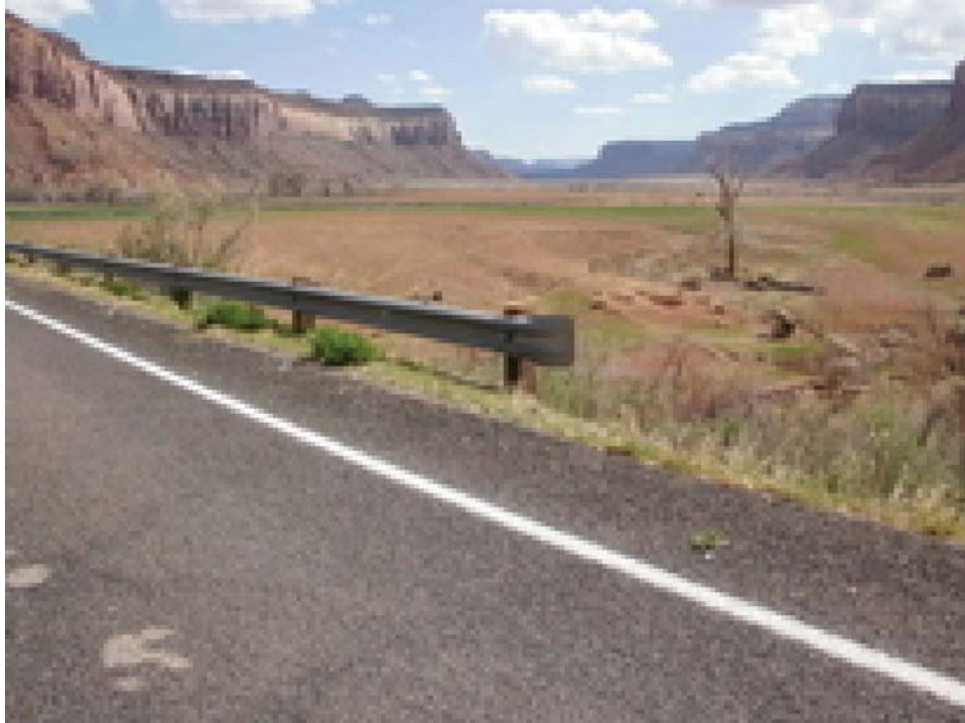
CANY_0010_0.762_L_1.JPG

Barrier ID:	CANY-0010-0.762-L				
Route Name:	NEEDLES ACCESS ROAD				
Inspection Date:	04/13/2010	Barrier Rating:	54.00		
Barrier Description					
Type:	W-BEAM WEAK POST	Barrier Function:	TRAFFIC		
Barrier Material:	GALVANIZED STEEL	Post Material:	WOOD		
Blockout Type:	N/A	Length (ft.):	457		
Speed Limit (MPH):	55	Placement with Respect to Road:	TANGENT		
Hazard Behind Barrier:	HIGH				
Barrier Crashworthiness					
Appropriate Test Level:	TL-3	Barrier Test Level:	TL-2	Is Barrier Crashworthy?:	NO
Beg. End Trtmt Type:	NONE	Is Beg. End Trtmt Crashworthy?:	N/A	Approach Transition Type:	NONE
Ending End Trtmt Type:	NONE	Ending End Trtmt Crashworthy?:	N/A		
Average Measurements					
Design Height (In.):	27	Width (In.):	0.0	Post Spacing (In.):	151.0
Height (In.):	20.7	Lateral Offset (In.):	77.6	Road Grade (%):	0.30
Physical Condition					
Barrier	Alignment and Height:	Alignment of barrier is acceptable. Barrier is more than 5-in below current design height standards of 27-in for entire length.

Breaking and Cracking:	No breaking or cracking of barrier.			
	Missing Elements:	No missing elements in barrier.			
	Corrosion and Weathering:	Minor corrosion of w-beam at a few posts.			
End Treatments	Alignment and Height:	End treatment consists of steel spoon section. Height is more than 5-in below 27-in. design height and is not crashworthy.			
	Breaking and Cracking:				
	Missing Elements:				
	Corrosion and Weathering:

Repair Action:	REPAIR	FMSS Work Type:	DEFERRED MAINTENANCE	Repair Cost:	\$10197
Brief Workorder:	Raise 457ft. of barrier to 27-in. design height.				
Workorder:	Adjust Guardrail at \$10- per -Lin. Ft. for 457 LF = \$4570. Raise 457ft. of barrier to 27-in. design height. High Speed Traffic Control at \$2350- per -Day for 2 Day(s) = \$4700.

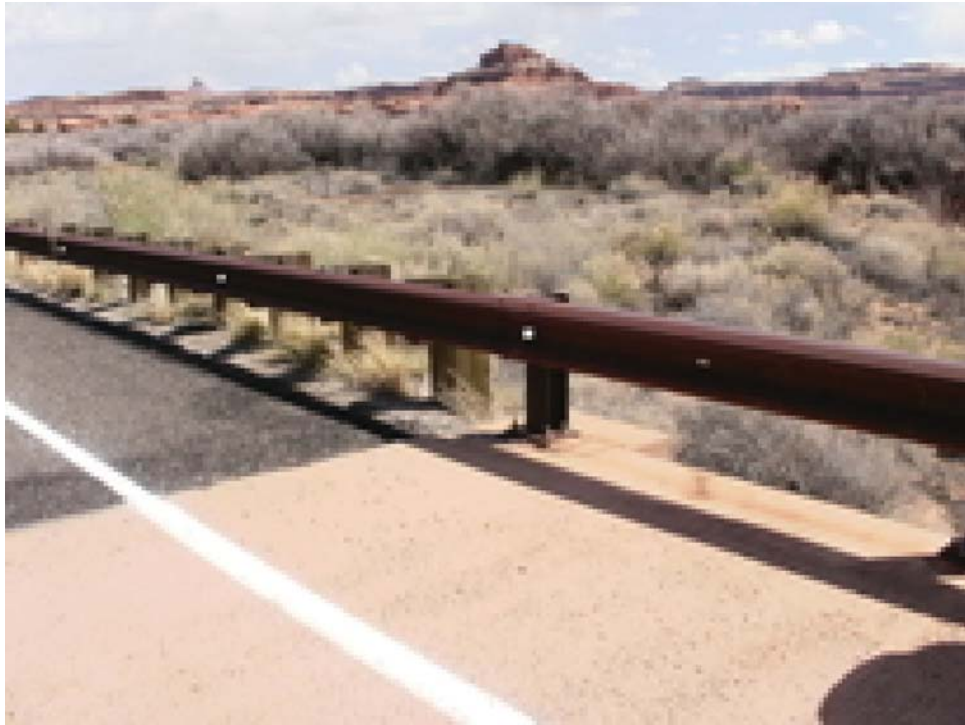
CANY_0010_14.756_L_1.JPG

Barrier ID:	CANY-0010-14.756-L				
Route Name:	NEEDLES ACCESS ROAD				
Inspection Date:	04/13/2010	Barrier Rating:	13.60		
Barrier Description					
Type:	W-BEAM STRONG POST	Barrier Function:	TRAFFIC		
Barrier Material:	WEATHERING STEEL/CORTEN	Post Material:	WOOD		
Blockout Type:	WOOD	Length (ft.):	127		
Speed Limit (MPH):	35	Placement with Respect to Road:	TANGENT		
Hazard Behind Barrier:	MEDIUM				
Barrier Crashworthiness					
Appropriate Test Level:	TL-2	Barrier Test Level:	TL-3	Is Barrier Crashworthy?:	YES
Beg. End Trtmt Type:	NONE	Is Beg. End Trtmt Crashworthy?:	N/A	Approach Transition Type:	RIGID W-BEAM - W-BEAM
Ending End Trtmt Type:	W-BEAM BCT	Ending End Trtmt Crashworthy?:	NO		
Average Measurements					
Design Height (In.):	27	Width (In.):	0.0	Post Spacing (In.):	75.3
Height (In.):	28.2	Lateral Offset (In.):	71.0	Road Grade (%):	0.80
Physical Condition					
Barrier	Alignment and Height:	Alignment acceptable. Height within 1-in of 27-in design height.

Breaking and Cracking:	Minor cracking of posts and blocks. No breaks in guardrail elements.			
	Missing Elements:	No missing barrier elements.			
	Corrosion and Weathering:	No corrosion. Minor weathering of posts and blocks. No erosion to compromise stability of guardrail posts.			
End Treatments	Alignment and Height:	Alignment acceptable. Height within 1-in of 27-in design height.			
	Breaking and Cracking:	No cracking or breaking of ending end treatment elements.			
	Missing Elements:	No elements missing from ending end treatment.			
	Corrosion and Weathering:	No corrosion. Minor weathering of posts and blocks.

Barrier ID:	CANY-0010-14.756-L				
Route Name:	NEEDLES ACCESS ROAD				
Inspection Date:	04/13/2010	Barrier Rating:		13.60	
Repair Recommendations					
Repair Action:	NO ACTION	FMSS Work Type:	N/A	Repair Cost:	\$0
Brief Workorder:	N/A				
Workorder:

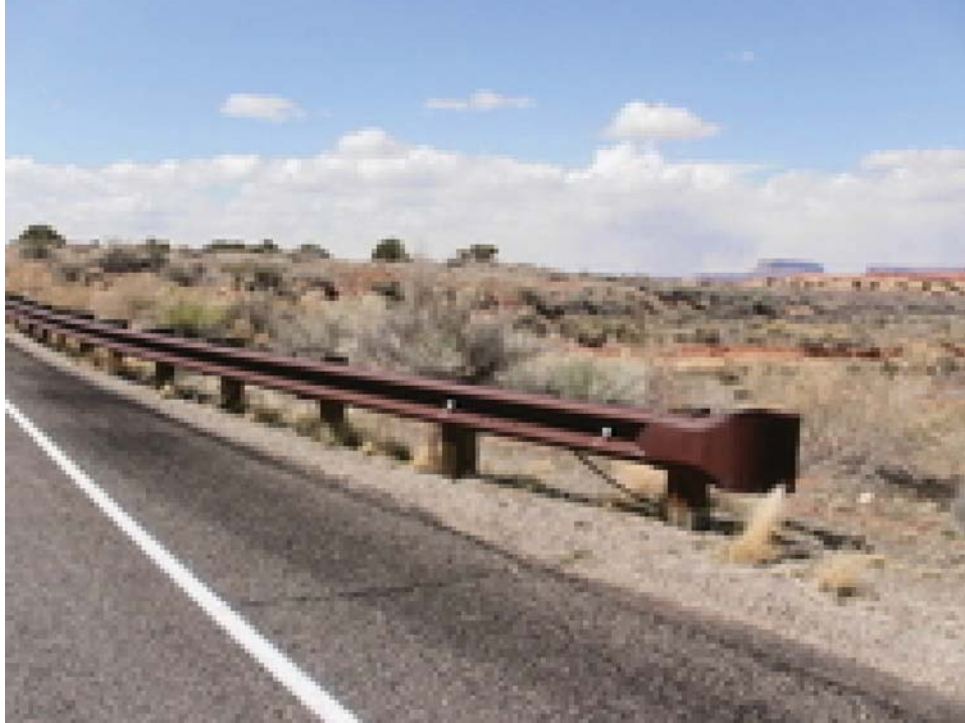
CANY_0010_14.761_R_1.JPG

Barrier ID:	CANY-0010-14.761-R				
Route Name:	NEEDLES ACCESS ROAD				
Inspection Date:	04/13/2010	Barrier Rating:	13.60		
Barrier Description					
Type:	W-BEAM STRONG POST	Barrier Function:	TRAFFIC		
Barrier Material:	WEATHERING STEEL/CORTEN	Post Material:	WOOD		
Blockout Type:	WOOD	Length (ft.):	129		
Speed Limit (MPH):	35	Placement with Respect to Road:	TANGENT		
Hazard Behind Barrier:	MEDIUM				
Barrier Crashworthiness					
Appropriate Test Level:	TL-2	Barrier Test Level:	TL-3	Is Barrier Crashworthy?:	YES
Beg. End Trtmt Type:	W-BEAM BCT	Is Beg. End Trtmt Crashworthy?:	NO	Approach Transition Type:	RIGID W-BEAM - W-BEAM
Ending End Trtmt Type:	NONE	Ending End Trtmt Crashworthy?:	N/A		
Average Measurements					
Design Height (In.):	27	Width (In.):	0.0	Post Spacing (In.):	75.0
Height (In.):	27.2	Lateral Offset (In.):	53.2	Road Grade (%):	1.40
Physical Condition					
Barrier	Alignment and Height:	Alignment acceptable. Height within 1-in of 27-in design height.

Breaking and Cracking:	No breaking or cracking in barrier.			
	Missing Elements:	No missing elements in barrier.			
	Corrosion and Weathering:	No corrosion or weathering in barrier.			
End Treatments	Alignment and Height:	Alignment acceptable. Height within 1-in of 27-in design height.			
	Breaking and Cracking:	No breaking or cracking in end treatment.			
	Missing Elements:	No missing elements in end treatment.			
	Corrosion and Weathering:	No corrosion or weathering in end treatment.

Barrier ID:	CANY-0010-14.761-R				
Route Name:	NEEDLES ACCESS ROAD				
Inspection Date:	04/13/2010	Barrier Rating:		13.60	
Repair Recommendations					
Repair Action:	NO ACTION	FMSS Work Type:	N/A	Repair Cost:	\$0
Brief Workorder:	N/A				
Workorder:

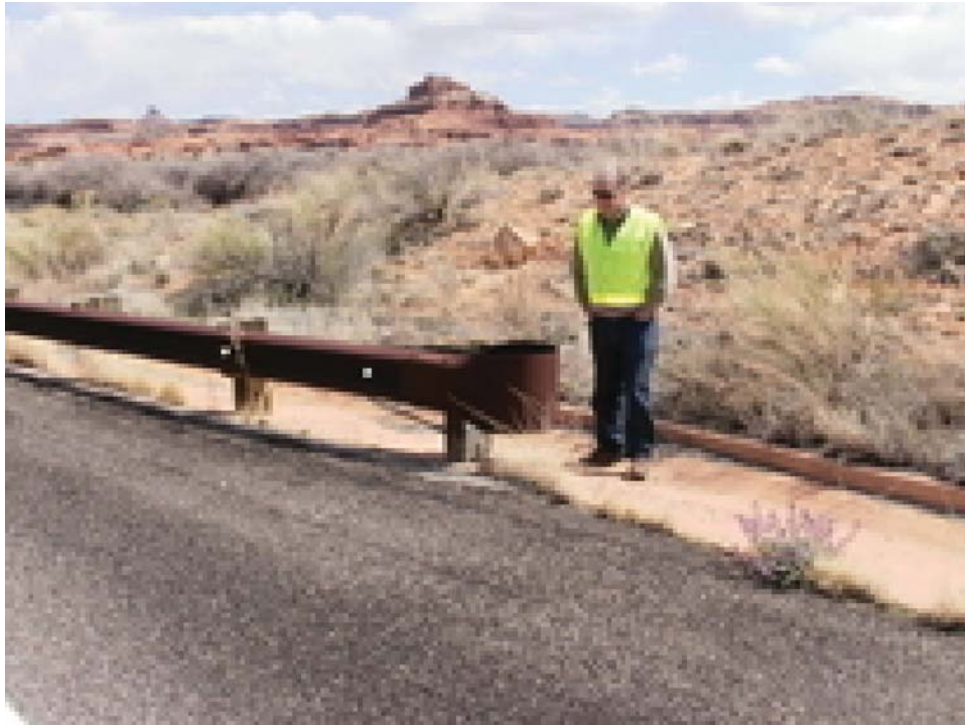
CANY_0010_14.794_L_1.JPG

Barrier ID:	CANY-0010-14.794-L				
Route Name:	NEEDLES ACCESS ROAD				
Inspection Date:	04/13/2010	Barrier Rating:	16.50		
Barrier Description					
Type:	W-BEAM STRONG POST	Barrier Function:	TRAFFIC		
Barrier Material:	WEATHERING STEEL/CORTEN	Post Material:	WOOD		
Blockout Type:	WOOD	Length (ft.):	127		
Speed Limit (MPH):	35	Placement with Respect to Road:	TANGENT		
Hazard Behind Barrier:	MEDIUM				
Barrier Crashworthiness					
Appropriate Test Level:	TL-2	Barrier Test Level:	TL-3	Is Barrier Crashworthy?:	YES
Beg. End Trtmt Type:	W-BEAM BCT	Is Beg. End Trtmt Crashworthy?:	NO	Approach Transition Type:	RIGID W-BEAM - W-BEAM
Ending End Trtmt Type:	NONE	Ending End Trtmt Crashworthy?:	N/A		
Average Measurements					
Design Height (In.):	27	Width (In.):	0.0	Post Spacing (In.):	74.0
Height (In.):	26.7	Lateral Offset (In.):	63.2	Road Grade (%):	2.10
Physical Condition					
Barrier	Alignment and Height:	Alignment of barrier is acceptable. 20ft. is 1-3 in below 27-in. design height

Breaking and Cracking:	No breaks in barrier elements. Minor cracking of posts and blocks. Six loose bolts.			
	Missing Elements:	No missing barrier elements.			
	Corrosion and Weathering:	No corrosion. Minor weathering of posts and blocks. No erosion at base - posts set in concrete.			
End Treatments	Alignment and Height:	Alignment is acceptable. 30ft. is 1-3 in below 27-in. design height			
	Breaking and Cracking:	No breaking or cracking of beginning end treatment elements.			
	Missing Elements:	No missing beginning end treatment elements.			
	Corrosion and Weathering:	No corrosion. Minor weathering of beginning end treatment blocks and posts.

Repair Action:	REPAIR	FMSS Work Type:	DEFERRED MAINTENANCE	Repair Cost:	\$2238
Brief Workorder:	Raise 50 L.F. of W-beam guardrail to 27-in. design height. Tighten loose bolts.				
Workorder:	Adjust Guardrail at \$10- per -Lin. Ft. for 50 LF = \$500. Raise 50ft. of barrier up to 27-in. design height. Labor at \$60- per -Hour for 1 Hrs = \$60. Tighten loose bolts. Low Speed Traffic Control at \$1475- per -Day for 1 Day(s) = \$1475.

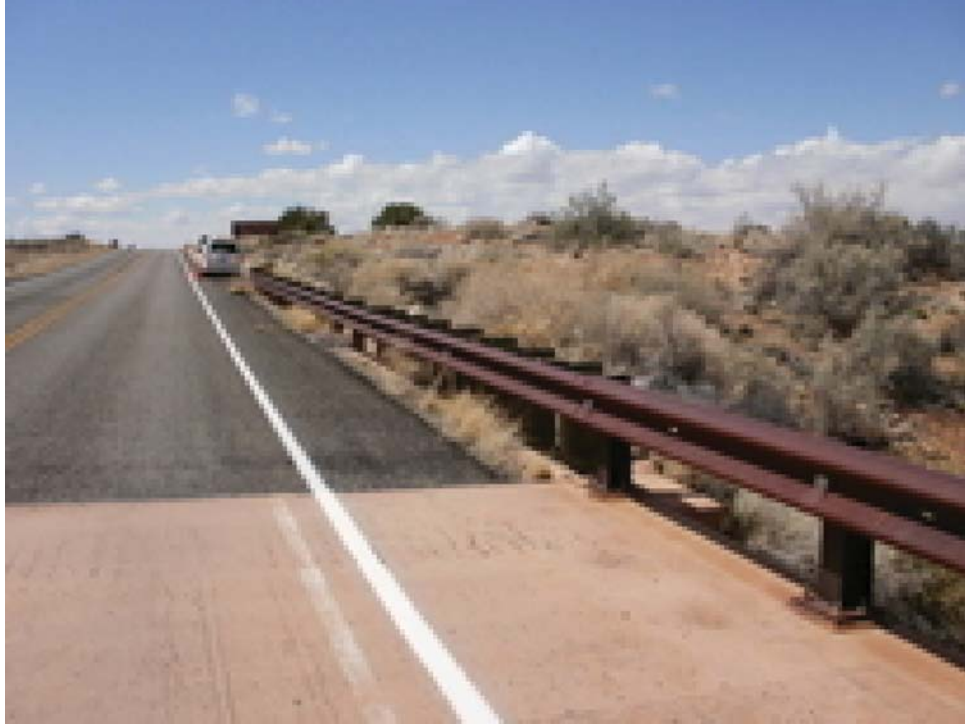
CANY_0010_14.795_R_1.JPG

Barrier ID:	CANY-0010-14.795-R				
Route Name:	NEEDLES ACCESS ROAD				
Inspection Date:	04/13/2010	Barrier Rating:	16.50		
Barrier Description					
Type:	W-BEAM STRONG POST	Barrier Function:	TRAFFIC		
Barrier Material:	WEATHERING STEEL/CORTEN	Post Material:	WOOD		
Blockout Type:	WOOD	Length (ft.):	128		
Speed Limit (MPH):	35	Placement with Respect to Road:	TANGENT		
Hazard Behind Barrier:	MEDIUM				
Barrier Crashworthiness					
Appropriate Test Level:	TL-2	Barrier Test Level:	TL-3	Is Barrier Crashworthy?:	YES
Beg. End Trtmt Type:	NONE	Is Beg. End Trtmt Crashworthy?:	N/A	Approach Transition Type:	RIGID W-BEAM - W-BEAM
Ending End Trtmt Type:	W-BEAM BCT	Ending End Trtmt Crashworthy?:	NO		
Average Measurements					
Design Height (In.):	27	Width (In.):	0.0	Post Spacing (In.):	74.6
Height (In.):	26.2	Lateral Offset (In.):	62.7	Road Grade (%):	2.70
Physical Condition					
Barrier	Alignment and Height:	Alignment acceptable. Height within 1-in of 27-in design height.

Breaking and Cracking:	No breaking and cracking in barrier.			
	Missing Elements:	No missing elements in barrier.			
	Corrosion and Weathering:	No corrosion or weathering in barrier.			
End Treatments	Alignment and Height:	Alignment acceptable. Height within 1-in of 27-in design height.			
	Breaking and Cracking:	No breaking or cracking in end treatment.			
	Missing Elements:	No missing elements in end treatment.			
	Corrosion and Weathering:	No corrosion or weathering in end treatment.

Barrier ID:	CANY-0010-14.795-R				
Route Name:	NEEDLES ACCESS ROAD				
Inspection Date:	04/13/2010	Barrier Rating:		16.50	
Repair Recommendations					
Repair Action:	NO ACTION	FMSS Work Type:	N/A	Repair Cost:	\$0
Brief Workorder:	N/A				
Workorder:

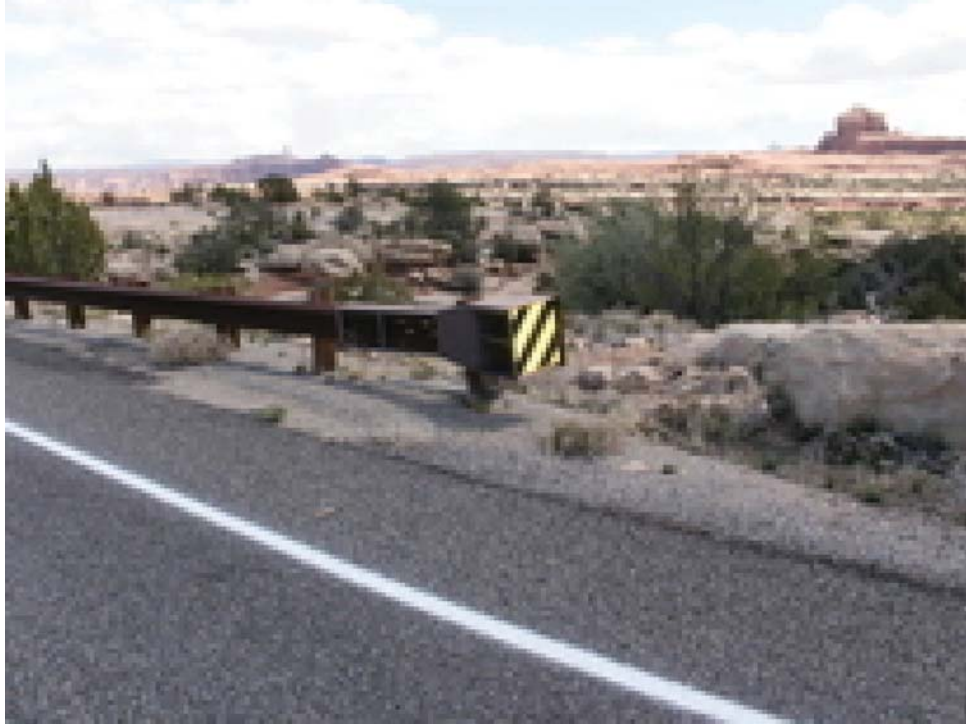
CANY_0010_17.678_L_1.JPG

Barrier ID:	CANY-0010-17.678-L				
Route Name:	NEEDLES ACCESS ROAD				
Inspection Date:	04/13/2010	Barrier Rating:	25.20		
Barrier Description					
Type:	W-BEAM STRONG POST	Barrier Function:	TRAFFIC		
Barrier Material:	WEATHERING STEEL/CORTEN	Post Material:	WOOD		
Blockout Type:	WOOD	Length (ft.):	345		
Speed Limit (MPH):	35	Placement with Respect to Road:	TANGENT		
Hazard Behind Barrier:	MEDIUM				
Barrier Crashworthiness					
Appropriate Test Level:	TL-2	Barrier Test Level:	TL-3	Is Barrier Crashworthy?:	YES
Beg. End Trtmt Type:	W-BEAM FLARED 350 COMPLIANT	Is Beg. End Trtmt Crashworthy?:	YES	Approach Transition Type:	NONE
Ending End Trtmt Type:	W-BEAM TANGENT 350	Ending End Trtmt Crashworthy?:	YES		
Average Measurements					
Design Height (In.):	27	Width (In.):	0.0	Post Spacing (In.):	75.6
Height (In.):	25.7	Lateral Offset (In.):	83.3	Road Grade (%):	1.10
Physical Condition					
Barrier	Alignment and Height:	Alignment of barrier is acceptable. No evidence of impact. 139ft. is 1-3 in below 27-in. design height

Breaking and Cracking:	No breaks in barrier elements. Minor cracking of posts and blocks. Some new blocks. No loose bolts.			
	Missing Elements:	No elements missing from barrier.			
	Corrosion and Weathering:	Minimal corrosion. Moderate weathering of posts and blocks. Erosion does not compromise stability of guardrail posts.			
End Treatments	Alignment and Height:	Alignment is acceptable. 30ft. is 1-3 in below 27-in. design height.			
	Breaking and Cracking:	No breaks. Minor cracking of end treatment posts and blocks.			
	Missing Elements:	No missing end treatment elements.			
	Corrosion and Weathering:	No corrosion. Moderate weathering of end treatment posts and blocks.

Repair Action:	REPAIR	FMSS Work Type:	DEFERRED MAINTENANCE	Repair Cost:	\$3482
Brief Workorder:	Raise 169 L.F. of W-beam guardrail to 27-in. design height.				
Workorder:	Adjust Guardrail at \$10- per -Lin. Ft. for 169 LF = \$1690. Raise 169ft. of barrier up to 27-in. design height.. Low Speed Traffic Control at \$1475- per -Day for 1 Day(s) = \$1475.

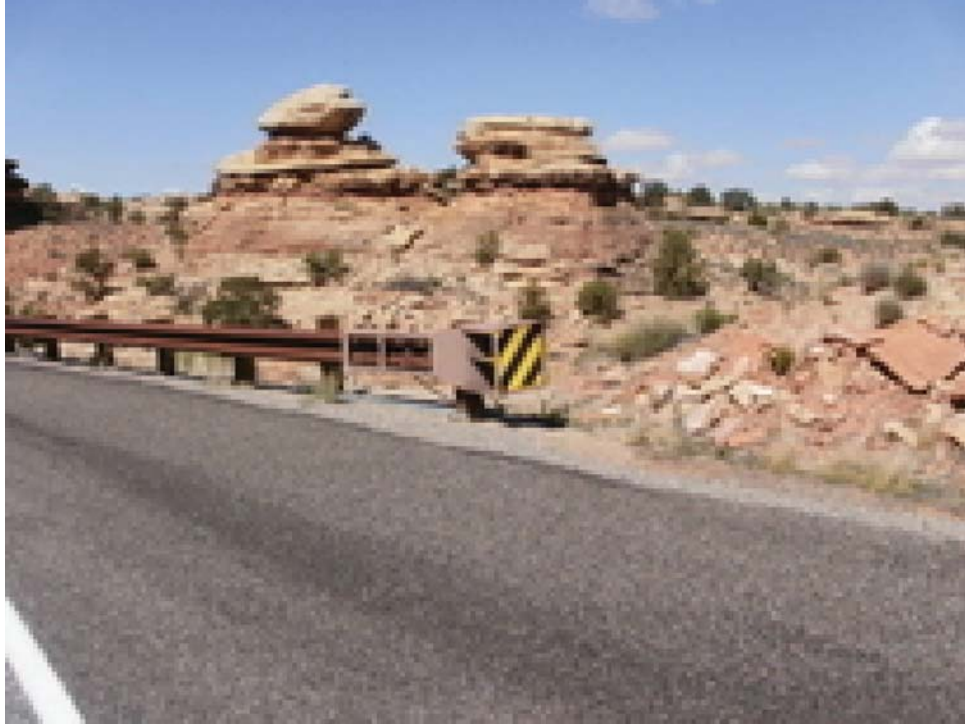
CANY_0010_19.347_R_1.JPG

Barrier ID:	CANY-0010-19.347-R				
Route Name:	NEEDLES ACCESS ROAD				
Inspection Date:	04/13/2010	Barrier Rating:	25.10		
Barrier Description					
Type:	W-BEAM STRONG POST	Barrier Function:	TRAFFIC		
Barrier Material:	WEATHERING STEEL/CORTEN	Post Material:	WOOD		
Blockout Type:	WOOD	Length (ft.):	560		
Speed Limit (MPH):	35	Placement with Respect to Road:	BOTH INSIDE AND OUTSIDE		
Hazard Behind Barrier:	MEDIUM				
Barrier Crashworthiness					
Appropriate Test Level:	TL-2	Barrier Test Level:	TL-3	Is Barrier Crashworthy?:	YES
Beg. End Trtmt Type:	W-BEAM TANGENT 350	Is Beg. End Trtmt Crashworthy?:	YES	Approach Transition Type:	BRIDGE RAIL W-BEAM
Ending End Trtmt Type:	NONE	Ending End Trtmt Crashworthy?:	N/A		
Average Measurements					
Design Height (In.):	27	Width (In.):	0.0	Post Spacing (In.):	75.0
Height (In.):	27.5	Lateral Offset (In.):	85.3	Road Grade (%):	1.90
Physical Condition					
Barrier	Alignment and Height:	Alignment acceptable. Height within 1-in of 27-in design height.

Breaking and Cracking:	Some new blocks. No breaking of barrier elements. Minor cracking of posts and blocks. Six loose bolts.			
	Missing Elements:	No missing barrier elements.			
	Corrosion and Weathering:	Moderate to severe erosion of posts and blocks. Replace four severely weathered posts. No soil erosion compromising stability.			
End Treatments	Alignment and Height:	Alignment acceptable. Height within 1-in of 27-in design height.			
	Breaking and Cracking:	No breaking of end treatment elements. Minor cracking of posts and blocks.			
	Missing Elements:	No missing end treatment elements.			
	Corrosion and Weathering:	Minor corrosion. Moderate weathering of posts and blocks.

Repair Action:	REPAIR	FMSS Work Type:	DEFERRED MAINTENANCE	Repair Cost:	\$2129
Brief Workorder:	Replace four eroded posts. Tighten loose bolts. Monitor erosion of posts and blocks.				
Workorder:	Replace Post at \$100- per -Each for 4 Post(s) = \$400. Replace four severely eroded posts. Labor at \$60- per -Hour for 1 Hrs = \$60. Tighten loose bolts. Low Speed Traffic Control at \$1475- per -Day for 1 Day(s) = \$1475.

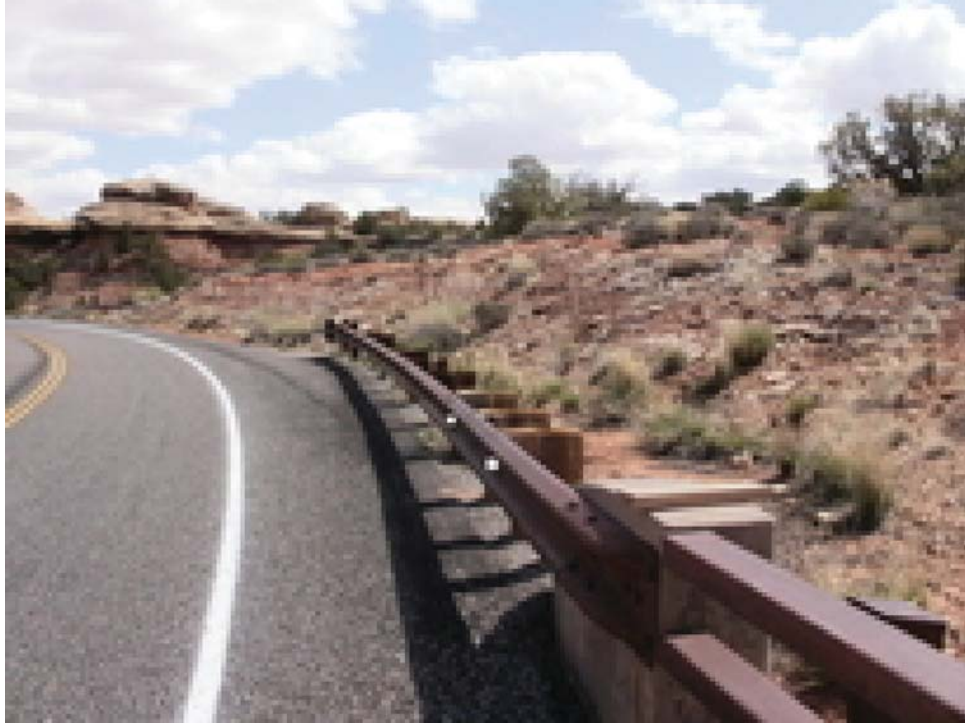
CANY_0010_19.441_L_1.JPG

Barrier ID:	CANY-0010-19.441-L				
Route Name:	NEEDLES ACCESS ROAD				
Inspection Date:	04/13/2010	Barrier Rating:	13.60		
Barrier Description					
Type:	W-BEAM STRONG POST	Barrier Function:	TRAFFIC		
Barrier Material:	WEATHERING STEEL/CORTEN	Post Material:	WOOD		
Blockout Type:	WOOD	Length (ft.):	68		
Speed Limit (MPH):	35	Placement with Respect to Road:	TANGENT		
Hazard Behind Barrier:	MEDIUM				
Barrier Crashworthiness					
Appropriate Test Level:	TL-2	Barrier Test Level:	TL-3	Is Barrier Crashworthy?:	YES
Beg. End Trtmt Type:	NONE	Is Beg. End Trtmt Crashworthy?:	N/A	Approach Transition Type:	BRIDGE RAIL W-BEAM
Ending End Trtmt Type:	W-BEAM FLARED 350 COMPLIANT	Ending End Trtmt Crashworthy?:	YES		
Average Measurements					
Design Height (In.):	27	Width (In.):	0.0	Post Spacing (In.):	74.3
Height (In.):	27.7	Lateral Offset (In.):	72.6	Road Grade (%):	1.90
Physical Condition					
Barrier	Alignment and Height:	Alignment acceptable. Height within 1-in of 27-in design height.

Breaking and Cracking:	No breaking or cracking in barrier.			
	Missing Elements:	No missing elements in barrier.			
	Corrosion and Weathering:	No corrosion or weathering in barrier.			
End Treatments	Alignment and Height:	Alignment acceptable. Height within 1-in of 27-in design height.			
	Breaking and Cracking:	No breaking or cracking in end treatment.			
	Missing Elements:	No missing elements in end treatment.			
	Corrosion and Weathering:	No corrosion or weathering in end treatment.

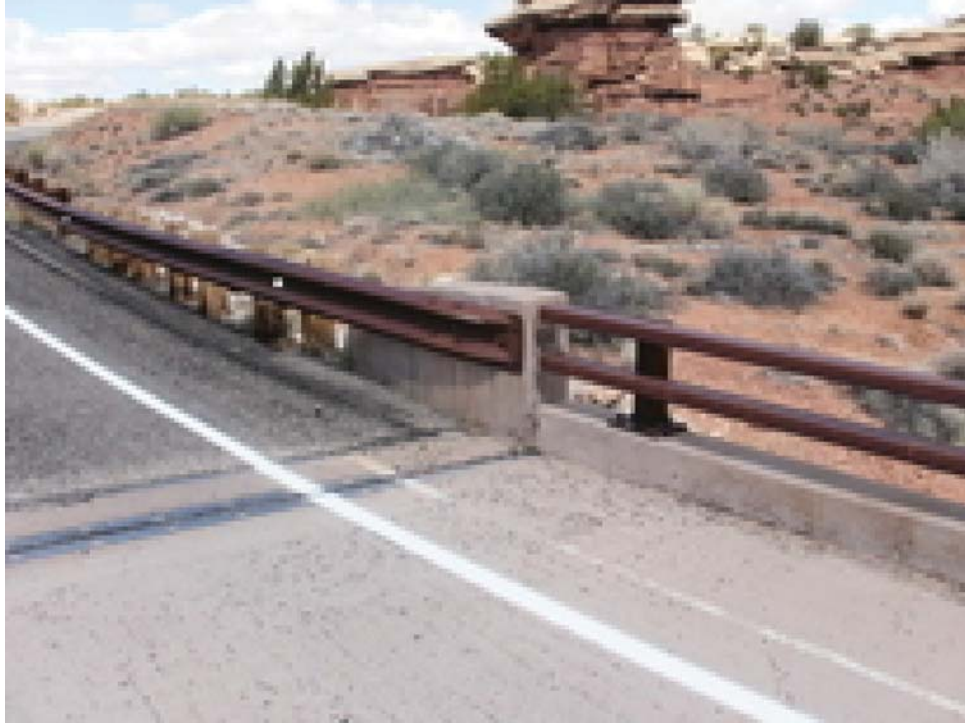
CANY_0010_19.485_R_1.JPG

Barrier ID:	CANY-0010-19.485-R				
Route Name:	NEEDLES ACCESS ROAD				
Inspection Date:	04/13/2010	Barrier Rating:	16.80		
Barrier Description					
Type:	W-BEAM STRONG POST	Barrier Function:	TRAFFIC		
Barrier Material:	WEATHERING STEEL/CORTEN	Post Material:	WOOD		
Blockout Type:	WOOD	Length (ft.):	81		
Speed Limit (MPH):	35	Placement with Respect to Road:	INSIDE OF CURVE		
Hazard Behind Barrier:	LOW				
Barrier Crashworthiness					
Appropriate Test Level:	TL-2	Barrier Test Level:	TL-3	Is Barrier Crashworthy?:	YES
Beg. End Trtmt Type:	NONE	Is Beg. End Trtmt Crashworthy?:	N/A	Approach Transition Type:	BRIDGE RAIL W-BEAM
Ending End Trtmt Type:	W-BEAM TANGENT 350	Ending End Trtmt Crashworthy?:	YES		
Average Measurements					
Design Height (In.):	27	Width (In.):	0.0	Post Spacing (In.):	75.0
Height (In.):	26.2	Lateral Offset (In.):	60.0	Road Grade (%):	4.70
Physical Condition					
Barrier	Alignment and Height:	Alignment acceptable. Height within 1-in of 27-in design height. No evidence of impact.

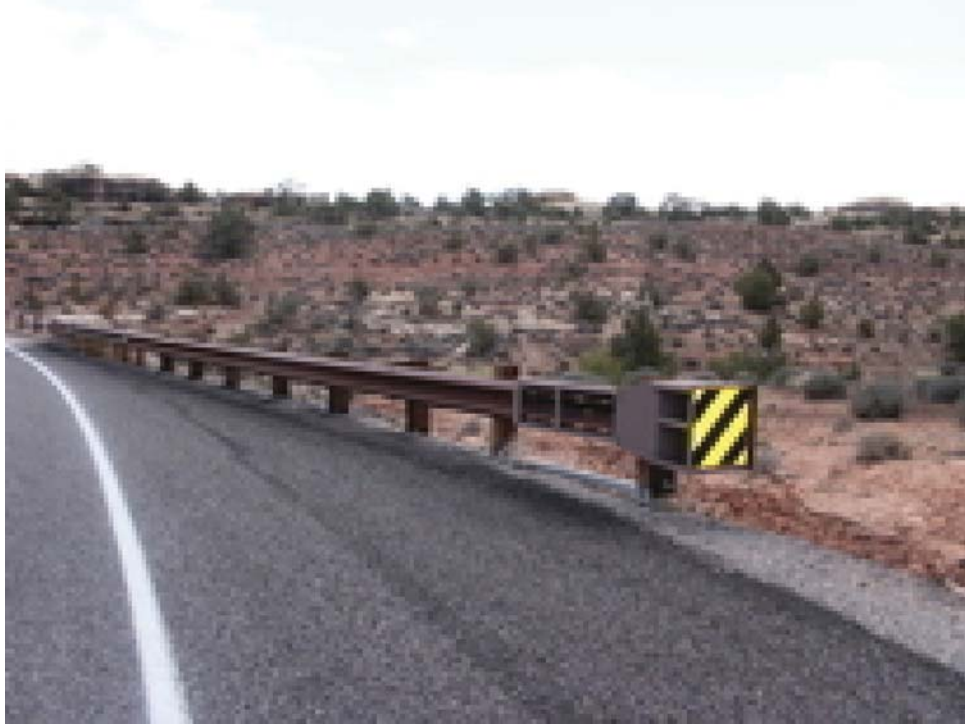
CANY_0010_19.486_L_1.JPG

Barrier ID:	CANY-0010-19.486-L				
Route Name:	NEEDLES ACCESS ROAD				
Inspection Date:	04/13/2010	Barrier Rating:	20.70		
Barrier Description					
Type:	W-BEAM STRONG POST	Barrier Function:	TRAFFIC		
Barrier Material:	WEATHERING STEEL/CORTEN	Post Material:	WOOD		
Blockout Type:	WOOD	Length (ft.):	80		
Speed Limit (MPH):	35	Placement with Respect to Road:	TANGENT		
Hazard Behind Barrier:	MEDIUM				
Barrier Crashworthiness					
Appropriate Test Level:	TL-2	Barrier Test Level:	TL-3	Is Barrier Crashworthy?:	YES
Beg. End Trtmt Type:	W-BEAM FLARED 350 COMPLIANT	Is Beg. End Trtmt Crashworthy?:	YES	Approach Transition Type:	BRIDGE RAIL W-BEAM
Ending End Trtmt Type:	NONE	Ending End Trtmt Crashworthy?:	N/A		
Average Measurements					
Design Height (In.):	27	Width (In.):	0.0	Post Spacing (In.):	75.0
Height (In.):	27.7	Lateral Offset (In.):	78.6	Road Grade (%):	3.90
Physical Condition					
Barrier	Alignment and Height:	Alignment acceptable. Height within 1-in of 27-in design height.

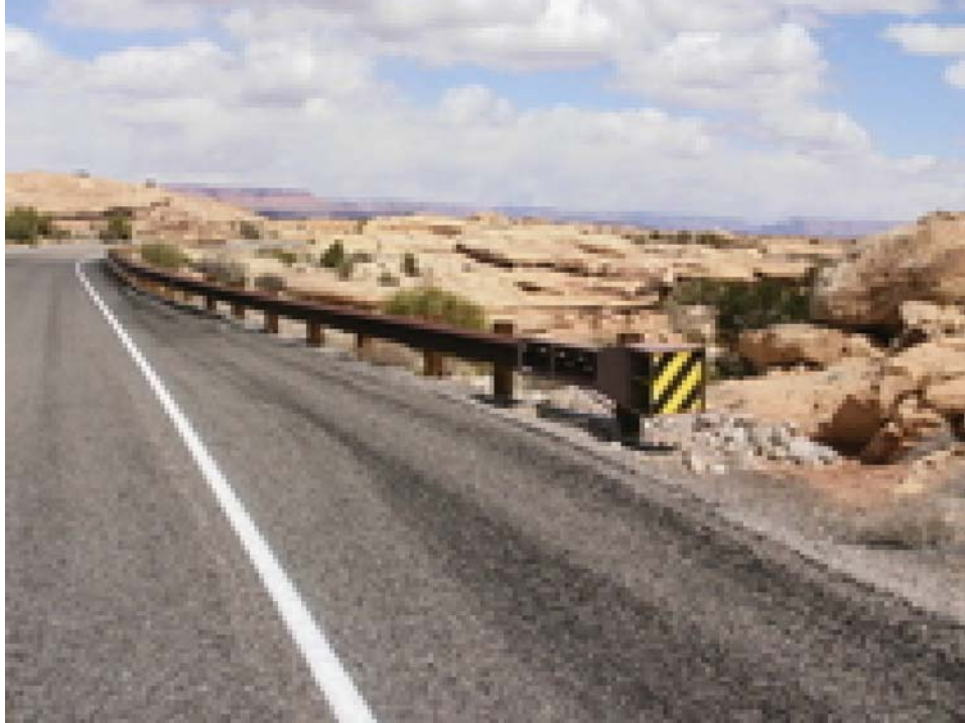
CANY_0010_20.520_R_1.JPG

Barrier ID:	CANY-0010-20.520-R				
Route Name:	NEEDLES ACCESS ROAD				
Inspection Date:	04/13/2010	Barrier Rating:	28.50		
Barrier Description					
Type:	W-BEAM STRONG POST	Barrier Function:	TRAFFIC		
Barrier Material:	WEATHERING STEEL/CORTEN	Post Material:	WOOD		
Blockout Type:	WOOD	Length (ft.):	420		
Speed Limit (MPH):	35	Placement with Respect to Road:	INSIDE OF CURVE		
Hazard Behind Barrier:	HIGH				
Barrier Crashworthiness					
Appropriate Test Level:	TL-2	Barrier Test Level:	TL-3	Is Barrier Crashworthy?:	YES
Beg. End Trtmt Type:	W-BEAM FLARED 350 COMPLIANT	Is Beg. End Trtmt Crashworthy?:	YES	Approach Transition Type:	NONE
Ending End Trtmt Type:	W-BEAM TANGENT 350	Ending End Trtmt Crashworthy?:	YES		
Average Measurements					
Design Height (In.):	27	Width (In.):	0.0	Post Spacing (In.):	74.3
Height (In.):	26.0	Lateral Offset (In.):	43.7	Road Grade (%):	2.10
Physical Condition					
Barrier	Alignment and Height:	Barrier alignment is acceptable. Barrier is below 27-in design height by 1 to 3 in for 206 ft.

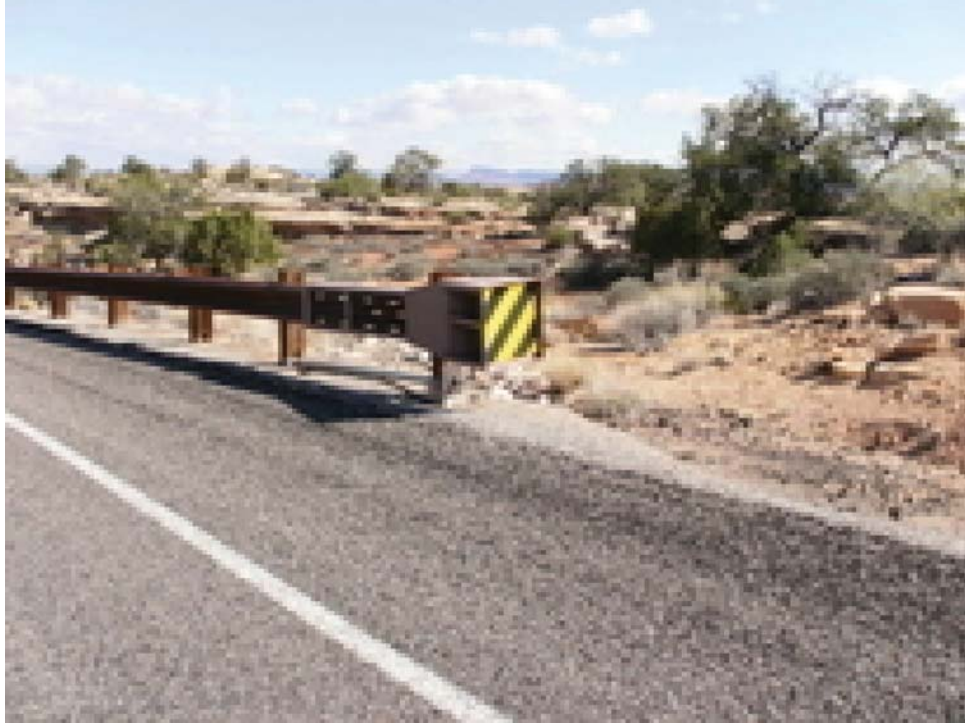
CANY_0010_20.781_R_1.JPG

Barrier ID:	CANY-0010-20.781-R				
Route Name:	NEEDLES ACCESS ROAD				
Inspection Date:	04/13/2010	Barrier Rating:	33.70		
Barrier Description					
Type:	W-BEAM STRONG POST	Barrier Function:	TRAFFIC		
Barrier Material:	WEATHERING STEEL/CORTEN	Post Material:	WOOD		
Blockout Type:	WOOD	Length (ft.):	634		
Speed Limit (MPH):	35	Placement with Respect to Road:	OUTSIDE OF CURVE		
Hazard Behind Barrier:	MEDIUM				
Barrier Crashworthiness					
Appropriate Test Level:	TL-2	Barrier Test Level:	TL-3	Is Barrier Crashworthy?:	YES
Beg. End Trtmt Type:	W-BEAM TANGENT 350	Is Beg. End Trtmt Crashworthy?:	YES	Approach Transition Type:	NONE
Ending End Trtmt Type:	W-BEAM FLARED 350 COMPLIANT	Ending End Trtmt Crashworthy?:	YES		
Average Measurements					
Design Height (In.):	27	Width (In.):	0.0	Post Spacing (In.):	75.8
Height (In.):	26.2	Lateral Offset (In.):	77.3	Road Grade (%):	6.30
Physical Condition					
Barrier	Alignment and Height:	Alignment of barrier is acceptable. No evidence of prior impact. 30ft. is 1-3 in below 27-in. design height.

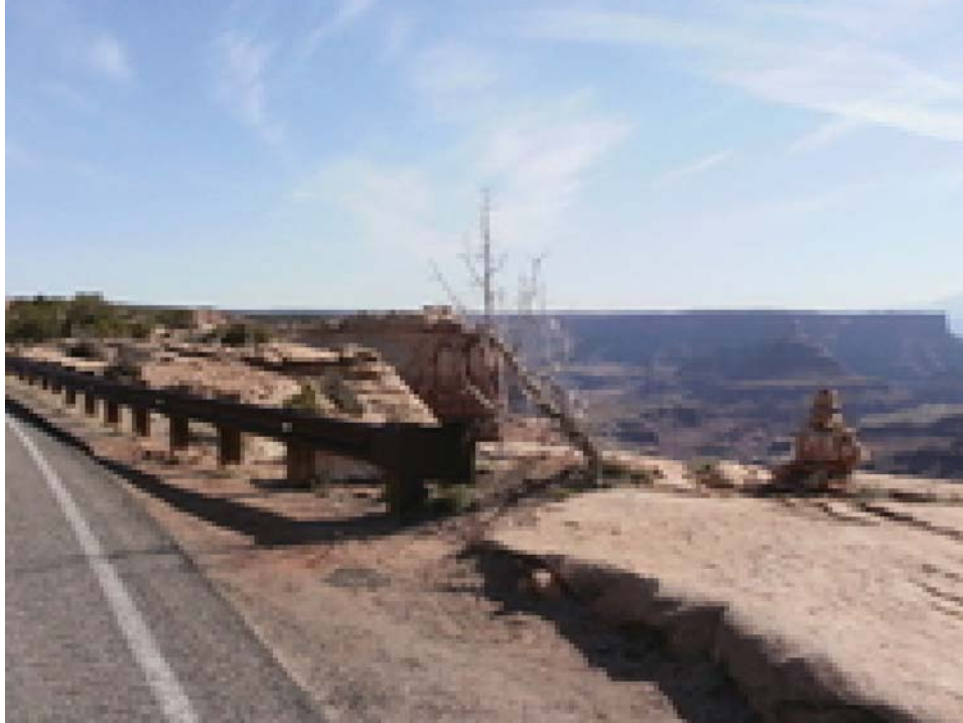
CANY_0011_7.471_L_1.JPG

Barrier ID:	CANY-0011-7.471-L				
Route Name:	ISLAND IN THE SKY ROAD				
Inspection Date:	04/14/2010	Barrier Rating:	28.60		
Barrier Description					
Type:	W-BEAM STRONG POST	Barrier Function:	TRAFFIC		
Barrier Material:	WEATHERING STEEL/CORTEN	Post Material:	WOOD		
Blockout Type:	WOOD	Length (ft.):	154		
Speed Limit (MPH):	35	Placement with Respect to Road:	OUTSIDE OF CURVE		
Hazard Behind Barrier:	EXTREME				
Barrier Crashworthiness					
Appropriate Test Level:	TL-2	Barrier Test Level:	TL-3	Is Barrier Crashworthy?:	YES
Beg. End Trtmt Type:	W-BEAM BCT	Is Beg. End Trtmt Crashworthy?:	NO	Approach Transition Type:	NONE
Ending End Trtmt Type:	W-BEAM BCT	Ending End Trtmt Crashworthy?:	NO		
Average Measurements					
Design Height (In.):	27	Width (In.):	0.0	Post Spacing (In.):	75.0
Height (In.):	28.0	Lateral Offset (In.):	42.2	Road Grade (%):	0.80
Physical Condition					
Barrier	Alignment and Height:	Alignment acceptable. Height within 1-in of 27-in design height.

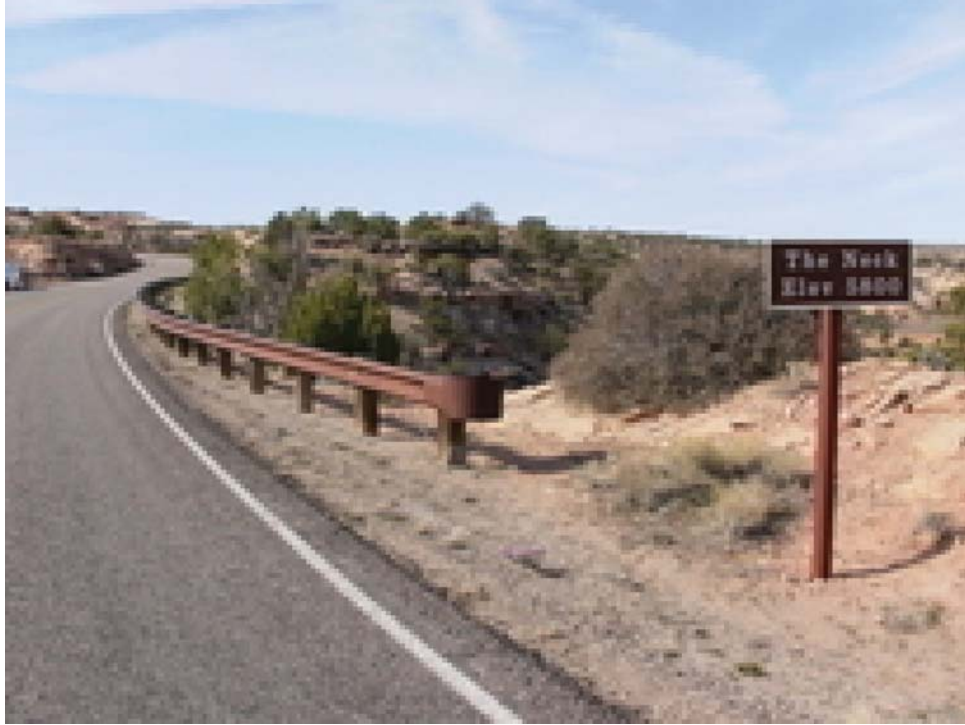
CANY_0011_7.472_R_1.JPG

Barrier ID:	CANY-0011-7.472-R				
Route Name:	ISLAND IN THE SKY ROAD				
Inspection Date:	04/14/2010	Barrier Rating:	22.80		
Barrier Description					
Type:	W-BEAM STRONG POST	Barrier Function:	TRAFFIC		
Barrier Material:	WEATHERING STEEL/CORTEN	Post Material:	WOOD		
Blockout Type:	WOOD	Length (ft.):	205		
Speed Limit (MPH):	35	Placement with Respect to Road:	INSIDE OF CURVE		
Hazard Behind Barrier:	EXTREME				
Barrier Crashworthiness					
Appropriate Test Level:	TL-2	Barrier Test Level:	TL-3	Is Barrier Crashworthy?:	YES
Beg. End Trtmt Type:	W-BEAM BCT	Is Beg. End Trtmt Crashworthy?:	NO	Approach Transition Type:	NONE
Ending End Trtmt Type:	W-BEAM BCT	Ending End Trtmt Crashworthy?:	NO		
Average Measurements					
Design Height (In.):	27	Width (In.):	0.0	Post Spacing (In.):	75.6
Height (In.):	26.7	Lateral Offset (In.):	34.7	Road Grade (%):	1.70
Physical Condition					
Barrier	Alignment and Height:	Alignment acceptable. Height within 1-in of 27-in design height.

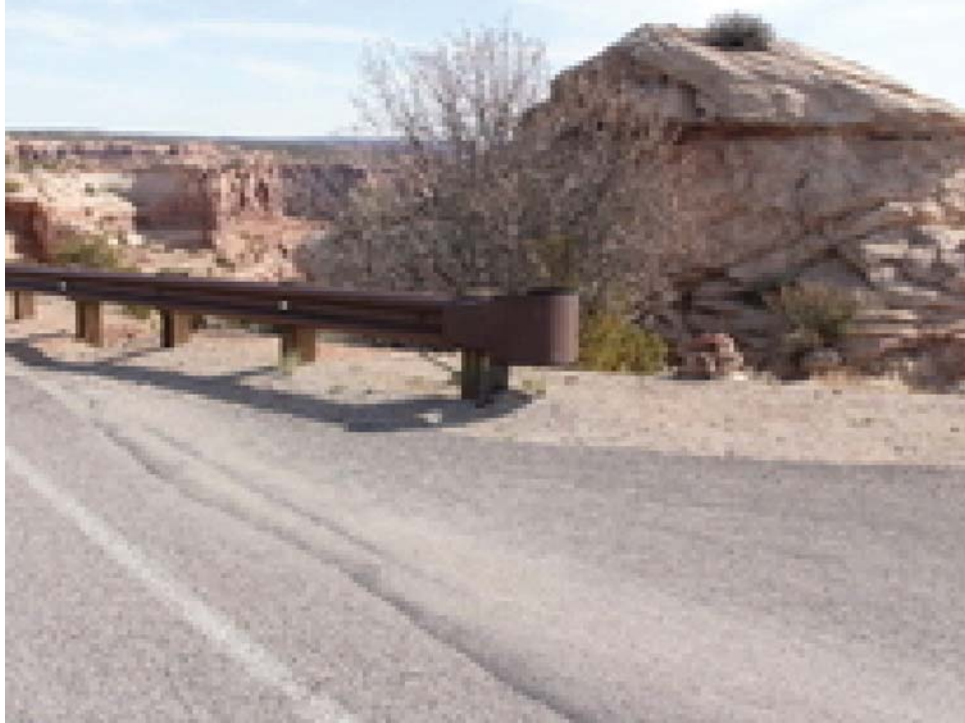
CANY_0011_7.619_L_1.JPG

Barrier ID:	CANY-0011-7.619-L				
Route Name:	ISLAND IN THE SKY ROAD				
Inspection Date:	04/14/2010	Barrier Rating:	24.20		
Barrier Description					
Type:	W-BEAM STRONG POST	Barrier Function:	TRAFFIC		
Barrier Material:	WEATHERING STEEL/CORTEN	Post Material:	WOOD		
Blockout Type:	WOOD	Length (ft.):	181		
Speed Limit (MPH):	35	Placement with Respect to Road:	TANGENT		
Hazard Behind Barrier:	EXTREME				
Barrier Crashworthiness					
Appropriate Test Level:	TL-2	Barrier Test Level:	TL-3	Is Barrier Crashworthy?:	YES
Beg. End Trtmt Type:	W-BEAM BCT	Is Beg. End Trtmt Crashworthy?:	NO	Approach Transition Type:	NONE
Ending End Trtmt Type:	W-BEAM BCT	Ending End Trtmt Crashworthy?:	NO		
Average Measurements					
Design Height (In.):	27	Width (In.):	0.0	Post Spacing (In.):	75.0
Height (In.):	27.7	Lateral Offset (In.):	39.0	Road Grade (%):	4.40
Physical Condition					
Barrier	Alignment and Height:	Alignment acceptable. Height within 1-in of 27-in design height. No evidence of impact.

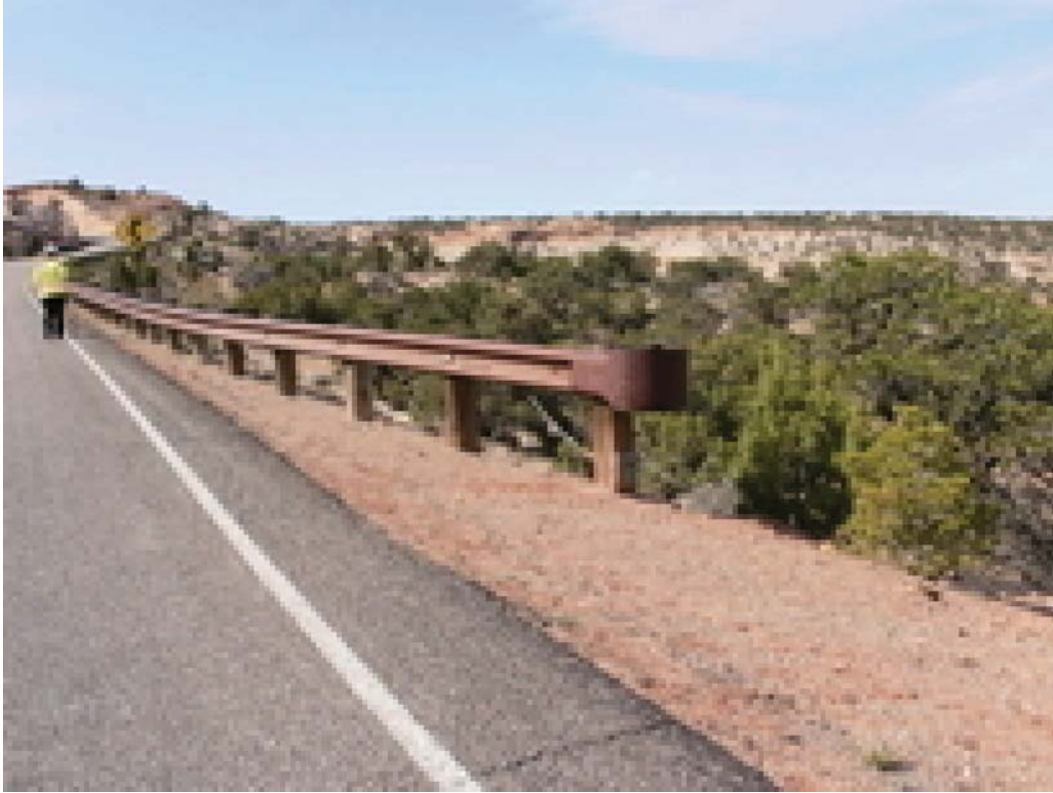
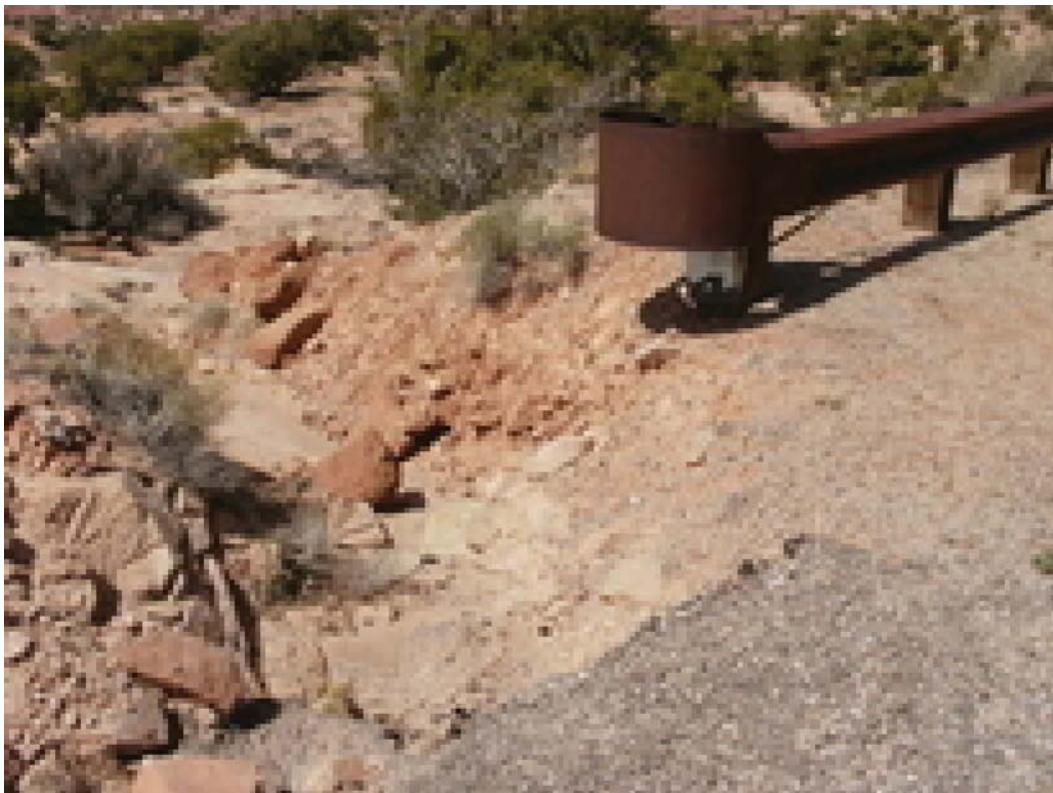
CANY_0011_7.622_R_1.JPG

Barrier ID:	CANY-0011-7.622-R				
Route Name:	ISLAND IN THE SKY ROAD				
Inspection Date:	04/14/2010	Barrier Rating:	32.40		
Barrier Description					
Type:	W-BEAM STRONG POST	Barrier Function:	TRAFFIC		
Barrier Material:	WEATHERING STEEL/CORTEN	Post Material:	WOOD		
Blockout Type:	WOOD	Length (ft.):	632		
Speed Limit (MPH):	35	Placement with Respect to Road:	BOTH INSIDE AND OUTSIDE		
Hazard Behind Barrier:	MEDIUM				
Barrier Crashworthiness					
Appropriate Test Level:	TL-2	Barrier Test Level:	TL-3	Is Barrier Crashworthy?:	YES
Beg. End Trtmt Type:	W-BEAM BCT	Is Beg. End Trtmt Crashworthy?:	NO	Approach Transition Type:	NONE
Ending End Trtmt Type:	W-BEAM BCT	Ending End Trtmt Crashworthy?:	NO		
Average Measurements					
Design Height (In.):	27	Width (In.):	0.0	Post Spacing (In.):	75.0
Height (In.):	26.2	Lateral Offset (In.):	40.7	Road Grade (%):	5.80
Physical Condition					
Barrier	Alignment and Height:	Alignment is acceptable. One minor impact at rail. 213 lf in middle of barrier is 1-3 in below 27-in. design height.
