# CHIR GIP Report

## NPS Guardwall/Rail Inventory Program Chiricahua National Monument

**Federal Highway Administration  
Eastern Federal Lands Highway Division  
Road Inventory Program (RIP)**

**Data Collection Date: March 2010  
Report Date: November 2015**

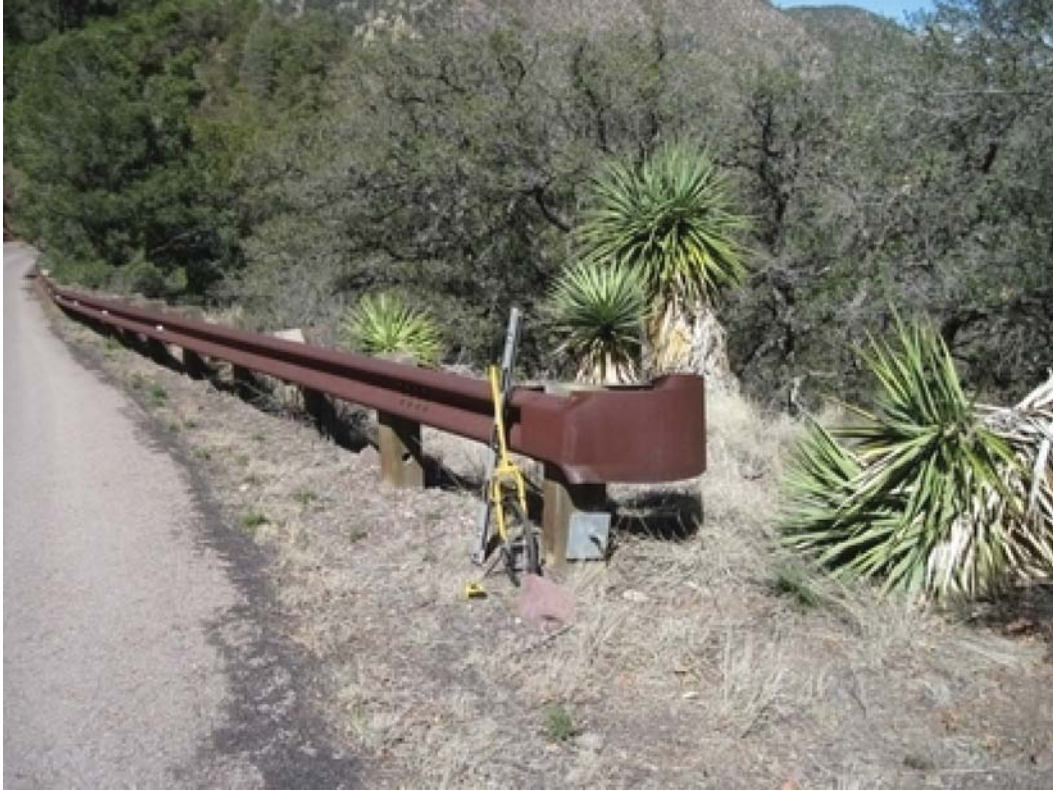
**CHIR\_0010\_5.790\_L\_1.jpg**

| | <b>Breaking and Cracking:</b> | The barrier shows no signs of breaking or cracking however there is minor cracking of the wood posts, but they are still in good condition. Some of the blockouts are twisted, but do not require replacement. | | | |

| <b>Repair Action:</b> | REPAIR | <b>FMSS Work Type:</b> | DEFERRED MAINTENANCE | <b>Repair Cost:</b> | \$3174 |

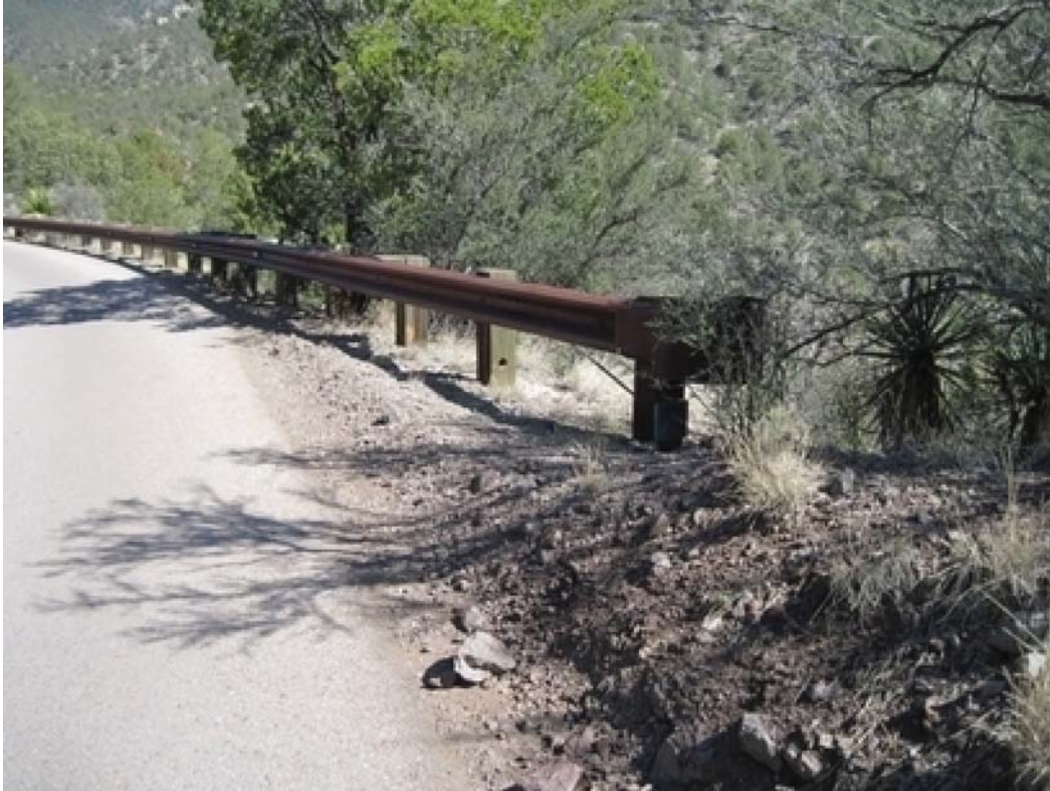
**CHIR\_0010\_5.865\_L\_1.jpg**

| | <b>Breaking and Cracking:</b> | 3 blocks exhibit large cracking and sideways rotation. 1 (12.5') rail section is bent. | | | |

| <b>Brief Workorder:</b> | Raise 30 L.F. of barrier up to 27-in. design height. Replace 13-ft. of rail and 3 blocks. | | | | |
| <b>Workorder:</b> | Adjust Guardrail at \$10- per -Lin. Ft. for 30 LF = \$300. Raise 30 ft of guardrail up to 27-in. design height.<br>Replace Block at \$30- per -Each for 3 Block(s) = \$90. Replace 3 cracked/rotated blocks.<br>Replace Rail at \$25- per -Lin. Ft. for 13 LF = \$325. Replace 13 ft of bent rail.<br>Low Speed Traffic Control at \$1475- per -Day for 1 Day(s) = \$1475. | | | | |

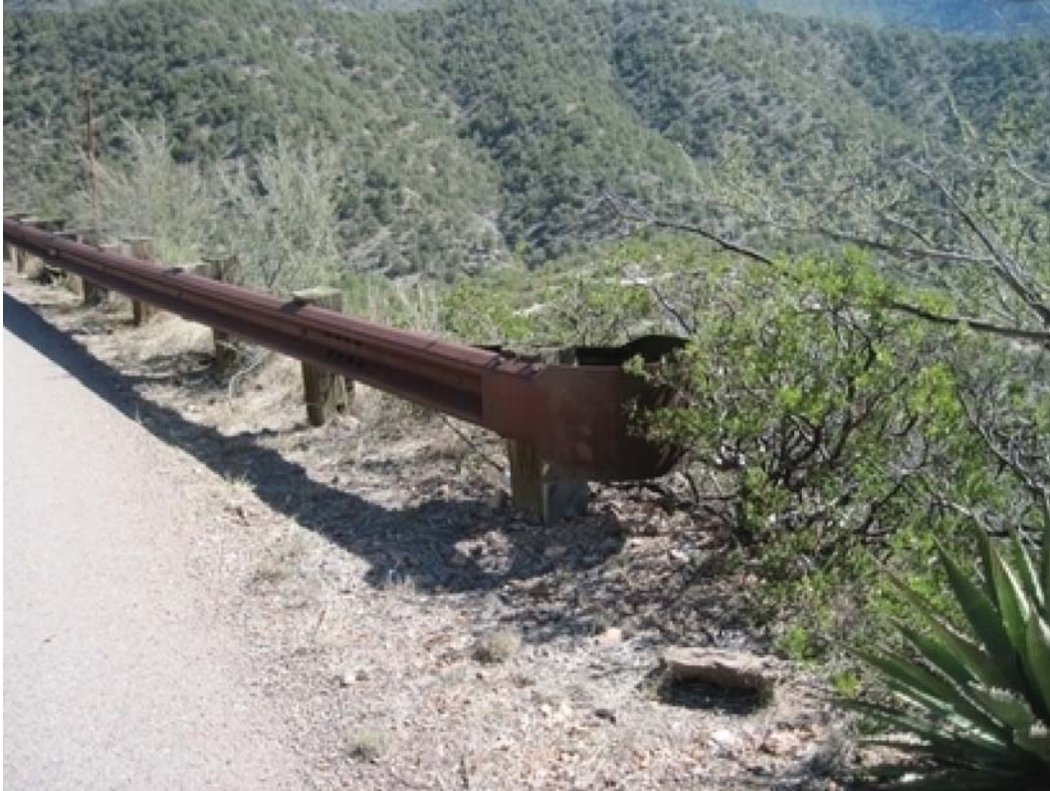
**CHIR\_0010\_5.910\_L\_1.jpg**

| | <b>Breaking and Cracking:</b> | The is minor cracking in the wood posts but they are functioning as designed. 1 blockout is cracked in half. | | | |

| <b>Brief Workorder:</b> | Raise 292 L.F. of barrier up to 27-in. design height and replace one block. | | | | |
| <b>Workorder:</b> | Adjust Guardrail at \$10- per -Lin. Ft. for 292 LF = \$2920. Raise 292-ft. of barrier up to 27-in. design height.<br>Replace Block at \$30- per -Each for 1 Block(s) = \$30. Replace one blockout cracked in half.<br>Low Speed Traffic Control at \$1475- per -Day for 2 Day(s) = \$2950. | | | | |

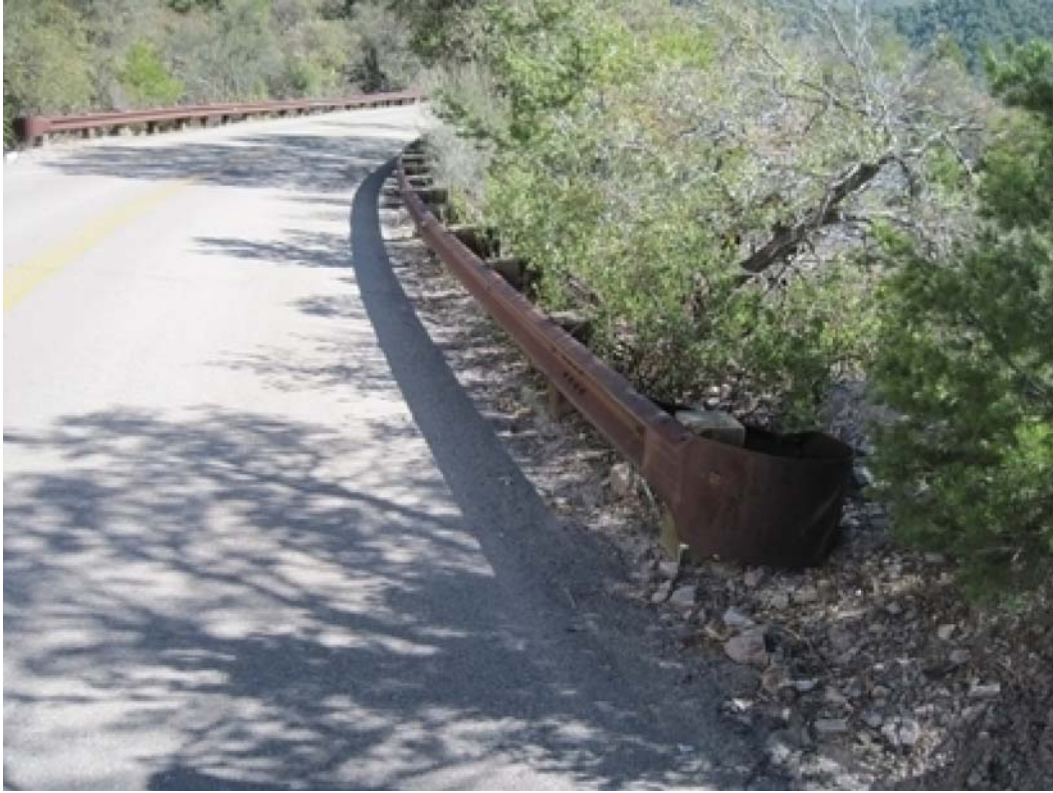
**CHIR\_0010\_6.118\_L\_1.jpg**

| | <b>Breaking and Cracking:</b> | Four blocks are badly cracked. 12.5 ft of rail is bent. | | | |

| <b>Brief Workorder:</b> | Adjust the height of the entire 191 L.F. of barrier up to 27-in. design height and replace 4 damaged blocks and 13 L.F. of rail. | | | | |
| <b>Workorder:</b> | Adjust Guardrail at \$10- per -Lin. Ft. for 191 LF = \$1910. Raise 191-ft. of barrier up to 27-in. design height.<br>Replace Block at \$30- per -Each for 4 Block(s) = \$120. Replace the 4 damaged blocks.<br>Replace Rail at \$25- per -Lin. Ft. for 13 LF = \$325. Replace the 12.5 ft of damaged rail.<br>Low Speed Traffic Control at \$1475- per -Day for 1 Day(s) = \$1475. | | | | |

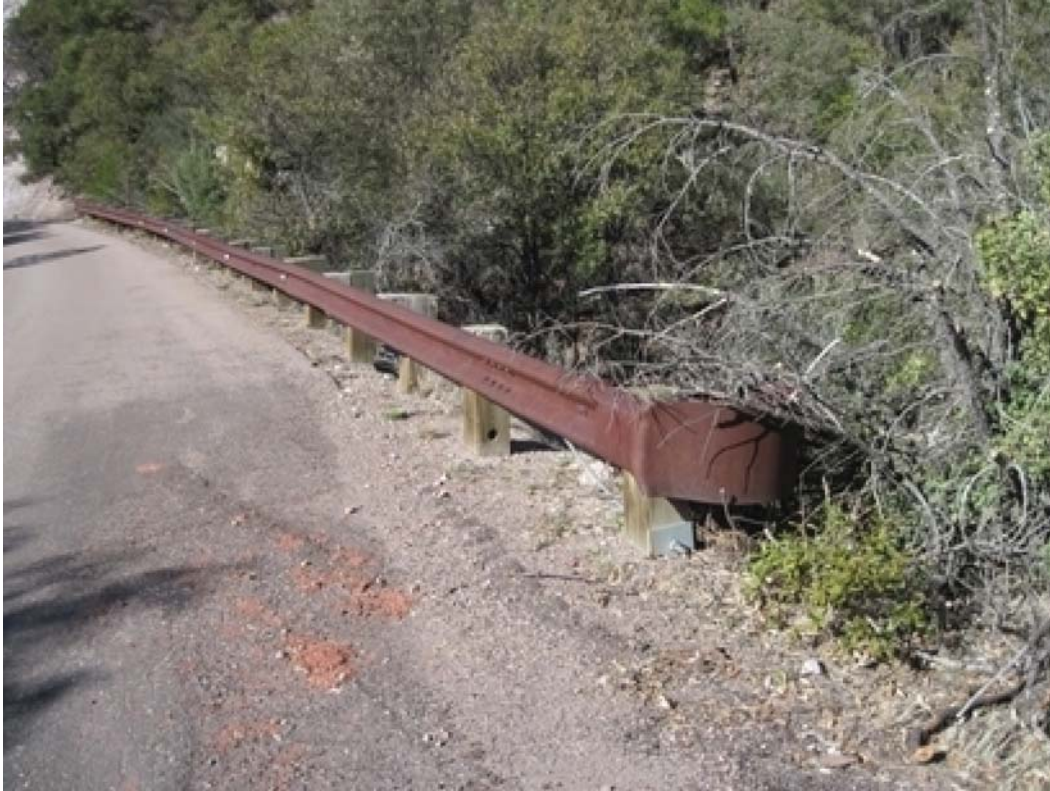
**CHIR\_0010\_6.122\_R\_1.jpg**

| | <b>Breaking and Cracking:</b> | Minor cracking in posts and blocks. | | | |
| | <b>Breaking and Cracking:</b> | 12-ft. of the beginning end treatment has a bent rail. | | | |

| <b>Brief Workorder:</b> | Raise 30 L.F. of barrier up to 27-in. design height and replace 12 feet of rail. | | | | |
| <b>Workorder:</b> | Adjust Guardrail at \$10- per -Lin. Ft. for 30 LF = \$300. Raise 30 ft of guardrail up to 27-in. design height.<br>Replace Rail at \$25- per -Lin. Ft. for 12 LF = \$300. Replace beginning buffer terminal.<br>Low Speed Traffic Control at \$1475- per -Day for 1 Day(s) = \$1475. | | | | |

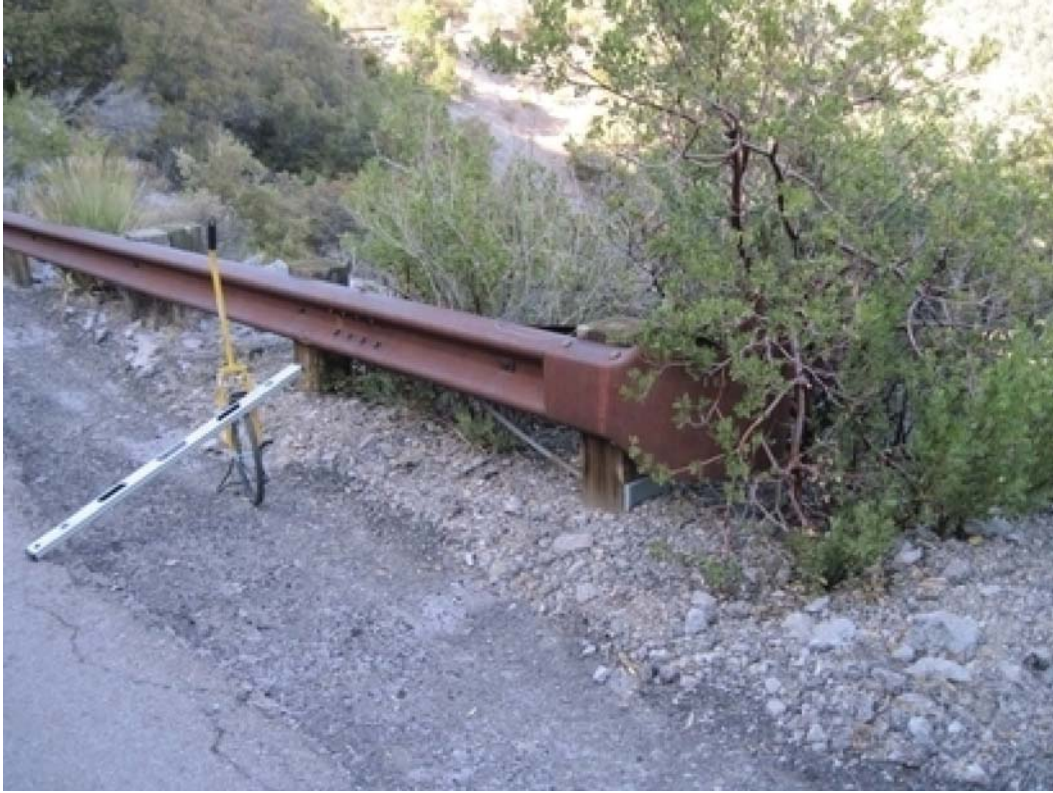
**CHIR\_0010\_6.174\_R\_1.jpg**

| | <b>Breaking and Cracking:</b> | There is 12.5 ft of rail that is bent. | | | |

| <b>Brief Workorder:</b> | Raise 65 L.F. of barrier up to 27-in. design height and replace 13 feet of rail. | | | | |
| <b>Workorder:</b> | Adjust Guardrail at \$10- per -Lin. Ft. for 65 LF = \$650. Raise 65 ft. of barrier up to 27-in. design height.<br>Replace Rail at \$25- per -Lin. Ft. for 13 LF = \$325. Replace 13 feet of damaged rail.<br>Low Speed Traffic Control at \$1475- per -Day for 1 Day(s) = \$1475. | | | | |

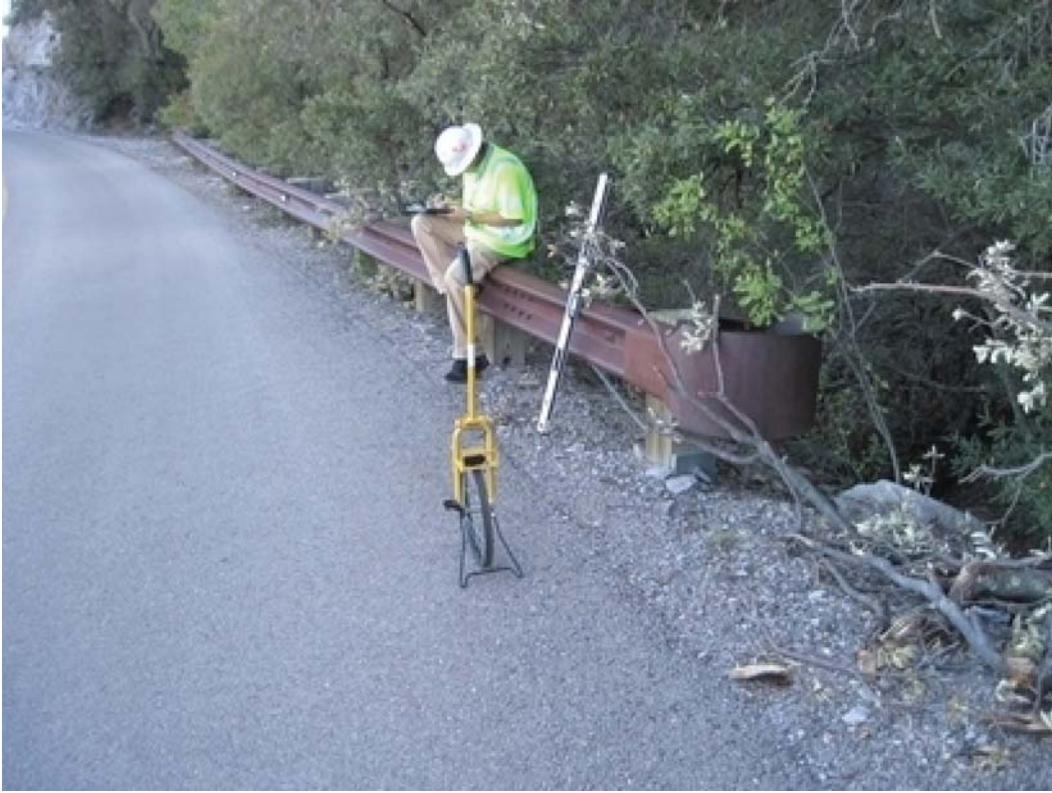
**CHIR\_0010\_6.182\_L\_1.jpg**

| | <b>Breaking and Cracking:</b> | There is 1 turned block. | | | |

| <b>Brief Workorder:</b> | Raise 130 L.F. of barrier up to 27-in. design height and replace one damaged blockout. | | | | |
| <b>Workorder:</b> | Adjust Guardrail at \$10- per -Lin. Ft. for 130 LF = \$1300. Raise 130 ft. of barrier up to 27-in. design height.<br>Replace Block at \$30- per -Each for 1 Block(s) = \$30. Replace one blockout.<br>Low Speed Traffic Control at \$1475- per -Day for 1 Day(s) = \$1475. | | | | |

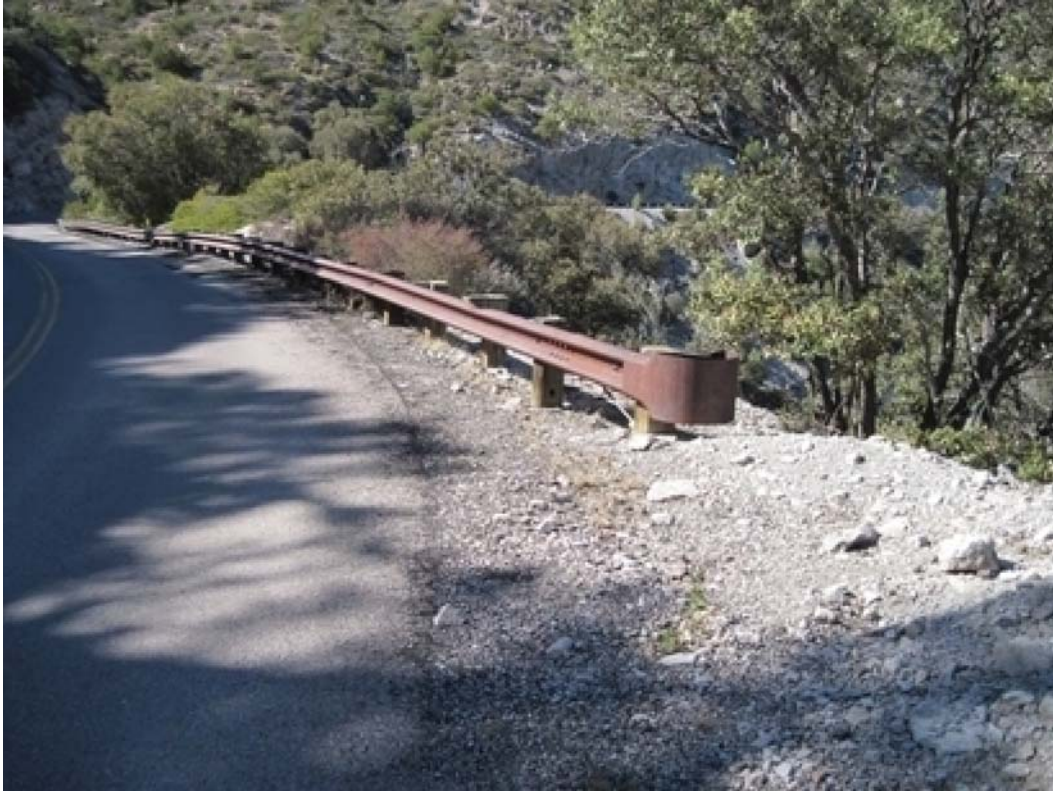
**CHIR\_0010\_6.357\_L\_1.jpg**

| | <b>Breaking and Cracking:</b> | 36-ft. of rail is bent 25 blocks and 11 posts are severely damaged. | | | |
| | <b>Missing Elements:</b> | There are 4 missing bolts all at the connection of the same two rail pieces. | | | |
| | <b>Breaking and Cracking:</b> | 1 (12.5 ft) section of rail in the ending end treatment has severe cracking. | | | |

| <b>Brief Workorder:</b> | Raise 1883 L.F. of barrier up to 27-in. design height replace 52-ft. of rail and damaged/missing barrier items. | | | | |
| <b>Workorder:</b> | Adjust Guardrail at \$10- per -Lin. Ft. for 1883 LF = \$18830. Raise 1883 ft. of guardrail up to 27-in. design height.<br>Replace Block at \$30- per -Each for 25 Block(s) = \$750. Replace 25 cracked/rotated blocks.<br>Replace Post at \$100- per -Each for 11 Post(s) = \$1100. Replace 11 cracked posts.<br>Replace Rail at \$25- per -Lin. Ft. for 52 LF = \$1300. Replace 52 ft of bent rail.<br>Labor at \$60- per -Hour for 1 Hrs = \$60. Replace 4 missing bolts.<br>Low Speed Traffic Control at \$1475- per -Day for 9 Day(s) = \$13275. 8 days for adjustment; 1 day for repairs. | | | | |

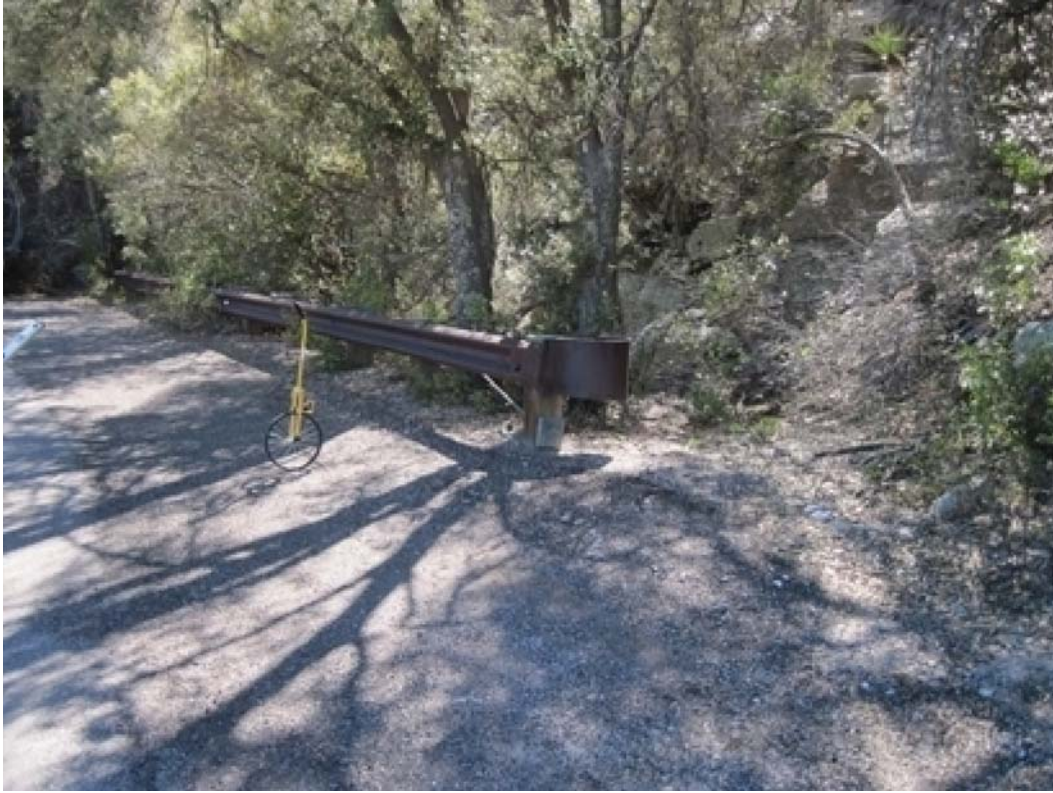
**CHIR\_0010\_6.625\_R\_1.jpg**

| | <b>Breaking and Cracking:</b> | There is no breaking or cracking along the length of the barrier. | | | |

| <b>Repair Action:</b> | REPAIR | <b>FMSS Work Type:</b> | DEFERRED MAINTENANCE | <b>Repair Cost:</b> | \$1953 |

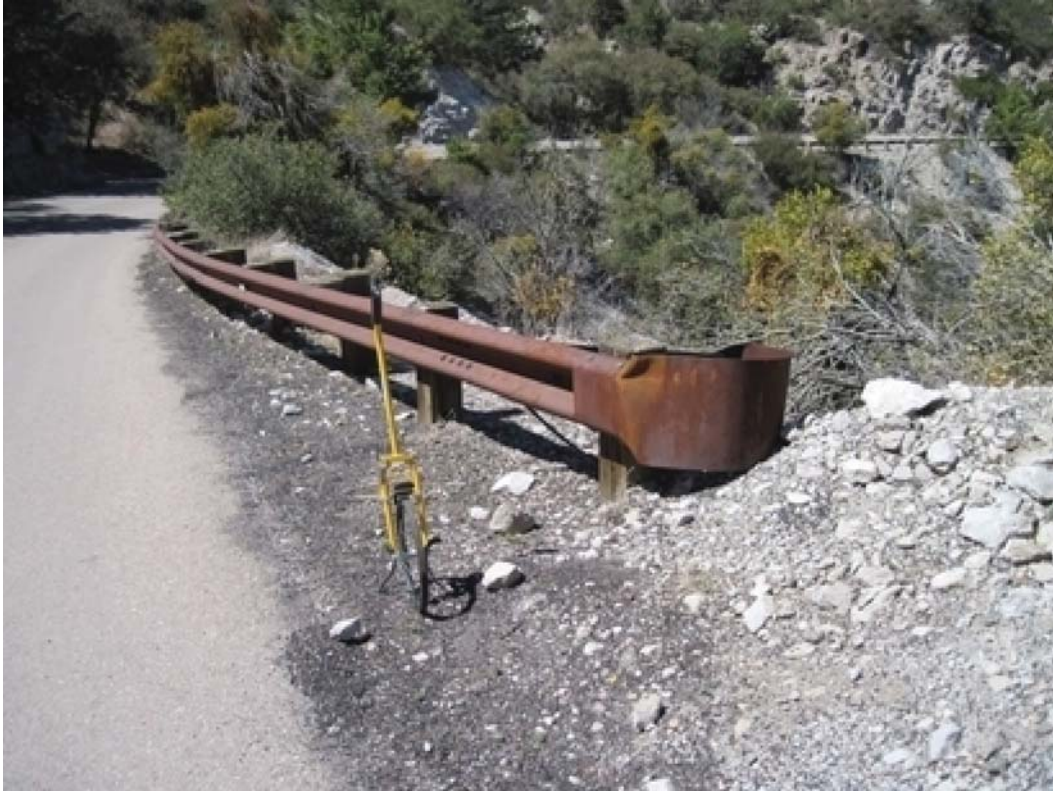
**CHIR\_0010\_6.826\_L\_1.jpg**

| | <b>Breaking and Cracking:</b> | There are 12 blocks and 8 posts that are either severely cracked or broken. There is 62.5 ft of bent rail. | | | |
