COLM GIP Report

NPS Guardwall/Rail Inventory Program Colorado National Monument

**Federal Lands Highway
Road Inventory Program**

Data Collection Date: March 2011
Report Date: November 2015

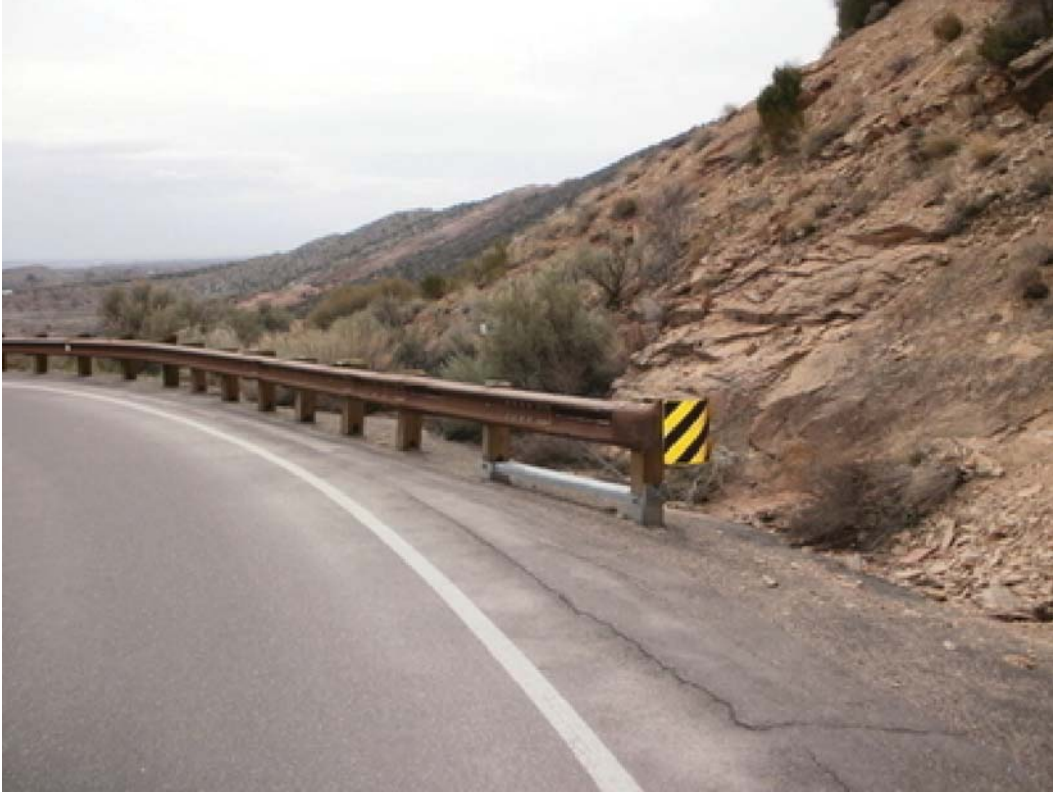
COLM_0010_0.738_L_1.JPG

Barrier ID:	COLM-0010-0.738-L				
Route Name:	RIMROCK DRIVE				
Inspection Date:	05/04/2010	Barrier Rating:	34.40		
Barrier Description					
Type:	W-BEAM STRONG POST	Barrier Function:	TRAFFIC		
Barrier Material:	WEATHERING STEEL/CORTEN	Post Material:	WOOD		
Blockout Type:	WOOD	Length (ft.):	386		
Speed Limit (MPH):	25	Placement with Respect to Road:	OUTSIDE OF CURVE		
Hazard Behind Barrier:	EXTREME				
Barrier Crashworthiness					
Appropriate Test Level:	TL-1	Barrier Test Level:	TL-3	Is Barrier Crashworthy?:	YES
Beg. End Trtmt Type:	W-BEAM TANGENT 350	Is Beg. End Trtmt Crashworthy?:	YES	Approach Transition Type:	NONE
Ending End Trtmt Type:	W-BEAM TANGENT 350	Ending End Trtmt Crashworthy?:	YES		
Average Measurements					
Design Height (In.):	27	Width (In.):	0.0	Post Spacing (In.):	75.6
Height (In.):	29.2	Lateral Offset (In.):	41.7	Road Grade (%):	4.20
Physical Condition					
Barrier	Alignment and Height:	Alignment acceptable. Height was 2 to 3-in above the 27-in design height.

Breaking and Cracking:	No breaking or cracking of barrier elements.			
	Missing Elements:	No missing barrier elements.			
	Corrosion and Weathering:	No corrosion of barrier elements. No erosion along back of barrier.			
End Treatments	Alignment and Height:	Alignment acceptable. Height within 1-in of 27-in design height.			
	Breaking and Cracking:	No breaking or cracking of end treatments.			
	Missing Elements:	No missing end treatment elements.			
	Corrosion and Weathering:	No corrosion/weathering of end treatment elements.

Barrier ID:	COLM-0010-0.738-L				
Route Name:	RIMROCK DRIVE				
Inspection Date:	05/04/2010	Barrier Rating:		34.40	
Repair Recommendations					
Repair Action:	NO ACTION	FMSS Work Type:	N/A	Repair Cost:	\$0
Brief Workorder:	N/A				
Workorder:

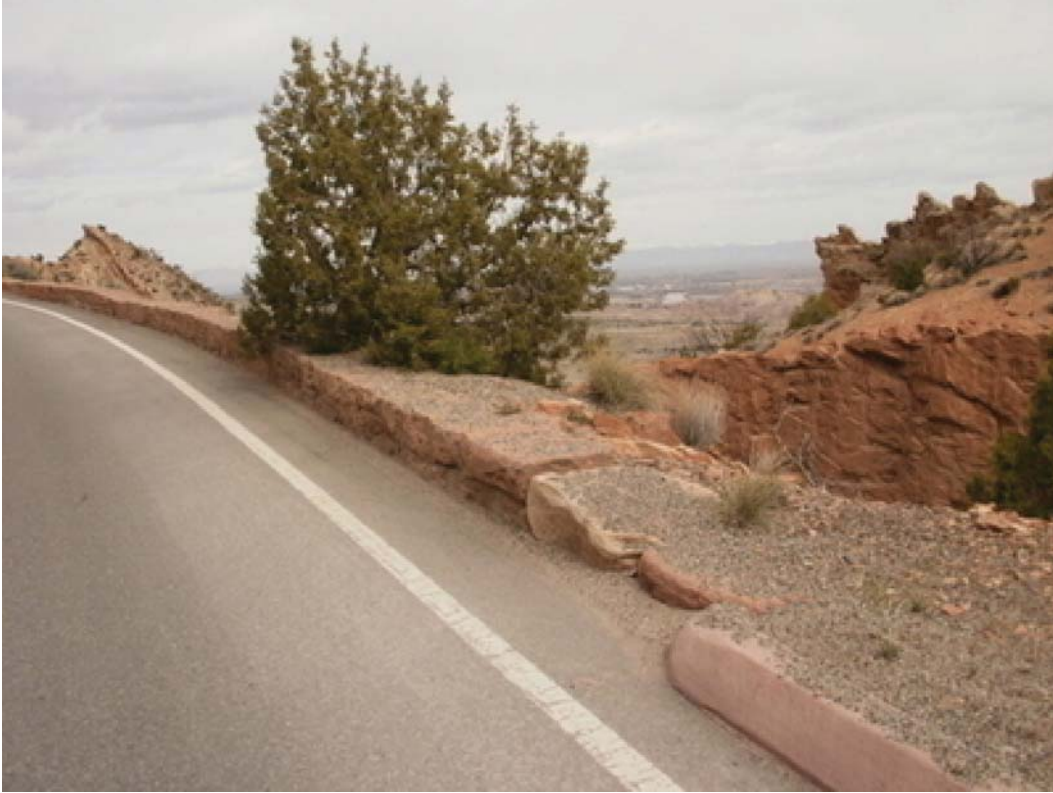
COLM_0010_0.836_R_1.JPG

Barrier ID:	COLM-0010-0.836-R				
Route Name:	RIMROCK DRIVE				
Inspection Date:	05/04/2010	Barrier Rating:	54.90		
Barrier Description					
Type:	STONE MASONRY WITHOUT CONCRETE CORE WALL	Barrier Function:	TRAFFIC		
Barrier Material:	STONE	Post Material:	N/A		
Blockout Type:	N/A	Length (ft.):	101		
Speed Limit (MPH):	25	Placement with Respect to Road:	OUTSIDE OF CURVE		
Hazard Behind Barrier:	HIGH				
Barrier Crashworthiness					
Appropriate Test Level:	TL-1	Barrier Test Level:	NCW	Is Barrier Crashworthy?:	NO
Beg. End Trtmt Type:	NONE	Is Beg. End Trtmt Crashworthy?:	N/A	Approach Transition Type:	NONE
Ending End Trtmt Type:	NONE	Ending End Trtmt Crashworthy?:	N/A		
Average Measurements					
Design Height (In.):	24	Width (In.):	20.7	Post Spacing (In.):	0.0
Height (In.):	13.8	Lateral Offset (In.):	18.7	Road Grade (%):	5.30
Physical Condition					
Barrier	Alignment and Height:	Alignment acceptable. Height was 7 to 12-in below 24-in design height.

Breaking and Cracking:	No breaking or cracking in barrier.			
	Missing Elements:	1 square yard of missing grout in barrier			
	Corrosion and Weathering:	No weathering in barrier.			
End Treatments	Alignment and Height:				
	Breaking and Cracking:				
	Missing Elements:				
	Corrosion and Weathering:

Repair Action:	REPAIR	FMSS Work Type:	DEFERRED MAINTENANCE	Repair Cost:	\$114813
Brief Workorder:	Raise guardwall 10-in. Remove and reset 101-ft of stone masonry guardwall on concrete footer to 24-in design height.				
Workorder:	Remove & Reset Stone Masonry Guardwall at \$250- per -Cu. Ft. for 364 CF = \$91000. (2ft)(1.8ft)(101ft) = 364 CF Structural Concrete at \$1000- per -Cu. Yd. for 6 CY = \$6000. [(0.8ft)(1.8ft)(101ft)]/27 = 5.2 CY Low Speed Traffic Control at \$1475- per -Day for 5 Day(s) = \$7375. 1 day removal and 4 days installation.

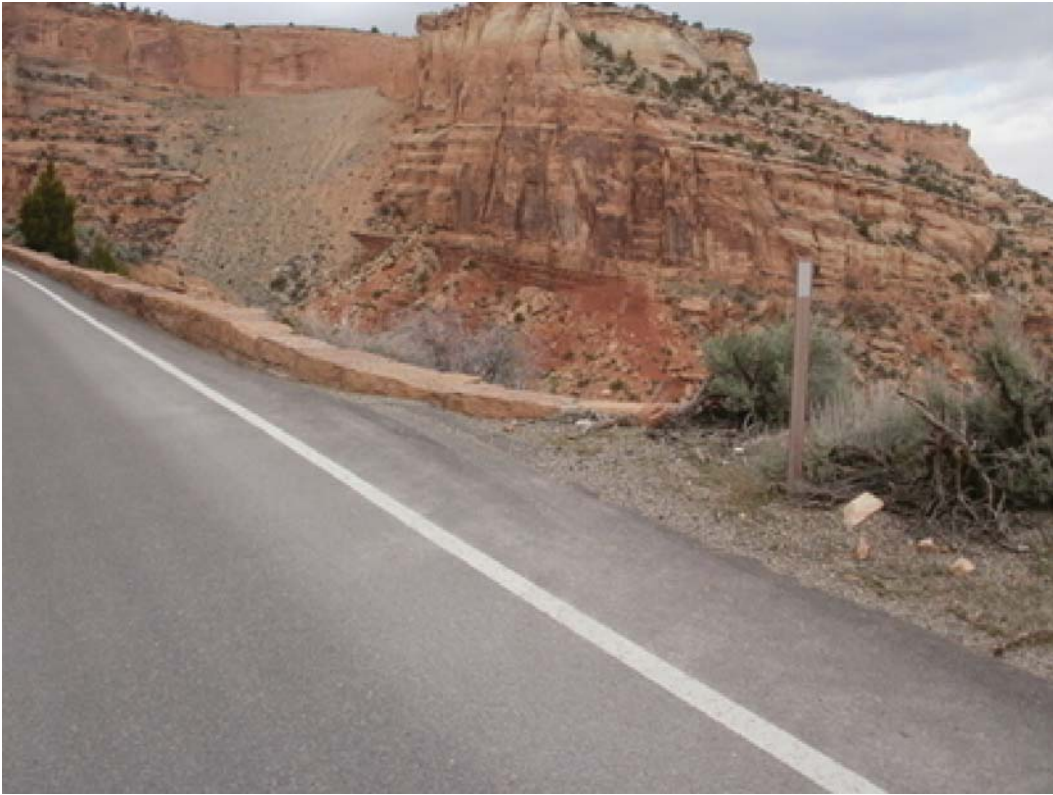
COLM_0010_1.082_R_1.JPG

Barrier ID:	COLM-0010-1.082-R				
Route Name:	RIMROCK DRIVE				
Inspection Date:	05/04/2010	Barrier Rating:	56.50		
Barrier Description					
Type:	STONE MASONRY WITHOUT CONCRETE CORE WALL	Barrier Function:	TRAFFIC		
Barrier Material:	STONE	Post Material:	N/A		
Blockout Type:	N/A	Length (ft.):	137		
Speed Limit (MPH):	25	Placement with Respect to Road:	OUTSIDE OF CURVE		
Hazard Behind Barrier:	EXTREME				
Barrier Crashworthiness					
Appropriate Test Level:	TL-1	Barrier Test Level:	NCW	Is Barrier Crashworthy?:	NO
Beg. End Trtmt Type:	NONE	Is Beg. End Trtmt Crashworthy?:	N/A	Approach Transition Type:	NONE
Ending End Trtmt Type:	NONE	Ending End Trtmt Crashworthy?:	N/A		
Average Measurements					
Design Height (In.):	24	Width (In.):	18.7	Post Spacing (In.):	0.0
Height (In.):	14.0	Lateral Offset (In.):	21.2	Road Grade (%):	4.90
Physical Condition					
Barrier	Alignment and Height:	Alignment acceptable. Height was 7 to 13-in below 24-in design height.

Breaking and Cracking:	Minor cracking of mortar (less than 1/4 in). No broken rocks in barrier.			
	Missing Elements:	No missing barrier elements.			
	Corrosion and Weathering:	No erosion along back of barrier.			
End Treatments	Alignment and Height:				
	Breaking and Cracking:				
	Missing Elements:				
	Corrosion and Weathering:

Repair Action:	REPAIR	FMSS Work Type:	DEFERRED MAINTENANCE	Repair Cost:	\$141130
Brief Workorder:	Raise guardwall 10-in. Remove and reset 137-ft of stone masonry guardwall on concrete footer to 24-in design height.				
Workorder:	Remove & Reset Stone Masonry Guardwall at \$250- per -Cu. Ft. for 438 CF = \$109500. (1.6ft)(2ft)(137ft) = 438 CF Structural Concrete at \$1000- per -Cu. Yd. for 7 CY = \$7000. [(1.6ft)(0.8ft)(137ft)]/27 = 6.5 CY Low Speed Traffic Control at \$1475- per -Day for 8 Day(s) = \$11800. 2 days removal and 6 days installation.

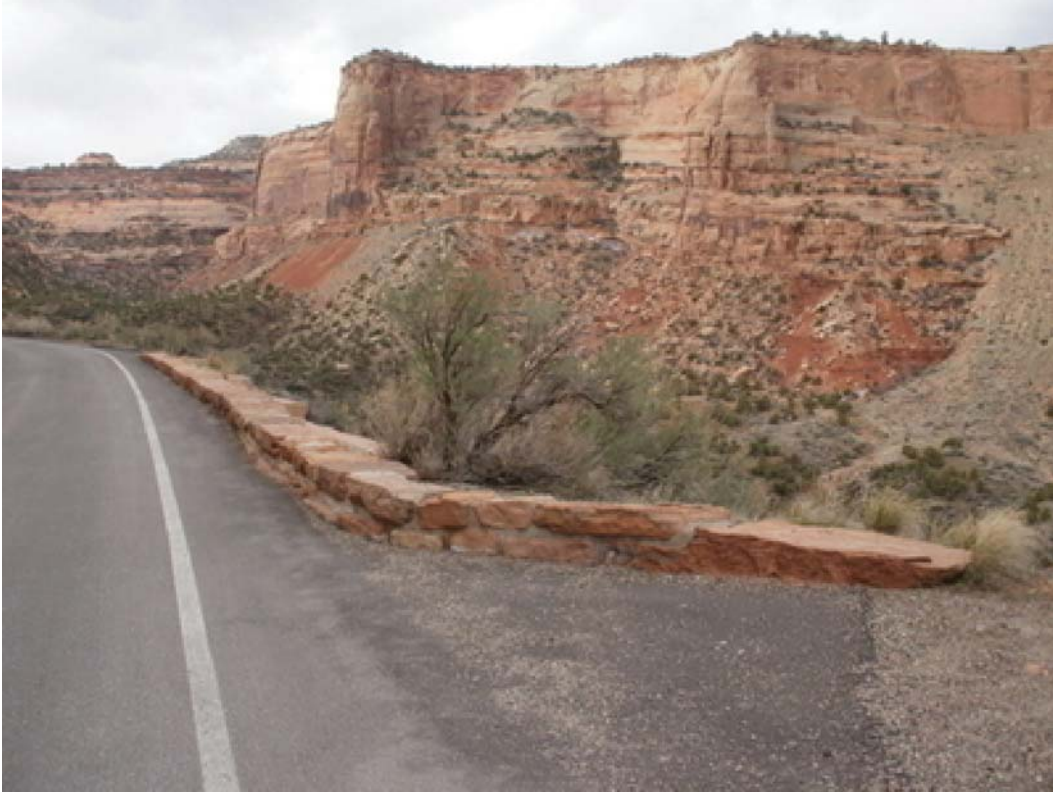
COLM_0010_1.144_R_1.JPG

Barrier ID:	COLM-0010-1.144-R				
Route Name:	RIMROCK DRIVE				
Inspection Date:	05/04/2010	Barrier Rating:	45.20		
Barrier Description					
Type:	STONE MASONRY WITHOUT CONCRETE CORE WALL	Barrier Function:	TRAFFIC		
Barrier Material:	STONE	Post Material:	N/A		
Blockout Type:	N/A	Length (ft.):	99		
Speed Limit (MPH):	25	Placement with Respect to Road:	TANGENT		
Hazard Behind Barrier:	EXTREME				
Barrier Crashworthiness					
Appropriate Test Level:	TL-1	Barrier Test Level:	NCW	Is Barrier Crashworthy?:	NO
Beg. End Trtmt Type:	NONE	Is Beg. End Trtmt Crashworthy?:	N/A	Approach Transition Type:	NONE
Ending End Trtmt Type:	NONE	Ending End Trtmt Crashworthy?:	N/A		
Average Measurements					
Design Height (In.):	24	Width (In.):	21.2	Post Spacing (In.):	0.0
Height (In.):	12.6	Lateral Offset (In.):	29.7	Road Grade (%):	4.50
Physical Condition					
Barrier	Alignment and Height:	Alignment acceptable. Height was 8 to 14-in below 24-in design height.

Breaking and Cracking:	Minor spalling of rocks and mortar within barrier.			
	Missing Elements:	No missing rocks or mortar in barrier.			
	Corrosion and Weathering:	No erosion along back of barrier.			
End Treatments	Alignment and Height:				
	Breaking and Cracking:				
	Missing Elements:				
	Corrosion and Weathering:

Repair Action:	REPAIR	FMSS Work Type:	DEFERRED MAINTENANCE	Repair Cost:	\$112888
Brief Workorder:	Raise guardwall 11 inches. Remove and reset 99-ft stone masonry guardwall on concrete footer to 24-in design height.				
Workorder:	Remove & Reset Stone Masonry Guardwall at \$250- per -Cu. Ft. for 357 CF = \$89250. (2ft)(1.8ft)(99ft) = 356.4 CF Structural Concrete at \$1000- per -Cu. Yd. for 6 CY = \$6000. [(1.8ft)(0.9ft)(99ft)]/27 = 5.9 CY Low Speed Traffic Control at \$1475- per -Day for 5 Day(s) = \$7375. 1 day removal and 4 days installation

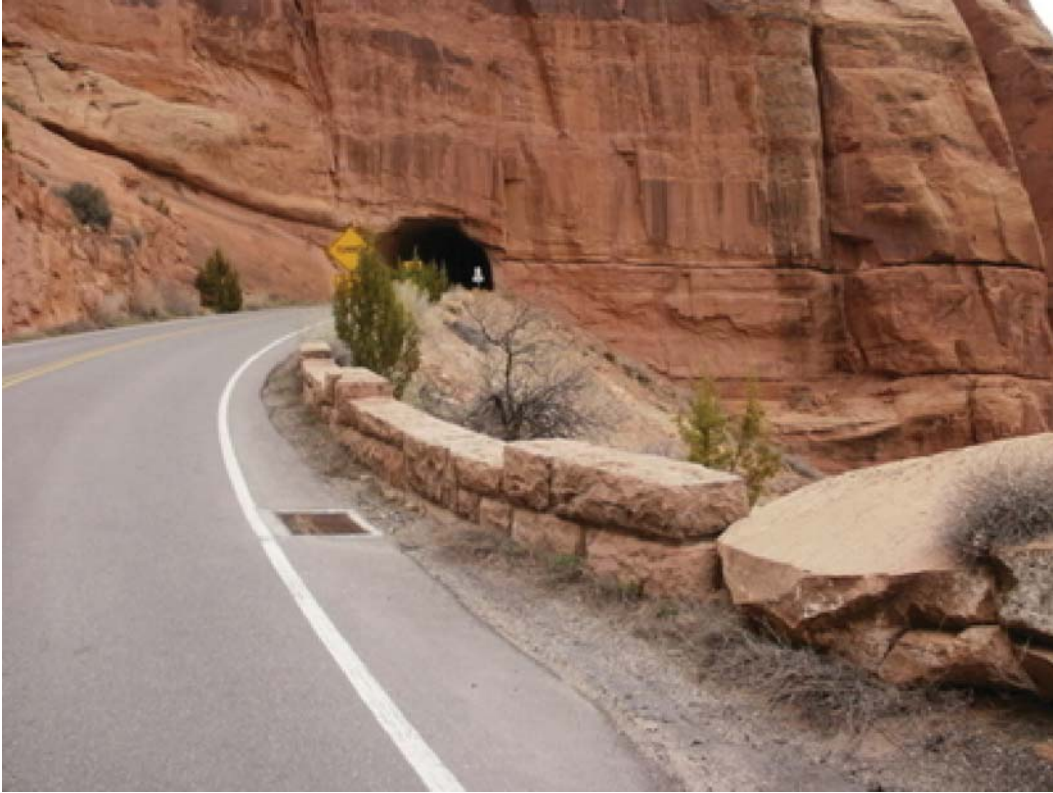
COLM_0010_2.100_R_1.JPG

Barrier ID:	COLM-0010-2.100-R				
Route Name:	RIMROCK DRIVE				
Inspection Date:	05/04/2010	Barrier Rating:	34.20		
Barrier Description					
Type:	STONE MASONRY CRENELLATED WITHOUT	Barrier Function:	TRAFFIC		
Barrier Material:	STONE	Post Material:	N/A		
Blockout Type:	N/A	Length (ft.):	48		
Speed Limit (MPH):	25	Placement with Respect to Road:	TANGENT		
Hazard Behind Barrier:	EXTREME				
Barrier Crashworthiness					
Appropriate Test Level:	TL-1	Barrier Test Level:	NCW	Is Barrier Crashworthy?:	NO
Beg. End Trtmt Type:	NONE	Is Beg. End Trtmt Crashworthy?:	N/A	Approach Transition Type:	NONE
Ending End Trtmt Type:	NONE	Ending End Trtmt Crashworthy?:	N/A		
Average Measurements					
Design Height (In.):	18	Width (In.):	19.0	Post Spacing (In.):	0.0
Height (In.):	19.2	Lateral Offset (In.):	47.2	Road Grade (%):	4.90
Physical Condition					
Barrier	Alignment and Height:	Alignment acceptable. Height was within 3-in of 18-in/24-in crenellated design height.

Breaking and Cracking:	No breaking or cracking in barrier.			
	Missing Elements:	Missing 2 square feet grout in barrier.			
	Corrosion and Weathering:	No weathering in barrier			
End Treatments	Alignment and Height:				
	Breaking and Cracking:				
	Missing Elements:				
	Corrosion and Weathering:

Repair Action:	REPAIR	FMSS Work Type:	DEFERRED MAINTENANCE	Repair Cost:	\$1777
Brief Workorder:	Repoint 1 SY of guardwall.				
Workorder:	Re-Point Masonry Barrier at \$140- per -Sq. Yd. for 1 SY = \$140. (2SF)/9 = 0.2 SY Low Speed Traffic Control at \$1475- per -Day for 1 Day(s) = \$1475.

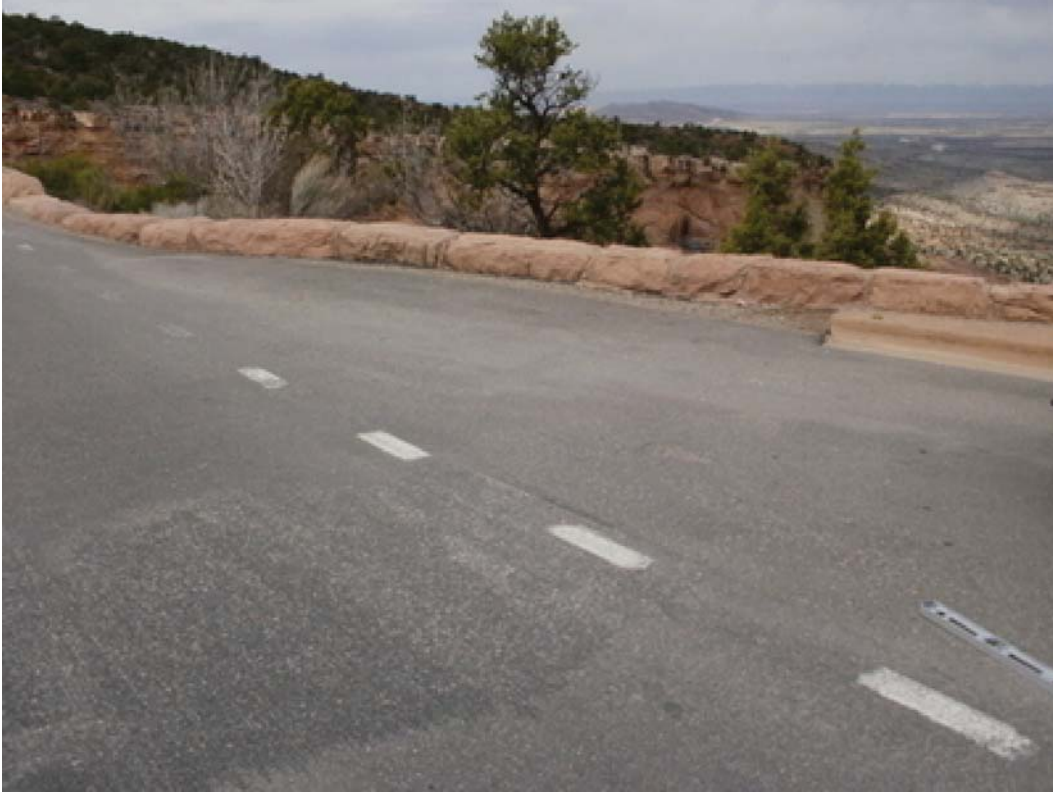
COLM_0010_2.525_R_1.JPG

Barrier ID:	COLM-0010-2.525-R				
Route Name:	RIMROCK DRIVE				
Inspection Date:	05/04/2010	Barrier Rating:	60.00		
Barrier Description					
Type:	STONE MASONRY WITHOUT CONCRETE CORE WALL	Barrier Function:	TRAFFIC		
Barrier Material:	STONE	Post Material:	N/A		
Blockout Type:	N/A	Length (ft.):	208		
Speed Limit (MPH):	25	Placement with Respect to Road:	OUTSIDE OF CURVE		
Hazard Behind Barrier:	EXTREME				
Barrier Crashworthiness					
Appropriate Test Level:	TL-1	Barrier Test Level:	NCW	Is Barrier Crashworthy?:	NO
Beg. End Trtmt Type:	NONE	Is Beg. End Trtmt Crashworthy?:	N/A	Approach Transition Type:	NONE
Ending End Trtmt Type:	NONE	Ending End Trtmt Crashworthy?:	N/A		
Average Measurements					
Design Height (In.):	24	Width (In.):	18.0	Post Spacing (In.):	0.0
Height (In.):	10.3	Lateral Offset (In.):	25.7	Road Grade (%):	5.10
Physical Condition					
Barrier	Alignment and Height:	Alignment acceptable. Height was 13 to 14-in below 24-in design height.

Breaking and Cracking:	Minor cracking of mortar (less than 1/4 in). All barrier stones intact.			
	Missing Elements:	No missing mortar or stones in barrier.			
	Corrosion and Weathering:	No erosion along back of barrier.			
End Treatments	Alignment and Height:				
	Breaking and Cracking:				
	Missing Elements:				
	Corrosion and Weathering:

Repair Action:	REPAIR	FMSS Work Type:	DEFERRED MAINTENANCE	Repair Cost:	\$204848
Brief Workorder:	Raise guardwall 14-in. Remove and reset 208-ft of stone masonry guardwall on concrete footer to 24-in design height.				
Workorder:	Remove & Reset Stone Masonry Guardwall at \$250- per -Cu. Ft. for 624 CF = \$156000. (2ft)(1.5ft)(208ft) = 624 CF Structural Concrete at \$1000- per -Cu. Yd. for 14 CY = \$14000. [(1.5ft)(1.2ft)(208ft)]/27 = 13.9 CY Low Speed Traffic Control at \$1475- per -Day for 11 Day(s) = \$16225. 2 days removal and 9 days installation.

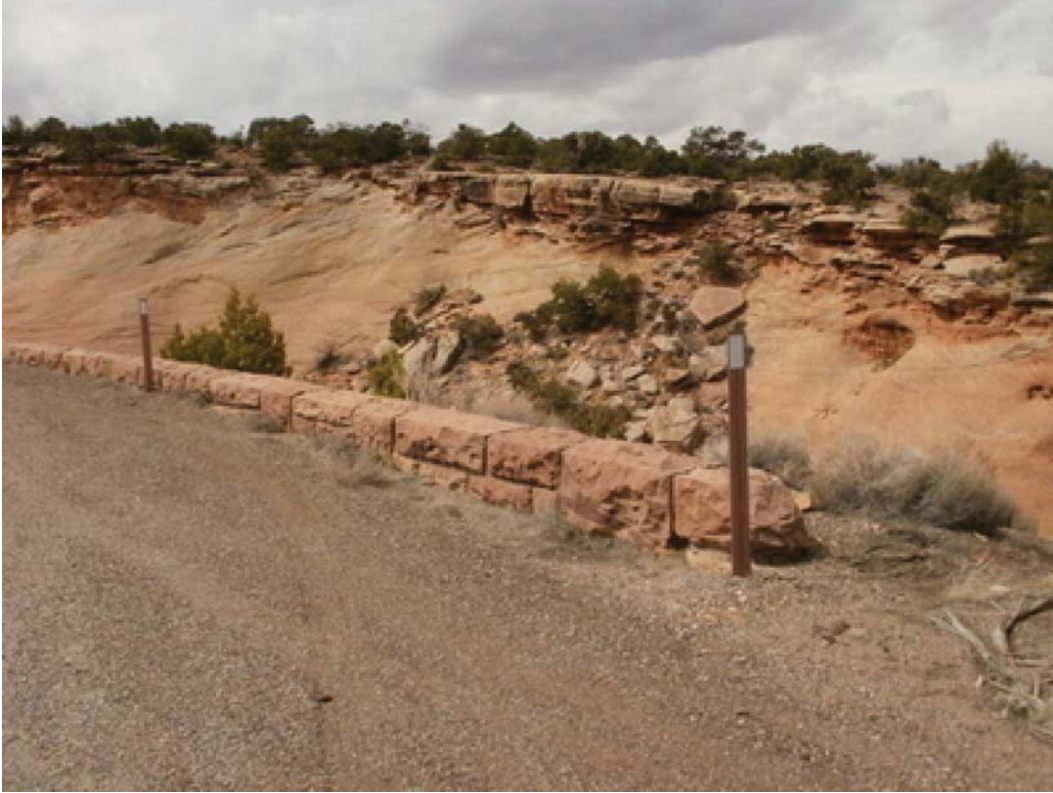
COLM_0010_2.935_R_1.JPG

Barrier ID:	COLM-0010-2.935-R				
Route Name:	RIMROCK DRIVE				
Inspection Date:	05/04/2010	Barrier Rating:	49.20		
Barrier Description					
Type:	STONE MASONRY WITHOUT CONCRETE CORE WALL	Barrier Function:	TRAFFIC		
Barrier Material:	STONE	Post Material:	N/A		
Blockout Type:	N/A	Length (ft.):	162		
Speed Limit (MPH):	25	Placement with Respect to Road:	OUTSIDE OF CURVE		
Hazard Behind Barrier:	HIGH				
Barrier Crashworthiness					
Appropriate Test Level:	TL-1	Barrier Test Level:	NCW	Is Barrier Crashworthy?:	NO
Beg. End Trtmt Type:	NONE	Is Beg. End Trtmt Crashworthy?:	N/A	Approach Transition Type:	NONE
Ending End Trtmt Type:	NONE	Ending End Trtmt Crashworthy?:	N/A		
Average Measurements					
Design Height (In.):	24	Width (In.):	18.7	Post Spacing (In.):	0.0
Height (In.):	15.6	Lateral Offset (In.):	113.0	Road Grade (%):	4.30
Physical Condition					
Barrier	Alignment and Height:	Alignment acceptable. 67-ft was 3 to 6-in below the 24-in design height and 95-ft was 6 to 11-in below.

Breaking and Cracking:	No breaking or cracking in barrier.			
	Missing Elements:	No missing elements in barrier.			
	Corrosion and Weathering:	No weathering in barrier.			
End Treatments	Alignment and Height:				
	Breaking and Cracking:				
	Missing Elements:				
	Corrosion and Weathering:

Repair Action:	REPAIR	FMSS Work Type:	DEFERRED MAINTENANCE	Repair Cost:	\$93913
Brief Workorder:	Raise guardwall 3-in. Remove and reset 95-ft of stone masonry guardwall on concrete footer to adjacent 18-in height.				
Workorder:	Remove & Reset Stone Masonry Guardwall at \$250- per -Cu. Ft. for 304 CF = \$76000. (2ft)(1.6ft)(95ft) = 304 CF Structural Concrete at \$1000- per -Cu. Yd. for 2 CY = \$2000. [(1.6ft)(0.5ft)(95ft)]/27 = 2.8 CY Low Speed Traffic Control at \$1475- per -Day for 5 Day(s) = \$7375. 1 day removal and 4 days installation.

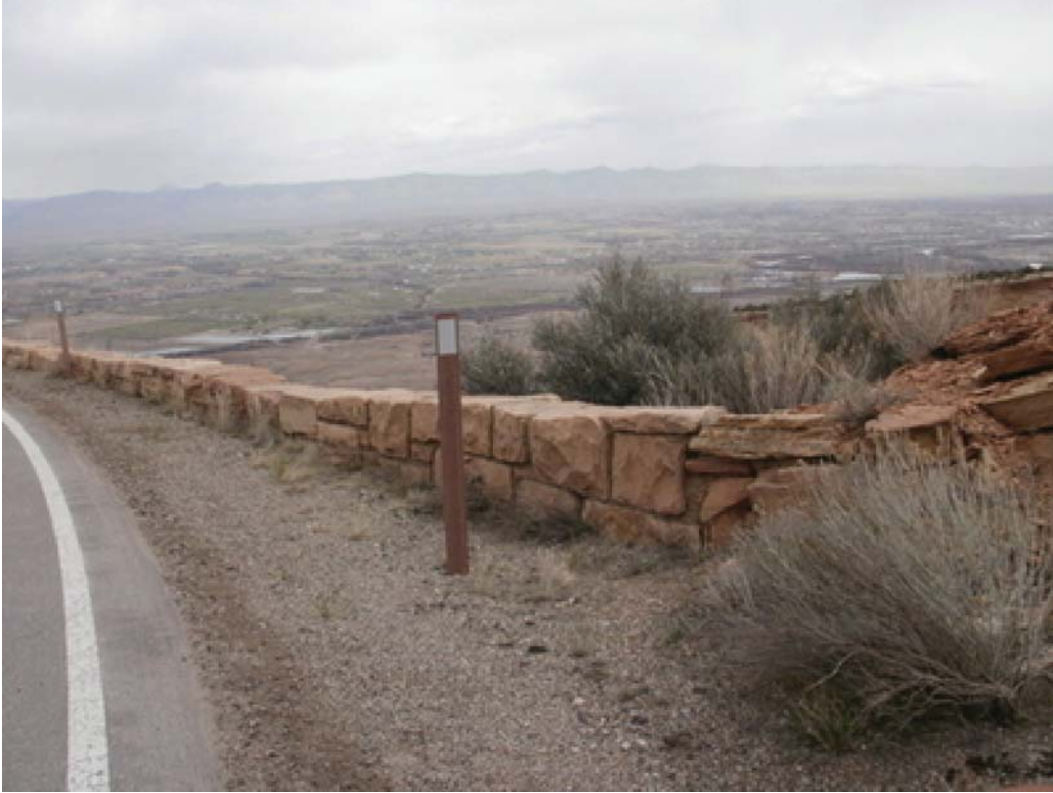
COLM_0010_3.128_L_1.JPG

Barrier ID:	COLM-0010-3.128-L				
Route Name:	RIMROCK DRIVE				
Inspection Date:	05/04/2010	Barrier Rating:	55.20		
Barrier Description					
Type:	STONE MASONRY WITHOUT CONCRETE CORE WALL	Barrier Function:	TRAFFIC		
Barrier Material:	STONE	Post Material:	N/A		
Blockout Type:	N/A	Length (ft.):	66		
Speed Limit (MPH):	25	Placement with Respect to Road:	OUTSIDE OF CURVE		
Hazard Behind Barrier:	EXTREME				
Barrier Crashworthiness					
Appropriate Test Level:	TL-1	Barrier Test Level:	NCW	Is Barrier Crashworthy?:	NO
Beg. End Trtmt Type:	NONE	Is Beg. End Trtmt Crashworthy?:	N/A	Approach Transition Type:	NONE
Ending End Trtmt Type:	NONE	Ending End Trtmt Crashworthy?:	N/A		
Average Measurements					
Design Height (In.):	24	Width (In.):	19.2	Post Spacing (In.):	0.0
Height (In.):	13.3	Lateral Offset (In.):	52.7	Road Grade (%):	4.40
Physical Condition					
Barrier	Alignment and Height:	Alignment is acceptable. 15-ft was 3 to 6-in below the 24-in design height and 51-ft was 6 to 12-in below.

Breaking and Cracking:	1 crack about 20-in long that is greater than 1/2 in wide in area that is of below design height by more than 6-in.			
	Missing Elements:	No missing mortar or stones in barrier.			
	Corrosion and Weathering:	No erosion on either side of barrier.			
End Treatments	Alignment and Height:				
	Breaking and Cracking:				
	Missing Elements:				
	Corrosion and Weathering:

Repair Action:	REPAIR	FMSS Work Type:	DEFERRED MAINTENANCE	Repair Cost:	\$53268
Brief Workorder:	Raise guardwall 5-in. Remove and reset 51-ft of stone masonry guardwall on concrete footer to adjacent 18-in height.				
Workorder:	Remove & Reset Stone Masonry Guardwall at \$250- per -Cu. Ft. for 164 CF = \$41000. (2ft)(1.6ft)(51ft) = 163.2 CF Structural Concrete at \$1000- per -Cu. Yd. for 3 CY = \$3000. [(1.6ft)(0.5ft)(51ft)]/27 = 1.5 CY Low Speed Traffic Control at \$1475- per -Day for 3 Day(s) = \$4425. 1 day removal and 2 days installation.

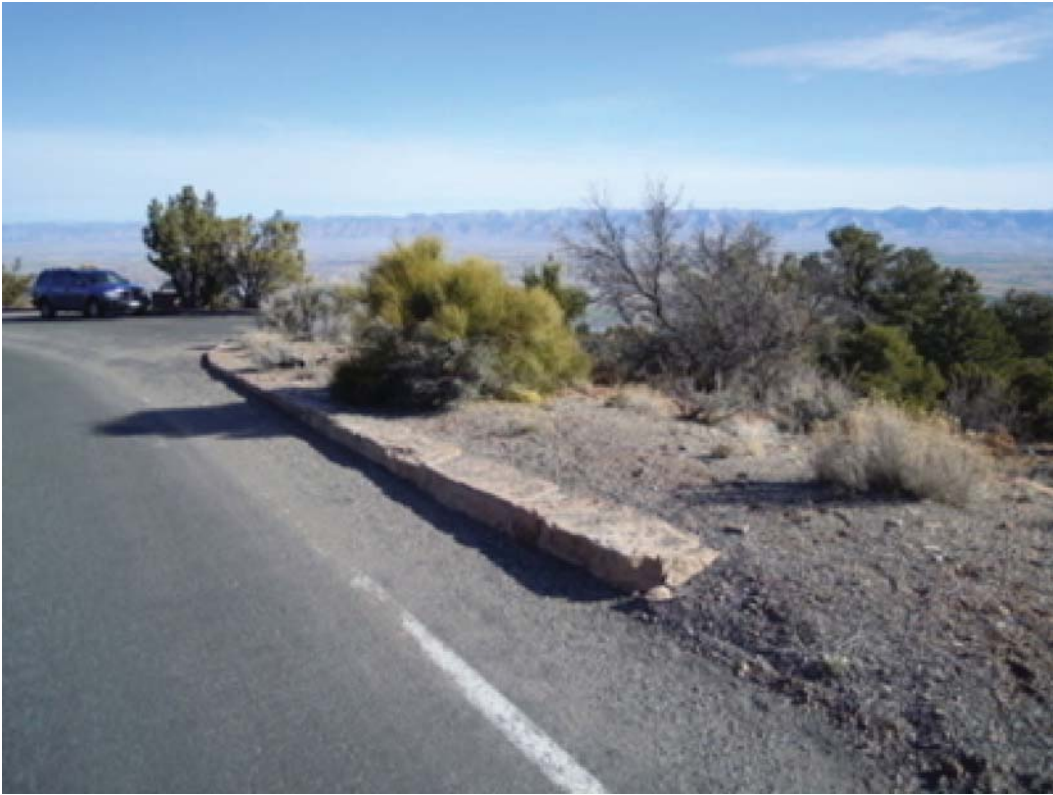
COLM_0010_3.463_L_1.jpg

Barrier ID:	COLM-0010-3.463-L				
Route Name:	RIMROCK DRIVE				
Inspection Date:	05/04/2010	Barrier Rating:	0.00		
Barrier Description					
Type:	STONE MASONRY WITHOUT CONCRETE CORE WALL	Barrier Function:	NON-TRAFFIC		
Barrier Material:	STONE	Post Material:	N/A		
Blockout Type:	N/A	Length (ft.):	245		
Speed Limit (MPH):	25	Placement with Respect to Road:	NON-TRAFFIC BARRIER		
Hazard Behind Barrier:	N/A				
Barrier Crashworthiness					
Appropriate Test Level:	TL-1	Barrier Test Level:	N/A	Is Barrier Crashworthy?:	N/A
Beg. End Trtmt Type:	NONE	Is Beg. End Trtmt Crashworthy?:	N/A	Approach Transition Type:	NONE
Ending End Trtmt Type:	NONE	Ending End Trtmt Crashworthy?:	N/A		
Average Measurements					
Design Height (In.):	24	Width (In.):	15.0	Post Spacing (In.):	0.0
Height (In.):	7.0	Lateral Offset (In.):	0.0	Road Grade (%):	0.00
Physical Condition					
Barrier	Alignment and Height:	Alignment acceptable. Height was 17-in below the 24-in design height.

Breaking and Cracking:	Grout showing no cracks.			
	Missing Elements:	No missing stones or gout.			
	Corrosion and Weathering:	Less than 5% of stones flaking.			
End Treatments	Alignment and Height:				
	Breaking and Cracking:				
	Missing Elements:				
	Corrosion and Weathering:

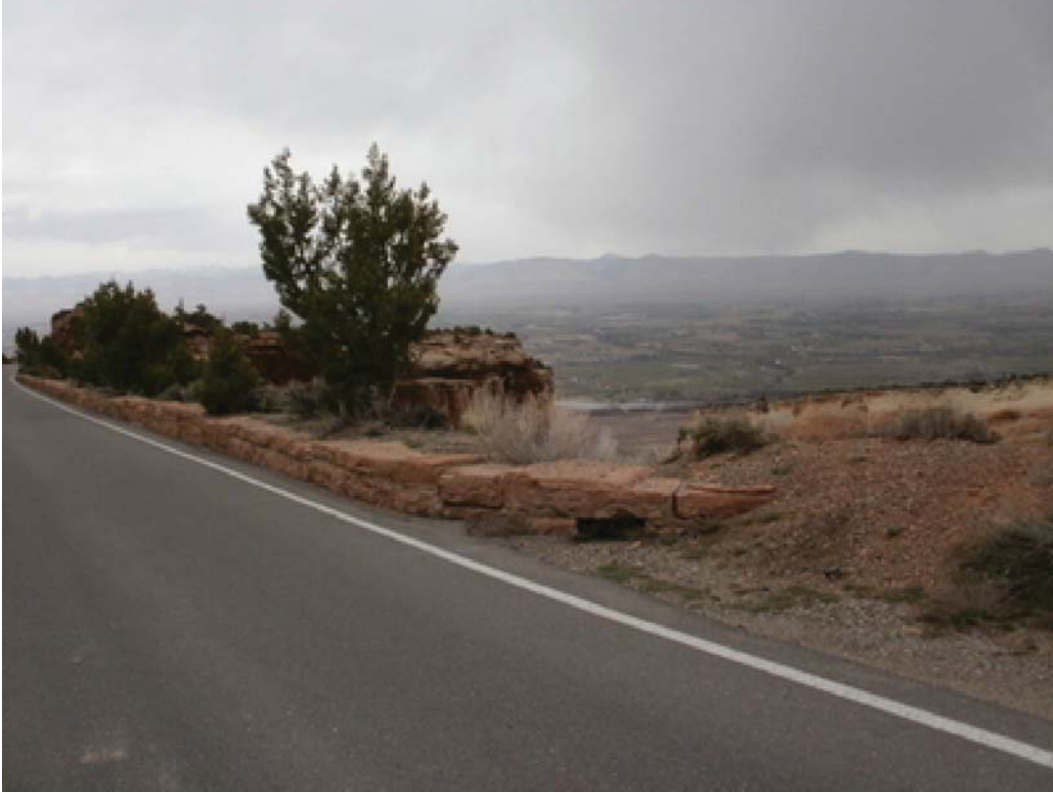
COLM_0010_3.583_L_1.JPG

Barrier ID:	COLM-0010-3.583-L				
Route Name:	RIMROCK DRIVE				
Inspection Date:	05/04/2010	Barrier Rating:	62.20		
Barrier Description					
Type:	STONE MASONRY WITHOUT CONCRETE CORE WALL	Barrier Function:	TRAFFIC		
Barrier Material:	STONE	Post Material:	N/A		
Blockout Type:	N/A	Length (ft.):	356		
Speed Limit (MPH):	25	Placement with Respect to Road:	TANGENT		
Hazard Behind Barrier:	EXTREME				
Barrier Crashworthiness					
Appropriate Test Level:	TL-1	Barrier Test Level:	NCW	Is Barrier Crashworthy?:	NO
Beg. End Trtmt Type:	NONE	Is Beg. End Trtmt Crashworthy?:	N/A	Approach Transition Type:	NONE
Ending End Trtmt Type:	NONE	Ending End Trtmt Crashworthy?:	N/A		
Average Measurements					
Design Height (In.):	24	Width (In.):	18.7	Post Spacing (In.):	0.0
Height (In.):	14.5	Lateral Offset (In.):	16.7	Road Grade (%):	5.10
Physical Condition					
Barrier	Alignment and Height:	Alignment acceptable. 101-ft was 3 to 6-in below the 24-in design height and 255-ft was 6 to 12-in below.

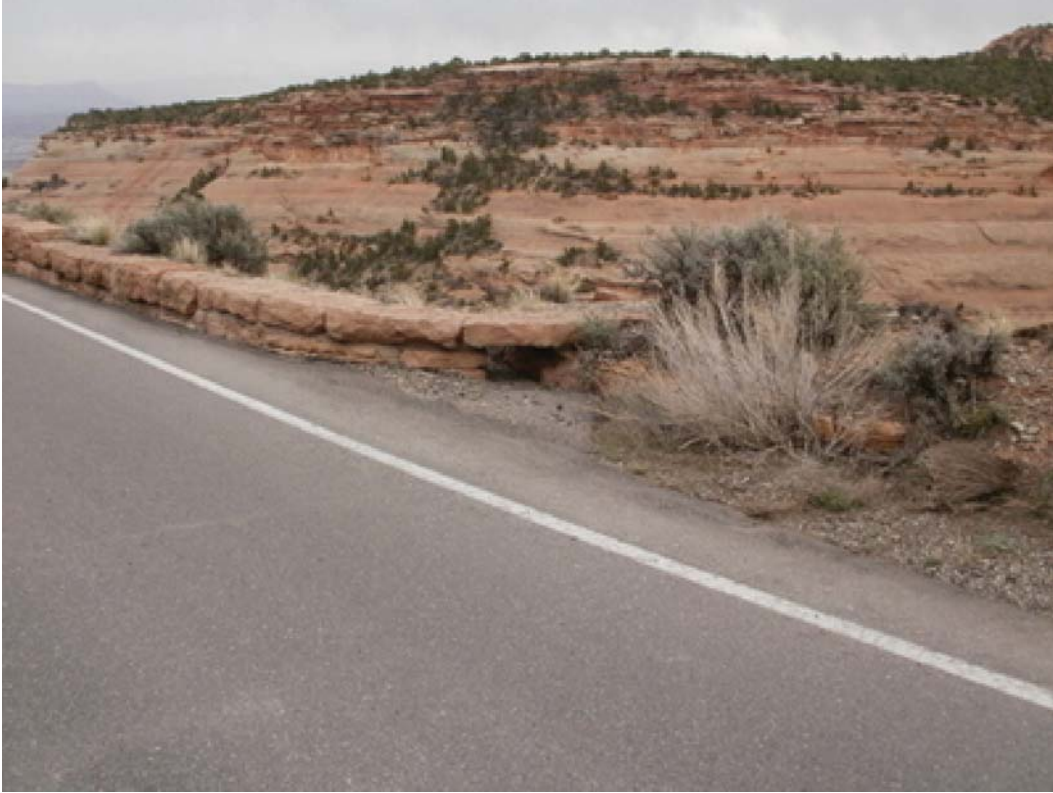
COLM_0010_3.740_L_1.JPG

Barrier ID:	COLM-0010-3.740-L				
Route Name:	RIMROCK DRIVE				
Inspection Date:	05/04/2010	Barrier Rating:	49.50		
Barrier Description					
Type:	STONE MASONRY WITHOUT CONCRETE CORE WALL	Barrier Function:	TRAFFIC		
Barrier Material:	STONE	Post Material:	N/A		
Blockout Type:	N/A	Length (ft.):	111		
Speed Limit (MPH):	25	Placement with Respect to Road:	TANGENT		
Hazard Behind Barrier:	EXTREME				
Barrier Crashworthiness					
Appropriate Test Level:	TL-1	Barrier Test Level:	NCW	Is Barrier Crashworthy?:	NO
Beg. End Trtmt Type:	NONE	Is Beg. End Trtmt Crashworthy?:	N/A	Approach Transition Type:	NONE
Ending End Trtmt Type:	NONE	Ending End Trtmt Crashworthy?:	N/A		
Average Measurements					
Design Height (In.):	24	Width (In.):	22.2	Post Spacing (In.):	0.0
Height (In.):	16.2	Lateral Offset (In.):	24.0	Road Grade (%):	4.60
Physical Condition					
Barrier	Alignment and Height:	Alignment acceptable. 34-ft was 3 to 6-in below the 24-in design height and 76-ft was 6 to 9-in below.

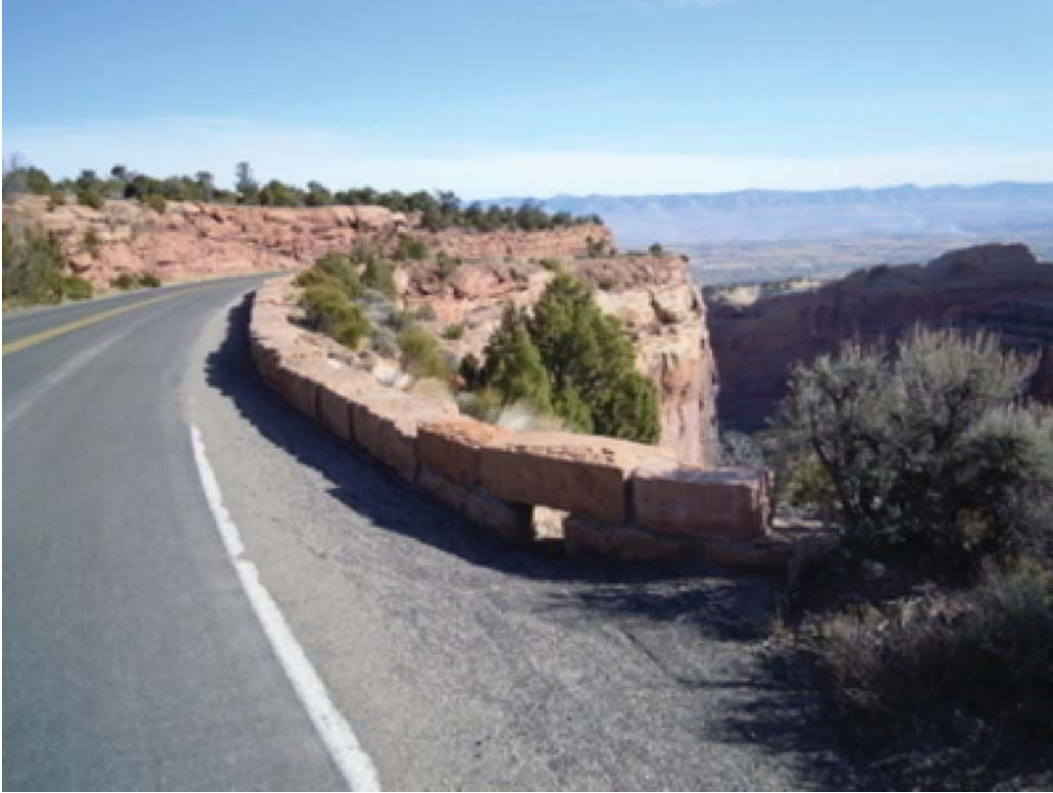
COLM_0010_3.798_L_1.jpg

Barrier ID:	COLM-0010-3.798-L				
Route Name:	RIMROCK DRIVE				
Inspection Date:	05/04/2010	Barrier Rating:	45.90		
Barrier Description					
Type:	STONE MASONRY WITHOUT CONCRETE CORE WALL	Barrier Function:	TRAFFIC		
Barrier Material:	STONE	Post Material:	N/A		
Blockout Type:	N/A	Length (ft.):	231		
Speed Limit (MPH):	25	Placement with Respect to Road:	INSIDE OF CURVE		
Hazard Behind Barrier:	EXTREME				
Barrier Crashworthiness					
Appropriate Test Level:	TL-1	Barrier Test Level:	NCW	Is Barrier Crashworthy?:	NO
Beg. End Trtmt Type:	NONE	Is Beg. End Trtmt Crashworthy?:	N/A	Approach Transition Type:	NONE
Ending End Trtmt Type:	NONE	Ending End Trtmt Crashworthy?:	N/A		
Average Measurements					
Design Height (In.):	24	Width (In.):	23.7	Post Spacing (In.):	0.0
Height (In.):	18.2	Lateral Offset (In.):	33.7	Road Grade (%):	3.80
Physical Condition					
Barrier	Alignment and Height:	Alignment acceptable. 89-ft was 3 to 6-in below the 24-in design height and 142-ft was 6 to 10-in below.
