GIP Report

NPS Guardwall/Rail Inventory Program Colonial National Historical Park

**Federal Highway Administration
Eastern Federal Lands Highway Division
Road Inventory Program (RIP)**

**Data Collection Date: November 2010
Report Date: December 2015**

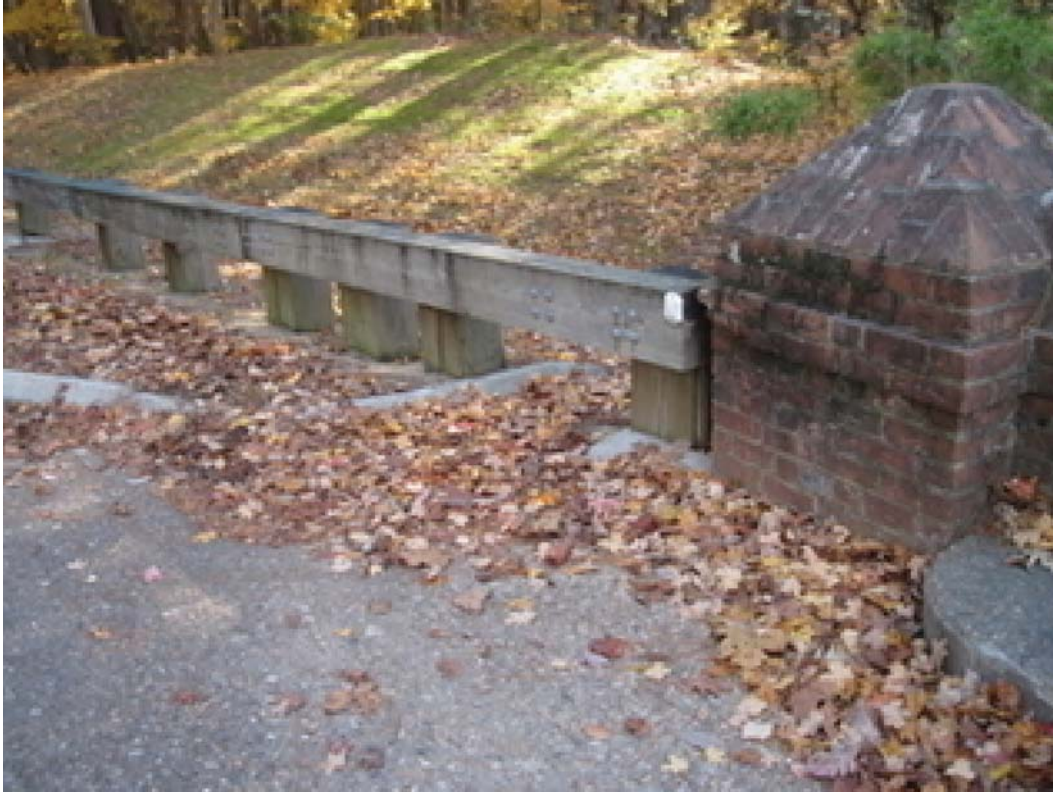
COLO_0001_0.424_L_1.jpg

Barrier ID:	COLO-0001-0.424-L				
Route Name:	COLONIAL PARKWAY				
Inspection Date:	11/18/2010	Barrier Rating:	21.20		
Barrier Description					
Type:	STEEL-BACKED TIMBER WITHOUT BLOCKOUT	Barrier Function:	TRAFFIC		
Barrier Material:	STEEL-BACKED TIMBER/LOG	Post Material:	WOOD		
Blockout Type:	N/A	Length (ft.):	97		
Speed Limit (MPH):	35	Placement with Respect to Road:	TANGENT		
Hazard Behind Barrier:	LOW				
Barrier Crashworthiness					
Appropriate Test Level:	TL-2	Barrier Test Level:	TL-2	Is Barrier Crashworthy?:	YES
Beg. End Trtmt Type:	SBT/LOG BURIED	Is Beg. End Trtmt Crashworthy?:	YES	Approach Transition Type:	RIGID SBT WALL - SBT
Ending End Trtmt Type:	NONE	Ending End Trtmt Crashworthy?:	N/A		
Average Measurements					
Design Height (In.):	27	Width (In.):	0.0	Post Spacing (In.):	99.6
Height (In.):	25.2	Lateral Offset (In.):	122.0	Road Grade (%):	0.20
Physical Condition					
Barrier	Alignment and Height:	No alignment deflection was observed. Height is 1 - 3 in below 27-in design height along 30 ft.

Breaking and Cracking:	No breaking or cracking was observed.			
	Missing Elements:	No missing elements were observed.			
	Corrosion and Weathering:	No corrosion or weathering was observed.			
End Treatments	Alignment and Height:	Alignment acceptable. Height within 1-in of 27-in design height.			
	Breaking and Cracking:	No breaking or cracking was observed.			
	Missing Elements:	No missing elements were observed.			
	Corrosion and Weathering:	No corrosion or weathering was observed.

Repair Action:	REPAIR	FMSS Work Type:	DEFERRED MAINTENANCE	Repair Cost:	\$1953
Brief Workorder:	Raise 30 feet of guardrail to 27-inch design height.				
Workorder:	Adjust Guardrail at \$10- per -Lin. Ft. for 30 LF = \$300. Raise 30ft. of guardrail to 27-inch design height. Low Speed Traffic Control at \$1475- per -Day for 1 Day(s) = \$1475.

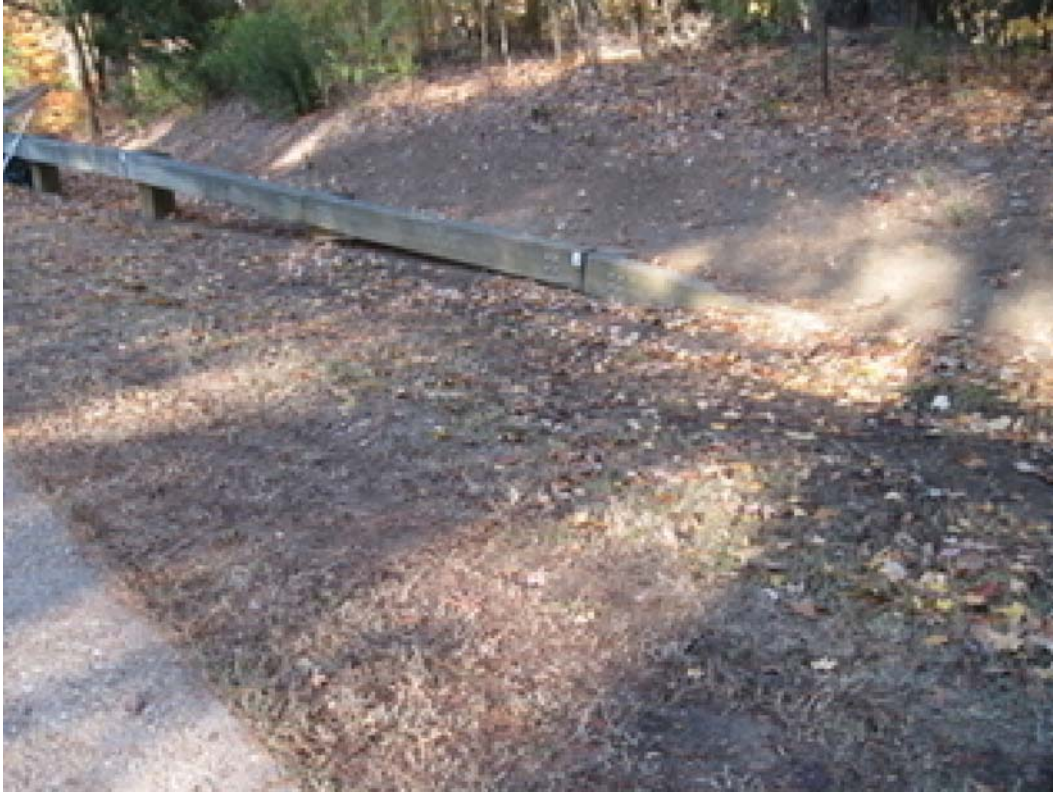
COLO_0001_0.433_R_1.jpg

Barrier ID:	COLO-0001-0.433-R				
Route Name:	COLONIAL PARKWAY				
Inspection Date:	11/18/2010	Barrier Rating:	19.20		
Barrier Description					
Type:	STEEL-BACKED TIMBER WITHOUT BLOCKOUT	Barrier Function:	TRAFFIC		
Barrier Material:	STEEL-BACKED TIMBER/LOG	Post Material:	WOOD		
Blockout Type:	N/A	Length (ft.):	56		
Speed Limit (MPH):	35	Placement with Respect to Road:	TANGENT		
Hazard Behind Barrier:	MEDIUM				
Barrier Crashworthiness					
Appropriate Test Level:	TL-2	Barrier Test Level:	TL-2	Is Barrier Crashworthy?:	YES
Beg. End Trtmt Type:	SBT/LOG FLARED	Is Beg. End Trtmt Crashworthy?:	NO	Approach Transition Type:	RIGID SBT WALL - SBT
Ending End Trtmt Type:	NONE	Ending End Trtmt Crashworthy?:	N/A		
Average Measurements					
Design Height (In.):	27	Width (In.):	0.0	Post Spacing (In.):	100.0
Height (In.):	27.2	Lateral Offset (In.):	122.0	Road Grade (%):	0.60
Physical Condition					
Barrier	Alignment and Height:	No alignment deflection observed. Height ranges from 0 in to 0.5 in above 27 in design height.

Breaking and Cracking:	No breaking or cracking observed.			
	Missing Elements:	No missing elements observed.			
	Corrosion and Weathering:	No corrosion or weathering observed.			
End Treatments	Alignment and Height:	Alignment acceptable. Height within 1-in of 27-in design height.			
	Breaking and Cracking:	No breaking or cracking observed.			
	Missing Elements:	No missing elements observed.			
	Corrosion and Weathering:	No corrosion or weathering observed.

Repair Action:	NO ACTION	FMSS Work Type:	N/A	Repair Cost:	\$0
Brief Workorder:	N/A				
Workorder:	No action.

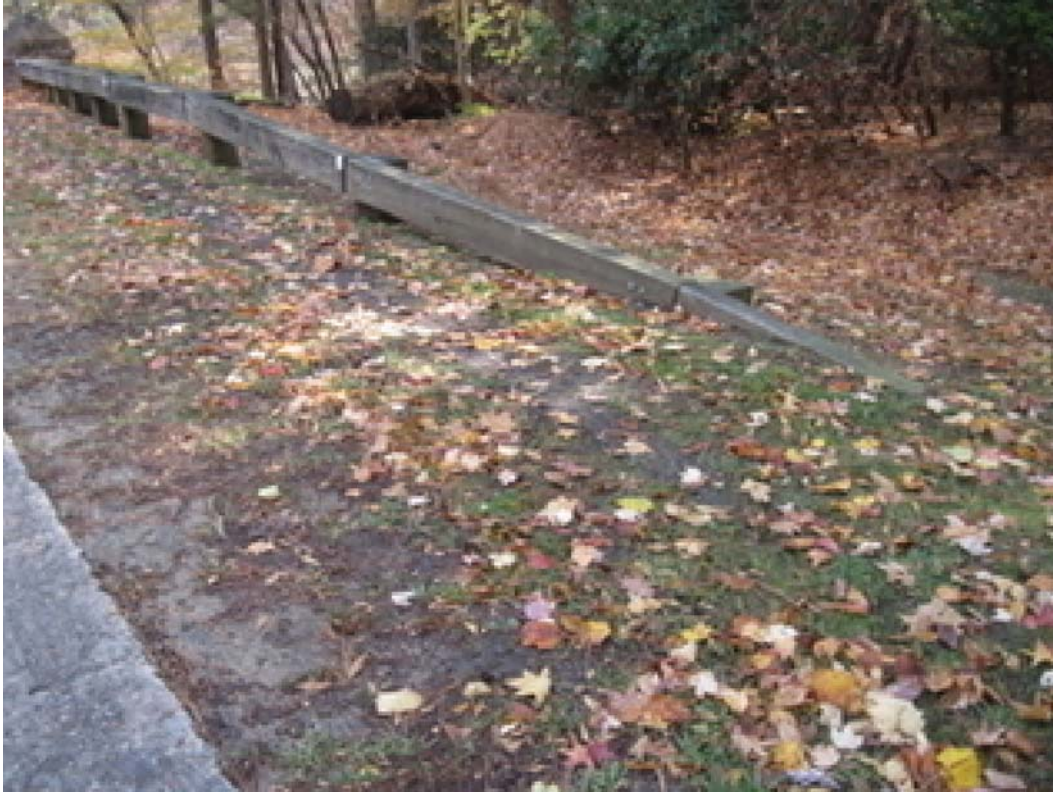
COLO_0001_0.500_L_1.jpg

Barrier ID:	COLO-0001-0.500-L				
Route Name:	COLONIAL PARKWAY				
Inspection Date:	11/18/2010	Barrier Rating:	23.60		
Barrier Description					
Type:	STEEL-BACKED TIMBER WITHOUT BLOCKOUT	Barrier Function:	TRAFFIC		
Barrier Material:	STEEL-BACKED TIMBER/LOG	Post Material:	WOOD		
Blockout Type:	N/A	Length (ft.):	55		
Speed Limit (MPH):	35	Placement with Respect to Road:	TANGENT		
Hazard Behind Barrier:	MEDIUM				
Barrier Crashworthiness					
Appropriate Test Level:	TL-2	Barrier Test Level:	TL-2	Is Barrier Crashworthy?:	YES
Beg. End Trtmt Type:	NONE	Is Beg. End Trtmt Crashworthy?:	N/A	Approach Transition Type:	RIGID SBT WALL - SBT
Ending End Trtmt Type:	SBT/LOG FLARED	Ending End Trtmt Crashworthy?:	N/A		
Average Measurements					
Design Height (In.):	27	Width (In.):	0.0	Post Spacing (In.):	80.0
Height (In.):	26.5	Lateral Offset (In.):	115.3	Road Grade (%):	3.10
Physical Condition					
Barrier	Alignment and Height:	No alignment deflection was observed. Height is 0 - 1 in below 27-in design height.

Breaking and Cracking:	No breaking or cracking was observed.			
	Missing Elements:	No missing elements were observed.			
	Corrosion and Weathering:	No corrosion or weathering was observed.			
End Treatments	Alignment and Height:	Alignment acceptable. Height within 1-in of 27-in design height.			
	Breaking and Cracking:	No breaking or cracking was observed.			
	Missing Elements:	No missing elements were observed.			
	Corrosion and Weathering:	No corrosion or weathering was observed.

Repair Action:	NO ACTION	FMSS Work Type:	N/A	Repair Cost:	\$0
Brief Workorder:	N/A				
Workorder:
