**GIP Report**

**NPS Guardwall/Rail Inventory Program  
Crater Lake National Park**

**Federal Highway Administration  
Eastern Federal Lands Highway Division  
Road Inventory Program (RIP)**

**Data Collection Date: July 2010  
Report Date: December 2015**

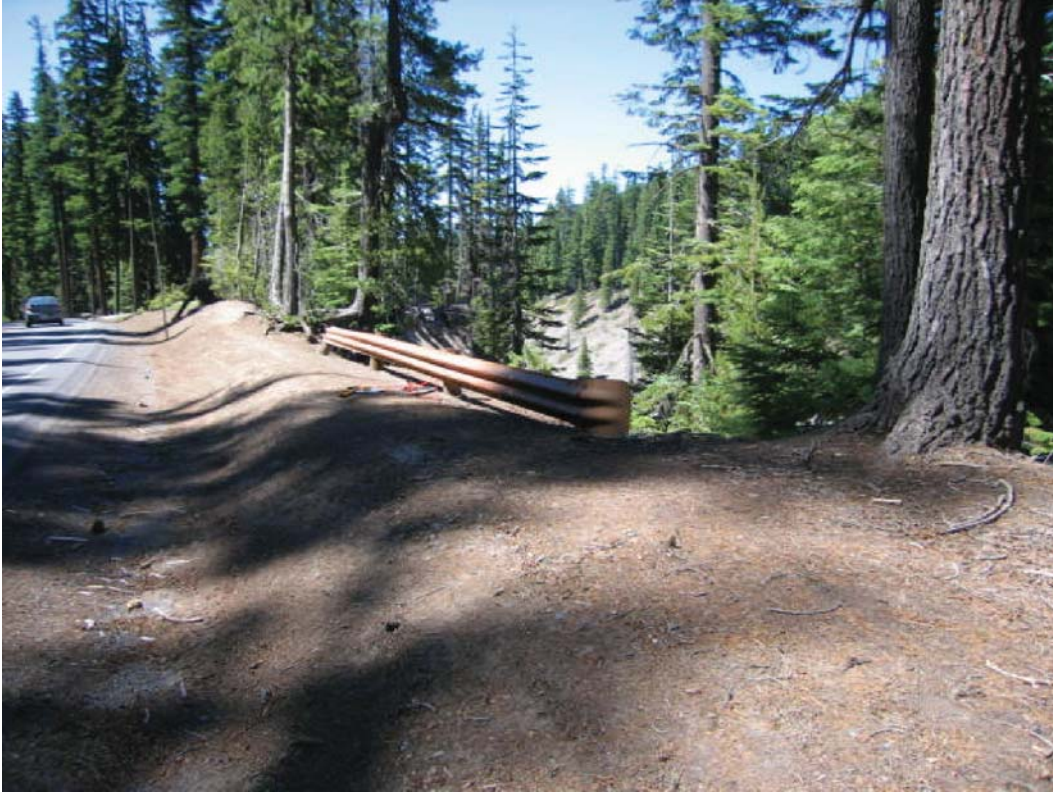
CRLA\_0011\_1.627\_L\_1.jpg

<b>Height (In.):</b>	20.0	<b>Lateral Offset (In.):</b>	0.0	<b>Road Grade (%):</b>	0.00
<b>Physical Condition</b>					
<b>Barrier</b>	<b>Alignment and Height:</b>	The height of the barrier is roughly 7-in lower than the design height of 27-in. The end of the barrier is twisted and the post is bent.			
	<b>Breaking and Cracking:</b>	Posts are cracked through the bolt hole.			
	<b>Missing Elements:</b>	None observed.			
	<b>Corrosion and Weathering:</b>	The rail is weathered and corroded. It needs to be painted.			
<b>End Treatments</b>	<b>Alignment and Height:</b>				
	<b>Breaking and Cracking:</b>				
	<b>Missing Elements:</b>				
	<b>Corrosion and Weathering:</b>

<b>Repair Action:</b>	REPAIR	<b>FMSS Work Type:</b>	DEFERRED MAINTENANCE	<b>Repair Cost:</b>	\$2920
<b>Brief Workorder:</b>	Reset and paint W-beam guardrail.				
<b>Workorder:</b>	Adjust Guardrail at \$10- per -Lin. Ft. for 40 LF = \$400. Adjust entire rail to design height of 27-in. Replace Post at \$100- per -Each for 2 Post(s) = \$200. Replace 2 posts. Labor at \$60- per -Hour for 8 Hrs = \$480. 8 hours labor to prep and paint rail. Paint at \$100- per - for 1 = \$100. Primer and paint. Low Speed Traffic Control at \$1475- per -Day for 1 Day(s) = \$1475. One day traffic control to reset barrier.

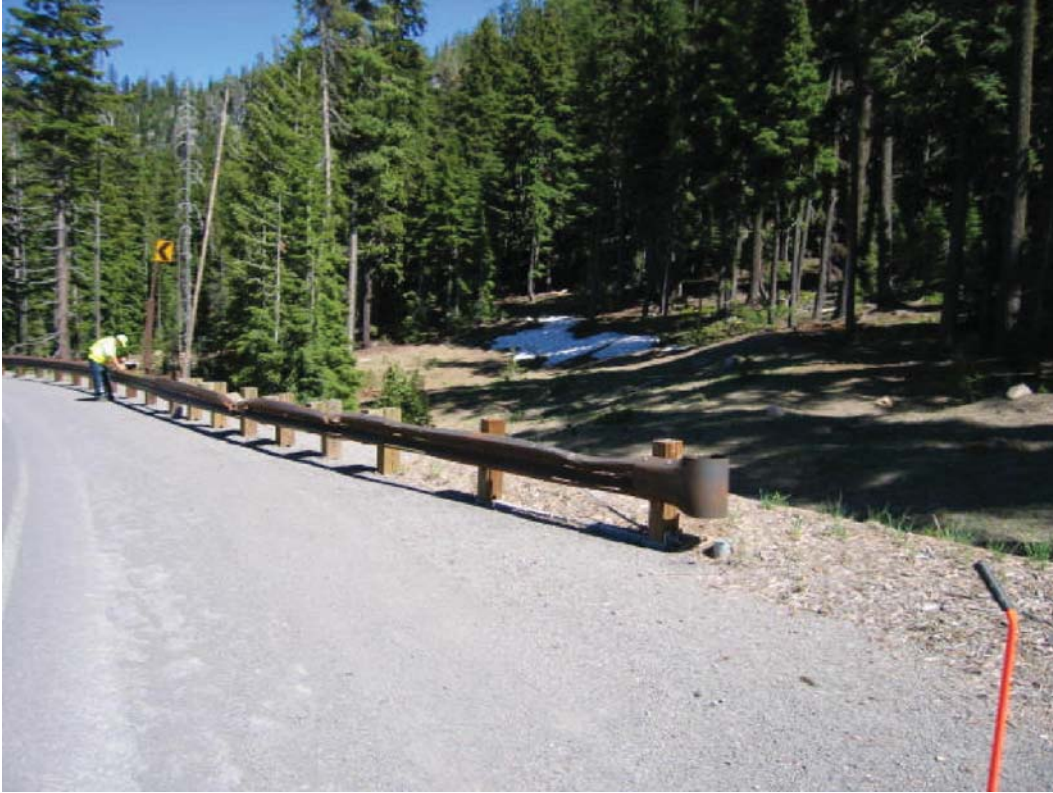
CRLA\_0011\_5.669\_L\_1.jpg

<b>Design Height (In.):</b>	27	<b>Width (In.):</b>	0.0	<b>Post Spacing (In.):</b>	75.0
<b>Height (In.):</b>	29.0	<b>Lateral Offset (In.):</b>	58.2	<b>Road Grade (%):</b>	4.00
<b>Physical Condition</b>					
<b>Barrier</b>	<b>Alignment and Height:</b>	Alignment and high are acceptable.			
	<b>Breaking and Cracking:</b>	The barrier had three 12-ft sections of damaged rail. The sections need to be replaced.			
	<b>Missing Elements:</b>	None observed.			
	<b>Corrosion and Weathering:</b>	Some corrosion on rail though not serious.			
<b>End Treatments</b>	<b>Alignment and Height:</b>	Alignment and height are OK.			
	<b>Breaking and Cracking:</b>	End treatment damaged replace 38-ft			
	<b>Missing Elements:</b>	None observed.			
	<b>Corrosion and Weathering:</b>	Slight weathering.

<b>Repair Action:</b>	REPAIR	<b>FMSS Work Type:</b>	DEFERRED MAINTENANCE	<b>Repair Cost:</b>	\$7508
<b>Brief Workorder:</b>	Replace end terminal and 74 l.f. of rail on W-beam.				
<b>Workorder:</b>	<p>Low Speed Traffic Control at \$1475- per -Day for 1 Day(s) = \$1475.</p> <p>Replace Rail at \$25- per -Lin. Ft. for 74 LF = \$1850. Replace 74-ft of rail in two sections first section is 36-ft; second section is 38-ft.</p> <p>W-beam flared 350 compliant at \$3500- per -Each for 1 Unit(s) = \$3500.</p>

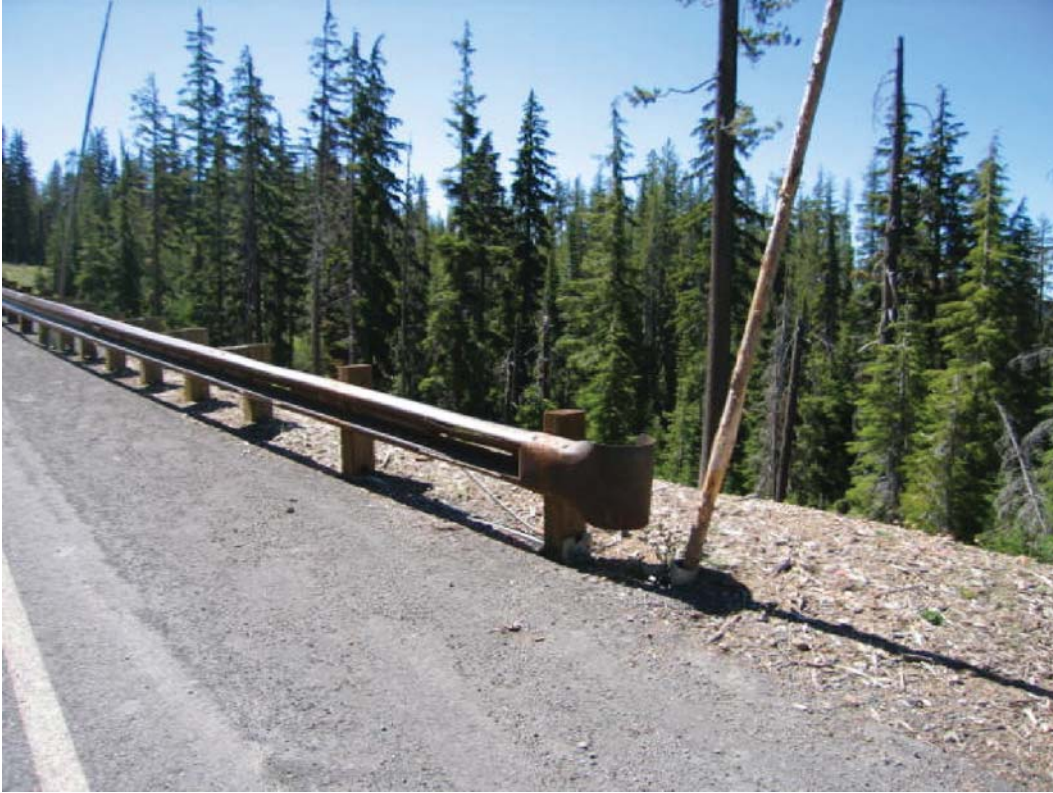
CRLA\_0011\_5.919\_R\_1.jpg

<b>Height (In.):</b>	27.6	<b>Lateral Offset (In.):</b>	45.5	<b>Road Grade (%):</b>	3.80
<b>Physical Condition</b>					
<b>Barrier</b>	<b>Alignment and Height:</b>	Alignment and high are acceptable.			
	<b>Breaking and Cracking:</b>	Two rails bend; replace two 12-ft sections.			
	<b>Missing Elements:</b>	None observed.			
	<b>Corrosion and Weathering:</b>	No corrosion observed.			
<b>End Treatments</b>	<b>Alignment and Height:</b>	No deviations.			
	<b>Breaking and Cracking:</b>	None observed.			
	<b>Missing Elements:</b>	None observed.			
	<b>Corrosion and Weathering:</b>	None observed.

<b>Repair Action:</b>	REPAIR	<b>FMSS Work Type:</b>	DEFERRED MAINTENANCE	<b>Repair Cost:</b>	\$2282
<b>Brief Workorder:</b>	Replace 24 l.f. of W-beam rail.				
<b>Workorder:</b>	Replace Rail at \$25- per -Lin. Ft. for 24 LF = \$600. Replace two 12-ft sections of rail. Low Speed Traffic Control at \$1475- per -Day for 1 Day(s) = \$1475. One day to replace 24-ft of rail.

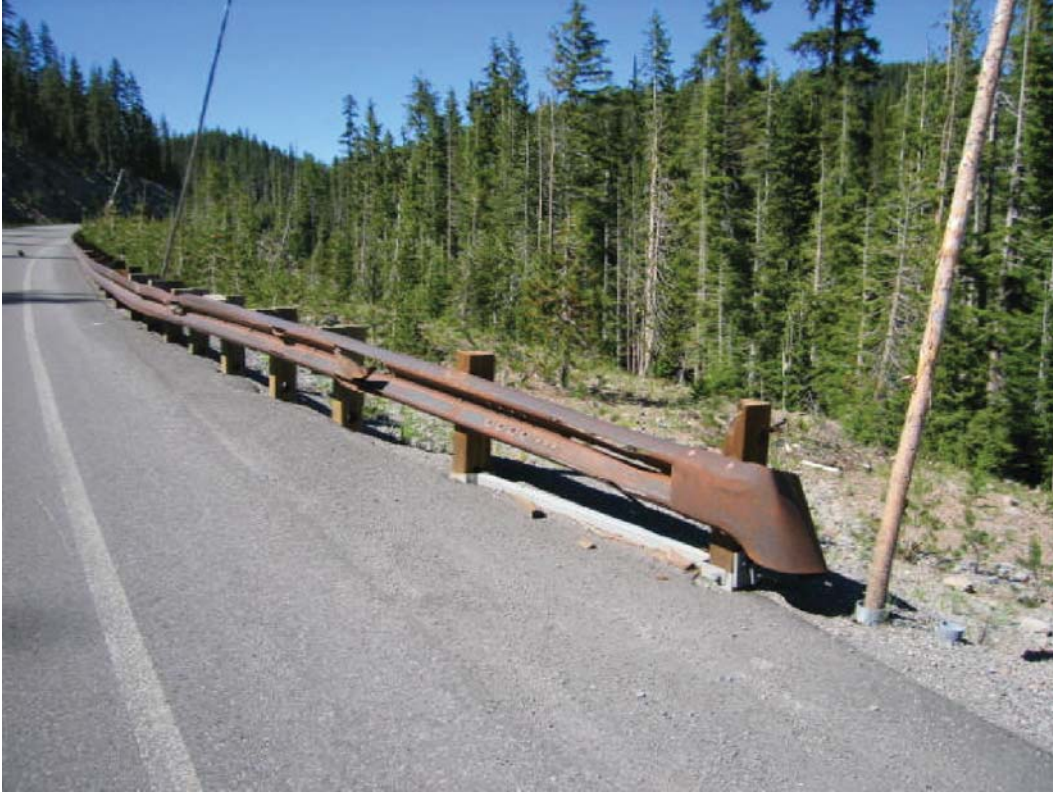
**CRLA\_0011\_7.373\_L\_1.jpg**

<b>Design Height (In.):</b>	27	<b>Width (In.):</b>	0.0	<b>Post Spacing (In.):</b>	75.0
<b>Height (In.):</b>	28.6	<b>Lateral Offset (In.):</b>	38.2	<b>Road Grade (%):</b>	2.70
<b>Physical Condition</b>					
<b>Barrier</b>	<b>Alignment and Height:</b>	400-ft of rail needs to be reshaped. (Looks like plow has flattened the rail section.) 75-ft of rail needs to be replaced.			
	<b>Breaking and Cracking:</b>	None observed.			
	<b>Missing Elements:</b>	None observed.			
	<b>Corrosion and Weathering:</b>	None observed.			
<b>End Treatments</b>	<b>Alignment and Height:</b>	All rail in end terminal nearest to milepoint 7.580 needs to be replaced (38-ft).			
	<b>Breaking and Cracking:</b>	Replace one post.			
	<b>Missing Elements:</b>	None observed.			
	<b>Corrosion and Weathering:</b>	None observed.

<b>Repair Action:</b>	REPAIR	<b>FMSS Work Type:</b>	DEFERRED MAINTENANCE	<b>Repair Cost:</b>	\$8574
<b>Brief Workorder:</b>	Replace 75 l.f. of guard rail and 38 l.f. of damaged rail sections; reshape 400 l.f. of W-beam.				
<b>Workorder:</b>	<p>Replace Rail at \$25- per -Lin. Ft. for 75 LF = \$1875. Replace 75-ft damaged rail.</p> <p>Replace Post at \$100- per -Each for 1 Post(s) = \$100. Replace one wooden post.</p> <p>Replace Rail at \$25- per -Lin. Ft. for 38 LF = \$950. Replace 38-ft of end terminal rail.</p> <p>Labor at \$60- per -Hour for 32 Hrs = \$1920. 32-hrs of labor to reshape 400-ft of rail.</p> <p>Low Speed Traffic Control at \$1475- per -Day for 2 Day(s) = \$2950. 1 day to replace rail sections 1 day to reshape 400-ft of rail.</p>

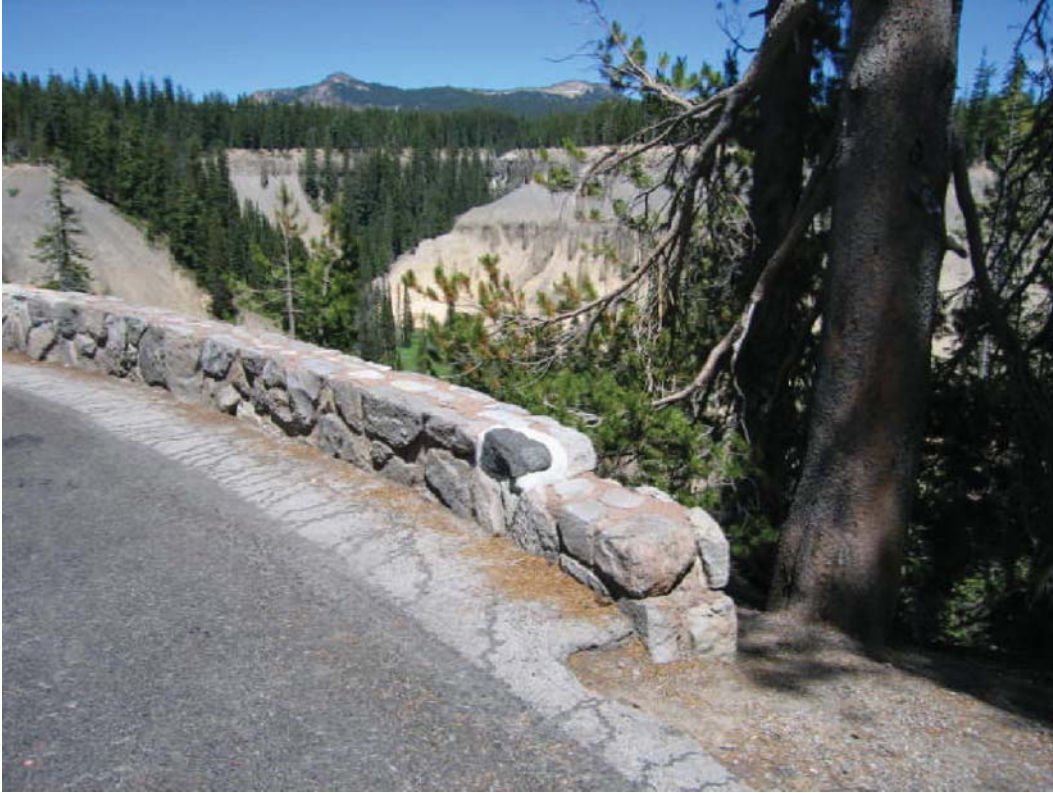
CRLA\_0011\_8.783\_L\_1.jpg

<b>Height (In.):</b>	22.0	<b>Lateral Offset (In.):</b>	0.0	<b>Road Grade (%):</b>	0.00
<b>Physical Condition</b>					
<b>Barrier</b>	<b>Alignment and Height:</b>	No deviation in horizontal and vertical alignments. 27-ft of barrier was more than 3-in below design height (24-in). Barrier was designed to rise from a low height of 18-in on both ends to a maximum height of 24-in at its center.			
	<b>Breaking and Cracking:</b>	No cracking or breaking observed.			
	<b>Missing Elements:</b>	One missing element observed -- small stone missing from back face of barrier approximately 1-ft x 1-ft.			
	<b>Corrosion and Weathering:</b>	No weathering or corrosion observed.			
<b>End Treatments</b>	<b>Alignment and Height:</b>				
	<b>Breaking and Cracking:</b>				
	<b>Missing Elements:</b>				
	<b>Corrosion and Weathering:</b>

<b>Repair Action:</b>	REPAIR	<b>FMSS Work Type:</b>	DEFERRED MAINTENANCE	<b>Repair Cost:</b>	\$132
<b>Brief Workorder:</b>	RegROUT missing stone.				
<b>Workorder:</b>	Labor at \$60- per -Hour for 2 Hrs = \$120. 2-hrs required to regROUT missing stones.

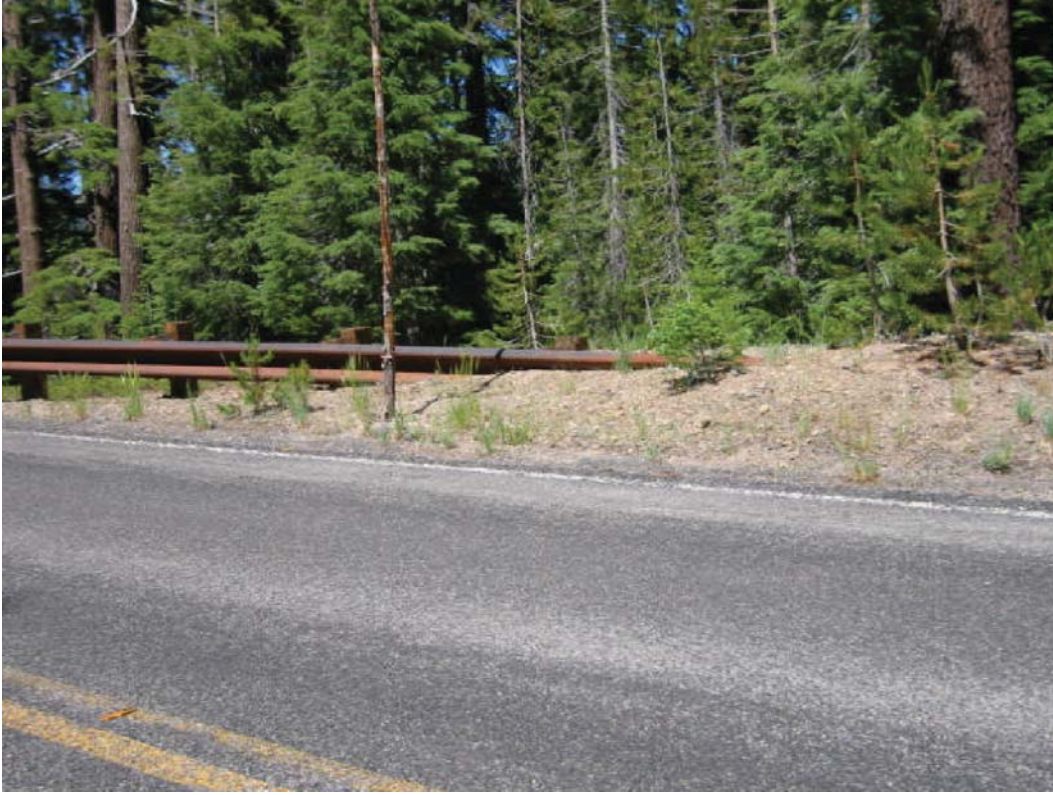
CRLA\_0011\_12.026\_L\_1.jpg

<b>Height (In.):</b>	27.0	<b>Lateral Offset (In.):</b>	19.2	<b>Road Grade (%):</b>	2.80
<b>Physical Condition</b>					
<b>Barrier</b>	<b>Alignment and Height:</b>	Post are plumb. Rail has some flattening from snow removal.			
	<b>Breaking and Cracking:</b>	80-ft of rail has been flattened and does not touch the top of the block by 1 to 3-in. Six blocks twisted.			
	<b>Missing Elements:</b>	Six posts and blocks need to be tightened; approximately 50-linear-ft. No missing elements observed.			
	<b>Corrosion and Weathering:</b>	The rail is corroded. Recommend monitoring.			
<b>End Treatments</b>	<b>Alignment and Height:</b>				
	<b>Breaking and Cracking:</b>				
	<b>Missing Elements:</b>				
	<b>Corrosion and Weathering:</b>

<b>Repair Action:</b>	REPAIR	<b>FMSS Work Type:</b>	DEFERRED MAINTENANCE	<b>Repair Cost:</b>	\$2678
<b>Brief Workorder:</b>	Reshape flattened W-beam tighten bolts and repair twisted blockouts.				
<b>Workorder:</b>	Labor at \$60- per -Hour for 8 Hrs = \$480. 8-hrs labor to reshape 80-ft of rail. Labor at \$60- per -Hour for 4 Hrs = \$240. 4-hrs labor to tighten bolts. Labor at \$60- per -Hour for 4 Hrs = \$240. 4-hrs labor to repair twisted blocks. Low Speed Traffic Control at \$1475- per -Day for 1 Day(s) = \$1475. One day low speed traffic control.
