DINO GIP Report

NPS Guardwall/Rail Inventory Program Dinosaur National Monument

**Data Collection Date: November 2009
Report Date: November 2015**

Dinosaur National Monument in Colorado and Utah

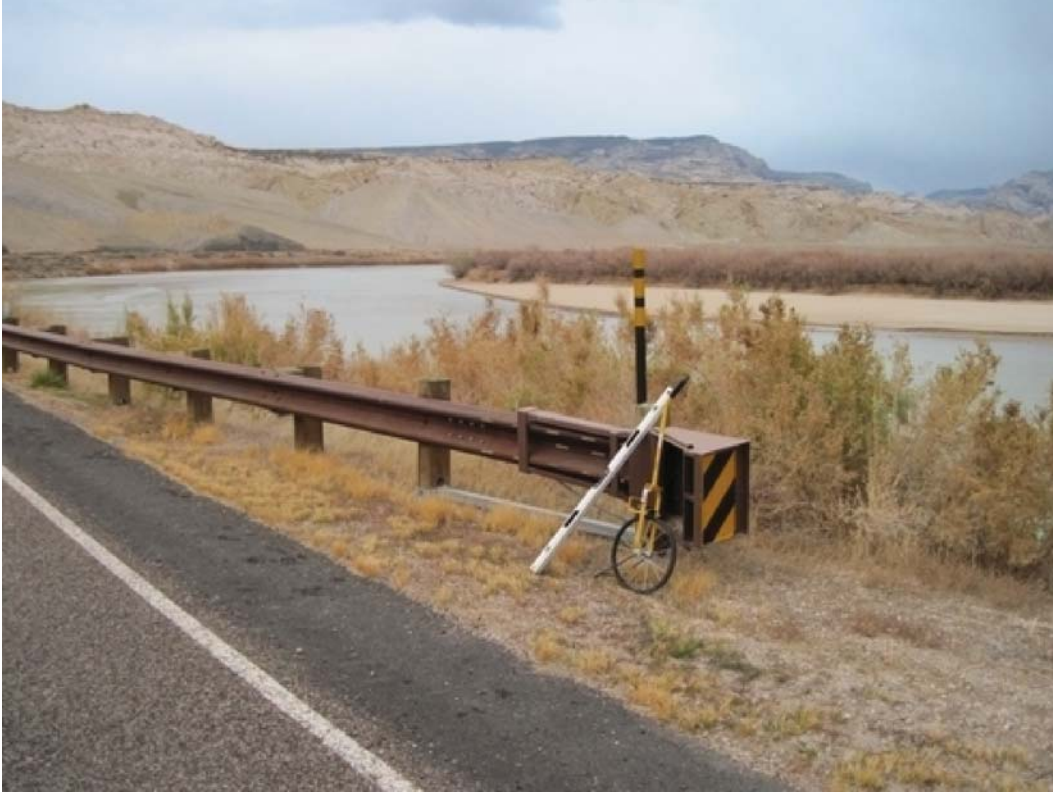
DINO_0010_0.310_R_1.jpg

Barrier ID:	DINO-0010-0.310-R				
Route Name:	GRD MAIN ENTRANCE ROAD				
Inspection Date:	12/11/2009	Barrier Rating:	31.20		
Barrier Description					
Type:	W-BEAM STRONG POST	Barrier Function:	TRAFFIC		
Barrier Material:	WEATHERING STEEL/CORTEN	Post Material:	WOOD		
Blockout Type:	WOOD	Length (ft.):	2142		
Speed Limit (MPH):	45	Placement with Respect to Road:	INSIDE OF CURVE		
Hazard Behind Barrier:	HIGH				
Barrier Crashworthiness					
Appropriate Test Level:	TL-2	Barrier Test Level:	TL-3	Is Barrier Crashworthy?:	YES
Beg. End Trtmt Type:	W-BEAM FLARED 350 COMPLIANT	Is Beg. End Trtmt Crashworthy?:	YES	Approach Transition Type:	NONE
Ending End Trtmt Type:	W-BEAM FLARED 350 COMPLIANT	Ending End Trtmt Crashworthy?:	YES		
Average Measurements					
Design Height (In.):	27	Width (In.):	0.0	Post Spacing (In.):	75.1
Height (In.):	27.5	Lateral Offset (In.):	42.0	Road Grade (%):	0.30
Physical Condition					
Barrier	Alignment and Height:	Alignment acceptable. Height is within 1-in. of 27-in. design height.

Breaking and Cracking:	26 LF of barrier rail has denting and damage.			
	Missing Elements:	No missing elements.			
	Corrosion and Weathering:	One post had 8+ in of erosion around the base of the post.			
End Treatments	Alignment and Height:	Alignment acceptable. Height is within 1-in of 27-in design height.			
	Breaking and Cracking:	No breaking or cracking observed.			
	Missing Elements:	No missing elements.			
	Corrosion and Weathering:	No corrosion or weathering.

Repair Action:	REPAIR	FMSS Work Type:	DEFERRED MAINTENANCE	Repair Cost:	\$2393
Brief Workorder:	Replace 26ft. of gaurdrail and use structural backfill to repair erosion around 1 post.				
Workorder:	Replace rail at \$25- per -Lin. Ft. for 26 LF = \$650. Replace 26 LF of dented/damaged W-beam. Structural backfill at \$50- per -Cu. Yd. for 1 CY = \$50. One post had 8+ inches of erosion around the base. Repair with backfill material. Low Speed Traffic Control at \$1475- per -Day for 1 = \$1475.

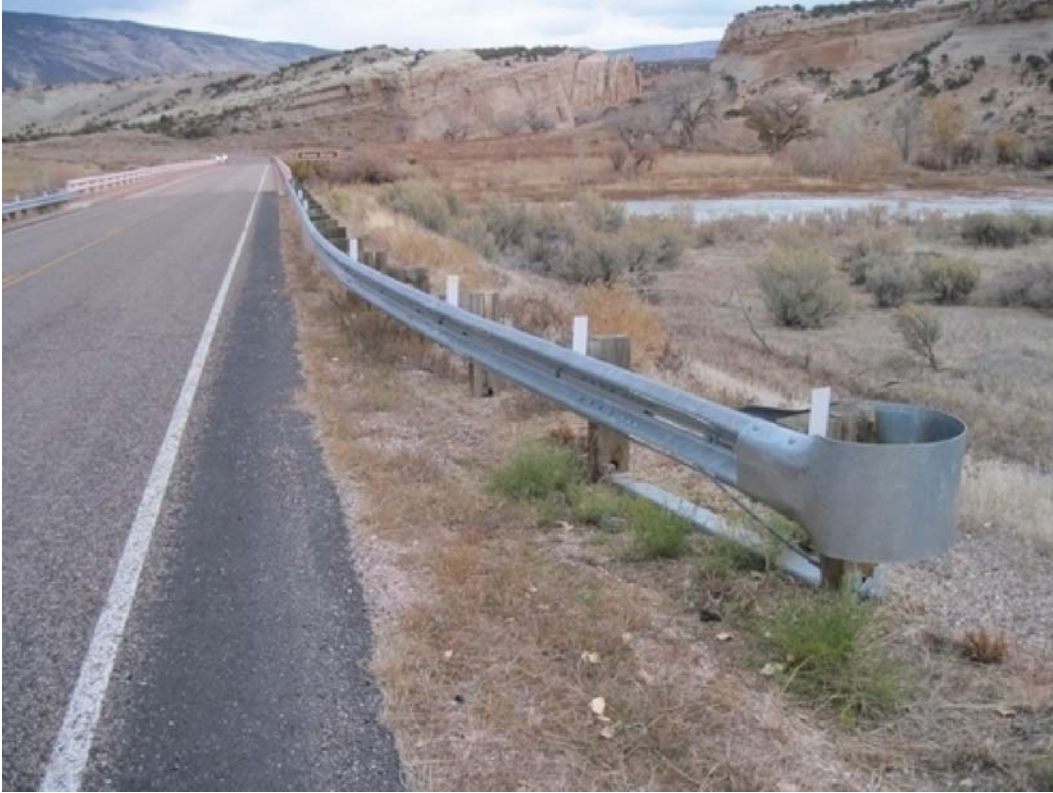
DINO_0010_7.150_R_1.jpg

Barrier ID:	DINO-0010-7.150-R				
Route Name:	GRD MAIN ENTRANCE ROAD				
Inspection Date:	12/11/2009	Barrier Rating:	29.60		
Barrier Description					
Type:	W-BEAM STRONG POST	Barrier Function:	TRAFFIC		
Barrier Material:	GALVANIZED STEEL	Post Material:	WOOD		
Blockout Type:	WOOD	Length (ft.):	155		
Speed Limit (MPH):	45	Placement with Respect to Road:	TANGENT		
Hazard Behind Barrier:	MEDIUM				
Barrier Crashworthiness					
Appropriate Test Level:	TL-2	Barrier Test Level:	TL-3	Is Barrier Crashworthy?:	YES
Beg. End Trtmt Type:	W-BEAM FLARED 350 COMPLIANT	Is Beg. End Trtmt Crashworthy?:	YES	Approach Transition Type:	BRIDGE RAIL W-BEAM
Ending End Trtmt Type:	NONE	Ending End Trtmt Crashworthy?:	N/A		
Average Measurements					
Design Height (In.):	27	Width (In.):	0.0	Post Spacing (In.):	75.3
Height (In.):	23.2	Lateral Offset (In.):	45.2	Road Grade (%):	0.60
Physical Condition					
Barrier	Alignment and Height:	Alignment acceptable. Height was 3-4in. below the 24-in. design height.

Breaking and Cracking:	2 blocks are cracked in half.			
	Missing Elements:	No missing elements.			
	Corrosion and Weathering:	No corrosion weathering or erosion at the barrier length.			
End Treatments	Alignment and Height:	Alignment acceptable. 30-ft. was between 1 and 3-in. below the 27-in. design height.			
	Breaking and Cracking:	No breaking or cracking observed.			
	Missing Elements:	No missing elements.			
	Corrosion and Weathering:	No corrosion weathering or erosion at the end treatment.

Repair Action:	REPAIR	FMSS Work Type:	DEFERRED MAINTENANCE	Repair Cost:	\$3394
Brief Workorder:	Raise 155-ft. of barrier up to 27-in. design height and replace 2 blocks.				
Workorder:	Adjust Guardrail at \$10- per -Lin. Ft. for 155 LF = \$1550. Raise 155-ft. of barrier up to 27-in. design height. Replace block at \$30- per -Each for 2 = \$60. Replace 2 cracked blocks. Low Speed Traffic Control at \$1475- per -Day for 1 = \$1475.

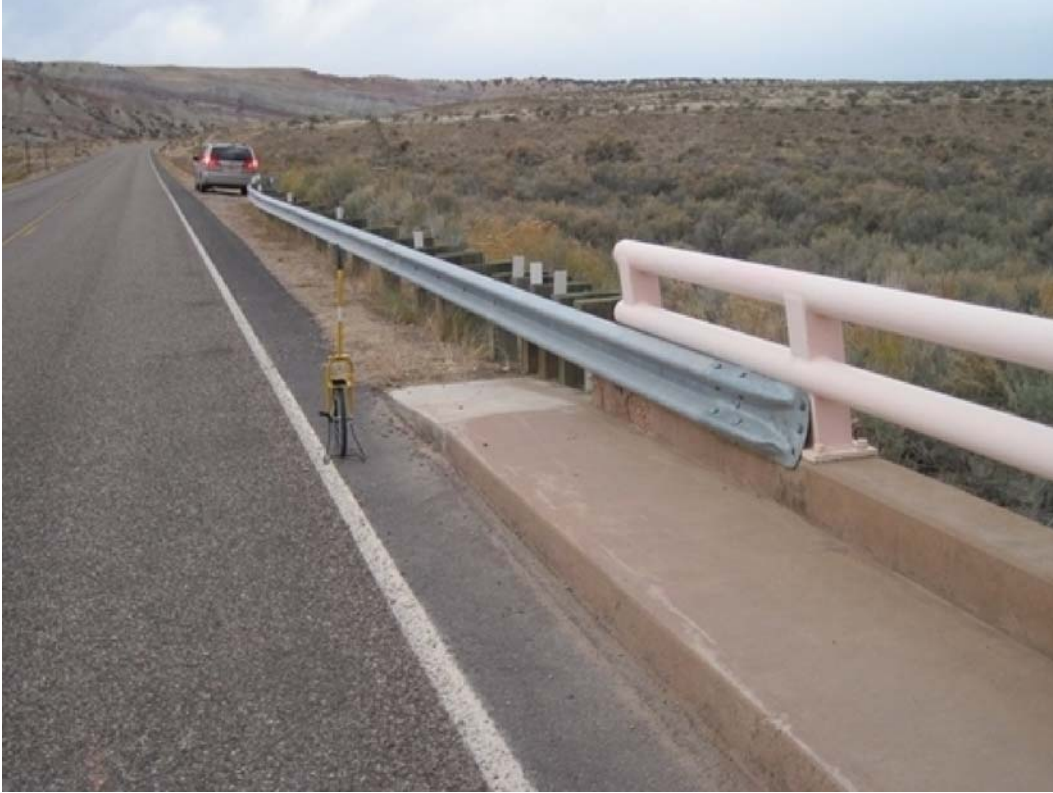
DINO_0010_7.157_L_1.jpg

Barrier ID:	DINO-0010-7.157-L				
Route Name:	GRD MAIN ENTRANCE ROAD				
Inspection Date:	12/11/2009	Barrier Rating:	24.10		
Barrier Description					
Type:	W-BEAM STRONG POST	Barrier Function:	TRAFFIC		
Barrier Material:	GALVANIZED STEEL	Post Material:	WOOD		
Blockout Type:	WOOD	Length (ft.):	110		
Speed Limit (MPH):	45	Placement with Respect to Road:	TANGENT		
Hazard Behind Barrier:	HIGH				
Barrier Crashworthiness					
Appropriate Test Level:	TL-2	Barrier Test Level:	TL-3	Is Barrier Crashworthy?:	YES
Beg. End Trtmt Type:	W-BEAM FLARED 350 COMPLIANT	Is Beg. End Trtmt Crashworthy?:	YES	Approach Transition Type:	BRIDGE RAIL W-BEAM
Ending End Trtmt Type:	NONE	Ending End Trtmt Crashworthy?:	N/A		
Average Measurements					
Design Height (In.):	27	Width (In.):	0.0	Post Spacing (In.):	75.0
Height (In.):	25.0	Lateral Offset (In.):	53.2	Road Grade (%):	0.50
Physical Condition					
Barrier	Alignment and Height:	Alignment acceptable. 110-ft. was between 1 and 3-in. below the 27-in. design height.

Breaking and Cracking:	1 block is cracked in half.			
	Missing Elements:	No missing elements.			
	Corrosion and Weathering:	No corrosion weathering or erosion at the barrier length.			
End Treatments	Alignment and Height:	Alignment acceptable. 30-ft. was between 1 and 3-in. below the 27-in. design height.			
	Breaking and Cracking:	No breaking or cracking observed.			
	Missing Elements:	No missing elements.			
	Corrosion and Weathering:	No erosion weathering or erosion.

Repair Action:	REPAIR	FMSS Work Type:	DEFERRED MAINTENANCE	Repair Cost:	\$2866
Brief Workorder:	Raise 110-ft. of barrier up to 27-in. design height and replace 1 block.				
Workorder:	Adjust Guardrail at \$10- per -Lin. Ft. for 110 LF = \$1100. Raise 110-ft. of barrier up to 27-in. design height. Replace block at \$30- per -Each for 1 = \$30. Replace one cracked block. Low Speed Traffic Control at \$1475- per -Day for 1 = \$1475.

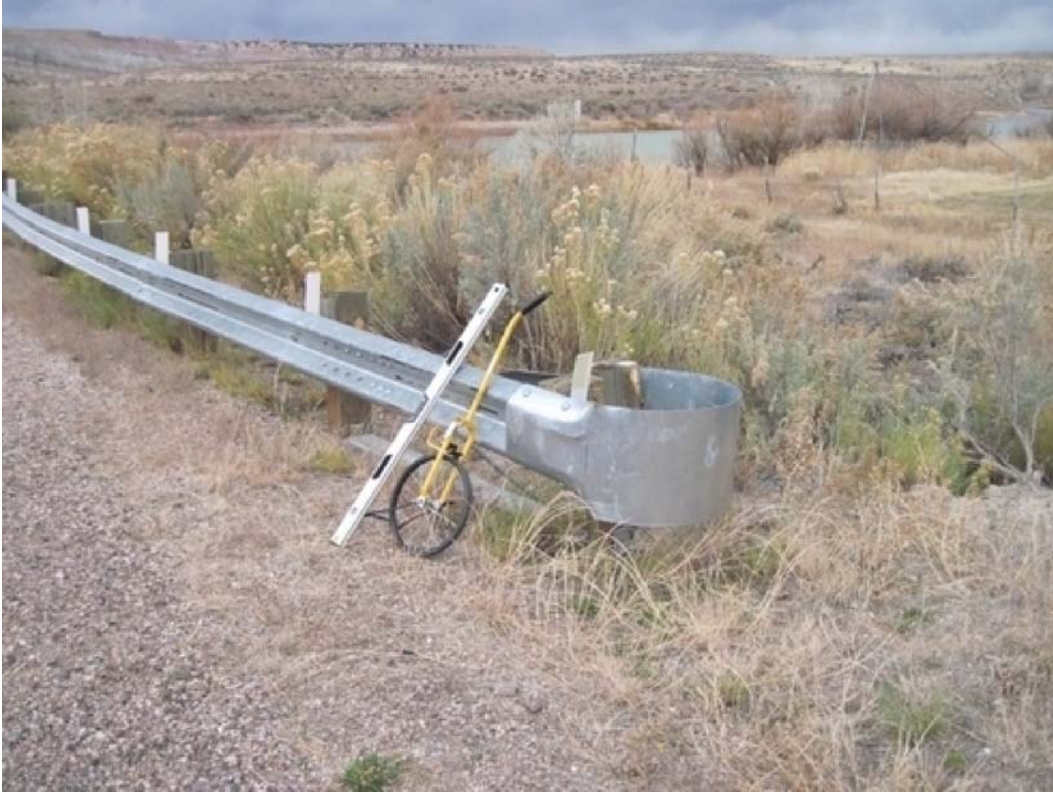
DINO_0010_7.261_L_1.jpg

Barrier ID:	DINO-0010-7.261-L				
Route Name:	GRD MAIN ENTRANCE ROAD				
Inspection Date:	12/11/2009	Barrier Rating:	17.80		
Barrier Description					
Type:	W-BEAM STRONG POST	Barrier Function:	TRAFFIC		
Barrier Material:	GALVANIZED STEEL	Post Material:	WOOD		
Blockout Type:	WOOD	Length (ft.):	153		
Speed Limit (MPH):	45	Placement with Respect to Road:	TANGENT		
Hazard Behind Barrier:	MEDIUM				
Barrier Crashworthiness					
Appropriate Test Level:	TL-2	Barrier Test Level:	TL-3	Is Barrier Crashworthy?:	YES
Beg. End Trtmt Type:	NONE	Is Beg. End Trtmt Crashworthy?:	N/A	Approach Transition Type:	BRIDGE RAIL W-BEAM
Ending End Trtmt Type:	W-BEAM FLARED 350 COMPLIANT	Ending End Trtmt Crashworthy?:	YES		
Average Measurements					
Design Height (In.):	27	Width (In.):	0.0	Post Spacing (In.):	75.6
Height (In.):	27.0	Lateral Offset (In.):	67.0	Road Grade (%):	1.20
Physical Condition					
Barrier	Alignment and Height:	Alignment acceptable. Height is within 1-in. of 27-in. design height.

Breaking and Cracking:	13 ft section of rail is torn.			
	Missing Elements:	No missing elements.			
	Corrosion and Weathering:	No notable corrosion/weathering or erosion.			
End Treatments	Alignment and Height:	Alignment acceptable. Height is within 1-in. of 27-in. design height.			
	Breaking and Cracking:	No breaking or cracking observed.			
	Missing Elements:	No missing elements.			
	Corrosion and Weathering:	No notable corrosion/weathering or erosion.

Repair Action:	REPAIR	FMSS Work Type:	DEFERRED MAINTENANCE	Repair Cost:	\$1980
Brief Workorder:	Replace 13 ft of torn rail.				
Workorder:	Replace rail at \$25- per -Lin. Ft. for 13 LF = \$325. Replace the 13 ft section or rail with tear. Low Speed Traffic Control at \$1475- per -Day for 1 Day(s) = \$1475.

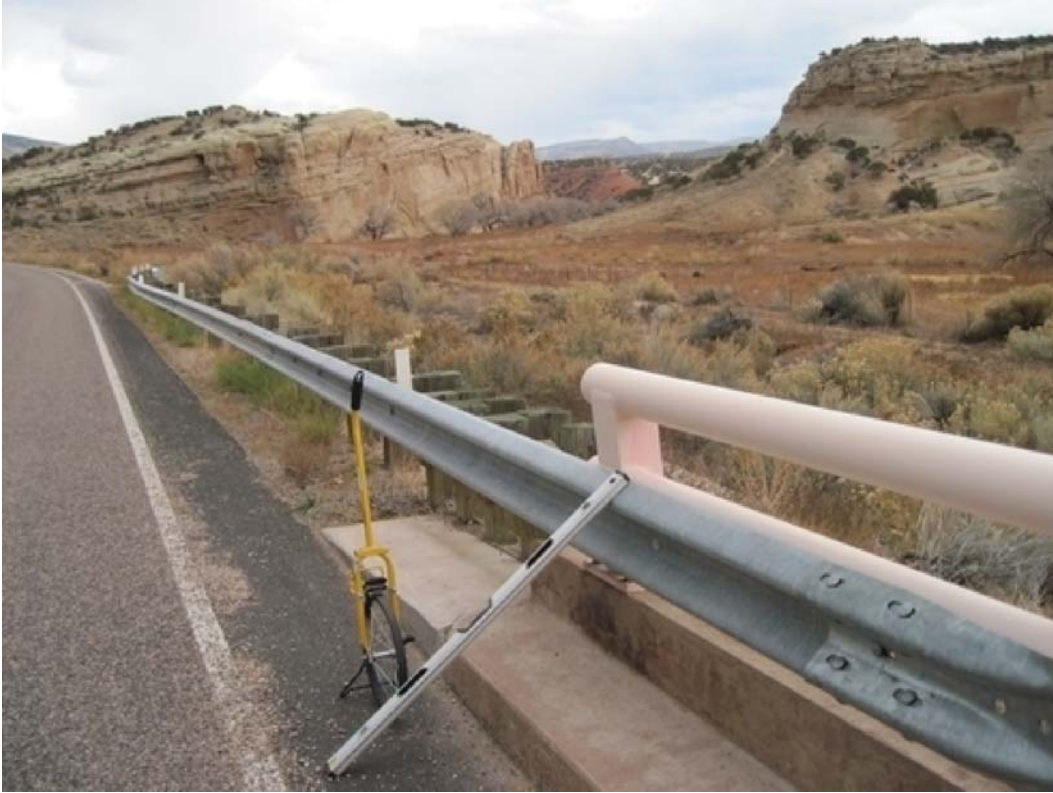
DINO_0010_7.262_R_1.jpg

Barrier ID:	DINO-0010-7.262-R				
Route Name:	GRD MAIN ENTRANCE ROAD				
Inspection Date:	12/11/2009	Barrier Rating:	25.20		
Barrier Description					
Type:	W-BEAM STRONG POST	Barrier Function:	TRAFFIC		
Barrier Material:	GALVANIZED STEEL	Post Material:	WOOD		
Blockout Type:	WOOD	Length (ft.):	111		
Speed Limit (MPH):	45	Placement with Respect to Road:	TANGENT		
Hazard Behind Barrier:	MEDIUM				
Barrier Crashworthiness					
Appropriate Test Level:	TL-2	Barrier Test Level:	TL-3	Is Barrier Crashworthy?:	YES
Beg. End Trtmt Type:	NONE	Is Beg. End Trtmt Crashworthy?:	N/A	Approach Transition Type:	NONE
Ending End Trtmt Type:	W-BEAM FLARED 350 COMPLIANT	Ending End Trtmt Crashworthy?:	YES		
Average Measurements					
Design Height (In.):	27	Width (In.):	0.0	Post Spacing (In.):	76.6
Height (In.):	25.7	Lateral Offset (In.):	39.2	Road Grade (%):	1.40
Physical Condition					
Barrier	Alignment and Height:	Alignment acceptable. 53-ft. was between 1 and 3-in. below the 27-in. design height.

Breaking and Cracking:	2 split blocks.			
	Missing Elements:	No missing elements.			
	Corrosion and Weathering:	No notable corrosion/weathering or erosion.			
End Treatments	Alignment and Height:	Alignment acceptable. 30-ft. was between 1 and 3-in. below the 27-in. design height.			
	Breaking and Cracking:	No breaking or cracking observed.			
	Missing Elements:	No missing elements			
	Corrosion and Weathering:	No notable corrosion/weathering or erosion.

Repair Action:	REPAIR	FMSS Work Type:	DEFERRED MAINTENANCE	Repair Cost:	\$2305
Brief Workorder:	Raise 53-ft. of barrier up to 27-in. design height and replace 3 blocks.				
Workorder:	Adjust Guardrail at \$10- per -Lin. Ft. for 53 LF = \$530. Raise 53-ft. of barrier up to 27-in. design height. Replace block at \$30- per -Each for 3 Block(s) = \$90. Need to replace 2 spit blocks and 1 turned block. Low Speed Traffic Control at \$1475- per -Day for 1 = \$1475.

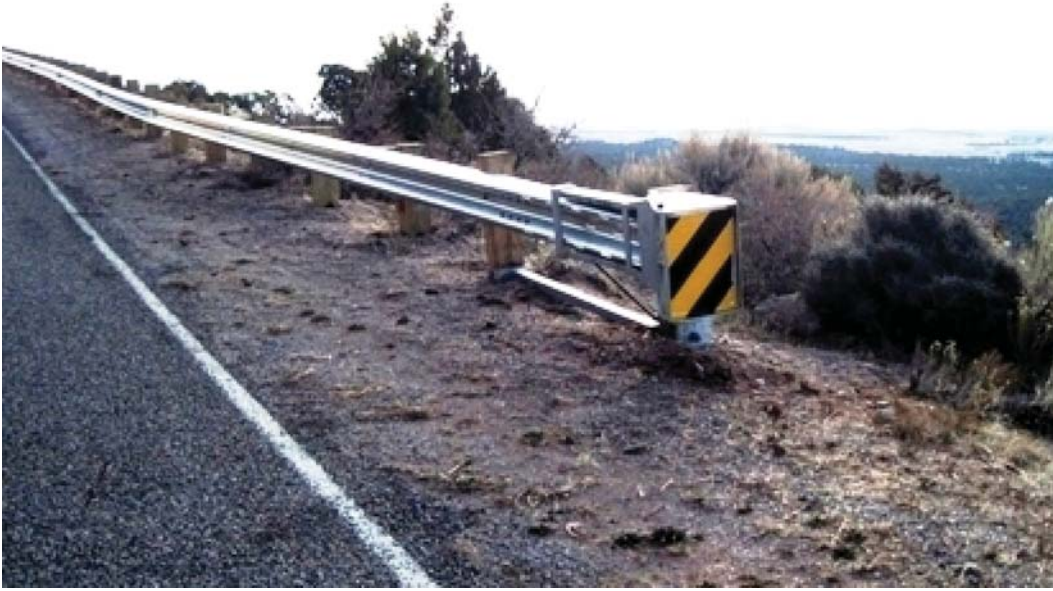
DINO_0011_3.795_R_1.jpg

Barrier ID:	DINO-0011-3.795-R				
Route Name:	HARPERS CORNER ROAD				
Inspection Date:	12/11/2009	Barrier Rating:	32.40		
Barrier Description					
Type:	W-BEAM STRONG POST	Barrier Function:	TRAFFIC		
Barrier Material:	GALVANIZED STEEL	Post Material:	WOOD		
Blockout Type:	WOOD	Length (ft.):	1394		
Speed Limit (MPH):	45	Placement with Respect to Road:	OUTSIDE OF CURVE		
Hazard Behind Barrier:	MEDIUM				
Barrier Crashworthiness					
Appropriate Test Level:	TL-2	Barrier Test Level:	TL-3	Is Barrier Crashworthy?:	YES
Beg. End Trtmt Type:	W-BEAM TANGENT 350	Is Beg. End Trtmt Crashworthy?:	YES	Approach Transition Type:	NONE
Ending End Trtmt Type:	W-BEAM TANGENT 350	Ending End Trtmt Crashworthy?:	YES		
Average Measurements					
Design Height (In.):	27	Width (In.):	0.0	Post Spacing (In.):	74.3
Height (In.):	27.2	Lateral Offset (In.):	87.0	Road Grade (%):	8.00
Physical Condition					
Barrier	Alignment and Height:	Alignment acceptable. Entire barrier is between 1-in. below to 4-in. above the 27-in. design height.

Breaking and Cracking:	No breaking or cracking for the barrier length.			
	Missing Elements:	No missing elements.			
	Corrosion and Weathering:	No corrosion weathering or erosion at the barrier length.			
End Treatments	Alignment and Height:	Alignment acceptable. Height is within 1-in. of 27-in. design height.			
	Breaking and Cracking:	No breaking or cracking observed.			
	Missing Elements:	No missing elements.			
	Corrosion and Weathering:	No corrosion weathering or erosion at the end treatments.

Barrier ID:	DINO-0011-3.795-R				
Route Name:	HARPERS CORNER ROAD				
Inspection Date:	12/11/2009	Barrier Rating:		32.40	
Repair Recommendations					
Repair Action:	NO ACTION	FMSS Work Type:	N/A	Repair Cost:	\$0
Brief Workorder:	N/A				
Workorder:

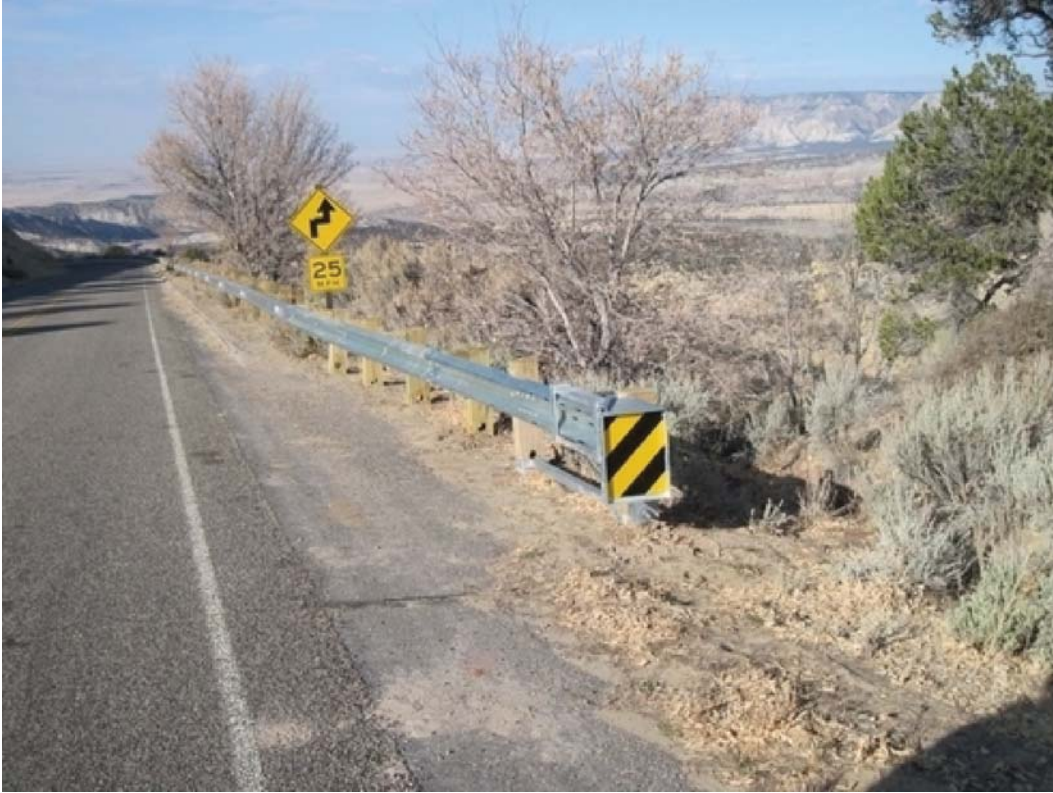
DINO_0011_4.068_L_1.jpg

Barrier ID:	DINO-0011-4.068-L				
Route Name:	HARPERS CORNER ROAD				
Inspection Date:	12/11/2009	Barrier Rating:	31.50		
Barrier Description					
Type:	W-BEAM STRONG POST	Barrier Function:	TRAFFIC		
Barrier Material:	GALVANIZED STEEL	Post Material:	WOOD		
Blockout Type:	WOOD	Length (ft.):	1093		
Speed Limit (MPH):	25	Placement with Respect to Road:	OUTSIDE OF CURVE		
Hazard Behind Barrier:	EXTREME				
Barrier Crashworthiness					
Appropriate Test Level:	TL-1	Barrier Test Level:	TL-3	Is Barrier Crashworthy?:	YES
Beg. End Trtmt Type:	W-BEAM TANGENT 350	Is Beg. End Trtmt Crashworthy?:	YES	Approach Transition Type:	NONE
Ending End Trtmt Type:	W-BEAM TANGENT 350	Ending End Trtmt Crashworthy?:	YES		
Average Measurements					
Design Height (In.):	27	Width (In.):	0.0	Post Spacing (In.):	74.4
Height (In.):	27.6	Lateral Offset (In.):	81.8	Road Grade (%):	8.20
Physical Condition					
Barrier	Alignment and Height:	Alignment acceptable. Height is within 1-in of 27-in design height.

Breaking and Cracking:	Two 13-ft rail sections are bent and or torn.			
	Missing Elements:	No missing elements.			
	Corrosion and Weathering:	No corrosion / weathering.			
End Treatments	Alignment and Height:	Alignment acceptable. Height is within 1-in of 27-in design height.			
	Breaking and Cracking:	No breaking or cracking observed.			
	Missing Elements:	No missing elements.			
	Corrosion and Weathering:	No corrosion / weathering.

Repair Action:	REPAIR	FMSS Work Type:	DEFERRED MAINTENANCE	Repair Cost:	\$2338
Brief Workorder:	Replace two 13- foot rail sections.				
Workorder:	Replace rail at \$25- per -Lin. Ft. for 26 = \$650. Replace two 13ft. rail sections that were damaged. Low Speed Traffic Control at \$1475- per -Day for 1 = \$1475.

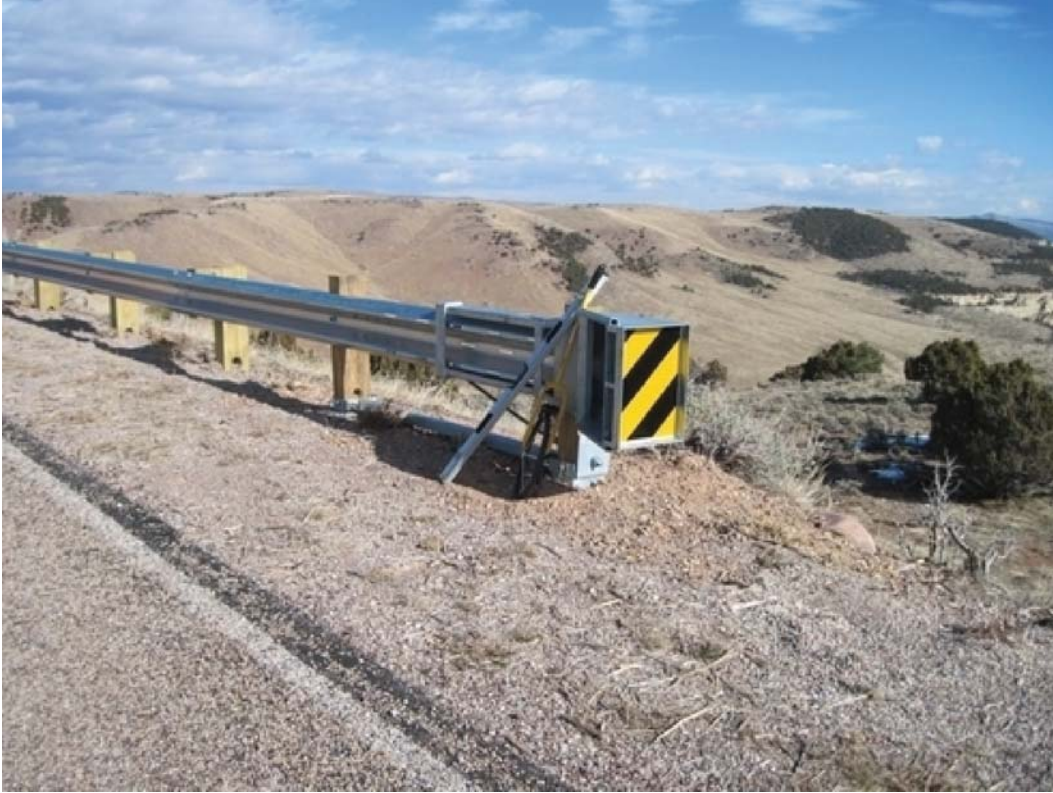
DINO_0011_27.475_R_1.jpg

Barrier ID:	DINO-0011-27.475-R				
Route Name:	HARPERS CORNER ROAD				
Inspection Date:	12/11/2009	Barrier Rating:	25.60		
Barrier Description					
Type:	W-BEAM STRONG POST	Barrier Function:	TRAFFIC		
Barrier Material:	GALVANIZED STEEL	Post Material:	WOOD		
Blockout Type:	WOOD	Length (ft.):	474		
Speed Limit (MPH):	35	Placement with Respect to Road:	OUTSIDE OF CURVE		
Hazard Behind Barrier:	HIGH				
Barrier Crashworthiness					
Appropriate Test Level:	TL-2	Barrier Test Level:	TL-3	Is Barrier Crashworthy?:	YES
Beg. End Trtmt Type:	W-BEAM TANGENT 350	Is Beg. End Trtmt Crashworthy?:	YES	Approach Transition Type:	NONE
Ending End Trtmt Type:	W-BEAM TANGENT 350	Ending End Trtmt Crashworthy?:	YES		
Average Measurements					
Design Height (In.):	27	Width (In.):	0.0	Post Spacing (In.):	75.0
Height (In.):	27.2	Lateral Offset (In.):	44.0	Road Grade (%):	2.40
Physical Condition					
Barrier	Alignment and Height:	Alignment acceptable. Height is within 1-in of 27-in. design height.

Breaking and Cracking:	No breaking or cracking observed.			
	Missing Elements:	No missing elements.			
	Corrosion and Weathering:	No notable corrosion/weathering or erosion.			
End Treatments	Alignment and Height:	Alignment is acceptable. Height is within 1-in. of 27-in. design height.			
	Breaking and Cracking:	No breaking or cracking observed.			
	Missing Elements:	No missing elements.			
	Corrosion and Weathering:	No notable corrosion/weathering or erosion.

Repair Action:	NO ACTION	FMSS Work Type:	N/A	Repair Cost:	\$0
Brief Workorder:	N/A				
Workorder:

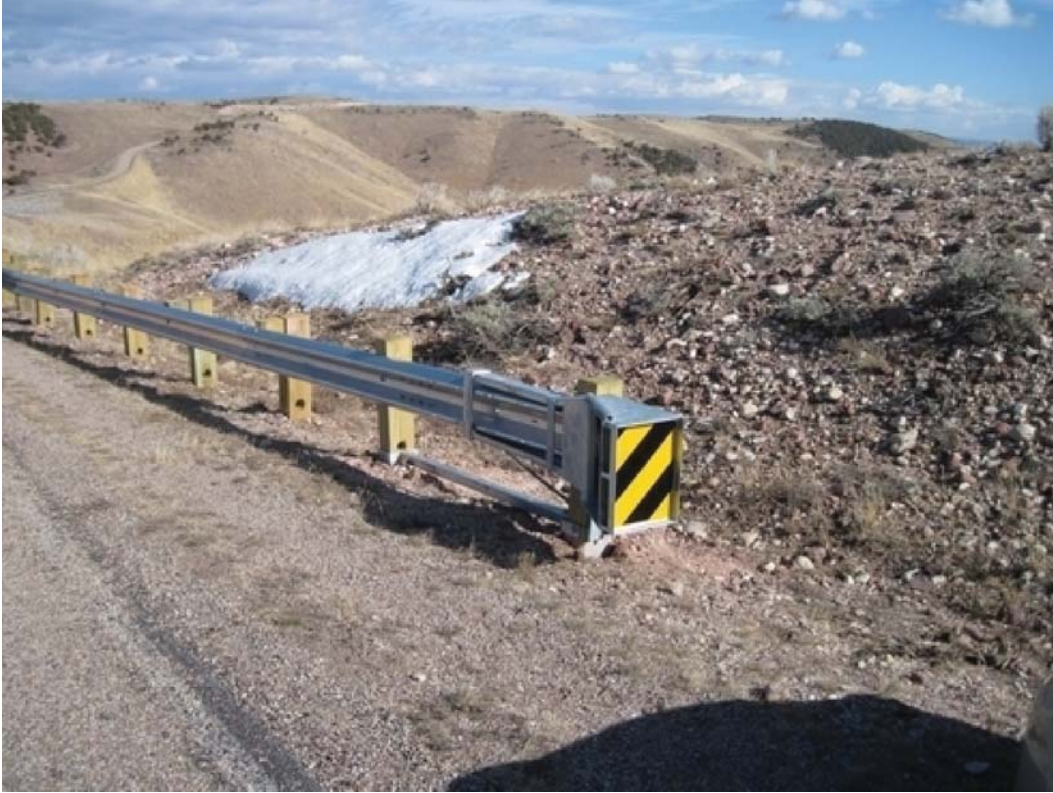
DINO_0011_27.716_R_1.jpg

Barrier ID:	DINO-0011-27.716-R				
Route Name:	HARPERS CORNER ROAD				
Inspection Date:	12/11/2009	Barrier Rating:	34.00		
Barrier Description					
Type:	W-BEAM STRONG POST	Barrier Function:	TRAFFIC		
Barrier Material:	GALVANIZED STEEL	Post Material:	WOOD		
Blockout Type:	WOOD	Length (ft.):	904		
Speed Limit (MPH):	35	Placement with Respect to Road:	BOTH INSIDE AND OUTSIDE		
Hazard Behind Barrier:	HIGH				
Barrier Crashworthiness					
Appropriate Test Level:	TL-2	Barrier Test Level:	TL-3	Is Barrier Crashworthy?:	YES
Beg. End Trtmt Type:	W-BEAM TANGENT 350	Is Beg. End Trtmt Crashworthy?:	YES	Approach Transition Type:	NONE
Ending End Trtmt Type:	W-BEAM TANGENT 350	Ending End Trtmt Crashworthy?:	YES		
Average Measurements					
Design Height (In.):	27	Width (In.):	0.0	Post Spacing (In.):	74.0
Height (In.):	27.0	Lateral Offset (In.):	51.7	Road Grade (%):	6.40
Physical Condition					
Barrier	Alignment and Height:	Alignment acceptable. Height is within 1-in of 27-in. design height.

Breaking and Cracking:	No breaking or cracking observed.			
	Missing Elements:	No missing elements.			
	Corrosion and Weathering:	No corrosion weathering or erosion at the barrier foundation.			
End Treatments	Alignment and Height:	Alignment is acceptable. Height is within 1-in. of 27-in. design height.			
	Breaking and Cracking:	No breaking or cracking observed.			
	Missing Elements:	No missing elements.			
	Corrosion and Weathering:	No corrosion weathering or erosion at the end sections.

Barrier ID:	DINO-0011-27.716-R				
Route Name:	HARPERS CORNER ROAD				
Inspection Date:	12/11/2009	Barrier Rating:		34.00	
Repair Recommendations					
Repair Action:	NO ACTION	FMSS Work Type:	N/A	Repair Cost:	\$0
Brief Workorder:	N/A				
Workorder:

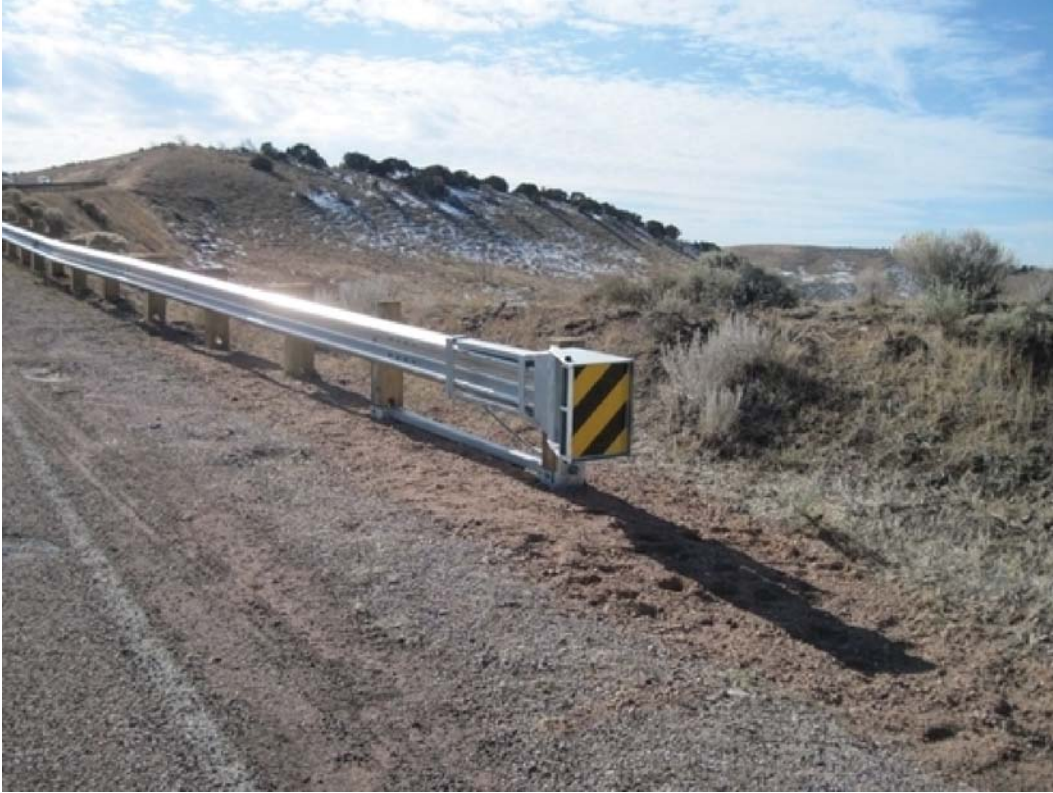
DINO_0011_27.721_L_1.jpg

Barrier ID:	DINO-0011-27.721-L				
Route Name:	HARPERS CORNER ROAD				
Inspection Date:	12/11/2009	Barrier Rating:	17.00		
Barrier Description					
Type:	W-BEAM STRONG POST	Barrier Function:	TRAFFIC		
Barrier Material:	GALVANIZED STEEL	Post Material:	WOOD		
Blockout Type:	WOOD	Length (ft.):	604		
Speed Limit (MPH):	35	Placement with Respect to Road:	INSIDE OF CURVE		
Hazard Behind Barrier:	HIGH				
Barrier Crashworthiness					
Appropriate Test Level:	TL-2	Barrier Test Level:	TL-3	Is Barrier Crashworthy?:	YES
Beg. End Trtmt Type:	W-BEAM FLARED 350 COMPLIANT	Is Beg. End Trtmt Crashworthy?:	YES	Approach Transition Type:	NONE
Ending End Trtmt Type:	W-BEAM FLARED 350 COMPLIANT	Ending End Trtmt Crashworthy?:	YES		
Average Measurements					
Design Height (In.):	27	Width (In.):	0.0	Post Spacing (In.):	74.3
Height (In.):	29.7	Lateral Offset (In.):	57.2	Road Grade (%):	7.10
Physical Condition					
Barrier	Alignment and Height:	Alignment acceptable. Height was 2-3in. above 27-in. design height.

Breaking and Cracking:	No breaking or cracking observed.			
	Missing Elements:	No missing elements.			
	Corrosion and Weathering:	No corrosion or weathering.			
End Treatments	Alignment and Height:	Alignment acceptable. Height was 2-3in. above 27-in design height.			
	Breaking and Cracking:	No breaking or cracking observed.			
	Missing Elements:	No missing elements.			
	Corrosion and Weathering:	No corrosion or weathering.

Repair Action:	NO ACTION	FMSS Work Type:	N/A	Repair Cost:	\$0
Brief Workorder:	N/A				
Workorder:

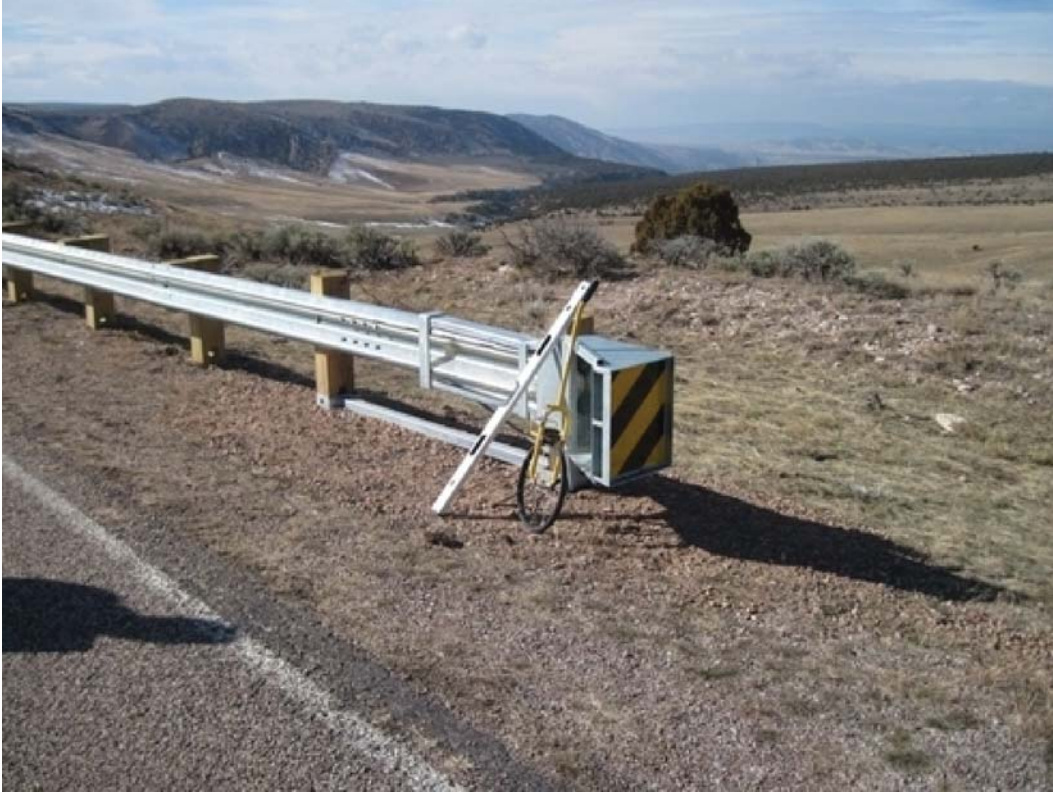
DINO_0011_27.927_L_1.jpg

Barrier ID:	DINO-0011-27.927-L				
Route Name:	HARPERS CORNER ROAD				
Inspection Date:	12/11/2009	Barrier Rating:	23.70		
Barrier Description					
Type:	W-BEAM STRONG POST	Barrier Function:	TRAFFIC		
Barrier Material:	GALVANIZED STEEL	Post Material:	WOOD		
Blockout Type:	WOOD	Length (ft.):	528		
Speed Limit (MPH):	35	Placement with Respect to Road:	OUTSIDE OF CURVE		
Hazard Behind Barrier:	MEDIUM				
Barrier Crashworthiness					
Appropriate Test Level:	TL-2	Barrier Test Level:	TL-3	Is Barrier Crashworthy?:	YES
Beg. End Trtmt Type:	W-BEAM TANGENT 350	Is Beg. End Trtmt Crashworthy?:	YES	Approach Transition Type:	NONE
Ending End Trtmt Type:	W-BEAM TANGENT 350	Ending End Trtmt Crashworthy?:	YES		
Average Measurements					
Design Height (In.):	27	Width (In.):	0.0	Post Spacing (In.):	75.6
Height (In.):	29.2	Lateral Offset (In.):	47.7	Road Grade (%):	2.20
Physical Condition					
Barrier	Alignment and Height:	Alignment acceptable. Height was 1-3in. above 27-in. design height.

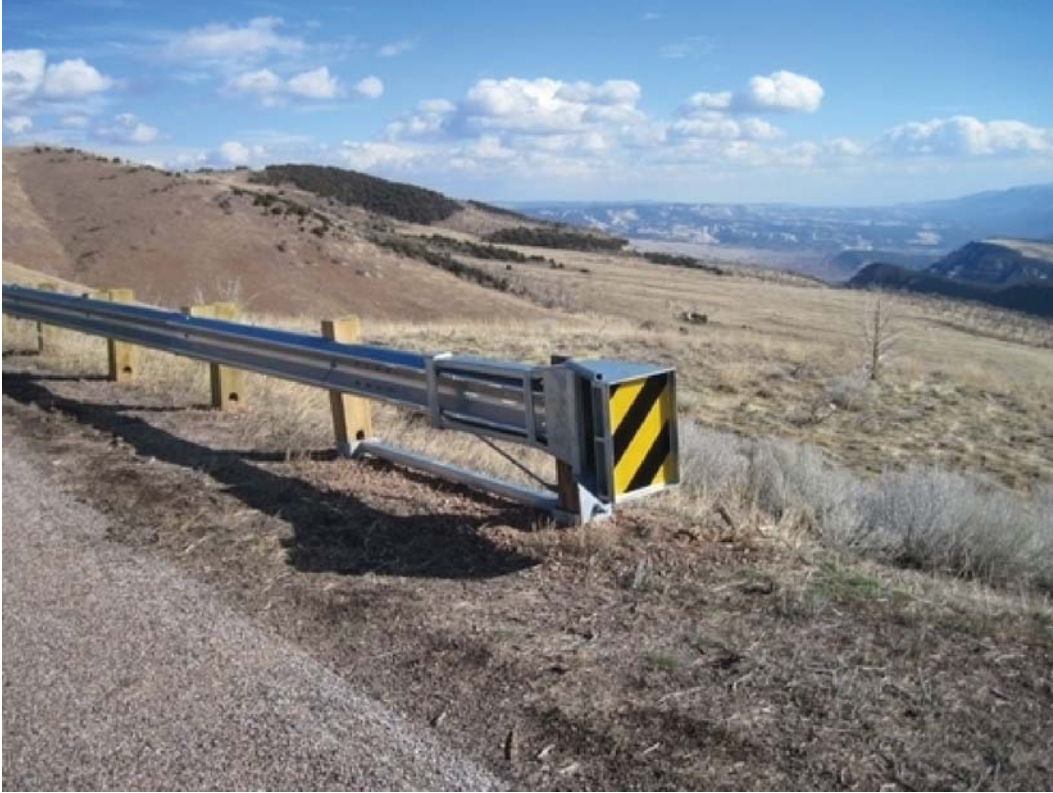
DINO_0011_28.005_R_1.jpg

Barrier ID:	DINO-0011-28.005-R				
Route Name:	HARPERS CORNER ROAD				
Inspection Date:	12/11/2009	Barrier Rating:	28.30		
Barrier Description					
Type:	W-BEAM STRONG POST	Barrier Function:	TRAFFIC		
Barrier Material:	GALVANIZED STEEL	Post Material:	WOOD		
Blockout Type:	WOOD	Length (ft.):	777		
Speed Limit (MPH):	35	Placement with Respect to Road:	BOTH INSIDE AND OUTSIDE		
Hazard Behind Barrier:	HIGH				
Barrier Crashworthiness					
Appropriate Test Level:	TL-2	Barrier Test Level:	TL-3	Is Barrier Crashworthy?:	YES
Beg. End Trtmt Type:	W-BEAM TANGENT 350	Is Beg. End Trtmt Crashworthy?:	YES	Approach Transition Type:	NONE
Ending End Trtmt Type:	W-BEAM TANGENT 350	Ending End Trtmt Crashworthy?:	YES		
Average Measurements					
Design Height (In.):	27	Width (In.):	0.0	Post Spacing (In.):	74.5
Height (In.):	29.0	Lateral Offset (In.):	40.7	Road Grade (%):	5.10
Physical Condition					
Barrier	Alignment and Height:	Alignment acceptable. Height was 1-3in. above 27-in. design height.

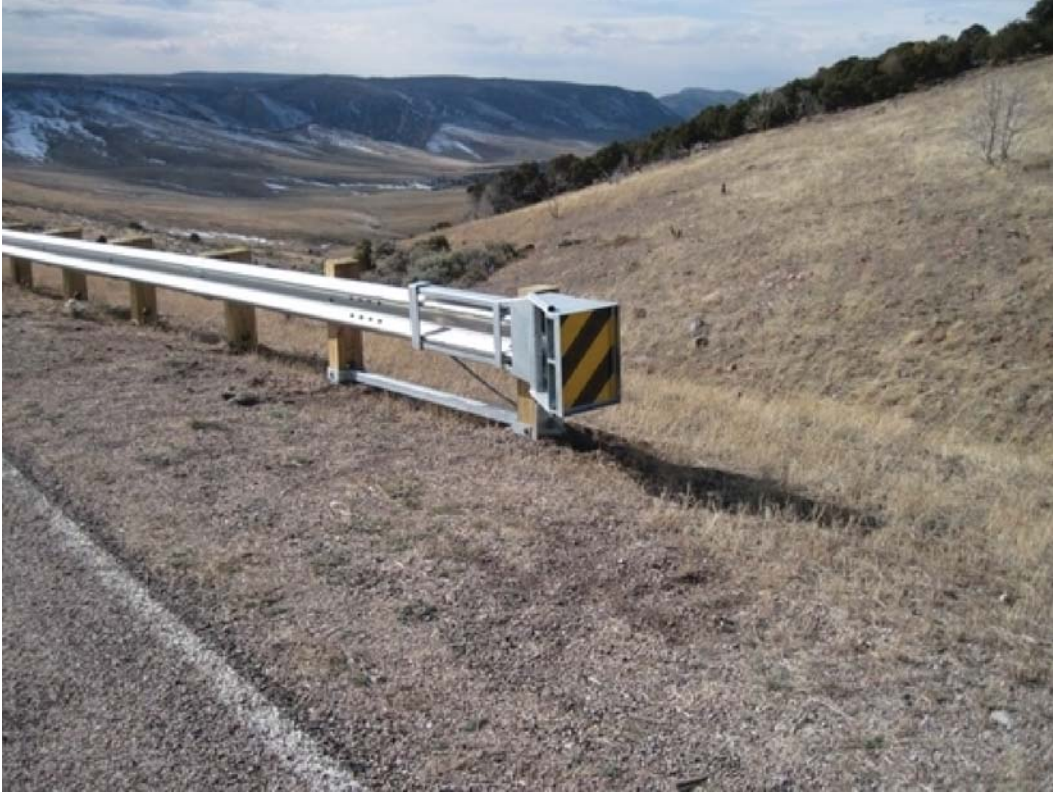
DINO_0011_28.059_L_1.jpg

Barrier ID:	DINO-0011-28.059-L				
Route Name:	HARPERS CORNER ROAD				
Inspection Date:	12/11/2009	Barrier Rating:	32.20		
Barrier Description					
Type:	W-BEAM STRONG POST	Barrier Function:	TRAFFIC		
Barrier Material:	GALVANIZED STEEL	Post Material:	WOOD		
Blockout Type:	WOOD	Length (ft.):	1270		
Speed Limit (MPH):	35	Placement with Respect to Road:	OUTSIDE OF CURVE		
Hazard Behind Barrier:	MEDIUM				
Barrier Crashworthiness					
Appropriate Test Level:	TL-2	Barrier Test Level:	TL-3	Is Barrier Crashworthy?:	YES
Beg. End Trtmt Type:	W-BEAM FLARED 350 COMPLIANT	Is Beg. End Trtmt Crashworthy?:	YES	Approach Transition Type:	NONE
Ending End Trtmt Type:	W-BEAM FLARED 350 COMPLIANT	Ending End Trtmt Crashworthy?:	YES		
Average Measurements					
Design Height (In.):	27	Width (In.):	0.0	Post Spacing (In.):	75.0
Height (In.):	28.5	Lateral Offset (In.):	53.5	Road Grade (%):	7.00
Physical Condition					
Barrier	Alignment and Height:	Alignment acceptable. Height was 1-3in. above 27-in. design height.

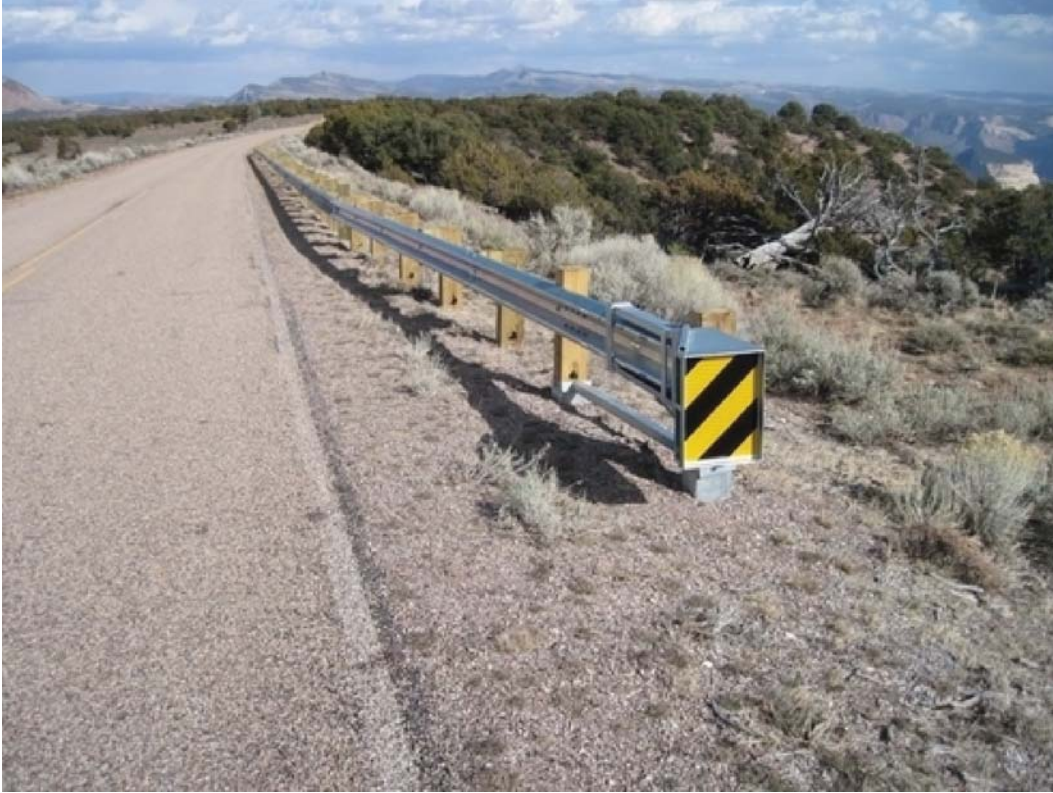
DINO_0011_30.500_R_1.jpg

Barrier ID:	DINO-0011-30.500-R				
Route Name:	HARPERS CORNER ROAD				
Inspection Date:	12/11/2009	Barrier Rating:	19.50		
Barrier Description					
Type:	W-BEAM STRONG POST	Barrier Function:	TRAFFIC		
Barrier Material:	GALVANIZED STEEL	Post Material:	WOOD		
Blockout Type:	WOOD	Length (ft.):	330		
Speed Limit (MPH):	35	Placement with Respect to Road:	TANGENT		
Hazard Behind Barrier:	MEDIUM				
Barrier Crashworthiness					
Appropriate Test Level:	TL-2	Barrier Test Level:	TL-3	Is Barrier Crashworthy?:	YES
Beg. End Trtmt Type:	W-BEAM TANGENT 350	Is Beg. End Trtmt Crashworthy?:	YES	Approach Transition Type:	NONE
Ending End Trtmt Type:	W-BEAM TANGENT 350	Ending End Trtmt Crashworthy?:	YES		
Average Measurements					
Design Height (In.):	27	Width (In.):	0.0	Post Spacing (In.):	75.3
Height (In.):	28.2	Lateral Offset (In.):	37.7	Road Grade (%):	3.80
Physical Condition					
Barrier	Alignment and Height:	Alignment acceptable. Height was 1-2in. above 27-in. design height.

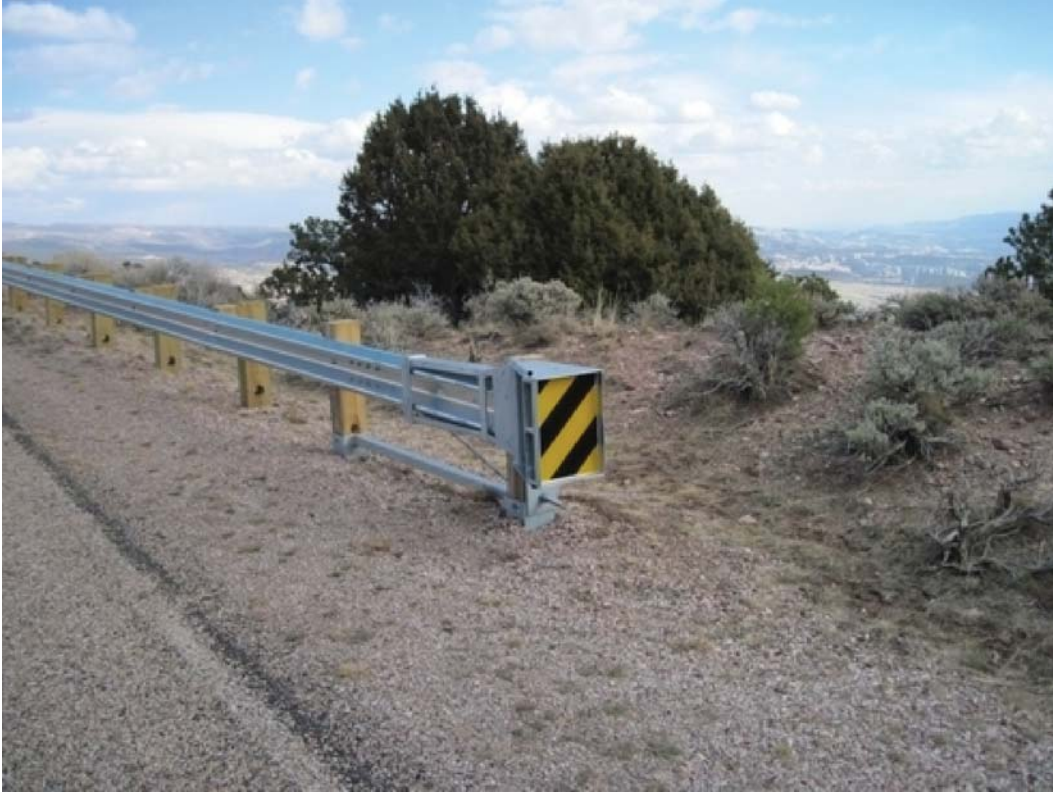
DINO_0011_31.377_R_1.jpg

Barrier ID:	DINO-0011-31.377-R				
Route Name:	HARPERS CORNER ROAD				
Inspection Date:	12/11/2009	Barrier Rating:	27.20		
Barrier Description					
Type:	W-BEAM STRONG POST	Barrier Function:	TRAFFIC		
Barrier Material:	GALVANIZED STEEL	Post Material:	WOOD		
Blockout Type:	WOOD	Length (ft.):	353		
Speed Limit (MPH):	35	Placement with Respect to Road:	OUTSIDE OF CURVE		
Hazard Behind Barrier:	EXTREME				
Barrier Crashworthiness					
Appropriate Test Level:	TL-2	Barrier Test Level:	TL-3	Is Barrier Crashworthy?:	YES
Beg. End Trtmt Type:	W-BEAM TANGENT 350	Is Beg. End Trtmt Crashworthy?:	YES	Approach Transition Type:	NONE
Ending End Trtmt Type:	W-BEAM BCT	Ending End Trtmt Crashworthy?:	NO		
Average Measurements					
Design Height (In.):	27	Width (In.):	0.0	Post Spacing (In.):	75.0
Height (In.):	28.0	Lateral Offset (In.):	46.7	Road Grade (%):	4.40
Physical Condition					
Barrier	Alignment and Height:	Alignment acceptable. Height is within 1-in of 27-in. design height.

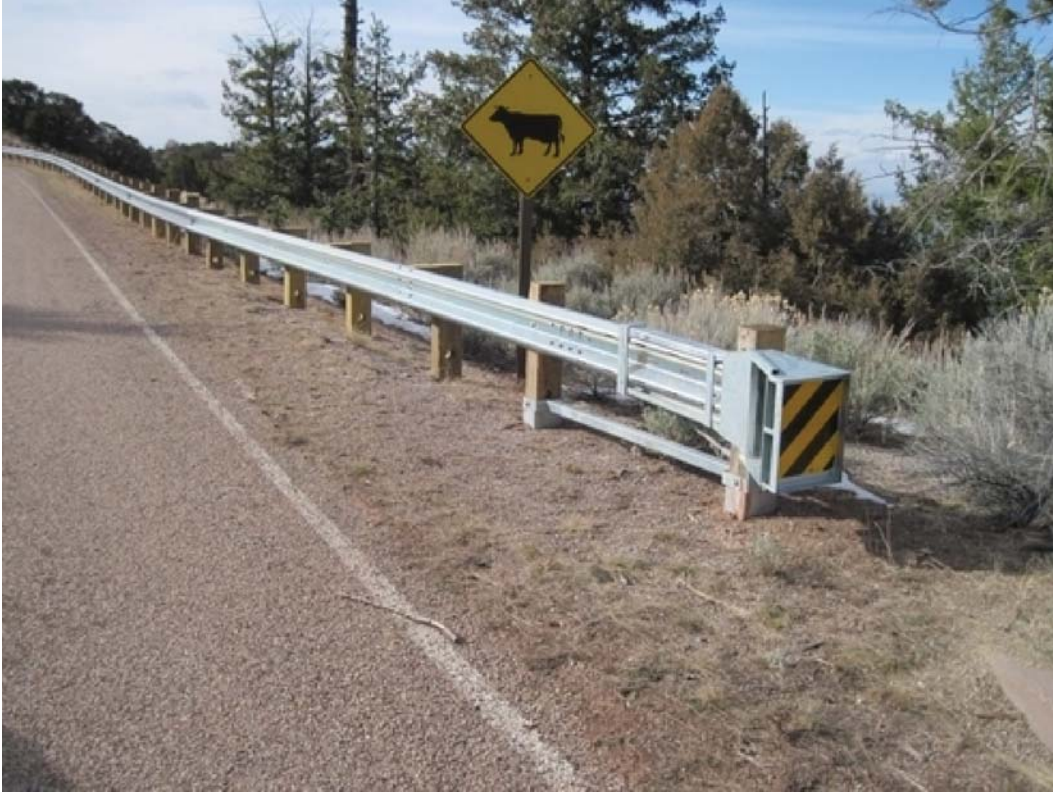
DINO_0011_31.728_R_1.jpg

Barrier ID:	DINO-0011-31.728-R				
Route Name:	HARPERS CORNER ROAD				
Inspection Date:	12/11/2009	Barrier Rating:	19.70		
Barrier Description					
Type:	W-BEAM STRONG POST	Barrier Function:	TRAFFIC		
Barrier Material:	GALVANIZED STEEL	Post Material:	WOOD		
Blockout Type:	WOOD	Length (ft.):	228		
Speed Limit (MPH):	35	Placement with Respect to Road:	OUTSIDE OF CURVE		
Hazard Behind Barrier:	HIGH				
Barrier Crashworthiness					
Appropriate Test Level:	TL-2	Barrier Test Level:	TL-3	Is Barrier Crashworthy?:	YES
Beg. End Trtmt Type:	W-BEAM FLARED 350 COMPLIANT	Is Beg. End Trtmt Crashworthy?:	YES	Approach Transition Type:	NONE
Ending End Trtmt Type:	W-BEAM BCT	Ending End Trtmt Crashworthy?:	NO		
Average Measurements					
Design Height (In.):	27	Width (In.):	0.0	Post Spacing (In.):	74.6
Height (In.):	28.7	Lateral Offset (In.):	56.0	Road Grade (%):	4.60
Physical Condition					
Barrier	Alignment and Height:	Alignment acceptable. Height was 1-2in. above 27-in. design height.

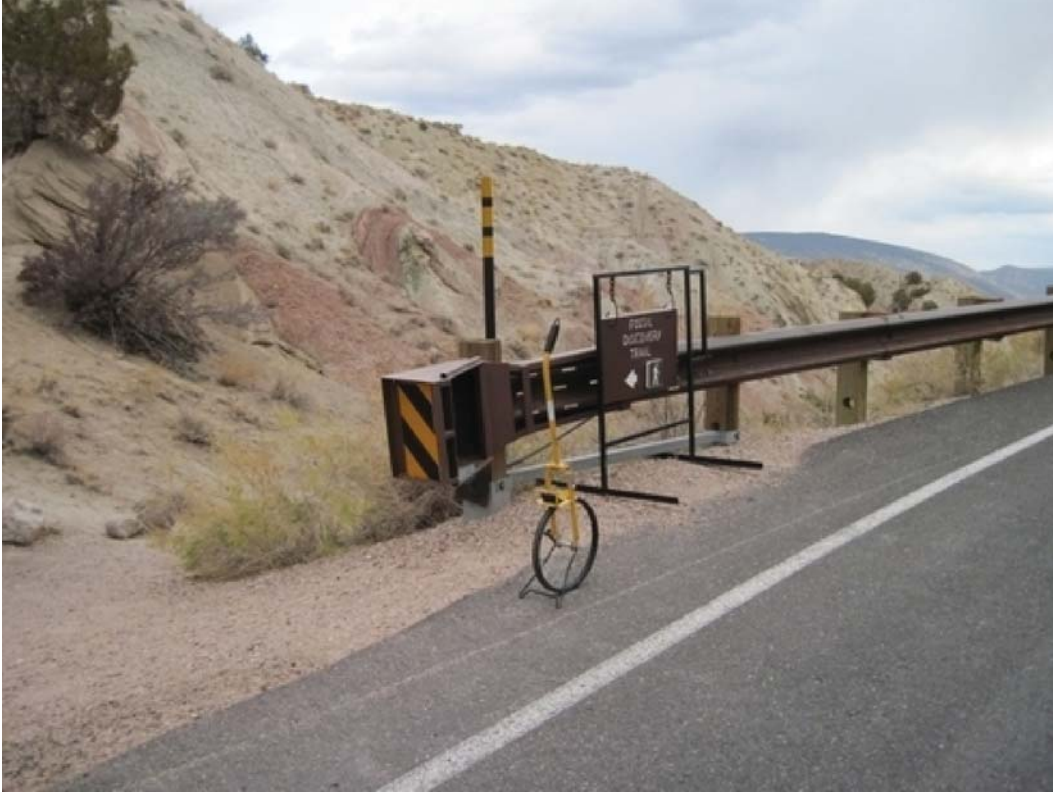
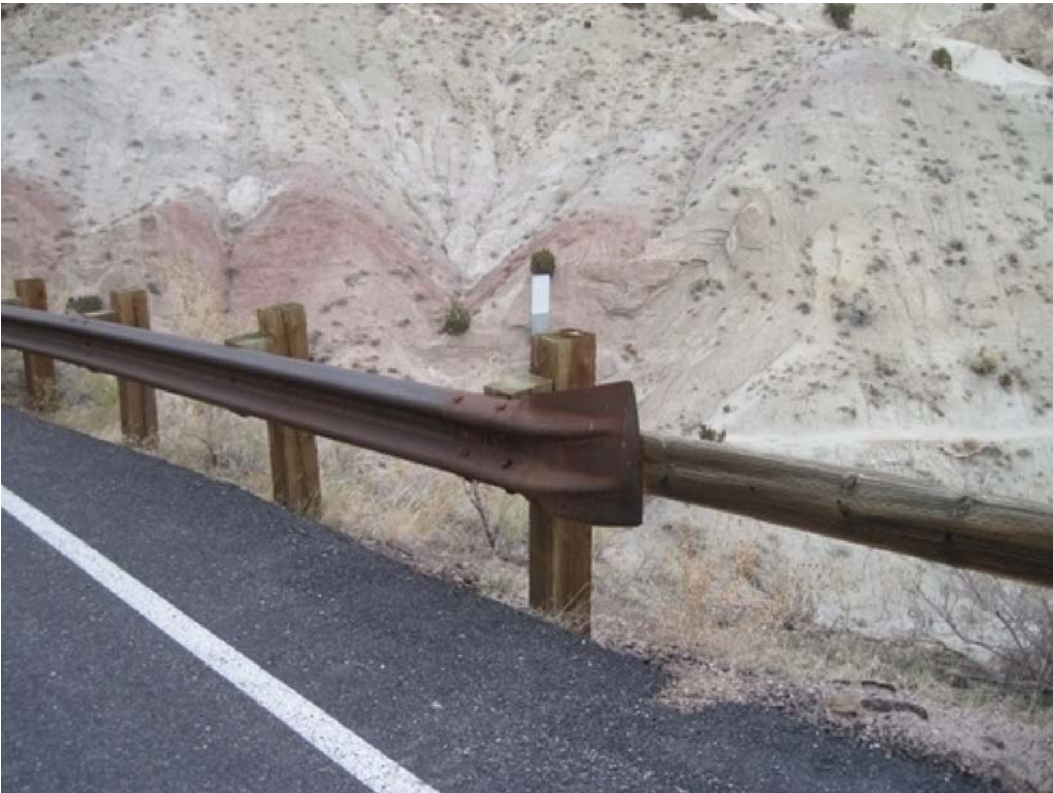
Barrier ID:	DINO-0100-0.557-L				
Route Name:	QUARRY ACCESS ROAD				
Inspection Date:	12/11/2009	Barrier Rating:	34.00		
Barrier Description					
Type:	W-BEAM STRONG POST	Barrier Function:	TRAFFIC		
Barrier Material:	WEATHERING STEEL/CORTEN	Post Material:	WOOD		
Blockout Type:	WOOD	Length (ft.):	254		
Speed Limit (MPH):	25	Placement with Respect to Road:	OUTSIDE OF CURVE		
Hazard Behind Barrier:	HIGH				
Barrier Crashworthiness					
Appropriate Test Level:	TL-1	Barrier Test Level:	TL-3	Is Barrier Crashworthy?:	YES
Beg. End Trtmt Type:	W-BEAM FLARED 350 COMPLIANT	Is Beg. End Trtmt Crashworthy?:	YES	Approach Transition Type:	NONE
Ending End Trtmt Type:	NONE	Ending End Trtmt Crashworthy?:	N/A		
Average Measurements					
Design Height (In.):	27	Width (In.):	0.0	Post Spacing (In.):	75.0
Height (In.):	28.0	Lateral Offset (In.):	24.2	Road Grade (%):	10.00
Physical Condition					
Barrier	Alignment and Height:	Alignment acceptable. Height is within 1-in of 27-in. design height.
