DINO GIP Report

NPS Guardwall/Rail Inventory Program Dinosaur National Monument

**Data Collection Date: November 2009
Report Date: November 2015**

Dinosaur National Monument in Colorado and Utah

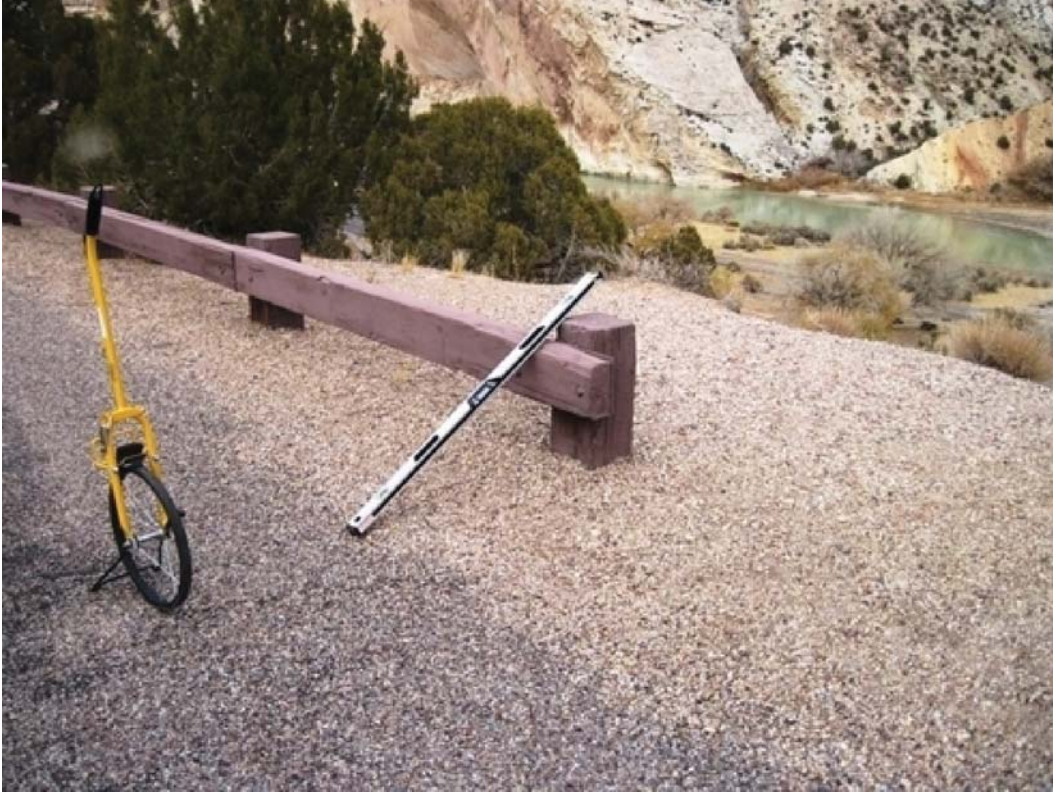
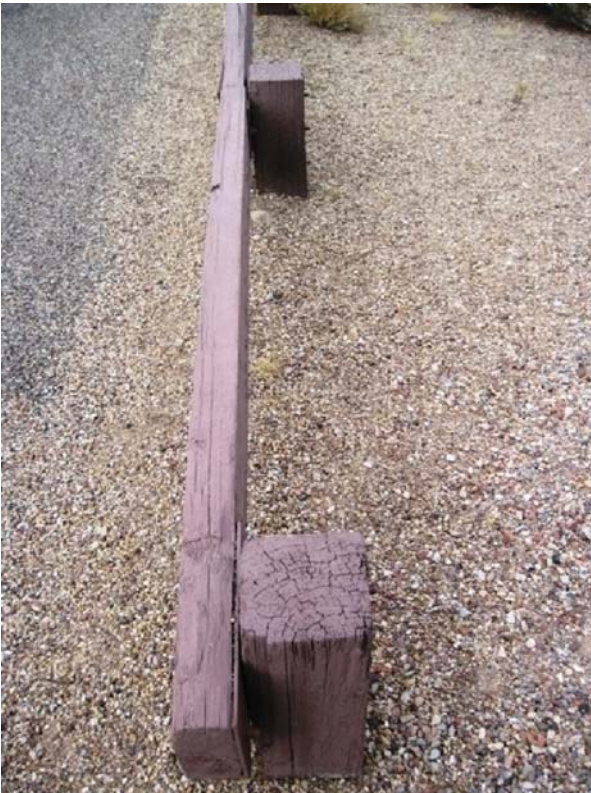
Barrier ID:	DINO-0216-0.735-R				
Route Name:	SPLIT MOUNTAIN CAMPGROUND ACCESS ROAD				
Inspection Date:	12/11/2009	Barrier Rating:	0.00		
Barrier Description					
Type:	OTHER: TIMBER RAIL ON TIMBER POSTS	Barrier Function:	NON-TRAFFIC		
Barrier Material:	LOG/TIMBER/WOOD	Post Material:	WOOD		
Blockout Type:	N/A	Length (ft.):	104		
Speed Limit (MPH):	15	Placement with Respect to Road:	NON-TRAFFIC BARRIER		
Hazard Behind Barrier:	N/A				
Barrier Crashworthiness					
Appropriate Test Level:	TL-1	Barrier Test Level:	N/A	Is Barrier Crashworthy?:	N/A
Beg. End Trtmt Type:	NONE	Is Beg. End Trtmt Crashworthy?:	N/A	Approach Transition Type:	NONE
Ending End Trtmt Type:	NONE	Ending End Trtmt Crashworthy?:	N/A		
Average Measurements					
Design Height (In.):	20	Width (In.):	0.0	Post Spacing (In.):	0.0
Height (In.):	16.7	Lateral Offset (In.):	0.0	Road Grade (%):	0.00
Physical Condition					
Barrier	Alignment and Height:	Alignment acceptable. Height was 3-4in. below assumed 20-in. design height.

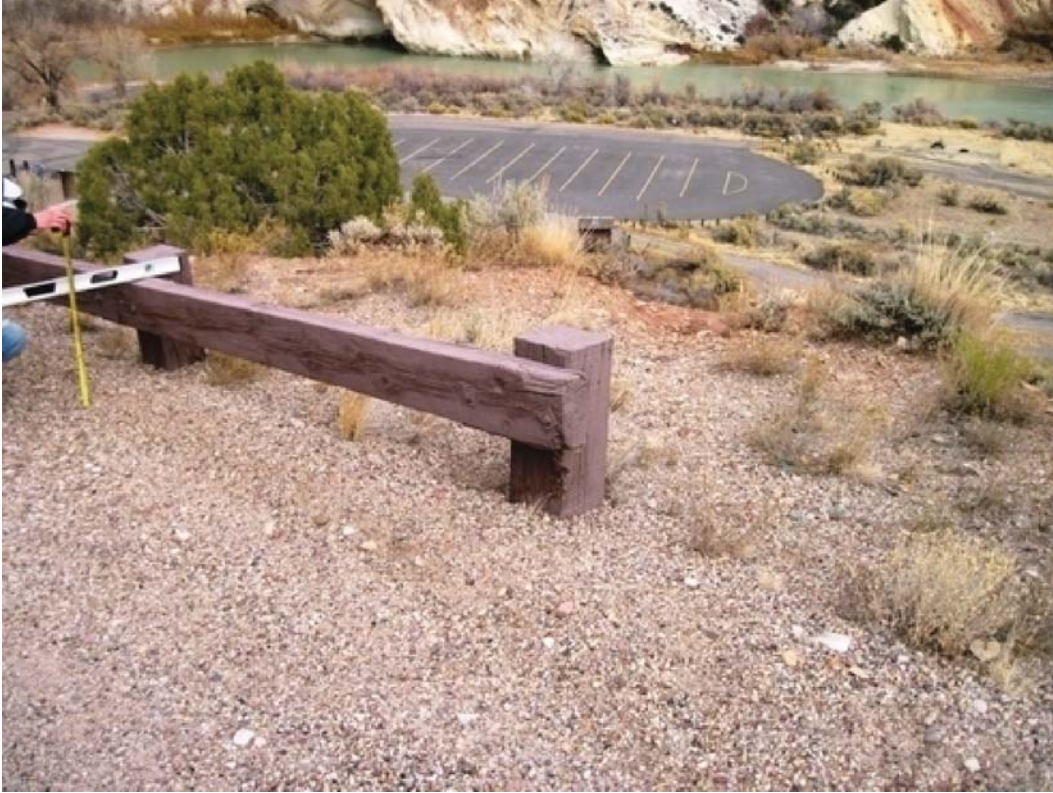
DINO_0216_0.825_R_1.jpg

Barrier ID:	DINO-0216-0.825-R				
Route Name:	SPLIT MOUNTAIN CAMPGROUND ACCESS ROAD				
Inspection Date:	12/11/2009	Barrier Rating:	29.70		
Barrier Description					
Type:	OTHER: TIMBER RAIL ON TIMBER POSTS	Barrier Function:	TRAFFIC		
Barrier Material:	LOG/TIMBER/WOOD	Post Material:	WOOD		
Blockout Type:	N/A	Length (ft.):	62		
Speed Limit (MPH):	15	Placement with Respect to Road:	OUTSIDE OF CURVE		
Hazard Behind Barrier:	HIGH				
Barrier Crashworthiness					
Appropriate Test Level:	TL-1	Barrier Test Level:	NCW	Is Barrier Crashworthy?:	NO
Beg. End Trtmt Type:	NONE	Is Beg. End Trtmt Crashworthy?:	N/A	Approach Transition Type:	NONE
Ending End Trtmt Type:	NONE	Ending End Trtmt Crashworthy?:	N/A		
Average Measurements					
Design Height (In.):	20	Width (In.):	4.0	Post Spacing (In.):	94.0
Height (In.):	17.2	Lateral Offset (In.):	72.3	Road Grade (%):	8.50
Physical Condition					
Barrier	Alignment and Height:	Alignment acceptable. Height was 2-3in. below assumed 20-in. design height.
