# FOPO GIP Report

## NPS Guardwall/Rail Inventory Program Fort Point National Historic Site

**Data Collection Date: November 2009  
Report Date: November 2015**

# Fort Point National Historic Site in California

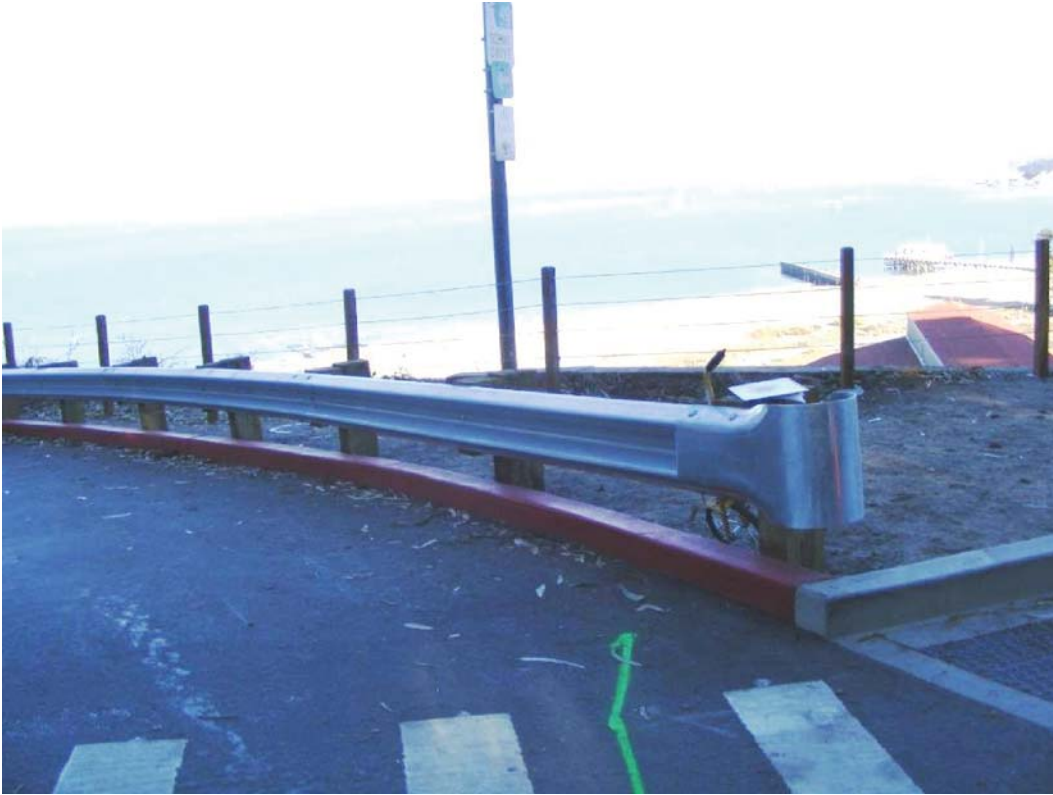
FOPO\_0110\_0.000\_R\_1.jpg

<b>Barrier ID:</b>	FOPO-0110-0.000-R				
<b>Route Name:</b>	LONG AVENUE				
<b>Inspection Date:</b>	02/11/2009	<b>Barrier Rating:</b>	25.20		
<b>Barrier Description</b>					
<b>Type:</b>	W-BEAM STRONG POST	<b>Barrier Function:</b>	TRAFFIC		
<b>Barrier Material:</b>	GALVANIZED STEEL	<b>Post Material:</b>	WOOD		
<b>Blockout Type:</b>	WOOD	<b>Length (ft.):</b>	43		
<b>Speed Limit (MPH):</b>	15	<b>Placement with Respect to Road:</b>	OUTSIDE OF CURVE		
<b>Hazard Behind Barrier:</b>	MEDIUM				
<b>Barrier Crashworthiness</b>					
<b>Appropriate Test Level:</b>	TL-1	<b>Barrier Test Level:</b>	TL-2	<b>Is Barrier Crashworthy?:</b>	YES
<b>Beg. End Trtmt Type:</b>	NONE	<b>Is Beg. End Trtmt Crashworthy?:</b>	N/A	<b>Approach Transition Type:</b>	NONE
<b>Ending End Trtmt Type:</b>	NONE	<b>Ending End Trtmt Crashworthy?:</b>	N/A		
<b>Average Measurements</b>					
<b>Design Height (In.):</b>	27	<b>Width (In.):</b>	0.0	<b>Post Spacing (In.):</b>	75.5

<b>Height (In.):</b>	28.0	<b>Lateral Offset (In.):</b>	36.0	<b>Road Grade (%):</b>	9.40
<b>Physical Condition</b>					
<b>Barrier</b>	<b>Alignment and Height:</b>	Alignment acceptable. Height was 0-2in above the 27-in design height.			
	<b>Breaking and Cracking:</b>	No cracks. No breaks or tears.			
	<b>Missing Elements:</b>	No missing elements.			
	<b>Corrosion and Weathering:</b>	No corrosion. No weathering of earth behind barrier.			
<b>End Treatments</b>	<b>Alignment and Height:</b>				
	<b>Breaking and Cracking:</b>				
	<b>Missing Elements:</b>				
	<b>Corrosion and Weathering:</b>

<b>Barrier ID:</b>	FOPO-0110-0.000-R				
<b>Route Name:</b>	LONG AVENUE				
<b>Inspection Date:</b>	02/11/2009	<b>Barrier Rating:</b>		25.20	
<b>Repair Recommendations</b>					
<b>Repair Action:</b>	NO ACTION	<b>FMSS Work Type:</b>	N/A	<b>Repair Cost:</b>	\$0
<b>Brief Workorder:</b>	N/A				
<b>Workorder:</b>

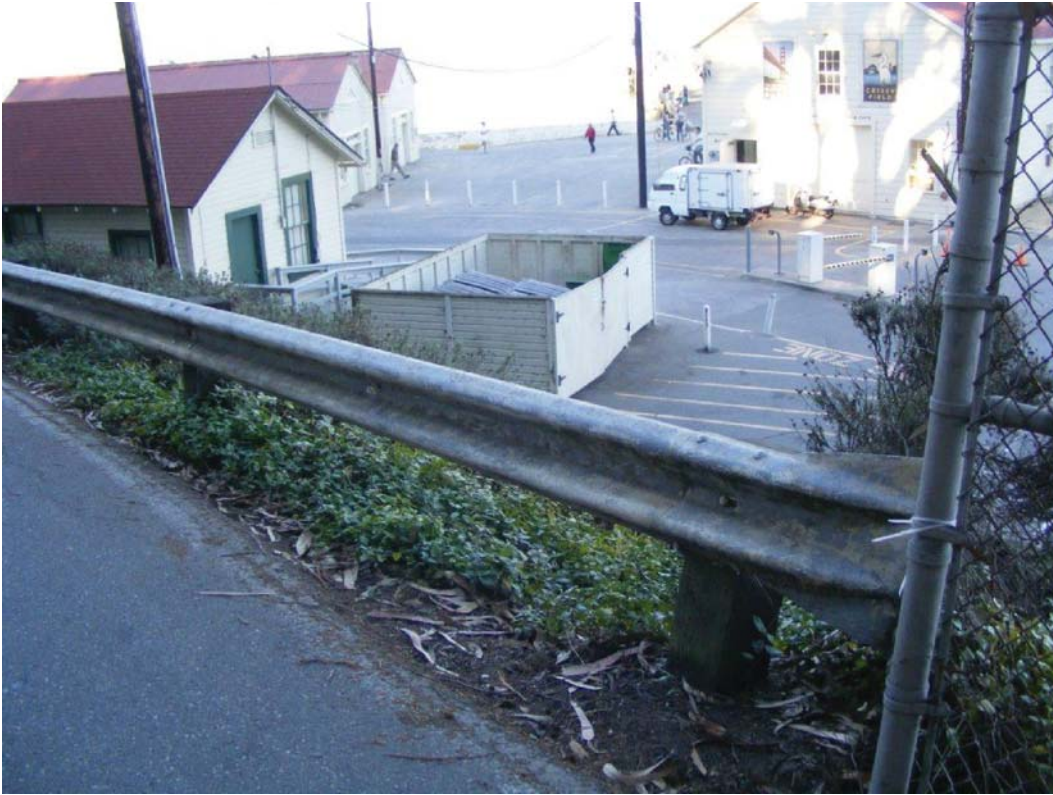
FOPO\_0110\_0.173\_R\_1.jpg

<b>Barrier ID:</b>	FOPO-0110-0.173-R				
<b>Route Name:</b>	LONG AVENUE				
<b>Inspection Date:</b>	02/11/2009	<b>Barrier Rating:</b>	32.40		
<b>Barrier Description</b>					
<b>Type:</b>	W-BEAM WEAK POST	<b>Barrier Function:</b>	TRAFFIC		
<b>Barrier Material:</b>	GALVANIZED STEEL	<b>Post Material:</b>	WOOD		
<b>Blockout Type:</b>	N/A	<b>Length (ft.):</b>	90		
<b>Speed Limit (MPH):</b>	15	<b>Placement with Respect to Road:</b>	OUTSIDE OF CURVE		
<b>Hazard Behind Barrier:</b>	MEDIUM				
<b>Barrier Crashworthiness</b>					
<b>Appropriate Test Level:</b>	TL-1	<b>Barrier Test Level:</b>	TL-2	<b>Is Barrier Crashworthy?:</b>	YES
<b>Beg. End Trtmt Type:</b>	NONE	<b>Is Beg. End Trtmt Crashworthy?:</b>	N/A	<b>Approach Transition Type:</b>	NONE
<b>Ending End Trtmt Type:</b>	NONE	<b>Ending End Trtmt Crashworthy?:</b>	N/A		
<b>Average Measurements</b>					
<b>Design Height (In.):</b>	27	<b>Width (In.):</b>	0.0	<b>Post Spacing (In.):</b>	74.3

<b>Height (In.):</b>	25.7	<b>Lateral Offset (In.):</b>	21.2	<b>Road Grade (%):</b>	7.00
<b>Physical Condition</b>					
<b>Barrier</b>	<b>Alignment and Height:</b>	Alignment acceptable. 60-ft was within 1-in of the 27-in design height and 30-ft was between 1 and 3-in below the design height.			
	<b>Breaking and Cracking:</b>	No breaks or tears.			
	<b>Missing Elements:</b>	No missing elements.			
	<b>Corrosion and Weathering:</b>	Minor weathering of posts.			
<b>End Treatments</b>	<b>Alignment and Height:</b>				
	<b>Breaking and Cracking:</b>				
	<b>Missing Elements:</b>				
	<b>Corrosion and Weathering:</b>

<b>Repair Action:</b>	REPAIR	<b>FMSS Work Type:</b>	DEFERRED MAINTENANCE	<b>Repair Cost:</b>	\$2041
<b>Brief Workorder:</b>	Lower 38 feet of barrier to 27-in design height.				
<b>Workorder:</b>	Adjust Guardrail at \$10- per -Lin. Ft. for 38 LF = \$380. Lower 38ft. of barrier down to 27-in design height. Low Speed Traffic Control at \$1475- per -Day for 1 Day(s) = \$1475.

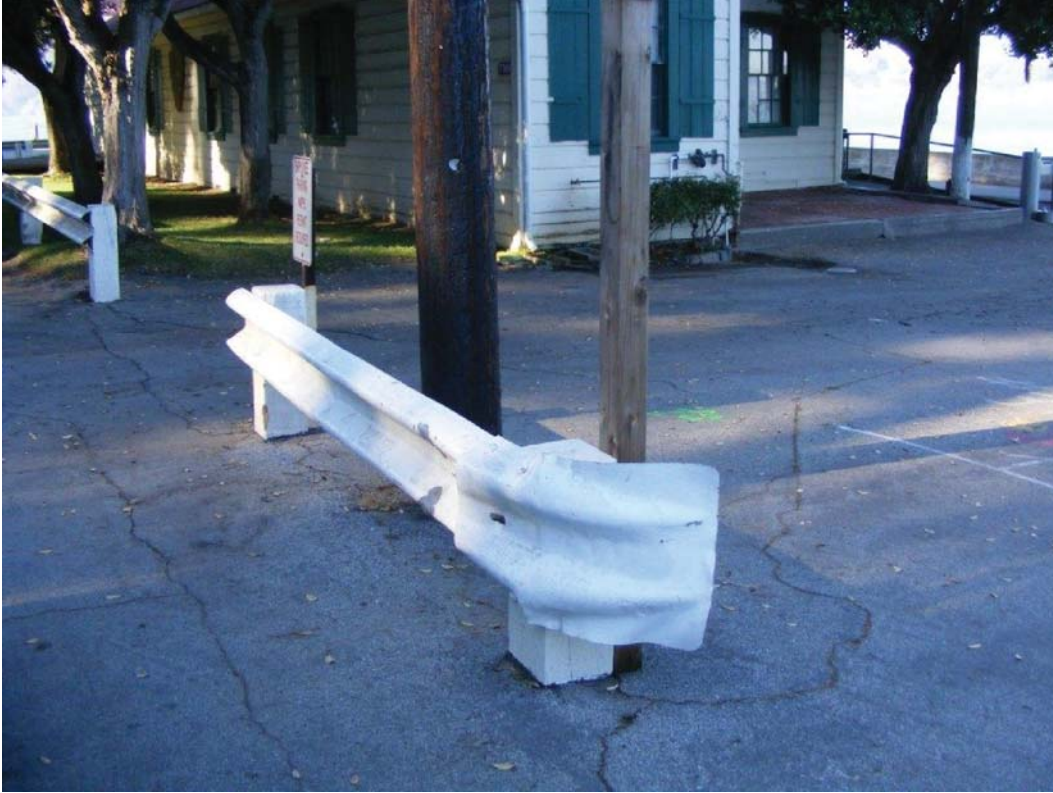
FOPO\_0601\_0.023\_R\_1.jpg

<b>Barrier ID:</b>	FOPO-0601-0.023-R				
<b>Route Name:</b>	MARINE DRIVE				
<b>Inspection Date:</b>	02/11/2009	<b>Barrier Rating:</b>	11.10		
<b>Barrier Description</b>					
<b>Type:</b>	W-BEAM WEAK POST	<b>Barrier Function:</b>	TRAFFIC		
<b>Barrier Material:</b>	GALVANIZED STEEL	<b>Post Material:</b>	WOOD		
<b>Blockout Type:</b>	N/A	<b>Length (ft.):</b>	89		
<b>Speed Limit (MPH):</b>	25	<b>Placement with Respect to Road:</b>	OUTSIDE OF CURVE		
<b>Hazard Behind Barrier:</b>	N/A				
<b>Barrier Crashworthiness</b>					
<b>Appropriate Test Level:</b>	TL-1	<b>Barrier Test Level:</b>	TL-2	<b>Is Barrier Crashworthy?:</b>	YES
<b>Beg. End Trtmt Type:</b>	NONE	<b>Is Beg. End Trtmt Crashworthy?:</b>	N/A	<b>Approach Transition Type:</b>	NONE
<b>Ending End Trtmt Type:</b>	NONE	<b>Ending End Trtmt Crashworthy?:</b>	N/A		
<b>Average Measurements</b>					
<b>Design Height (In.):</b>	27	<b>Width (In.):</b>	0.0	<b>Post Spacing (In.):</b>	150.3

<b>Height (In.):</b>	29.0	<b>Lateral Offset (In.):</b>	298.2	<b>Road Grade (%):</b>	1.20
<b>Physical Condition</b>					
<b>Barrier</b>	<b>Alignment and Height:</b>	Alignment acceptable. Height was 2-in above the 27-in design height.			
	<b>Breaking and Cracking:</b>	No cracks or breaks.			
	<b>Missing Elements:</b>	No missing elements.			
	<b>Corrosion and Weathering:</b>	Painted no visible weathering.			
<b>End Treatments</b>	<b>Alignment and Height:</b>				
	<b>Breaking and Cracking:</b>				
	<b>Missing Elements:</b>				
	<b>Corrosion and Weathering:</b>

<b>Repair Action:</b>	NO ACTION	<b>FMSS Work Type:</b>	N/A	<b>Repair Cost:</b>	\$0
<b>Brief Workorder:</b>	N/A				
<b>Workorder:</b>

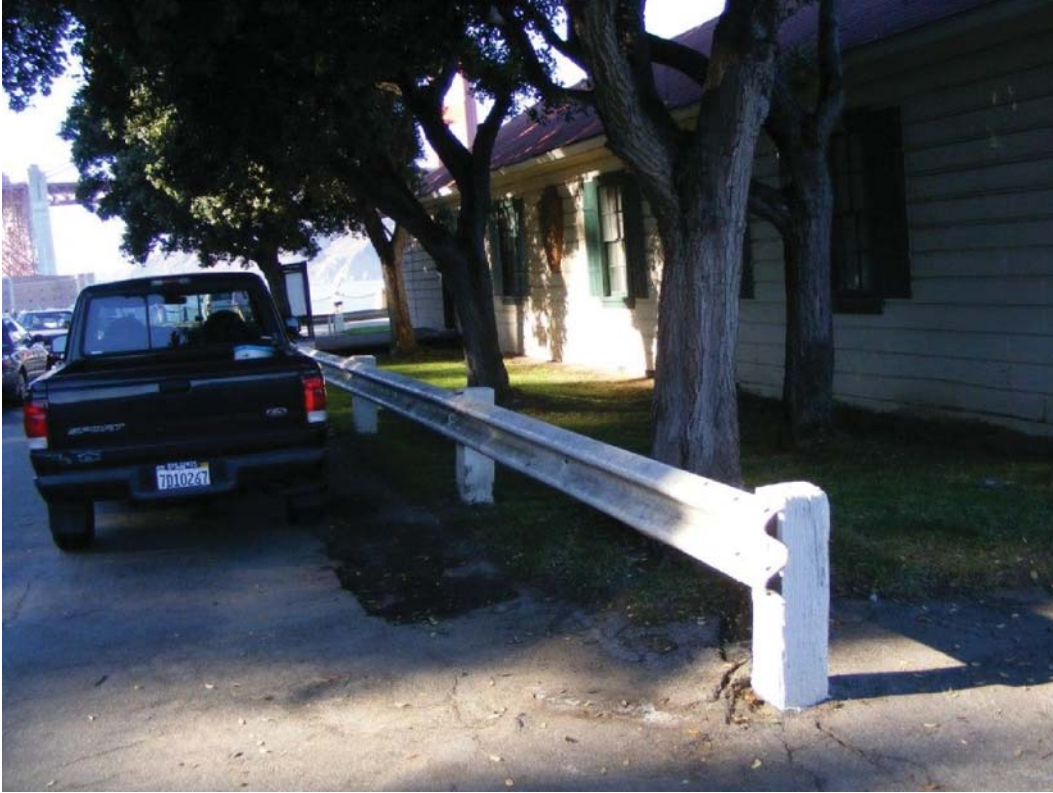
FOPO\_0601\_0.026\_R\_1.jpg

<b>Barrier ID:</b>	FOPO-0601-0.026-R				
<b>Route Name:</b>	MARINE DRIVE				
<b>Inspection Date:</b>	02/11/2009	<b>Barrier Rating:</b>	7.00		
<b>Barrier Description</b>					
<b>Type:</b>	W-BEAM WEAK POST	<b>Barrier Function:</b>	TRAFFIC		
<b>Barrier Material:</b>	GALVANIZED STEEL	<b>Post Material:</b>	WOOD		
<b>Blockout Type:</b>	N/A	<b>Length (ft.):</b>	11		
<b>Speed Limit (MPH):</b>	25	<b>Placement with Respect to Road:</b>	TANGENT		
<b>Hazard Behind Barrier:</b>	LOW				
<b>Barrier Crashworthiness</b>					
<b>Appropriate Test Level:</b>	TL-1	<b>Barrier Test Level:</b>	TL-2	<b>Is Barrier Crashworthy?:</b>	YES
<b>Beg. End Trtmt Type:</b>	NONE	<b>Is Beg. End Trtmt Crashworthy?:</b>	N/A	<b>Approach Transition Type:</b>	NONE
<b>Ending End Trtmt Type:</b>	NONE	<b>Ending End Trtmt Crashworthy?:</b>	N/A		
<b>Average Measurements</b>					
<b>Design Height (In.):</b>	27	<b>Width (In.):</b>	0.0	<b>Post Spacing (In.):</b>	101.0

<b>Height (In.):</b>	23.0	<b>Lateral Offset (In.):</b>	127.3	<b>Road Grade (%):</b>	0.50
<b>Physical Condition</b>					
<b>Barrier</b>	<b>Alignment and Height:</b>	Alignment acceptable. Entire barrier is 4-in below the 27-in design height.			
	<b>Breaking and Cracking:</b>	No cracks or breaks.			
	<b>Missing Elements:</b>	No missing elements.			
	<b>Corrosion and Weathering:</b>	Painted no visible weathering.			
<b>End Treatments</b>	<b>Alignment and Height:</b>				
	<b>Breaking and Cracking:</b>				
	<b>Missing Elements:</b>				
	<b>Corrosion and Weathering:</b>

<b>Repair Action:</b>	REPAIR	<b>FMSS Work Type:</b>	DEFERRED MAINTENANCE	<b>Repair Cost:</b>	\$1744
<b>Brief Workorder:</b>	Raise 11 L.F. of W-Beam to 27-in design height.				
<b>Workorder:</b>	Adjust Guardrail at \$10- per -Lin. Ft. for 11 LF = \$110. Raise 11-ft of barrier up to 27-in design height. Low Speed Traffic Control at \$1475- per -Day for 1 Day(s) = \$1475.

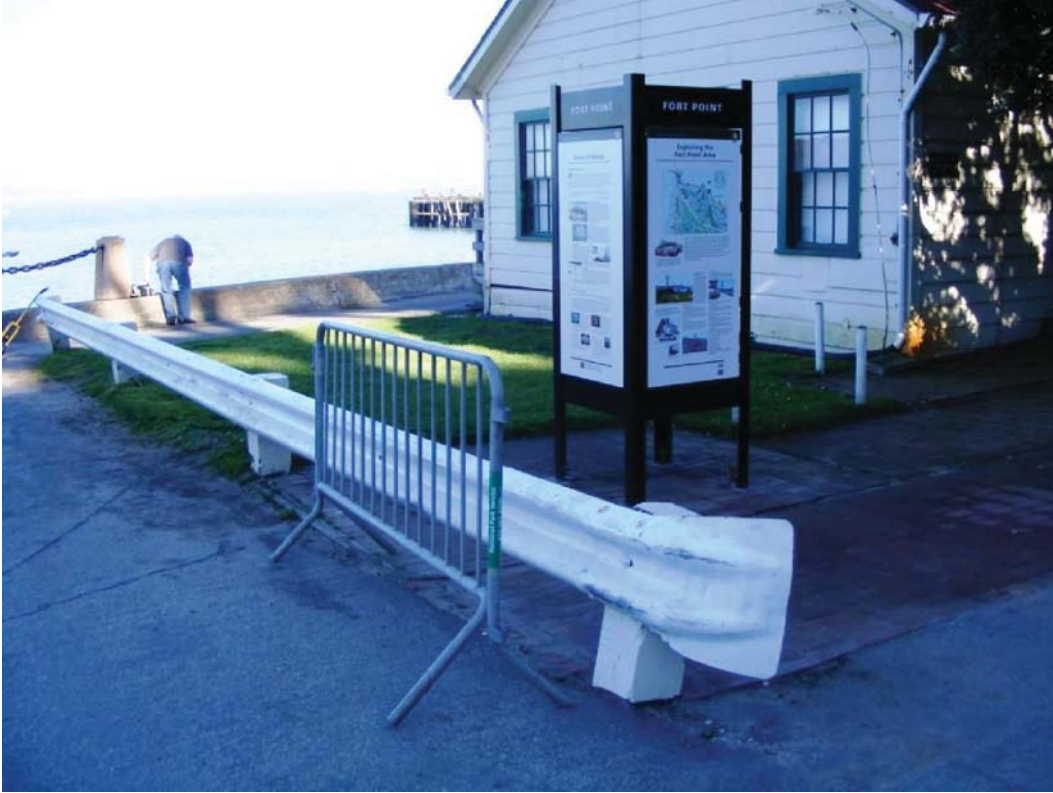
FOPO\_0601\_0.050\_R\_1.jpg

<b>Barrier ID:</b>	FOPO-0601-0.050-R				
<b>Route Name:</b>	MARINE DRIVE				
<b>Inspection Date:</b>	02/11/2009	<b>Barrier Rating:</b>	4.40		
<b>Barrier Description</b>					
<b>Type:</b>	W-BEAM WEAK POST	<b>Barrier Function:</b>	NON-TRAFFIC		
<b>Barrier Material:</b>	GALVANIZED STEEL	<b>Post Material:</b>	WOOD		
<b>Blockout Type:</b>	N/A	<b>Length (ft.):</b>	39		
<b>Speed Limit (MPH):</b>	25	<b>Placement with Respect to Road:</b>	NON-TRAFFIC BARRIER		
<b>Hazard Behind Barrier:</b>	N/A				
<b>Barrier Crashworthiness</b>					
<b>Appropriate Test Level:</b>	TL-1	<b>Barrier Test Level:</b>	N/A	<b>Is Barrier Crashworthy?:</b>	N/A
<b>Beg. End Trtmt Type:</b>	NONE	<b>Is Beg. End Trtmt Crashworthy?:</b>	N/A	<b>Approach Transition Type:</b>	NONE
<b>Ending End Trtmt Type:</b>	NONE	<b>Ending End Trtmt Crashworthy?:</b>	N/A		
<b>Average Measurements</b>					
<b>Design Height (In.):</b>	27	<b>Width (In.):</b>	0.0	<b>Post Spacing (In.):</b>	150.3

<b>Height (In.):</b>	25.2	<b>Lateral Offset (In.):</b>	0.0	<b>Road Grade (%):</b>	0.00
<b>Physical Condition</b>					
<b>Barrier</b>	<b>Alignment and Height:</b>	Alignment acceptable. 20-ft was 1-3 in below the 27-in design height.			
	<b>Breaking and Cracking:</b>	No breaks or cracks.			
	<b>Missing Elements:</b>	No missing elements.			
	<b>Corrosion and Weathering:</b>	Painted no visible weathering.			
<b>End Treatments</b>	<b>Alignment and Height:</b>				
	<b>Breaking and Cracking:</b>				
	<b>Missing Elements:</b>				
	<b>Corrosion and Weathering:</b>

<b>Repair Action:</b>	NO ACTION	<b>FMSS Work Type:</b>	N/A	<b>Repair Cost:</b>	\$0
<b>Brief Workorder:</b>	N/A				
<b>Workorder:</b>
