GLAC GIP Report

NPS Guardwall/Rail Inventory Program Glacier National Park

**Federal Lands Highway
Road Inventory Program**

**Data Collection Date: October 2010
Report Date: November 2015**

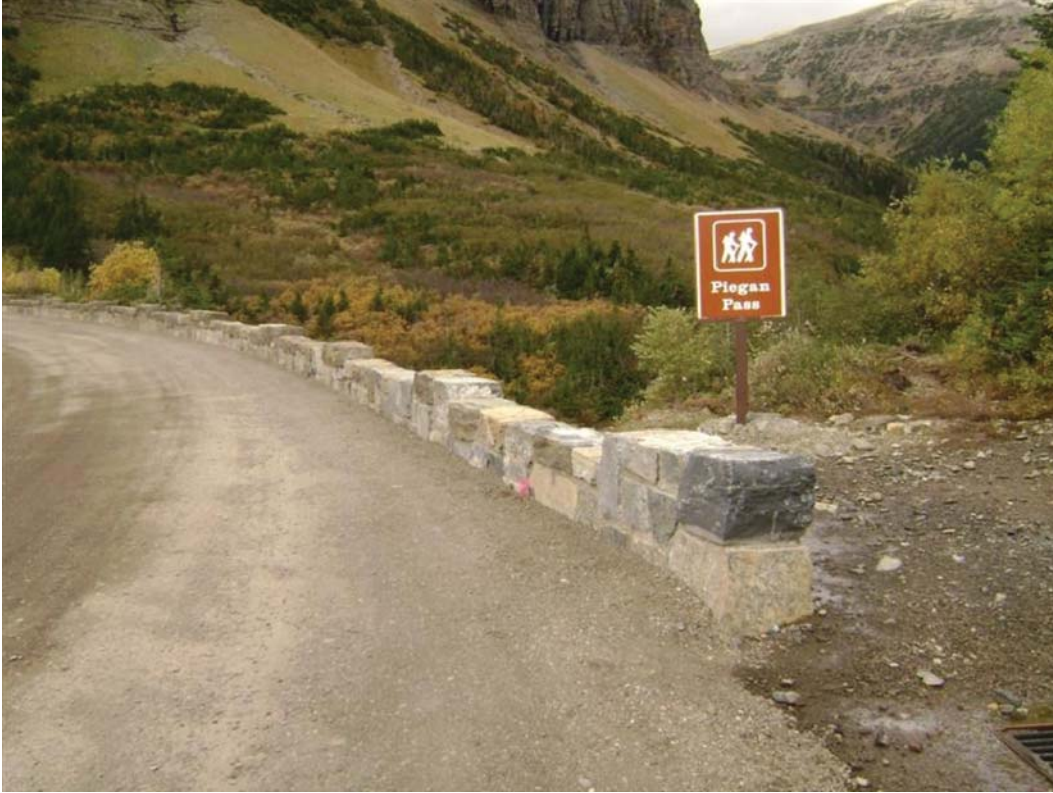
GLAC_0010E_34.621_L_1.JPG

Barrier ID:	GLAC-0010E-34.621-L				
Route Name:	GOING TO THE SUN ROAD EAST				
Inspection Date:	09/27/2010	Barrier Rating:	42.50		
Barrier Description					
Type:	STONE MASONRY CRENELLATED WITHOUT	Barrier Function:	TRAFFIC		
Barrier Material:	STONE	Post Material:	N/A		
Blockout Type:	N/A	Length (ft.):	307		
Speed Limit (MPH):	45	Placement with Respect to Road:	OUTSIDE OF CURVE		
Hazard Behind Barrier:	HIGH				
Barrier Crashworthiness					
Appropriate Test Level:	TL-2	Barrier Test Level:	NCW	Is Barrier Crashworthy?:	NO
Beg. End Trtmt Type:	NONE	Is Beg. End Trtmt Crashworthy?:	N/A	Approach Transition Type:	NONE
Ending End Trtmt Type:	NONE	Ending End Trtmt Crashworthy?:	N/A		
Average Measurements					
Design Height (In.):	18	Width (In.):	18.6	Post Spacing (In.):	0.0
Height (In.):	21.0	Lateral Offset (In.):	11.3	Road Grade (%):	2.20
Physical Condition					
Barrier	Alignment and Height:	Alignment acceptable. Height was 0 to 4-in above design height of 18 in for entire barrier length.

Breaking and Cracking:	No observed breaking or cracking.			
	Missing Elements:	No observed missing elements.			
	Corrosion and Weathering:	No observed corrosion or weathering.			
End Treatments	Alignment and Height:				
	Breaking and Cracking:				
	Missing Elements:				
	Corrosion and Weathering:

Repair Action:	NO ACTION	FMSS Work Type:	N/A	Repair Cost:	\$0
Brief Workorder:	N/A				
Workorder:

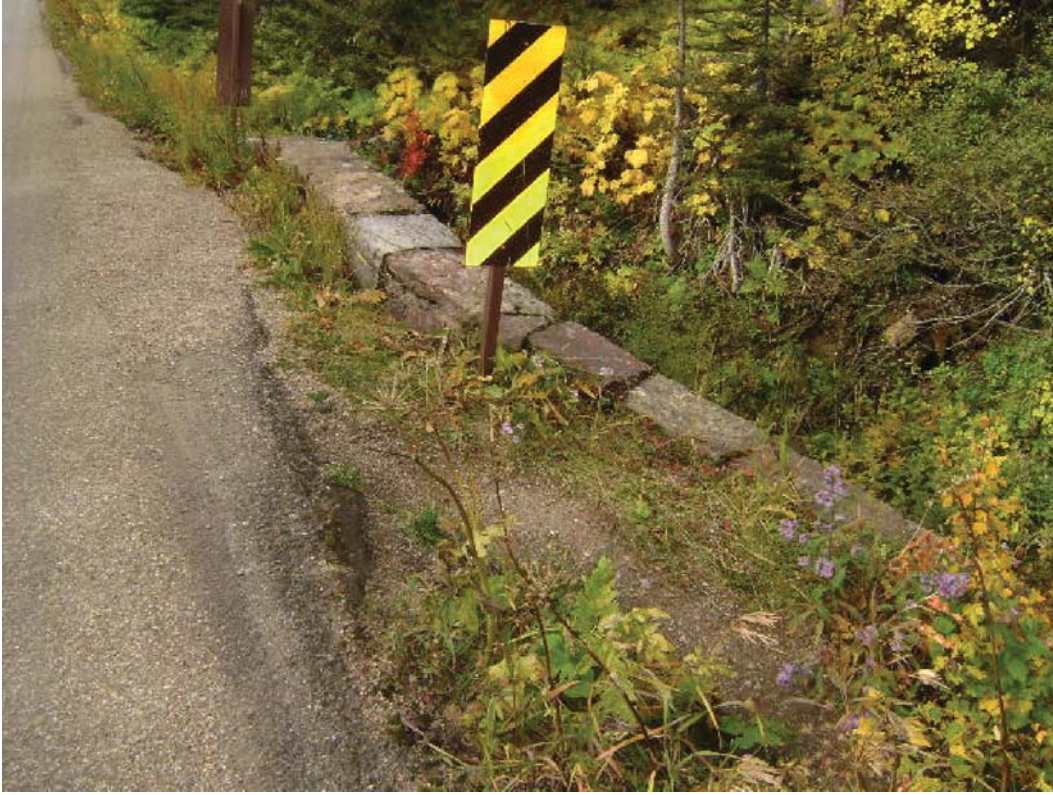
GLAC_0010E_36.560_L_1.JPG

Barrier ID:	GLAC-0010E-36.560-L				
Route Name:	GOING TO THE SUN ROAD EAST				
Inspection Date:	09/27/2010	Barrier Rating:	48.70		
Barrier Description					
Type:	STONE MASONRY WITHOUT CONCRETE CORE WALL	Barrier Function:	TRAFFIC		
Barrier Material:	STONE	Post Material:	N/A		
Blockout Type:	N/A	Length (ft.):	20		
Speed Limit (MPH):	45	Placement with Respect to Road:	TANGENT		
Hazard Behind Barrier:	MEDIUM				
Barrier Crashworthiness					
Appropriate Test Level:	TL-2	Barrier Test Level:	NCW	Is Barrier Crashworthy?:	NO
Beg. End Trtmt Type:	NONE	Is Beg. End Trtmt Crashworthy?:	N/A	Approach Transition Type:	NONE
Ending End Trtmt Type:	NONE	Ending End Trtmt Crashworthy?:	N/A		
Average Measurements					
Design Height (In.):	24	Width (In.):	18.2	Post Spacing (In.):	0.0
Height (In.):	14.3	Lateral Offset (In.):	18.0	Road Grade (%):	5.20
Physical Condition					
Barrier	Alignment and Height:	Alignment acceptable. Height over 6 in below 24 in design height for entire barrier length.

Breaking and Cracking:	No breaking or cracking observed.			
	Missing Elements:	No missing elements observed.			
	Corrosion and Weathering:	No corrosion or weathering observed.			
End Treatments	Alignment and Height:				
	Breaking and Cracking:				
	Missing Elements:				
	Corrosion and Weathering:

Repair Action:	REPAIR	FMSS Work Type:	DEFERRED MAINTENANCE	Repair Cost:	\$19222
Brief Workorder:	Remove and reset 20 LF of stone guardwall to 24 inch design height.				
Workorder:	Remove & Reset Stone Masonry Guardwall at \$250- per -Cu. Ft. for 60 CF = \$15000. $[(20 \text{ ft})(1.5 \text{ ft})(2\text{ft})] = 60 \text{ CF}$. Structural Concrete at \$1000- per -Cu. Yd. for 1 CY = \$1000. $[(20 \text{ ft})(1.5 \text{ ft})(.83)]/27 = .92 \text{ CY}$. Low Speed Traffic Control at \$1475- per -Day for 1 Day(s) = \$1475.

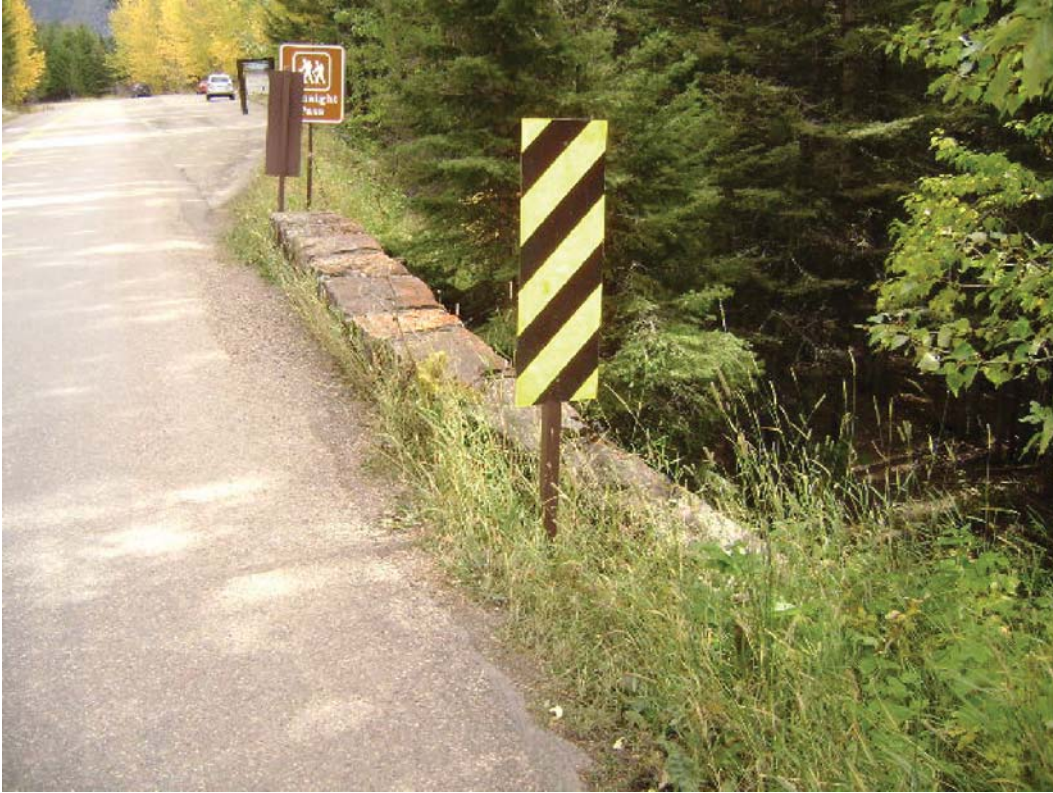
GLAC_0010E_36.560_R_1.JPG

Barrier ID:	GLAC-0010E-36.560-R				
Route Name:	GOING TO THE SUN ROAD EAST				
Inspection Date:	09/27/2010	Barrier Rating:	53.00		
Barrier Description					
Type:	STONE MASONRY WITHOUT CONCRETE CORE WALL	Barrier Function:	TRAFFIC		
Barrier Material:	STONE	Post Material:	N/A		
Blockout Type:	N/A	Length (ft.):	20		
Speed Limit (MPH):	45	Placement with Respect to Road:	TANGENT		
Hazard Behind Barrier:	MEDIUM				
Barrier Crashworthiness					
Appropriate Test Level:	TL-2	Barrier Test Level:	NCW	Is Barrier Crashworthy?:	NO
Beg. End Trtmt Type:	NONE	Is Beg. End Trtmt Crashworthy?:	N/A	Approach Transition Type:	NONE
Ending End Trtmt Type:	NONE	Ending End Trtmt Crashworthy?:	N/A		
Average Measurements					
Design Height (In.):	24	Width (In.):	19.2	Post Spacing (In.):	0.0
Height (In.):	16.2	Lateral Offset (In.):	9.0	Road Grade (%):	4.70
Physical Condition					
Barrier	Alignment and Height:	Alignment acceptable. Height over 6 in below 24 in design height for entire barrier length.

Breaking and Cracking:	No breaking or cracking observed.			
	Missing Elements:	No missing elements observed.			
	Corrosion and Weathering:	No corrosion or weathering observed.			
End Treatments	Alignment and Height:				
	Breaking and Cracking:				
	Missing Elements:				
	Corrosion and Weathering:

Repair Action:	REPAIR	FMSS Work Type:	DEFERRED MAINTENANCE	Repair Cost:	\$20322
Brief Workorder:	Remove and reset 20 LF of stone guardwall to 24 inch design height.				
Workorder:	Remove & Reset Stone Masonry Guardwall at \$250- per -Cu. Ft. for 64 CF = \$16000. [(20 ft)(1.6 ft)(2ft)] = 64 CF. Structural Concrete at \$1000- per -Cu. Yd. for 1 CY = \$1000. [(20 ft)(1.6 ft)(.7ft)]/27 = .83 CY. Low Speed Traffic Control at \$1475- per -Day for 1 Day(s) = \$1475.

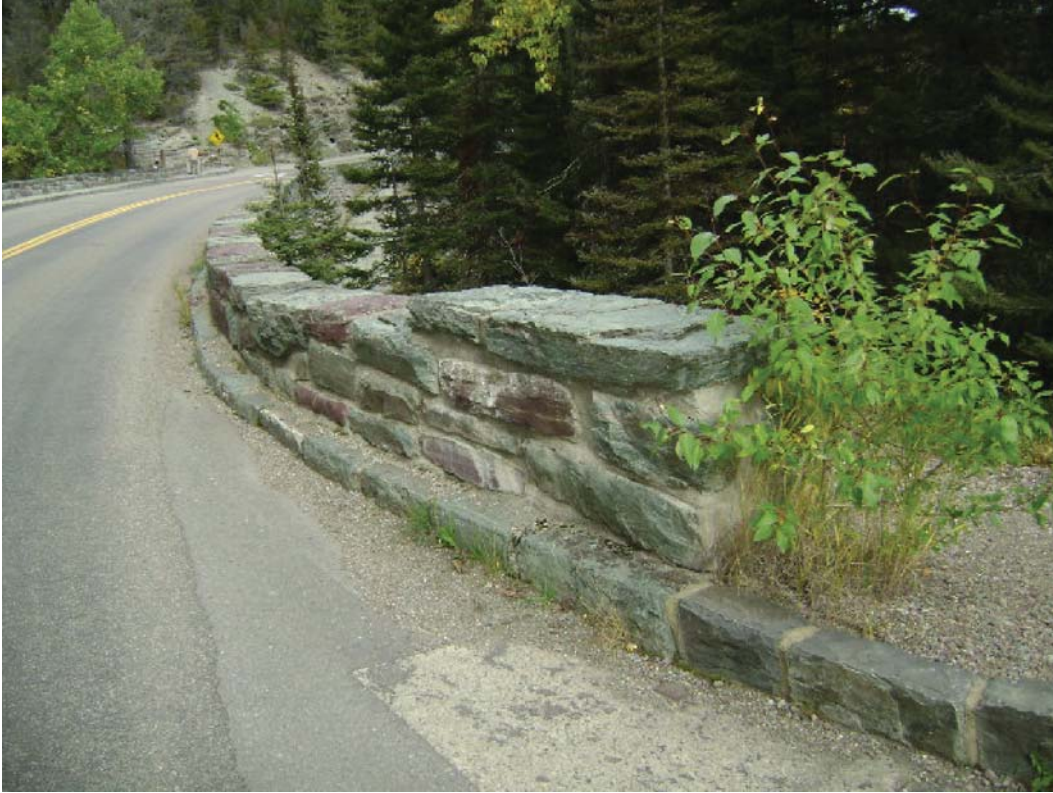
GLAC_0010E_39.344_R_1.JPG

Barrier ID:	GLAC-0010E-39.344-R				
Route Name:	GOING TO THE SUN ROAD EAST				
Inspection Date:	09/27/2010	Barrier Rating:	27.10		
Barrier Description					
Type:	STONE MASONRY WITHOUT CONCRETE CORE WALL	Barrier Function:	TRAFFIC		
Barrier Material:	STONE	Post Material:	N/A		
Blockout Type:	N/A	Length (ft.):	58		
Speed Limit (MPH):	25	Placement with Respect to Road:	INSIDE OF CURVE		
Hazard Behind Barrier:	EXTREME				
Barrier Crashworthiness					
Appropriate Test Level:	TL-1	Barrier Test Level:	NCW	Is Barrier Crashworthy?:	NO
Beg. End Trtmt Type:	NONE	Is Beg. End Trtmt Crashworthy?:	N/A	Approach Transition Type:	NONE
Ending End Trtmt Type:	NONE	Ending End Trtmt Crashworthy?:	N/A		
Average Measurements					
Design Height (In.):	24	Width (In.):	21.2	Post Spacing (In.):	0.0
Height (In.):	28.2	Lateral Offset (In.):	8.6	Road Grade (%):	0.50
Physical Condition					
Barrier	Alignment and Height:	Alignment acceptable. Height at or above design height of 24 in.

Breaking and Cracking:	No breaking or cracking observed.			
	Missing Elements:	No missing elements observed.			
	Corrosion and Weathering:	No corrosion or weathering observed.			
End Treatments	Alignment and Height:				
	Breaking and Cracking:				
	Missing Elements:				
	Corrosion and Weathering:

Repair Action:	NO ACTION	FMSS Work Type:	N/A	Repair Cost:	\$0
Brief Workorder:	N/A				
Workorder:
