# GLCA GIP Report

## NPS Guardwall/Rail Inventory Program Glen Canyon National Recreation Area

Federal Highway Administration  
Eastern Federal Lands Highway Division  
Road Inventory Program (RIP)

Data Collection Date: April 2010  
Report Date: November 2015

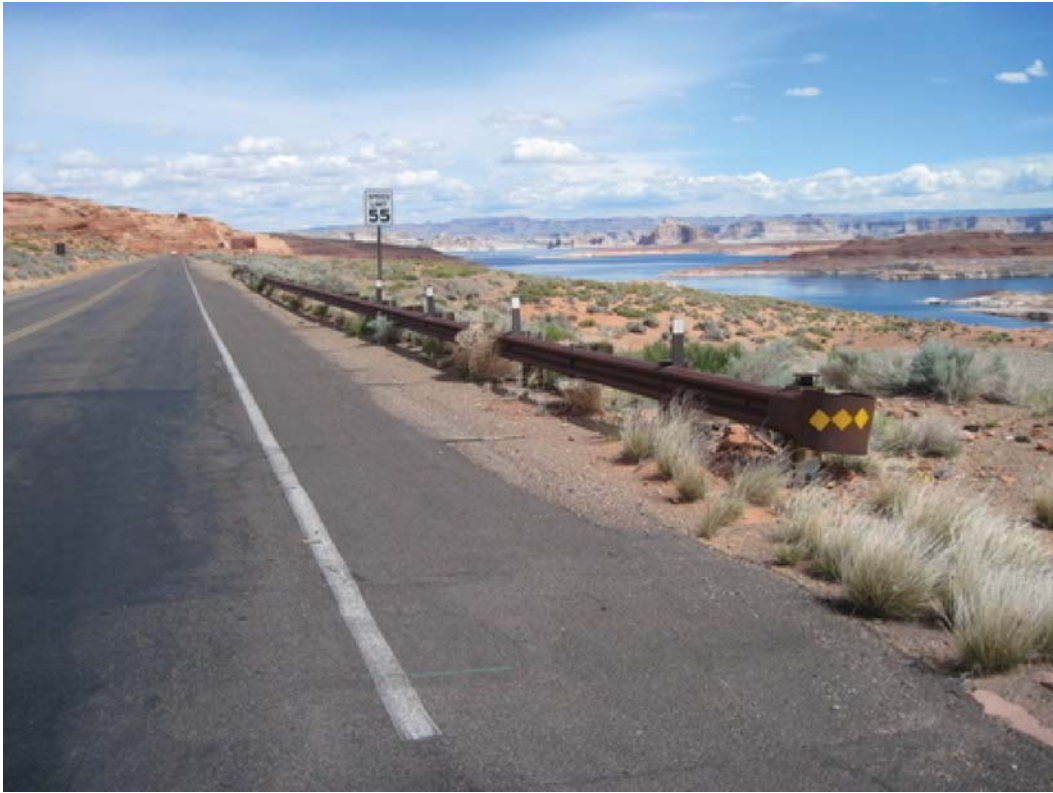
GLCA\_0001\_0.361\_R\_1.jpg

<b>Barrier ID:</b>	GLCA-0001-0.361-R				
<b>Route Name:</b>	LAKESHORE DRIVE				
<b>Inspection Date:</b>	04/22/2010	<b>Barrier Rating:</b>	20.70		
<b>Barrier Description</b>					
<b>Type:</b>	W-BEAM STRONG POST	<b>Barrier Function:</b>	TRAFFIC		
<b>Barrier Material:</b>	WEATHERING STEEL/CORTEN	<b>Post Material:</b>	WOOD		
<b>Blockout Type:</b>	WOOD	<b>Length (ft.):</b>	238		
<b>Speed Limit (MPH):</b>	55	<b>Placement with Respect to Road:</b>	TANGENT		
<b>Hazard Behind Barrier:</b>	MEDIUM				
<b>Barrier Crashworthiness</b>					
<b>Appropriate Test Level:</b>	TL-3	<b>Barrier Test Level:</b>	TL-3	<b>Is Barrier Crashworthy?:</b>	YES
<b>Beg. End Trtmt Type:</b>	W-BEAM BCT	<b>Is Beg. End Trtmt Crashworthy?:</b>	NO	<b>Approach Transition Type:</b>	NONE
<b>Ending End Trtmt Type:</b>	W-BEAM TRAILING END	<b>Ending End Trtmt Crashworthy?:</b>	YES		
<b>Average Measurements</b>					
<b>Design Height (In.):</b>	27	<b>Width (In.):</b>	0.0	<b>Post Spacing (In.):</b>	75.3

<b>Height (In.):</b>	26.7	<b>Lateral Offset (In.):</b>	114.0	<b>Road Grade (%):</b>	0.60
<b>Physical Condition</b>					
<b>Barrier</b>	<b>Alignment and Height:</b>	Alignment is acceptable. Height is within 1-in of 27-in design height.			
	<b>Breaking and Cracking:</b>	3 blocks and 2 posts were broken. 1 (13 ft) rail piece is bent.			
	<b>Missing Elements:</b>	There were no missing elements observed.			
	<b>Corrosion and Weathering:</b>	There was no corrosion or weathering observed. There was some vegetation and gravel build-up next to the guardrail.			
<b>End Treatments</b>	<b>Alignment and Height:</b>	Alignment acceptable. Height is within 1-in of 27-in design height.			
	<b>Breaking and Cracking:</b>	There was no breaking or cracking observed in the end treatments.			
	<b>Missing Elements:</b>	No missing elements in end treatments observed.			
	<b>Corrosion and Weathering:</b>	There was no corrosion or weathering observed.

<b>Repair Action:</b>	REPAIR	<b>FMSS Work Type:</b>	DEFERRED MAINTENANCE	<b>Repair Cost:</b>	\$3394
<b>Brief Workorder:</b>	Replace 3 broken blocks 2 broken posts and 13 feet of rail. Remove vegetation growing in front of guardrail.				
<b>Workorder:</b>	Replace Block at \$30- per -Each for 3 Block(s) = \$90. Replace 3 broken blocks. Replace Post at \$100- per -Each for 2 Post(s) = \$200. Replace Rail at \$25- per -Lin. Ft. for 13 LF = \$325. Labor at \$60- per -Hour for 2 Hrs = \$120. Remove vegetation and gravel build-up. High Speed Traffic Control at \$2350- per -Day for 1 Day(s) = \$2350.

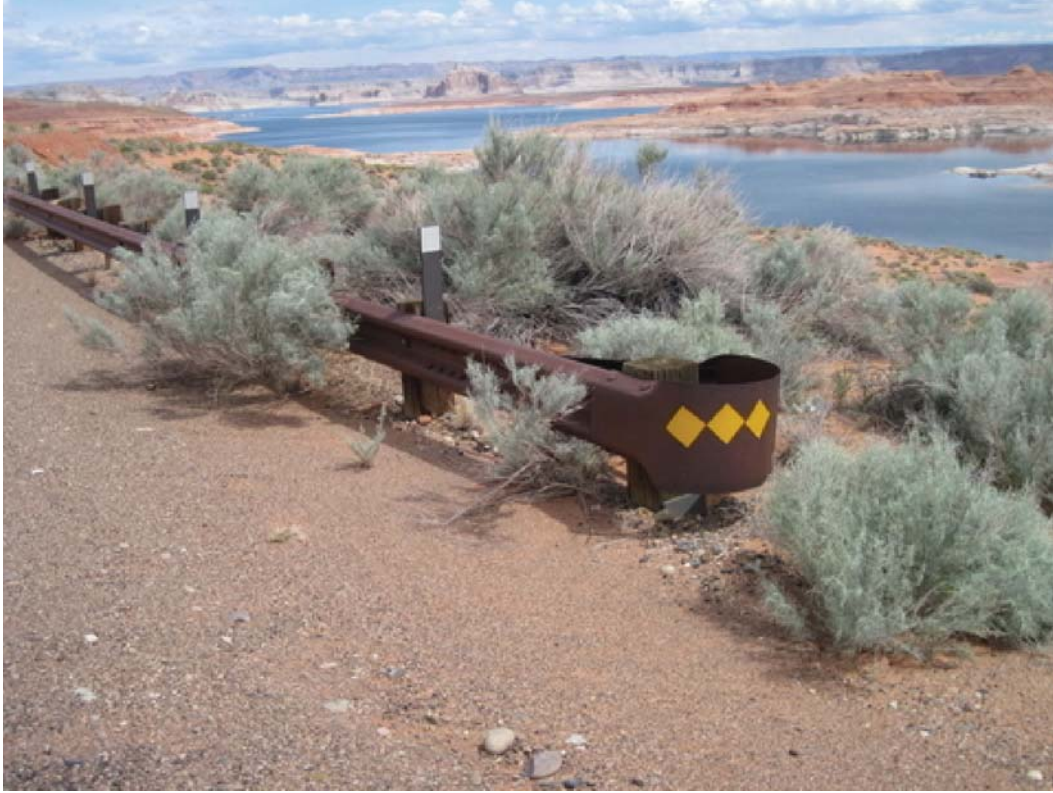
GLCA\_0001\_0.498\_R\_1.jpg

<b>Barrier ID:</b>	GLCA-0001-0.498-R				
<b>Route Name:</b>	LAKESHORE DRIVE				
<b>Inspection Date:</b>	04/22/2010	<b>Barrier Rating:</b>	32.50		
<b>Barrier Description</b>					
<b>Type:</b>	W-BEAM STRONG POST	<b>Barrier Function:</b>	TRAFFIC		
<b>Barrier Material:</b>	WEATHERING STEEL/CORTEN	<b>Post Material:</b>	WOOD		
<b>Blockout Type:</b>	WOOD	<b>Length (ft.):</b>	278		
<b>Speed Limit (MPH):</b>	55	<b>Placement with Respect to Road:</b>	TANGENT		
<b>Hazard Behind Barrier:</b>	MEDIUM				
<b>Barrier Crashworthiness</b>					
<b>Appropriate Test Level:</b>	TL-3	<b>Barrier Test Level:</b>	TL-3	<b>Is Barrier Crashworthy?:</b>	YES
<b>Beg. End Trtmt Type:</b>	W-BEAM BCT	<b>Is Beg. End Trtmt Crashworthy?:</b>	NO	<b>Approach Transition Type:</b>	NONE
<b>Ending End Trtmt Type:</b>	W-BEAM TRAILING END	<b>Ending End Trtmt Crashworthy?:</b>	YES		
<b>Average Measurements</b>					
<b>Design Height (In.):</b>	27	<b>Width (In.):</b>	0.0	<b>Post Spacing (In.):</b>	75.0

<b>Height (In.):</b>	25.2	<b>Lateral Offset (In.):</b>	140.3	<b>Road Grade (%):</b>	0.10
<b>Physical Condition</b>					
<b>Barrier</b>	<b>Alignment and Height:</b>	Alignment acceptable. 200-ft was between 1 and 3-in below the 27-in design height.			
	<b>Breaking and Cracking:</b>	One post is broken/cracked.			
	<b>Missing Elements:</b>	No missing elements			
	<b>Corrosion and Weathering:</b>	Sediment is built up and vegetation is present under the barrier.			
<b>End Treatments</b>	<b>Alignment and Height:</b>	Alignment acceptable. Height is within 1-in of 27-in design height.			
	<b>Breaking and Cracking:</b>	There was no breaking or cracking observed in the end treatments.			
	<b>Missing Elements:</b>	No missing elements in end treatments observed.			
	<b>Corrosion and Weathering:</b>	Sediment is built up and vegetation is present under the barrier.

<b>Repair Action:</b>	REPAIR	<b>FMSS Work Type:</b>	DEFERRED MAINTENANCE	<b>Repair Cost:</b>	\$5170
<b>Brief Workorder:</b>	Raise 200 ft. of barrier up to 27-in. design height replace post remove sediment and vegetation from under barrier				
<b>Workorder:</b>	Replace Post at \$100- per -Each for 1 Post(s) = \$100. One post cracked Adjust Guardrail at \$10- per -Lin. Ft. for 200 LF = \$2000. Raise 200 ft. of barrier up to 27-in. design height. Loader at \$125- per -Hour for 2 Hrs = \$250. Remove sediment and vegetation. High Speed Traffic Control at \$2350- per -Day for 1 Day(s) = \$2350.

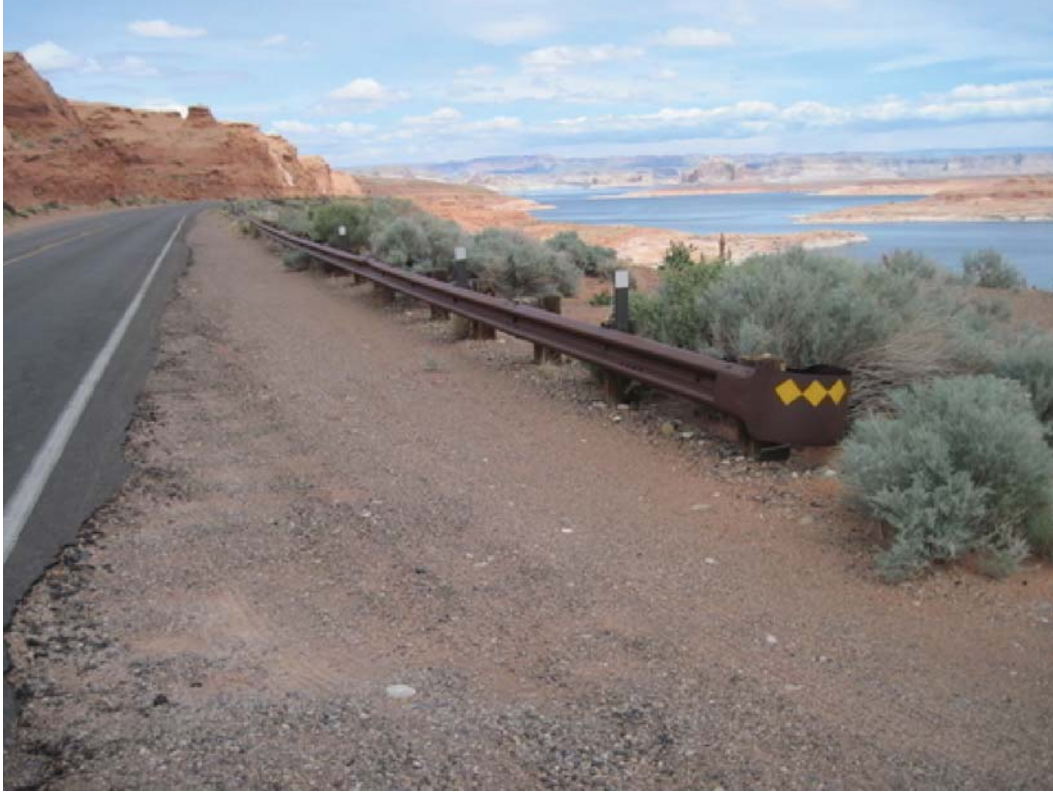
GLCA\_0001\_0.598\_R\_1.jpg

<b>Barrier ID:</b>	GLCA-0001-0.598-R				
<b>Route Name:</b>	LAKESHORE DRIVE				
<b>Inspection Date:</b>	04/22/2010	<b>Barrier Rating:</b>	60.00		
<b>Barrier Description</b>					
<b>Type:</b>	W-BEAM STRONG POST	<b>Barrier Function:</b>	TRAFFIC		
<b>Barrier Material:</b>	WEATHERING STEEL/CORTEN	<b>Post Material:</b>	WOOD		
<b>Blockout Type:</b>	WOOD	<b>Length (ft.):</b>	3541		
<b>Speed Limit (MPH):</b>	55	<b>Placement with Respect to Road:</b>	BOTH INSIDE AND OUTSIDE		
<b>Hazard Behind Barrier:</b>	EXTREME				
<b>Barrier Crashworthiness</b>					
<b>Appropriate Test Level:</b>	TL-3	<b>Barrier Test Level:</b>	TL-3	<b>Is Barrier Crashworthy?:</b>	YES
<b>Beg. End Trtmt Type:</b>	W-BEAM BCT	<b>Is Beg. End Trtmt Crashworthy?:</b>	NO	<b>Approach Transition Type:</b>	NONE
<b>Ending End Trtmt Type:</b>	W-BEAM TRAILING END	<b>Ending End Trtmt Crashworthy?:</b>	YES		
<b>Average Measurements</b>					
<b>Design Height (In.):</b>	27	<b>Width (In.):</b>	0.0	<b>Post Spacing (In.):</b>	75.5

<b>Height (In.):</b>	26.8	<b>Lateral Offset (In.):</b>	176.6	<b>Road Grade (%):</b>	0.60
<b>Physical Condition</b>					
<b>Barrier</b>	<b>Alignment and Height:</b>	Alignment acceptable. 800-ft was between 1 and 3-in below the 27-in design height. Approximately 200 LF is 4.5 in. above the 27 in. design height.			
	<b>Breaking and Cracking:</b>	There are 52 cracked or broken blocks along with 16 damaged posts and 338 LF of bent and or torn rail.			
	<b>Missing Elements:</b>	There are approximately 200 LF that the bolt that fastens the rail block and post are all missing the nut. There is also one location where all of the hardware that fastens two of the rail sections together is missing.			
	<b>Corrosion and Weathering:</b>	There are numerous badly cracked and/or warped blocks and posts that could be attributed to weathering and or corrosion.			
<b>End Treatments</b>	<b>Alignment and Height:</b>	The alignment is acceptable but the height of the ending end treatment was 2.5 in below the 27 in design height.

<b>Breaking and Cracking:</b>	The beginning end treatment is damaged.			
	<b>Missing Elements:</b>	One block is missing from the ending end treatment.			
	<b>Corrosion and Weathering:</b>	There was no corrosion or weathering observed.

<b>Repair Action:</b>	REPLACE	<b>FMSS Work Type:</b>	CAPITAL IMPROVEMENT	<b>Repair Cost:</b>	\$57805
<b>Brief Workorder:</b>	Raise 800ft. Of barrier and lower 200ft. To 27in. Design height.				
<b>Workorder:</b>	<p>Remove Guardrail at \$10- per -Lin. Ft. for 30 LF = \$300. Remove the damaged beginning end treatment.</p> <p>W-beam tangent 350 compliant at \$3500- per -Each for 1 Unit(s) = \$3500. Replace the beginning end treatment.</p> <p>Adjust Guardrail at \$10- per -Lin. Ft. for 800 LF = \$8000. Raise 800ft. of barrier up to 27in. design height.</p> <p>Adjust Guardrail at \$10- per -Lin. Ft. for 200 LF = \$2000. Lower 200ft. of barrier down to 27in. design height.</p> <p>Replace Block at \$30- per -Each for 53 Block(s) = \$1590. Replace all of the damaged blocks.</p> <p>Replace Post at \$100- per -Each for 16 Post(s) = \$1600. Replace the damaged post.</p> <p>Replace Rail at \$25- per -Lin. Ft. for 338 LF = \$8450. Replace the damaged rail.</p> <p>Labor at \$60- per -Hour for 21 Hrs = \$1260. Replace the nuts on the bolt that fastens the block rail and posts and remove the vegetation.</p> <p>High Speed Traffic Control at \$2350- per -Day for 11 Day(s) = \$25850.</p>

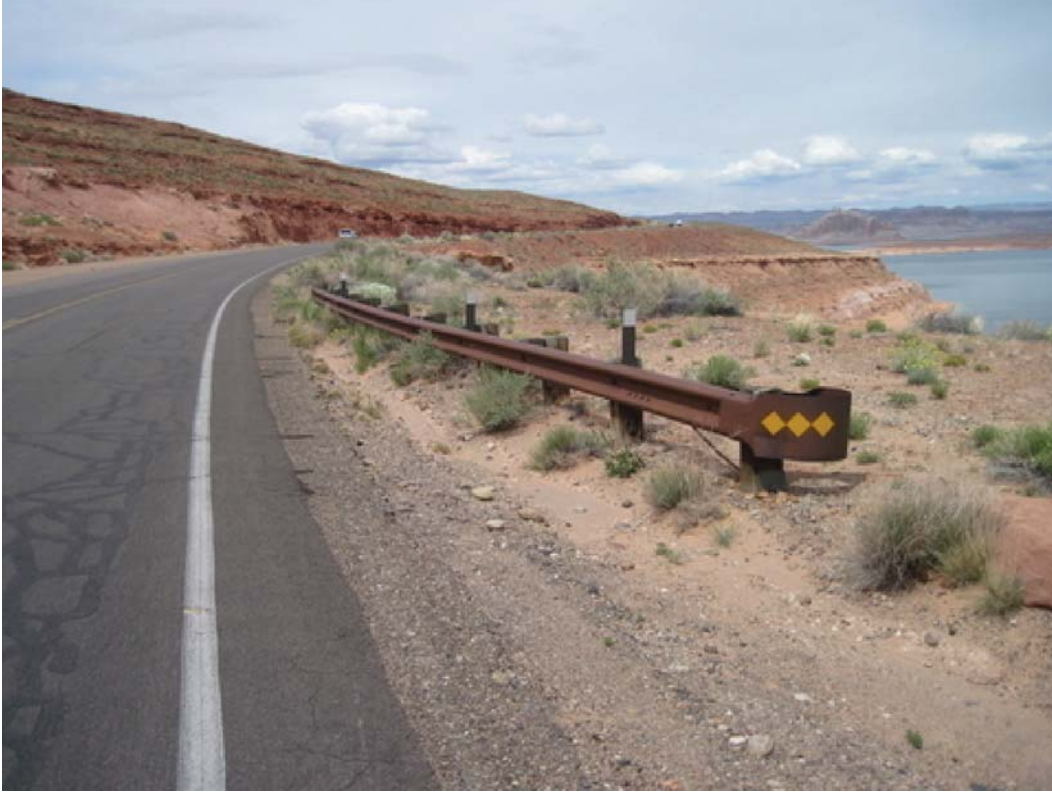
GLCA\_0001\_1.374\_R\_1.jpg

<b>Barrier ID:</b>	GLCA-0001-1.374-R				
<b>Route Name:</b>	LAKESHORE DRIVE				
<b>Inspection Date:</b>	04/22/2010	<b>Barrier Rating:</b>	35.50		
<b>Barrier Description</b>					
<b>Type:</b>	W-BEAM STRONG POST	<b>Barrier Function:</b>	TRAFFIC		
<b>Barrier Material:</b>	WEATHERING STEEL/CORTEN	<b>Post Material:</b>	WOOD		
<b>Blockout Type:</b>	WOOD	<b>Length (ft.):</b>	1920		
<b>Speed Limit (MPH):</b>	55	<b>Placement with Respect to Road:</b>	INSIDE OF CURVE		
<b>Hazard Behind Barrier:</b>	HIGH				
<b>Barrier Crashworthiness</b>					
<b>Appropriate Test Level:</b>	TL-3	<b>Barrier Test Level:</b>	TL-3	<b>Is Barrier Crashworthy?:</b>	YES
<b>Beg. End Trtmt Type:</b>	W-BEAM BCT	<b>Is Beg. End Trtmt Crashworthy?:</b>	NO	<b>Approach Transition Type:</b>	NONE
<b>Ending End Trtmt Type:</b>	W-BEAM TRAILING END	<b>Ending End Trtmt Crashworthy?:</b>	YES		
<b>Average Measurements</b>					
<b>Design Height (In.):</b>	27	<b>Width (In.):</b>	0.0	<b>Post Spacing (In.):</b>	75.0

<b>Height (In.):</b>	26.7	<b>Lateral Offset (In.):</b>	191.8	<b>Road Grade (%):</b>	1.10
<b>Physical Condition</b>					
<b>Barrier</b>	<b>Alignment and Height:</b>	Alignment acceptable. 720-ft was between 1 and 3-in below the 27-in design height. For about 1200 ft the height was 0-3in. above the 27-in design height.			
	<b>Breaking and Cracking:</b>	There were 25 blocks and 5 posts that were broken or badly splintered. 4 (13 ft each) rail pieces were bent. About 35 posts/blocks have loose bolts.			
	<b>Missing Elements:</b>	There were no missing elements observed.			
	<b>Corrosion and Weathering:</b>	The posts and blocks are old and appear to be splintering out. Vegetation and gravel was next to the guardrail.			
<b>End Treatments</b>	<b>Alignment and Height:</b>	Alignment acceptable. The height was 2 in below 27 in design height.			
	<b>Breaking and Cracking:</b>	There was no breaking or cracking observed in the end treatments.

<b>Missing Elements:</b>	No missing elements in end treatments observed.			
	<b>Corrosion and Weathering:</b>	The blocks and posts are old and splintering out.

<b>Repair Action:</b>	REPAIR	<b>FMSS Work Type:</b>	DEFERRED MAINTENANCE	<b>Repair Cost:</b>	\$21857
<b>Brief Workorder:</b>	Raise 720 feet of barrier up to 27-in. design height. Replace 4 (13 ft each) rail pieces 25 blocks and 5 posts. Tighten bolts and remove vegetation and gravel build-up along the length of the barrier.				
<b>Workorder:</b>	Adjust Guardrail at \$10- per -Lin. Ft. for 720 LF = \$7200. Raise 720 ft of barrier up to 27-in. design height. Replace Rail at \$25- per -Lin. Ft. for 52 LF = \$1300. Replace 52 ft of bent rail. Replace Block at \$30- per -Each for 25 Block(s) = \$750. Replace 25 damaged blocks. Replace Post at \$100- per -Each for 5 Post(s) = \$500. Replace 5 damaged posts. Labor at \$60- per -Hour for 12 Hrs = \$720. Labor to tighten loose bolts remove vegetation and gravel build-up. High Speed Traffic Control at \$2350- per -Day for 4 Day(s) = \$9400. 3 days to raise rail 1 day all other work.

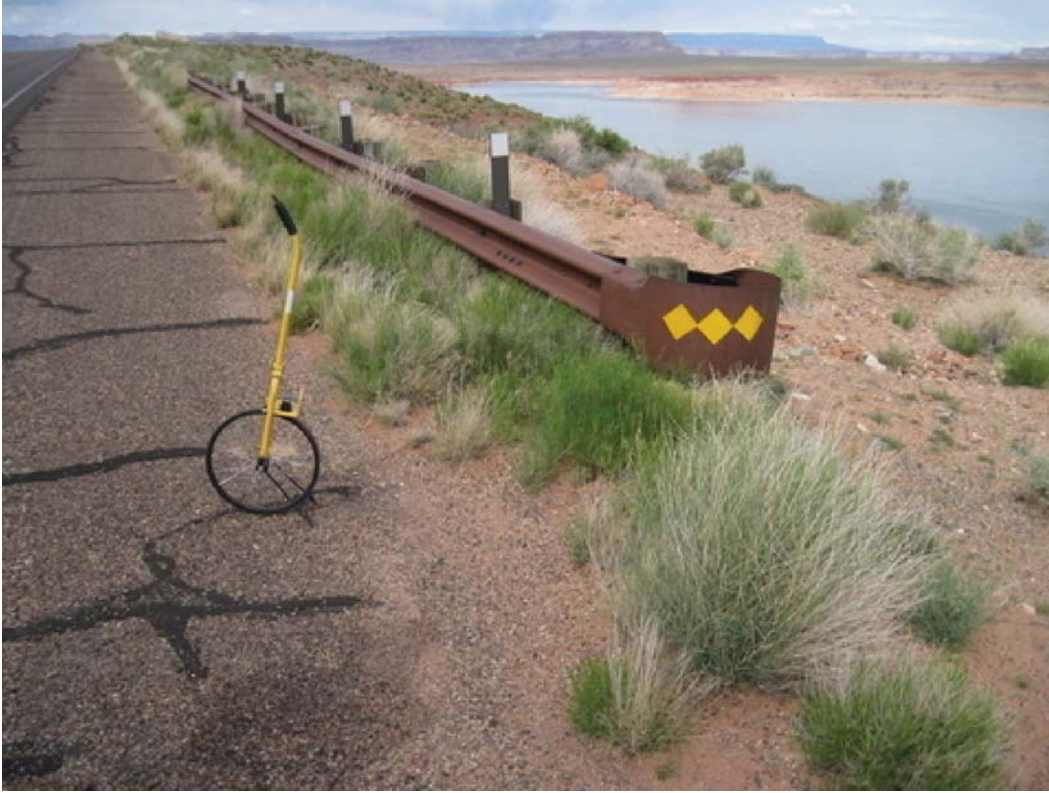
GLCA\_0001\_1.834\_R\_1.jpg

<b>Barrier ID:</b>	GLCA-0001-1.834-R				
<b>Route Name:</b>	LAKESHORE DRIVE				
<b>Inspection Date:</b>	04/22/2010	<b>Barrier Rating:</b>	47.00		
<b>Barrier Description</b>					
<b>Type:</b>	W-BEAM STRONG POST	<b>Barrier Function:</b>	TRAFFIC		
<b>Barrier Material:</b>	WEATHERING STEEL/CORTEN	<b>Post Material:</b>	WOOD		
<b>Blockout Type:</b>	WOOD	<b>Length (ft.):</b>	356		
<b>Speed Limit (MPH):</b>	55	<b>Placement with Respect to Road:</b>	TANGENT		
<b>Hazard Behind Barrier:</b>	HIGH				
<b>Barrier Crashworthiness</b>					
<b>Appropriate Test Level:</b>	TL-3	<b>Barrier Test Level:</b>	TL-3	<b>Is Barrier Crashworthy?:</b>	YES
<b>Beg. End Trtmt Type:</b>	W-BEAM BCT	<b>Is Beg. End Trtmt Crashworthy?:</b>	NO	<b>Approach Transition Type:</b>	NONE
<b>Ending End Trtmt Type:</b>	W-BEAM TRAILING END	<b>Ending End Trtmt Crashworthy?:</b>	YES		
<b>Average Measurements</b>					
<b>Design Height (In.):</b>	27	<b>Width (In.):</b>	0.0	<b>Post Spacing (In.):</b>	75.3

<b>Height (In.):</b>	22.0	<b>Lateral Offset (In.):</b>	153.0	<b>Road Grade (%):</b>	2.30
<b>Physical Condition</b>					
<b>Barrier</b>	<b>Alignment and Height:</b>	Alignment acceptable. Entire barrier is between 4-6in. below the 27-in design height.			
	<b>Breaking and Cracking:</b>	Four (4) posts and one (1) blockout are breaking and cracking.			
	<b>Missing Elements:</b>	There are no missing elements.			
	<b>Corrosion and Weathering:</b>	Sediment and vegetation are under the barrier. Vegetation is thick and is overgrowing the w-beam.			
<b>End Treatments</b>	<b>Alignment and Height:</b>	Alignment acceptable. Entire barrier is between 4-6in. below the 27-in design height.			
	<b>Breaking and Cracking:</b>	One (1) post is breaking and cracking.			
	<b>Missing Elements:</b>	No missing elements in end treatments observed.			
	<b>Corrosion and Weathering:</b>	Sediment and vegetation are under the barrier. Vegetation is thick and overgrowing the w-beam.

<b>Repair Action:</b>	REPAIR	<b>FMSS Work Type:</b>	DEFERRED MAINTENANCE	<b>Repair Cost:</b>	\$10219
<b>Brief Workorder:</b>	Raise 356 ft of barrier up to 27-in. design height. replaced damaged barrier items and remove sediment and vegetation.				
<b>Workorder:</b>	Adjust Guardrail at \$10- per -Lin. Ft. for 356 LF = \$3560. Raise 356 ft of barrier up to 27-in. design height. Replace Post at \$100- per -Each for 5 Post(s) = \$500. Replace Block at \$30- per -Each for 1 Block(s) = \$30. Loader at \$125- per -Hour for 4 Hrs = \$500. Removal of sediment and vegetation. High Speed Traffic Control at \$2350- per -Day for 2 Day(s) = \$4700.

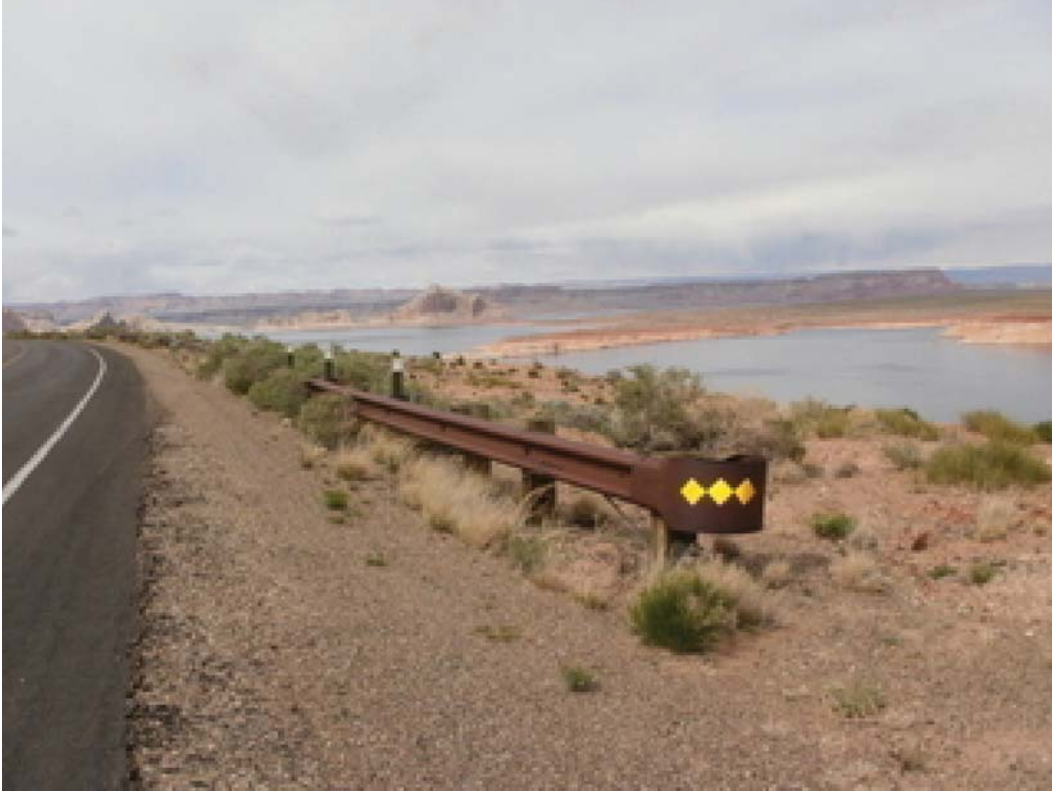
GLCA\_0001\_1.996\_R\_1.JPG

<b>Barrier ID:</b>	GLCA-0001-1.996-R				
<b>Route Name:</b>	LAKESHORE DRIVE				
<b>Inspection Date:</b>	04/22/2010	<b>Barrier Rating:</b>	66.90		
<b>Barrier Description</b>					
<b>Type:</b>	W-BEAM STRONG POST	<b>Barrier Function:</b>	TRAFFIC		
<b>Barrier Material:</b>	WEATHERING STEEL/CORTEN	<b>Post Material:</b>	WOOD		
<b>Blockout Type:</b>	WOOD	<b>Length (ft.):</b>	1013		
<b>Speed Limit (MPH):</b>	55	<b>Placement with Respect to Road:</b>	OUTSIDE OF CURVE		
<b>Hazard Behind Barrier:</b>	HIGH				
<b>Barrier Crashworthiness</b>					
<b>Appropriate Test Level:</b>	TL-3	<b>Barrier Test Level:</b>	TL-3	<b>Is Barrier Crashworthy?:</b>	YES
<b>Beg. End Trtmt Type:</b>	W-BEAM BCT	<b>Is Beg. End Trtmt Crashworthy?:</b>	NO	<b>Approach Transition Type:</b>	NONE
<b>Ending End Trtmt Type:</b>	W-BEAM TRAILING END	<b>Ending End Trtmt Crashworthy?:</b>	YES		
<b>Average Measurements</b>					
<b>Design Height (In.):</b>	27	<b>Width (In.):</b>	0.0	<b>Post Spacing (In.):</b>	74.8

<b>Height (In.):</b>	22.6	<b>Lateral Offset (In.):</b>	143.8	<b>Road Grade (%):</b>	0.30
<b>Physical Condition</b>					
<b>Barrier</b>	<b>Alignment and Height:</b>	Alignment acceptable. 76-ft was between 1 and 3-in below the 27-in design height and 625-ft was more than 3-in. below the design height due to soil and vegetation build up in front of rail.			
	<b>Breaking and Cracking:</b>	60 ft of w-beam is bent and torn in barrier. 7 posts are cracked or broken and 14 blocks are broken.			
	<b>Missing Elements:</b>	2 missing blocks in barrier.			
	<b>Corrosion and Weathering:</b>	12-in deep gullying between posts near approach end of rail. Posts and blocks are dried and weathered with 1/4 to 1/2 inch cracks.			
<b>End Treatments</b>	<b>Alignment and Height:</b>	Alignment acceptable. Height is within 1-in of 27-in design height.			
	<b>Breaking and Cracking:</b>	There was no breaking or cracking observed in the end treatments.

<b>Missing Elements:</b>	No missing elements in end treatments observed.			
	<b>Corrosion and Weathering:</b>	There was no corrosion or weathering observed.

<b>Barrier ID:</b>	GLCA-0001-1.996-R				
<b>Route Name:</b>	LAKESHORE DRIVE				
<b>Inspection Date:</b>	04/22/2010	<b>Barrier Rating:</b>		66.90	
<b>Repair Recommendations</b>					
<b>Repair Action:</b>	REPAIR	<b>FMSS Work Type:</b>	DEFERRED MAINTENANCE	<b>Repair Cost:</b>	\$12958
<b>Brief Workorder:</b>	Remove 1 to 10 inches deep of soil build up in front of 701 linear ft of barrier to bring barrier up to 27-in. design height. Replace 60 ft of W-beam 7 damaged posts and 14 damaged blocks. Add 2 missing blocks and backfill to one eroded area.				
<b>Workorder:</b>	Loader at \$125- per -Hour for 16 Hrs = \$2000. Removal of soil buildup in front of rail. Replace Rail at \$25- per -Lin. Ft. for 60 LF = \$1500. Replace damaged W-beam. Replace Post at \$100- per -Each for 7 Post(s) = \$700. Replace damaged posts. Replace Block at \$30- per -Each for 16 Block(s) = \$480. Replace missing or damaged blocks. Structural Backfill at \$50- per -Cu. Yd. for 1 CY = \$50. Add backfill to erosion area. High Speed Traffic Control at \$2350- per -Day for 3 Day(s) = \$7050.

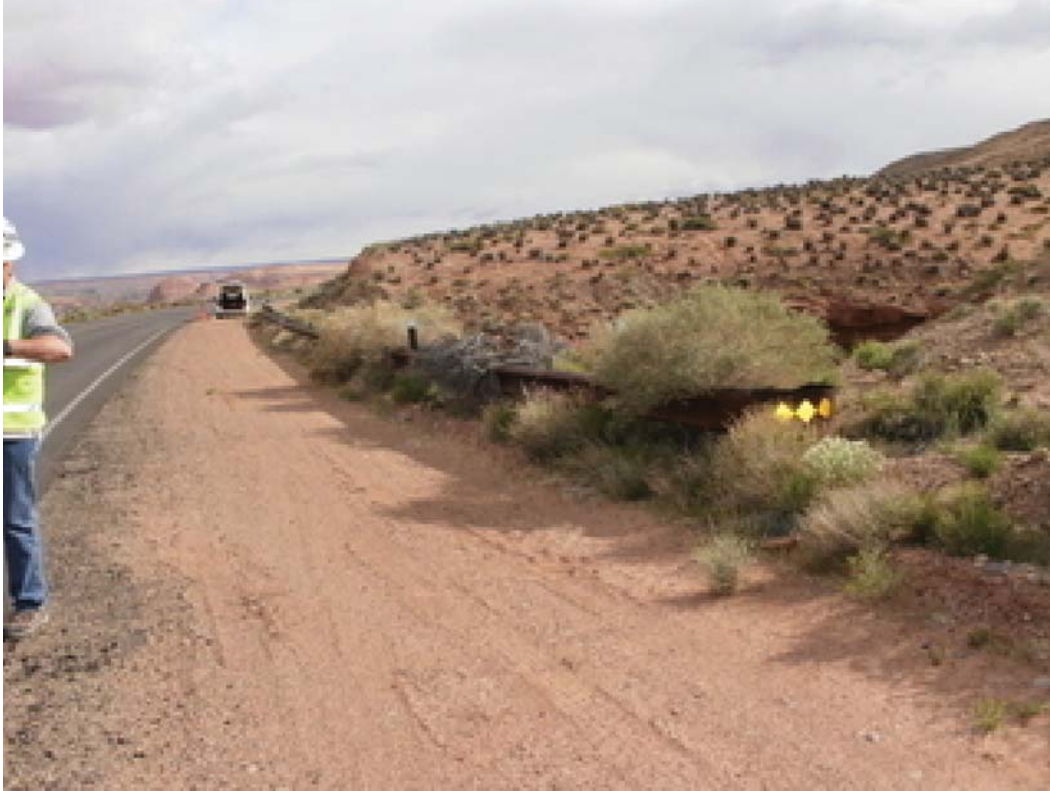
GLCA\_0001\_2.094\_L\_1.JPG

<b>Barrier ID:</b>	GLCA-0001-2.094-L				
<b>Route Name:</b>	LAKESHORE DRIVE				
<b>Inspection Date:</b>	04/22/2010	<b>Barrier Rating:</b>	32.50		
<b>Barrier Description</b>					
<b>Type:</b>	W-BEAM STRONG POST	<b>Barrier Function:</b>	TRAFFIC		
<b>Barrier Material:</b>	WEATHERING STEEL/CORTEN	<b>Post Material:</b>	WOOD		
<b>Blockout Type:</b>	WOOD	<b>Length (ft.):</b>	165		
<b>Speed Limit (MPH):</b>	55	<b>Placement with Respect to Road:</b>	INSIDE OF CURVE		
<b>Hazard Behind Barrier:</b>	MEDIUM				
<b>Barrier Crashworthiness</b>					
<b>Appropriate Test Level:</b>	TL-3	<b>Barrier Test Level:</b>	TL-3	<b>Is Barrier Crashworthy?:</b>	YES
<b>Beg. End Trtmt Type:</b>	W-BEAM BCT	<b>Is Beg. End Trtmt Crashworthy?:</b>	NO	<b>Approach Transition Type:</b>	NONE
<b>Ending End Trtmt Type:</b>	W-BEAM TRAILING END	<b>Ending End Trtmt Crashworthy?:</b>	YES		
<b>Average Measurements</b>					
<b>Design Height (In.):</b>	27	<b>Width (In.):</b>	0.0	<b>Post Spacing (In.):</b>	74.5

<b>Height (In.):</b>	23.0	<b>Lateral Offset (In.):</b>	172.0	<b>Road Grade (%):</b>	0.70
<b>Physical Condition</b>					
<b>Barrier</b>	<b>Alignment and Height:</b>	Alignment acceptable. Height of barrier is 3 in to 5 in below design height of 27 in for entire barrier.			
	<b>Breaking and Cracking:</b>	1/4 to 1/2 in wide minor cracking of posts and blocks.			
	<b>Missing Elements:</b>	No missing elements in barrier.			
	<b>Corrosion and Weathering:</b>	Minor weathering of barrier parts. Soil and gravel piling up in front of barrier.			
<b>End Treatments</b>	<b>Alignment and Height:</b>	Alignment acceptable. Height is 3 in below design height of 27 in for end treatment.			
	<b>Breaking and Cracking:</b>	1/4 to 1/2 in wide minor cracking of posts and blocks of end treatment.			
	<b>Missing Elements:</b>	No missing elements in end treatments observed.			
	<b>Corrosion and Weathering:</b>	Minor weathering of end treatment.

<b>Repair Action:</b>	REPAIR	<b>FMSS Work Type:</b>	DEFERRED MAINTENANCE	<b>Repair Cost:</b>	\$4950
<b>Brief Workorder:</b>	Raise 165 ft. of barrier to 27-in. design height and remove soil berm.				
<b>Workorder:</b>	Adjust Guardrail at \$10- per -Lin. Ft. for 165 LF = \$1650. Raise 165 ft. of barrier to 27-in. design height. Loader at \$125- per -Hour for 4 Hrs = \$500. Remove soil berm from front of barrier. High Speed Traffic Control at \$2350- per -Day for 1 Day(s) = \$2350.

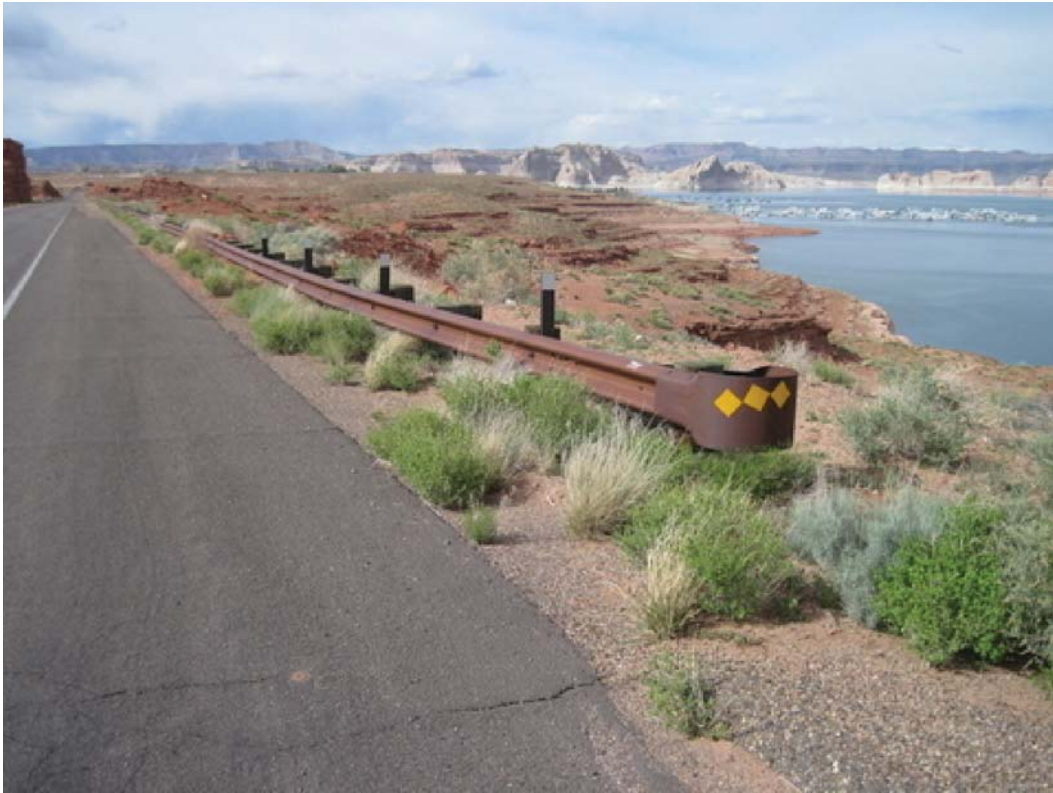
GLCA\_0001\_2.487\_R\_1.jpg

<b>Barrier ID:</b>	GLCA-0001-2.487-R				
<b>Route Name:</b>	LAKESHORE DRIVE				
<b>Inspection Date:</b>	04/22/2010	<b>Barrier Rating:</b>	41.20		
<b>Barrier Description</b>					
<b>Type:</b>	W-BEAM STRONG POST	<b>Barrier Function:</b>	TRAFFIC		
<b>Barrier Material:</b>	WEATHERING STEEL/CORTEN	<b>Post Material:</b>	WOOD		
<b>Blockout Type:</b>	WOOD	<b>Length (ft.):</b>	918		
<b>Speed Limit (MPH):</b>	55	<b>Placement with Respect to Road:</b>	TANGENT		
<b>Hazard Behind Barrier:</b>	HIGH				
<b>Barrier Crashworthiness</b>					
<b>Appropriate Test Level:</b>	TL-3	<b>Barrier Test Level:</b>	TL-3	<b>Is Barrier Crashworthy?:</b>	YES
<b>Beg. End Trtmt Type:</b>	W-BEAM BCT	<b>Is Beg. End Trtmt Crashworthy?:</b>	NO	<b>Approach Transition Type:</b>	NONE
<b>Ending End Trtmt Type:</b>	W-BEAM TRAILING END	<b>Ending End Trtmt Crashworthy?:</b>	YES		
<b>Average Measurements</b>					
<b>Design Height (In.):</b>	27	<b>Width (In.):</b>	0.0	<b>Post Spacing (In.):</b>	74.8

<b>Height (In.):</b>	25.2	<b>Lateral Offset (In.):</b>	180.1	<b>Road Grade (%):</b>	1.40
<b>Physical Condition</b>					
<b>Barrier</b>	<b>Alignment and Height:</b>	Alignment acceptable. 174-ft was between 1 and 3-in below the 27-in design height and 200-ft was more than 3-in. below the design height.			
	<b>Breaking and Cracking:</b>	There were six broken or cracked blocks and 38 LF of bent rail.			
	<b>Missing Elements:</b>	There were no missing elements observed.			
	<b>Corrosion and Weathering:</b>	There was no corrosion or weathering observed.			
<b>End Treatments</b>	<b>Alignment and Height:</b>	Alignment acceptable but the height of the beginning end treatment was 6 in below the 27 in design height.			
	<b>Breaking and Cracking:</b>	There was no breaking or cracking observed in the end treatments.			
	<b>Missing Elements:</b>	No missing elements in end treatments observed.			
	<b>Corrosion and Weathering:</b>	There was no corrosion or weathering observed.

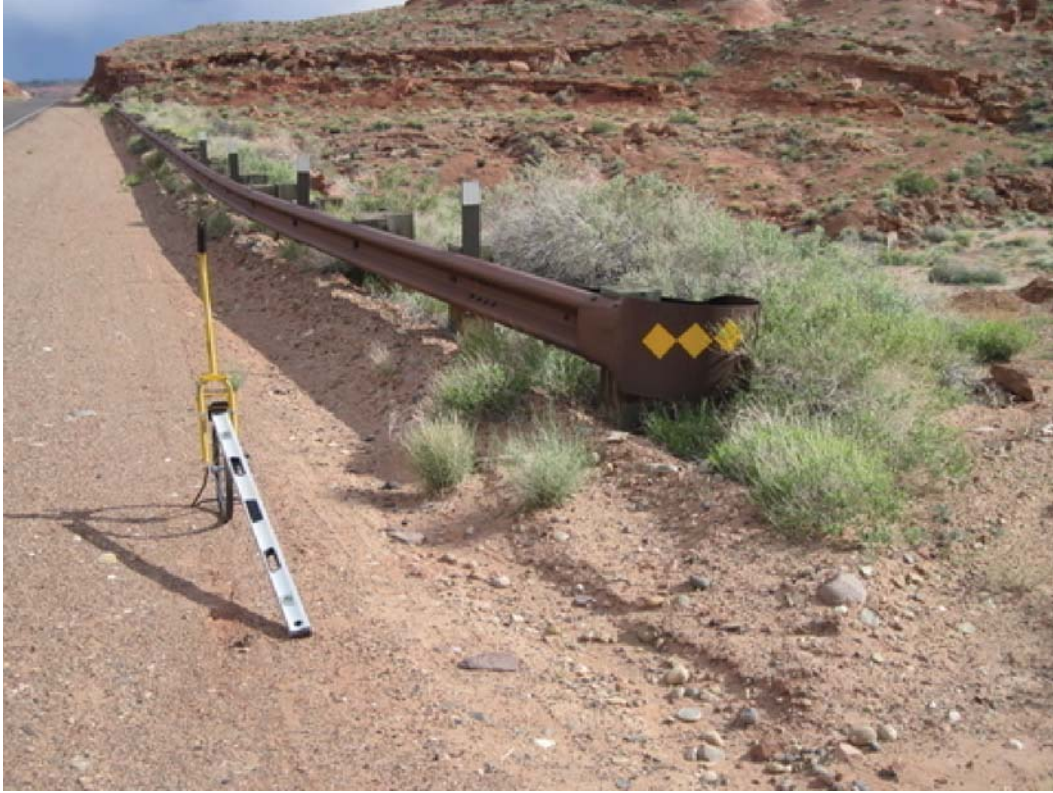
GLCA\_0001\_2.593\_L\_1.jpg

<b>Barrier ID:</b>	GLCA-0001-2.593-L				
<b>Route Name:</b>	LAKESHORE DRIVE				
<b>Inspection Date:</b>	04/22/2010	<b>Barrier Rating:</b>	42.20		
<b>Barrier Description</b>					
<b>Type:</b>	W-BEAM STRONG POST	<b>Barrier Function:</b>	TRAFFIC		
<b>Barrier Material:</b>	WEATHERING STEEL/CORTEN	<b>Post Material:</b>	WOOD		
<b>Blockout Type:</b>	WOOD	<b>Length (ft.):</b>	241		
<b>Speed Limit (MPH):</b>	55	<b>Placement with Respect to Road:</b>	TANGENT		
<b>Hazard Behind Barrier:</b>	MEDIUM				
<b>Barrier Crashworthiness</b>					
<b>Appropriate Test Level:</b>	TL-3	<b>Barrier Test Level:</b>	TL-3	<b>Is Barrier Crashworthy?:</b>	YES
<b>Beg. End Trtmt Type:</b>	W-BEAM BCT	<b>Is Beg. End Trtmt Crashworthy?:</b>	NO	<b>Approach Transition Type:</b>	NONE
<b>Ending End Trtmt Type:</b>	W-BEAM TRAILING END	<b>Ending End Trtmt Crashworthy?:</b>	YES		
<b>Average Measurements</b>					
<b>Design Height (In.):</b>	27	<b>Width (In.):</b>	0.0	<b>Post Spacing (In.):</b>	75.6

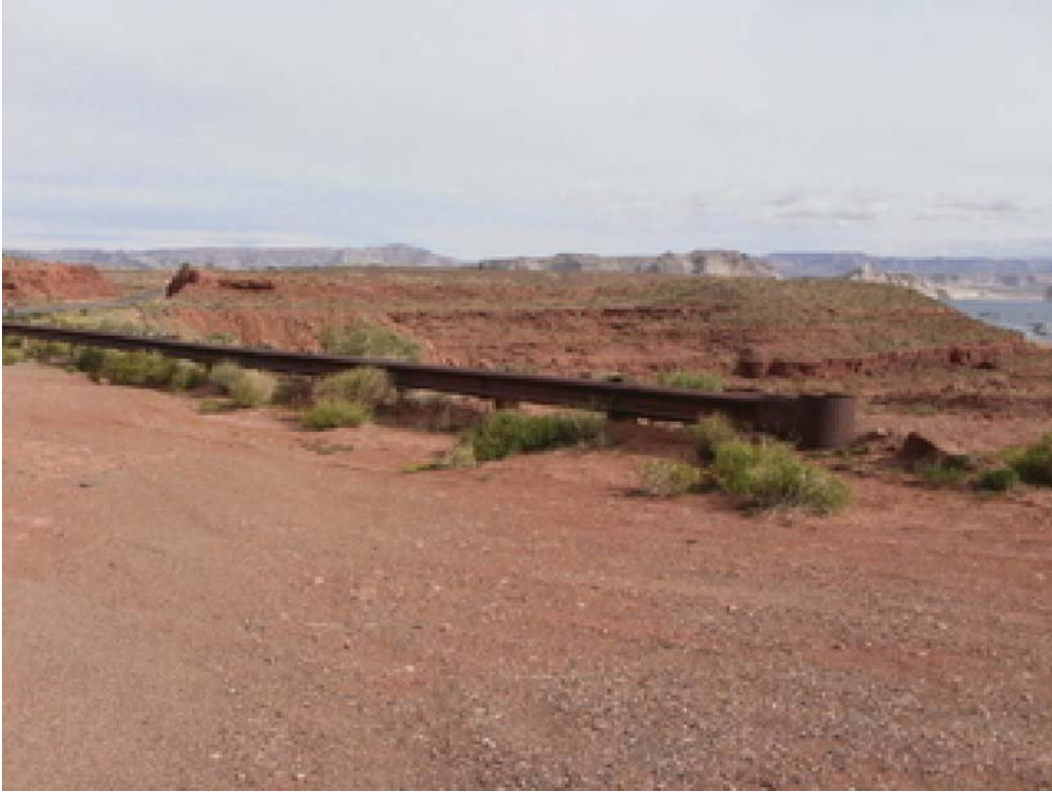
GLCA\_0001\_2.725\_R\_1.JPG

<b>Barrier ID:</b>	GLCA-0001-2.725-R				
<b>Route Name:</b>	LAKESHORE DRIVE				
<b>Inspection Date:</b>	04/22/2010	<b>Barrier Rating:</b>	35.70		
<b>Barrier Description</b>					
<b>Type:</b>	W-BEAM STRONG POST	<b>Barrier Function:</b>	TRAFFIC		
<b>Barrier Material:</b>	WEATHERING STEEL/CORTEN	<b>Post Material:</b>	WOOD		
<b>Blockout Type:</b>	WOOD	<b>Length (ft.):</b>	526		
<b>Speed Limit (MPH):</b>	55	<b>Placement with Respect to Road:</b>	TANGENT		
<b>Hazard Behind Barrier:</b>	EXTREME				
<b>Barrier Crashworthiness</b>					
<b>Appropriate Test Level:</b>	TL-3	<b>Barrier Test Level:</b>	TL-3	<b>Is Barrier Crashworthy?:</b>	YES
<b>Beg. End Trtmt Type:</b>	W-BEAM BCT	<b>Is Beg. End Trtmt Crashworthy?:</b>	NO	<b>Approach Transition Type:</b>	NONE
<b>Ending End Trtmt Type:</b>	W-BEAM TRAILING END	<b>Ending End Trtmt Crashworthy?:</b>	YES		
<b>Average Measurements</b>					
<b>Design Height (In.):</b>	27	<b>Width (In.):</b>	0.0	<b>Post Spacing (In.):</b>	75.3

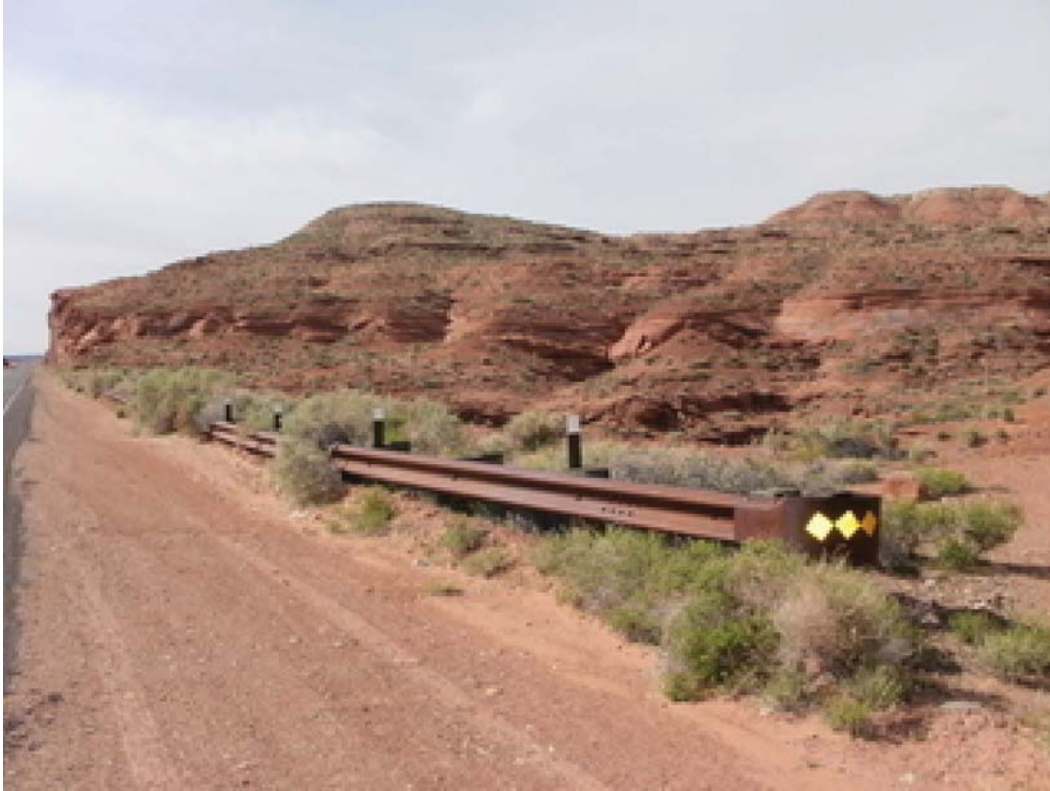
GLCA\_0001\_2.769\_L\_1.JPG

<b>Barrier ID:</b>	GLCA-0001-2.769-L				
<b>Route Name:</b>	LAKESHORE DRIVE				
<b>Inspection Date:</b>	04/22/2010	<b>Barrier Rating:</b>	51.20		
<b>Barrier Description</b>					
<b>Type:</b>	W-BEAM STRONG POST	<b>Barrier Function:</b>	TRAFFIC		
<b>Barrier Material:</b>	WEATHERING STEEL/CORTEN	<b>Post Material:</b>	WOOD		
<b>Blockout Type:</b>	WOOD	<b>Length (ft.):</b>	402		
<b>Speed Limit (MPH):</b>	55	<b>Placement with Respect to Road:</b>	TANGENT		
<b>Hazard Behind Barrier:</b>	HIGH				
<b>Barrier Crashworthiness</b>					
<b>Appropriate Test Level:</b>	TL-3	<b>Barrier Test Level:</b>	TL-3	<b>Is Barrier Crashworthy?:</b>	YES
<b>Beg. End Trtmt Type:</b>	W-BEAM BCT	<b>Is Beg. End Trtmt Crashworthy?:</b>	NO	<b>Approach Transition Type:</b>	NONE
<b>Ending End Trtmt Type:</b>	W-BEAM TRAILING END	<b>Ending End Trtmt Crashworthy?:</b>	YES		
<b>Average Measurements</b>					
<b>Design Height (In.):</b>	27	<b>Width (In.):</b>	0.0	<b>Post Spacing (In.):</b>	76.0

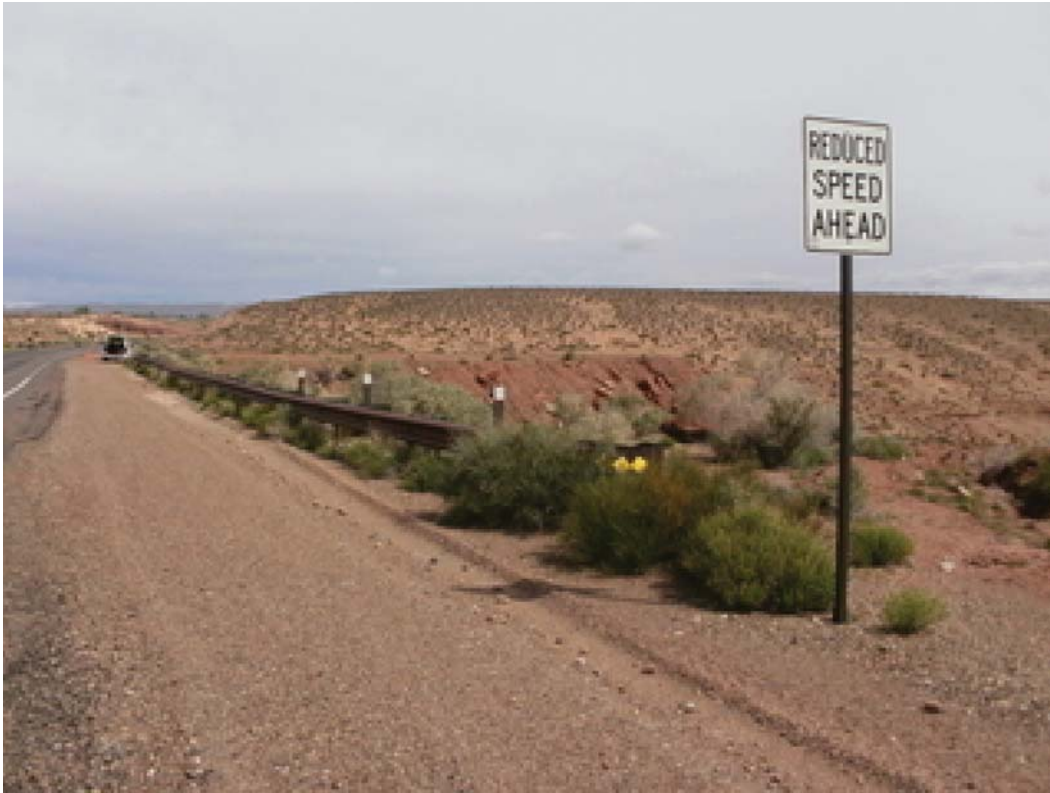
GLCA\_0001\_3.034\_R\_1.JPG

<b>Barrier ID:</b>	GLCA-0001-3.034-R				
<b>Route Name:</b>	LAKESHORE DRIVE				
<b>Inspection Date:</b>	04/23/2010	<b>Barrier Rating:</b>	28.70		
<b>Barrier Description</b>					
<b>Type:</b>	W-BEAM STRONG POST	<b>Barrier Function:</b>	TRAFFIC		
<b>Barrier Material:</b>	WEATHERING STEEL/CORTEN	<b>Post Material:</b>	WOOD		
<b>Blockout Type:</b>	WOOD	<b>Length (ft.):</b>	215		
<b>Speed Limit (MPH):</b>	55	<b>Placement with Respect to Road:</b>	TANGENT		
<b>Hazard Behind Barrier:</b>	EXTREME				
<b>Barrier Crashworthiness</b>					
<b>Appropriate Test Level:</b>	TL-3	<b>Barrier Test Level:</b>	TL-3	<b>Is Barrier Crashworthy?:</b>	YES
<b>Beg. End Trtmt Type:</b>	W-BEAM BCT	<b>Is Beg. End Trtmt Crashworthy?:</b>	NO	<b>Approach Transition Type:</b>	NONE
<b>Ending End Trtmt Type:</b>	W-BEAM TRAILING END	<b>Ending End Trtmt Crashworthy?:</b>	YES		
<b>Average Measurements</b>					
<b>Design Height (In.):</b>	27	<b>Width (In.):</b>	0.0	<b>Post Spacing (In.):</b>	75.0

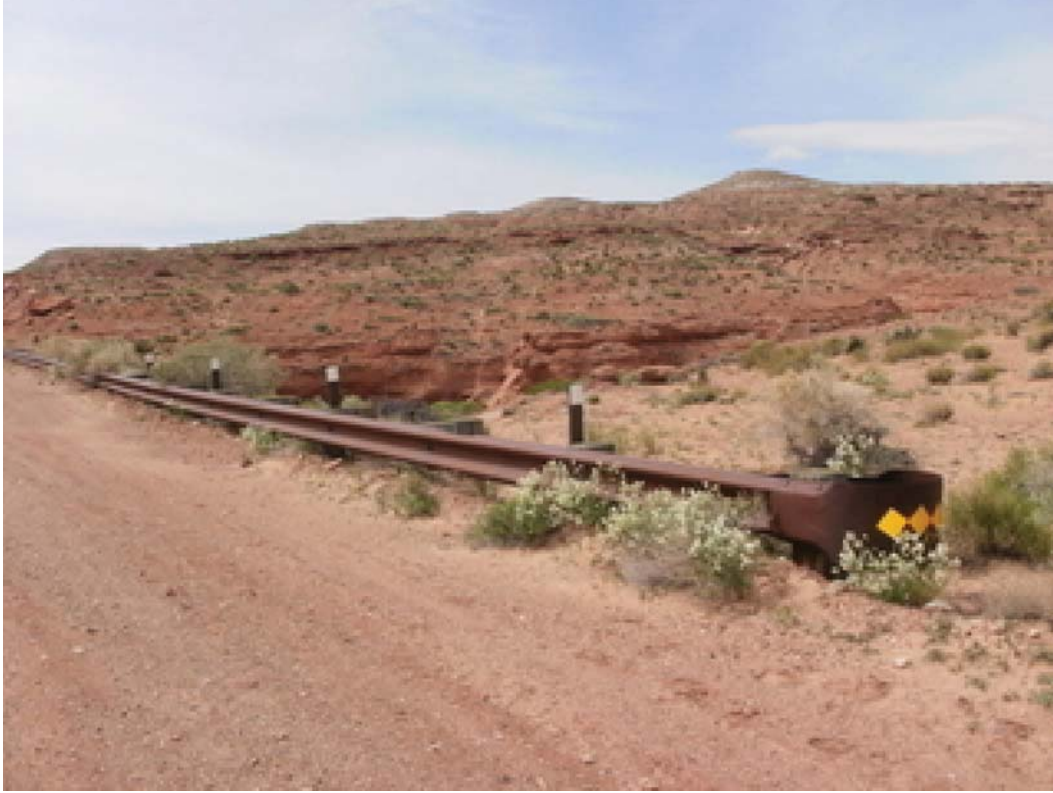
GLCA\_0001\_3.045\_L\_1.JPG

<b>Barrier ID:</b>	GLCA-0001-3.045-L				
<b>Route Name:</b>	LAKESHORE DRIVE				
<b>Inspection Date:</b>	04/23/2010	<b>Barrier Rating:</b>	55.50		
<b>Barrier Description</b>					
<b>Type:</b>	W-BEAM STRONG POST	<b>Barrier Function:</b>	TRAFFIC		
<b>Barrier Material:</b>	WEATHERING STEEL/CORTEN	<b>Post Material:</b>	WOOD		
<b>Blockout Type:</b>	WOOD	<b>Length (ft.):</b>	253		
<b>Speed Limit (MPH):</b>	55	<b>Placement with Respect to Road:</b>	TANGENT		
<b>Hazard Behind Barrier:</b>	HIGH				
<b>Barrier Crashworthiness</b>					
<b>Appropriate Test Level:</b>	TL-3	<b>Barrier Test Level:</b>	TL-3	<b>Is Barrier Crashworthy?:</b>	YES
<b>Beg. End Trtmt Type:</b>	W-BEAM BCT	<b>Is Beg. End Trtmt Crashworthy?:</b>	NO	<b>Approach Transition Type:</b>	NONE
<b>Ending End Trtmt Type:</b>	W-BEAM TRAILING END	<b>Ending End Trtmt Crashworthy?:</b>	YES		
<b>Average Measurements</b>					
<b>Design Height (In.):</b>	27	<b>Width (In.):</b>	0.0	<b>Post Spacing (In.):</b>	74.0

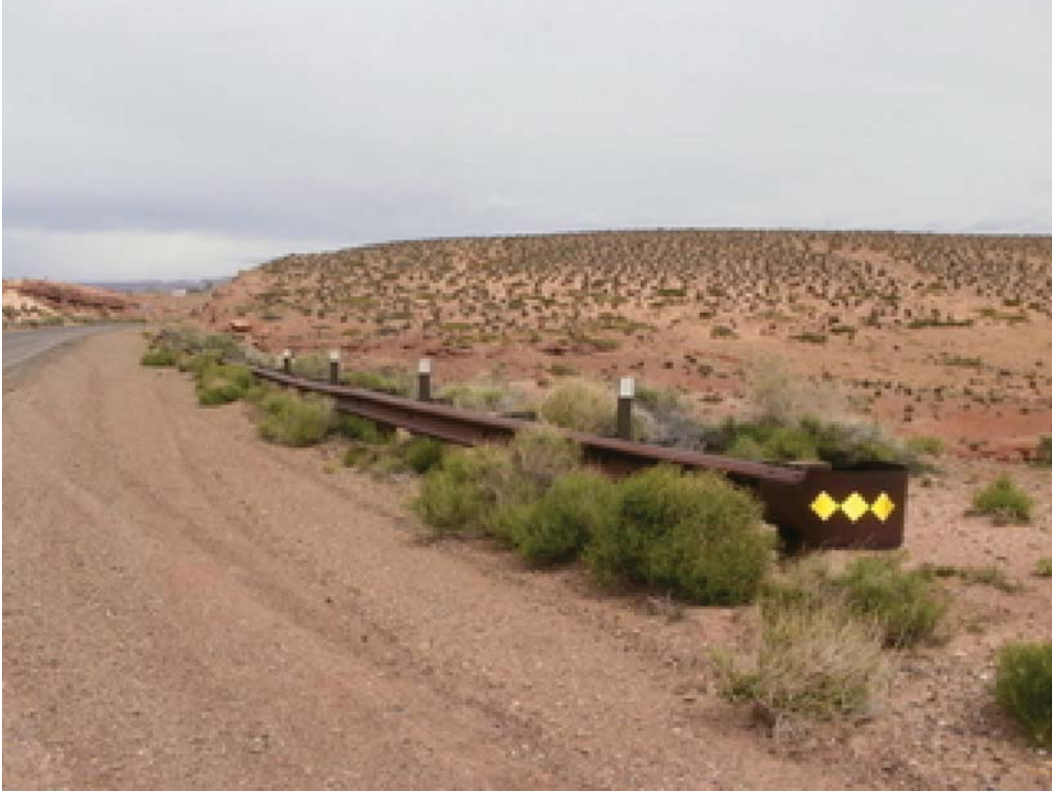
GLCA\_0001\_3.109\_R\_1.JPG

<b>Barrier ID:</b>	GLCA-0001-3.109-R				
<b>Route Name:</b>	LAKESHORE DRIVE				
<b>Inspection Date:</b>	04/23/2010	<b>Barrier Rating:</b>	33.00		
<b>Barrier Description</b>					
<b>Type:</b>	W-BEAM STRONG POST	<b>Barrier Function:</b>	TRAFFIC		
<b>Barrier Material:</b>	WEATHERING STEEL/CORTEN	<b>Post Material:</b>	WOOD		
<b>Blockout Type:</b>	WOOD	<b>Length (ft.):</b>	240		
<b>Speed Limit (MPH):</b>	55	<b>Placement with Respect to Road:</b>	TANGENT		
<b>Hazard Behind Barrier:</b>	EXTREME				
<b>Barrier Crashworthiness</b>					
<b>Appropriate Test Level:</b>	TL-3	<b>Barrier Test Level:</b>	TL-3	<b>Is Barrier Crashworthy?:</b>	YES
<b>Beg. End Trtmt Type:</b>	W-BEAM BCT	<b>Is Beg. End Trtmt Crashworthy?:</b>	NO	<b>Approach Transition Type:</b>	NONE
<b>Ending End Trtmt Type:</b>	W-BEAM TRAILING END	<b>Ending End Trtmt Crashworthy?:</b>	YES		
<b>Average Measurements</b>					
<b>Design Height (In.):</b>	27	<b>Width (In.):</b>	0.0	<b>Post Spacing (In.):</b>	75.6

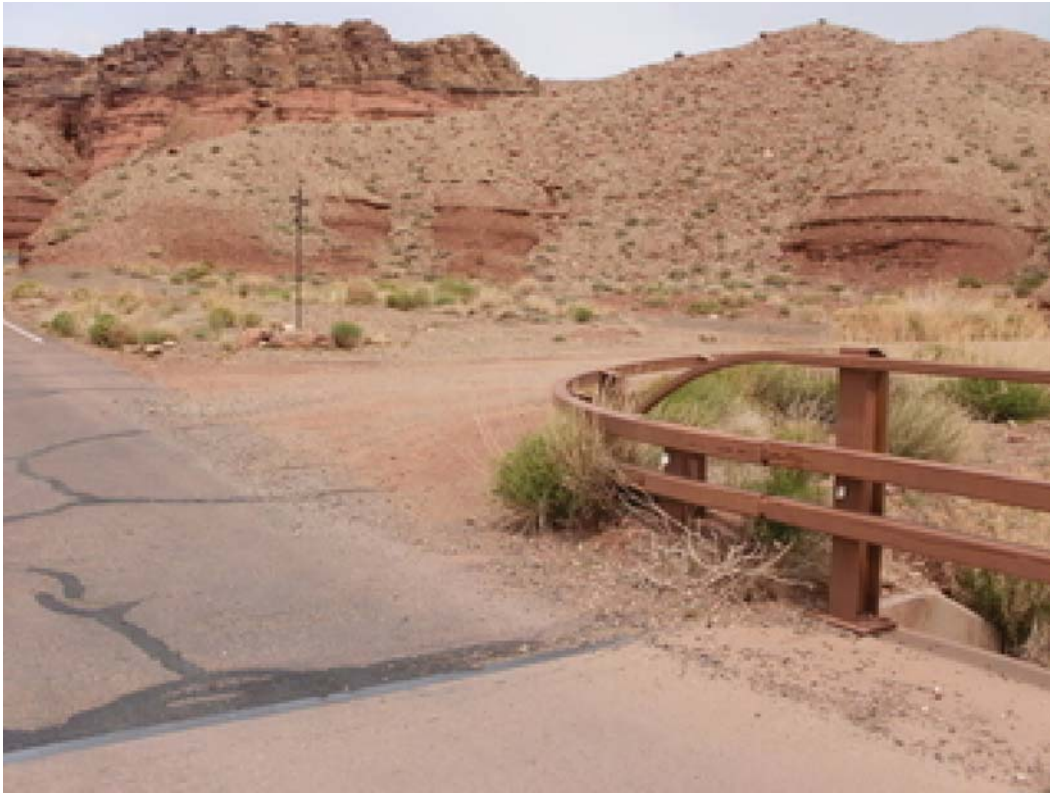
GLCA\_0005\_5.147\_L\_1.JPG

<b>Barrier ID:</b>	GLCA-0005-5.147-L				
<b>Route Name:</b>	LEES FERRY ACCESS ROAD				
<b>Inspection Date:</b>	04/23/2010	<b>Barrier Rating:</b>	14.10		
<b>Barrier Description</b>					
<b>Type:</b>	BOX BEAM	<b>Barrier Function:</b>	TRAFFIC		
<b>Barrier Material:</b>	OTHER: STEEL	<b>Post Material:</b>	OTHER: STEEL		
<b>Blockout Type:</b>	N/A	<b>Length (ft.):</b>	34		
<b>Speed Limit (MPH):</b>	25	<b>Placement with Respect to Road:</b>	INSIDE OF CURVE		
<b>Hazard Behind Barrier:</b>	HIGH				
<b>Barrier Crashworthiness</b>					
<b>Appropriate Test Level:</b>	TL-1	<b>Barrier Test Level:</b>	TL-3	<b>Is Barrier Crashworthy?:</b>	YES
<b>Beg. End Trtmt Type:</b>	NONE	<b>Is Beg. End Trtmt Crashworthy?:</b>	N/A	<b>Approach Transition Type:</b>	NONE
<b>Ending End Trtmt Type:</b>	NONE	<b>Ending End Trtmt Crashworthy?:</b>	N/A		
<b>Average Measurements</b>					
<b>Design Height (In.):</b>	27	<b>Width (In.):</b>	4.0	<b>Post Spacing (In.):</b>	74.0
