GOGA GIP Report

NPS Guardwall/Rail Inventory Program Golden Gate National Recreation Area

**Federal Highway Administration
Eastern Federal Lands Highway Division
Road Inventory Program (RIP)**

**Data Collection Date: November 2009
Report Date: November 2015**

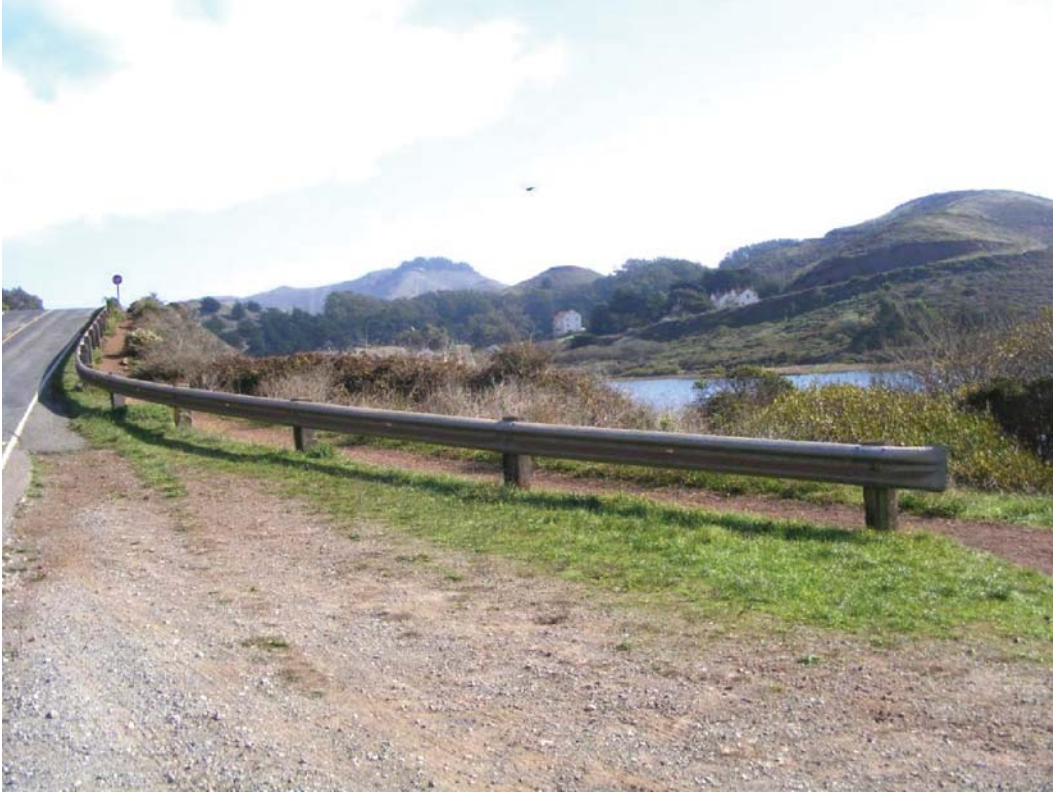
GOGA_0104_0.000_L_1.jpg

Barrier ID:	GOGA-0104-0.000-L				
Route Name:	MITCHELL ROAD				
Inspection Date:	04/11/2009	Barrier Rating:	18.00		
Barrier Description					
Type:	W-BEAM WEAK POST	Barrier Function:	TRAFFIC		
Barrier Material:	GALVANIZED STEEL	Post Material:	WOOD		
Blockout Type:	N/A	Length (ft.):	303		
Speed Limit (MPH):	25	Placement with Respect to Road:	TANGENT		
Hazard Behind Barrier:	MEDIUM				
Barrier Crashworthiness					
Appropriate Test Level:	TL-1	Barrier Test Level:	TL-2	Is Barrier Crashworthy?:	YES
Beg. End Trtmt Type:	NONE	Is Beg. End Trtmt Crashworthy?:	N/A	Approach Transition Type:	NONE
Ending End Trtmt Type:	NONE	Ending End Trtmt Crashworthy?:	N/A		
Average Measurements					
Design Height (In.):	27	Width (In.):	0.0	Post Spacing (In.):	150.0
Height (In.):	26.2	Lateral Offset (In.):	30.2	Road Grade (%):	9.40
Physical Condition					
Barrier	Alignment and Height:	Alignment acceptable. 216-ft was within 1-in of the 27-in design height and 87-ft was between 1 and 3-in below the design height.

Breaking and Cracking:	No tears / no major cracks.			
	Missing Elements:	No missing elements.			
	Corrosion and Weathering:	Minor weathering. Some rusting occurring along the rail.			
End Treatments	Alignment and Height:				
	Breaking and Cracking:				
	Missing Elements:				
	Corrosion and Weathering:

Repair Action:	REPAIR	FMSS Work Type:	DEFERRED MAINTENANCE	Repair Cost:	\$2580
Brief Workorder:	Raise 87 L.F. of W-Beam to 27-in design height.				
Workorder:	Adjust Guardrail at \$10- per -Lin. Ft. for 87 LF = \$870. Raise 87-ft of barrier up to 27-in design height. Low Speed Traffic Control at \$1475- per -Day for 1 Day(s) = \$1475.

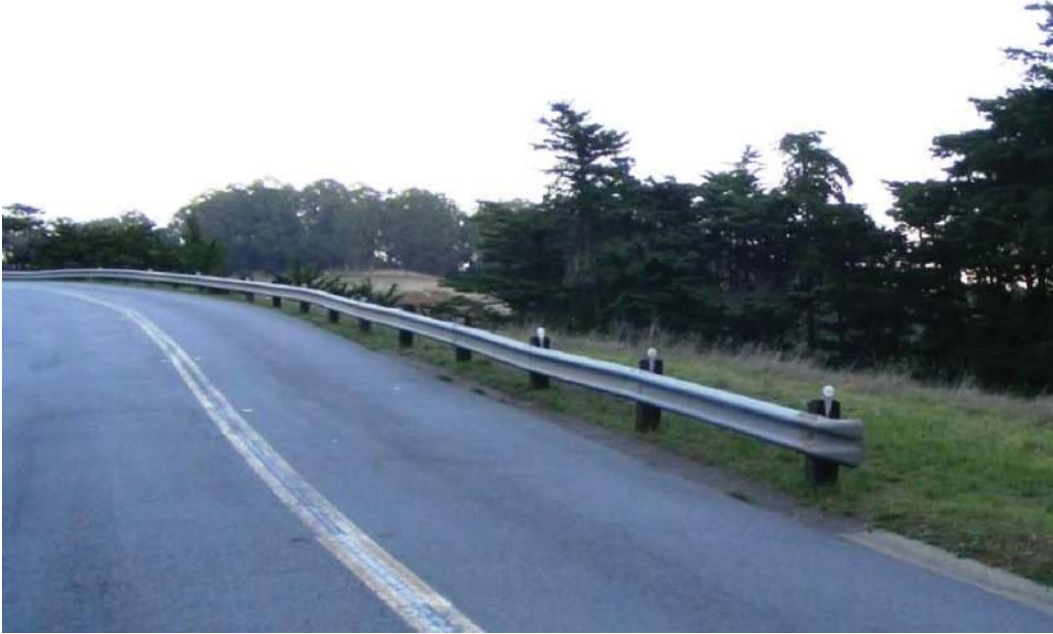
GOGA_0105_0.172_R_1.jpg

Barrier ID:	GOGA-0105-0.172-R				
Route Name:	BUNKER ROAD				
Inspection Date:	03/11/2009	Barrier Rating:	73.00		
Barrier Description					
Type:	W-BEAM WEAK POST	Barrier Function:	TRAFFIC		
Barrier Material:	GALVANIZED STEEL	Post Material:	WOOD		
Blockout Type:	N/A	Length (ft.):	1247		
Speed Limit (MPH):	25	Placement with Respect to Road:	BOTH INSIDE AND OUTSIDE		
Hazard Behind Barrier:	MEDIUM				
Barrier Crashworthiness					
Appropriate Test Level:	TL-1	Barrier Test Level:	TL-2	Is Barrier Crashworthy?:	YES
Beg. End Trtmt Type:	NONE	Is Beg. End Trtmt Crashworthy?:	N/A	Approach Transition Type:	NONE
Ending End Trtmt Type:	NONE	Ending End Trtmt Crashworthy?:	N/A		
Average Measurements					
Design Height (In.):	27	Width (In.):	0.0	Post Spacing (In.):	150.0
Height (In.):	19.7	Lateral Offset (In.):	14.3	Road Grade (%):	6.70
Physical Condition					
Barrier	Alignment and Height:	Alignment has deflection greater than 12 in in several locations by impact. Entire barrier is between 6-9in below the 27-in design height.

Breaking and Cracking:	11 bent/impacted rails and 4 cracked posts.			
	Missing Elements:	No missing elements (all bolts and posts intact).			
	Corrosion and Weathering:	Minimal corrosion and weathering. No erosion along back of barrier.			
End Treatments	Alignment and Height:				
	Breaking and Cracking:				
	Missing Elements:				
	Corrosion and Weathering:

Repair Action:	REPAIR	FMSS Work Type:	DEFERRED MAINTENANCE	Repair Cost:	\$86020
Brief Workorder:	Raise 1247 L.F. of W-Beam to 27-in design height; replace 4 damaged posts and replace 264 L.F. of rail.				
Workorder:	Adjust Guardrail at \$10- per -Lin. Ft. for 1247 LF = \$62350. Raise 1247-ft of barrier up to 27-in design height. Replace post at \$100- per -Each for 4 Post(s) = \$400. Replace rail at \$25- per -Lin. Ft. for 264 LF = \$6600. Low Speed Traffic Control at \$1475- per -Day for 6 Day(s) = \$8850. 5 days to raise rail 1 day to replace rail.

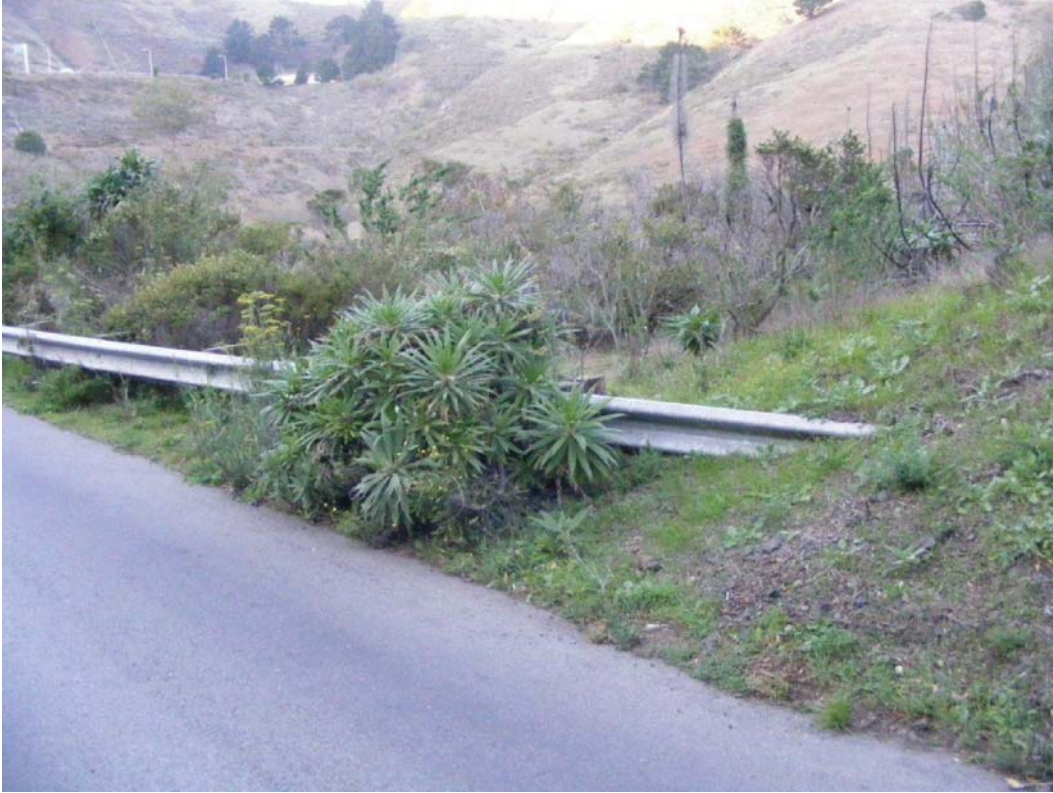
GOGA_0105_0.438_R_1.jpg

Barrier ID:	GOGA-0105-0.438-R				
Route Name:	BUNKER ROAD				
Inspection Date:	03/11/2009	Barrier Rating:	40.00		
Barrier Description					
Type:	W-BEAM STRONG POST	Barrier Function:	TRAFFIC		
Barrier Material:	GALVANIZED STEEL	Post Material:	WOOD		
Blockout Type:	WOOD	Length (ft.):	655		
Speed Limit (MPH):	25	Placement with Respect to Road:	OUTSIDE OF CURVE		
Hazard Behind Barrier:	HIGH				
Barrier Crashworthiness					
Appropriate Test Level:	TL-1	Barrier Test Level:	TL-3	Is Barrier Crashworthy?:	YES
Beg. End Trtmt Type:	W-BEAM BURIED END	Is Beg. End Trtmt Crashworthy?:	YES	Approach Transition Type:	NONE
Ending End Trtmt Type:	W-BEAM TRAILING END	Ending End Trtmt Crashworthy?:	YES		
Average Measurements					
Design Height (In.):	27	Width (In.):	0.0	Post Spacing (In.):	75.1
Height (In.):	25.0	Lateral Offset (In.):	10.1	Road Grade (%):	6.10
Physical Condition					
Barrier	Alignment and Height:	Alignment has less than 6 in of deflection. 655-ft was between 1 and 3-in below the 27-in design height.

Breaking and Cracking:	Minor cracking of posts and blocks no tears or major bends			
	Missing Elements:	No missing elements.			
	Corrosion and Weathering:	No major weathering.			
End Treatments	Alignment and Height:	Alignment acceptable. Height within 1-in of 27-in design height.			
	Breaking and Cracking:	No breaking or cracking observed.			
	Missing Elements:	No missing elements observed.			
	Corrosion and Weathering:	No corrosion or weathering observed.

Repair Action:	REPAIR	FMSS Work Type:	DEFERRED MAINTENANCE	Repair Cost:	\$12073
Brief Workorder:	Raise 655 L.F. of W-Beam to 27-in design height.				
Workorder:	Adjust Guardrail at \$10- per -Lin. Ft. for 655 LF = \$6550. Raise 655-ft of barrier up to 27-in design height. Low Speed Traffic Control at \$1475- per -Day for 3 Day(s) = \$4425.

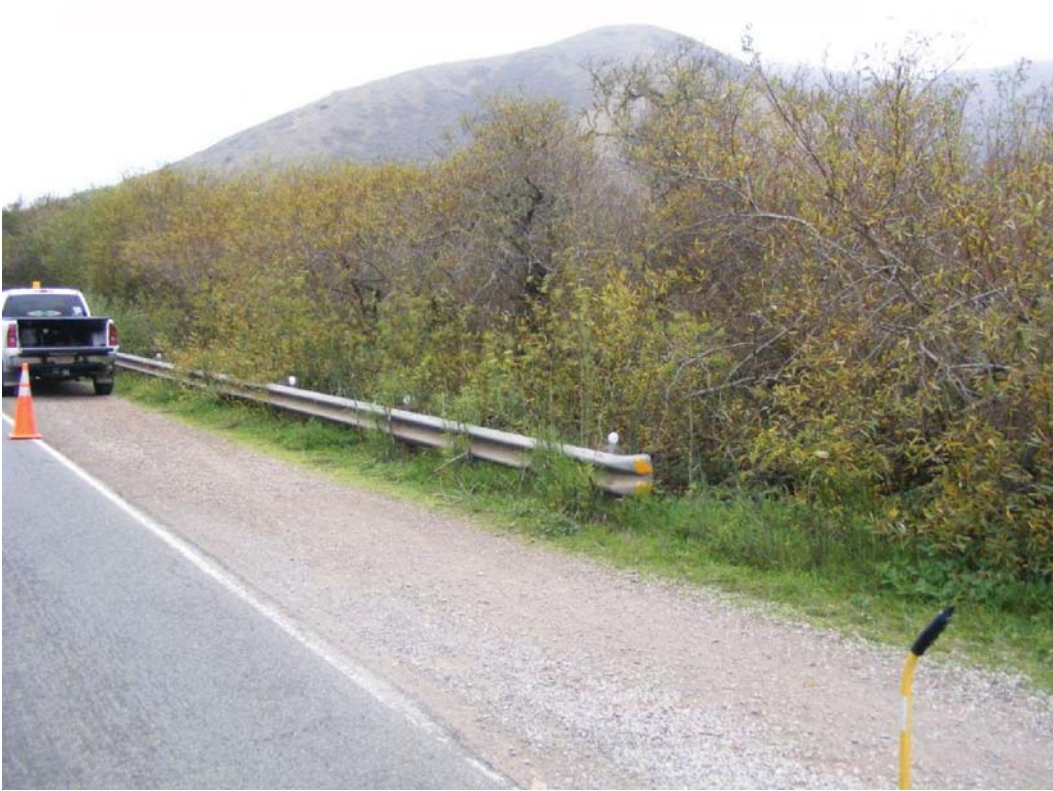
GOGA_0105_2.845_R_1.jpg

Barrier ID:	GOGA-0105-2.845-R				
Route Name:	BUNKER ROAD				
Inspection Date:	04/11/2009	Barrier Rating:	18.50		
Barrier Description					
Type:	W-BEAM WEAK POST	Barrier Function:	TRAFFIC		
Barrier Material:	GALVANIZED STEEL	Post Material:	WOOD		
Blockout Type:	N/A	Length (ft.):	140		
Speed Limit (MPH):	25	Placement with Respect to Road:	TANGENT		
Hazard Behind Barrier:	LOW				
Barrier Crashworthiness					
Appropriate Test Level:	TL-1	Barrier Test Level:	TL-2	Is Barrier Crashworthy?:	YES
Beg. End Trtmt Type:	NONE	Is Beg. End Trtmt Crashworthy?:	N/A	Approach Transition Type:	NONE
Ending End Trtmt Type:	NONE	Ending End Trtmt Crashworthy?:	N/A		
Average Measurements					
Design Height (In.):	27	Width (In.):	0.0	Post Spacing (In.):	150.0
Height (In.):	24.0	Lateral Offset (In.):	123.3	Road Grade (%):	0.30
Physical Condition					
Barrier	Alignment and Height:	Alignment acceptable. 140-ft was between 1 and 3-in below the 27-in design height.

Breaking and Cracking:	No tears no major cracks			
	Missing Elements:	No missing elements.			
	Corrosion and Weathering:	Minor weathering			
End Treatments	Alignment and Height:				
	Breaking and Cracking:				
	Missing Elements:				
	Corrosion and Weathering:

Repair Action:	REPAIR	FMSS Work Type:	DEFERRED MAINTENANCE	Repair Cost:	\$3163
Brief Workorder:	Raise 140 L.F. of W-Beam to 27-in design height.				
Workorder:	Adjust Guardrail at \$10- per -Lin. Ft. for 140 LF = \$1400. Raise 140-ft of barrier up to 27-in design height. Low Speed Traffic Control at \$1475- per -Day for 1 Day(s) = \$1475.

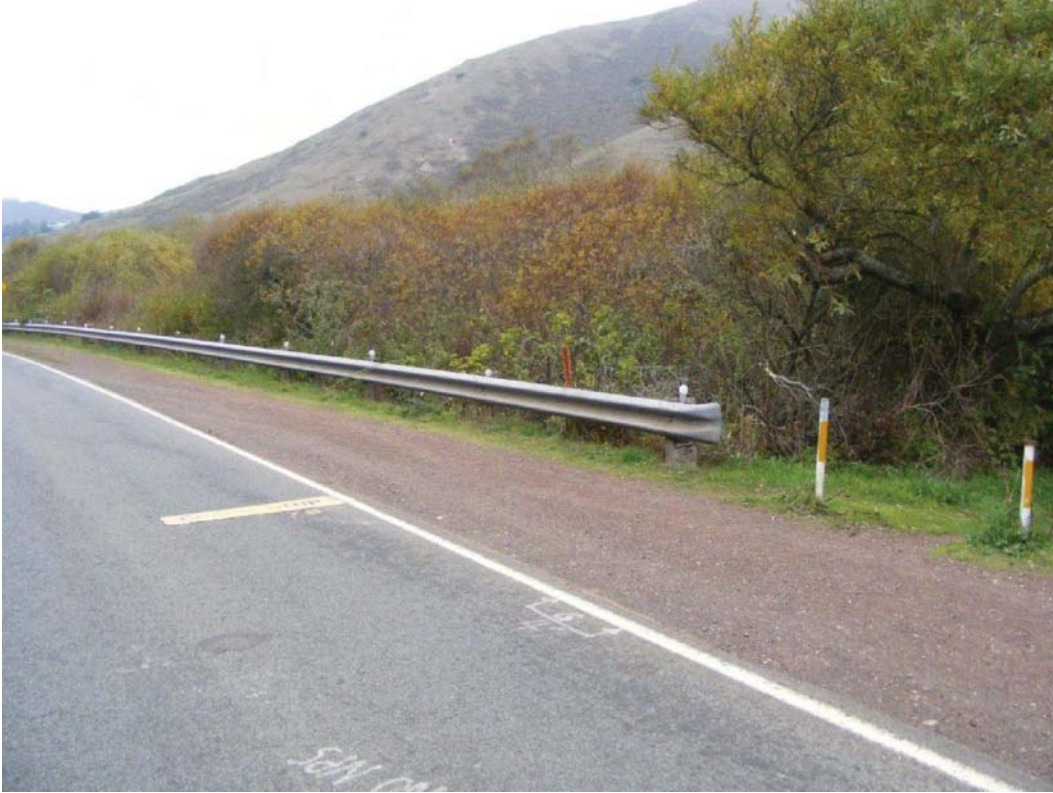
GOGA_0105_2.871_R_1.jpg

Barrier ID:	GOGA-0105-2.871-R				
Route Name:	BUNKER ROAD				
Inspection Date:	04/11/2009	Barrier Rating:	37.00		
Barrier Description					
Type:	W-BEAM WEAK POST	Barrier Function:	TRAFFIC		
Barrier Material:	GALVANIZED STEEL	Post Material:	WOOD		
Blockout Type:	N/A	Length (ft.):	860		
Speed Limit (MPH):	25	Placement with Respect to Road:	OUTSIDE OF CURVE		
Hazard Behind Barrier:	LOW				
Barrier Crashworthiness					
Appropriate Test Level:	TL-1	Barrier Test Level:	TL-2	Is Barrier Crashworthy?:	YES
Beg. End Trtmt Type:	NONE	Is Beg. End Trtmt Crashworthy?:	N/A	Approach Transition Type:	NONE
Ending End Trtmt Type:	NONE	Ending End Trtmt Crashworthy?:	N/A		
Average Measurements					
Design Height (In.):	27	Width (In.):	0.0	Post Spacing (In.):	150.1
Height (In.):	24.6	Lateral Offset (In.):	98.4	Road Grade (%):	0.40
Physical Condition					
Barrier	Alignment and Height:	Alignment acceptable. 70-ft was within 1-in of the 27-in design height 715-ft was between 1 and 3-in below and 75-ft was more than 3-in below the design height.

Breaking and Cracking:	No tears no major cracks			
	Missing Elements:	No missing elements.			
	Corrosion and Weathering:	No corrosion or weathering observed.			
End Treatments	Alignment and Height:				
	Breaking and Cracking:				
	Missing Elements:				
	Corrosion and Weathering:

Repair Action:	REPAIR	FMSS Work Type:	DEFERRED MAINTENANCE	Repair Cost:	\$15180
Brief Workorder:	Raise 790-ft of barrier up to 27-in design height.				
Workorder:	Adjust Guardrail at \$10- per -Lin. Ft. for 790 LF = \$7900. Raise 790-ft of barrier up to 27-in design height. Low Speed Traffic Control at \$1475- per -Day for 4 Day(s) = \$5900.

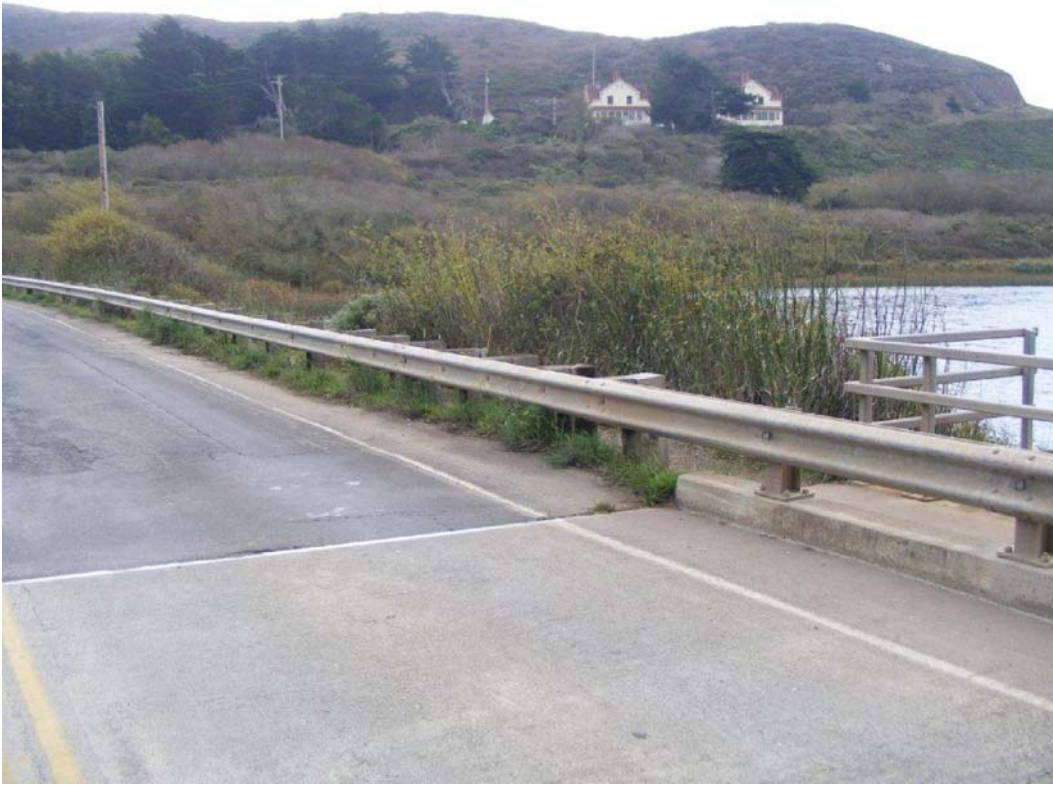
GOGA_0105_3.219_L_1.jpg

Barrier ID:	GOGA-0105-3.219-L				
Route Name:	BUNKER ROAD				
Inspection Date:	04/11/2009	Barrier Rating:	18.00		
Barrier Description					
Type:	W-BEAM STRONG POST	Barrier Function:	TRAFFIC		
Barrier Material:	GALVANIZED STEEL	Post Material:	WOOD		
Blockout Type:	WOOD	Length (ft.):	318		
Speed Limit (MPH):	25	Placement with Respect to Road:	TANGENT		
Hazard Behind Barrier:	MEDIUM				
Barrier Crashworthiness					
Appropriate Test Level:	TL-1	Barrier Test Level:	TL-3	Is Barrier Crashworthy?:	YES
Beg. End Trtmt Type:	NONE	Is Beg. End Trtmt Crashworthy?:	N/A	Approach Transition Type:	BRIDGE RAIL W-BEAM
Ending End Trtmt Type:	NONE	Ending End Trtmt Crashworthy?:	N/A		
Average Measurements					
Design Height (In.):	27	Width (In.):	0.0	Post Spacing (In.):	74.5
Height (In.):	29.2	Lateral Offset (In.):	38.0	Road Grade (%):	1.10
Physical Condition					
Barrier	Alignment and Height:	Alignment acceptable. Height was 2-3in. above the 27-in design height.

Breaking and Cracking:	No major cracks/ no tears			
	Missing Elements:	No missing elements.			
	Corrosion and Weathering:	No corrosion or weathering observed.			
End Treatments	Alignment and Height:				
	Breaking and Cracking:				
	Missing Elements:				
	Corrosion and Weathering:

Repair Action:	NO ACTION	FMSS Work Type:	N/A	Repair Cost:	\$0
Brief Workorder:	N/A				
Workorder:

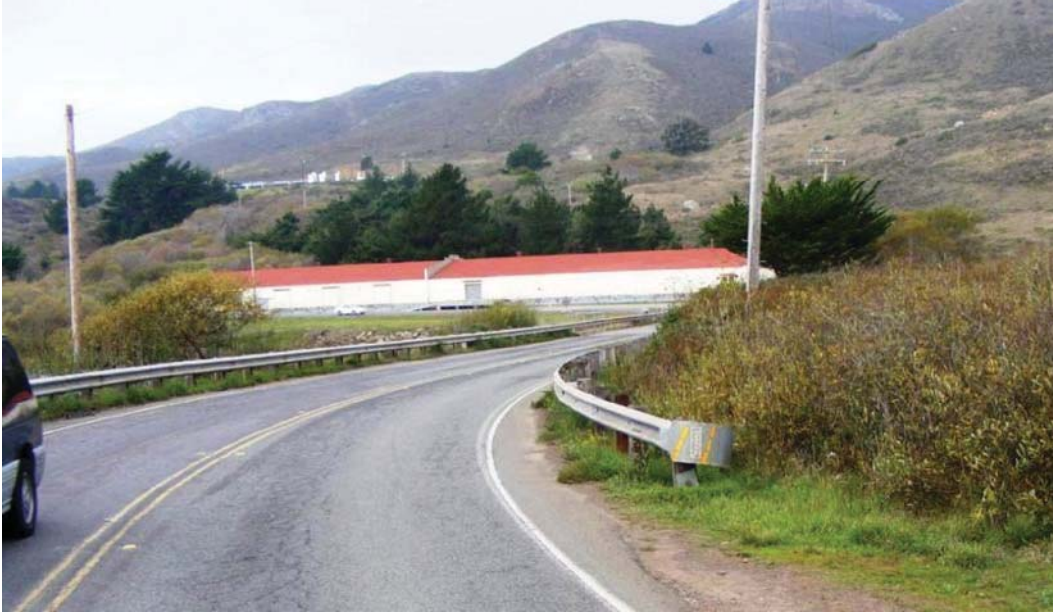
GOGA_0105_3.240_R_1.jpg

Barrier ID:	GOGA-0105-3.240-R				
Route Name:	BUNKER ROAD				
Inspection Date:	04/11/2009	Barrier Rating:	15.50		
Barrier Description					
Type:	W-BEAM STRONG POST	Barrier Function:	TRAFFIC		
Barrier Material:	GALVANIZED STEEL	Post Material:	WOOD		
Blockout Type:	WOOD	Length (ft.):	206		
Speed Limit (MPH):	25	Placement with Respect to Road:	INSIDE OF CURVE		
Hazard Behind Barrier:	LOW				
Barrier Crashworthiness					
Appropriate Test Level:	TL-1	Barrier Test Level:	TL-3	Is Barrier Crashworthy?:	YES
Beg. End Trtmt Type:	W-BEAM BCT	Is Beg. End Trtmt Crashworthy?:	NO	Approach Transition Type:	BRIDGE RAIL W-BEAM
Ending End Trtmt Type:	NONE	Ending End Trtmt Crashworthy?:	N/A		
Average Measurements					
Design Height (In.):	27	Width (In.):	0.0	Post Spacing (In.):	75.3
Height (In.):	32.0	Lateral Offset (In.):	31.2	Road Grade (%):	0.50
Physical Condition					
Barrier	Alignment and Height:	Alignment acceptable. Height was 0-5in. above the 27-in design height.

Breaking and Cracking:	No major cracks or tears			
	Missing Elements:	No missing elements.			
	Corrosion and Weathering:	No corrosion or weathering observed.			
End Treatments	Alignment and Height:	Alignment acceptable. Height within 1-in of 27-in design height.			
	Breaking and Cracking:	No major cracks or tears.			
	Missing Elements:	No missing elements.			
	Corrosion and Weathering:	No corrosion or weathering observed.

Barrier ID:	GOGA-0105-3.240-R				
Route Name:	BUNKER ROAD				
Inspection Date:	04/11/2009	Barrier Rating:		15.50	
Repair Recommendations					
Repair Action:	NO ACTION	FMSS Work Type:	N/A	Repair Cost:	\$0
Brief Workorder:	N/A				
Workorder:
