GIP Report

NPS Guardwall/Rail Inventory Program
Grand Canyon National Park

Federal Highway Administration
Eastern Federal Lands Highway Division
Road Inventory Program (RIP)

Data Collection Date: October 2010
Report Date: November 2015

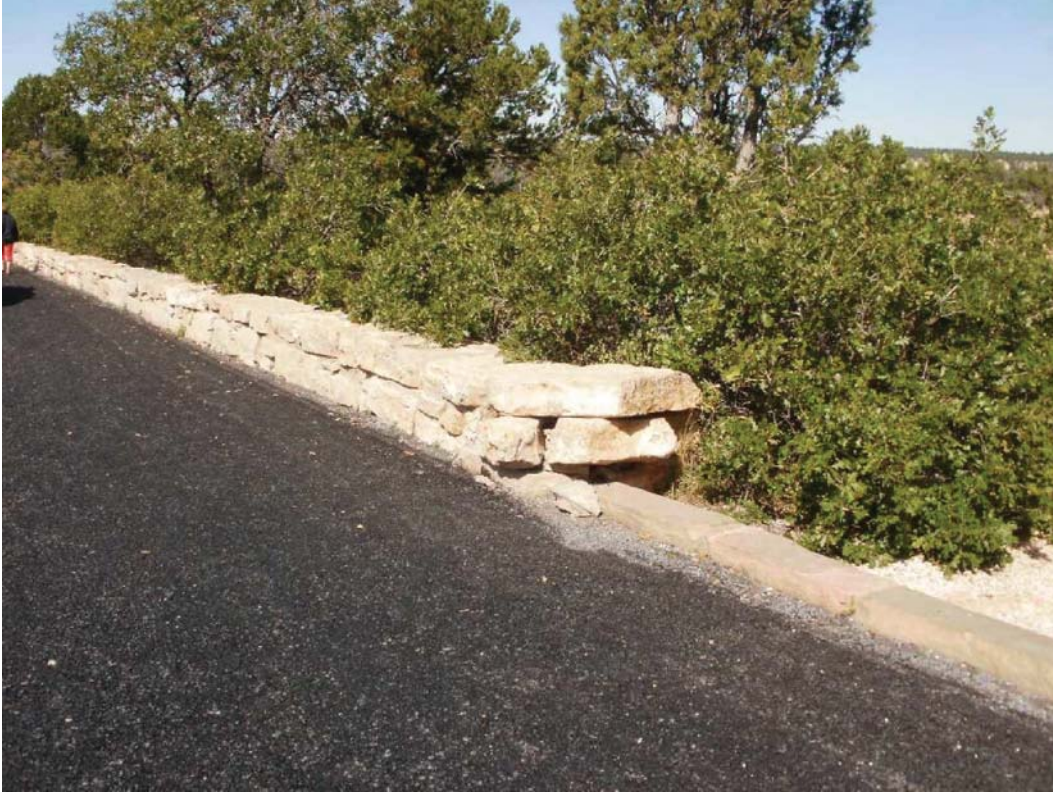
GRCA_0011_4.766_L_1.JPG

Barrier ID:	GRCA-0011-4.766-L				
Route Name:	DESERT VIEW DRIVE				
Inspection Date:	10/10/2010	Barrier Rating:	58.70		
Barrier Description					
Type:	STONE MASONRY WITHOUT CONCRETE CORE WALL	Barrier Function:	TRAFFIC		
Barrier Material:	STONE	Post Material:	N/A		
Blockout Type:	N/A	Length (ft.):	172		
Speed Limit (MPH):	45	Placement with Respect to Road:	TANGENT		
Hazard Behind Barrier:	EXTREME				
Barrier Crashworthiness					
Appropriate Test Level:	TL-2	Barrier Test Level:	NCW	Is Barrier Crashworthy?:	NO
Beg. End Trtmt Type:	NONE	Is Beg. End Trtmt Crashworthy?:	N/A	Approach Transition Type:	NONE
Ending End Trtmt Type:	NONE	Ending End Trtmt Crashworthy?:	N/A		
Average Measurements					
Design Height (In.):	24	Width (In.):	26.7	Post Spacing (In.):	0.0
Height (In.):	19.2	Lateral Offset (In.):	0.0	Road Grade (%):	6.50
Physical Condition					
Barrier	Alignment and Height:	No deviation in barrier alignment was observed. Barrier was 4 to 6 in below 24 in design height for entire length of barrier.

Breaking and Cracking:	4 linear ft of barrier was destroyed by impact at beginning end. Grout was gone but stones remain stacked in place at end of barrier.			
	Missing Elements:	No missing elements were observed.			
	Corrosion and Weathering:	No corrosion or weathering was observed.			
End Treatments	Alignment and Height:				
	Breaking and Cracking:				
	Missing Elements:				
	Corrosion and Weathering:

Repair Action:	REPAIR	FMSS Work Type:	DEFERRED MAINTENANCE	Repair Cost:	\$6848
Brief Workorder:	Remove and reset 4 linear feet of barrier to existing height.				
Workorder:	Remove & Reset Stone Masonry Guardwall at \$250- per -Cu. Ft. for 19 CF = \$4750. [(4ft)(2ft)(2.3ft)] = 18.4 CF. To repair damage at end of barrier. Low Speed Traffic Control at \$1475- per -Day for 1 Day(s) = \$1475.

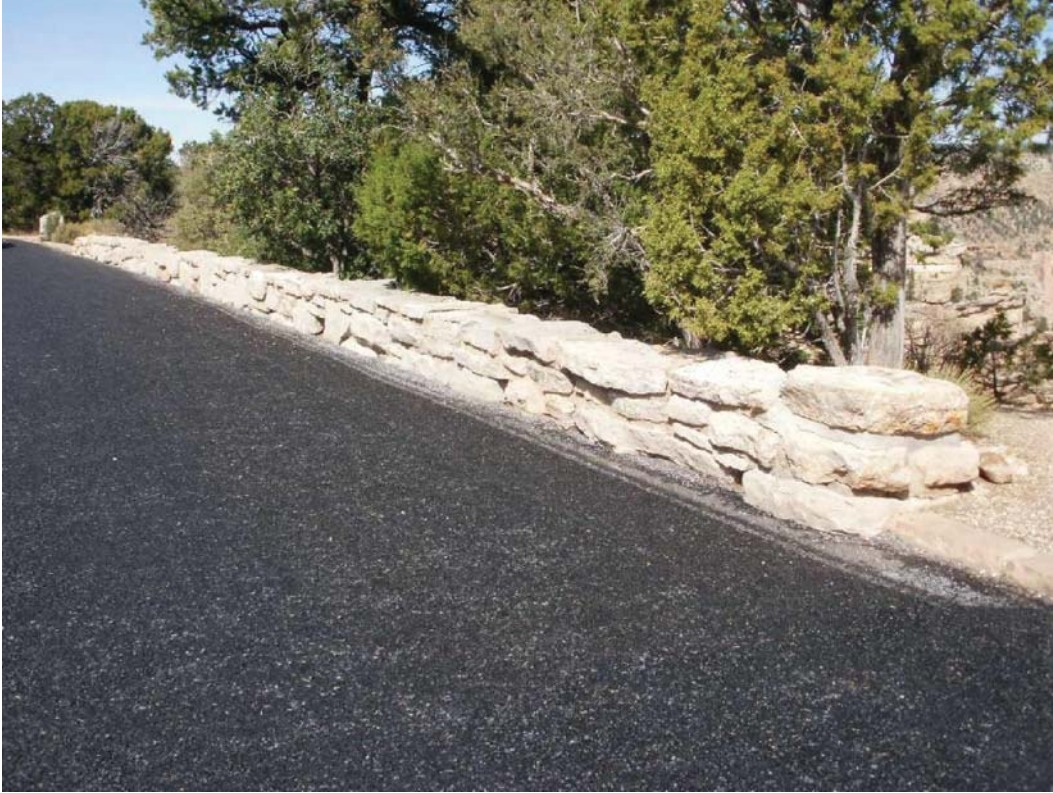
GRCA_0011_4.858_L_1.JPG

Barrier ID:	GRCA-0011-4.858-L				
Route Name:	DESERT VIEW DRIVE				
Inspection Date:	10/10/2010	Barrier Rating:	41.40		
Barrier Description					
Type:	STONE MASONRY WITHOUT CONCRETE CORE WALL	Barrier Function:	TRAFFIC		
Barrier Material:	STONE	Post Material:	N/A		
Blockout Type:	N/A	Length (ft.):	102		
Speed Limit (MPH):	45	Placement with Respect to Road:	OUTSIDE OF CURVE		
Hazard Behind Barrier:	EXTREME				
Barrier Crashworthiness					
Appropriate Test Level:	TL-2	Barrier Test Level:	NCW	Is Barrier Crashworthy?:	NO
Beg. End Trtmt Type:	NONE	Is Beg. End Trtmt Crashworthy?:	N/A	Approach Transition Type:	NONE
Ending End Trtmt Type:	NONE	Ending End Trtmt Crashworthy?:	N/A		
Average Measurements					
Design Height (In.):	24	Width (In.):	25.0	Post Spacing (In.):	0.0
Height (In.):	23.0	Lateral Offset (In.):	0.0	Road Grade (%):	2.50
Physical Condition					
Barrier	Alignment and Height:	No deviation was observed in barrier alignment. Height was at or below 24 in design height by 1 to 2 in for entire barrier length.

Breaking and Cracking:	2 ft of barrier had 1/2 in wide crack between rock and mortar.			
	Missing Elements:	No missing elements were observed.			
	Corrosion and Weathering:	No corrosion or weathering was observed.			
End Treatments	Alignment and Height:				
	Breaking and Cracking:				
	Missing Elements:				
	Corrosion and Weathering:

Repair Action:	REPAIR	FMSS Work Type:	DEFERRED MAINTENANCE	Repair Cost:	\$1931
Brief Workorder:	Repoint 2 square yards of mortar.				
Workorder:	Re-Point Masonry Barrier at \$140- per -Sq. Yd. for 2 SY = \$280. [(2ft)(2ft)(12ft)] /9 = 1.3 SY. Low Speed Traffic Control at \$1475- per -Day for 1 Day(s) = \$1475.

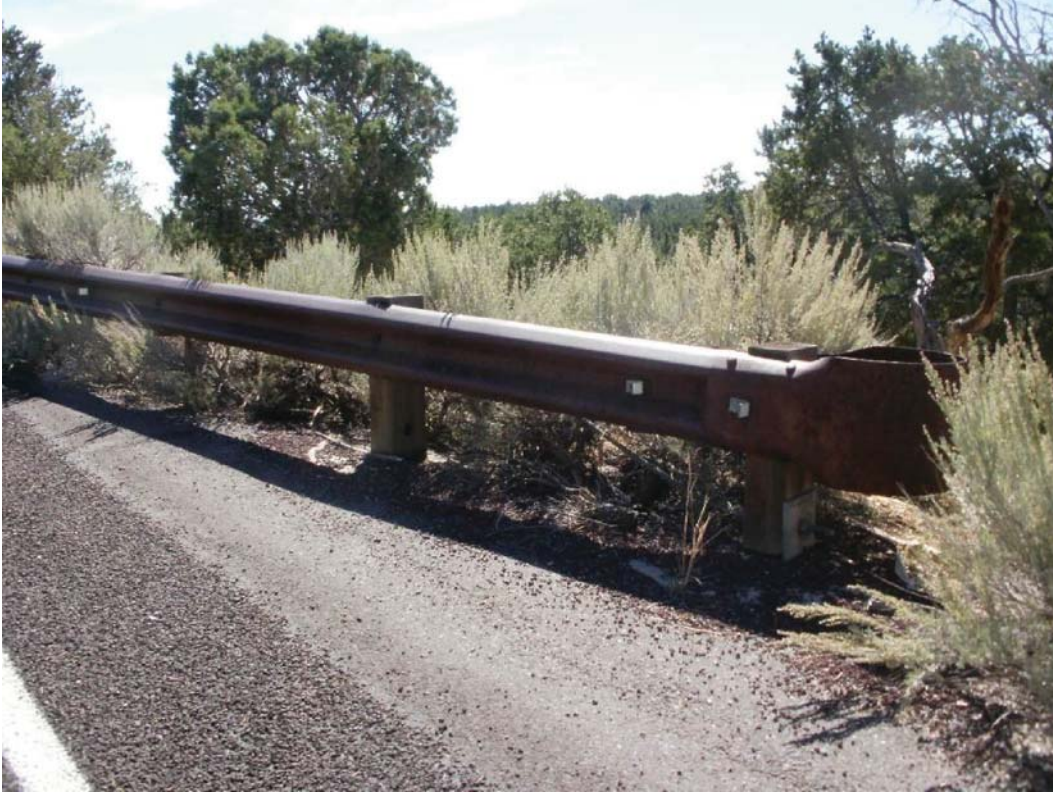
GRCA_0011_18.056_R_1.JPG

Barrier ID:	GRCA-0011-18.056-R				
Route Name:	DESERT VIEW DRIVE				
Inspection Date:	10/10/2010	Barrier Rating:	37.00		
Barrier Description					
Type:	W-BEAM STRONG POST	Barrier Function:	TRAFFIC		
Barrier Material:	WEATHERING STEEL/CORTEN	Post Material:	WOOD		
Blockout Type:	WOOD	Length (ft.):	490		
Speed Limit (MPH):	45	Placement with Respect to Road:	OUTSIDE OF CURVE		
Hazard Behind Barrier:	HIGH				
Barrier Crashworthiness					
Appropriate Test Level:	TL-2	Barrier Test Level:	TL-3	Is Barrier Crashworthy?:	YES
Beg. End Trtmt Type:	W-BEAM BCT	Is Beg. End Trtmt Crashworthy?:	NO	Approach Transition Type:	NONE
Ending End Trtmt Type:	W-BEAM BCT	Ending End Trtmt Crashworthy?:	NO		
Average Measurements					
Design Height (In.):	27	Width (In.):	0.0	Post Spacing (In.):	74.3
Height (In.):	28.7	Lateral Offset (In.):	28.2	Road Grade (%):	4.10
Physical Condition					
Barrier	Alignment and Height:	Two 10 ft sections had alignment less than 6 in off due to impact. Height was at or up to 3 in above the 27 in design height.

Breaking and Cracking:	2 cracked blockouts were observed.			
	Missing Elements:	2 missing blockouts were observed.			
	Corrosion and Weathering:	No corrosion or weathering was observed.			
End Treatments	Alignment and Height:	No deviation was observed in alignment of end treatments and height was 0-3in. above the 27-in design height.			
	Breaking and Cracking:	No breaking or cracking was observed.			
	Missing Elements:	No missing end treatment elements were observed.			
	Corrosion and Weathering:	No corrosion or weathering was observed.

Repair Action:	REPAIR	FMSS Work Type:	DEFERRED MAINTENANCE	Repair Cost:	\$1755
Brief Workorder:	Replace 4 blockouts.				
Workorder:	Replace Block at \$30- per -Each for 4 Block(s) = \$120. Low Speed Traffic Control at \$1475- per -Day for 1 Day(s) = \$1475.

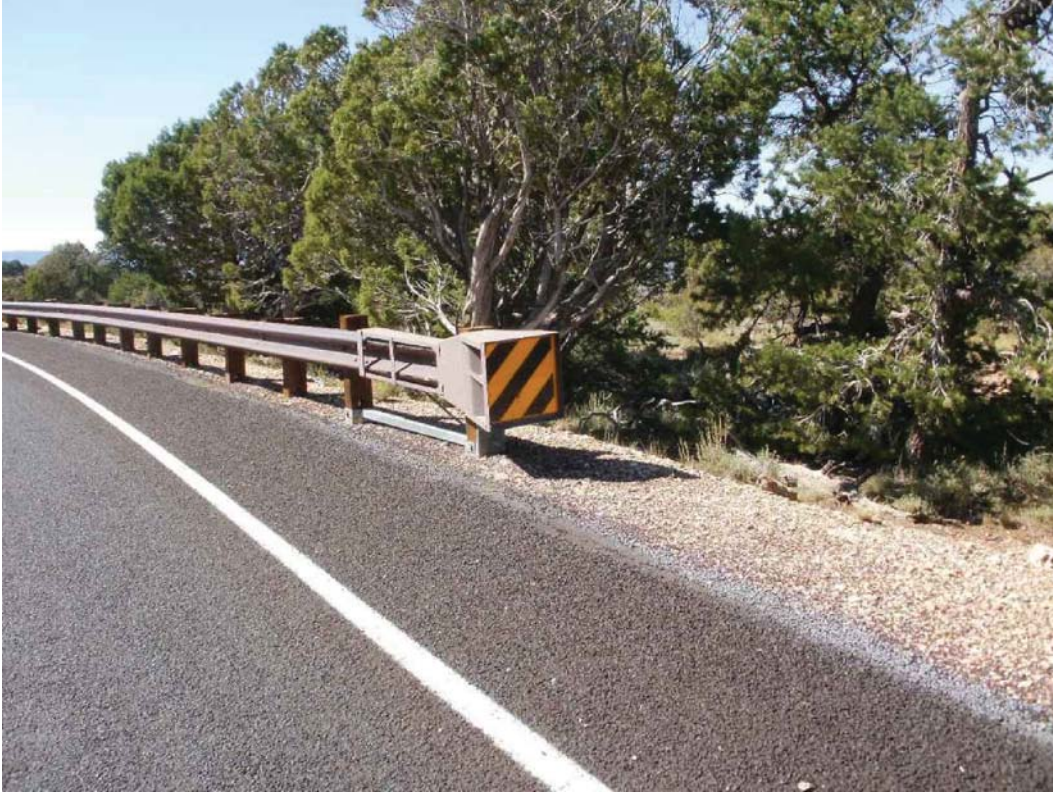
GRCA_0011_20.922_L_1.JPG

Barrier ID:	GRCA-0011-20.922-L				
Route Name:	DESERT VIEW DRIVE				
Inspection Date:	10/10/2010	Barrier Rating:	38.70		
Barrier Description					
Type:	W-BEAM STRONG POST	Barrier Function:	TRAFFIC		
Barrier Material:	WEATHERING STEEL/CORTEN	Post Material:	WOOD		
Blockout Type:	WOOD	Length (ft.):	446		
Speed Limit (MPH):	45	Placement with Respect to Road:	OUTSIDE OF CURVE		
Hazard Behind Barrier:	EXTREME				
Barrier Crashworthiness					
Appropriate Test Level:	TL-2	Barrier Test Level:	TL-3	Is Barrier Crashworthy?:	YES
Beg. End Trtmt Type:	W-BEAM TANGENT 350	Is Beg. End Trtmt Crashworthy?:	YES	Approach Transition Type:	NONE
Ending End Trtmt Type:	W-BEAM TANGENT 350	Ending End Trtmt Crashworthy?:	YES		
Average Measurements					
Design Height (In.):	27	Width (In.):	0.0	Post Spacing (In.):	74.6
Height (In.):	28.0	Lateral Offset (In.):	39.7	Road Grade (%):	2.50
Physical Condition					
Barrier	Alignment and Height:	No deviation was observed in barrier alignment. Height of barrier was 1 in below to 3 in above 27 in design height.

Breaking and Cracking:	No breaking or cracking was observed.			
	Missing Elements:	Two tilted blocks and two loose bolts were observed.			
	Corrosion and Weathering:	Minimal corrosion/weathering of barrier elements and no erosion to compromise stability of posts was observed.			
End Treatments	Alignment and Height:	No deviation was observed in alignment of end treatments. End treatments were 0-3in. above the 27-in design height.			
	Breaking and Cracking:	No cracked or broken end treatment elements were observed.			
	Missing Elements:	No missing end treatment elements were observed.			
	Corrosion and Weathering:	Minimal corrosion/weathering of end treatment elements was observed.

Repair Action:	REPAIR	FMSS Work Type:	DEFERRED MAINTENANCE	Repair Cost:	\$1755
Brief Workorder:	Right tilted blocks and tighten loose bolts.				
Workorder:	Labor at \$60- per -Hour for 2 Hrs = \$120. Labor to right tilted blocks and tighten loose bolts. Low Speed Traffic Control at \$1475- per -Day for 1 Day(s) = \$1475.

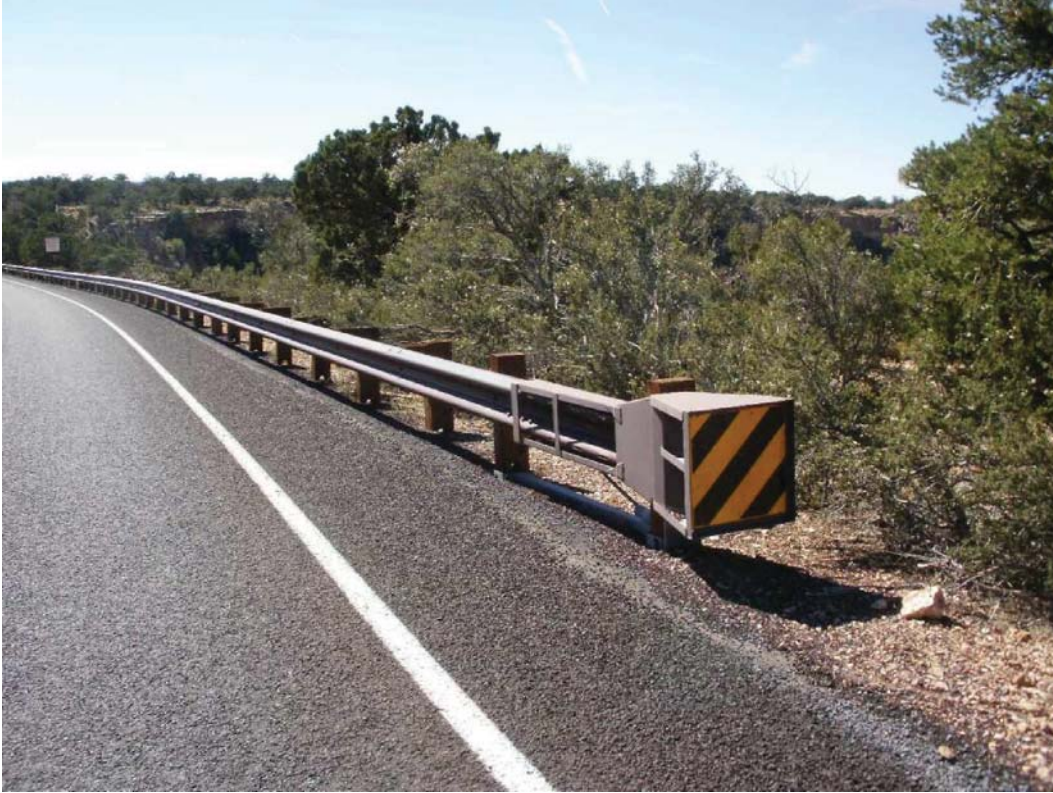
GRCA_0011_21.305_L_1.JPG

Barrier ID:	GRCA-0011-21.305-L				
Route Name:	DESERT VIEW DRIVE				
Inspection Date:	10/10/2010	Barrier Rating:	43.00		
Barrier Description					
Type:	W-BEAM STRONG POST	Barrier Function:	TRAFFIC		
Barrier Material:	WEATHERING STEEL/CORTEN	Post Material:	WOOD		
Blockout Type:	WOOD	Length (ft.):	532		
Speed Limit (MPH):	45	Placement with Respect to Road:	OUTSIDE OF CURVE		
Hazard Behind Barrier:	EXTREME				
Barrier Crashworthiness					
Appropriate Test Level:	TL-2	Barrier Test Level:	TL-3	Is Barrier Crashworthy?:	YES
Beg. End Trtmt Type:	W-BEAM TANGENT 350	Is Beg. End Trtmt Crashworthy?:	YES	Approach Transition Type:	NONE
Ending End Trtmt Type:	W-BEAM TANGENT 350	Ending End Trtmt Crashworthy?:	YES		
Average Measurements					
Design Height (In.):	27	Width (In.):	0.0	Post Spacing (In.):	75.3
Height (In.):	27.2	Lateral Offset (In.):	44.0	Road Grade (%):	4.60
Physical Condition					
Barrier	Alignment and Height:	No deviation in barrier alignment was observed. Barrier was within 1 in of 27 in design height.

Breaking and Cracking:	1 block was broken in half.			
	Missing Elements:	4 blocks had loose bolts.			
	Corrosion and Weathering:	No corrosion or weathering was observed.			
End Treatments	Alignment and Height:	No deviation in alignment of end treatments was observed. End treatments were 0-3in. above the 27-in design height.			
	Breaking and Cracking:	No breaking or cracking was observed.			
	Missing Elements:	No missing end treatment elements were observed.			
	Corrosion and Weathering:	No corrosion or weathering was observed.
