# GRTE GIP Report

## NPS Guardwall/Rail Inventory Program Grand Teton National Park

**Federal Highway Administration  
Eastern Federal Lands Highway Division  
Road Inventory Program (RIP)**

**Data Collection Date: July 2010  
Report Date: November 2015**

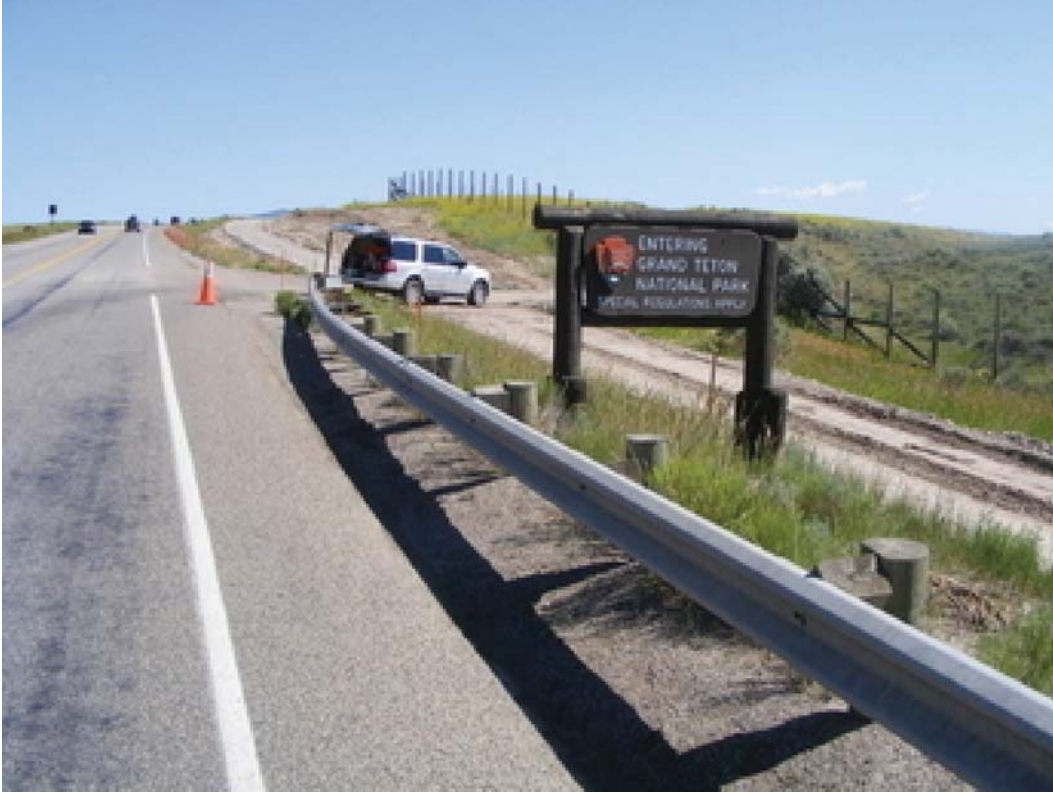
GRTE\_0010\_0.006\_R\_1.JPG

<b>Height (In.):</b>	26.2	<b>Lateral Offset (In.):</b>	66.0	<b>Road Grade (%):</b>	2.50
<b>Physical Condition</b>					
<b>Barrier</b>	<b>Alignment and Height:</b>	Alignment is acceptable. Height is within 1-in of 27-in. design height.			
	<b>Breaking and Cracking:</b>	No major breaking or cracking of barrier.			
	<b>Missing Elements:</b>	No missing elements in barrier.			
	<b>Corrosion and Weathering:</b>	No major weathering of barrier.			
<b>End Treatments</b>	<b>Alignment and Height:</b>	Alignment is acceptable. Height is within 1-in of 27-in. design height.			
	<b>Breaking and Cracking:</b>	No major breaking or cracking of barrier.			
	<b>Missing Elements:</b>	No missing elements in barrier.			
	<b>Corrosion and Weathering:</b>	No major weathering of barrier.

<b>Barrier ID:</b>	GRTE-0010-0.006-R				
<b>Route Name:</b>	U.S. HIGHWAY 26/89/191				
<b>Inspection Date:</b>	07/29/2010		<b>Barrier Rating:</b>	21.10	
<b>Repair Recommendations</b>					
<b>Repair Action:</b>	NO ACTION	<b>FMSS Work Type:</b>	N/A	<b>Repair Cost:</b>	\$0
<b>Brief Workorder:</b>	N/A				
<b>Workorder:</b>

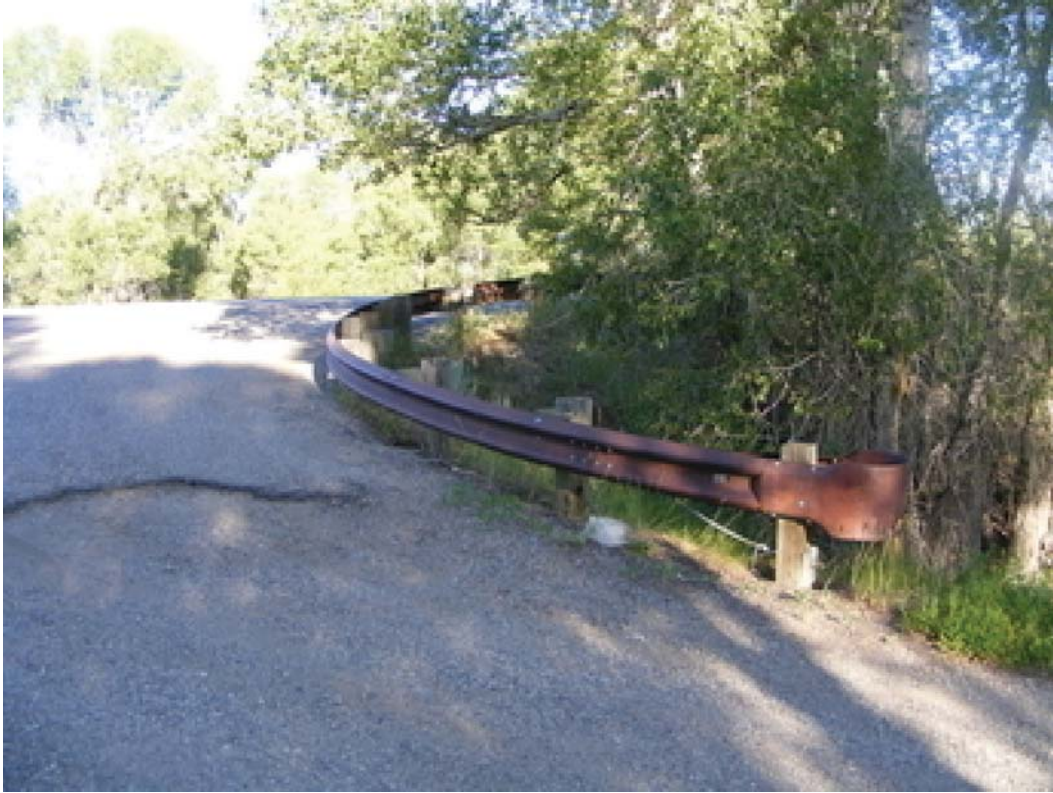
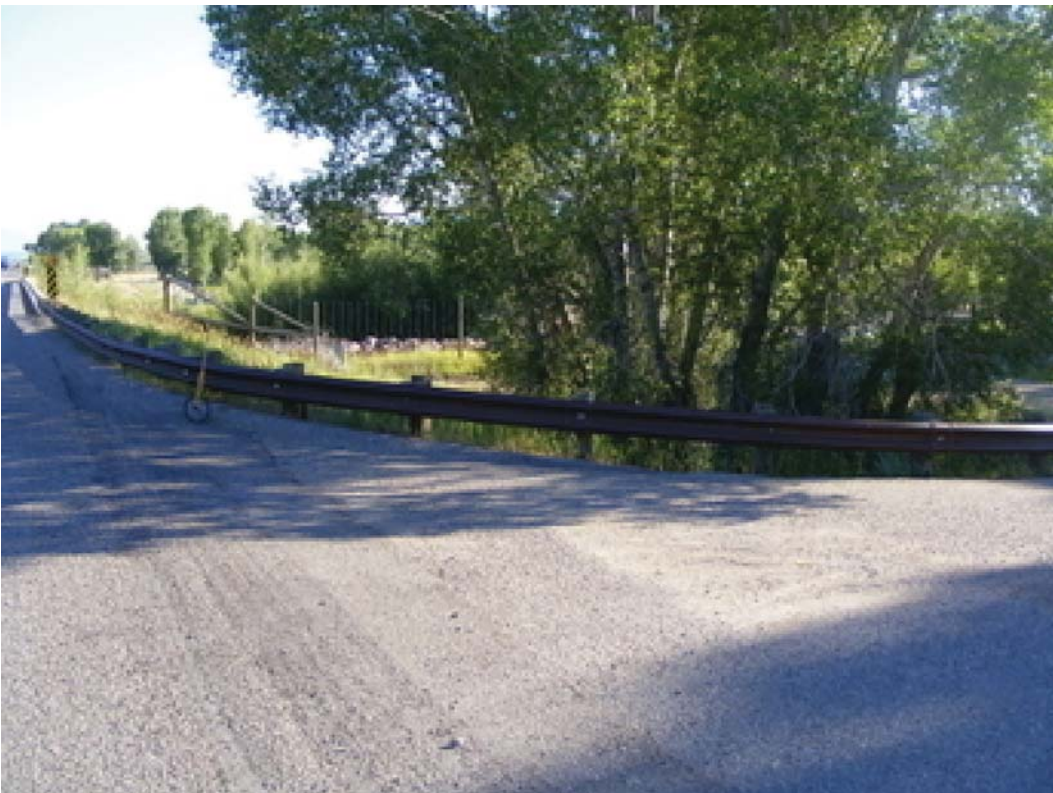
GRTE\_0010\_1.948\_R\_1.JPG

<b>Height (In.):</b>	21.2	<b>Lateral Offset (In.):</b>	117.5	<b>Road Grade (%):</b>	0.30
<b>Physical Condition</b>					
<b>Barrier</b>	<b>Alignment and Height:</b>	Alignment is acceptable. Barrier height is low by 4-7 in from the design height of 27 in.			
	<b>Breaking and Cracking:</b>	No major cracking or breaking of the barrier. One broken block.			
	<b>Missing Elements:</b>	No missing Barrier elements.			
	<b>Corrosion and Weathering:</b>	No major weathering of barrier.			
<b>End Treatments</b>	<b>Alignment and Height:</b>	The end treatment alignment is acceptable. The end treatment height is low by 4 in or less from the design height of 27 in.			
	<b>Breaking and Cracking:</b>	No major cracking or breaking of end treatment.			
	<b>Missing Elements:</b>	No missing elements in the end treatment.			
	<b>Corrosion and Weathering:</b>	No major weathering of the end treatment.

<b>Repair Action:</b>	REPAIR	<b>FMSS Work Type:</b>	DEFERRED MAINTENANCE	<b>Repair Cost:</b>	\$4378
<b>Brief Workorder:</b>	Raise 160ft. of barrier up to 27-in design height. Replace broken block.				
<b>Workorder:</b>	Adjust Guardrail at \$10- per -Lin. Ft. for 160 LF = \$1600. Raise 160-ft. of barrier up to 27-in design height. Replace Block at \$30- per -Each for 1 Block(s) = \$30. Replace broken block. High Speed Traffic Control at \$2350- per -Day for 1 Day(s) = \$2350.

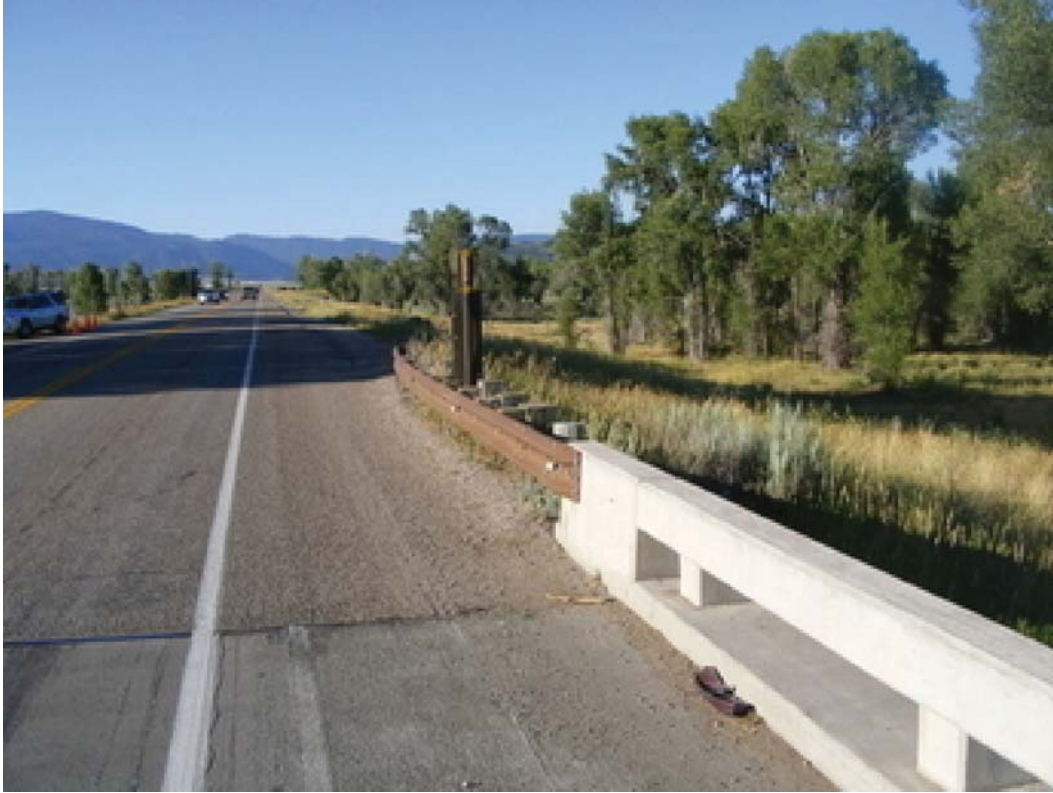
GRTE\_0010\_1.957\_L\_1.JPG

<b>Height (In.):</b>	22.7	<b>Lateral Offset (In.):</b>	91.6	<b>Road Grade (%):</b>	0.70
<b>Physical Condition</b>					
<b>Barrier</b>	<b>Alignment and Height:</b>	End terminal and transition only.			
	<b>Breaking and Cracking:</b>	End terminal and transition only.			
	<b>Missing Elements:</b>	End terminal and transition only.			
	<b>Corrosion and Weathering:</b>	End terminal and transition only.			
<b>End Treatments</b>	<b>Alignment and Height:</b>	Height is more than 3 in below 27-in. design height. Impact to trailing end treatment. One tilted block.			
	<b>Breaking and Cracking:</b>	No cracked or broken end treatment elements.			
	<b>Missing Elements:</b>	No missing end treatment elements.			
	<b>Corrosion and Weathering:</b>	Moderate corrosion of end treatment elements.

<b>Repair Action:</b>	REPLACE	<b>FMSS Work Type:</b>	CAPITAL IMPROVEMENT	<b>Repair Cost:</b>	\$5632
<b>Brief Workorder:</b>	Replace BCT end terminal remove gravel from face of barrier and raise transition section to 27-in. design height.				
<b>Workorder:</b>	<p>W-beam Trailing End at \$2500- per -Each for 1 Unit(s) = \$2500. Replace BCT end terminal.</p> <p>Labor at \$60- per -Hour for 2 Hrs = \$120. Remove gravel from in front of barrier.</p> <p>Adjust Guardrail at \$10- per -Lin. Ft. for 15 LF = \$150. Raise 15-ft. of barrier up to 27-in design height.</p> <p>High Speed Traffic Control at \$2350- per -Day for 1 Day(s) = \$2350.</p>

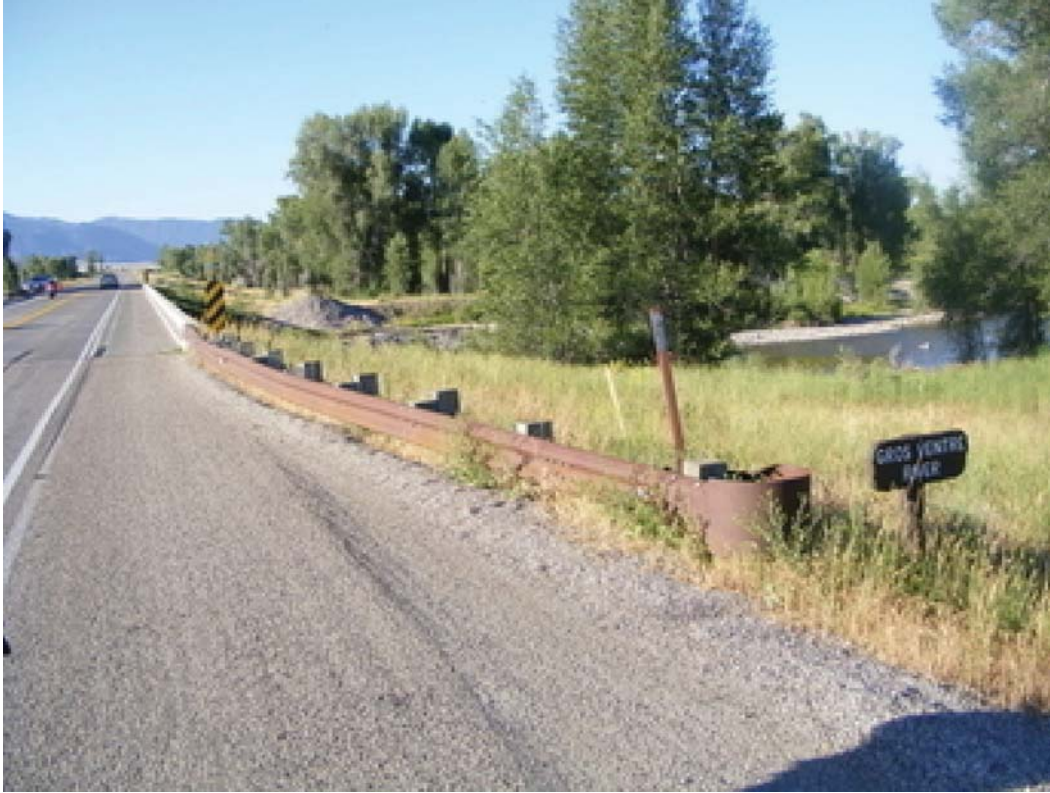
GRTE\_0010\_2.018\_L\_1.JPG

<b>Height (In.):</b>	22.0	<b>Lateral Offset (In.):</b>	101.6	<b>Road Grade (%):</b>	0.60
<b>Physical Condition</b>					
<b>Barrier</b>	<b>Alignment and Height:</b>	End terminal and transition only.			
	<b>Breaking and Cracking:</b>	End terminal and transition only.			
	<b>Missing Elements:</b>	End terminal and transition only.			
	<b>Corrosion and Weathering:</b>	End terminal and transition only.			
<b>End Treatments</b>	<b>Alignment and Height:</b>	Alignment of end treatment is acceptable. Height is more than 3 in below 27-in. design height. Gravel piled up in front of barrier.			
	<b>Breaking and Cracking:</b>	No cracked or broken end treatment elements.			
	<b>Missing Elements:</b>	No missing end treatment elements.			
	<b>Corrosion and Weathering:</b>	Moderate corrosion and weathering of end treatment elements.

<b>Repair Action:</b>	REPAIR	<b>FMSS Work Type:</b>	DEFERRED MAINTENANCE	<b>Repair Cost:</b>	\$3267
<b>Brief Workorder:</b>	Raise 50-ft. of barrier up to 27-in design height and remove gravel from face of barrier and right tilted blocks.				
<b>Workorder:</b>	Adjust Guardrail at \$10- per -Lin. Ft. for 50 LF = \$500. Raise 50-ft. of barrier up to 27-in design height. Labor at \$60- per -Hour for 2 Hrs = \$120. Remove gravel from face of barrier and right tilted blocks. High Speed Traffic Control at \$2350- per -Day for 1 Day(s) = \$2350.

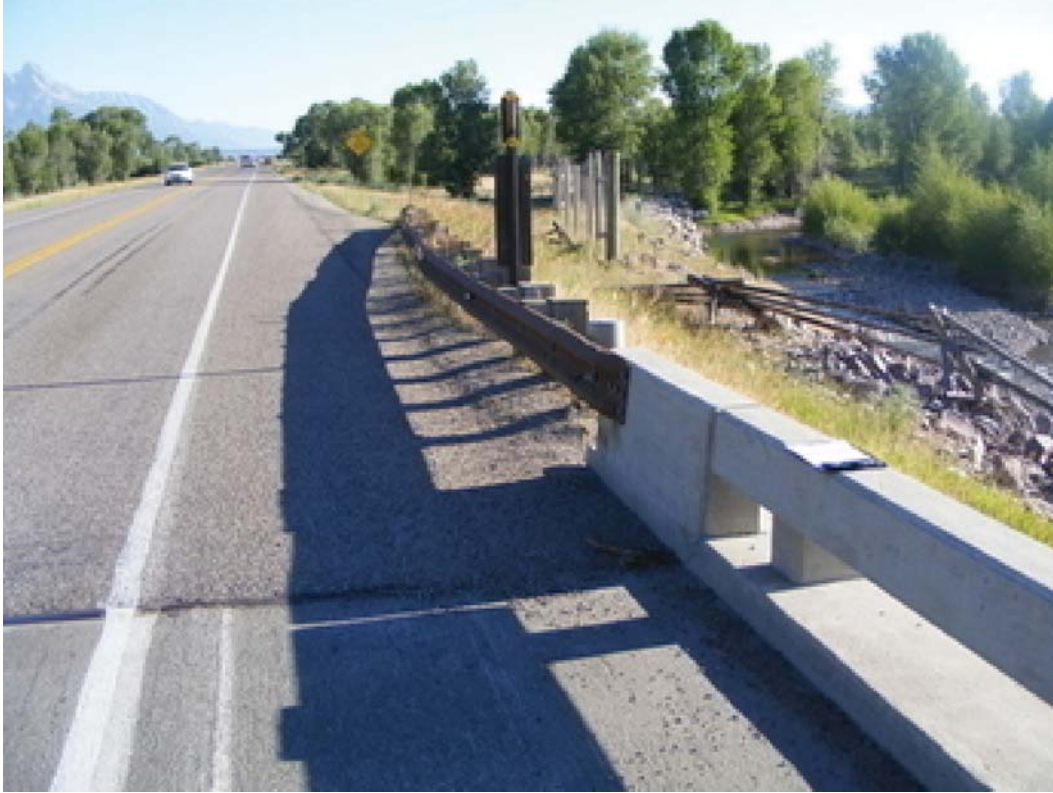
GRTE\_0010\_2.018\_R\_1.JPG

<b>Height (In.):</b>	22.6	<b>Lateral Offset (In.):</b>	103.5	<b>Road Grade (%):</b>	0.60
<b>Physical Condition</b>					
<b>Barrier</b>	<b>Alignment and Height:</b>	End treatment and transition only.			
	<b>Breaking and Cracking:</b>	End treatment and transition only.			
	<b>Missing Elements:</b>	End treatment and transition only.			
	<b>Corrosion and Weathering:</b>	End treatment and transition only. Chip seal sweeping piled up in front of barrier.			
<b>End Treatments</b>	<b>Alignment and Height:</b>	The end treatment alignment is acceptable. The end treatment height is low by 4 in or less from the design height of 27 ins.			
	<b>Breaking and Cracking:</b>	No major cracking or breaking of the end treatment.			
	<b>Missing Elements:</b>	No missing elements in the end treatment.			
	<b>Corrosion and Weathering:</b>	No major weathering of the end treatment.

<b>Repair Action:</b>	REPAIR	<b>FMSS Work Type:</b>	DEFERRED MAINTENANCE	<b>Repair Cost:</b>	\$3564
<b>Brief Workorder:</b>	Raise 65-ft. of barrier up to 27-in design height and remove chip seal sweepings from front of rail.				
<b>Workorder:</b>	Adjust Guardrail at \$10- per -Lin. Ft. for 65 LF = \$650. Raise 65-ft. of barrier up to 27-in design height. Labor at \$60- per -Hour for 4 Hrs = \$240. Remove chip seal sweepings from in front of rail. High Speed Traffic Control at \$2350- per -Day for 1 Day(s) = \$2350.

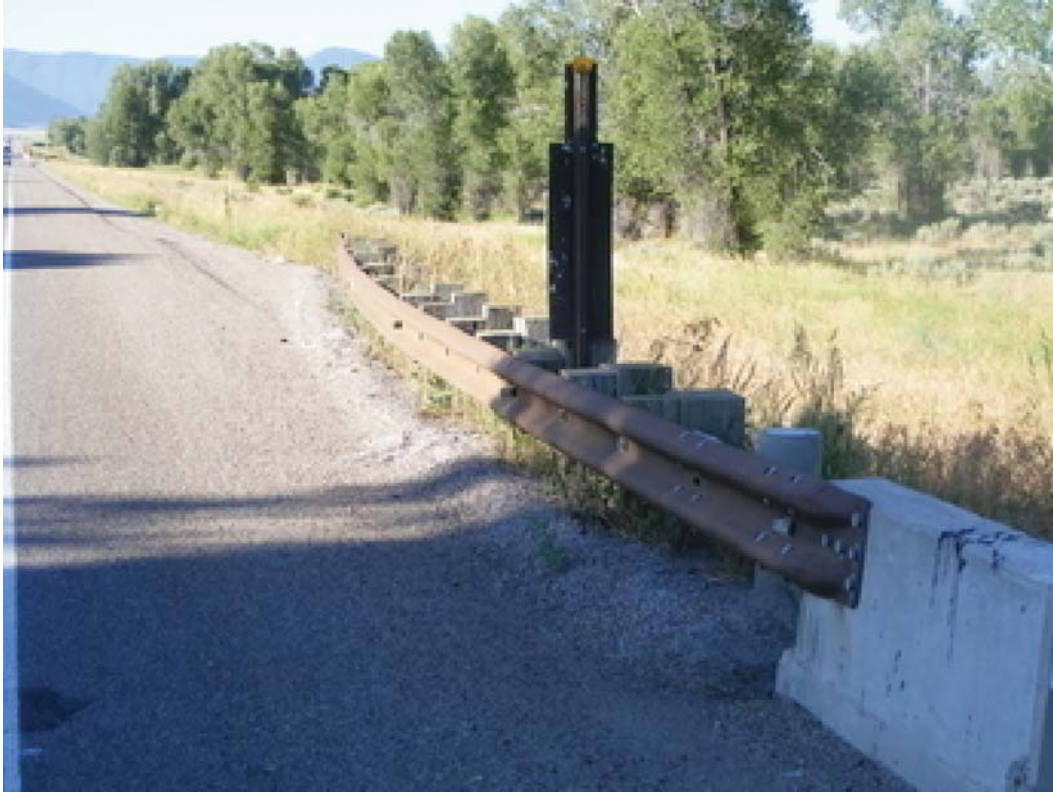
GRTE\_0010\_2.188\_L\_1.JPG

<b>Height (In.):</b>	22.0	<b>Lateral Offset (In.):</b>	108.3	<b>Road Grade (%):</b>	0.70
<b>Physical Condition</b>					
<b>Barrier</b>	<b>Alignment and Height:</b>	End terminal and transition only.			
	<b>Breaking and Cracking:</b>	End terminal and transition only.			
	<b>Missing Elements:</b>	End terminal and transition only.			
	<b>Corrosion and Weathering:</b>	End terminal and transition only.			
<b>End Treatments</b>	<b>Alignment and Height:</b>	Alignment of end treatment is acceptable. Height of end treatment is more than 3 in below 27-in. design height. Gravel piled up in front of barrier.			
	<b>Breaking and Cracking:</b>	No cracked or broken end treatment elements.			
	<b>Missing Elements:</b>	No missing end treatment elements.			
	<b>Corrosion and Weathering:</b>	Moderate corrosion and weathering of end treatment.

<b>Repair Action:</b>	REPAIR	<b>FMSS Work Type:</b>	DEFERRED MAINTENANCE	<b>Repair Cost:</b>	\$3421
<b>Brief Workorder:</b>	Remove gravel from face of barrier and raise 64-ft. of barrier up to 27-in design height.				
<b>Workorder:</b>	Adjust Guardrail at \$10- per -Lin. Ft. for 64 LF = \$640. Raise 64-ft. of barrier up to 27-in design height. Labor at \$60- per -Hour for 2 Hrs = \$120. Remove gravel from face of barrier. High Speed Traffic Control at \$2350- per -Day for 1 Day(s) = \$2350.

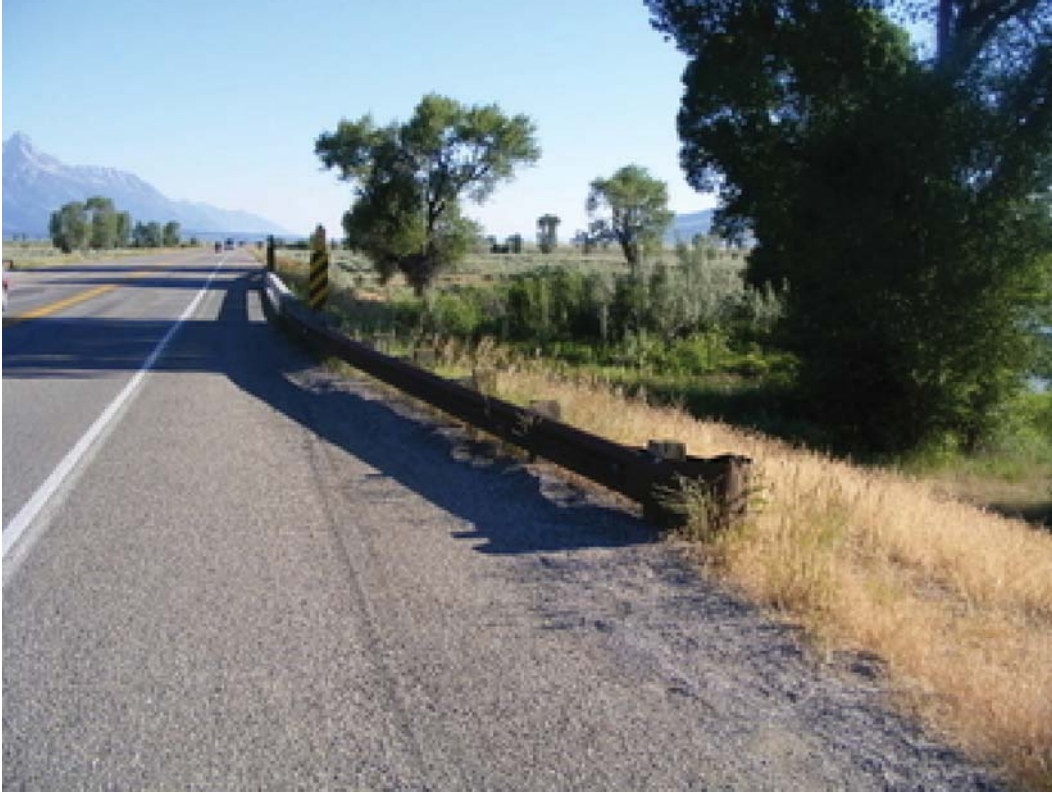
GRTE\_0010\_2.190\_R\_1.JPG

<b>Height (In.):</b>	21.6	<b>Lateral Offset (In.):</b>	105.0	<b>Road Grade (%):</b>	0.50
<b>Physical Condition</b>					
<b>Barrier</b>	<b>Alignment and Height:</b>	End treatment and transition only.			
	<b>Breaking and Cracking:</b>	End treatment and transition only.			
	<b>Missing Elements:</b>	End treatment and transition only.			
	<b>Corrosion and Weathering:</b>	End treatment and transition only.			
<b>End Treatments</b>	<b>Alignment and Height:</b>	The end treatment alignment is acceptable. The end treatment height is low by 7 in or less from the design height of 27 in.			
	<b>Breaking and Cracking:</b>	No major cracking or breaking of the end treatment.			
	<b>Missing Elements:</b>	No missing elements in the end treatment.			
	<b>Corrosion and Weathering:</b>	No major weathering of the end treatment.

<b>Repair Action:</b>	REPAIR	<b>FMSS Work Type:</b>	DEFERRED MAINTENANCE	<b>Repair Cost:</b>	\$3575
<b>Brief Workorder:</b>	Raise 66-ft. of barrier up to 27-in design height clean chip seal sweepings from front of barrier.				
<b>Workorder:</b>	Adjust Guardrail at \$10- per -Lin. Ft. for 66 LF = \$660. Raise 66-ft. of barrier up to 27-in design height. Labor at \$60- per -Hour for 4 Hrs = \$240. remove chip seal sweepings from front of rail. High Speed Traffic Control at \$2350- per -Day for 1 Day(s) = \$2350.
