# GUIS GIP Report

## NPS Guardwall/Rail Inventory Program Gulf Islands National Seashore

Data Collection Date: November 2010  
Report Date: November 2015

# Gulf Islands National Seashore in Florida and Mississippi

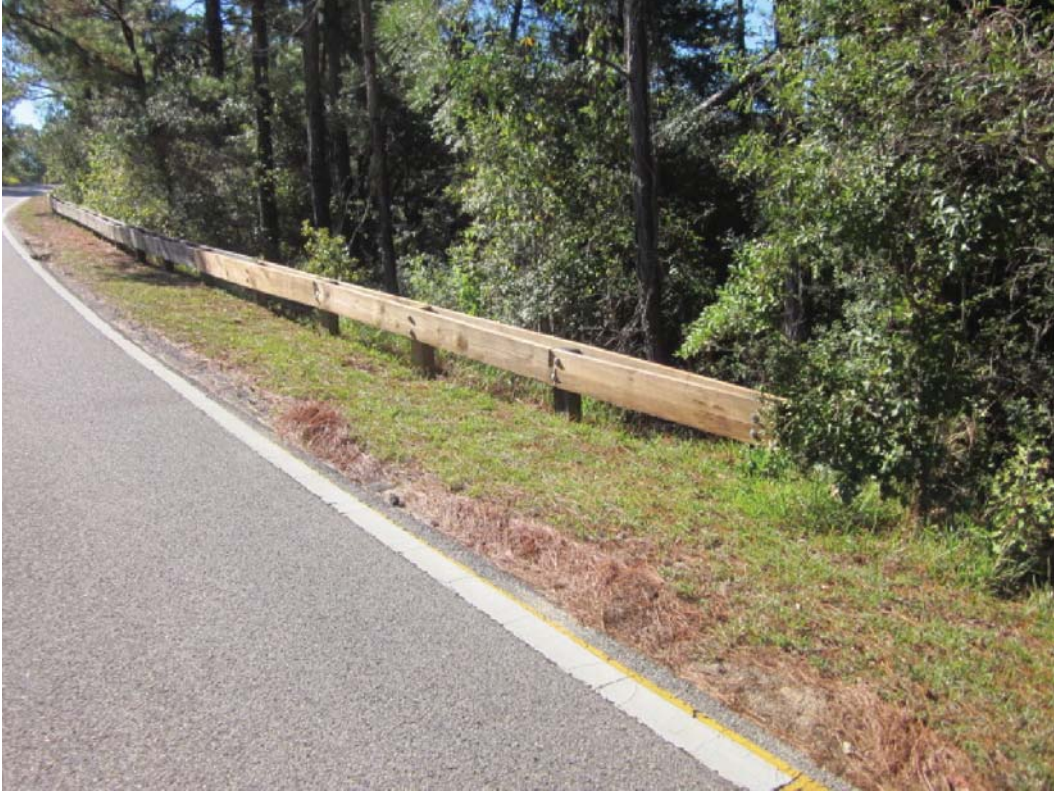
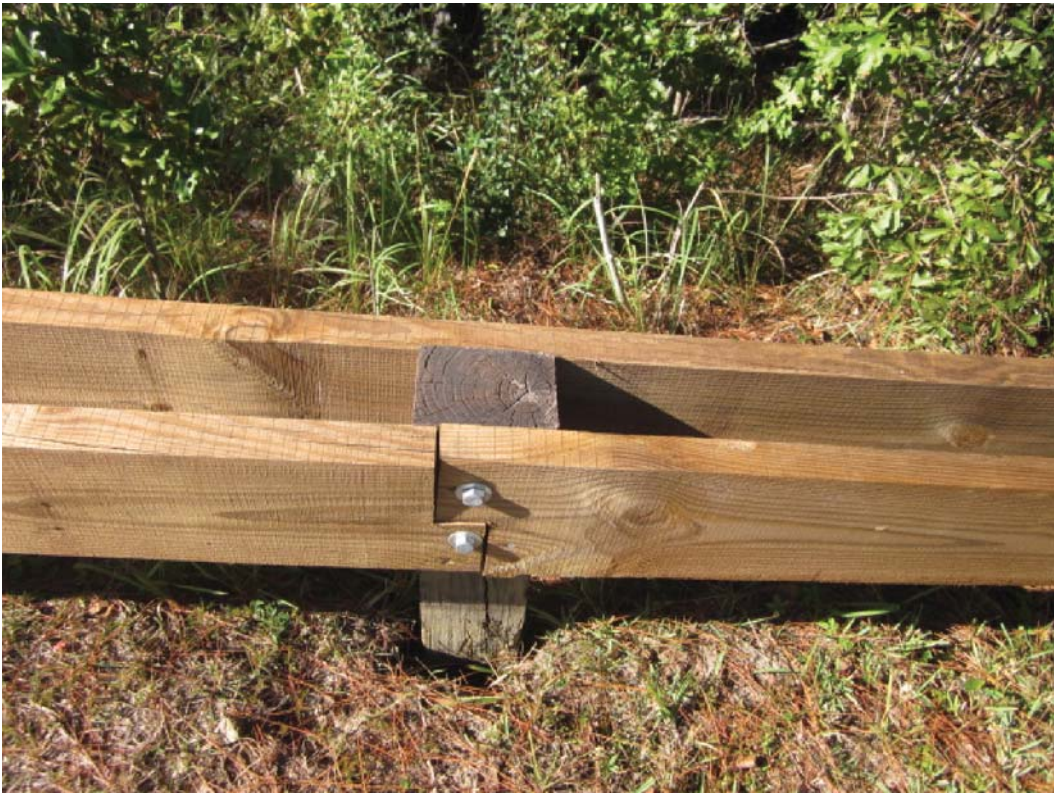
<b>Barrier ID:</b>	GUIS-0015-0.090-R				
<b>Route Name:</b>	PARK ROAD				
<b>Inspection Date:</b>	08/11/2010	<b>Barrier Rating:</b>	25.10		
<b>Barrier Description</b>					
<b>Type:</b>	OTHER: TIMBER RAIL ON TIMBER POSTS	<b>Barrier Function:</b>	TRAFFIC		
<b>Barrier Material:</b>	LOG/TIMBER/WOOD	<b>Post Material:</b>	WOOD		
<b>Blockout Type:</b>	N/A	<b>Length (ft.):</b>	397		
<b>Speed Limit (MPH):</b>	35	<b>Placement with Respect to Road:</b>	INSIDE OF CURVE		
<b>Hazard Behind Barrier:</b>	MEDIUM				
<b>Barrier Crashworthiness</b>					
<b>Appropriate Test Level:</b>	TL-2	<b>Barrier Test Level:</b>	NCW	<b>Is Barrier Crashworthy?:</b>	NO
<b>Beg. End Trtmt Type:</b>	NONE	<b>Is Beg. End Trtmt Crashworthy?:</b>	N/A	<b>Approach Transition Type:</b>	OTHER: BRIDGE RAIL TIMBER
<b>Ending End Trtmt Type:</b>	NONE	<b>Ending End Trtmt Crashworthy?:</b>	N/A		
<b>Average Measurements</b>					
<b>Design Height (In.):</b>	20	<b>Width (In.):</b>	0.0	<b>Post Spacing (In.):</b>	75.3

<b>Height (In.):</b>	21.0	<b>Lateral Offset (In.):</b>	78.6	<b>Road Grade (%):</b>	4.90
<b>Physical Condition</b>					
<b>Barrier</b>	<b>Alignment and Height:</b>	Alignment has no deviation and height is 1 in below and 2 in above the design height of 20 in.			
	<b>Breaking and Cracking:</b>	No breaking or cracking observed.			
	<b>Missing Elements:</b>	No missing elements observed.			
	<b>Corrosion and Weathering:</b>	No corrosion or weathering observed.			
<b>End Treatments</b>	<b>Alignment and Height:</b>				
	<b>Breaking and Cracking:</b>				
	<b>Missing Elements:</b>				
	<b>Corrosion and Weathering:</b>

<b>Repair Action:</b>	NO ACTION	<b>FMSS Work Type:</b>	N/A	<b>Repair Cost:</b>	\$0
<b>Brief Workorder:</b>	N/A				
<b>Workorder:</b>

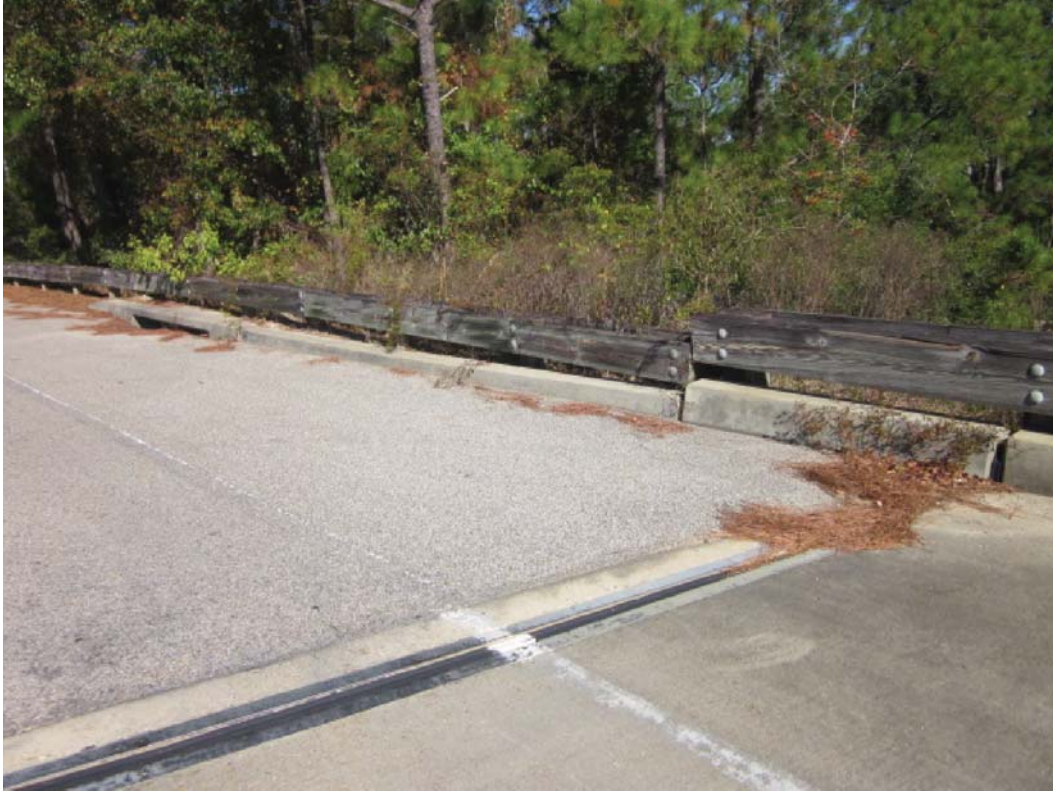
GUIS\_0015\_0.107\_L\_1.JPG

<b>Barrier ID:</b>	GUIS-0015-0.107-L				
<b>Route Name:</b>	PARK ROAD				
<b>Inspection Date:</b>	08/11/2010	<b>Barrier Rating:</b>	28.20		
<b>Barrier Description</b>					
<b>Type:</b>	OTHER: TIMBER RAIL ON TIMBER POSTS	<b>Barrier Function:</b>	TRAFFIC		
<b>Barrier Material:</b>	LOG/TIMBER/WOOD	<b>Post Material:</b>	WOOD		
<b>Blockout Type:</b>	N/A	<b>Length (ft.):</b>	408		
<b>Speed Limit (MPH):</b>	35	<b>Placement with Respect to Road:</b>	TANGENT		
<b>Hazard Behind Barrier:</b>	HIGH				
<b>Barrier Crashworthiness</b>					
<b>Appropriate Test Level:</b>	TL-2	<b>Barrier Test Level:</b>	NCW	<b>Is Barrier Crashworthy?:</b>	NO
<b>Beg. End Trtmt Type:</b>	NONE	<b>Is Beg. End Trtmt Crashworthy?:</b>	N/A	<b>Approach Transition Type:</b>	OTHER: BRIDGE RAIL TIMBER
<b>Ending End Trtmt Type:</b>	NONE	<b>Ending End Trtmt Crashworthy?:</b>	N/A		
<b>Average Measurements</b>					
<b>Design Height (In.):</b>	20	<b>Width (In.):</b>	0.0	<b>Post Spacing (In.):</b>	74.6

<b>Height (In.):</b>	20.7	<b>Lateral Offset (In.):</b>	79.3	<b>Road Grade (%):</b>	4.30
<b>Physical Condition</b>					
<b>Barrier</b>	<b>Alignment and Height:</b>	Alignment had no deviation and height is from 1 in below to 2 in above the 20 in design height.			
	<b>Breaking and Cracking:</b>	No breaking or cracking observed.			
	<b>Missing Elements:</b>	No missing elements observed.			
	<b>Corrosion and Weathering:</b>	Minor weathering on 18 ft of rail (monitor). No corrosion observed.			
<b>End Treatments</b>	<b>Alignment and Height:</b>				
	<b>Breaking and Cracking:</b>				
	<b>Missing Elements:</b>				
	<b>Corrosion and Weathering:</b>

<b>Repair Action:</b>	NO ACTION	<b>FMSS Work Type:</b>	N/A	<b>Repair Cost:</b>	\$0
<b>Brief Workorder:</b>	N/A				
<b>Workorder:</b>

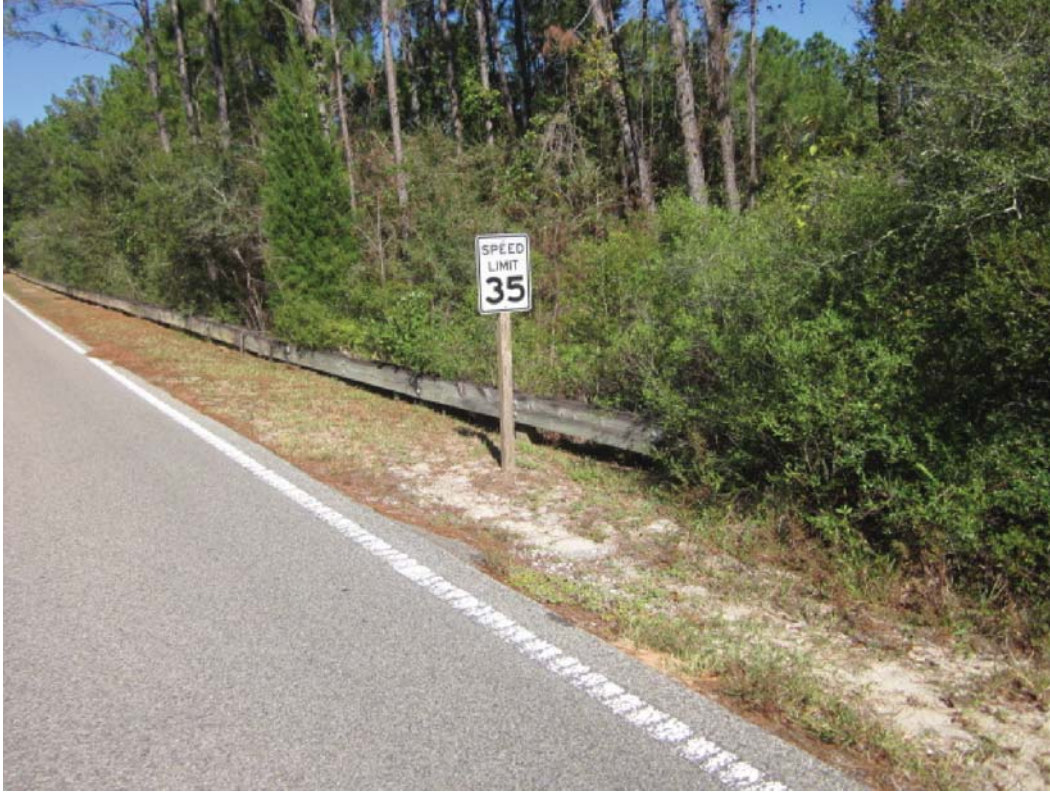
GUIS\_0015\_0.210\_L\_1.JPG

<b>Barrier ID:</b>	GUIS-0015-0.210-L				
<b>Route Name:</b>	PARK ROAD				
<b>Inspection Date:</b>	08/11/2010	<b>Barrier Rating:</b>	28.20		
<b>Barrier Description</b>					
<b>Type:</b>	OTHER: TIMBER RAIL ON TIMBER POSTS	<b>Barrier Function:</b>	TRAFFIC		
<b>Barrier Material:</b>	LOG/TIMBER/WOOD	<b>Post Material:</b>	WOOD		
<b>Blockout Type:</b>	N/A	<b>Length (ft.):</b>	692		
<b>Speed Limit (MPH):</b>	35	<b>Placement with Respect to Road:</b>	TANGENT		
<b>Hazard Behind Barrier:</b>	LOW				
<b>Barrier Crashworthiness</b>					
<b>Appropriate Test Level:</b>	TL-2	<b>Barrier Test Level:</b>	NCW	<b>Is Barrier Crashworthy?:</b>	NO
<b>Beg. End Trtmt Type:</b>	NONE	<b>Is Beg. End Trtmt Crashworthy?:</b>	N/A	<b>Approach Transition Type:</b>	OTHER: BRIDGE RAIL TIMBER
<b>Ending End Trtmt Type:</b>	NONE	<b>Ending End Trtmt Crashworthy?:</b>	N/A		
<b>Average Measurements</b>					
<b>Design Height (In.):</b>	20	<b>Width (In.):</b>	0.0	<b>Post Spacing (In.):</b>	75.5

<b>Height (In.):</b>	16.0	<b>Lateral Offset (In.):</b>	76.5	<b>Road Grade (%):</b>	3.70
<b>Physical Condition</b>					
<b>Barrier</b>	<b>Alignment and Height:</b>	The barrier alignment had no deviation and height is 1-3 in below the 20 in design height for 150 ft and 3-5 in below 20-in. design height for 350 ft.			
	<b>Breaking and Cracking:</b>	No breaking or cracking observed.			
	<b>Missing Elements:</b>	No missing elements observed.			
	<b>Corrosion and Weathering:</b>	No corrosion or weathering observed.			
<b>End Treatments</b>	<b>Alignment and Height:</b>				
	<b>Breaking and Cracking:</b>				
	<b>Missing Elements:</b>				
	<b>Corrosion and Weathering:</b>

<b>Repair Action:</b>	REPAIR	<b>FMSS Work Type:</b>	DEFERRED MAINTENANCE	<b>Repair Cost:</b>	\$8745
<b>Brief Workorder:</b>	Raise 500 feet of guardrail up to 20 inch design height.				
<b>Workorder:</b>	Adjust Guardrail at \$10- per -Lin. Ft. for 500 LF = \$5000. Raise 500 feet of guardrail up to 20 inch design height. Low Speed Traffic Control at \$1475- per -Day for 2 Day(s) = \$2950.

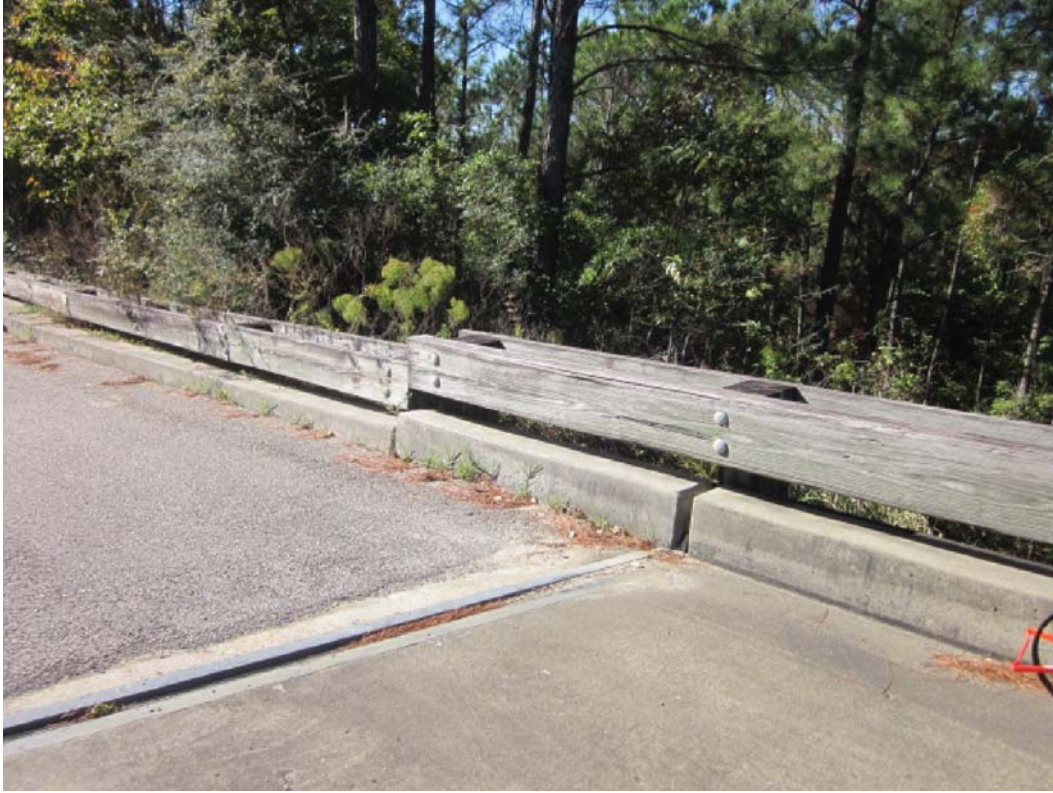
GUIS\_0015\_0.210\_R\_1.JPG

<b>Barrier ID:</b>	GUIS-0015-0.210-R				
<b>Route Name:</b>	PARK ROAD				
<b>Inspection Date:</b>	08/11/2010	<b>Barrier Rating:</b>	24.00		
<b>Barrier Description</b>					
<b>Type:</b>	OTHER: TIMBER RAIL ON TIMBER POSTS	<b>Barrier Function:</b>	TRAFFIC		
<b>Barrier Material:</b>	LOG/TIMBER/WOOD	<b>Post Material:</b>	WOOD		
<b>Blockout Type:</b>	N/A	<b>Length (ft.):</b>	704		
<b>Speed Limit (MPH):</b>	35	<b>Placement with Respect to Road:</b>	TANGENT		
<b>Hazard Behind Barrier:</b>	LOW				
<b>Barrier Crashworthiness</b>					
<b>Appropriate Test Level:</b>	TL-2	<b>Barrier Test Level:</b>	NCW	<b>Is Barrier Crashworthy?:</b>	NO
<b>Beg. End Trtmt Type:</b>	NONE	<b>Is Beg. End Trtmt Crashworthy?:</b>	N/A	<b>Approach Transition Type:</b>	OTHER: BRIDGE RAIL TIMBER
<b>Ending End Trtmt Type:</b>	NONE	<b>Ending End Trtmt Crashworthy?:</b>	N/A		
<b>Average Measurements</b>					
<b>Design Height (In.):</b>	20	<b>Width (In.):</b>	0.0	<b>Post Spacing (In.):</b>	74.1

<b>Height (In.):</b>	19.7	<b>Lateral Offset (In.):</b>	84.6	<b>Road Grade (%):</b>	3.20
<b>Physical Condition</b>					
<b>Barrier</b>	<b>Alignment and Height:</b>	The barrier alignment had no deviation and the height ranged from 1 in below to 2 in above the 20 in design height.			
	<b>Breaking and Cracking:</b>	Some breaking and cracking from 1/4 in to 1/2 inch observed. One rail had cracking larger than 1/2 inch.			
	<b>Missing Elements:</b>	No missing elements observed.			
	<b>Corrosion and Weathering:</b>	No corrosion and some weathering of the wood due to sun exposure.			
<b>End Treatments</b>	<b>Alignment and Height:</b>				
	<b>Breaking and Cracking:</b>				
	<b>Missing Elements:</b>				
	<b>Corrosion and Weathering:</b>

<b>Repair Action:</b>	REPAIR	<b>FMSS Work Type:</b>	DEFERRED MAINTENANCE	<b>Repair Cost:</b>	\$1953
<b>Brief Workorder:</b>	Replace 12 foot section of rail.				
<b>Workorder:</b>	Replace Rail at \$25- per -Lin. Ft. for 12 LF = \$300. Low Speed Traffic Control at \$1475- per -Day for 1 Day(s) = \$1475.

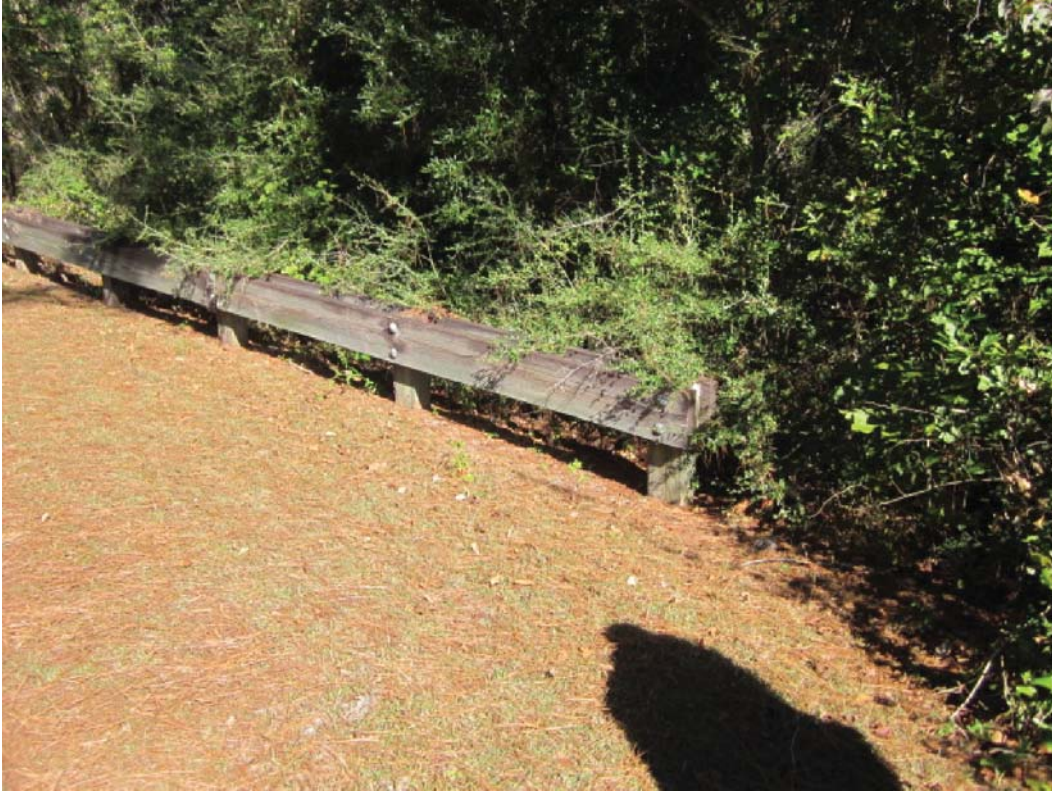
GUIS\_0015\_0.659\_L\_1.JPG

<b>Barrier ID:</b>	GUIS-0015-0.659-L				
<b>Route Name:</b>	PARK ROAD				
<b>Inspection Date:</b>	08/11/2010	<b>Barrier Rating:</b>	16.70		
<b>Barrier Description</b>					
<b>Type:</b>	OTHER: TIMBER RAIL ON TIMBER POSTS	<b>Barrier Function:</b>	TRAFFIC		
<b>Barrier Material:</b>	LOG/TIMBER/WOOD	<b>Post Material:</b>	WOOD		
<b>Blockout Type:</b>	N/A	<b>Length (ft.):</b>	226		
<b>Speed Limit (MPH):</b>	35	<b>Placement with Respect to Road:</b>	TANGENT		
<b>Hazard Behind Barrier:</b>	LOW				
<b>Barrier Crashworthiness</b>					
<b>Appropriate Test Level:</b>	TL-2	<b>Barrier Test Level:</b>	NCW	<b>Is Barrier Crashworthy?:</b>	NO
<b>Beg. End Trtmt Type:</b>	NONE	<b>Is Beg. End Trtmt Crashworthy?:</b>	N/A	<b>Approach Transition Type:</b>	NONE
<b>Ending End Trtmt Type:</b>	NONE	<b>Ending End Trtmt Crashworthy?:</b>	N/A		
<b>Average Measurements</b>					
<b>Design Height (In.):</b>	20	<b>Width (In.):</b>	0.0	<b>Post Spacing (In.):</b>	72.6

<b>Height (In.):</b>	24.0	<b>Lateral Offset (In.):</b>	70.0	<b>Road Grade (%):</b>	0.40
<b>Physical Condition</b>					
<b>Barrier</b>	<b>Alignment and Height:</b>	Alignment has no deviation and height is 3 to 5 in above the 20 in design height.			
	<b>Breaking and Cracking:</b>	No breaking or cracking observed.			
	<b>Missing Elements:</b>	No missing elements observed.			
	<b>Corrosion and Weathering:</b>	No corrosion or weathering observed.			
<b>End Treatments</b>	<b>Alignment and Height:</b>				
	<b>Breaking and Cracking:</b>				
	<b>Missing Elements:</b>				
	<b>Corrosion and Weathering:</b>

<b>Repair Action:</b>	NO ACTION	<b>FMSS Work Type:</b>	N/A	<b>Repair Cost:</b>	\$0
<b>Brief Workorder:</b>	N/A				
<b>Workorder:</b>	No Action

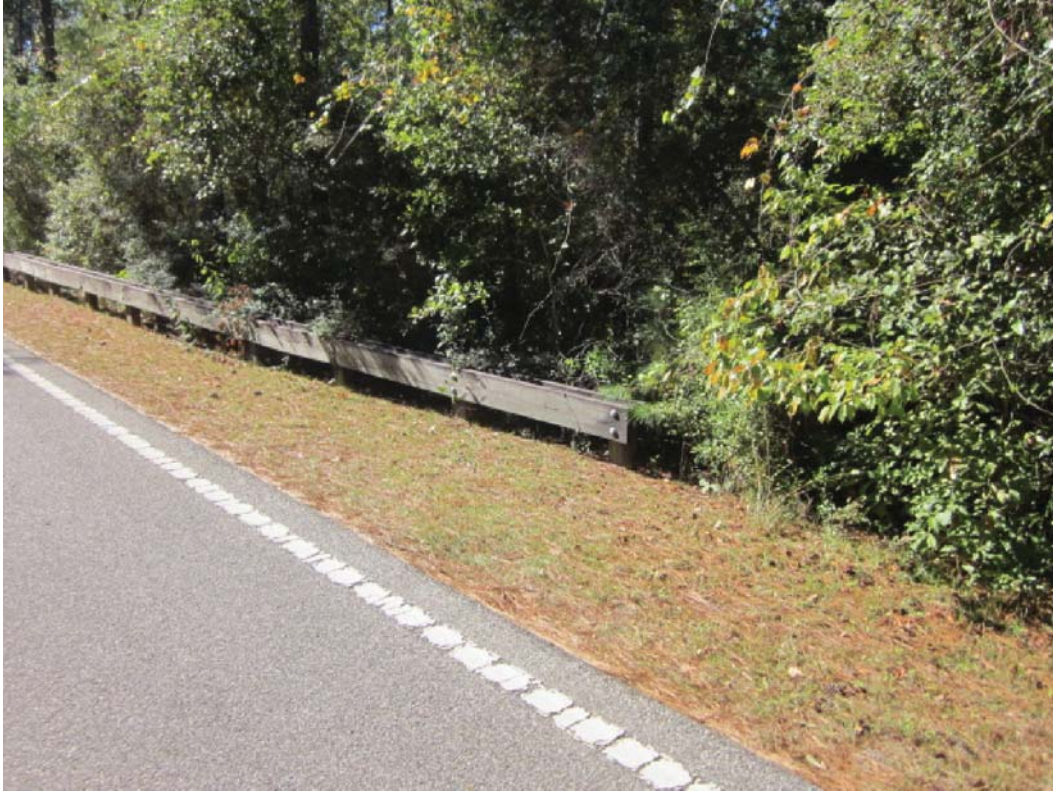
GUIS\_0015\_0.659\_R\_1.JPG

<b>Barrier ID:</b>	GUIS-0015-0.659-R				
<b>Route Name:</b>	PARK ROAD				
<b>Inspection Date:</b>	08/11/2010	<b>Barrier Rating:</b>	19.20		
<b>Barrier Description</b>					
<b>Type:</b>	OTHER: TIMBER RAIL ON TIMBER POSTS	<b>Barrier Function:</b>	TRAFFIC		
<b>Barrier Material:</b>	LOG/TIMBER/WOOD	<b>Post Material:</b>	WOOD		
<b>Blockout Type:</b>	N/A	<b>Length (ft.):</b>	226		
<b>Speed Limit (MPH):</b>	35	<b>Placement with Respect to Road:</b>	TANGENT		
<b>Hazard Behind Barrier:</b>	MEDIUM				
<b>Barrier Crashworthiness</b>					
<b>Appropriate Test Level:</b>	TL-2	<b>Barrier Test Level:</b>	NCW	<b>Is Barrier Crashworthy?:</b>	NO
<b>Beg. End Trtmt Type:</b>	NONE	<b>Is Beg. End Trtmt Crashworthy?:</b>	N/A	<b>Approach Transition Type:</b>	NONE
<b>Ending End Trtmt Type:</b>	NONE	<b>Ending End Trtmt Crashworthy?:</b>	N/A		
<b>Average Measurements</b>					
<b>Design Height (In.):</b>	20	<b>Width (In.):</b>	0.0	<b>Post Spacing (In.):</b>	78.0

<b>Height (In.):</b>	25.7	<b>Lateral Offset (In.):</b>	73.0	<b>Road Grade (%):</b>	0.10
<b>Physical Condition</b>					
<b>Barrier</b>	<b>Alignment and Height:</b>	Alignment has no deviation and height is at or above the design of 20 in by up to 7 in. 31 ft of barrier is 2 in above 25 in.			
	<b>Breaking and Cracking:</b>	No breaking or cracking observed.			
	<b>Missing Elements:</b>	No missing elements observed.			
	<b>Corrosion and Weathering:</b>	No corrosion or weathering observed.			
<b>End Treatments</b>	<b>Alignment and Height:</b>				
	<b>Breaking and Cracking:</b>				
	<b>Missing Elements:</b>				
	<b>Corrosion and Weathering:</b>

<b>Repair Action:</b>	REPAIR	<b>FMSS Work Type:</b>	DEFERRED MAINTENANCE	<b>Repair Cost:</b>	\$1964
<b>Brief Workorder:</b>	Lower 31feet of guardrail to match adjacent 25 inch height.				
<b>Workorder:</b>	Adjust Guardrail at \$10- per -Lin. Ft. for 31 LF = \$310. Lower 31feet of guardrail to match adjacent 25 inch height. Low Speed Traffic Control at \$1475- per -Day for 1 Day(s) = \$1475.

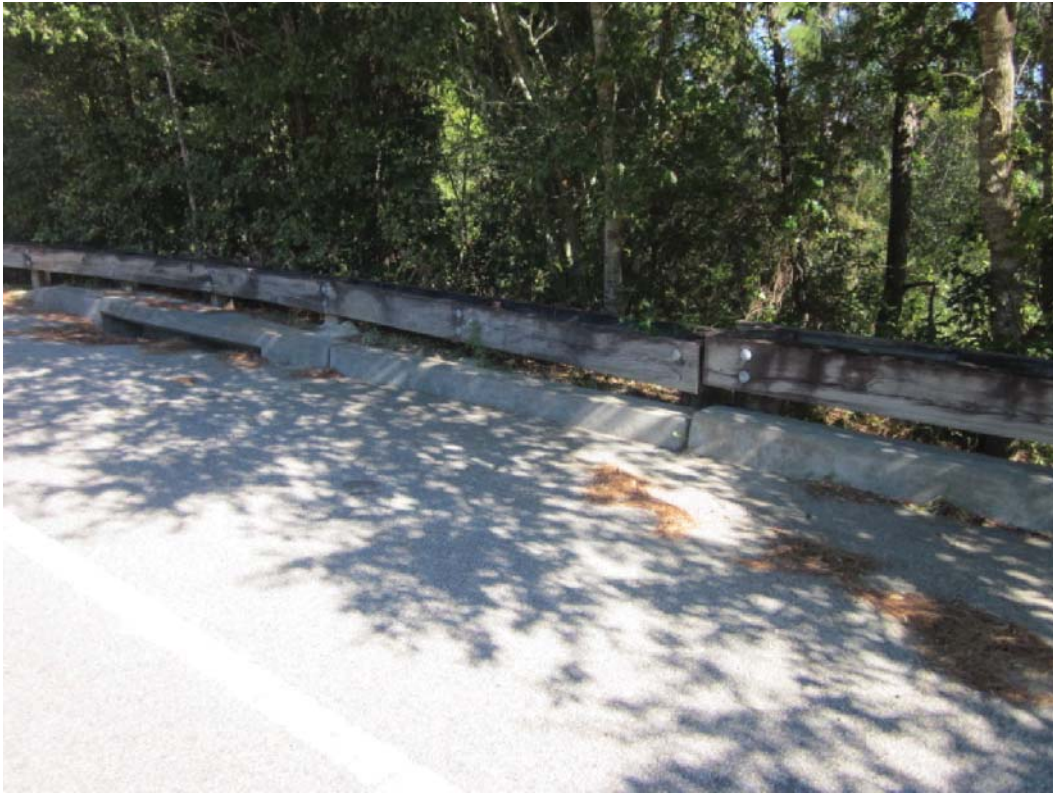
GUIIS\_0015\_0.771\_L\_1.JPG

<b>Barrier ID:</b>	GUIS-0015-0.771-L				
<b>Route Name:</b>	PARK ROAD				
<b>Inspection Date:</b>	08/11/2010	<b>Barrier Rating:</b>	28.20		
<b>Barrier Description</b>					
<b>Type:</b>	OTHER: TIMBER RAIL ON TIMBER POSTS	<b>Barrier Function:</b>	TRAFFIC		
<b>Barrier Material:</b>	LOG/TIMBER/WOOD	<b>Post Material:</b>	WOOD		
<b>Blockout Type:</b>	N/A	<b>Length (ft.):</b>	710		
<b>Speed Limit (MPH):</b>	35	<b>Placement with Respect to Road:</b>	TANGENT		
<b>Hazard Behind Barrier:</b>	LOW				
<b>Barrier Crashworthiness</b>					
<b>Appropriate Test Level:</b>	TL-2	<b>Barrier Test Level:</b>	NCW	<b>Is Barrier Crashworthy?:</b>	NO
<b>Beg. End Trtmt Type:</b>	NONE	<b>Is Beg. End Trtmt Crashworthy?:</b>	N/A	<b>Approach Transition Type:</b>	OTHER: BRIDGE RAIL TIMBER
<b>Ending End Trtmt Type:</b>	NONE	<b>Ending End Trtmt Crashworthy?:</b>	N/A		
<b>Average Measurements</b>					
<b>Design Height (In.):</b>	20	<b>Width (In.):</b>	0.0	<b>Post Spacing (In.):</b>	76.0

<b>Height (In.):</b>	25.7	<b>Lateral Offset (In.):</b>	73.1	<b>Road Grade (%):</b>	2.60
<b>Physical Condition</b>					
<b>Barrier</b>	<b>Alignment and Height:</b>	The barrier alignment had no deviation and height is 5 to 9 in above the 20 in design height for 300 ft.			
	<b>Breaking and Cracking:</b>	No breaking or cracking observed.			
	<b>Missing Elements:</b>	No missing elements observed.			
	<b>Corrosion and Weathering:</b>	No corrosion or weathering observed.			
<b>End Treatments</b>	<b>Alignment and Height:</b>				
	<b>Breaking and Cracking:</b>				
	<b>Missing Elements:</b>				
	<b>Corrosion and Weathering:</b>

<b>Repair Action:</b>	REPAIR	<b>FMSS Work Type:</b>	DEFERRED MAINTENANCE	<b>Repair Cost:</b>	\$6545
<b>Brief Workorder:</b>	Lower 300 feet of guardrail to match adjacent 25 inch height.				
<b>Workorder:</b>	Adjust Guardrail at \$10- per -Lin. Ft. for 300 LF = \$3000. Lower 300 feet of guardrail to match adjacent 25 inch height. Low Speed Traffic Control at \$1475- per -Day for 2 Day(s) = \$2950.

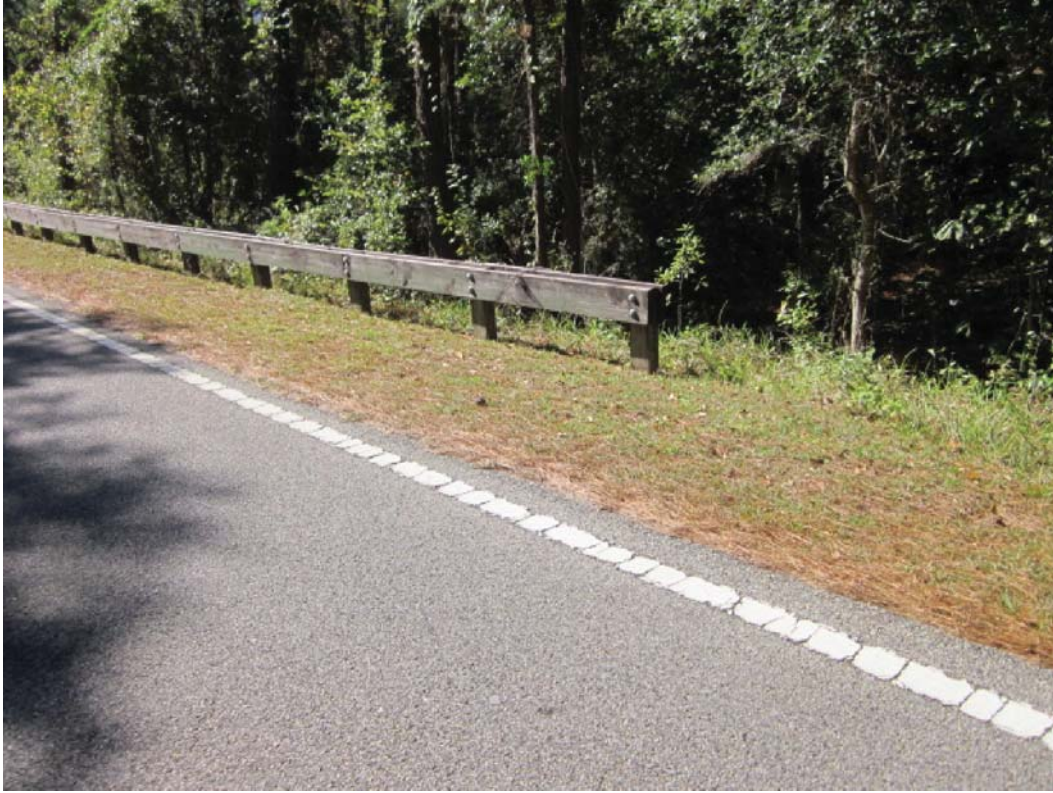
GUIS\_0015\_0.783\_R\_1.JPG

<b>Barrier ID:</b>	GUIS-0015-0.783-R				
<b>Route Name:</b>	PARK ROAD				
<b>Inspection Date:</b>	08/11/2010	<b>Barrier Rating:</b>	24.10		
<b>Barrier Description</b>					
<b>Type:</b>	OTHER: TIMBER RAIL ON TIMBER POSTS	<b>Barrier Function:</b>	TRAFFIC		
<b>Barrier Material:</b>	LOG/TIMBER/WOOD	<b>Post Material:</b>	WOOD		
<b>Blockout Type:</b>	N/A	<b>Length (ft.):</b>	647		
<b>Speed Limit (MPH):</b>	35	<b>Placement with Respect to Road:</b>	TANGENT		
<b>Hazard Behind Barrier:</b>	LOW				
<b>Barrier Crashworthiness</b>					
<b>Appropriate Test Level:</b>	TL-2	<b>Barrier Test Level:</b>	NCW	<b>Is Barrier Crashworthy?:</b>	NO
<b>Beg. End Trtmt Type:</b>	NONE	<b>Is Beg. End Trtmt Crashworthy?:</b>	N/A	<b>Approach Transition Type:</b>	OTHER: BRIDGE RAIL TIMBER
<b>Ending End Trtmt Type:</b>	NONE	<b>Ending End Trtmt Crashworthy?:</b>	N/A		
<b>Average Measurements</b>					
<b>Design Height (In.):</b>	20	<b>Width (In.):</b>	0.0	<b>Post Spacing (In.):</b>	72.5

<b>Height (In.):</b>	25.0	<b>Lateral Offset (In.):</b>	74.0	<b>Road Grade (%):</b>	3.10
<b>Physical Condition</b>					
<b>Barrier</b>	<b>Alignment and Height:</b>	The barrier alignment has no deviation and height is 5 to 6 in above the 20 in design height for 150 ft.			
	<b>Breaking and Cracking:</b>	No breaking or cracking observed.			
	<b>Missing Elements:</b>	No missing elements observed.			
	<b>Corrosion and Weathering:</b>	No weathering or corrosion observed.			
<b>End Treatments</b>	<b>Alignment and Height:</b>				
	<b>Breaking and Cracking:</b>				
	<b>Missing Elements:</b>				
	<b>Corrosion and Weathering:</b>

<b>Repair Action:</b>	REPAIR	<b>FMSS Work Type:</b>	DEFERRED MAINTENANCE	<b>Repair Cost:</b>	\$3273
<b>Brief Workorder:</b>	Lower 150 ft. of guardrail to match adjacent 25 inch height.				
<b>Workorder:</b>	Adjust Guardrail at \$10- per -Lin. Ft. for 150 LF = \$1500. Lower 150 ft. of guardrail to match adjacent 25 inch height. Low Speed Traffic Control at \$1475- per -Day for 1 Day(s) = \$1475.

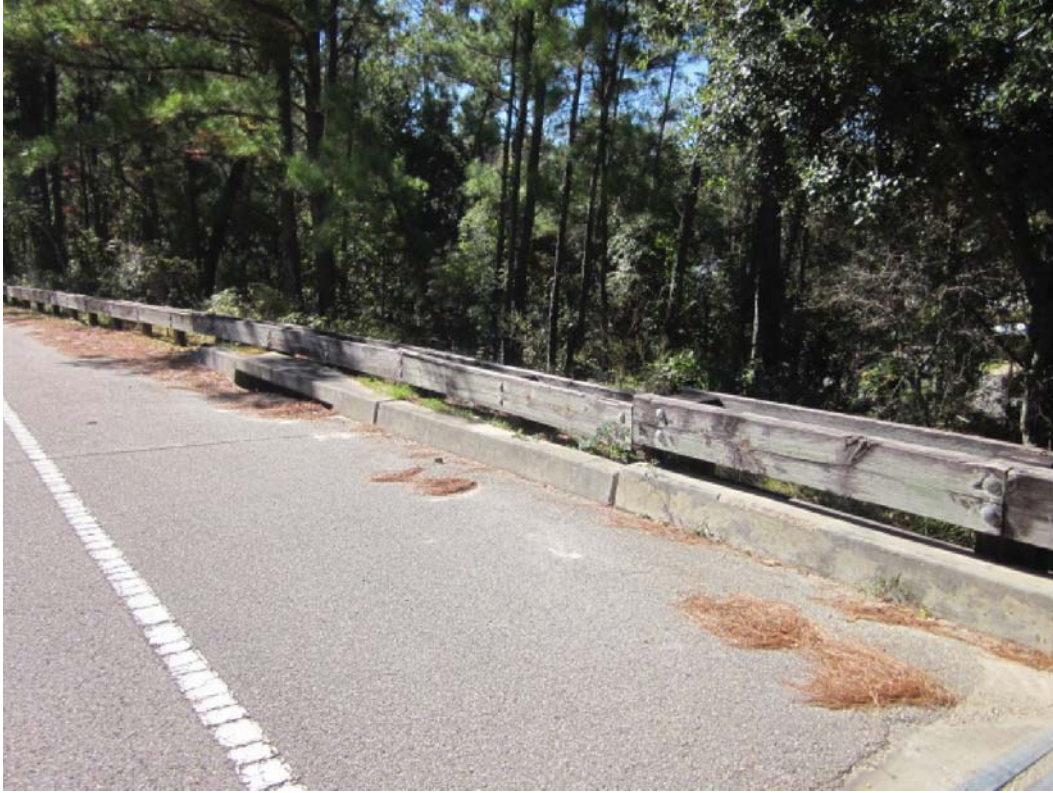
GUIS\_0015\_0.932\_R\_1.JPG

<b>Barrier ID:</b>	GUIS-0015-0.932-R				
<b>Route Name:</b>	PARK ROAD				
<b>Inspection Date:</b>	08/11/2010	<b>Barrier Rating:</b>	24.00		
<b>Barrier Description</b>					
<b>Type:</b>	OTHER: TIMBER RAIL ON TIMBER POSTS	<b>Barrier Function:</b>	TRAFFIC		
<b>Barrier Material:</b>	LOG/TIMBER/WOOD	<b>Post Material:</b>	WOOD		
<b>Blockout Type:</b>	N/A	<b>Length (ft.):</b>	595		
<b>Speed Limit (MPH):</b>	35	<b>Placement with Respect to Road:</b>	TANGENT		
<b>Hazard Behind Barrier:</b>	HIGH				
<b>Barrier Crashworthiness</b>					
<b>Appropriate Test Level:</b>	TL-2	<b>Barrier Test Level:</b>	NCW	<b>Is Barrier Crashworthy?:</b>	NO
<b>Beg. End Trtmt Type:</b>	NONE	<b>Is Beg. End Trtmt Crashworthy?:</b>	N/A	<b>Approach Transition Type:</b>	OTHER: BRIDGE RAIL TIMBER
<b>Ending End Trtmt Type:</b>	NONE	<b>Ending End Trtmt Crashworthy?:</b>	N/A		
<b>Average Measurements</b>					
<b>Design Height (In.):</b>	20	<b>Width (In.):</b>	0.0	<b>Post Spacing (In.):</b>	75.3

<b>Height (In.):</b>	24.2	<b>Lateral Offset (In.):</b>	75.6	<b>Road Grade (%):</b>	2.90
<b>Physical Condition</b>					
<b>Barrier</b>	<b>Alignment and Height:</b>	Alignment has no deviation and height is above the design height of 20 in by 4 to 5 in.			
	<b>Breaking and Cracking:</b>	No breaking or cracking observed.			
	<b>Missing Elements:</b>	No missing elements observed.			
	<b>Corrosion and Weathering:</b>	24 ft of rail has 10 in eroded.			
<b>End Treatments</b>	<b>Alignment and Height:</b>				
	<b>Breaking and Cracking:</b>				
	<b>Missing Elements:</b>				
	<b>Corrosion and Weathering:</b>

<b>Repair Action:</b>	REPAIR	<b>FMSS Work Type:</b>	DEFERRED MAINTENANCE	<b>Repair Cost:</b>	\$1843
<b>Brief Workorder:</b>	Add 4 CY of structural backfill along 24 feet of guardrail to fix erosion.				
<b>Workorder:</b>	Structural Backfill at \$50- per -Cu. Yd. for 4 CY = \$200. $[(0.8ft)(5ft)(24ft)]/27 = 3.6$ CY. Add structural backfill to fix erosion. Low Speed Traffic Control at \$1475- per -Day for 1 Day(s) = \$1475.

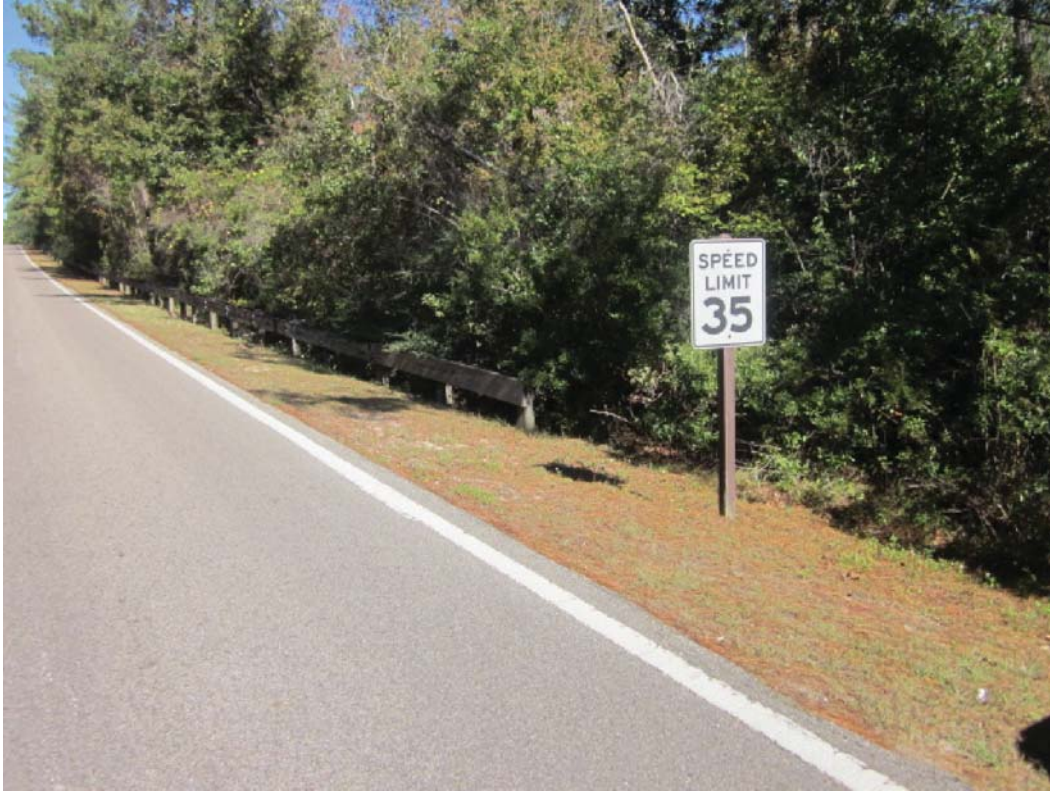
GUIS\_0015\_0.934\_L\_1.JPG

<b>Barrier ID:</b>	GUIS-0015-0.934-L				
<b>Route Name:</b>	PARK ROAD				
<b>Inspection Date:</b>	08/11/2010	<b>Barrier Rating:</b>	22.20		
<b>Barrier Description</b>					
<b>Type:</b>	OTHER: TIMBER RAIL DOUBLE FACE ON TIMBER	<b>Barrier Function:</b>	TRAFFIC		
<b>Barrier Material:</b>	LOG/TIMBER/WOOD	<b>Post Material:</b>	WOOD		
<b>Blockout Type:</b>	N/A	<b>Length (ft.):</b>	598		
<b>Speed Limit (MPH):</b>	35	<b>Placement with Respect to Road:</b>	TANGENT		
<b>Hazard Behind Barrier:</b>	MEDIUM				
<b>Barrier Crashworthiness</b>					
<b>Appropriate Test Level:</b>	TL-2	<b>Barrier Test Level:</b>	NCW	<b>Is Barrier Crashworthy?:</b>	NO
<b>Beg. End Trtmt Type:</b>	NONE	<b>Is Beg. End Trtmt Crashworthy?:</b>	N/A	<b>Approach Transition Type:</b>	OTHER: BRIDGE RAIL TIMBER
<b>Ending End Trtmt Type:</b>	NONE	<b>Ending End Trtmt Crashworthy?:</b>	N/A		
<b>Average Measurements</b>					
<b>Design Height (In.):</b>	20	<b>Width (In.):</b>	0.0	<b>Post Spacing (In.):</b>	73.0

<b>Height (In.):</b>	25.0	<b>Lateral Offset (In.):</b>	81.0	<b>Road Grade (%):</b>	3.20
<b>Physical Condition</b>					
<b>Barrier</b>	<b>Alignment and Height:</b>	Alignment has no deviation and height is above the 20 in design height by up to 5 in.			
	<b>Breaking and Cracking:</b>	No breaking or cracking observed.			
	<b>Missing Elements:</b>	No missing elements observed.			
	<b>Corrosion and Weathering:</b>	12 ft of rail has 11 in eroded. 3 eroded holes along 10 ft of rail totaling 87 cubic feet.			
<b>End Treatments</b>	<b>Alignment and Height:</b>				
	<b>Breaking and Cracking:</b>				
	<b>Missing Elements:</b>				
	<b>Corrosion and Weathering:</b>

<b>Repair Action:</b>	REPAIR	<b>FMSS Work Type:</b>	DEFERRED MAINTENANCE	<b>Repair Cost:</b>	\$1953
<b>Brief Workorder:</b>	12 feet of rail has erosion that needs structural backfill.				
<b>Workorder:</b>	Structural Backfill at \$50- per -Cu. Yd. for 6 CY = \$300. [(3ft)(3ft)(3ft) + (4ft)(3ft)(2ft) + (3ft)(4ft)(3ft) + (1ft)(5ft)(12ft)] / 27 = 5.4 CY. Structural backfill for four holes. Low Speed Traffic Control at \$1475- per -Day for 1 Day(s) = \$1475.

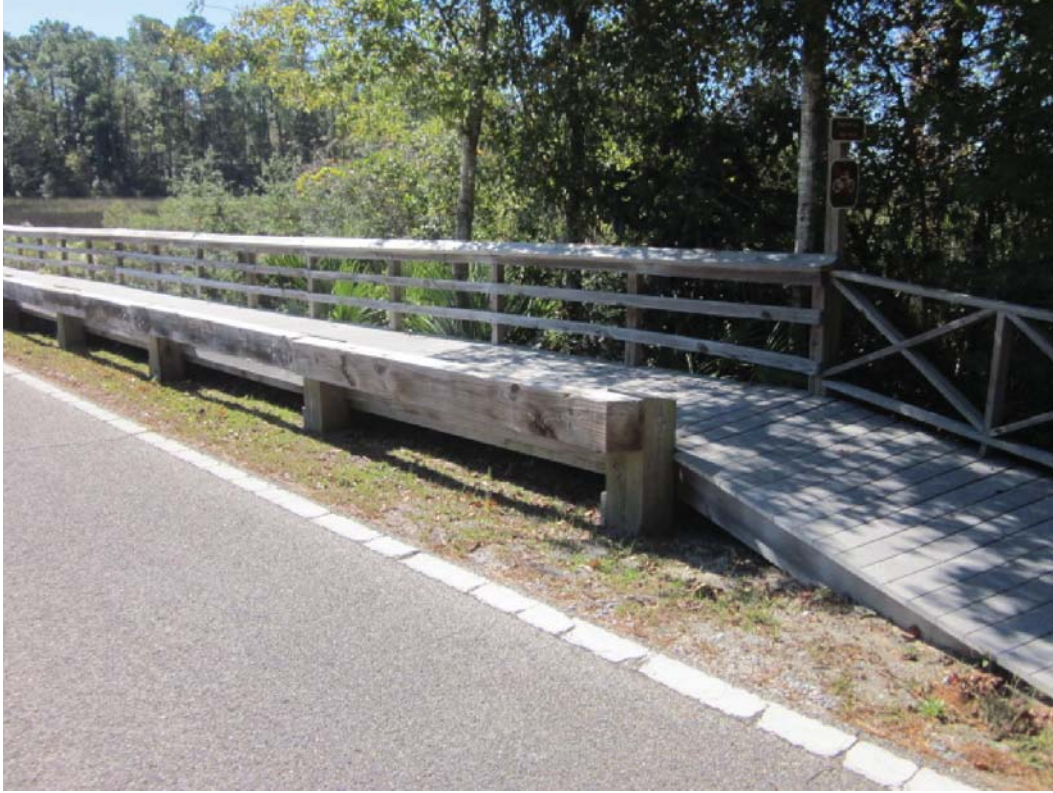
GUIS\_0015\_1.830\_R\_1.JPG

<b>Barrier ID:</b>	GUIS-0015-1.830-R				
<b>Route Name:</b>	PARK ROAD				
<b>Inspection Date:</b>	08/11/2010	<b>Barrier Rating:</b>	21.30		
<b>Barrier Description</b>					
<b>Type:</b>	STEEL-BACKED TIMBER WITHOUT BLOCKOUT	<b>Barrier Function:</b>	TRAFFIC		
<b>Barrier Material:</b>	STEEL-BACKED TIMBER/LOG	<b>Post Material:</b>	WOOD		
<b>Blockout Type:</b>	N/A	<b>Length (ft.):</b>	294		
<b>Speed Limit (MPH):</b>	25	<b>Placement with Respect to Road:</b>	TANGENT		
<b>Hazard Behind Barrier:</b>	LOW				
<b>Barrier Crashworthiness</b>					
<b>Appropriate Test Level:</b>	TL-1	<b>Barrier Test Level:</b>	TL-2	<b>Is Barrier Crashworthy?:</b>	YES
<b>Beg. End Trtmt Type:</b>	NONE	<b>Is Beg. End Trtmt Crashworthy?:</b>	N/A	<b>Approach Transition Type:</b>	NONE
<b>Ending End Trtmt Type:</b>	NONE	<b>Ending End Trtmt Crashworthy?:</b>	N/A		
<b>Average Measurements</b>					
<b>Design Height (In.):</b>	27	<b>Width (In.):</b>	0.0	<b>Post Spacing (In.):</b>	121.3

<b>Height (In.):</b>	24.6	<b>Lateral Offset (In.):</b>	35.0	<b>Road Grade (%):</b>	1.20
<b>Physical Condition</b>					
<b>Barrier</b>	<b>Alignment and Height:</b>	The barrier alignment has no deviation and height is 2 to 3 in below the 27 in design height for 244 ft.			
	<b>Breaking and Cracking:</b>	No breaking or cracking observed.			
	<b>Missing Elements:</b>	No missing elements observed.			
	<b>Corrosion and Weathering:</b>	No corrosion or weathering observed.			
<b>End Treatments</b>	<b>Alignment and Height:</b>				
	<b>Breaking and Cracking:</b>				
	<b>Missing Elements:</b>				
	<b>Corrosion and Weathering:</b>

<b>Repair Action:</b>	REPAIR	<b>FMSS Work Type:</b>	DEFERRED MAINTENANCE	<b>Repair Cost:</b>	\$4307
<b>Brief Workorder:</b>	Raise 244 L.F. of guardrail up to 27 inch design height.				
<b>Workorder:</b>	Adjust Guardrail at \$10- per -Lin. Ft. for 244 LF = \$2440. Raise 244 L.F. of barrier up to 27 inch design height. Low Speed Traffic Control at \$1475- per -Day for 1 Day(s) = \$1475.

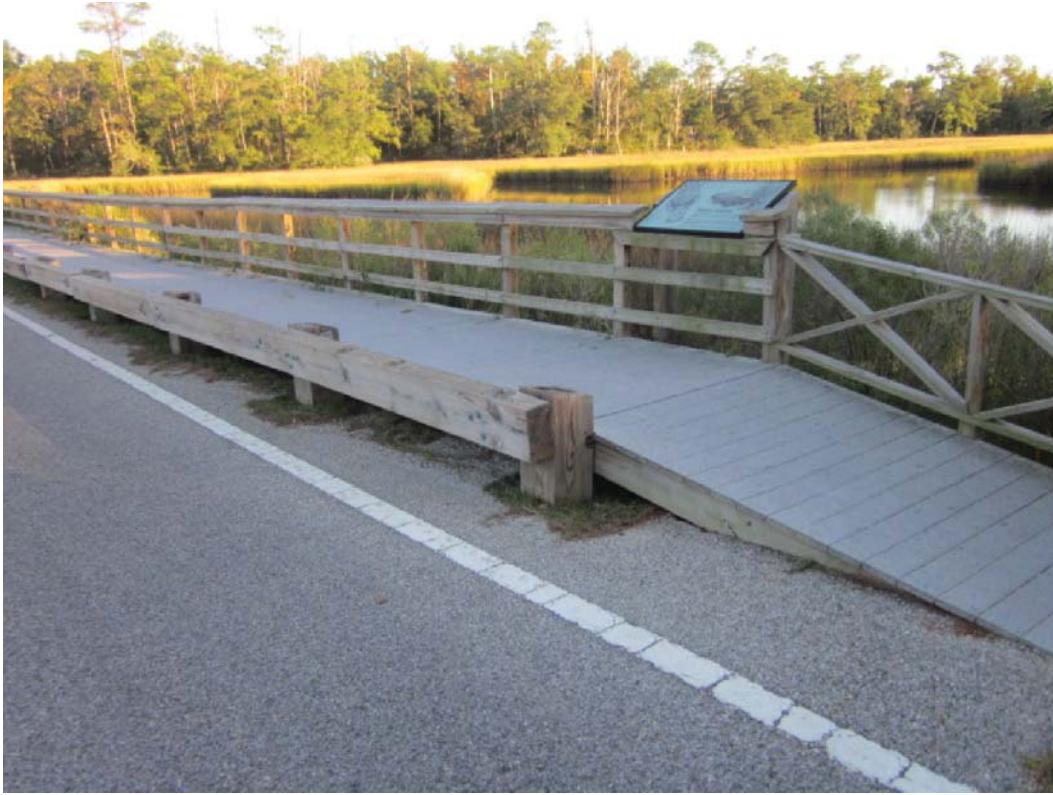
GUIS\_0016\_0.257\_L\_1.JPG

<b>Barrier ID:</b>	GUIS-0016-0.257-L				
<b>Route Name:</b>	ROBERT MCGEE ROAD				
<b>Inspection Date:</b>	08/11/2010		<b>Barrier Rating:</b>	51.20	
<b>Barrier Description</b>					
<b>Type:</b>	STEEL-BACKED TIMBER WITHOUT BLOCKOUT		<b>Barrier Function:</b>	TRAFFIC	
<b>Barrier Material:</b>	STEEL-BACKED TIMBER/LOG		<b>Post Material:</b>	WOOD	
<b>Blockout Type:</b>	N/A		<b>Length (ft.):</b>	638	
<b>Speed Limit (MPH):</b>	25		<b>Placement with Respect to Road:</b>	OUTSIDE OF CURVE	
<b>Hazard Behind Barrier:</b>	LOW				
<b>Barrier Crashworthiness</b>					
<b>Appropriate Test Level:</b>	TL-1	<b>Barrier Test Level:</b>	TL-2	<b>Is Barrier Crashworthy?:</b>	YES
<b>Beg. End Trtmt Type:</b>	NONE	<b>Is Beg. End Trtmt Crashworthy?:</b>	N/A	<b>Approach Transition Type:</b>	NONE
<b>Ending End Trtmt Type:</b>	NONE	<b>Ending End Trtmt Crashworthy?:</b>	N/A		
<b>Average Measurements</b>					
<b>Design Height (In.):</b>	27	<b>Width (In.):</b>	0.0	<b>Post Spacing (In.):</b>	115.0

<b>Height (In.):</b>	20.6	<b>Lateral Offset (In.):</b>	24.0	<b>Road Grade (%):</b>	0.30
<b>Physical Condition</b>					
<b>Barrier</b>	<b>Alignment and Height:</b>	The barrier alignment has no deviation and the height is 5 to 8 in below the 27 in design height for 638 ft.			
	<b>Breaking and Cracking:</b>	No breaking or cracking observed.			
	<b>Missing Elements:</b>	No missing elements observed.			
	<b>Corrosion and Weathering:</b>	No corrosion or weathering observed.			
<b>End Treatments</b>	<b>Alignment and Height:</b>				
	<b>Breaking and Cracking:</b>				
	<b>Missing Elements:</b>				
	<b>Corrosion and Weathering:</b>

<b>Repair Action:</b>	REPAIR	<b>FMSS Work Type:</b>	DEFERRED MAINTENANCE	<b>Repair Cost:</b>	\$11886
<b>Brief Workorder:</b>	Raise 638 feet of guardrail to 27 inch design height.				
<b>Workorder:</b>	Adjust Guardrail at \$10- per -Lin. Ft. for 638 LF = \$6380. Raise 638 feet of guardrail to 27 inch design height. Low Speed Traffic Control at \$1475- per -Day for 3 Day(s) = \$4425.
