# KICA GIP Report

## NPS Guardwall/Rail Inventory Program Kings Canyon National Park

Federal Highway Administration  
Eastern Federal Lands Highway Division  
Road Inventory Program (RIP)

Data Collection Date: October 2009  
Report Date: November 2015

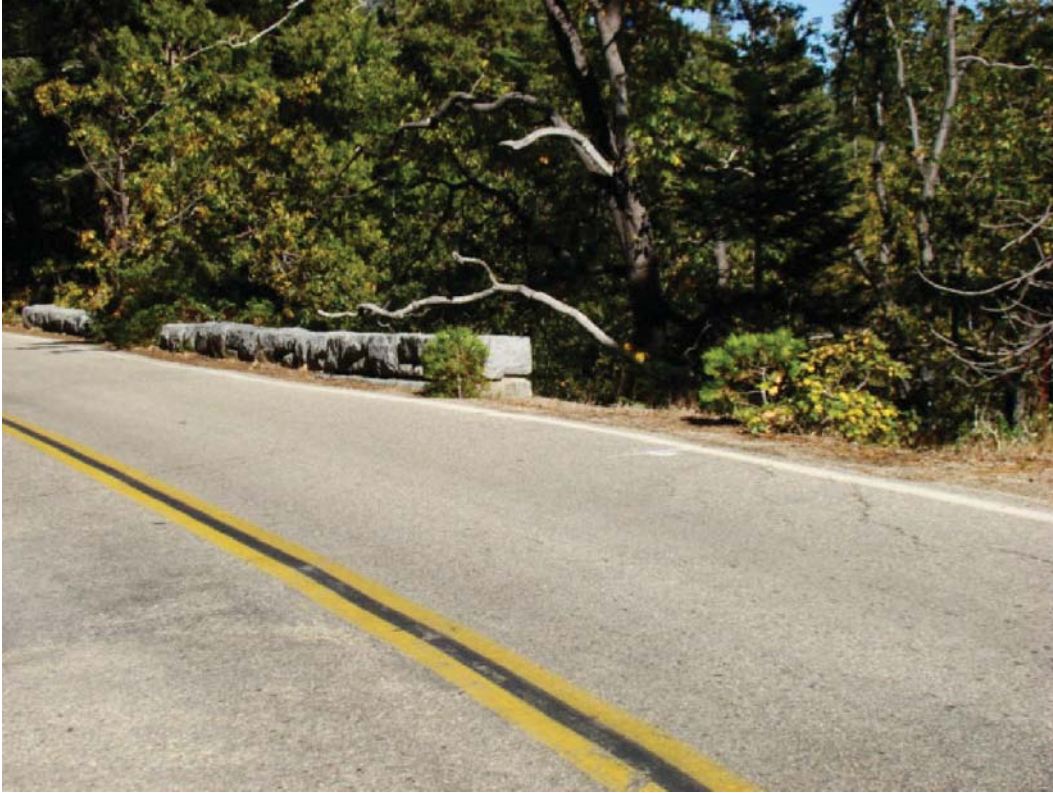
**KICA\_0010\_43.022\_L\_1.JPG**

<b>Barrier ID:</b>	KICA-0010-43.022-L				
<b>Route Name:</b>	GENERALS HIGHWAY HISTORIC				
<b>Inspection Date:</b>	10/20/2009	<b>Barrier Rating:</b>	35.50		
<b>Barrier Description</b>					
<b>Type:</b>	STONE MASONRY WITHOUT CONCRETE CORE WALL	<b>Barrier Function:</b>	TRAFFIC		
<b>Barrier Material:</b>	STONE	<b>Post Material:</b>	N/A		
<b>Blockout Type:</b>	N/A	<b>Length (ft.):</b>	42		
<b>Speed Limit (MPH):</b>	25	<b>Placement with Respect to Road:</b>	TANGENT		
<b>Hazard Behind Barrier:</b>	HIGH				
<b>Barrier Crashworthiness</b>					
<b>Appropriate Test Level:</b>	TL-1	<b>Barrier Test Level:</b>	NCW	<b>Is Barrier Crashworthy?:</b>	NO
<b>Beg. End Trtmt Type:</b>	NONE	<b>Is Beg. End Trtmt Crashworthy?:</b>	N/A	<b>Approach Transition Type:</b>	NONE
<b>Ending End Trtmt Type:</b>	NONE	<b>Ending End Trtmt Crashworthy?:</b>	N/A		
<b>Average Measurements</b>					
<b>Design Height (In.):</b>	24	<b>Width (In.):</b>	20.0	<b>Post Spacing (In.):</b>	0.0

<b>Height (In.):</b>	18.2	<b>Lateral Offset (In.):</b>	28.2	<b>Road Grade (%):</b>	0.60
<b>Physical Condition</b>					
<b>Barrier</b>	<b>Alignment and Height:</b>	Alignment is acceptable. 34 ft was 3-6 in below the 24-in design height and 8 ft was 6-8in below.			
	<b>Breaking and Cracking:</b>	No breaking or cracking of stones or grout.			
	<b>Missing Elements:</b>	No missing elements.			
	<b>Corrosion and Weathering:</b>	No corrosion or weathering.			
<b>End Treatments</b>	<b>Alignment and Height:</b>				
	<b>Breaking and Cracking:</b>				
	<b>Missing Elements:</b>				
	<b>Corrosion and Weathering:</b>

<b>Repair Action:</b>	REPAIR	<b>FMSS Work Type:</b>	DEFERRED MAINTENANCE	<b>Repair Cost:</b>	\$12177
<b>Brief Workorder:</b>	Remove and reset the approx. 8 foot section of guardwall that is below 18 inches in height and raise up to 18 inches.				
<b>Workorder:</b>	Remove & reset stone masonry guardwall at \$250- per -Cu. Ft. for 28 CF = \$7000. [(2ft)(1.7ft)(8ft)] = 27.2 CF. Structural Concrete at \$1000- per -Cu. Yd. for 1 CY = \$1000. [(1.7ft)(0.5ft)(8ft)] /27 = 0.3 CY. Labor at \$60- per -Hour for 2 Hrs = \$120. Remove loose soil and vegetation from front of the guardwall. Low Speed Traffic Control at \$1475- per -Day for 2 Day(s) = \$2950. 1 day removal 1 day installation.

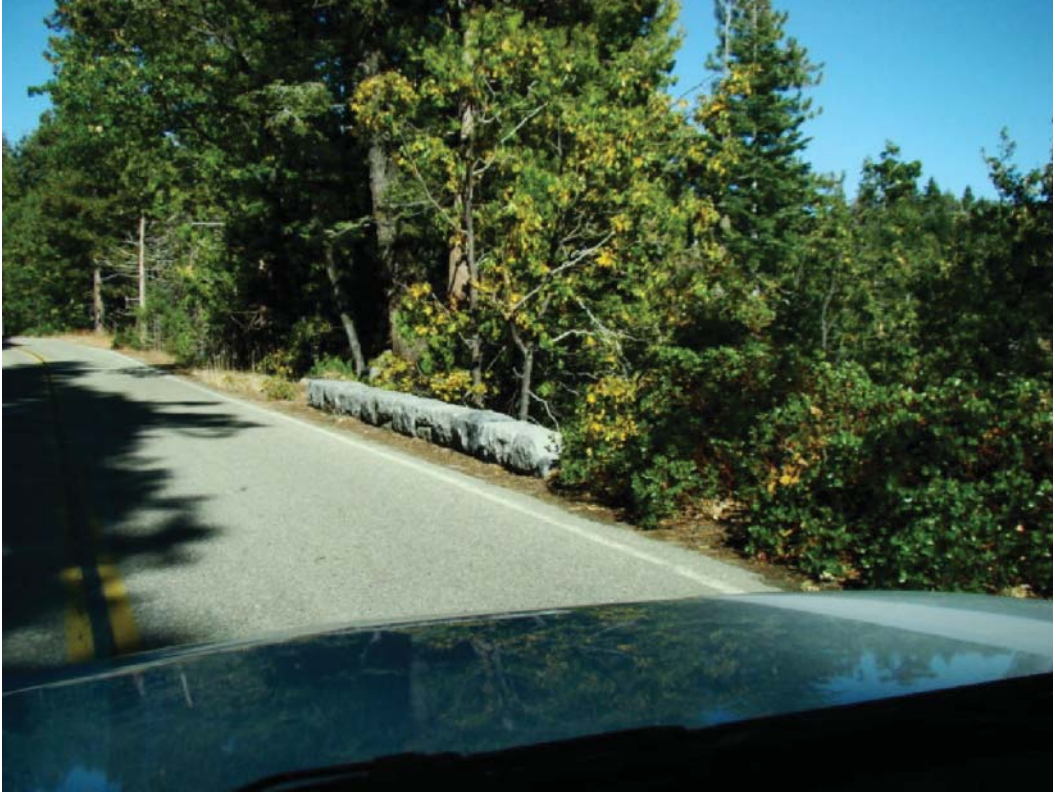
**KICA\_0010\_43.035\_L\_1.JPG**

<b>Barrier ID:</b>	KICA-0010-43.035-L				
<b>Route Name:</b>	GENERALS HIGHWAY HISTORIC				
<b>Inspection Date:</b>	10/20/2009	<b>Barrier Rating:</b>	35.50		
<b>Barrier Description</b>					
<b>Type:</b>	STONE MASONRY WITHOUT CONCRETE CORE WALL	<b>Barrier Function:</b>	TRAFFIC		
<b>Barrier Material:</b>	STONE	<b>Post Material:</b>	N/A		
<b>Blockout Type:</b>	N/A	<b>Length (ft.):</b>	57		
<b>Speed Limit (MPH):</b>	25	<b>Placement with Respect to Road:</b>	TANGENT		
<b>Hazard Behind Barrier:</b>	HIGH				
<b>Barrier Crashworthiness</b>					
<b>Appropriate Test Level:</b>	TL-1	<b>Barrier Test Level:</b>	NCW	<b>Is Barrier Crashworthy?:</b>	NO
<b>Beg. End Trtmt Type:</b>	NONE	<b>Is Beg. End Trtmt Crashworthy?:</b>	N/A	<b>Approach Transition Type:</b>	NONE
<b>Ending End Trtmt Type:</b>	NONE	<b>Ending End Trtmt Crashworthy?:</b>	N/A		
<b>Average Measurements</b>					
<b>Design Height (In.):</b>	24	<b>Width (In.):</b>	19.2	<b>Post Spacing (In.):</b>	0.0

<b>Height (In.):</b>	19.2	<b>Lateral Offset (In.):</b>	31.7	<b>Road Grade (%):</b>	0.50
<b>Physical Condition</b>					
<b>Barrier</b>	<b>Alignment and Height:</b>	Alignment is acceptable. Height is between 3 and 6-in below 24-in design height.			
	<b>Breaking and Cracking:</b>	No breaking or cracking observed.			
	<b>Missing Elements:</b>	No missing elements.			
	<b>Corrosion and Weathering:</b>	No corrosion or weathering.			
<b>End Treatments</b>	<b>Alignment and Height:</b>				
	<b>Breaking and Cracking:</b>				
	<b>Missing Elements:</b>				
	<b>Corrosion and Weathering:</b>

<b>Barrier ID:</b>	KICA-0010-43.035-L				
<b>Route Name:</b>	GENERALS HIGHWAY HISTORIC				
<b>Inspection Date:</b>	10/20/2009	<b>Barrier Rating:</b>	35.50		
<b>Repair Recommendations</b>					
<b>Repair Action:</b>	NO ACTION	<b>FMSS Work Type:</b>	N/A	<b>Repair Cost:</b>	\$0
<b>Brief Workorder:</b>	N/A				
<b>Workorder:</b>

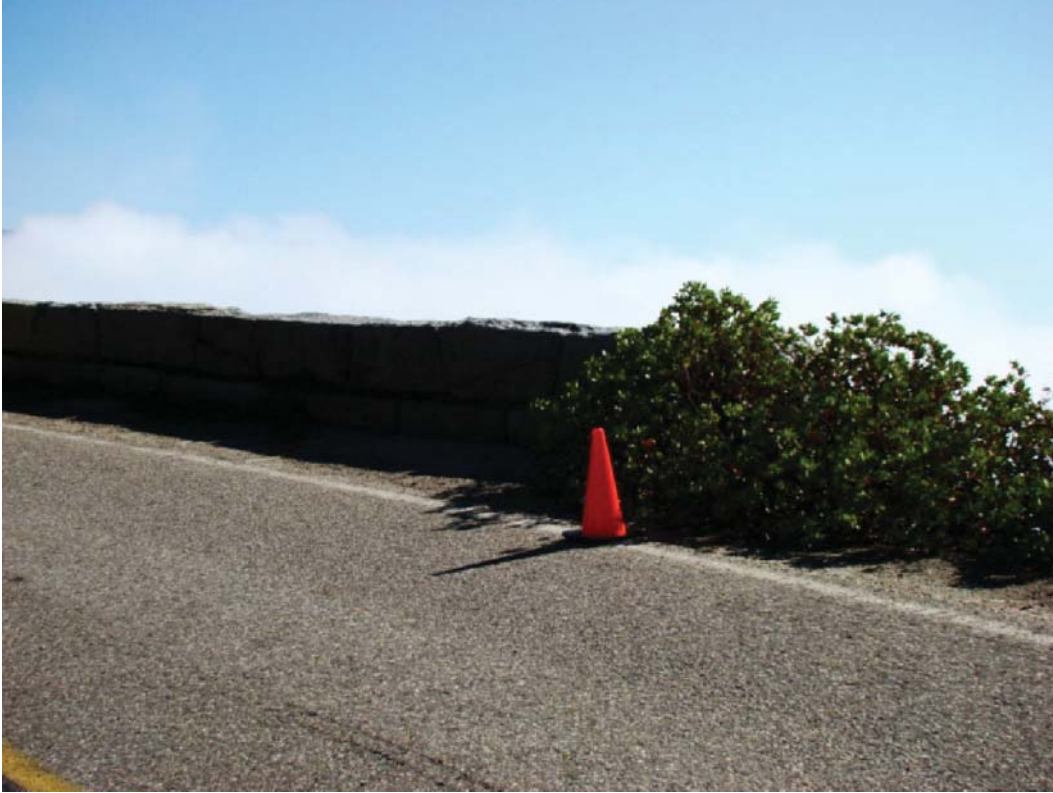
**KICA\_0010\_43.120\_L\_1.JPG**

<b>Barrier ID:</b>	KICA-0010-43.120-L				
<b>Route Name:</b>	GENERALS HIGHWAY HISTORIC				
<b>Inspection Date:</b>	10/20/2009	<b>Barrier Rating:</b>	28.60		
<b>Barrier Description</b>					
<b>Type:</b>	STONE MASONRY WITH CONCRETE CORE WALL	<b>Barrier Function:</b>	TRAFFIC		
<b>Barrier Material:</b>	CONCRETE	<b>Post Material:</b>	N/A		
<b>Blockout Type:</b>	N/A	<b>Length (ft.):</b>	167		
<b>Speed Limit (MPH):</b>	25	<b>Placement with Respect to Road:</b>	OUTSIDE OF CURVE		
<b>Hazard Behind Barrier:</b>	EXTREME				
<b>Barrier Crashworthiness</b>					
<b>Appropriate Test Level:</b>	TL-1	<b>Barrier Test Level:</b>	TL-3	<b>Is Barrier Crashworthy?:</b>	YES
<b>Beg. End Trtmt Type:</b>	NONE	<b>Is Beg. End Trtmt Crashworthy?:</b>	N/A	<b>Approach Transition Type:</b>	NONE
<b>Ending End Trtmt Type:</b>	NONE	<b>Ending End Trtmt Crashworthy?:</b>	N/A		
<b>Average Measurements</b>					
<b>Design Height (In.):</b>	27	<b>Width (In.):</b>	19.0	<b>Post Spacing (In.):</b>	0.0

<b>Height (In.):</b>	27.7	<b>Lateral Offset (In.):</b>	57.0	<b>Road Grade (%):</b>	5.00
<b>Physical Condition</b>					
<b>Barrier</b>	<b>Alignment and Height:</b>	Alignment is acceptable. Entire barrier is between 1-in below to 2-in above the 27-in design height.			
	<b>Breaking and Cracking:</b>	No breaking or cracking observed.			
	<b>Missing Elements:</b>	There are (3) 1 in gaps in the grout.			
	<b>Corrosion and Weathering:</b>	No corrosion or weathering.			
<b>End Treatments</b>	<b>Alignment and Height:</b>				
	<b>Breaking and Cracking:</b>				
	<b>Missing Elements:</b>				
	<b>Corrosion and Weathering:</b>

<b>Repair Action:</b>	REPAIR	<b>FMSS Work Type:</b>	DEFERRED MAINTENANCE	<b>Repair Cost:</b>	\$1777
<b>Brief Workorder:</b>	Repoint 1 SY of barrier.				
<b>Workorder:</b>	Re-point masonry barrier at \$140- per -Sq. Yd. for 1 SY = \$140. Low Speed Traffic Control at \$1475- per -Day for 1 Day(s) = \$1475.
