LAKE GIP Report

NPS Guardwall/Rail Inventory Program Lake Mead National Recreation Area

**Data Collection Date: May 2010
Report Date: November 2015**

Lake Mead National Recreation Area in Arizona and Nevada

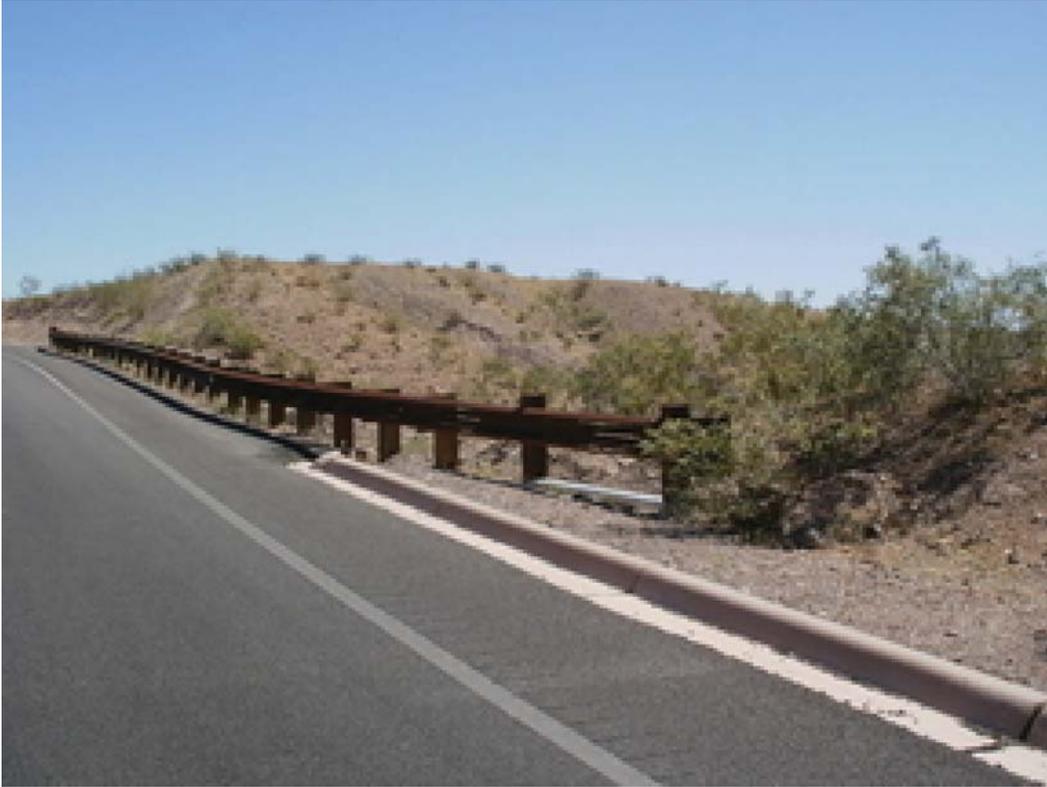
LAKE_0001_1.066_R_1.JPG

Barrier ID:	LAKE-0001-1.066-R				
Route Name:	EB NORTSHORE ROAD				
Inspection Date:	05/03/2010	Barrier Rating:	22.60		
Barrier Description					
Type:	W-BEAM STRONG POST	Barrier Function:	TRAFFIC		
Barrier Material:	WEATHERING STEEL/CORTEN	Post Material:	WOOD		
Blockout Type:	WOOD	Length (ft.):	166		
Speed Limit (MPH):	50	Placement with Respect to Road:	TANGENT		
Hazard Behind Barrier:	HIGH				
Barrier Crashworthiness					
Appropriate Test Level:	TL-3	Barrier Test Level:	TL-3	Is Barrier Crashworthy?:	YES
Beg. End Trtmt Type:	W-BEAM FLARED 350 COMPLIANT	Is Beg. End Trtmt Crashworthy?:	YES	Approach Transition Type:	NONE
Ending End Trtmt Type:	W-BEAM FLARED 350 COMPLIANT	Ending End Trtmt Crashworthy?:	YES		
Average Measurements					
Design Height (In.):	27	Width (In.):	0.0	Post Spacing (In.):	75.0
Height (In.):	26.7	Lateral Offset (In.):	68.0	Road Grade (%):	3.90
Physical Condition					
Barrier	Alignment and Height:	Alignment of barrier is acceptable. 10 ft. of barrier has a height 2-in. below the the 27-in. design height. Rest of barrier is within 1-in. of 27-in. design height.

Breaking and Cracking:	No major breaking or cracking was observed.			
	Missing Elements:	No missing barrier elements were observed.			
	Corrosion and Weathering:	No major corrosion or weathering was observed.			
End Treatments	Alignment and Height:	End treatment alignment is acceptable but the beginning end treatment (37-ft) is 2 in below the 27 in design height for 37-ft.			
	Breaking and Cracking:	No breaks or cracks were observed in the end treatments.			
	Missing Elements:	No missing end treatment elements observed.			
	Corrosion and Weathering:	No corrosion or weathering observed in end treatments.

Repair Action:	REPAIR	FMSS Work Type:	DEFERRED MAINTENANCE	Repair Cost:	\$3102
Brief Workorder:	Raise the height of the first 47 feet of barrier up to the 27 inch design height.				
Workorder:	Adjust Guardrail at \$10- per -Lin. Ft. for 47 LF = \$470. Raise 47-ft of barrier up to the 27 inch design height. High Speed Traffic Control at \$2350- per -Day for 1 Day(s) = \$2350.

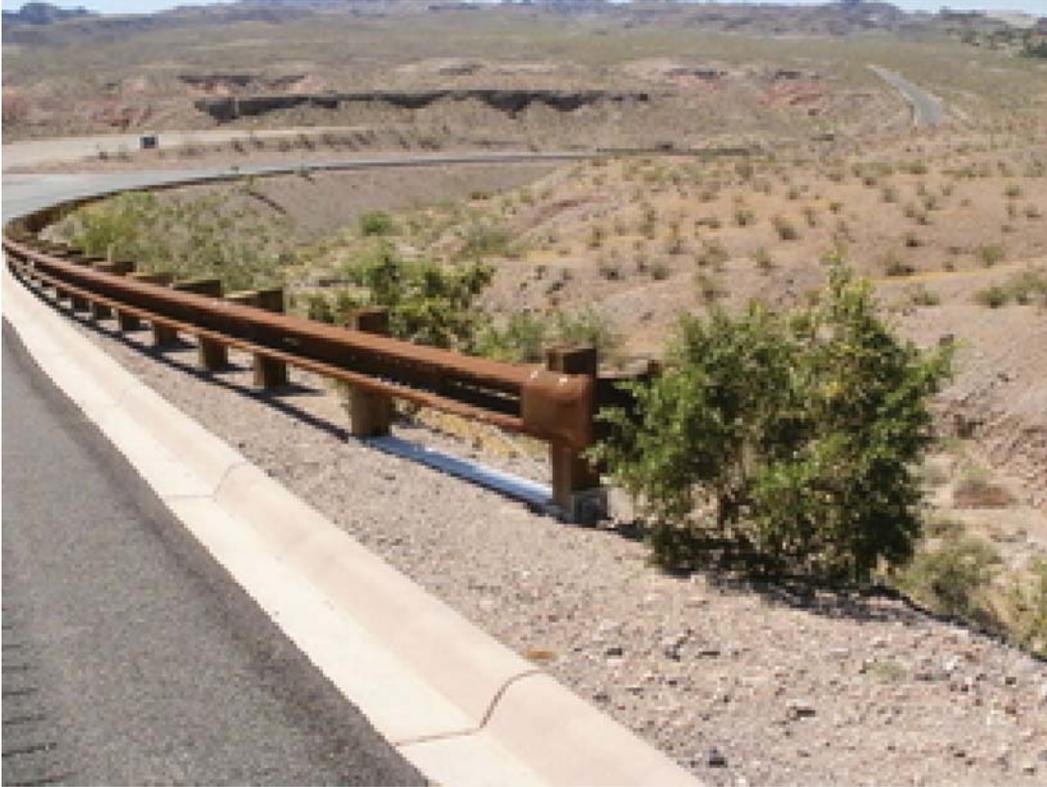
LAKE_0001_1.072_L_1.JPG

Barrier ID:	LAKE-0001-1.072-L				
Route Name:	EB NORTHSORE ROAD				
Inspection Date:	05/03/2010	Barrier Rating:	33.70		
Barrier Description					
Type:	W-BEAM STRONG POST	Barrier Function:	TRAFFIC		
Barrier Material:	WEATHERING STEEL/CORTEN	Post Material:	WOOD		
Blockout Type:	WOOD	Length (ft.):	983		
Speed Limit (MPH):	50	Placement with Respect to Road:	INSIDE OF CURVE		
Hazard Behind Barrier:	MEDIUM				
Barrier Crashworthiness					
Appropriate Test Level:	TL-3	Barrier Test Level:	TL-3	Is Barrier Crashworthy?:	YES
Beg. End Trtmt Type:	W-BEAM FLARED 350 COMPLIANT	Is Beg. End Trtmt Crashworthy?:	YES	Approach Transition Type:	NONE
Ending End Trtmt Type:	W-BEAM FLARED 350 COMPLIANT	Ending End Trtmt Crashworthy?:	YES		
Average Measurements					
Design Height (In.):	27	Width (In.):	0.0	Post Spacing (In.):	74.4
Height (In.):	26.8	Lateral Offset (In.):	63.5	Road Grade (%):	5.00
Physical Condition					
Barrier	Alignment and Height:	Alignment is acceptable. 958-ft of barrier is within 1-in. of 27-in. design height.

Breaking and Cracking:	4 loose blocks in barrier. 25 ft of bent rail from probable impact.			
	Missing Elements:	No missing elements in barrier.			
	Corrosion and Weathering:	Minor erosion 4 to 6 in deep around 5 posts in barrier.			
End Treatments	Alignment and Height:	End treatments are in alignment. Approach end treatment (20-ft) is below 27 in design height by 2 in.			
	Breaking and Cracking:	Trailing end treatment buffered end is severely bent.			
	Missing Elements:	No missing end treatment elements observed.			
	Corrosion and Weathering:	Minor erosion around approach end treatment post is 6-in deep.

Repair Action:	REPAIR	FMSS Work Type:	DEFERRED MAINTENANCE	Repair Cost:	\$3624
Brief Workorder:	Raise 20-ft of barrier to 27-in. design height replace bent rail sections tighten loose blocks.				
Workorder:	Replace Rail at \$25- per -Lin. Ft. for 25 LF = \$625. Replace bent rail and replace the buffer end of the end treatment. Adjust Guardrail at \$10- per -Lin. Ft. for 20 LF = \$200. Raise 20-ft. of barrier up to 27-in design height. Labor at \$60- per -Hour for 2 Hrs = \$120. Tighten 4 loose blocks. High Speed Traffic Control at \$2350- per -Day for 1 Day(s) = \$2350.

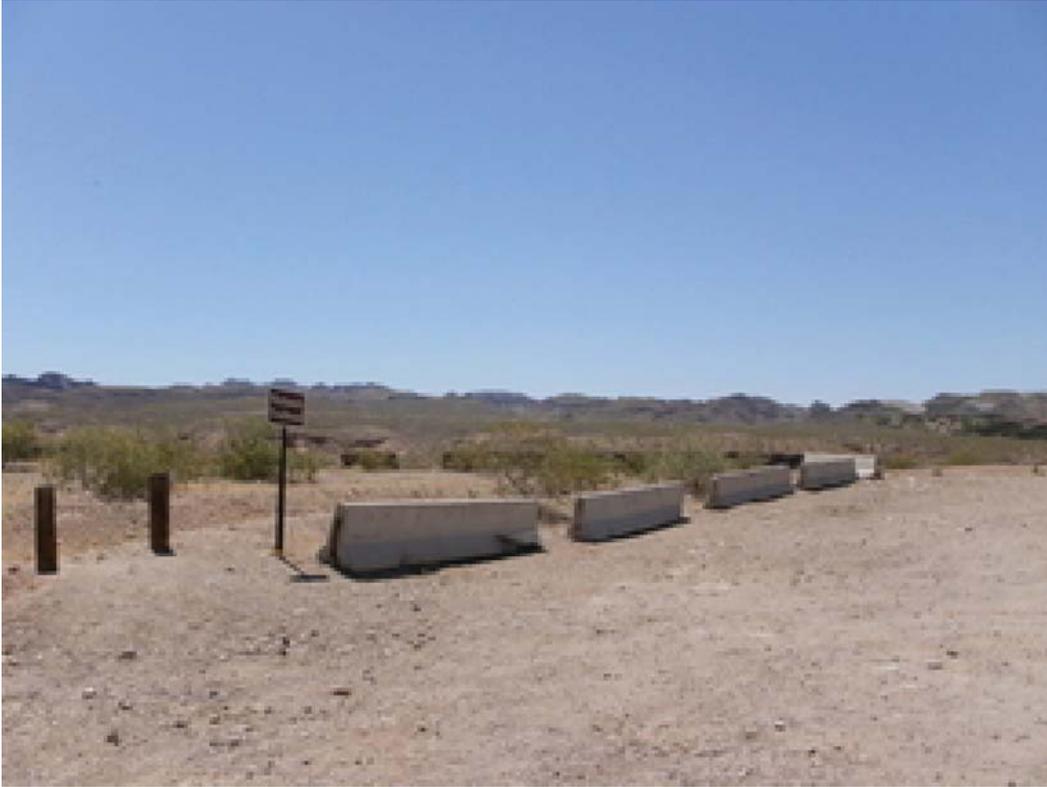
LAKE_0001_1.131_R_1.JPG

Barrier ID:	LAKE-0001-1.131-R				
Route Name:	EB NORTHSORE ROAD				
Inspection Date:	05/03/2010	Barrier Rating:	4.40		
Barrier Description					
Type:	CONCRETE BARRIER	Barrier Function:	NON-TRAFFIC		
Barrier Material:	CONCRETE	Post Material:	N/A		
Blockout Type:	N/A	Length (ft.):	120		
Speed Limit (MPH):	15	Placement with Respect to Road:	NON-TRAFFIC BARRIER		
Hazard Behind Barrier:	N/A				
Barrier Crashworthiness					
Appropriate Test Level:	TL-1	Barrier Test Level:	N/A	Is Barrier Crashworthy?:	N/A
Beg. End Trtmt Type:	NONE	Is Beg. End Trtmt Crashworthy?:	N/A	Approach Transition Type:	NONE
Ending End Trtmt Type:	NONE	Ending End Trtmt Crashworthy?:	N/A		
Average Measurements					
Design Height (In.):	32	Width (In.):	6.0	Post Spacing (In.):	0.0
Height (In.):	31.0	Lateral Offset (In.):	0.0	Road Grade (%):	0.00
Physical Condition					
Barrier	Alignment and Height:	Alignment acceptable. Barrier height is within 1-in of the 32-in design height.

Breaking and Cracking:	Breaking and cracking over 3 in deep; exposed rebar on two 20 ft long sections of barrier.			
	Missing Elements:	No missing barrier elements.			
	Corrosion and Weathering:	No major corrosion or weathering was observed.			
End Treatments	Alignment and Height:				
	Breaking and Cracking:				
	Missing Elements:				
	Corrosion and Weathering:

Repair Action:	REPAIR	FMSS Work Type:	DEFERRED MAINTENANCE	Repair Cost:	\$4840
Brief Workorder:	Replace two 20 ft sections of broken type 7 guardwalls (Jersey barriers).				
Workorder:	Remove Concrete Barrier at \$50- per -Lin. Ft. for 40 LF = \$2000. Replace two 20-ft long sections of type 7 guardwall (Jersey barriers). Concrete Barrier at \$60- per -Lin. Ft. for 40 LF = \$2400. replace two 20-ft long sections of type 7 guardwall.

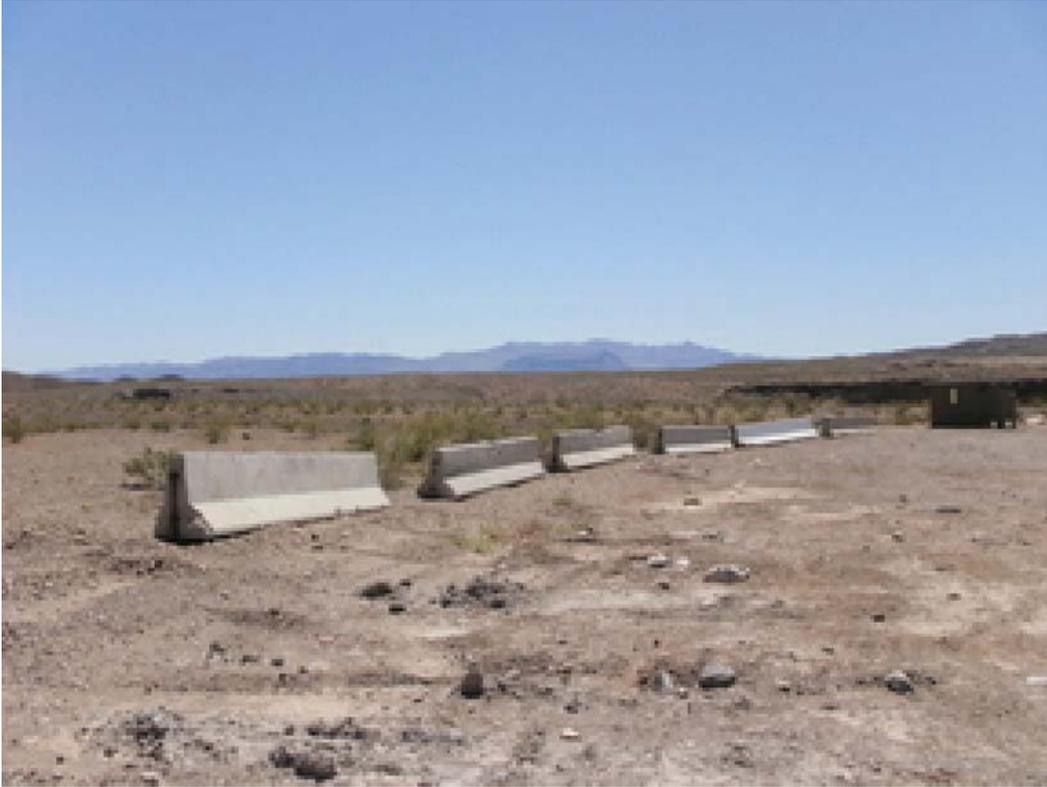
LAKE_0001_1.174_R_1.JPG

Barrier ID:	LAKE-0001-1.174-R				
Route Name:	EB NORTHSORE ROAD				
Inspection Date:	05/03/2010	Barrier Rating:	4.40		
Barrier Description					
Type:	CONCRETE BARRIER	Barrier Function:	NON-TRAFFIC		
Barrier Material:	CONCRETE	Post Material:	N/A		
Blockout Type:	N/A	Length (ft.):	169		
Speed Limit (MPH):	15	Placement with Respect to Road:	NON-TRAFFIC BARRIER		
Hazard Behind Barrier:	N/A				
Barrier Crashworthiness					
Appropriate Test Level:	TL-1	Barrier Test Level:	N/A	Is Barrier Crashworthy?:	N/A
Beg. End Trtmt Type:	NONE	Is Beg. End Trtmt Crashworthy?:	N/A	Approach Transition Type:	NONE
Ending End Trtmt Type:	NONE	Ending End Trtmt Crashworthy?:	N/A		
Average Measurements					
Design Height (In.):	23	Width (In.):	6.0	Post Spacing (In.):	0.0
Height (In.):	31.0	Lateral Offset (In.):	0.0	Road Grade (%):	0.00
Physical Condition					
Barrier	Alignment and Height:	Alignment acceptable. Barrier height is within 1-in of the 32-in design height.

Breaking and Cracking:	Breaking and cracking over 3 in deep; exposed rebar on three 20 ft. long sections.			
	Missing Elements:	No missing barrier elements.			
	Corrosion and Weathering:	No corrosion or weathering observed.			
End Treatments	Alignment and Height:				
	Breaking and Cracking:				
	Missing Elements:				
	Corrosion and Weathering:
