# LAMR GIP Report

## NPS Guardwall/Rail Inventory Program Lake Meredith National Recreation Area

Federal Highway Administration  
Eastern Federal Lands Highway Division  
Road Inventory Program (RIP)

Data Collection Date: November 2009  
Report Date: November 2015

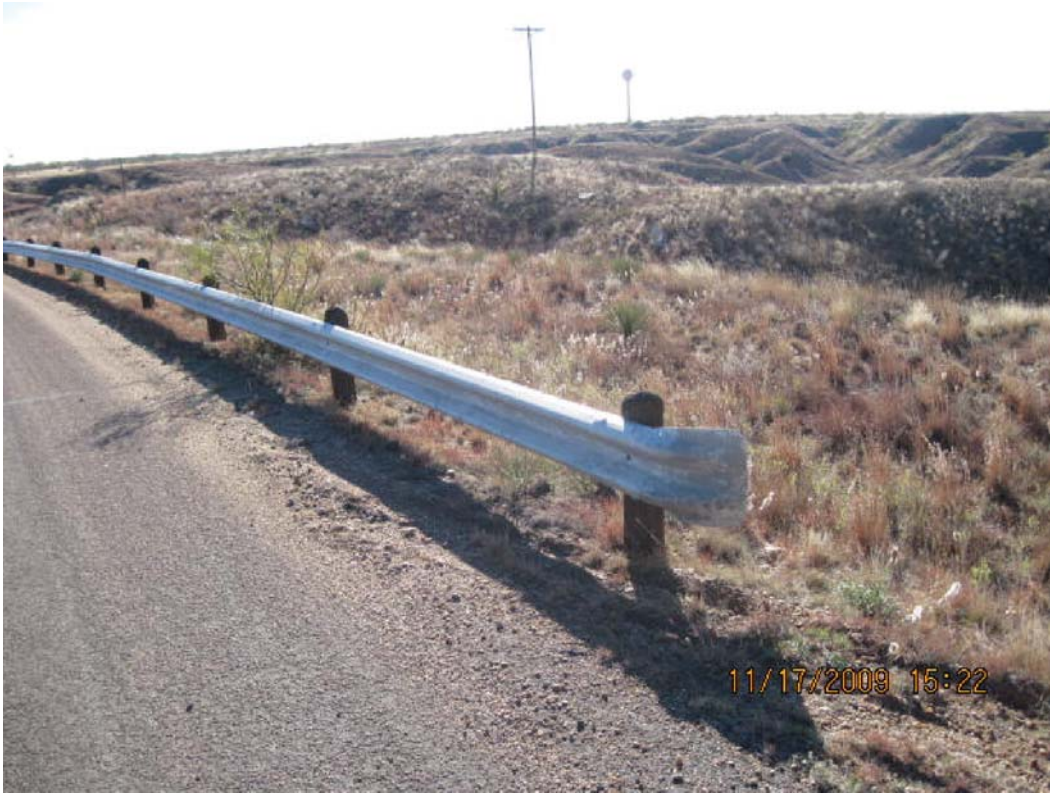
LAMR\_0010\_0.949\_L\_1.jpg

<b>Barrier ID:</b>	LAMR-0010-0.949-L				
<b>Route Name:</b>	SANFORD YAKE ROAD				
<b>Inspection Date:</b>	11/17/2009	<b>Barrier Rating:</b>	51.20		
<b>Barrier Description</b>					
<b>Type:</b>	W-BEAM WEAK POST	<b>Barrier Function:</b>	TRAFFIC		
<b>Barrier Material:</b>	GALVANIZED STEEL	<b>Post Material:</b>	WOOD		
<b>Blockout Type:</b>	N/A	<b>Length (ft.):</b>	302		
<b>Speed Limit (MPH):</b>	35	<b>Placement with Respect to Road:</b>	OUTSIDE OF CURVE		
<b>Hazard Behind Barrier:</b>	LOW				
<b>Barrier Crashworthiness</b>					
<b>Appropriate Test Level:</b>	TL-2	<b>Barrier Test Level:</b>	TL-2	<b>Is Barrier Crashworthy?:</b>	YES
<b>Beg. End Trtmt Type:</b>	NONE	<b>Is Beg. End Trtmt Crashworthy?:</b>	N/A	<b>Approach Transition Type:</b>	NONE
<b>Ending End Trtmt Type:</b>	NONE	<b>Ending End Trtmt Crashworthy?:</b>	N/A		
<b>Average Measurements</b>					
<b>Design Height (In.):</b>	27	<b>Width (In.):</b>	0.0	<b>Post Spacing (In.):</b>	149.6

<b>Height (In.):</b>	20.2	<b>Lateral Offset (In.):</b>	44.2	<b>Road Grade (%):</b>	3.20
<b>Physical Condition</b>					
<b>Barrier</b>	<b>Alignment and Height:</b>	Alignment is between 6 to 12 in of deflection. 274 ft. of the barrier is more than 3in below 27-in. design height.			
	<b>Breaking and Cracking:</b>	There are 2-13-ft. long guardrails that are bent and 1 post is broken..			
	<b>Missing Elements:</b>	None.			
	<b>Corrosion and Weathering:</b>	None.			
<b>End Treatments</b>	<b>Alignment and Height:</b>				
	<b>Breaking and Cracking:</b>	None			
	<b>Missing Elements:</b>	None			
	<b>Corrosion and Weathering:</b>	None

<b>Repair Action:</b>	REPAIR	<b>FMSS Work Type:</b>	DEFERRED MAINTENANCE	<b>Repair Cost:</b>	\$7084
<b>Brief Workorder:</b>	Adjust 274 L.F. of barrier to 27" design height. Replace 26 L.F. of barrier and 1 post.				
<b>Workorder:</b>	Adjust Guardrail at \$10- per -Lin. Ft. for 274 LF = \$2740. Raise 274-ft. of barrier up to 27-in. design height. Replace post at \$100- per -Each for 1 Post(s) = \$100. Replace rail at \$25- per -Lin. Ft. for 26 LF = \$650. Low Speed Traffic Control at \$1475- per -Day for 2 Day(s) = \$2950.

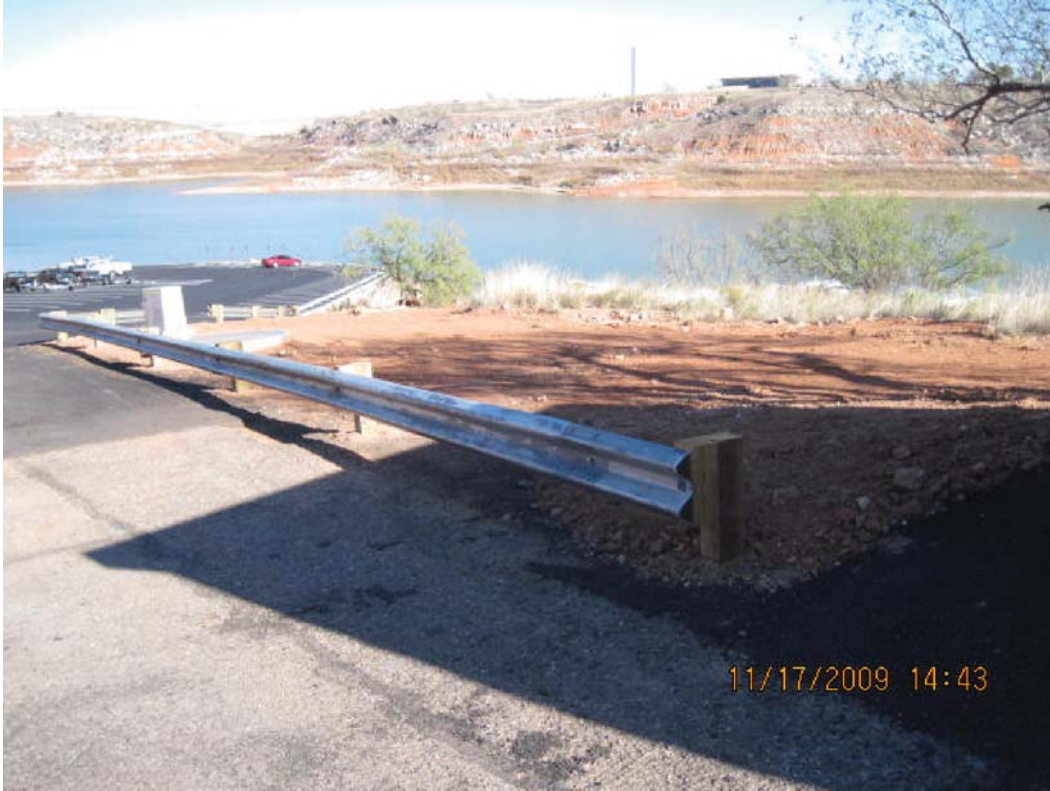
LAMR\_0010\_1.395\_R\_1.jpg

<b>Barrier ID:</b>	LAMR-0010-1.395-R				
<b>Route Name:</b>	SANFORD YAKE ROAD				
<b>Inspection Date:</b>	11/17/2009	<b>Barrier Rating:</b>	32.70		
<b>Barrier Description</b>					
<b>Type:</b>	W-BEAM STRONG POST	<b>Barrier Function:</b>	TRAFFIC		
<b>Barrier Material:</b>	GALVANIZED STEEL	<b>Post Material:</b>	WOOD		
<b>Blockout Type:</b>	WOOD	<b>Length (ft.):</b>	90		
<b>Speed Limit (MPH):</b>	15	<b>Placement with Respect to Road:</b>	TANGENT		
<b>Hazard Behind Barrier:</b>	LOW				
<b>Barrier Crashworthiness</b>					
<b>Appropriate Test Level:</b>	TL-1	<b>Barrier Test Level:</b>	TL-3	<b>Is Barrier Crashworthy?:</b>	YES
<b>Beg. End Trtmt Type:</b>	NONE	<b>Is Beg. End Trtmt Crashworthy?:</b>	N/A	<b>Approach Transition Type:</b>	NONE
<b>Ending End Trtmt Type:</b>	NONE	<b>Ending End Trtmt Crashworthy?:</b>	N/A		
<b>Average Measurements</b>					
<b>Design Height (In.):</b>	27	<b>Width (In.):</b>	0.0	<b>Post Spacing (In.):</b>	142.0

<b>Height (In.):</b>	21.2	<b>Lateral Offset (In.):</b>	169.3	<b>Road Grade (%):</b>	12.00
<b>Physical Condition</b>					
<b>Barrier</b>	<b>Alignment and Height:</b>	Alignment is acceptable. Height is more than 3in below 27-in. design height.			
	<b>Breaking and Cracking:</b>	None.			
	<b>Missing Elements:</b>	None.			
	<b>Corrosion and Weathering:</b>	None.			
<b>End Treatments</b>	<b>Alignment and Height:</b>				
	<b>Breaking and Cracking:</b>	None			
	<b>Missing Elements:</b>	None			
	<b>Corrosion and Weathering:</b>	None

<b>Repair Action:</b>	REPAIR	<b>FMSS Work Type:</b>	DEFERRED MAINTENANCE	<b>Repair Cost:</b>	\$2613
<b>Brief Workorder:</b>	Adjust entire 90 L.F. of guardrail up to 27" design height.				
<b>Workorder:</b>	Adjust Guardrail at \$10- per -Lin. Ft. for 90 LF = \$900. Raise 90-ft. of barrier up to 27-in. design height. Low Speed Traffic Control at \$1475- per -Day for 1 Day(s) = \$1475.

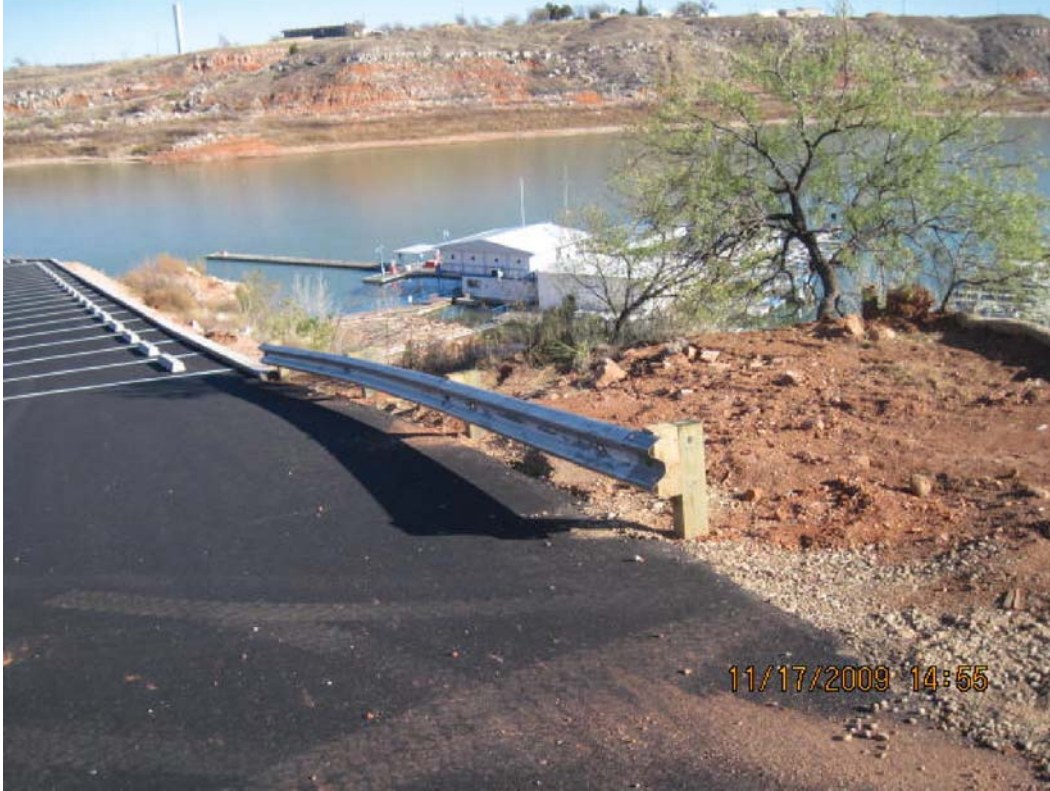
LAMR\_0010\_1.414\_R\_1.jpg

<b>Barrier ID:</b>	LAMR-0010-1.414-R				
<b>Route Name:</b>	SANFORD YAKE ROAD				
<b>Inspection Date:</b>	11/17/2009	<b>Barrier Rating:</b>	26.60		
<b>Barrier Description</b>					
<b>Type:</b>	W-BEAM STRONG POST	<b>Barrier Function:</b>	NON-TRAFFIC		
<b>Barrier Material:</b>	GALVANIZED STEEL	<b>Post Material:</b>	WOOD		
<b>Blockout Type:</b>	WOOD	<b>Length (ft.):</b>	38		
<b>Speed Limit (MPH):</b>	15	<b>Placement with Respect to Road:</b>	NON-TRAFFIC BARRIER		
<b>Hazard Behind Barrier:</b>	MEDIUM				
<b>Barrier Crashworthiness</b>					
<b>Appropriate Test Level:</b>	TL-1	<b>Barrier Test Level:</b>	N/A	<b>Is Barrier Crashworthy?:</b>	N/A
<b>Beg. End Trtmt Type:</b>	NONE	<b>Is Beg. End Trtmt Crashworthy?:</b>	N/A	<b>Approach Transition Type:</b>	NONE
<b>Ending End Trtmt Type:</b>	NONE	<b>Ending End Trtmt Crashworthy?:</b>	N/A		
<b>Average Measurements</b>					
<b>Design Height (In.):</b>	27	<b>Width (In.):</b>	0.0	<b>Post Spacing (In.):</b>	150.0

<b>Height (In.):</b>	20.7	<b>Lateral Offset (In.):</b>	0.0	<b>Road Grade (%):</b>	0.00
<b>Physical Condition</b>					
<b>Barrier</b>	<b>Alignment and Height:</b>	The alignment had no deflection. Height is more than 3in below the 27-in. design height.			
	<b>Breaking and Cracking:</b>	None.			
	<b>Missing Elements:</b>	None.			
	<b>Corrosion and Weathering:</b>	None.			
<b>End Treatments</b>	<b>Alignment and Height:</b>				
	<b>Breaking and Cracking:</b>	None			
	<b>Missing Elements:</b>	None			
	<b>Corrosion and Weathering:</b>	None

<b>Repair Action:</b>	REPAIR	<b>FMSS Work Type:</b>	DEFERRED MAINTENANCE	<b>Repair Cost:</b>	\$418
<b>Brief Workorder:</b>	Adjust the entire 38 L.F. of guardrail up to the 27" design height.				
<b>Workorder:</b>	Adjust Guardrail at \$10- per -Lin. Ft. for 38 LF = \$380. Raise 38-ft. of barrier up to 27-in. design height.

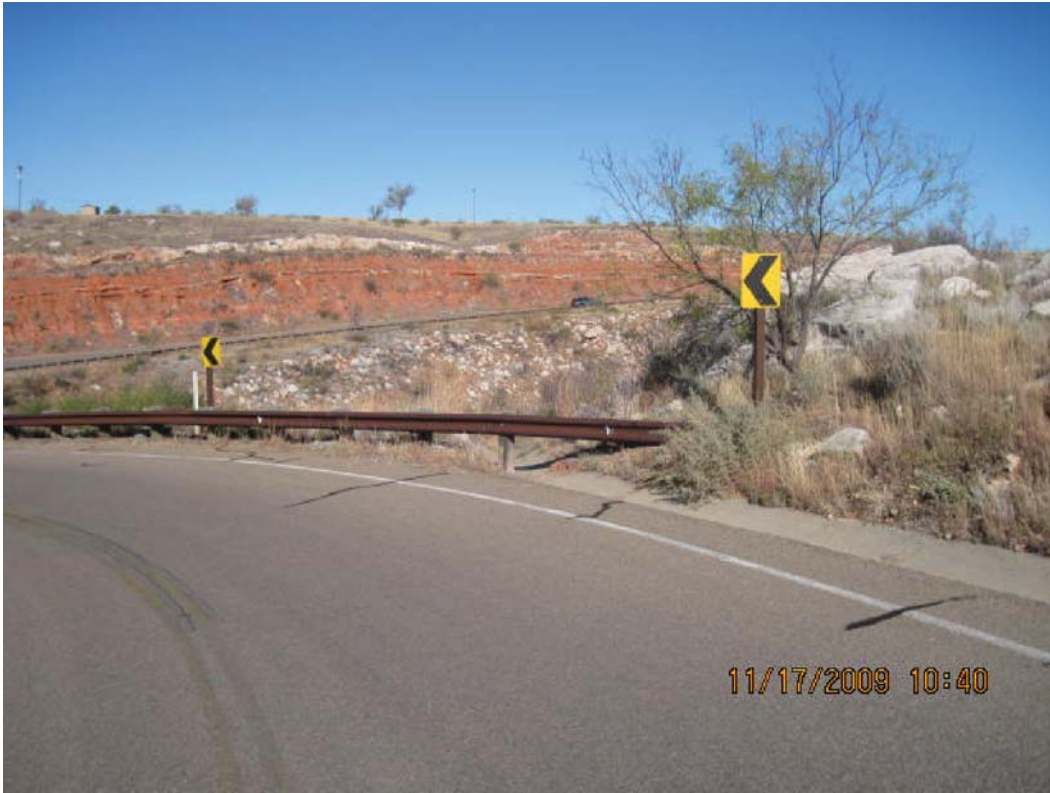
LAMR\_0100\_0.123\_R\_1.jpg

<b>Barrier ID:</b>	LAMR-0100-0.123-R				
<b>Route Name:</b>	FRITCH FORTRESS ROAD				
<b>Inspection Date:</b>	11/17/2009	<b>Barrier Rating:</b>	40.90		
<b>Barrier Description</b>					
<b>Type:</b>	W-BEAM STRONG POST	<b>Barrier Function:</b>	TRAFFIC		
<b>Barrier Material:</b>	WEATHERING STEEL/CORTEN	<b>Post Material:</b>	WOOD		
<b>Blockout Type:</b>	WOOD	<b>Length (ft.):</b>	1584		
<b>Speed Limit (MPH):</b>	25	<b>Placement with Respect to Road:</b>	BOTH INSIDE AND OUTSIDE		
<b>Hazard Behind Barrier:</b>	MEDIUM				
<b>Barrier Crashworthiness</b>					
<b>Appropriate Test Level:</b>	TL-1	<b>Barrier Test Level:</b>	TL-3	<b>Is Barrier Crashworthy?:</b>	YES
<b>Beg. End Trtmt Type:</b>	W-BEAM BURIED END	<b>Is Beg. End Trtmt Crashworthy?:</b>	YES	<b>Approach Transition Type:</b>	NONE
<b>Ending End Trtmt Type:</b>	W-BEAM BCT	<b>Ending End Trtmt Crashworthy?:</b>	NO		
<b>Average Measurements</b>					
<b>Design Height (In.):</b>	27	<b>Width (In.):</b>	0.0	<b>Post Spacing (In.):</b>	75.3

<b>Height (In.):</b>	25.3	<b>Lateral Offset (In.):</b>	56.0	<b>Road Grade (%):</b>	7.10
<b>Physical Condition</b>					
<b>Barrier</b>	<b>Alignment and Height:</b>	Alignment is acceptable. 500 ft. is between 1in-2" below the 27-in. design height and 500 ft. is more than 3" below the 27-in. design height.			
	<b>Breaking and Cracking:</b>	There are 23 broken or cracked posts with cracks ranging from 1/4 in to 3/4 inch. There are 21 cracked or broken blocks with 1/4 to 1/2 inch cracking. Included in the 21 broken blocks are a few completely broken blockouts.			
	<b>Missing Elements:</b>	No missing elements.			
	<b>Corrosion and Weathering:</b>	None			
<b>End Treatments</b>	<b>Alignment and Height:</b>	Alignment is acceptable. Height is within 1in of 27-in. design height.			
	<b>Breaking and Cracking:</b>	The last 2 posts on the ending end treatment are broken.			
	<b>Missing Elements:</b>	None			
	<b>Corrosion and Weathering:</b>	None

<b>Repair Action:</b>	REPAIR	<b>FMSS Work Type:</b>	DEFERRED MAINTENANCE	<b>Repair Cost:</b>	\$24178
<b>Brief Workorder:</b>	Adjust 1000 feet of guardrail to 27" design height and replace 25 posts and 21 blockouts.				
<b>Workorder:</b>	Adjust Guardrail at \$10- per -Lin. Ft. for 1000 = \$10000. Raise 1000-ft. of barrier up to 27-in. design height. Replace post at \$100 - per -Each for 25 = \$2500. Replace block at \$30 - per -Each for 21 = \$630. Low Speed Traffic Control at \$1475- per -Day for 6 Day(s) = \$8850. 4 days to raise barrier; 2 days to replace posts and blocks.

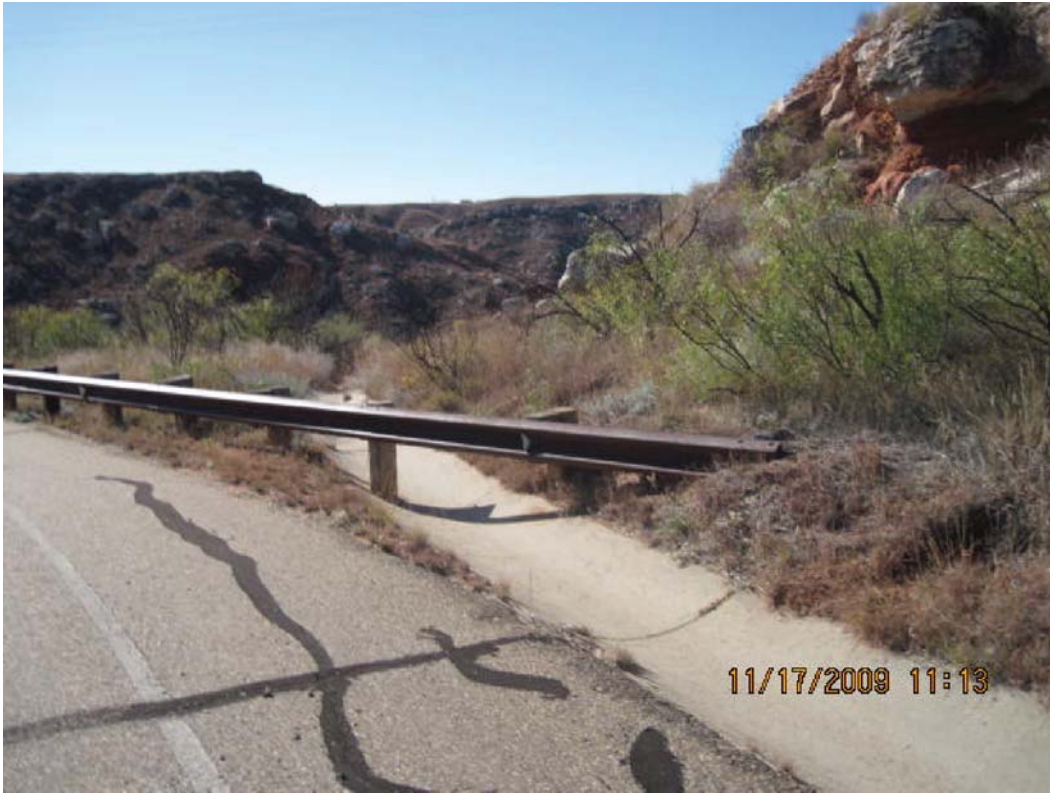
LAMR\_0100\_0.157\_L\_1.jpg

<b>Barrier ID:</b>	LAMR-0100-0.157-L				
<b>Route Name:</b>	FRITCH FORTRESS ROAD				
<b>Inspection Date:</b>	11/17/2009	<b>Barrier Rating:</b>	25.20		
<b>Barrier Description</b>					
<b>Type:</b>	W-BEAM STRONG POST	<b>Barrier Function:</b>	TRAFFIC		
<b>Barrier Material:</b>	WEATHERING STEEL/CORTEN	<b>Post Material:</b>	WOOD		
<b>Blockout Type:</b>	WOOD	<b>Length (ft.):</b>	342		
<b>Speed Limit (MPH):</b>	25	<b>Placement with Respect to Road:</b>	OUTSIDE OF CURVE		
<b>Hazard Behind Barrier:</b>	MEDIUM				
<b>Barrier Crashworthiness</b>					
<b>Appropriate Test Level:</b>	TL-1	<b>Barrier Test Level:</b>	TL-3	<b>Is Barrier Crashworthy?:</b>	YES
<b>Beg. End Trtmt Type:</b>	W-BEAM BURIED END	<b>Is Beg. End Trtmt Crashworthy?:</b>	YES	<b>Approach Transition Type:</b>	NONE
<b>Ending End Trtmt Type:</b>	W-BEAM BURIED END	<b>Ending End Trtmt Crashworthy?:</b>	YES		
<b>Average Measurements</b>					
<b>Design Height (In.):</b>	27	<b>Width (In.):</b>	0.0	<b>Post Spacing (In.):</b>	75.3

<b>Height (In.):</b>	27.7	<b>Lateral Offset (In.):</b>	56.0	<b>Road Grade (%):</b>	5.60
<b>Physical Condition</b>					
<b>Barrier</b>	<b>Alignment and Height:</b>	Alignment is acceptable. Height is within 1in of 27-in. design height.			
	<b>Breaking and Cracking:</b>	5 posts and 2 blocks need to be replaced due to breaking/fire damage.			
	<b>Missing Elements:</b>	None.			
	<b>Corrosion and Weathering:</b>	None.			
<b>End Treatments</b>	<b>Alignment and Height:</b>	Alignment had no deflection. 36-ft. is 1in- 3" below the 27-in. design height and 36-ft. is more than 3" below the 27-in. design height.			
	<b>Breaking and Cracking:</b>	None.			
	<b>Missing Elements:</b>	None.			
	<b>Corrosion and Weathering:</b>	None.

<b>Repair Action:</b>	REPAIR	<b>FMSS Work Type:</b>	DEFERRED MAINTENANCE	<b>Repair Cost:</b>	\$3031
<b>Brief Workorder:</b>	Adjust 72-ft. of barrier up to 27" design height replace 5 posts and 2 blocks.				
<b>Workorder:</b>	Adjust Guardrail at \$10- per -Lin. Ft. for 72 LF = \$720. Raise 72-ft. of barrier up to 27-in. design height. Replace post at \$100- per -Each for 5 Post(s) = \$500. Replace block at \$30- per -Each for 2 Block(s) = \$60. Low Speed Traffic Control at \$1475- per -Day for 1 Day(s) = \$1475.

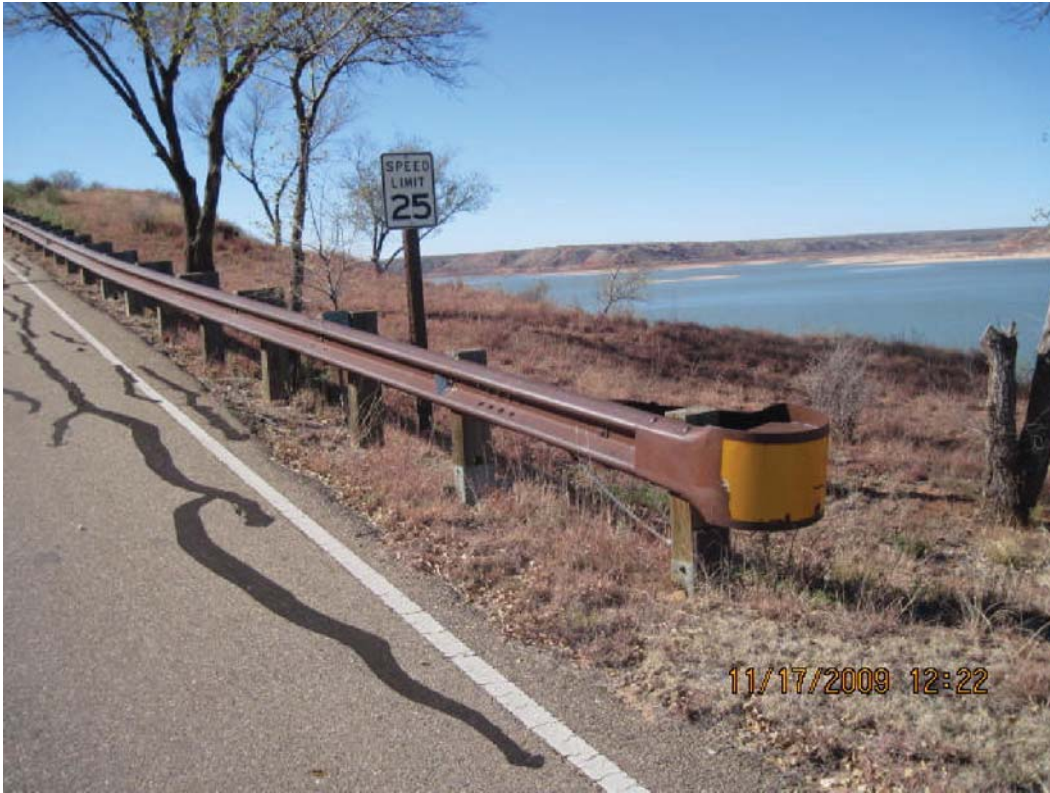
LAMR\_0100\_1.016\_L\_1.jpg

<b>Barrier ID:</b>	LAMR-0100-1.016-L				
<b>Route Name:</b>	FRITCH FORTRESS ROAD				
<b>Inspection Date:</b>	11/17/2009	<b>Barrier Rating:</b>	42.20		
<b>Barrier Description</b>					
<b>Type:</b>	W-BEAM STRONG POST	<b>Barrier Function:</b>	TRAFFIC		
<b>Barrier Material:</b>	WEATHERING STEEL/CORTEN	<b>Post Material:</b>	WOOD		
<b>Blockout Type:</b>	WOOD	<b>Length (ft.):</b>	1466		
<b>Speed Limit (MPH):</b>	25	<b>Placement with Respect to Road:</b>	BOTH INSIDE AND OUTSIDE		
<b>Hazard Behind Barrier:</b>	MEDIUM				
<b>Barrier Crashworthiness</b>					
<b>Appropriate Test Level:</b>	TL-1	<b>Barrier Test Level:</b>	TL-3	<b>Is Barrier Crashworthy?:</b>	YES
<b>Beg. End Trtmt Type:</b>	W-BEAM BCT	<b>Is Beg. End Trtmt Crashworthy?:</b>	NO	<b>Approach Transition Type:</b>	NONE
<b>Ending End Trtmt Type:</b>	W-BEAM BCT	<b>Ending End Trtmt Crashworthy?:</b>	NO		
<b>Average Measurements</b>					
<b>Design Height (In.):</b>	27	<b>Width (In.):</b>	0.0	<b>Post Spacing (In.):</b>	75.0

<b>Height (In.):</b>	26.1	<b>Lateral Offset (In.):</b>	19.7	<b>Road Grade (%):</b>	8.20
<b>Physical Condition</b>					
<b>Barrier</b>	<b>Alignment and Height:</b>	Alignment is acceptable. 50 ft. of barrier is 1in-3" below 27-in. design height and 425 ft. is more than 3" below 27-in. design height.			
	<b>Breaking and Cracking:</b>	There are 12 blocks that are breaking/cracking with cracks of 1/4in to 3/4 inch visible. There are 18 posts with breaking and cracking of 1/4 inch to 3/4 inch. One 25' section of rail is bent.			
	<b>Missing Elements:</b>	No missing elements.			
	<b>Corrosion and Weathering:</b>	Slight rusting occuring on entire length of rail observed.			
<b>End Treatments</b>	<b>Alignment and Height:</b>	15 ft. of end treatment is 1in- 3" below the 27-in. design height. Alignment is within the 0 to 6 in design tolerance.			
	<b>Breaking and Cracking:</b>	None			
	<b>Missing Elements:</b>	None

<b>Corrosion and Weathering:</b>	Slight rusting occuring on entire length of rail observed.

<b>Repair Action:</b>	REPAIR	<b>FMSS Work Type:</b>	DEFERRED MAINTENANCE	<b>Repair Cost:</b>	\$14944
<b>Brief Workorder:</b>	Replace 25 ft of W-Beam adjust 490 L.F. of barrier to 27" design height and replace 12 blockouts and 18 posts.				
<b>Workorder:</b>	Replace rail at \$25- per -Lin. Ft. for 25 LF = \$625. Adjust Guardrail at \$10- per -Lin. Ft. for 490 LF = \$4900. Raise 490-ft. of barrier up to 27-in. design height. Replace post at \$100- per -Each for 18 Post(s) = \$1800. Replace block at \$30- per -Each for 12 Block(s) = \$360. Low Speed Traffic Control at \$1475- per -Day for 4 Day(s) = \$5900. 2 days to raise barrier; 2 days to replace hardware.

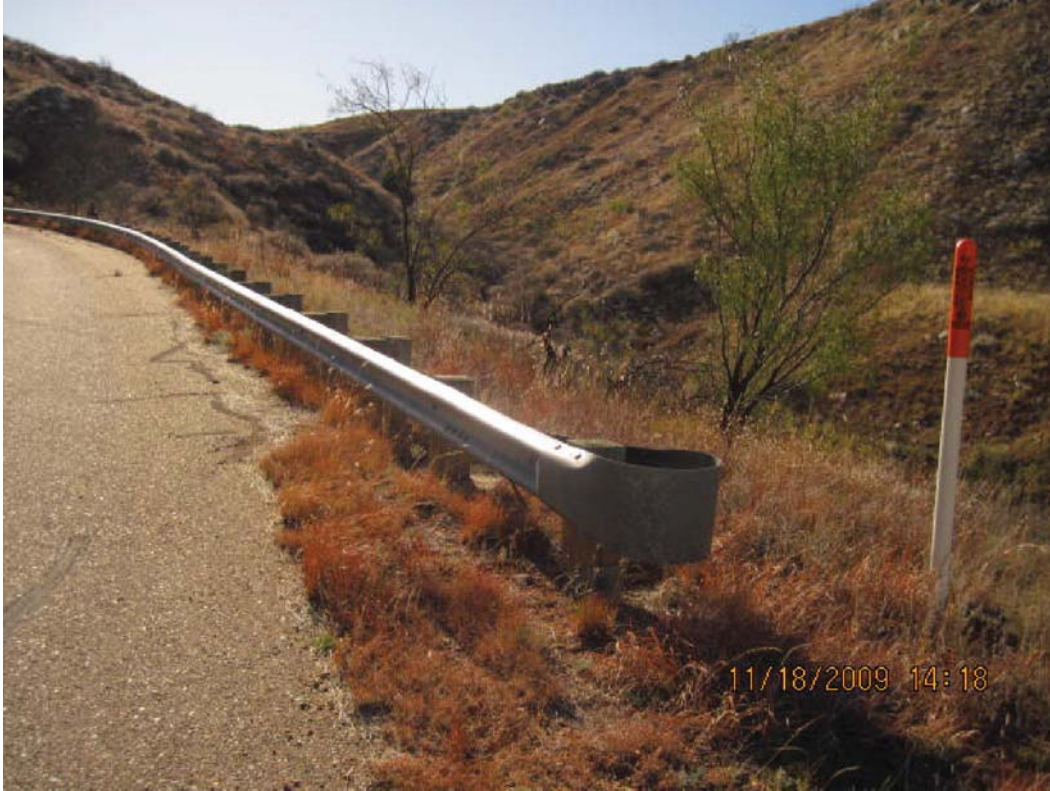
LAMR\_0103\_0.043\_L\_1.jpg

<b>Barrier ID:</b>	LAMR-0103-0.043-L				
<b>Route Name:</b>	BATES CANYON ROAD				
<b>Inspection Date</b>	11/18/2009	<b>Barrier Rating:</b>	32.50		
<b>Barrier Description</b>					
<b>Type:</b>	W-BEAM STRONG POST	<b>Barrier Function:</b>	TRAFFIC		
<b>Barrier Material:</b>	GALVANIZED STEEL	<b>Post Material:</b>	WOOD		
<b>Blockout Type:</b>	WOOD	<b>Length (ft.):</b>	302		
<b>Speed Limit (MPH):</b>	35	<b>Placement with Respect to Road:</b>	OUTSIDE OF CURVE		
<b>Hazard Behind Barrier:</b>	MEDIUM				
<b>Barrier Crashworthiness</b>					
<b>Appropriate Test Level:</b>	TL-2	<b>Barrier Test Level:</b>	TL-3	<b>Is Barrier Crashworthy?:</b>	YES
<b>Beg. End Trtmt Type:</b>	W-BEAM BCT	<b>Is Beg. End Trtmt Crashworthy?:</b>	NO	<b>Approach Transition Type:</b>	NONE
<b>Ending End Trtmt Type:</b>	W-BEAM BCT	<b>Ending End Trtmt Crashworthy?:</b>	NO		
<b>Average Measurements</b>					
<b>Design Height (In.):</b>	27	<b>Width (In.):</b>	0.0	<b>Post Spacing (In.):</b>	75.6

<b>Height (In.):</b>	25.2	<b>Lateral Offset (In.):</b>	47.7	<b>Road Grade (%):</b>	10.70
<b>Physical Condition</b>					
<b>Barrier</b>	<b>Alignment and Height:</b>	The alignment had no deflection. 276 ft. of barrier is 1in-3" below 27-in. design height and 26 ft. is more than 3" below 27-in. design height.			
	<b>Breaking and Cracking:</b>	4 blocks are broken. 6 posts have cracks 1in in width running up the entire length of the post.			
	<b>Missing Elements:</b>	None.			
	<b>Corrosion and Weathering:</b>	None.			
<b>End Treatments</b>	<b>Alignment and Height:</b>	Alignment had no deflection. 36-ft. of the leading end treatment is 1in- 3" below the 27-in. design height and 36-ft. of the trailing end treatment is more than 3" below the 27-in. design height.			
	<b>Breaking and Cracking:</b>	None.			
	<b>Missing Elements:</b>	None.			
	<b>Corrosion and Weathering:</b>	None.

<b>Repair Action:</b>	REPAIR	<b>FMSS Work Type:</b>	DEFERRED MAINTENANCE	<b>Repair Cost:</b>	\$8151
<b>Brief Workorder:</b>	Adjust the entire 374 L.F. of the guardrail up to the 27" design height. Replace 4 broken blocks and 6 posts.				
<b>Workorder:</b>	Adjust Guardrail at \$10- per -Lin. Ft. for 374 LF = \$3740. Raise 374-ft. of barrier up to 27-in. design height. Replace post at \$100- per -Each for 6 Post(s) = \$600. Replace block at \$30- per -Each for 4 Block(s) = \$120. Low Speed Traffic Control at \$1475- per -Day for 2 Day(s) = \$2950.

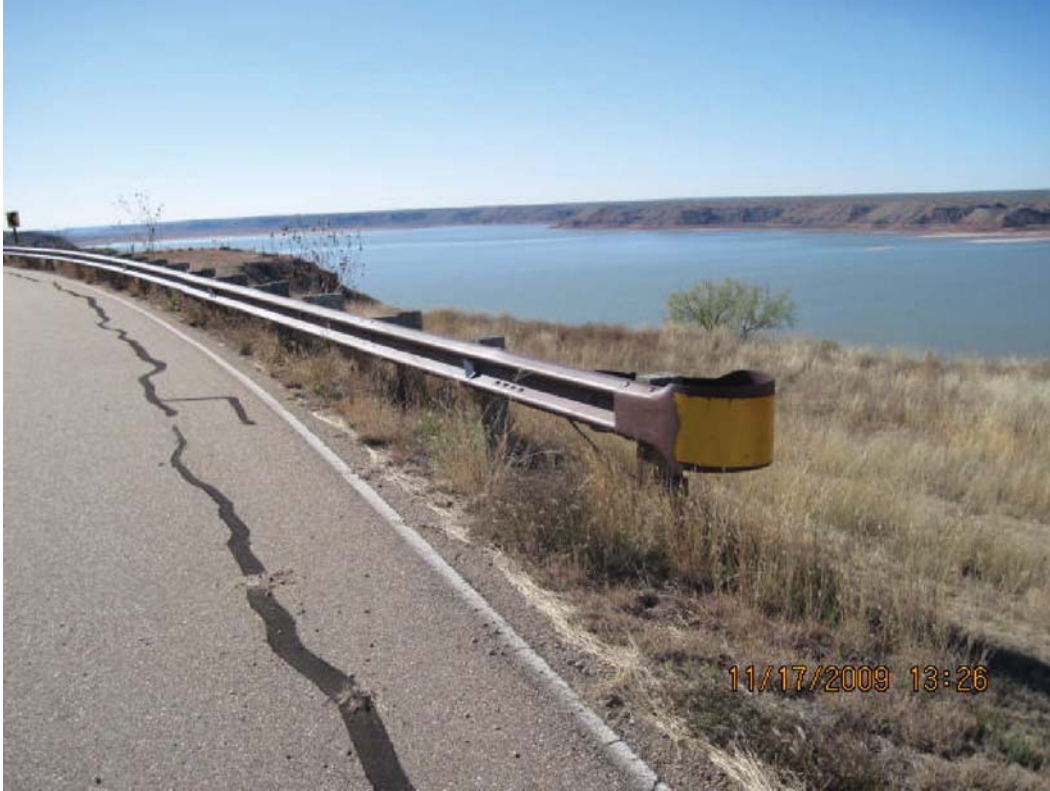
LAMR\_0200\_0.568\_R\_1.jpg

<b>Barrier ID:</b>	LAMR-0200-0.568-R				
<b>Route Name:</b>	FRITCH FORTRESS AMPHITHEATER ROAD				
<b>Inspection Date:</b>	11/17/2009	<b>Barrier Rating:</b>	21.20		
<b>Barrier Description</b>					
<b>Type:</b>	W-BEAM STRONG POST	<b>Barrier Function:</b>	TRAFFIC		
<b>Barrier Material:</b>	WEATHERING STEEL/CORTEN	<b>Post Material:</b>	WOOD		
<b>Blockout Type:</b>	WOOD	<b>Length (ft.):</b>	227		
<b>Speed Limit (MPH):</b>	25	<b>Placement with Respect to Road:</b>	OUTSIDE OF CURVE		
<b>Hazard Behind Barrier:</b>	HIGH				
<b>Barrier Crashworthiness</b>					
<b>Appropriate Test Level:</b>	TL-1	<b>Barrier Test Level:</b>	TL-3	<b>Is Barrier Crashworthy?:</b>	YES
<b>Beg. End Trtmt Type:</b>	W-BEAM BCT	<b>Is Beg. End Trtmt Crashworthy?:</b>	NO	<b>Approach Transition Type:</b>	NONE
<b>Ending End Trtmt Type:</b>	W-BEAM TRAILING END	<b>Ending End Trtmt Crashworthy?:</b>	YES		
<b>Average Measurements</b>					
<b>Design Height (In.):</b>	27	<b>Width (In.):</b>	0.0	<b>Post Spacing (In.):</b>	75.6

<b>Height (In.):</b>	26.0	<b>Lateral Offset (In.):</b>	10.0	<b>Road Grade (%):</b>	0.70
<b>Physical Condition</b>					
<b>Barrier</b>	<b>Alignment and Height:</b>	Alignment is acceptable. Height is within 1-in of 27-in. design height.			
	<b>Breaking and Cracking:</b>	None.			
	<b>Missing Elements:</b>	None.			
	<b>Corrosion and Weathering:</b>	Some slight rusting on the rail observed.			
<b>End Treatments</b>	<b>Alignment and Height:</b>	The alignment had no deflection. 36-ft. is 1in- 3" below the 27-in. design height.			
	<b>Breaking and Cracking:</b>	None.			
	<b>Missing Elements:</b>	None.			
	<b>Corrosion and Weathering:</b>	Some slight rusting on the rail observed.

<b>Repair Action:</b>	REPAIR	<b>FMSS Work Type:</b>	DEFERRED MAINTENANCE	<b>Repair Cost:</b>	\$2019
<b>Brief Workorder:</b>	Adjust 36 L.F. of guardrail up to 27" design height.				
<b>Workorder:</b>	Adjust Guardrail at \$10- per -Lin. Ft. for 36 LF = \$360. Adjust height of end treatment up to 27-in. design height. Low Speed Traffic Control at \$1475- per -Day for 1 Day(s) = \$1475.

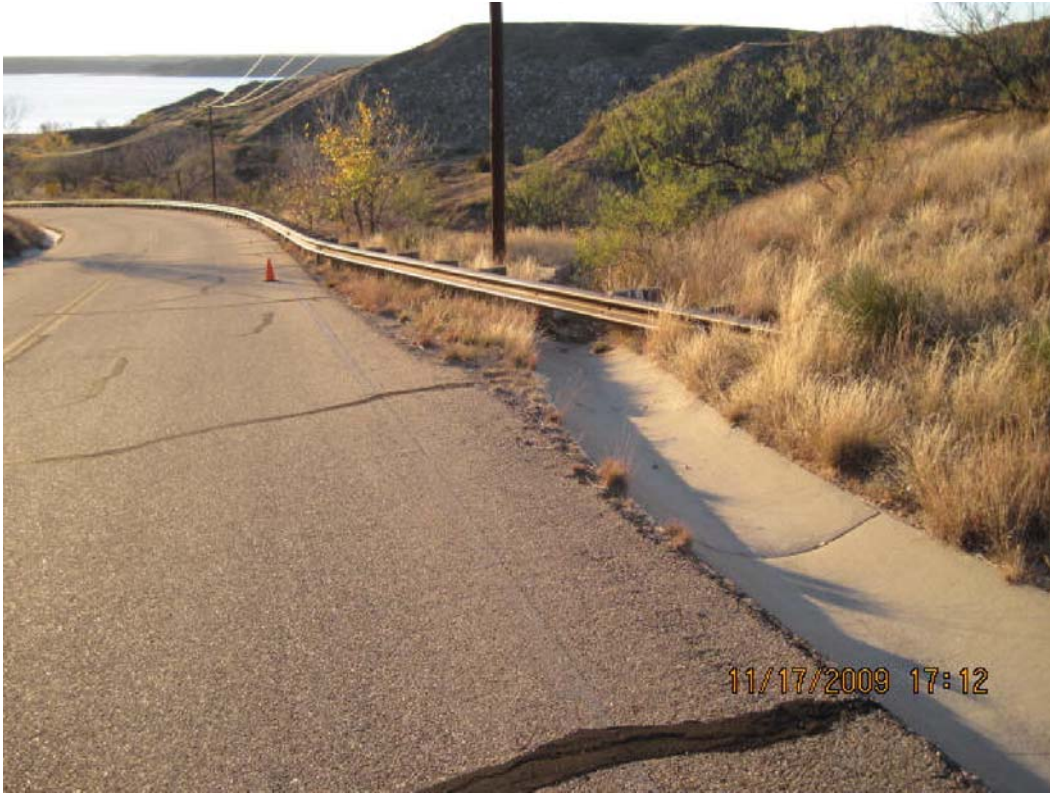
LAMR\_0201\_0.353\_R\_1.jpg

<b>Barrier ID:</b>	LAMR-0201-0.353-R				
<b>Route Name:</b>	CEDAR CANYON ACCESS ROAD				
<b>Inspection Date:</b>	11/17/2009	<b>Barrier Rating:</b>	37.90		
<b>Barrier Description</b>					
<b>Type:</b>	W-BEAM STRONG POST	<b>Barrier Function:</b>	TRAFFIC		
<b>Barrier Material:</b>	WEATHERING STEEL/CORTEN	<b>Post Material:</b>	WOOD		
<b>Blockout Type:</b>	WOOD	<b>Length (ft.):</b>	917		
<b>Speed Limit (MPH):</b>	25	<b>Placement with Respect to Road:</b>	BOTH INSIDE AND OUTSIDE		
<b>Hazard Behind Barrier:</b>	MEDIUM				
<b>Barrier Crashworthiness</b>					
<b>Appropriate Test Level:</b>	TL-1	<b>Barrier Test Level:</b>	TL-3	<b>Is Barrier Crashworthy?:</b>	YES
<b>Beg. End Trtmt Type:</b>	W-BEAM BURIED END	<b>Is Beg. End Trtmt Crashworthy?:</b>	YES	<b>Approach Transition Type:</b>	NONE
<b>Ending End Trtmt Type:</b>	W-BEAM BCT	<b>Ending End Trtmt Crashworthy?:</b>	NO		
<b>Average Measurements</b>					
<b>Design Height (In.):</b>	27	<b>Width (In.):</b>	0.0	<b>Post Spacing (In.):</b>	74.8

<b>Height (In.):</b>	27.0	<b>Lateral Offset (In.):</b>	22.6	<b>Road Grade (%):</b>	9.50
<b>Physical Condition</b>					
<b>Barrier</b>	<b>Alignment and Height:</b>	The alignment had no deflection. The height is at 27in the entire length.			
	<b>Breaking and Cracking:</b>	1 block with cross-sectional cracking of more than 1/2 in needs replaced. 2 rail sections (12') bent replace. Several minor cracks on most posts blocks.			
	<b>Missing Elements:</b>	None.			
	<b>Corrosion and Weathering:</b>	Some rusting on the guardrail observed.			
<b>End Treatments</b>	<b>Alignment and Height:</b>	No deflection and height is at design height of 27in.			
	<b>Breaking and Cracking:</b>	None.			
	<b>Missing Elements:</b>	None.			
	<b>Corrosion and Weathering:</b>	Some rusting on guardrail observed.

<b>Repair Action:</b>	REPAIR	<b>FMSS Work Type:</b>	DEFERRED MAINTENANCE	<b>Repair Cost:</b>	\$2316
<b>Brief Workorder:</b>	Replace 24 ft. of bent rail and 1 cracked block.				
<b>Workorder:</b>	Replace rail at \$25- per -Lin. Ft. for 24 LF = \$600. Replace block at \$30 - per -Each for 1 Block(s) = \$30. Low Speed Traffic Control at \$1475- per -Day for 1 Day(s) = \$1475.

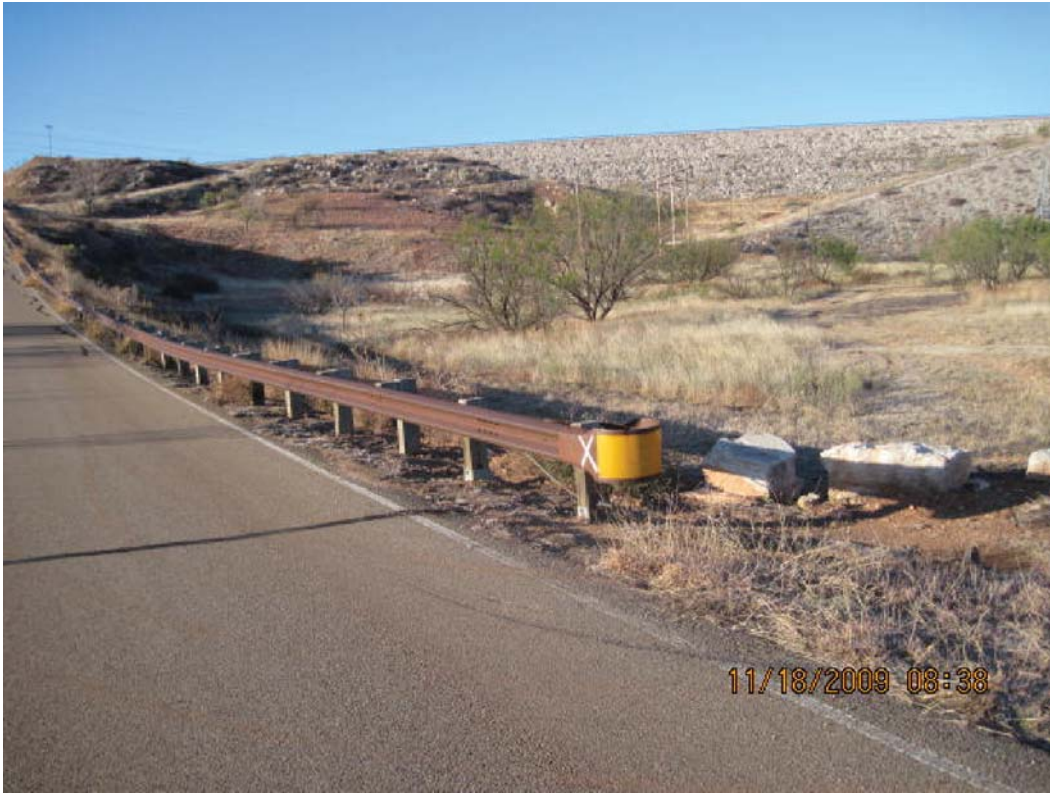
LAMR\_0203\_0.135\_L\_1.jpg

<b>Barrier ID:</b>	LAMR-0203-0.135-L				
<b>Route Name:</b>	SPRING CANYON STILLING BASIN ROAD				
<b>Inspection Date:</b>	11/18/2009	<b>Barrier Rating:</b>	22.60		
<b>Barrier Description</b>					
<b>Type:</b>	W-BEAM STRONG POST	<b>Barrier Function:</b>	TRAFFIC		
<b>Barrier Material:</b>	WEATHERING STEEL/CORTEN	<b>Post Material:</b>	WOOD		
<b>Blockout Type:</b>	WOOD	<b>Length (ft.):</b>	798		
<b>Speed Limit (MPH):</b>	25	<b>Placement with Respect to Road:</b>	TANGENT		
<b>Hazard Behind Barrier:</b>	LOW				
<b>Barrier Crashworthiness</b>					
<b>Appropriate Test Level:</b>	TL-1	<b>Barrier Test Level:</b>	TL-3	<b>Is Barrier Crashworthy?:</b>	YES
<b>Beg. End Trtmt Type:</b>	W-BEAM BCT	<b>Is Beg. End Trtmt Crashworthy?:</b>	NO	<b>Approach Transition Type:</b>	NONE
<b>Ending End Trtmt Type:</b>	W-BEAM BCT	<b>Ending End Trtmt Crashworthy?:</b>	NO		
<b>Average Measurements</b>					
<b>Design Height (In.):</b>	27	<b>Width (In.):</b>	0.0	<b>Post Spacing (In.):</b>	74.8

<b>Height (In.):</b>	26.2	<b>Lateral Offset (In.):</b>	12.1	<b>Road Grade (%):</b>	13.50
<b>Physical Condition</b>					
<b>Barrier</b>	<b>Alignment and Height:</b>	The alignment is within the 0 to 6 in deflection standard. 450 ft. of barrier is 1in-3" below 27-in. design height and 50 ft. is more than 3" below 27-in. design height.			
	<b>Breaking and Cracking:</b>	11 posts have breaking/cracking with cracks between 1/2 in and 1 inch. 8 blockouts have breaking/cracking with cracks of 1/4 inch to 3/4 inch.			
	<b>Missing Elements:</b>	There are 2 missing blockouts.			
	<b>Corrosion and Weathering:</b>	Minor rusting occurring along rail observed.			
<b>End Treatments</b>	<b>Alignment and Height:</b>	Alignment showed no deflection. Height is within 1-in of 27-in. design height.			
	<b>Breaking and Cracking:</b>	None			
	<b>Missing Elements:</b>	None			
	<b>Corrosion and Weathering:</b>	None

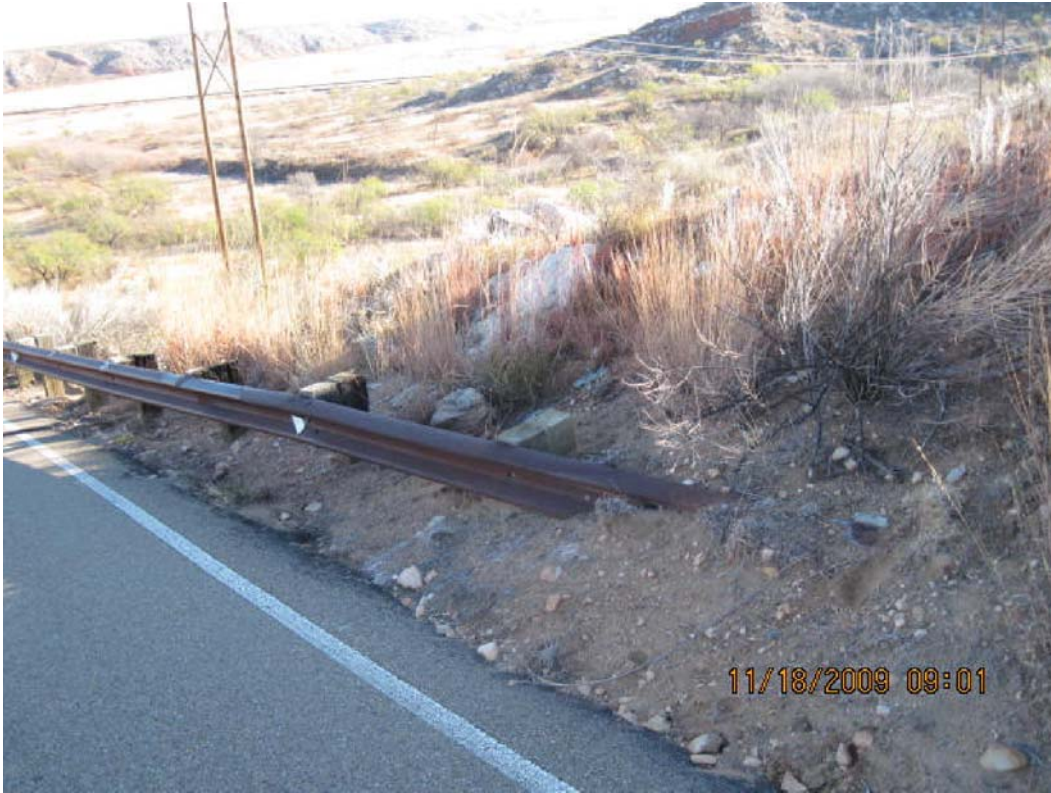
LAMR\_0203\_0.192\_R\_1.jpg

<b>Barrier ID:</b>	LAMR-0203-0.192-R				
<b>Route Name:</b>	SPRING CANYON STILLING BASIN ROAD				
<b>Inspection Date:</b>	11/18/2009	<b>Barrier Rating:</b>	35.00		
<b>Barrier Description</b>					
<b>Type:</b>	W-BEAM STRONG POST	<b>Barrier Function:</b>	TRAFFIC		
<b>Barrier Material:</b>	WEATHERING STEEL/CORTEN	<b>Post Material:</b>	WOOD		
<b>Blockout Type:</b>	WOOD	<b>Length (ft.):</b>	495		
<b>Speed Limit (MPH):</b>	25	<b>Placement with Respect to Road:</b>	TANGENT		
<b>Hazard Behind Barrier:</b>	MEDIUM				
<b>Barrier Crashworthiness</b>					
<b>Appropriate Test Level:</b>	TL-1	<b>Barrier Test Level:</b>	TL-3	<b>Is Barrier Crashworthy?:</b>	YES
<b>Beg. End Trtmt Type:</b>	W-BEAM BURIED END	<b>Is Beg. End Trtmt Crashworthy?:</b>	YES	<b>Approach Transition Type:</b>	NONE
<b>Ending End Trtmt Type:</b>	W-BEAM BCT	<b>Ending End Trtmt Crashworthy?:</b>	NO		
<b>Average Measurements</b>					
<b>Design Height (In.):</b>	27	<b>Width (In.):</b>	0.0	<b>Post Spacing (In.):</b>	75.3

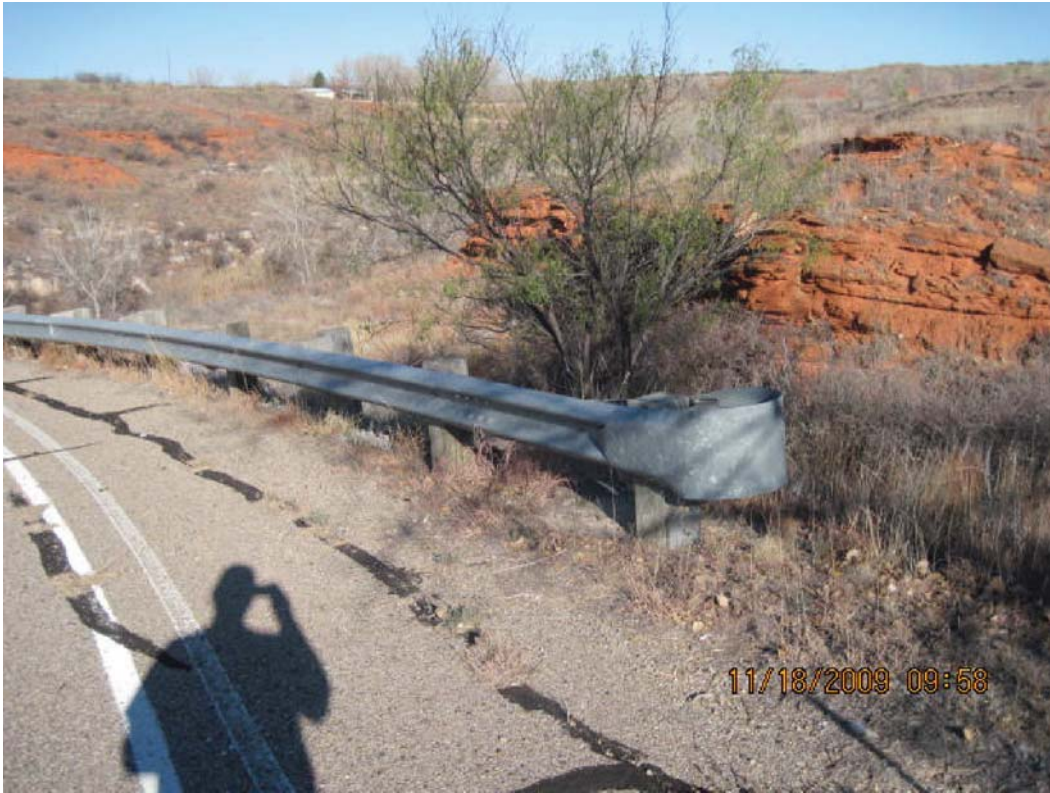
LAMR\_0219\_0.160\_R\_1.jpg

<b>Barrier ID:</b>	LAMR-0219-0.160-R				
<b>Route Name:</b>	BUGBEE ACCESS ROAD				
<b>Inspection Date:</b>	11/18/2009	<b>Barrier Rating:</b>	41.00		
<b>Barrier Description</b>					
<b>Type:</b>	W-BEAM STRONG POST	<b>Barrier Function:</b>	TRAFFIC		
<b>Barrier Material:</b>	GALVANIZED STEEL	<b>Post Material:</b>	WOOD		
<b>Blockout Type:</b>	WOOD	<b>Length (ft.):</b>	297		
<b>Speed Limit (MPH):</b>	20	<b>Placement with Respect to Road:</b>	OUTSIDE OF CURVE		
<b>Hazard Behind Barrier:</b>	MEDIUM				
<b>Barrier Crashworthiness</b>					
<b>Appropriate Test Level:</b>	TL-1	<b>Barrier Test Level:</b>	TL-3	<b>Is Barrier Crashworthy?:</b>	YES
<b>Beg. End Trtmt Type:</b>	W-BEAM BCT	<b>Is Beg. End Trtmt Crashworthy?:</b>	NO	<b>Approach Transition Type:</b>	NONE
<b>Ending End Trtmt Type:</b>	W-BEAM BCT	<b>Ending End Trtmt Crashworthy?:</b>	NO		
<b>Average Measurements</b>					
<b>Design Height (In.):</b>	27	<b>Width (In.):</b>	0.0	<b>Post Spacing (In.):</b>	74.8

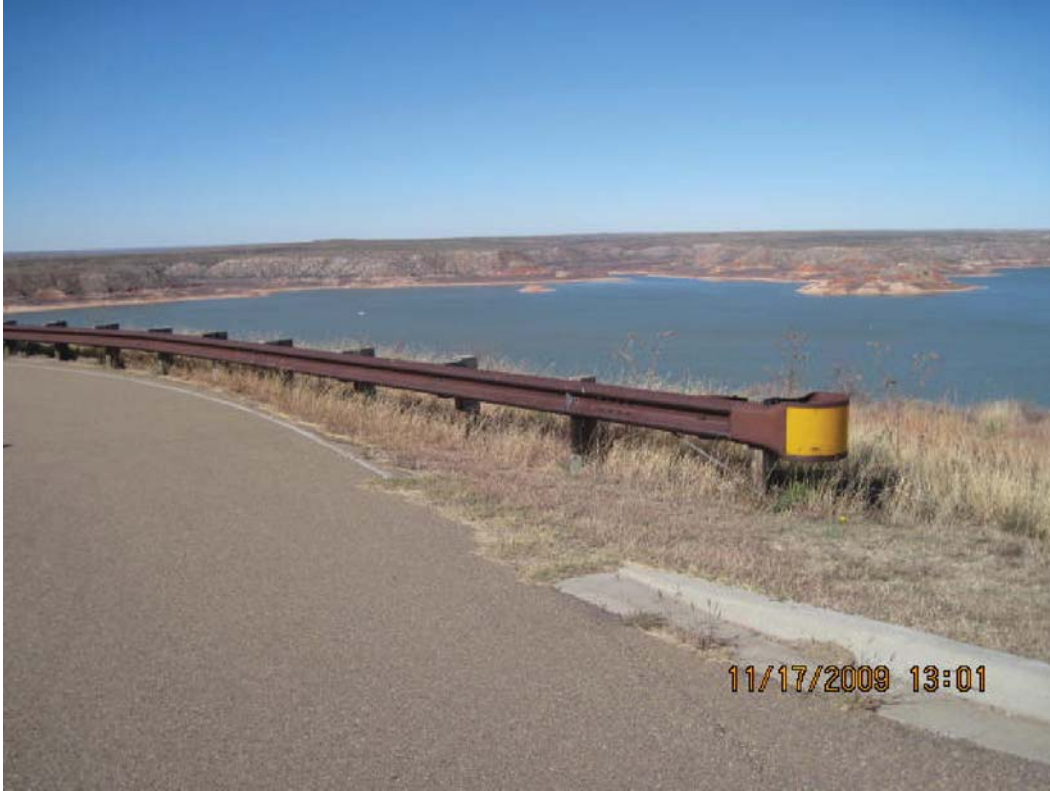
**LAMR\_0901\_0.000\_P1\_1.jpg**

<b>Barrier ID:</b>	LAMR-0901-0.000-P1				
<b>Route Name:</b>	FRITCH FORTRESS AMPHITHEATER PARKING				
<b>Inspection Date:</b>	11/17/2009	<b>Barrier Rating:</b>	25.60		
<b>Barrier Description</b>					
<b>Type:</b>	W-BEAM STRONG POST	<b>Barrier Function:</b>	TRAFFIC		
<b>Barrier Material:</b>	WEATHERING STEEL/CORTEN	<b>Post Material:</b>	WOOD		
<b>Blockout Type:</b>	WOOD	<b>Length (ft.):</b>	203		
<b>Speed Limit (MPH):</b>	15	<b>Placement with Respect to Road:</b>	OUTSIDE OF CURVE		
<b>Hazard Behind Barrier:</b>	HIGH				
<b>Barrier Crashworthiness</b>					
<b>Appropriate Test Level:</b>	TL-1	<b>Barrier Test Level:</b>	TL-3	<b>Is Barrier Crashworthy?:</b>	YES
<b>Beg. End Trtmt Type:</b>	W-BEAM BCT	<b>Is Beg. End Trtmt Crashworthy?:</b>	NO	<b>Approach Transition Type:</b>	NONE
<b>Ending End Trtmt Type:</b>	W-BEAM BCT	<b>Ending End Trtmt Crashworthy?:</b>	NO		
<b>Average Measurements</b>					
<b>Design Height (In.):</b>	27	<b>Width (In.):</b>	0.0	<b>Post Spacing (In.):</b>	75.6
