MACA GIP Report

NPS Guardwall/Rail Inventory Program Mammoth Cave National Park

**Federal Lands Highway
Road Inventory Program**

Data Collection Date: October 2010
Report Date: November 2015

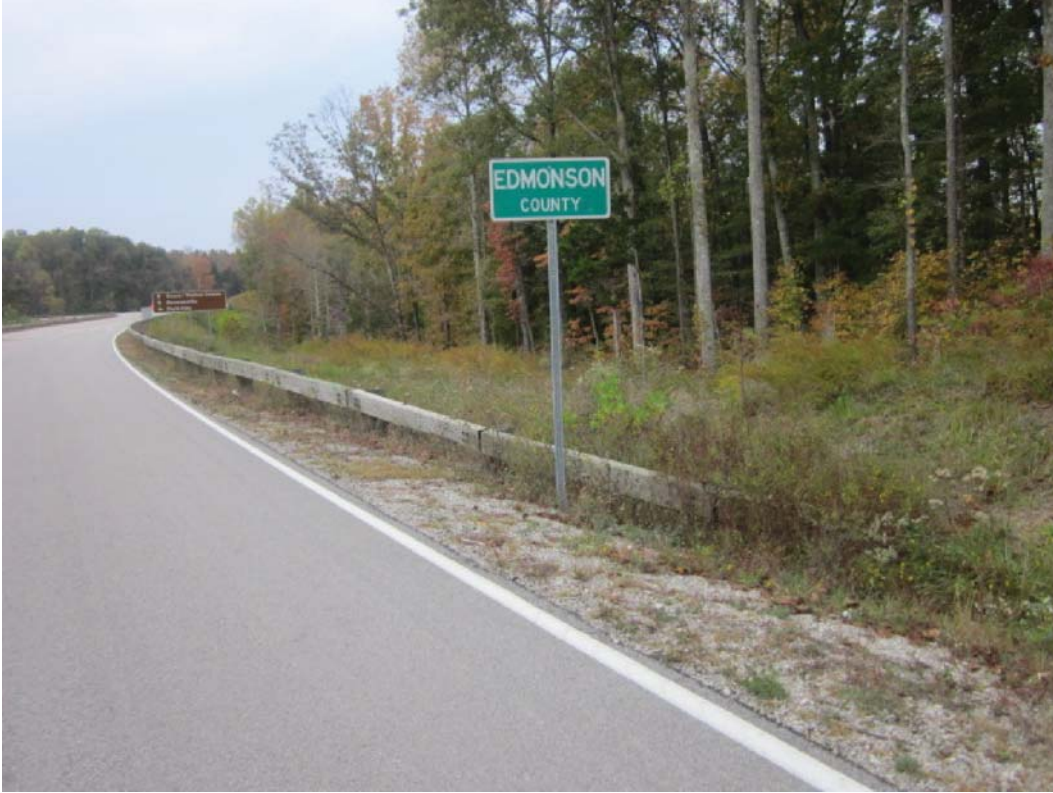
MACA_0010_0.028_R_1.JPG

Barrier ID:	MACA-0010-0.028-R				
Route Name:	MAMMOTH CAVE PARKWAY				
Inspection Date:	10/13/2010	Barrier Rating:	31.20		
Barrier Description					
Type:	STEEL-BACKED TIMBER WITH BLOCKOUT	Barrier Function:	TRAFFIC		
Barrier Material:	STEEL-BACKED TIMBER/LOG	Post Material:	WOOD		
Blockout Type:	WOOD	Length (ft.):	588		
Speed Limit (MPH):	50	Placement with Respect to Road:	INSIDE OF CURVE		
Hazard Behind Barrier:	HIGH				
Barrier Crashworthiness					
Appropriate Test Level:	TL-3	Barrier Test Level:	TL-3	Is Barrier Crashworthy?:	YES
Beg. End Trtmt Type:	SBT/LOG FLARED	Is Beg. End Trtmt Crashworthy?:	NO	Approach Transition Type:	NONE
Ending End Trtmt Type:	SBT/LOG FLARED	Ending End Trtmt Crashworthy?:	NO		
Average Measurements					
Design Height (In.):	27	Width (In.):	0.0	Post Spacing (In.):	120.0
Height (In.):	26.6	Lateral Offset (In.):	36.0	Road Grade (%):	0.10
Physical Condition					
Barrier	Alignment and Height:	Alignment has no deviation and height is within 1 in of the 27 in design height.

Breaking and Cracking:	No breaking or cracking observed.			
	Missing Elements:	No missing elements observed.			
	Corrosion and Weathering:	No corrosion or weathering observed.			
End Treatments	Alignment and Height:	Alignment acceptable. Height within 1-in of 27-in design height.			
	Breaking and Cracking:	No breaking or cracking observed.			
	Missing Elements:	No missing elements observed.			
	Corrosion and Weathering:	No corrosion or weathering observed.

Barrier ID:	MACA-0010-0.028-R				
Route Name:	MAMMOTH CAVE PARKWAY				
Inspection Date:	10/13/2010	Barrier Rating:		31.20	
Repair Recommendations					
Repair Action:	NO ACTION	FMSS Work Type:	N/A	Repair Cost:	\$0
Brief Workorder:	N/A				
Workorder:

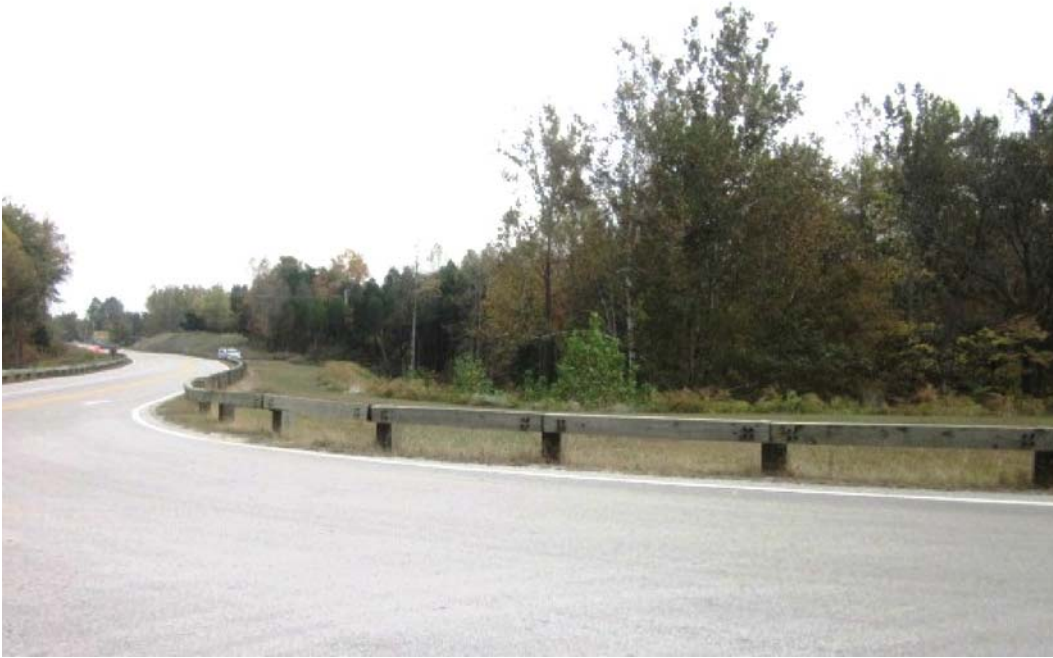
MACA_0010_0.075_L_1.JPG

Barrier ID:	MACA-0010-0.075-L				
Route Name:	MAMMOTH CAVE PARKWAY				
Inspection Date:	10/13/2010	Barrier Rating:	35.20		
Barrier Description					
Type:	STEEL-BACKED TIMBER WITH BLOCKOUT	Barrier Function:	TRAFFIC		
Barrier Material:	STEEL-BACKED TIMBER/LOG	Post Material:	WOOD		
Blockout Type:	WOOD	Length (ft.):	447		
Speed Limit (MPH):	50	Placement with Respect to Road:	OUTSIDE OF CURVE		
Hazard Behind Barrier:	MEDIUM				
Barrier Crashworthiness					
Appropriate Test Level:	TL-3	Barrier Test Level:	TL-3	Is Barrier Crashworthy?:	YES
Beg. End Trtmt Type:	SBT/LOG FLARED	Is Beg. End Trtmt Crashworthy?:	NO	Approach Transition Type:	NONE
Ending End Trtmt Type:	NONE	Ending End Trtmt Crashworthy?:	N/A		
Average Measurements					
Design Height (In.):	27	Width (In.):	0.0	Post Spacing (In.):	120.0
Height (In.):	28.0	Lateral Offset (In.):	38.0	Road Grade (%):	0.20
Physical Condition					
Barrier	Alignment and Height:	Alignment has no deviation and height is 0-2 in above the design height of 27 in.

Breaking and Cracking:	No breaking or cracking observed.			
	Missing Elements:	No missing elements observed.			
	Corrosion and Weathering:	No corrosion or weathering observed.			
End Treatments	Alignment and Height:	Alignment acceptable. Height within 1-in of 27-in design height.			
	Breaking and Cracking:	No breaking or cracking observed.			
	Missing Elements:	No missing elements observed.			
	Corrosion and Weathering:	No corrosion or weathering observed.

Barrier ID:	MACA-0010-0.075-L				
Route Name:	MAMMOTH CAVE PARKWAY				
Inspection Date:	10/13/2010	Barrier Rating:		35.20	
Repair Recommendations					
Repair Action:	NO ACTION	FMSS Work Type:	N/A	Repair Cost:	\$0
Brief Workorder:	N/A				
Workorder:

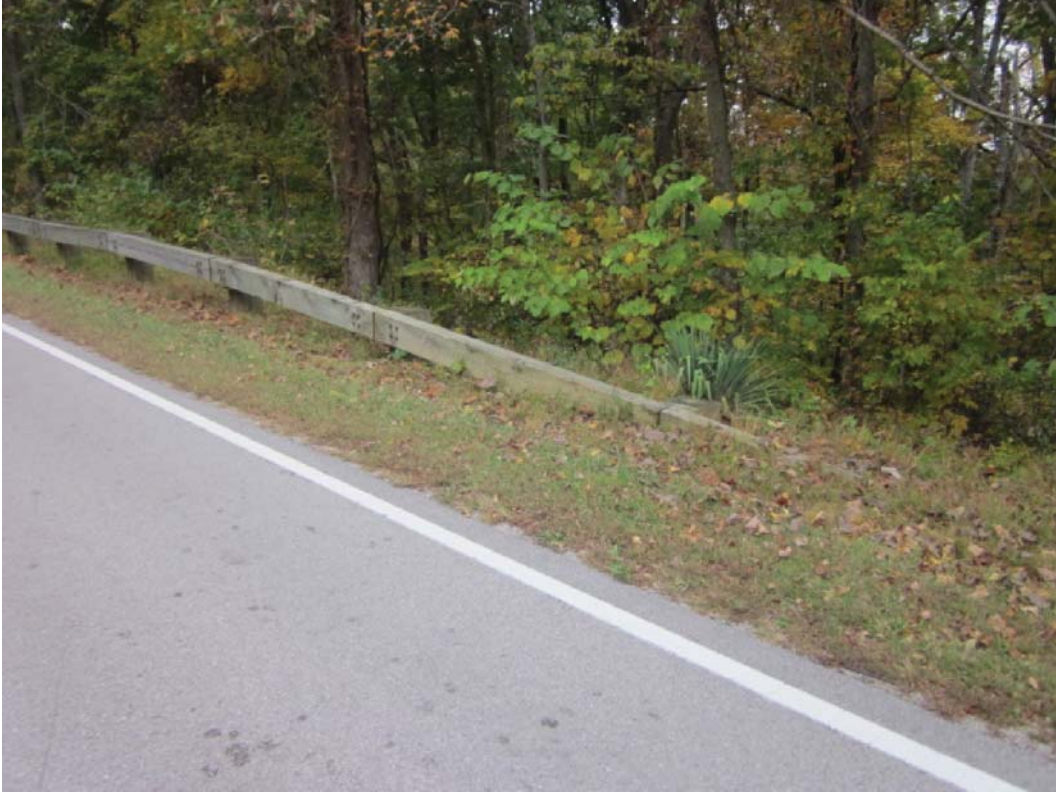
MACA_0010_2.565_R_1.JPG

Barrier ID:	MACA-0010-2.565-R				
Route Name:	MAMMOTH CAVE PARKWAY				
Inspection Date:	10/13/2010	Barrier Rating:	26.60		
Barrier Description					
Type:	STEEL-BACKED TIMBER WITH BLOCKOUT	Barrier Function:	TRAFFIC		
Barrier Material:	STEEL-BACKED TIMBER/LOG	Post Material:	WOOD		
Blockout Type:	WOOD	Length (ft.):	403		
Speed Limit (MPH):	50	Placement with Respect to Road:	INSIDE OF CURVE		
Hazard Behind Barrier:	MEDIUM				
Barrier Crashworthiness					
Appropriate Test Level:	TL-3	Barrier Test Level:	TL-3	Is Barrier Crashworthy?:	YES
Beg. End Trtmt Type:	SBT/LOG FLARED	Is Beg. End Trtmt Crashworthy?:	NO	Approach Transition Type:	NONE
Ending End Trtmt Type:	SBT/LOG FLARED	Ending End Trtmt Crashworthy?:	NO		
Average Measurements					
Design Height (In.):	27	Width (In.):	0.0	Post Spacing (In.):	120.0
Height (In.):	31.2	Lateral Offset (In.):	79.6	Road Grade (%):	0.50
Physical Condition					
Barrier	Alignment and Height:	Alignment has no deviation and height is 3 to 5 in above the 27 in design height.

Breaking and Cracking:	No breaking or cracking observed.			
	Missing Elements:	No missing elements observed.			
	Corrosion and Weathering:	No corrosion or weathering observed.			
End Treatments	Alignment and Height:	Alignment acceptable. Height within 1-in of 27-in design height.			
	Breaking and Cracking:	No breaking or cracking observed.			
	Missing Elements:	No missing elements observed.			
	Corrosion and Weathering:	No corrosion or weathering observed.

Barrier ID:	MACA-0010-2.565-R				
Route Name:	MAMMOTH CAVE PARKWAY				
Inspection Date:	10/13/2010	Barrier Rating:		26.60	
Repair Recommendations					
Repair Action:	NO ACTION	FMSS Work Type:	N/A	Repair Cost:	\$0
Brief Workorder:	N/A				
Workorder:

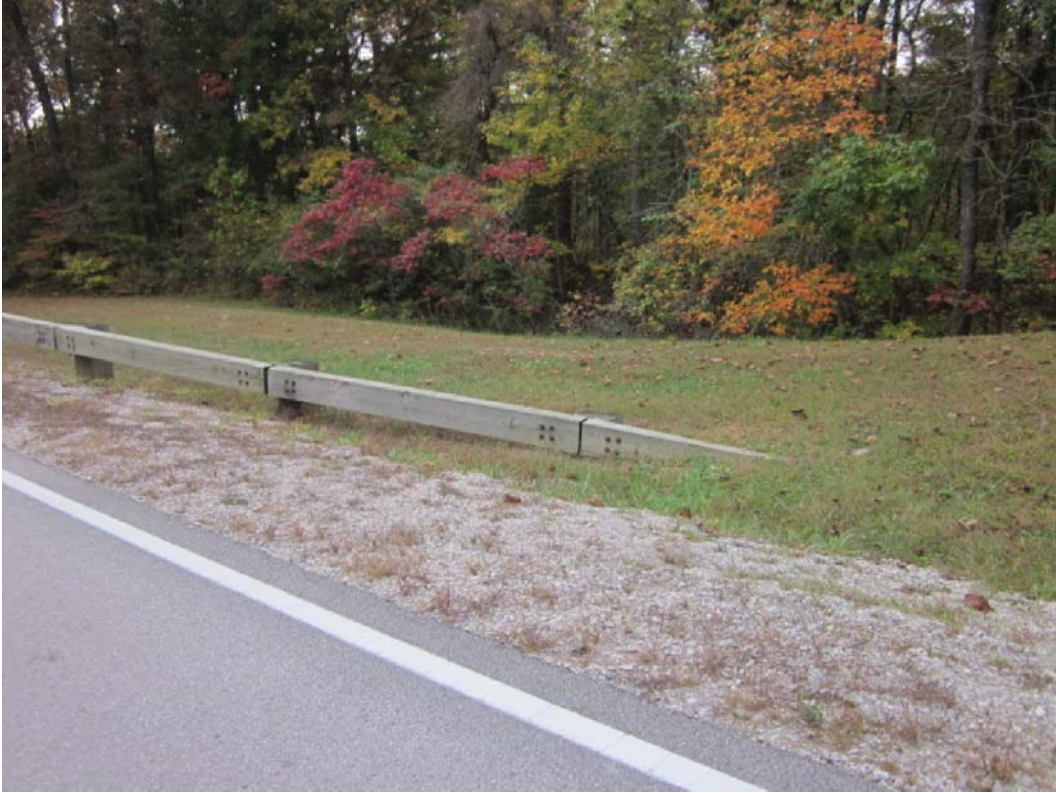
MACA_0010_2.837_R_1.JPG

Barrier ID:	MACA-0010-2.837-R				
Route Name:	MAMMOTH CAVE PARKWAY				
Inspection Date:	10/13/2010	Barrier Rating:	22.60		
Barrier Description					
Type:	STEEL-BACKED TIMBER WITH BLOCKOUT	Barrier Function:	TRAFFIC		
Barrier Material:	STEEL-BACKED TIMBER/LOG	Post Material:	WOOD		
Blockout Type:	WOOD	Length (ft.):	225		
Speed Limit (MPH):	45	Placement with Respect to Road:	TANGENT		
Hazard Behind Barrier:	LOW				
Barrier Crashworthiness					
Appropriate Test Level:	TL-2	Barrier Test Level:	TL-3	Is Barrier Crashworthy?:	YES
Beg. End Trtmt Type:	SBT/LOG FLARED	Is Beg. End Trtmt Crashworthy?:	NO	Approach Transition Type:	NONE
Ending End Trtmt Type:	SBT/LOG FLARED	Ending End Trtmt Crashworthy?:	NO		
Average Measurements					
Design Height (In.):	27	Width (In.):	0.0	Post Spacing (In.):	120.0
Height (In.):	30.6	Lateral Offset (In.):	57.5	Road Grade (%):	5.50
Physical Condition					
Barrier	Alignment and Height:	Alignment has no deviation and height is at or above the design height of 27 in by 3 to 4 in.

Breaking and Cracking:	No breaking or cracking observed.			
	Missing Elements:	No missing elements observed.			
	Corrosion and Weathering:	No corrosion or weathering observed.			
End Treatments	Alignment and Height:	Alignment acceptable. Height within 1-in of 27-in design height.			
	Breaking and Cracking:	No breaking or cracking observed.			
	Missing Elements:	No missing elements observed.			
	Corrosion and Weathering:	No corrosion or weathering observed.

Barrier ID:	MACA-0010-2.837-R				
Route Name:	MAMMOTH CAVE PARKWAY				
Inspection Date:	10/13/2010	Barrier Rating:		22.60	
Repair Recommendations					
Repair Action:	NO ACTION	FMSS Work Type:	N/A	Repair Cost:	\$0
Brief Workorder:	N/A				
Workorder:

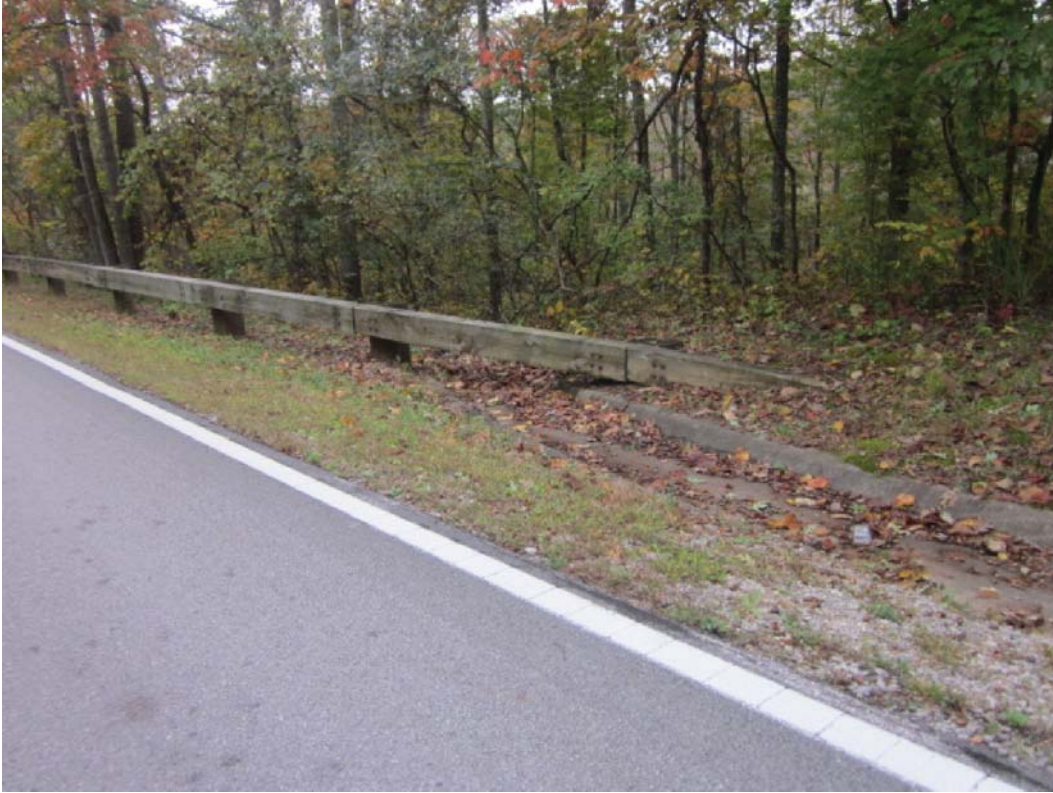
MACA_0010_2.921_R_1.JPG

Barrier ID:	MACA-0010-2.921-R				
Route Name:	MAMMOTH CAVE PARKWAY				
Inspection Date:	10/13/2010	Barrier Rating:	58.50		
Barrier Description					
Type:	STEEL-BACKED TIMBER WITH BLOCKOUT	Barrier Function:	TRAFFIC		
Barrier Material:	STEEL-BACKED TIMBER/LOG	Post Material:	WOOD		
Blockout Type:	WOOD	Length (ft.):	717		
Speed Limit (MPH):	45	Placement with Respect to Road:	OUTSIDE OF CURVE		
Hazard Behind Barrier:	HIGH				
Barrier Crashworthiness					
Appropriate Test Level:	TL-2	Barrier Test Level:	TL-3	Is Barrier Crashworthy?:	YES
Beg. End Trtmt Type:	SBT/LOG FLARED	Is Beg. End Trtmt Crashworthy?:	NO	Approach Transition Type:	NONE
Ending End Trtmt Type:	SBT/LOG FLARED	Ending End Trtmt Crashworthy?:	NO		
Average Measurements					
Design Height (In.):	27	Width (In.):	0.0	Post Spacing (In.):	119.8
Height (In.):	22.7	Lateral Offset (In.):	48.0	Road Grade (%):	3.60
Physical Condition					
Barrier	Alignment and Height:	Alignment acceptable. 40-ft was between 1 and 3-in below the 27-in design height and 170-ft was more than 3-in below the design height.

Breaking and Cracking:	No breaking or cracking observed.			
	Missing Elements:	No missing elements observed.			
	Corrosion and Weathering:	Some corrosion and weathering observed.			
End Treatments	Alignment and Height:	Alignment acceptable. Height within 1-in of 27-in design height.			
	Breaking and Cracking:	No breaking or cracking observed.			
	Missing Elements:	No missing elements observed.			
	Corrosion and Weathering:	Some corrosion and weathering observed.

Repair Action:	REPAIR	FMSS Work Type:	DEFERRED MAINTENANCE	Repair Cost:	\$3933
Brief Workorder:	Raise 210 feet of guardrail up to 27 inch design height.				
Workorder:	Adjust Guardrail at \$10- per -Lin. Ft. for 210 LF = \$2100. Raise 210 feet of guardrail up to 27 inch design height. Low Speed Traffic Control at \$1475- per -Day for 1 Day(s) = \$1475.

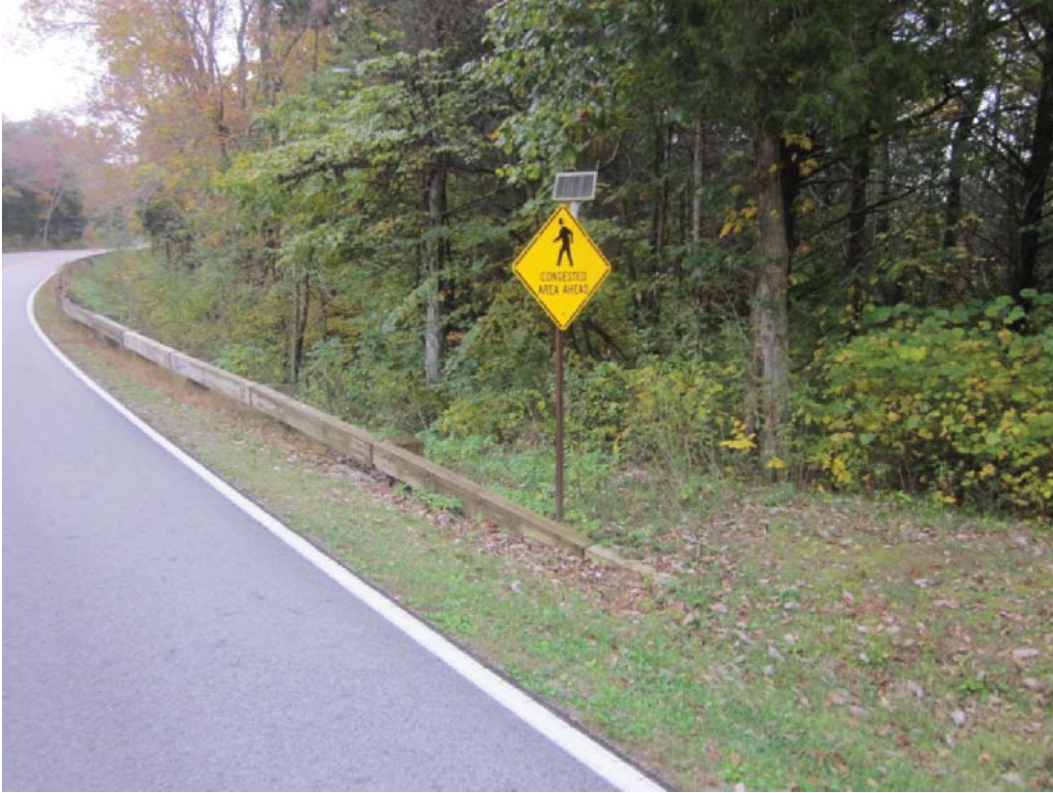
MACA_0010_3.450_R_1.JPG

Barrier ID:	MACA-0010-3.450-R				
Route Name:	MAMMOTH CAVE PARKWAY				
Inspection Date:	10/13/2010	Barrier Rating:	57.00		
Barrier Description					
Type:	STEEL-BACKED TIMBER WITH BLOCKOUT	Barrier Function:	TRAFFIC		
Barrier Material:	STEEL-BACKED TIMBER/LOG	Post Material:	WOOD		
Blockout Type:	WOOD	Length (ft.):	653		
Speed Limit (MPH):	35	Placement with Respect to Road:	INSIDE OF CURVE		
Hazard Behind Barrier:	HIGH				
Barrier Crashworthiness					
Appropriate Test Level:	TL-2	Barrier Test Level:	TL-3	Is Barrier Crashworthy?:	YES
Beg. End Trtmt Type:	SBT/LOG FLARED	Is Beg. End Trtmt Crashworthy?:	NO	Approach Transition Type:	NONE
Ending End Trtmt Type:	SBT/LOG FLARED	Ending End Trtmt Crashworthy?:	NO		
Average Measurements					
Design Height (In.):	27	Width (In.):	0.0	Post Spacing (In.):	118.0
Height (In.):	21.0	Lateral Offset (In.):	24.7	Road Grade (%):	3.70
Physical Condition					
Barrier	Alignment and Height:	Alignment has no deviation and height is 5 to 7 in below the 27 in design height.

Breaking and Cracking:	No breaking or cracking observed.			
	Missing Elements:	No missing elements observed.			
	Corrosion and Weathering:	No corrosion or weathering observed.			
End Treatments	Alignment and Height:	Alignment acceptable. Height within 1-in of 27-in design height.			
	Breaking and Cracking:	No breaking or cracking observed.			
	Missing Elements:	No missing elements observed.			
	Corrosion and Weathering:	No corrosion or weathering observed.

Repair Action:	REPAIR	FMSS Work Type:	DEFERRED MAINTENANCE	Repair Cost:	\$12051
Brief Workorder:	Raise 653 feet of guardrail up to 27 inch design height.				
Workorder:	Adjust Guardrail at \$10- per -Lin. Ft. for 653 LF = \$6530. Raise 653 feet of guardrail up to 27 inch design height. Low Speed Traffic Control at \$1475- per -Day for 3 Day(s) = \$4425.

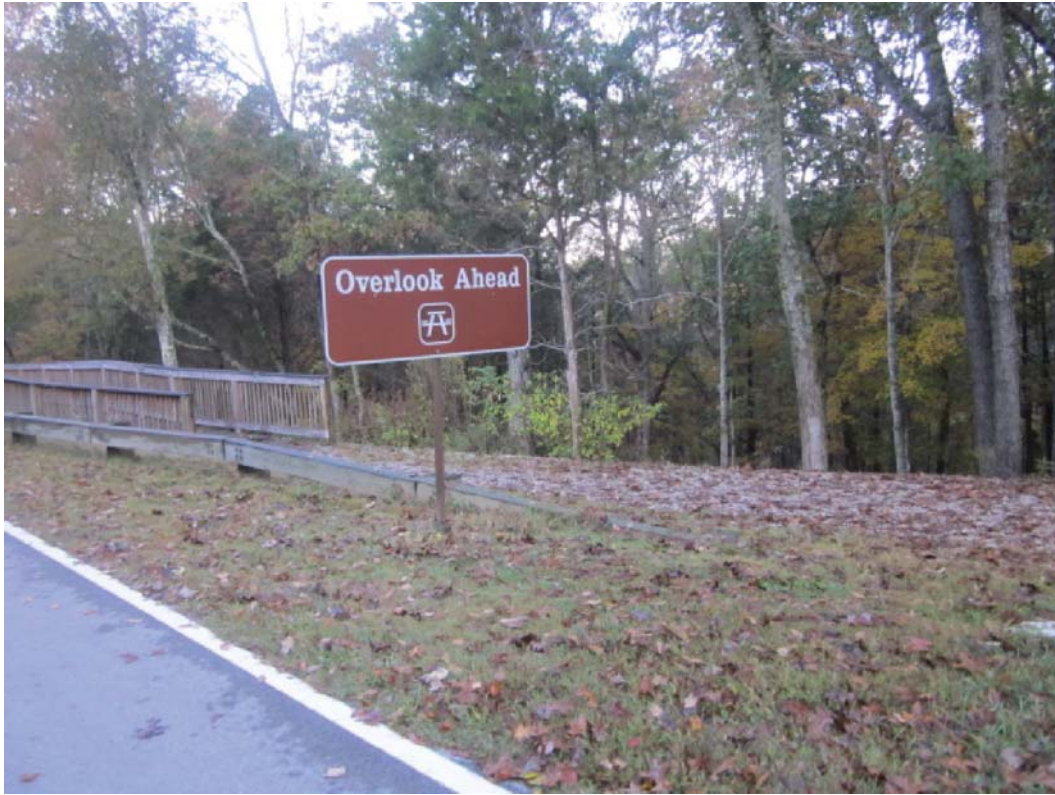
MACA_0010_3.617_L_1.JPG

Barrier ID:	MACA-0010-3.617-L				
Route Name:	MAMMOTH CAVE PARKWAY				
Inspection Date:	10/13/2010	Barrier Rating:	48.50		
Barrier Description					
Type:	STEEL-BACKED TIMBER WITH BLOCKOUT	Barrier Function:	TRAFFIC		
Barrier Material:	STEEL-BACKED TIMBER/LOG	Post Material:	WOOD		
Blockout Type:	WOOD	Length (ft.):	511		
Speed Limit (MPH):	35	Placement with Respect to Road:	INSIDE OF CURVE		
Hazard Behind Barrier:	LOW				
Barrier Crashworthiness					
Appropriate Test Level:	TL-2	Barrier Test Level:	TL-3	Is Barrier Crashworthy?:	YES
Beg. End Trtmt Type:	NONE	Is Beg. End Trtmt Crashworthy?:	N/A	Approach Transition Type:	NONE
Ending End Trtmt Type:	SBT/LOG FLARED	Ending End Trtmt Crashworthy?:	NO		
Average Measurements					
Design Height (In.):	27	Width (In.):	0.0	Post Spacing (In.):	119.3
Height (In.):	21.2	Lateral Offset (In.):	46.2	Road Grade (%):	3.70
Physical Condition					
Barrier	Alignment and Height:	Alignment acceptable. 200-ft was between 1 and 3-in below the 27-in design height and 311-ft was more than 3-in below the design height.

Breaking and Cracking:	No breaking or cracking observed.			
	Missing Elements:	No missing elements observed.			
	Corrosion and Weathering:	No corrosion or weathering observed.			
End Treatments	Alignment and Height:	Alignment acceptable. Height within 1-in of 27-in design height.			
	Breaking and Cracking:	No breaking or cracking observed.			
	Missing Elements:	No missing elements observed.			
	Corrosion and Weathering:	No corrosion or weathering observed.

Repair Action:	REPAIR	FMSS Work Type:	DEFERRED MAINTENANCE	Repair Cost:	\$10489
Brief Workorder:	Raise 511 feet of guardrail up to 27 inch design height.				
Workorder:	Adjust Guardrail at \$10- per -Lin. Ft. for 511 LF = \$5110. Raise 511 feet of guardrail up to 27 inch design height. Low Speed Traffic Control at \$1475- per -Day for 3 Day(s) = \$4425.

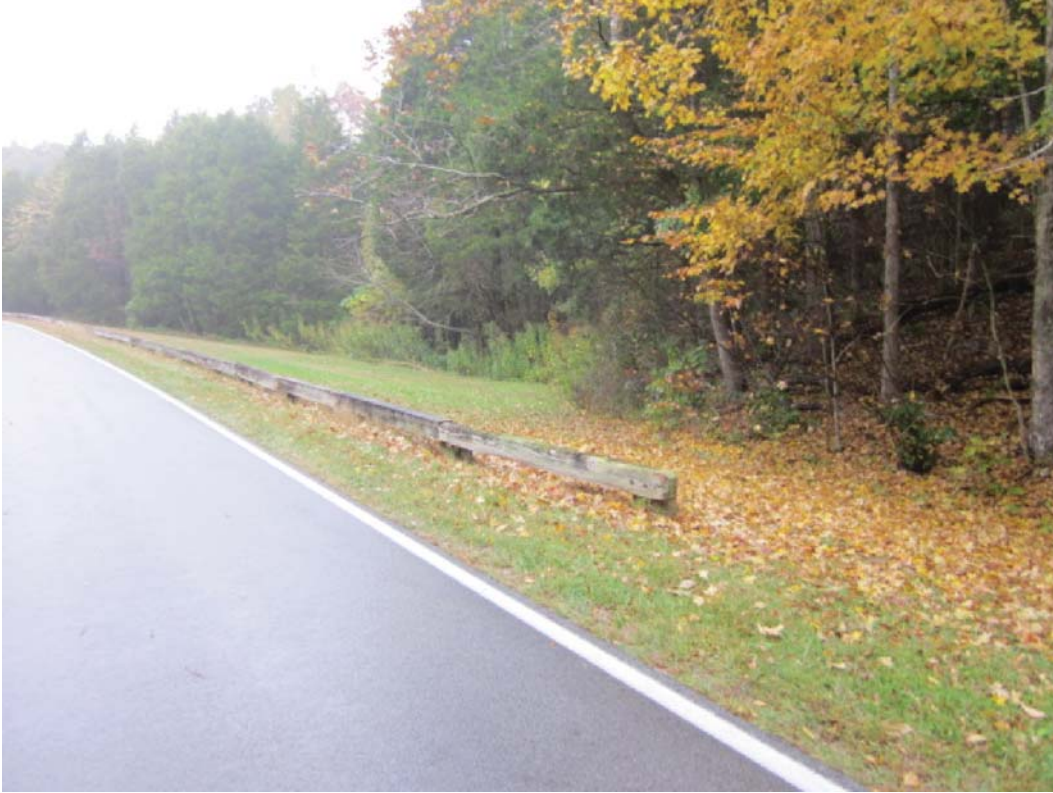
MACA_0015_0.870_L_1.JPG

Barrier ID:	MACA-0015-0.870-L				
Route Name:	BROWNSVILLE ROAD				
Inspection Date:	10/12/2010	Barrier Rating:	59.70		
Barrier Description					
Type:	OTHER: TIMBER RAIL ON CONCRETE POSTS	Barrier Function:	TRAFFIC		
Barrier Material:	LOG/TIMBER/WOOD	Post Material:	OTHER: CONCRETE		
Blockout Type:	N/A	Length (ft.):	1097		
Speed Limit (MPH):	50	Placement with Respect to Road:	BOTH INSIDE AND OUTSIDE		
Hazard Behind Barrier:	LOW				
Barrier Crashworthiness					
Appropriate Test Level:	TL-3	Barrier Test Level:	NCW	Is Barrier Crashworthy?:	NO
Beg. End Trtmt Type:	NONE	Is Beg. End Trtmt Crashworthy?:	N/A	Approach Transition Type:	NONE
Ending End Trtmt Type:	NONE	Ending End Trtmt Crashworthy?:	N/A		
Average Measurements					
Design Height (In.):	20	Width (In.):	0.0	Post Spacing (In.):	117.5
Height (In.):	15.1	Lateral Offset (In.):	50.2	Road Grade (%):	2.20
Physical Condition					
Barrier	Alignment and Height:	Alignment has no deviation and height is 2 to 8 in below the design height of 20 in.

Breaking and Cracking:	138 rails severely cracked and broken.			
	Missing Elements:	No missing elements observed.			
	Corrosion and Weathering:	Severe corrosion and weathering of guardrail observed on 138 rails.			
End Treatments	Alignment and Height:				
	Breaking and Cracking:				
	Missing Elements:				
	Corrosion and Weathering:

Repair Action:	REPLACE	FMSS Work Type:	CAPITAL IMPROVEMENT	Repair Cost:	\$105952
Brief Workorder:	Replace entire barrier with Steel-Backed Timber with blockout guardrail and install two end treatments.				
Workorder:	Remove Guardrail at \$10- per -Lin. Ft. for 1097 LF = \$10970. Steel-Backed Timber w/ Blockout at \$50- per -Lin. Ft. for 1037 LF = \$51850. SBT / Log Flared at \$5000- per -Each for 2 Unit(s) = \$10000. High Speed Traffic Control at \$2350- per -Day for 10 Day(s) = \$23500. 5 days removal 5 days installation.

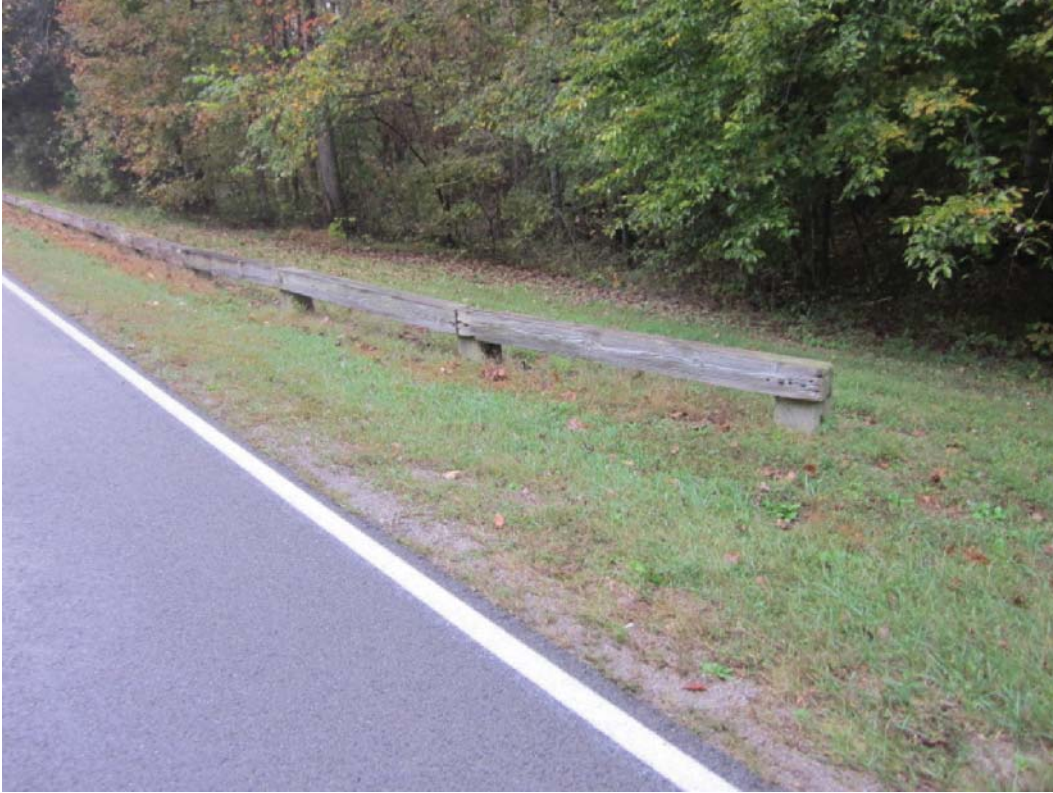
MACA_0015_0.888_R_1.JPG

Barrier ID:	MACA-0015-0.888-R				
Route Name:	BROWNSVILLE ROAD				
Inspection Date:	10/12/2010	Barrier Rating:	64.00		
Barrier Description					
Type:	OTHER: TIMBER RAIL ON CONCRETE POSTS	Barrier Function:	TRAFFIC		
Barrier Material:	LOG/TIMBER/WOOD	Post Material:	OTHER: CONCRETE		
Blockout Type:	N/A	Length (ft.):	1308		
Speed Limit (MPH):	50	Placement with Respect to Road:	BOTH INSIDE AND OUTSIDE		
Hazard Behind Barrier:	HIGH				
Barrier Crashworthiness					
Appropriate Test Level:	TL-3	Barrier Test Level:	NCW	Is Barrier Crashworthy?:	NO
Beg. End Trtmt Type:	NONE	Is Beg. End Trtmt Crashworthy?:	N/A	Approach Transition Type:	NONE
Ending End Trtmt Type:	NONE	Ending End Trtmt Crashworthy?:	N/A		
Average Measurements					
Design Height (In.):	20	Width (In.):	0.0	Post Spacing (In.):	120.3
Height (In.):	17.3	Lateral Offset (In.):	62.5	Road Grade (%):	0.60
Physical Condition					
Barrier	Alignment and Height:	Alignment has no deviation and height is 2 to 4 in below the 20 in design height.

Breaking and Cracking:	1218 ft of rail has cracking from 1/4 in to 3 in wide.			
	Missing Elements:	No missing elements observed.			
	Corrosion and Weathering:	1218 ft of rail has moss and severe rotting.			
End Treatments	Alignment and Height:				
	Breaking and Cracking:				
	Missing Elements:				
	Corrosion and Weathering:
