MEVE GIP Report

NPS Guardwall/Rail Inventory Program Mesa Verde National Park

**Federal Lands Highway
Road Inventory Program**

**Data Collection Date: November 2009
Report Date: November 2015**

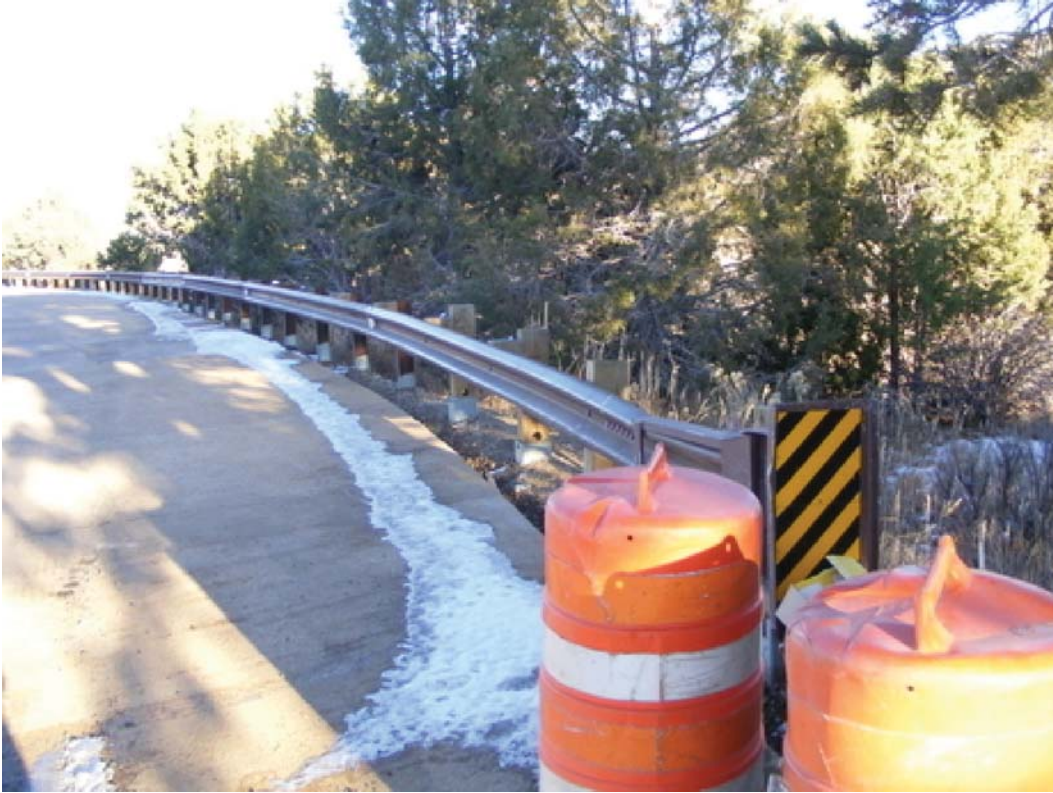
MEVE_0010_0.669_L_1.JPG

Barrier ID:	MEVE-0010-0.669-L				
Route Name:	ENTRANCE ROAD				
Inspection Date:	11/18/2009	Barrier Rating:	9.60		
Barrier Description					
Type:	W-BEAM STRONG POST	Barrier Function:	TRAFFIC		
Barrier Material:	WEATHERING STEEL/CORTEN	Post Material:	GALVANIZED STEEL		
Blockout Type:	WOOD	Length (ft.):	228		
Speed Limit (MPH):	15	Placement with Respect to Road:	TANGENT		
Hazard Behind Barrier:	LOW				
Barrier Crashworthiness					
Appropriate Test Level:	TL-1	Barrier Test Level:	TL-3	Is Barrier Crashworthy?:	YES
Beg. End Trtmt Type:	W-BEAM TANGENT 350	Is Beg. End Trtmt Crashworthy?:	YES	Approach Transition Type:	NONE
Ending End Trtmt Type:	W-BEAM TANGENT 350	Ending End Trtmt Crashworthy?:	YES		
Average Measurements					
Design Height (In.):	27	Width (In.):	0.0	Post Spacing (In.):	74.3
Height (In.):	29.2	Lateral Offset (In.):	103.0	Road Grade (%):	2.50
Physical Condition					
Barrier	Alignment and Height:	Alignment acceptable. Height is within 1-in of 27-in design height.

Breaking and Cracking:	No breaking or cracking observed.			
	Missing Elements:	No missing elements observed.			
	Corrosion and Weathering:	No corrosion or weathering observed.			
End Treatments	Alignment and Height:	Alignment acceptable. Height is within 1-in of 27-in design height.			
	Breaking and Cracking:	No breaking or cracking observed.			
	Missing Elements:	No missing elements observed.			
	Corrosion and Weathering:	No corrosion or weathering observed.

Repair Action:	NO ACTION	FMSS Work Type:	N/A	Repair Cost:	\$0
Brief Workorder:	N/A				
Workorder:

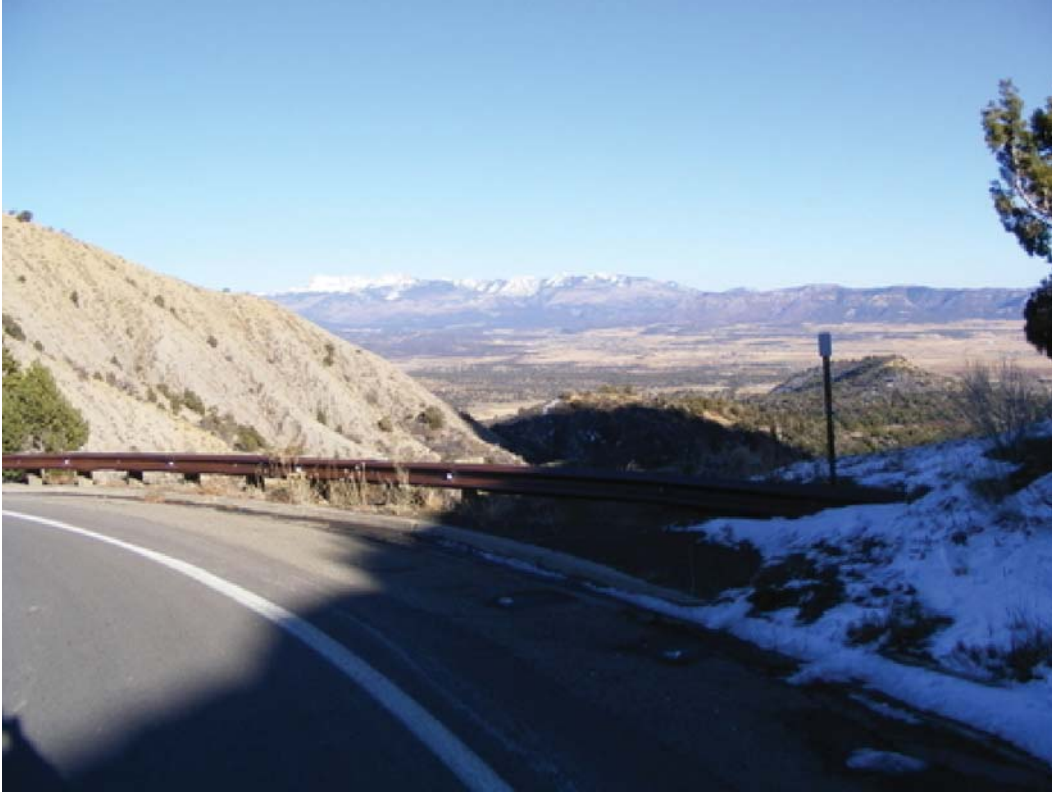
MEVE_0010_1.508_L_1.JPG

Barrier ID:	MEVE-0010-1.508-L				
Route Name:	ENTRANCE ROAD				
Inspection Date:	11/18/2009	Barrier Rating:	36.90		
Barrier Description					
Type:	W-BEAM STRONG POST	Barrier Function:	TRAFFIC		
Barrier Material:	WEATHERING STEEL/CORTEN	Post Material:	WOOD		
Blockout Type:	WOOD	Length (ft.):	950		
Speed Limit (MPH):	35	Placement with Respect to Road:	OUTSIDE OF CURVE		
Hazard Behind Barrier:	HIGH				
Barrier Crashworthiness					
Appropriate Test Level:	TL-2	Barrier Test Level:	TL-3	Is Barrier Crashworthy?:	YES
Beg. End Trtmt Type:	W-BEAM BURIED END	Is Beg. End Trtmt Crashworthy?:	YES	Approach Transition Type:	NONE
Ending End Trtmt Type:	W-BEAM BCT	Ending End Trtmt Crashworthy?:	NO		
Average Measurements					
Design Height (In.):	27	Width (In.):	0.0	Post Spacing (In.):	74.5
Height (In.):	28.2	Lateral Offset (In.):	57.4	Road Grade (%):	4.40
Physical Condition					
Barrier	Alignment and Height:	Alignment acceptable. Entire barrier is between 1-in below to 4-in above the 27-in design height.

Breaking and Cracking:	Minor cracking in posts and blocks less than 1/4in some bending of rails. No torn spots. Two broken blocks.			
	Missing Elements:	Missing 2 bolts.			
	Corrosion and Weathering:	Posts and blocks show weathering.			
End Treatments	Alignment and Height:	Alignment acceptable. Height is within 1-in of 27-in design height.			
	Breaking and Cracking:	No breaking or cracking observed.			
	Missing Elements:	No missing elements observed.			
	Corrosion and Weathering:	No corrosion or weathering observed.

Repair Action:	REPAIR	FMSS Work Type:	DEFERRED MAINTENANCE	Repair Cost:	\$1782
Brief Workorder:	Replace 2 broken blocks and replace missing bolts.				
Workorder:	Replace block at \$30- per -Each for 2 Block(s) = \$60. Labor at \$60- per -Hour for 1 Hrs = \$60. Labor to replace missing bolts. Lump Sum at \$25- per - for 1 = \$25. For new bolts. Low Speed Traffic Control at \$1475- per -Day for 1 Day(s) = \$1475.

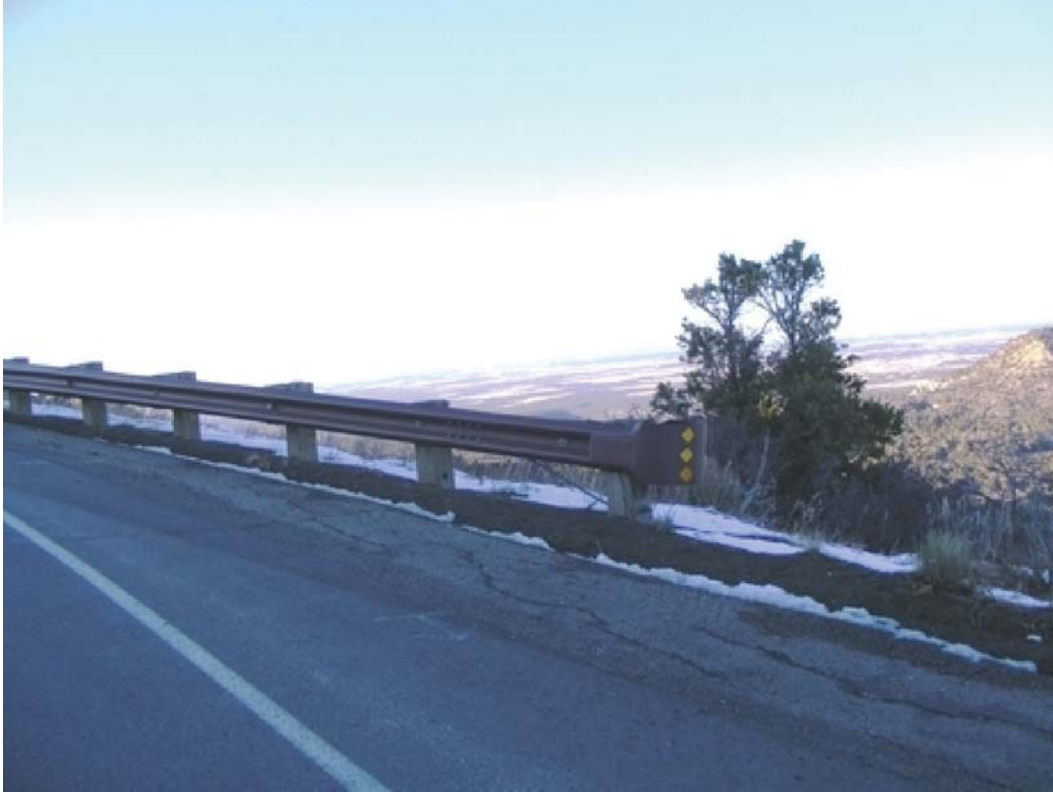
MEVE_0010_1.717_R_1.JPG

Barrier ID:	MEVE-0010-1.717-R				
Route Name:	ENTRANCE ROAD				
Inspection Date:	11/17/2009	Barrier Rating:	31.50		
Barrier Description					
Type:	W-BEAM STRONG POST	Barrier Function:	TRAFFIC		
Barrier Material:	WEATHERING STEEL/CORTEN	Post Material:	WOOD		
Blockout Type:	WOOD	Length (ft.):	299		
Speed Limit (MPH):	35	Placement with Respect to Road:	OUTSIDE OF CURVE		
Hazard Behind Barrier:	EXTREME				
Barrier Crashworthiness					
Appropriate Test Level:	TL-2	Barrier Test Level:	TL-3	Is Barrier Crashworthy?:	YES
Beg. End Trtmt Type:	W-BEAM BCT	Is Beg. End Trtmt Crashworthy?:	NO	Approach Transition Type:	NONE
Ending End Trtmt Type:	W-BEAM BCT	Ending End Trtmt Crashworthy?:	NO		
Average Measurements					
Design Height (In.):	27	Width (In.):	0.0	Post Spacing (In.):	75.5
Height (In.):	28.2	Lateral Offset (In.):	50.5	Road Grade (%):	6.50
Physical Condition					
Barrier	Alignment and Height:	Alignment acceptable. Height was 1-2in above the 27-in design height.

Breaking and Cracking:	Minor cracking less than 1/2 no bends or tears.			
	Missing Elements:	No missing elements.			
	Corrosion and Weathering:	Minor weathering of posts and blocks.			
End Treatments	Alignment and Height:	Alignment acceptable. Height is within 1-in of 27-in design height.			
	Breaking and Cracking:	No breaking or cracking observed.			
	Missing Elements:	No missing elements observed.			
	Corrosion and Weathering:	Some weathering of posts and blocks

Barrier ID:	MEVE-0010-1.717-R				
Route Name:	ENTRANCE ROAD				
Inspection Date:	11/17/2009	Barrier Rating:		31.50	
Repair Recommendations					
Repair Action:	NO ACTION	FMSS Work Type:	N/A	Repair Cost:	\$0
Brief Workorder:	N/A				
Workorder:

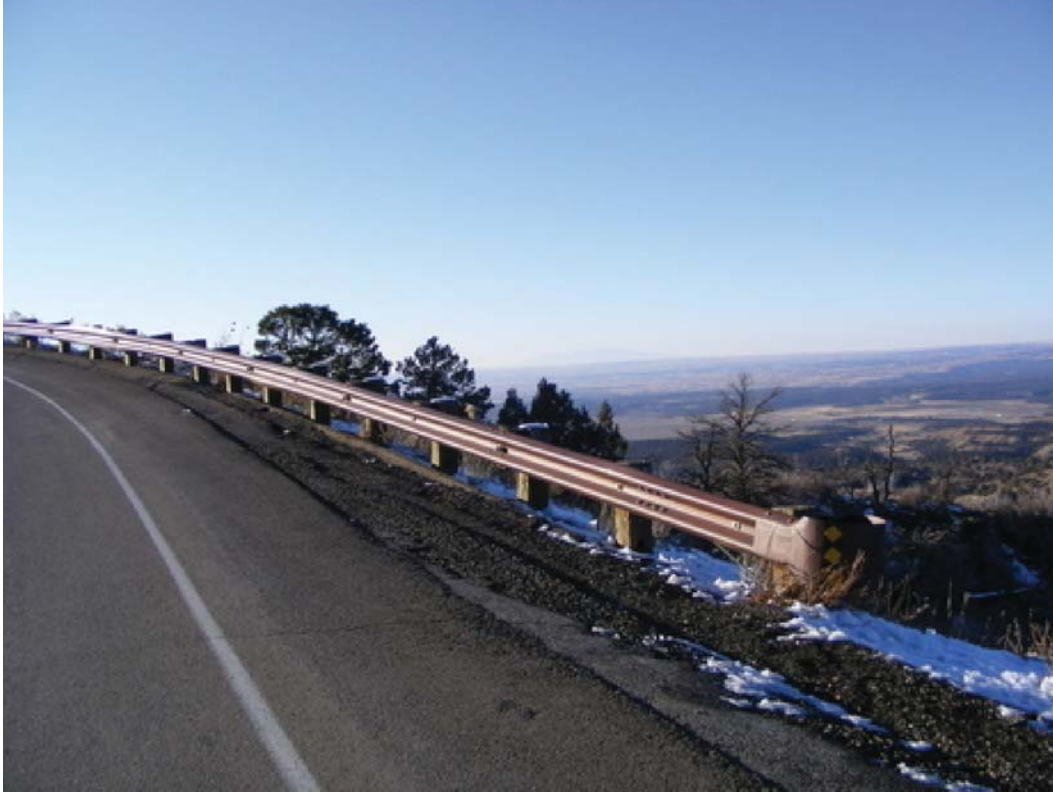
MEVE_0010_1.991_R_1.JPG

Barrier ID:	MEVE-0010-1.991-R				
Route Name:	ENTRANCE ROAD				
Inspection Date:	11/17/2009	Barrier Rating:	31.50		
Barrier Description					
Type:	W-BEAM STRONG POST	Barrier Function:	TRAFFIC		
Barrier Material:	WEATHERING STEEL/CORTEN	Post Material:	WOOD		
Blockout Type:	WOOD	Length (ft.):	283		
Speed Limit (MPH):	35	Placement with Respect to Road:	OUTSIDE OF CURVE		
Hazard Behind Barrier:	EXTREME				
Barrier Crashworthiness					
Appropriate Test Level:	TL-2	Barrier Test Level:	TL-3	Is Barrier Crashworthy?:	YES
Beg. End Trtmt Type:	W-BEAM BCT	Is Beg. End Trtmt Crashworthy?:	NO	Approach Transition Type:	NONE
Ending End Trtmt Type:	W-BEAM TRAILING END	Ending End Trtmt Crashworthy?:	YES		
Average Measurements					
Design Height (In.):	27	Width (In.):	0.0	Post Spacing (In.):	75.3
Height (In.):	28.2	Lateral Offset (In.):	118.6	Road Grade (%):	5.10
Physical Condition					
Barrier	Alignment and Height:	Alignment acceptable. Entire barrier is between 1-in below to 4-in above the 27-in design height.

Breaking and Cracking:	36 ft of impacted rail.			
	Missing Elements:	No missing elements.			
	Corrosion and Weathering:	No erosion along back of barrier.			
End Treatments	Alignment and Height:	Alignment acceptable. 20-ft was between 1 and 3-in below the 27-in design height.			
	Breaking and Cracking:	No breaks or cracks.			
	Missing Elements:	No missing elements.			
	Corrosion and Weathering:	No corrosion or weathering observed.

Repair Action:	REPAIR	FMSS Work Type:	DEFERRED MAINTENANCE	Repair Cost:	\$2833
Brief Workorder:	Raise 20-ft of barrier up to 27-in design height and replace 36-ft of rail.				
Workorder:	Adjust Guardrail at \$10- per -Lin. Ft. for 20 LF = \$200. Raise 20-ft of barrier up to 27-in design height. Replace rail at \$25- per -Lin. Ft. for 36 LF = \$900. Low Speed Traffic Control at \$1475- per -Day for 1 Day(s) = \$1475.

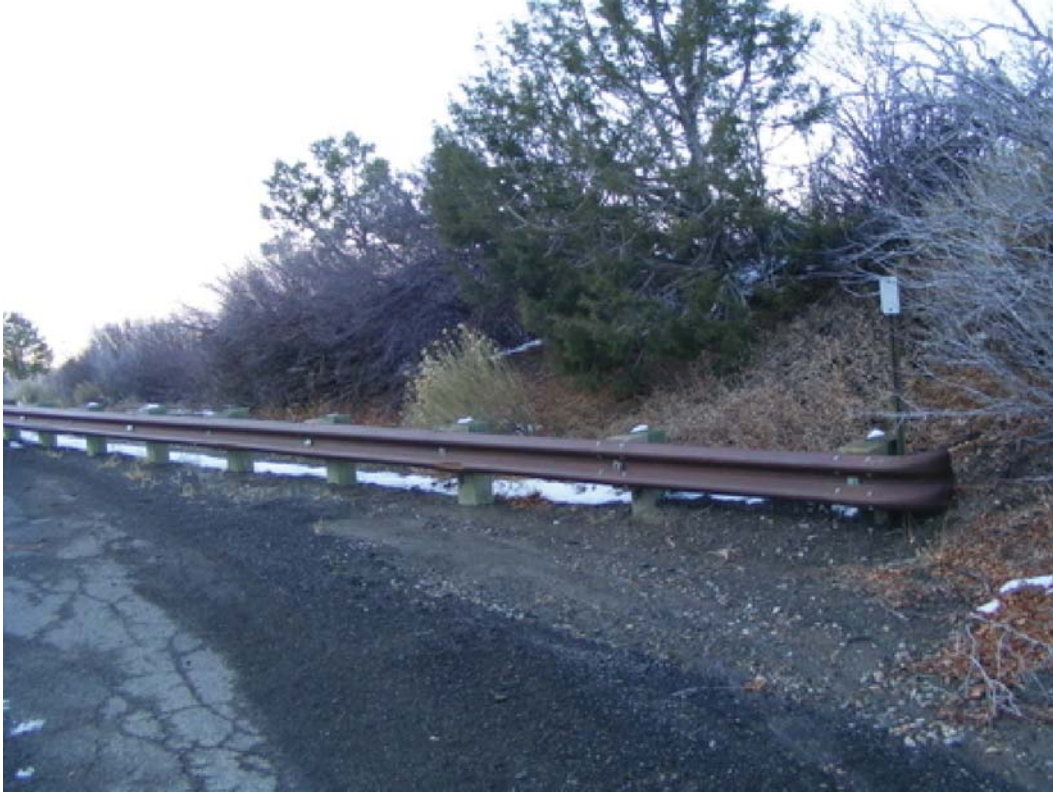
MEVE_0010_2.055_L_1.JPG

Barrier ID:	MEVE-0010-2.055-L				
Route Name:	ENTRANCE ROAD				
Inspection Date:	11/18/2009	Barrier Rating:	37.00		
Barrier Description					
Type:	W-BEAM STRONG POST	Barrier Function:	TRAFFIC		
Barrier Material:	WEATHERING STEEL/CORTEN	Post Material:	WOOD		
Blockout Type:	WOOD	Length (ft.):	644		
Speed Limit (MPH):	35	Placement with Respect to Road:	OUTSIDE OF CURVE		
Hazard Behind Barrier:	HIGH				
Barrier Crashworthiness					
Appropriate Test Level:	TL-2	Barrier Test Level:	TL-3	Is Barrier Crashworthy?:	YES
Beg. End Trtmt Type:	NONE	Is Beg. End Trtmt Crashworthy?:	N/A	Approach Transition Type:	NONE
Ending End Trtmt Type:	W-BEAM BCT	Ending End Trtmt Crashworthy?:	NO		
Average Measurements					
Design Height (In.):	27	Width (In.):	0.0	Post Spacing (In.):	74.5
Height (In.):	30.2	Lateral Offset (In.):	45.5	Road Grade (%):	4.00
Physical Condition					
Barrier	Alignment and Height:	Alignment acceptable. Height was 0-6in above the 27-in design height with 125 ft being more than 5 in above . Impact evident along the entire length of barrier due to snow plow.

Breaking and Cracking:	1 cracked post 36 ft of damaged rail 1 broken block and loose bolts.			
	Missing Elements:	No missing elements.			
	Corrosion and Weathering:	No erosion along back of barrier.			
End Treatments	Alignment and Height:	Alignment acceptable. Height is within 1-in of 27-in design height.			
	Breaking and Cracking:	No breaks or cracks.			
	Missing Elements:	No missing elements.			
	Corrosion and Weathering:	No corrosion or weathering observed.

Repair Action:	REPAIR	FMSS Work Type:	DEFERRED MAINTENANCE	Repair Cost:	\$4406
Brief Workorder:	Lower 125-ft of barrier to 27-in design height replace 1 post 1 block and 36-ft of rail. Tighten bolts and remove gravel from in front of barrier.				
Workorder:	Adjust Guardrail at \$10- per -Lin. Ft. for 125 LF = \$1250. Lower 125-ft of barrier to 27-in design height. Replace rail at \$25- per -Lin. Ft. for 36 LF = \$900. Replace post at \$100- per -Each for 1 Post(s) = \$100. Replace block at \$30- per -Each for 1 Block(s) = \$30. Grader at \$125- per -Hour for 2 Hrs = \$250. To remove gravel from in front of barrier. Low Speed Traffic Control at \$1475- per -Day for 1 Day(s) = \$1475.

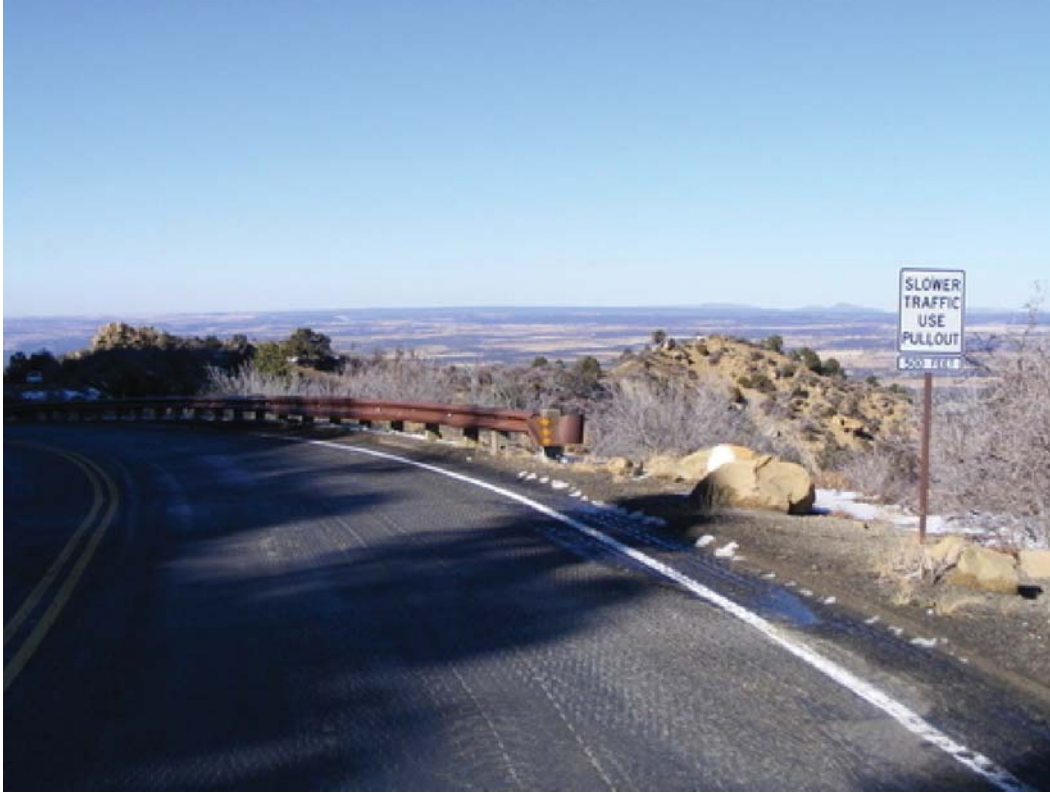
MEVE_0010_2.289_L_1.JPG

Barrier ID:	MEVE-0010-2.289-L				
Route Name:	ENTRANCE ROAD				
Inspection Date:	11/18/2009	Barrier Rating:	35.70		
Barrier Description					
Type:	W-BEAM STRONG POST	Barrier Function:	TRAFFIC		
Barrier Material:	WEATHERING STEEL/CORTEN	Post Material:	WOOD		
Blockout Type:	WOOD	Length (ft.):	152		
Speed Limit (MPH):	35	Placement with Respect to Road:	OUTSIDE OF CURVE		
Hazard Behind Barrier:	EXTREME				
Barrier Crashworthiness					
Appropriate Test Level:	TL-2	Barrier Test Level:	TL-3	Is Barrier Crashworthy?:	YES
Beg. End Trtmt Type:	W-BEAM BCT	Is Beg. End Trtmt Crashworthy?:	NO	Approach Transition Type:	NONE
Ending End Trtmt Type:	W-BEAM BCT	Ending End Trtmt Crashworthy?:	NO		
Average Measurements					
Design Height (In.):	27	Width (In.):	0.0	Post Spacing (In.):	75.0
Height (In.):	31.2	Lateral Offset (In.):	34.2	Road Grade (%):	5.20
Physical Condition					
Barrier	Alignment and Height:	Alignment acceptable. Height was 4-5in above the 27-in design height.

Breaking and Cracking:	No tears no major cracks less than 1/4in, bent spoon on BCT.			
	Missing Elements:	No missing elements.			
	Corrosion and Weathering:	Posts and blocks showing weathering.			
End Treatments	Alignment and Height:	Alignment acceptable. Height is within 1-in of 27-in design height.			
	Breaking and Cracking:	Bent end piece.			
	Missing Elements:	No missing elements observed.			
	Corrosion and Weathering:	No corrosion or weathering observed.

Repair Action:	NO ACTION	FMSS Work Type:	N/A	Repair Cost:	\$0
Brief Workorder:	N/A				
Workorder:

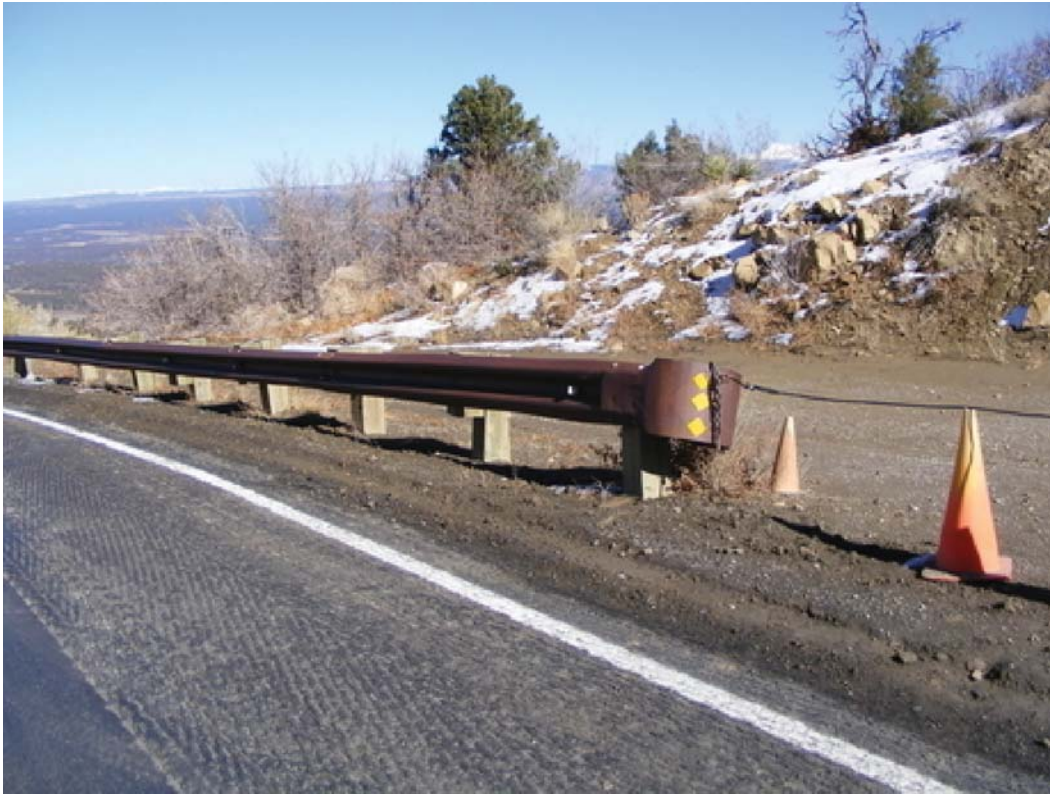
MEVE_0010_2.390_L_1.JPG

Barrier ID:	MEVE-0010-2.390-L				
Route Name:	ENTRANCE ROAD				
Inspection Date:	11/18/2009	Barrier Rating:	43.00		
Barrier Description					
Type:	W-BEAM STRONG POST	Barrier Function:	TRAFFIC		
Barrier Material:	WEATHERING STEEL/CORTEN	Post Material:	WOOD		
Blockout Type:	WOOD	Length (ft.):	345		
Speed Limit (MPH):	35	Placement with Respect to Road:	OUTSIDE OF CURVE		
Hazard Behind Barrier:	EXTREME				
Barrier Crashworthiness					
Appropriate Test Level:	TL-2	Barrier Test Level:	TL-3	Is Barrier Crashworthy?:	YES
Beg. End Trtmt Type:	W-BEAM BCT	Is Beg. End Trtmt Crashworthy?:	NO	Approach Transition Type:	NONE
Ending End Trtmt Type:	W-BEAM BCT	Ending End Trtmt Crashworthy?:	NO		
Average Measurements					
Design Height (In.):	27	Width (In.):	0.0	Post Spacing (In.):	76.0
Height (In.):	30.6	Lateral Offset (In.):	35.0	Road Grade (%):	5.70
Physical Condition					
Barrier	Alignment and Height:	Alignment acceptable. Height was 3-5in above the 27-in design height.

Breaking and Cracking:	100lf of bent and torn rail 7 blocks and 3 posts w/large cracks over 1/2 in.			
	Missing Elements:	No missing elements.			
	Corrosion and Weathering:	All posts and blocks are weathered with cracks less than 1/4 in.			
End Treatments	Alignment and Height:	Alignment acceptable. Height is within 1-in of 27-in design height.			
	Breaking and Cracking:	No torn or bent elements.			
	Missing Elements:	No missing elements observed.			
	Corrosion and Weathering:	Small weather cracks less than 1/4 in

Repair Action:	REPAIR	FMSS Work Type:	DEFERRED MAINTENANCE	Repair Cost:	\$6557
Brief Workorder:	Replace 3 posts 7 blocks and 100 L.F. of W-beam barrier.				
Workorder:	Replace post at \$100- per -Each for 3 Post(s) = \$300. Replace block at \$30- per -Each for 7 Block(s) = \$210. Replace rail at \$25- per -Lin. Ft. for 100 LF = \$2500. Low Speed Traffic Control at \$1475- per -Day for 2 Day(s) = \$2950.

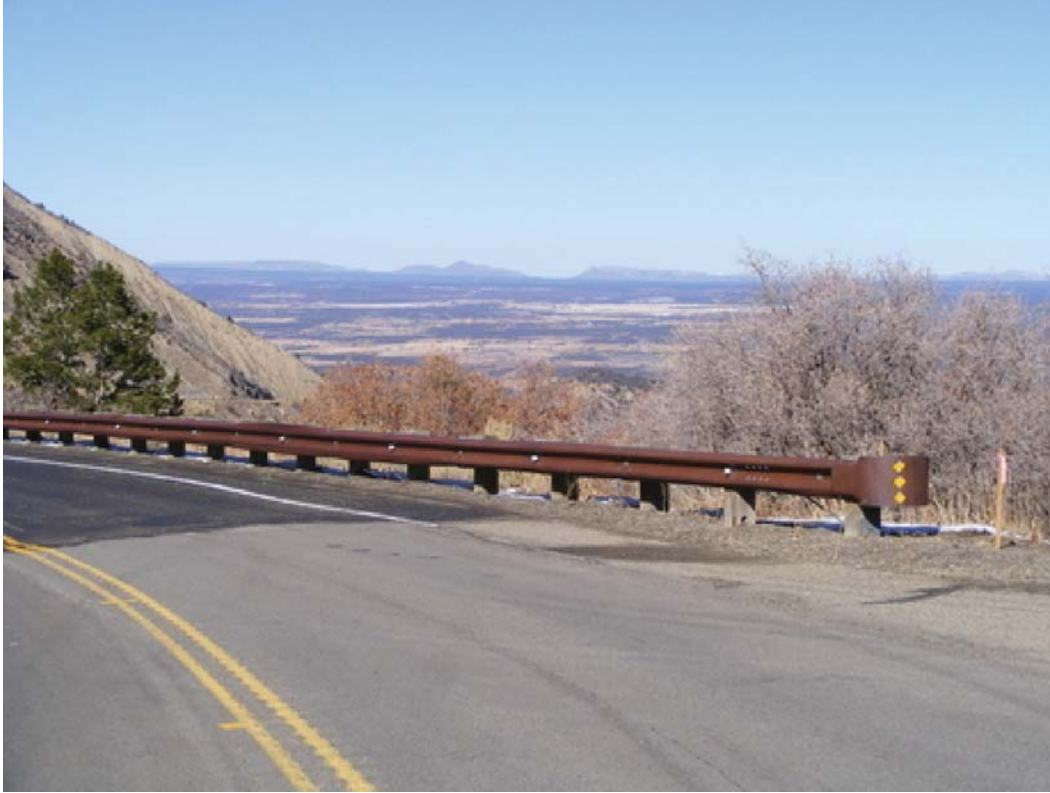
MEVE_0010_2.457_L_1.JPG

Barrier ID:	MEVE-0010-2.457-L				
Route Name:	ENTRANCE ROAD				
Inspection Date:	11/18/2009	Barrier Rating:	63.00		
Barrier Description					
Type:	W-BEAM STRONG POST	Barrier Function:	TRAFFIC		
Barrier Material:	WEATHERING STEEL/CORTEN	Post Material:	WOOD		
Blockout Type:	WOOD	Length (ft.):	4882		
Speed Limit (MPH):	35	Placement with Respect to Road:	BOTH INSIDE AND OUTSIDE		
Hazard Behind Barrier:	EXTREME				
Barrier Crashworthiness					
Appropriate Test Level:	TL-2	Barrier Test Level:	TL-3	Is Barrier Crashworthy?:	YES
Beg. End Trtmt Type:	W-BEAM BCT	Is Beg. End Trtmt Crashworthy?:	NO	Approach Transition Type:	NONE
Ending End Trtmt Type:	W-BEAM BCT	Ending End Trtmt Crashworthy?:	NO		
Average Measurements					
Design Height (In.):	27	Width (In.):	0.0	Post Spacing (In.):	75.0
Height (In.):	27.2	Lateral Offset (In.):	43.7	Road Grade (%):	5.00
Physical Condition					
Barrier	Alignment and Height:	Alignment is good for entire length. Almost every rail has evidence of impact. 420-ft was 1-7in below the 27-in design height remaining height was between 1-in below to 5-in above design height.

Breaking and Cracking:	33 cracked/broken posts 30 cracked/broken blocks 396-ft of bent rail and 49 loose bolts.			
	Missing Elements:	27 missing bolts 5 missing posts 3 missing blocks.			
	Corrosion and Weathering:	No erosion evident at base of wall.			
End Treatments	Alignment and Height:	Alignment acceptable. Trailing end is 1-3in below 27-in design height.			
	Breaking and Cracking:	No impacts. No breaks or cracks.			
	Missing Elements:	No missing elements.			
	Corrosion and Weathering:	No corrosion or weathering observed.

Repair Action:	REPAIR	FMSS Work Type:	DEFERRED MAINTENANCE	Repair Cost:	\$31042
Brief Workorder:	Raise 420-ft of barrier up to 27-in design height replace 396-ft of rail 38 posts and 33 blocks.				
Workorder:	Adjust Guardrail at \$10- per -Lin. Ft. for 420 LF = \$4200. Raise 420-ft of barrier up to 27-in design height. Replace rail at \$25- per -Lin. Ft. for 396 LF = \$9900. Replace post at \$100- per -Each for 38 Post(s) = \$3800. Replace block at \$30- per -Each for 33 Block(s) = \$990. Labor at \$60- per -Hour for 8 Hrs = \$480. Replace and tighten bolts. Low Speed Traffic Control at \$1475- per -Day for 6 Day(s) = \$8850. 2 days to raise barrier 2 days to replace rail 2 days all other work.

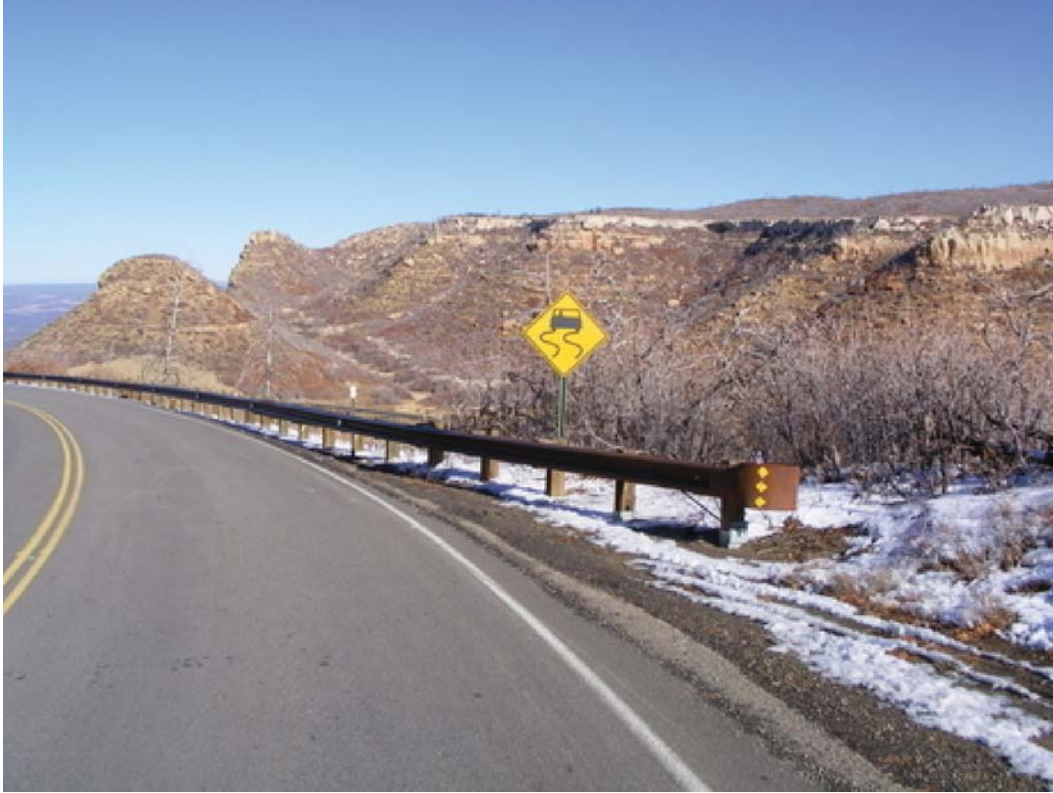
MEVE_0010_6.641_L_1.JPG

Barrier ID:	MEVE-0010-6.641-L				
Route Name:	ENTRANCE ROAD				
Inspection Date:	11/17/2009	Barrier Rating:	39.70		
Barrier Description					
Type:	W-BEAM STRONG POST	Barrier Function:	TRAFFIC		
Barrier Material:	WEATHERING STEEL/CORTEN	Post Material:	WOOD		
Blockout Type:	WOOD	Length (ft.):	3255		
Speed Limit (MPH):	35	Placement with Respect to Road:	BOTH INSIDE AND OUTSIDE		
Hazard Behind Barrier:	HIGH				
Barrier Crashworthiness					
Appropriate Test Level:	TL-2	Barrier Test Level:	TL-3	Is Barrier Crashworthy?:	YES
Beg. End Trtmt Type:	W-BEAM BCT	Is Beg. End Trtmt Crashworthy?:	NO	Approach Transition Type:	NONE
Ending End Trtmt Type:	W-BEAM BCT	Ending End Trtmt Crashworthy?:	NO		
Average Measurements					
Design Height (In.):	27	Width (In.):	0.0	Post Spacing (In.):	75.0
Height (In.):	27.0	Lateral Offset (In.):	33.2	Road Grade (%):	4.20
Physical Condition					
Barrier	Alignment and Height:	Alignment acceptable. Height is within 1-in of 27-in design height.

Breaking and Cracking:	325-ft of bent rail cracks over 1/2in 5 broken posts, 6 broken blocks.			
	Missing Elements:	2 missing blocks.			
	Corrosion and Weathering:	Posts and blocks are weathered.			
End Treatments	Alignment and Height:	Alignment acceptable. Height is within 1-in of 27-in design height.			
	Breaking and Cracking:	No major cracks less than 1/4in.			
	Missing Elements:	No missing elements observed.			
	Corrosion and Weathering:	Posts and blocks are weathered.

Repair Action:	REPAIR	FMSS Work Type:	DEFERRED MAINTENANCE	Repair Cost:	\$12997
Brief Workorder:	Replace 325-ft of rail 8 blocks and 5 posts.				
Workorder:	Replace rail at \$25- per -Lin. Ft. for 325 LF = \$8125. Replace bent and twisted rail sections. Replace post at \$100- per -Each for 5 Post(s) = \$500. Replace block at \$30- per -Each for 8 Block(s) = \$240. Low Speed Traffic Control at \$1475- per -Day for 2 Day(s) = \$2950.

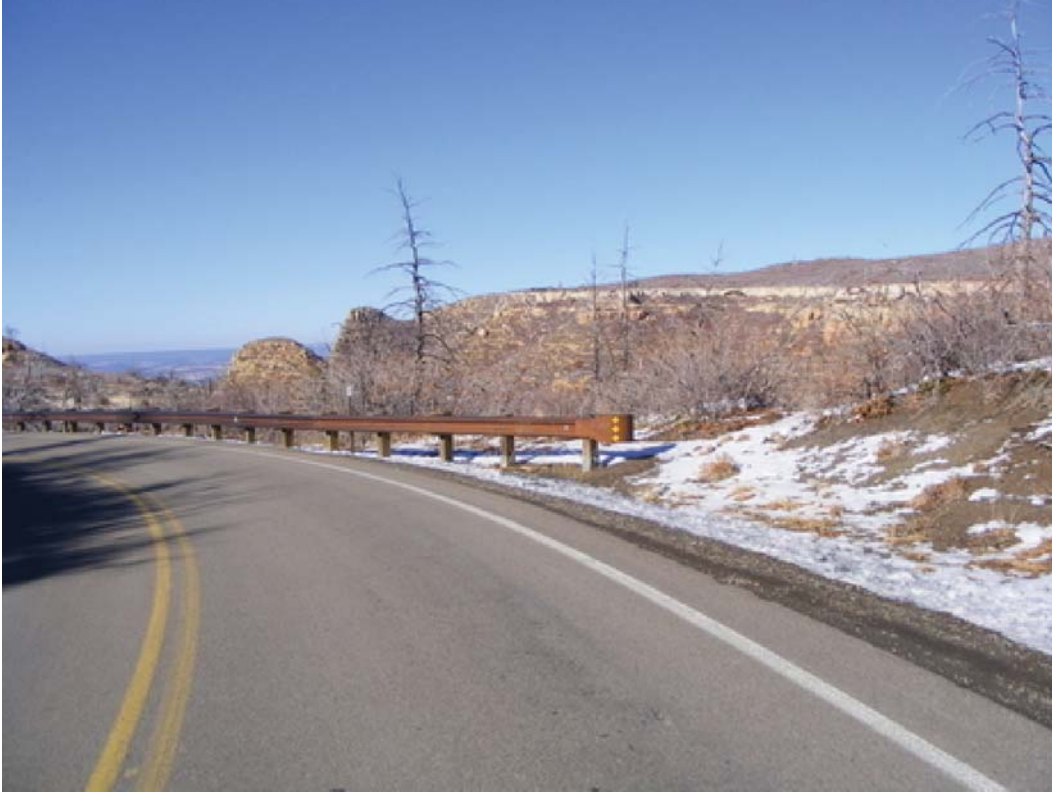
MEVE_0010_7.278_L_1.JPG

Barrier ID:	MEVE-0010-7.278-L				
Route Name:	ENTRANCE ROAD				
Inspection Date:	11/17/2009	Barrier Rating:	45.90		
Barrier Description					
Type:	W-BEAM STRONG POST	Barrier Function:	TRAFFIC		
Barrier Material:	GALVANIZED STEEL	Post Material:	WOOD		
Blockout Type:	WOOD	Length (ft.):	795		
Speed Limit (MPH):	35	Placement with Respect to Road:	BOTH INSIDE AND OUTSIDE		
Hazard Behind Barrier:	EXTREME				
Barrier Crashworthiness					
Appropriate Test Level:	TL-2	Barrier Test Level:	TL-3	Is Barrier Crashworthy?:	YES
Beg. End Trtmt Type:	W-BEAM BCT	Is Beg. End Trtmt Crashworthy?:	NO	Approach Transition Type:	NONE
Ending End Trtmt Type:	W-BEAM BCT	Ending End Trtmt Crashworthy?:	NO		
Average Measurements					
Design Height (In.):	27	Width (In.):	0.0	Post Spacing (In.):	75.1
Height (In.):	26.7	Lateral Offset (In.):	36.5	Road Grade (%):	4.00
Physical Condition					
Barrier	Alignment and Height:	Alignment acceptable. 60-ft was 1-3in below 27-in design height.

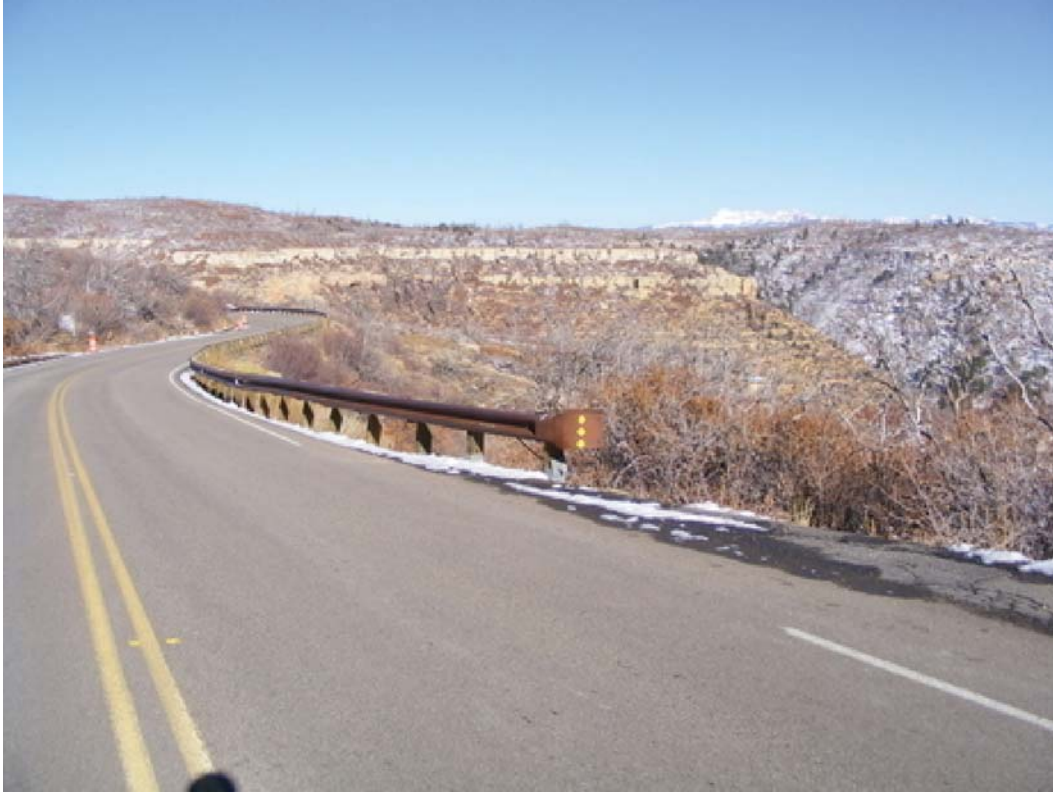
MEVE_0010_7.443_L_1.JPG

Barrier ID:	MEVE-0010-7.443-L				
Route Name:	ENTRANCE ROAD				
Inspection Date:	11/17/2009	Barrier Rating:	35.20		
Barrier Description					
Type:	W-BEAM STRONG POST	Barrier Function:	TRAFFIC		
Barrier Material:	WEATHERING STEEL/CORTEN	Post Material:	WOOD		
Blockout Type:	WOOD	Length (ft.):	524		
Speed Limit (MPH):	35	Placement with Respect to Road:	BOTH INSIDE AND OUTSIDE		
Hazard Behind Barrier:	MEDIUM				
Barrier Crashworthiness					
Appropriate Test Level:	TL-2	Barrier Test Level:	TL-3	Is Barrier Crashworthy?:	YES
Beg. End Trtmt Type:	W-BEAM BCT	Is Beg. End Trtmt Crashworthy?:	NO	Approach Transition Type:	NONE
Ending End Trtmt Type:	W-BEAM BURIED END	Ending End Trtmt Crashworthy?:	YES		
Average Measurements					
Design Height (In.):	27	Width (In.):	0.0	Post Spacing (In.):	75.0
Height (In.):	27.2	Lateral Offset (In.):	26.2	Road Grade (%):	2.80
Physical Condition					
Barrier	Alignment and Height:	130-ft of the barrier is leaning greater than 6 in. Height is within 1-in of 27-in design height.

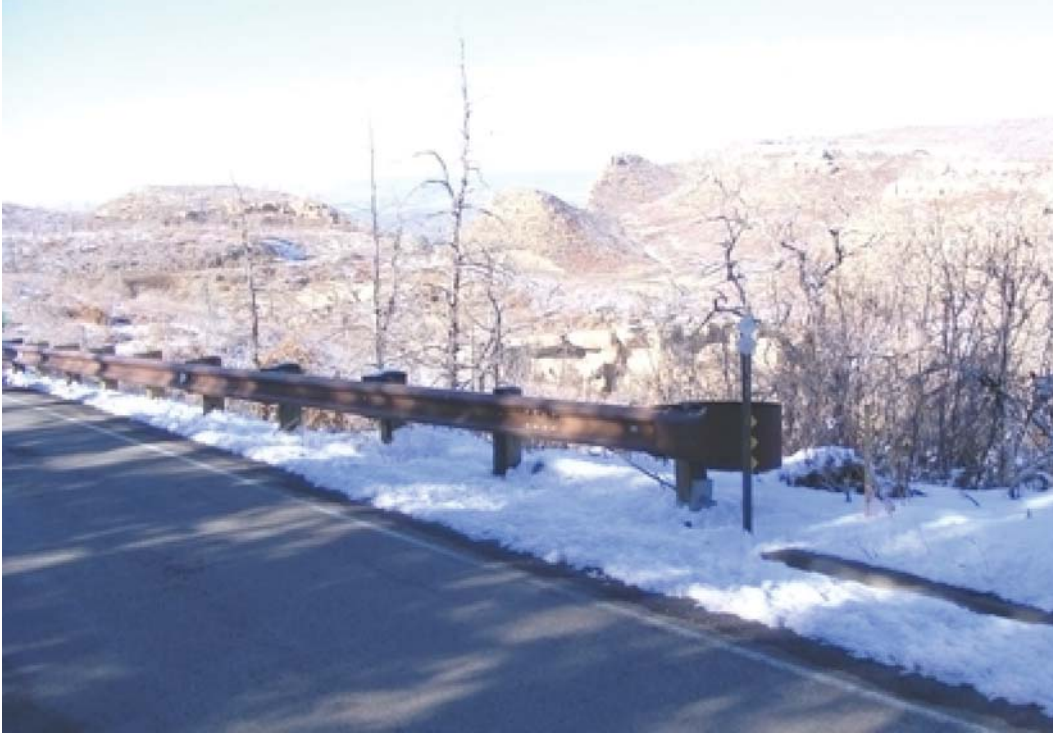
MEVE_0010_7.768_L_1.JPG

Barrier ID:	MEVE-0010-7.768-L				
Route Name:	ENTRANCE ROAD				
Inspection Date:	11/17/2009	Barrier Rating:	55.20		
Barrier Description					
Type:	W-BEAM STRONG POST	Barrier Function:	TRAFFIC		
Barrier Material:	WEATHERING STEEL/CORTEN	Post Material:	WOOD		
Blockout Type:	WOOD	Length (ft.):	455		
Speed Limit (MPH):	35	Placement with Respect to Road:	TANGENT		
Hazard Behind Barrier:	MEDIUM				
Barrier Crashworthiness					
Appropriate Test Level:	TL-2	Barrier Test Level:	TL-3	Is Barrier Crashworthy?:	YES
Beg. End Trtmt Type:	W-BEAM BCT	Is Beg. End Trtmt Crashworthy?:	NO	Approach Transition Type:	NONE
Ending End Trtmt Type:	W-BEAM BCT	Ending End Trtmt Crashworthy?:	NO		
Average Measurements					
Design Height (In.):	27	Width (In.):	0.0	Post Spacing (In.):	75.0
Height (In.):	22.6	Lateral Offset (In.):	18.0	Road Grade (%):	5.10
Physical Condition					
Barrier	Alignment and Height:	Alignment acceptable. Entire barrier is between 4-5in below the 27-in design height.

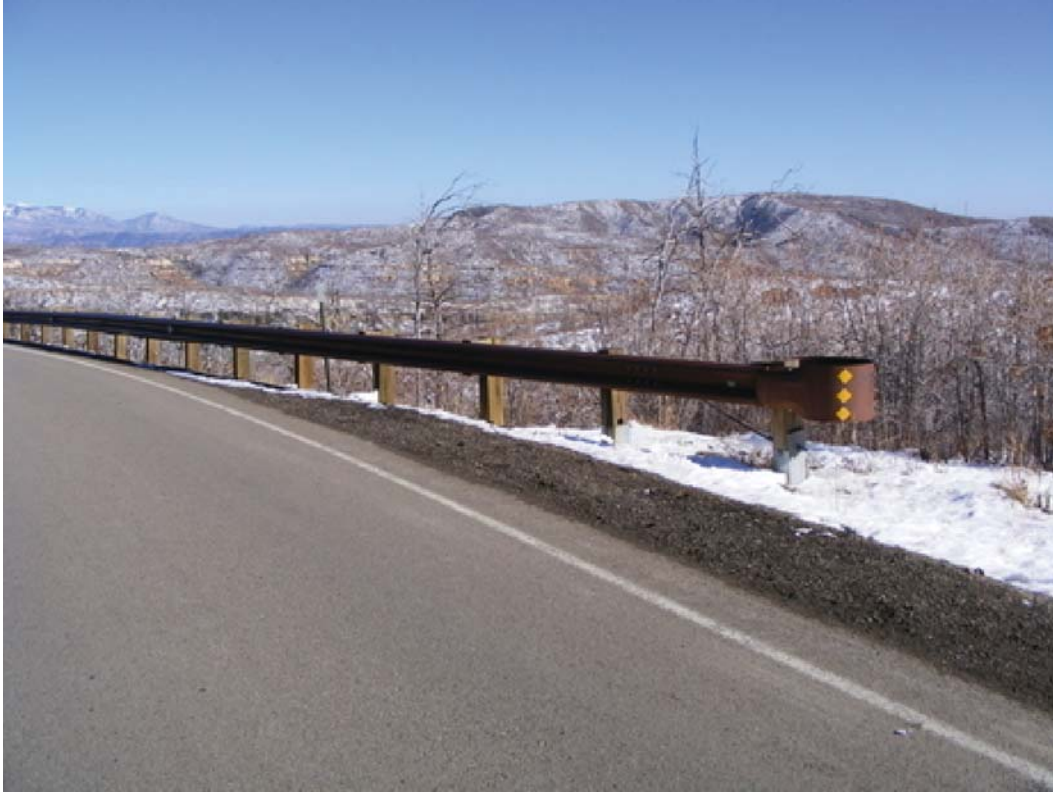
MEVE_0010_7.897_L_1.JPG

Barrier ID:	MEVE-0010-7.897-L				
Route Name:	ENTRANCE ROAD				
Inspection Date:	11/17/2009	Barrier Rating:	39.90		
Barrier Description					
Type:	W-BEAM STRONG POST	Barrier Function:	TRAFFIC		
Barrier Material:	WEATHERING STEEL/CORTEN	Post Material:	WOOD		
Blockout Type:	WOOD	Length (ft.):	615		
Speed Limit (MPH):	35	Placement with Respect to Road:	OUTSIDE OF CURVE		
Hazard Behind Barrier:	HIGH				
Barrier Crashworthiness					
Appropriate Test Level:	TL-2	Barrier Test Level:	TL-3	Is Barrier Crashworthy?:	YES
Beg. End Trtmt Type:	W-BEAM BCT	Is Beg. End Trtmt Crashworthy?:	NO	Approach Transition Type:	NONE
Ending End Trtmt Type:	W-BEAM BCT	Ending End Trtmt Crashworthy?:	NO		
Average Measurements					
Design Height (In.):	27	Width (In.):	0.0	Post Spacing (In.):	74.6
Height (In.):	25.7	Lateral Offset (In.):	23.0	Road Grade (%):	0.90
Physical Condition					
Barrier	Alignment and Height:	Alignment acceptable. 526-ft was within 1-in of the 27-in design height and 89-ft was 1-3in below.

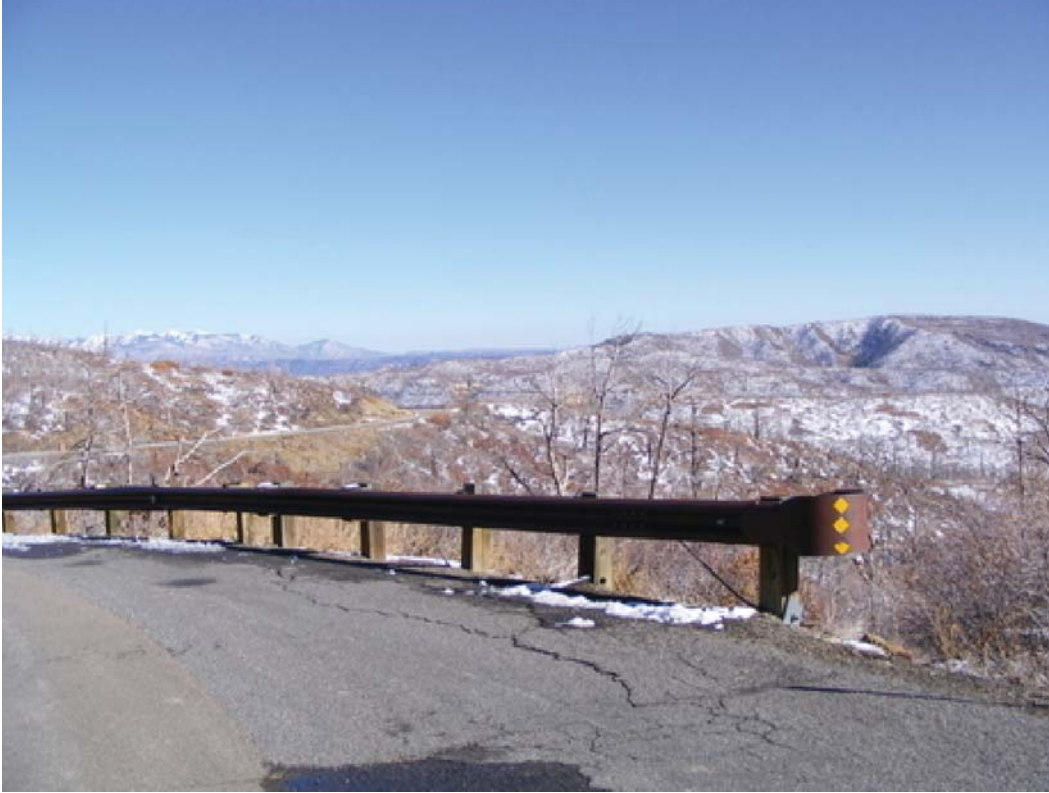
MEVE_0010_8.126_L_1.JPG

Barrier ID:	MEVE-0010-8.126-L				
Route Name:	ENTRANCE ROAD				
Inspection Date:	11/17/2009	Barrier Rating:	39.50		
Barrier Description					
Type:	W-BEAM STRONG POST	Barrier Function:	TRAFFIC		
Barrier Material:	WEATHERING STEEL/CORTEN	Post Material:	WOOD		
Blockout Type:	WOOD	Length (ft.):	415		
Speed Limit (MPH):	35	Placement with Respect to Road:	INSIDE OF CURVE		
Hazard Behind Barrier:	MEDIUM				
Barrier Crashworthiness					
Appropriate Test Level:	TL-2	Barrier Test Level:	TL-3	Is Barrier Crashworthy?:	YES
Beg. End Trtmt Type:	W-BEAM BCT	Is Beg. End Trtmt Crashworthy?:	NO	Approach Transition Type:	NONE
Ending End Trtmt Type:	W-BEAM TRAILING END	Ending End Trtmt Crashworthy?:	YES		
Average Measurements					
Design Height (In.):	27	Width (In.):	0.0	Post Spacing (In.):	74.6
Height (In.):	24.7	Lateral Offset (In.):	48.2	Road Grade (%):	4.40
Physical Condition					
Barrier	Alignment and Height:	Alignment is good for the entire length. Minor impact to rails. Height was 4-in below 27-in design height for 375 ft.

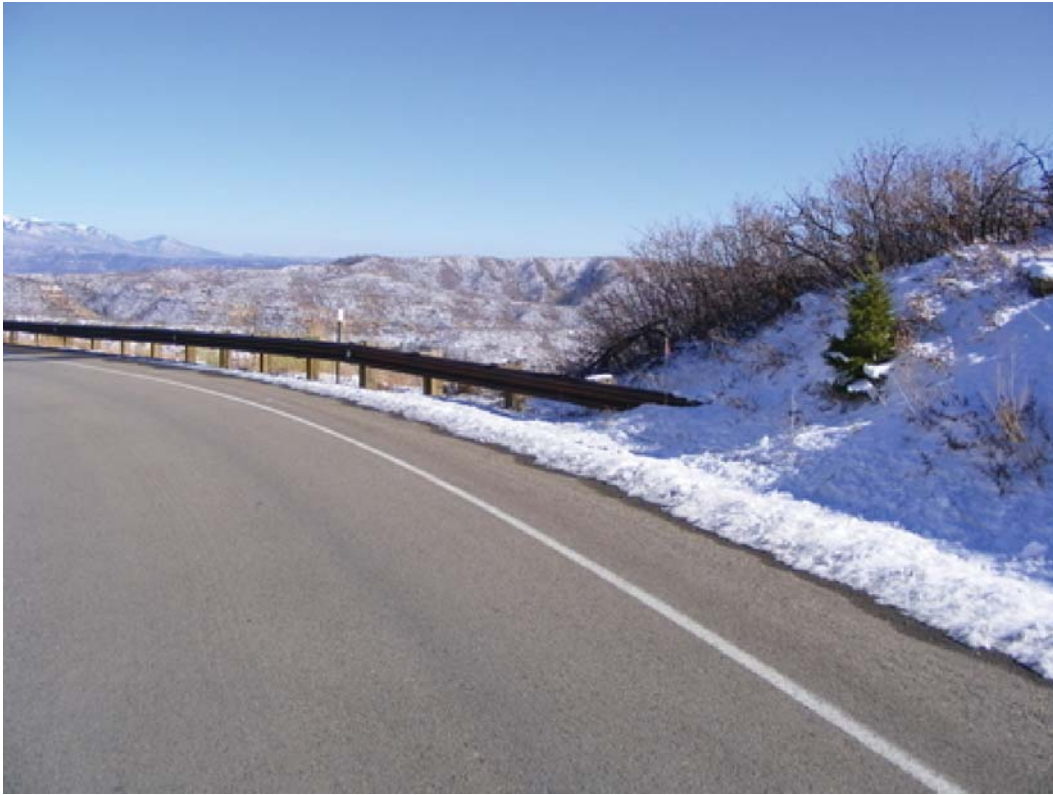
MEVE_0010_8.396_L_1.JPG

Barrier ID:	MEVE-0010-8.396-L				
Route Name:	ENTRANCE ROAD				
Inspection Date:	11/17/2009	Barrier Rating:	53.00		
Barrier Description					
Type:	W-BEAM STRONG POST	Barrier Function:	TRAFFIC		
Barrier Material:	WEATHERING STEEL/CORTEN	Post Material:	WOOD		
Blockout Type:	WOOD	Length (ft.):	610		
Speed Limit (MPH):	35	Placement with Respect to Road:	BOTH INSIDE AND OUTSIDE		
Hazard Behind Barrier:	EXTREME				
Barrier Crashworthiness					
Appropriate Test Level:	TL-2	Barrier Test Level:	TL-3	Is Barrier Crashworthy?:	YES
Beg. End Trtmt Type:	W-BEAM BURIED END	Is Beg. End Trtmt Crashworthy?:	YES	Approach Transition Type:	NONE
Ending End Trtmt Type:	W-BEAM TRAILING END	Ending End Trtmt Crashworthy?:	YES		
Average Measurements					
Design Height (In.):	27	Width (In.):	0.0	Post Spacing (In.):	74.5
Height (In.):	23.7	Lateral Offset (In.):	64.5	Road Grade (%):	2.60
Physical Condition					
Barrier	Alignment and Height:	Alignment acceptable - only minor impacts to rails. Entire barrier is between 2-4in below the 27-in design height.

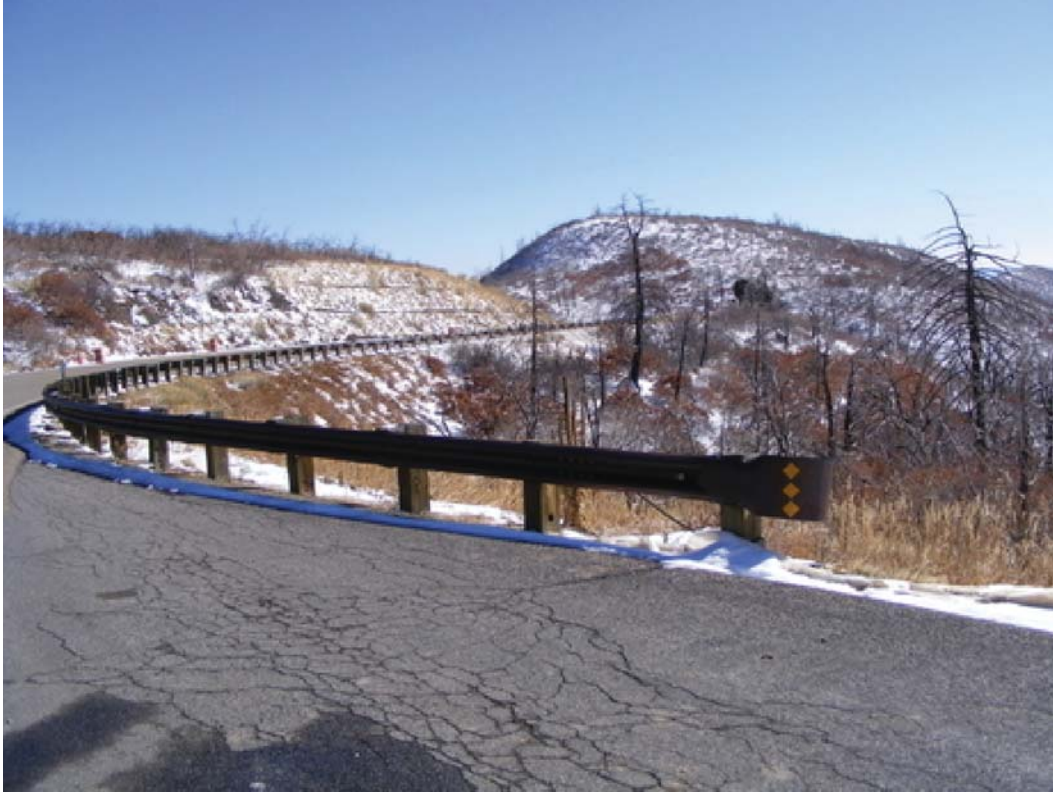
MEVE_0010_8.544_L_1.JPG

Barrier ID:	MEVE-0010-8.544-L				
Route Name:	ENTRANCE ROAD				
Inspection Date:	11/17/2009	Barrier Rating:	49.90		
Barrier Description					
Type:	W-BEAM STRONG POST	Barrier Function:	TRAFFIC		
Barrier Material:	WEATHERING STEEL/CORTEN	Post Material:	WOOD		
Blockout Type:	WOOD	Length (ft.):	1046		
Speed Limit (MPH):	35	Placement with Respect to Road:	BOTH INSIDE AND OUTSIDE		
Hazard Behind Barrier:	HIGH				
Barrier Crashworthiness					
Appropriate Test Level:	TL-2	Barrier Test Level:	TL-3	Is Barrier Crashworthy?:	YES
Beg. End Trtmt Type:	W-BEAM BCT	Is Beg. End Trtmt Crashworthy?:	NO	Approach Transition Type:	NONE
Ending End Trtmt Type:	W-BEAM BCT	Ending End Trtmt Crashworthy?:	NO		
Average Measurements					
Design Height (In.):	27	Width (In.):	0.0	Post Spacing (In.):	75.0
Height (In.):	23.7	Lateral Offset (In.):	57.7	Road Grade (%):	3.30
Physical Condition					
Barrier	Alignment and Height:	Alignment acceptable. Entire barrier is between 2-5in below the 27-in design height.
