**NPS Guardwall/Rail Inventory Program
Mount Rainier National Park**

**Federal Lands Highway
Road Inventory Program**

**Federal Highway Administration
Eastern Federal Lands Highway Division
Road Inventory Program (RIP)**

**Data Collection Date: October 2009
Report Date: December 2015**

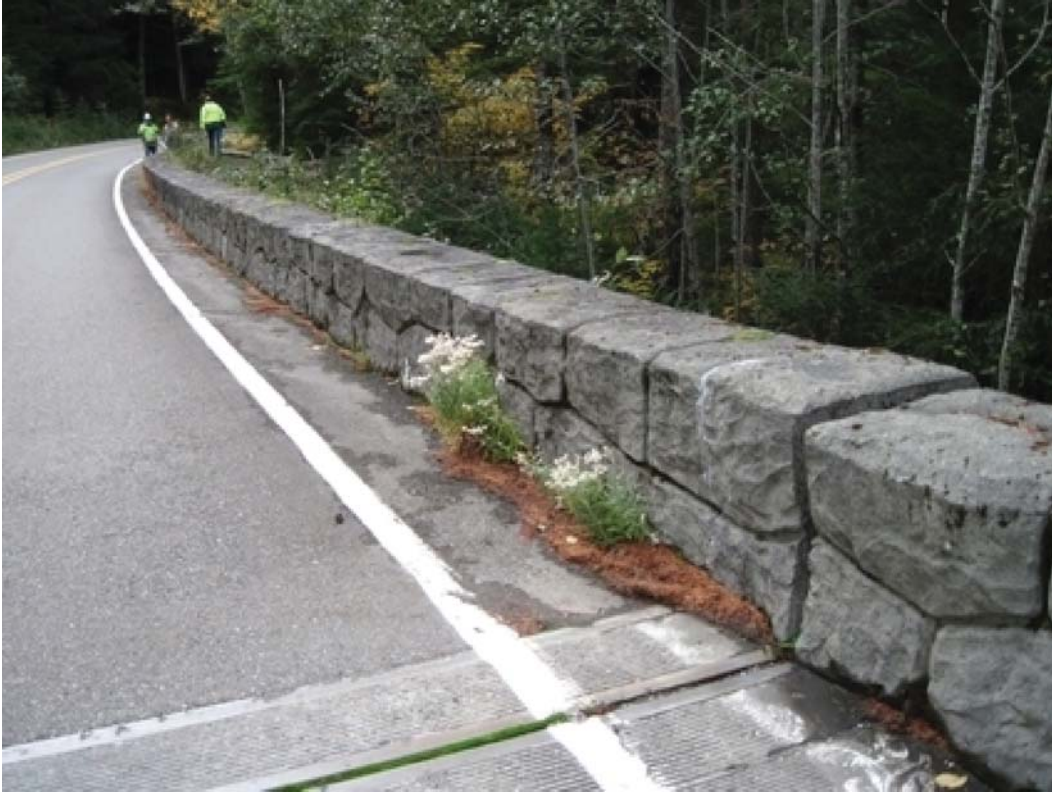
MORA_0010_2.418_L_1.jpg

Barrier ID:	MORA-0010-2.418-L				
Route Name:	STATE ROUTE 123 (EAST SIDE HIGHWAY)				
Inspection Date:	10/19/2009	Barrier Rating:	26.60		
Barrier Description					
Type:	CONCRETE WITH SIMULATED STONE FACE	Barrier Function:	TRAFFIC		
Barrier Material:	CONCRETE	Post Material:	N/A		
Blockout Type:	N/A	Length (ft.):	130		
Speed Limit (MPH):	45	Placement with Respect to Road:	INSIDE OF CURVE		
Hazard Behind Barrier:	MEDIUM				
Barrier Crashworthiness					
Appropriate Test Level:	TL-2	Barrier Test Level:	TL-3	Is Barrier Crashworthy?:	YES
Beg. End Trtmt Type:	NONE	Is Beg. End Trtmt Crashworthy?:	N/A	Approach Transition Type:	NONE
Ending End Trtmt Type:	NONE	Ending End Trtmt Crashworthy?:	N/A		
Average Measurements					
Design Height (In.):	27	Width (In.):	27.0	Post Spacing (In.):	0.0
Height (In.):	27.0	Lateral Offset (In.):	25.7	Road Grade (%):	2.20
Physical Condition					
Barrier	Alignment and Height:	Alignment acceptable. Height within 3-in of 27-in design height.

Repair Recommendations
