PEFO GIP Report

NPS Guardwall/Rail Inventory Program Petrified Forest National Park

Data Collection Date: April 2010
Report Date: November 2015

Petrified Forest National Park in Arizona

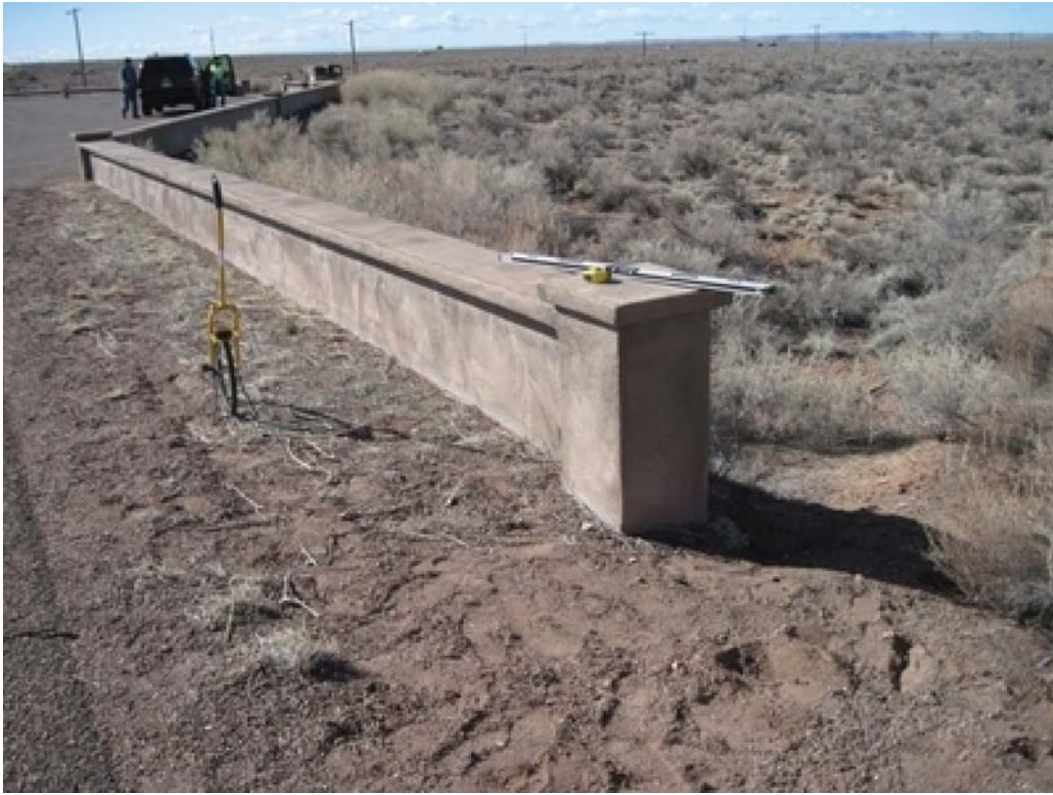
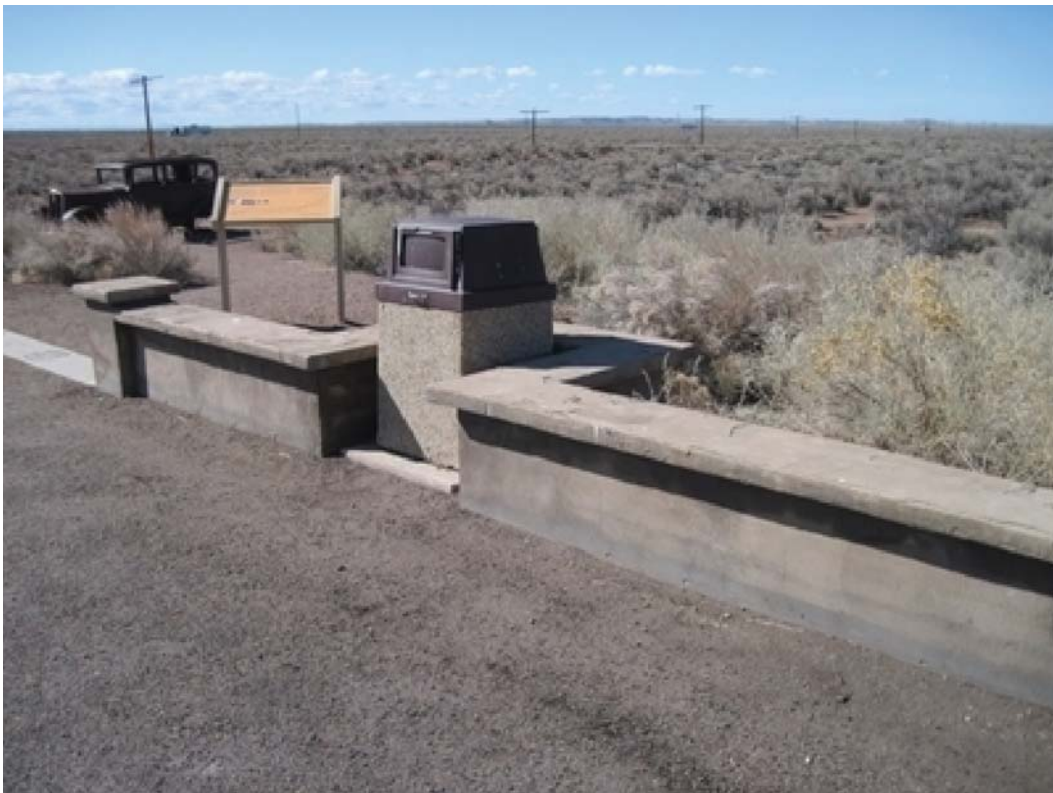
Barrier ID:	PEFO-0010-5.776-R				
Route Name:	NORTH-SOUTH HIGHWAY				
Inspection Date:	02/04/2010	Barrier Rating:	21.10		
Barrier Description					
Type:	OTHER: CONCRETE BLOCK	Barrier Function:	NON-TRAFFIC		
Barrier Material:	CONCRETE	Post Material:	N/A		
Blockout Type:	N/A	Length (ft.):	171		
Speed Limit (MPH):	45	Placement with Respect to Road:	NON-TRAFFIC BARRIER		
Hazard Behind Barrier:	N/A				
Barrier Crashworthiness					
Appropriate Test Level:	TL-2	Barrier Test Level:	N/A	Is Barrier Crashworthy?:	N/A
Beg. End Trtmt Type:	NONE	Is Beg. End Trtmt Crashworthy?:	N/A	Approach Transition Type:	NONE
Ending End Trtmt Type:	NONE	Ending End Trtmt Crashworthy?:	N/A		
Average Measurements					
Design Height (In.):	24	Width (In.):	8.0	Post Spacing (In.):	0.0
Height (In.):	23.7	Lateral Offset (In.):	0.0	Road Grade (%):	0.00
Physical Condition					
Barrier	Alignment and Height:	Alignment is acceptable. Height is within 3-in of 24-in design height.

Breaking and Cracking:	There was no breaking or cracking observed.			
	Missing Elements:	There were no missing elements observed.			
	Corrosion and Weathering:	There is no corrosion or weathering to the wall. There is minor weathering/peeling of the painted finish.			
End Treatments	Alignment and Height:				
	Breaking and Cracking:				
	Missing Elements:				
	Corrosion and Weathering:

Barrier ID:	PEFO-0010-5.776-R				
Route Name:	NORTH-SOUTH HIGHWAY				
Inspection Date:	02/04/2010	Barrier Rating:		21.10	
Repair Recommendations					
Repair Action:	NO ACTION	FMSS Work Type:	N/A	Repair Cost:	\$0
Brief Workorder:	N/A				
Workorder:

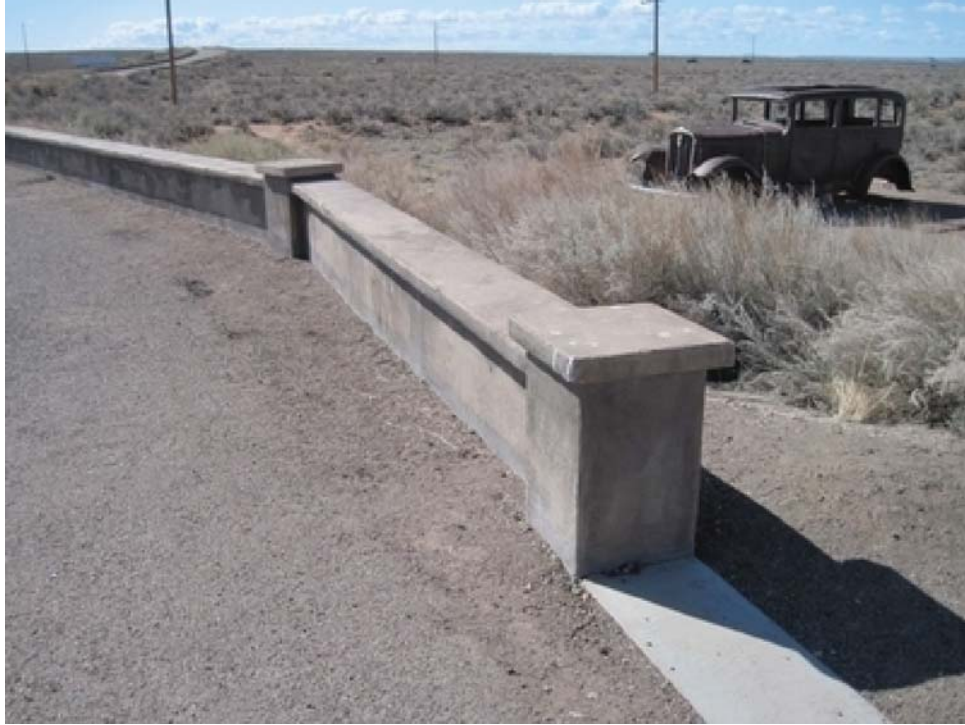
PEFO_0010_5.804_R_1.jpg

Barrier ID:	PEFO-0010-5.804-R				
Route Name:	NORTH-SOUTH HIGHWAY				
Inspection Date:	02/04/2010	Barrier Rating:	24.00		
Barrier Description					
Type:	OTHER: CONCRETE BLOCK	Barrier Function:	NON-TRAFFIC		
Barrier Material:	CONCRETE	Post Material:	N/A		
Blockout Type:	N/A	Length (ft.):	135		
Speed Limit (MPH):	45	Placement with Respect to Road:	NON-TRAFFIC BARRIER		
Hazard Behind Barrier:	N/A				
Barrier Crashworthiness					
Appropriate Test Level:	TL-2	Barrier Test Level:	N/A	Is Barrier Crashworthy?:	N/A
Beg. End Trtmt Type:	NONE	Is Beg. End Trtmt Crashworthy?:	N/A	Approach Transition Type:	NONE
Ending End Trtmt Type:	NONE	Ending End Trtmt Crashworthy?:	N/A		
Average Measurements					
Design Height (In.):	24	Width (In.):	8.0	Post Spacing (In.):	0.0
Height (In.):	23.0	Lateral Offset (In.):	0.0	Road Grade (%):	0.00
Physical Condition					
Barrier	Alignment and Height:	Alignment is acceptable. Height is within 3-in of 24-in design height.

Breaking and Cracking:	There was no breaking or cracking observed.			
	Missing Elements:	There were no missing elements observed.			
	Corrosion and Weathering:	There is no corrosion or weathering to the wall. There is minor weathering and peeling of the painted finish.			
End Treatments	Alignment and Height:				
	Breaking and Cracking:				
	Missing Elements:				
	Corrosion and Weathering:

Barrier ID:	PEFO-0010-5.804-R				
Route Name:	NORTH-SOUTH HIGHWAY				
Inspection Date:	02/04/2010	Barrier Rating:		24.00	
Repair Recommendations					
Repair Action:	NO ACTION	FMSS Work Type:	N/A	Repair Cost:	\$0
Brief Workorder:	N/A				
Workorder:

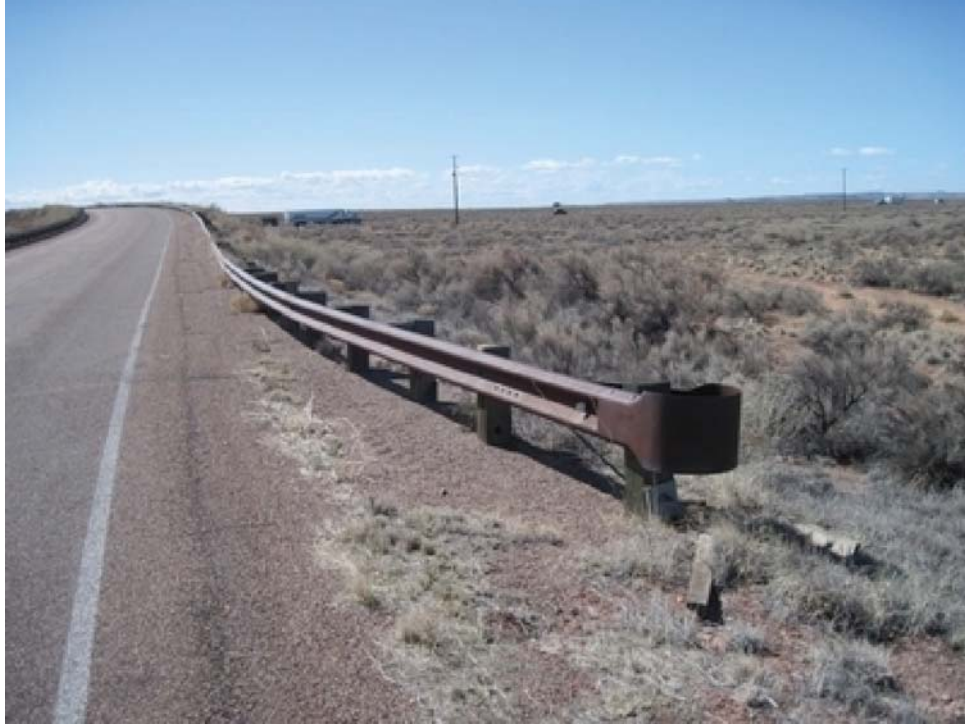
PEFO_0010_5.907_R_1.jpg

Barrier ID:	PEFO-0010-5.907-R				
Route Name:	NORTH-SOUTH HIGHWAY				
Inspection Date:	02/04/2010	Barrier Rating:	42.90		
Barrier Description					
Type:	W-BEAM STRONG POST	Barrier Function:	TRAFFIC		
Barrier Material:	WEATHERING STEEL/CORTEN	Post Material:	WOOD		
Blockout Type:	WOOD	Length (ft.):	749		
Speed Limit (MPH):	45	Placement with Respect to Road:	OUTSIDE OF CURVE		
Hazard Behind Barrier:	HIGH				
Barrier Crashworthiness					
Appropriate Test Level:	TL-2	Barrier Test Level:	TL-3	Is Barrier Crashworthy?:	YES
Beg. End Trtmt Type:	W-BEAM BCT	Is Beg. End Trtmt Crashworthy?:	NO	Approach Transition Type:	BRIDGE RAIL W-BEAM
Ending End Trtmt Type:	NONE	Ending End Trtmt Crashworthy?:	N/A		
Average Measurements					
Design Height (In.):	27	Width (In.):	0.0	Post Spacing (In.):	75.0
Height (In.):	25.5	Lateral Offset (In.):	71.3	Road Grade (%):	2.50
Physical Condition					
Barrier	Alignment and Height:	Alignment acceptable. 350-ft was between 1 and 3-in below the 27-in design height.

Breaking and Cracking:	There are 2 posts and 2 blocks that are badly cracked.			
	Missing Elements:	There were no missing elements observed.			
	Corrosion and Weathering:	There was no corrosion or weathering observed.			
End Treatments	Alignment and Height:	Alignment acceptable. 30-ft was between 1 and 3-in below the 27-in design height.			
	Breaking and Cracking:	There was no breaking or cracking observed.			
	Missing Elements:	There were no missing elements observed.			
	Corrosion and Weathering:	There was no corrosion or weathering observed.

Repair Action:	REPAIR	FMSS Work Type:	DEFERRED MAINTENANCE	Repair Cost:	\$7381
Brief Workorder:	Raise 350 L.F. to 27-in design height and replace 2 posts and 2 blocks.				
Workorder:	Adjust Guardrail at \$10- per -Lin. Ft. for 350 LF = \$3500. Raise 350-ft. of barrier up to 27-in design height. Replace Post at \$100- per -Each for 2 Post(s) = \$200. Replace the 2 cracked posts. Replace Block at \$30- per -Each for 2 Block(s) = \$60. Replace the 2 cracked and turned blocks. Low Speed Traffic Control at \$1475- per -Day for 2 Day(s) = \$2950.

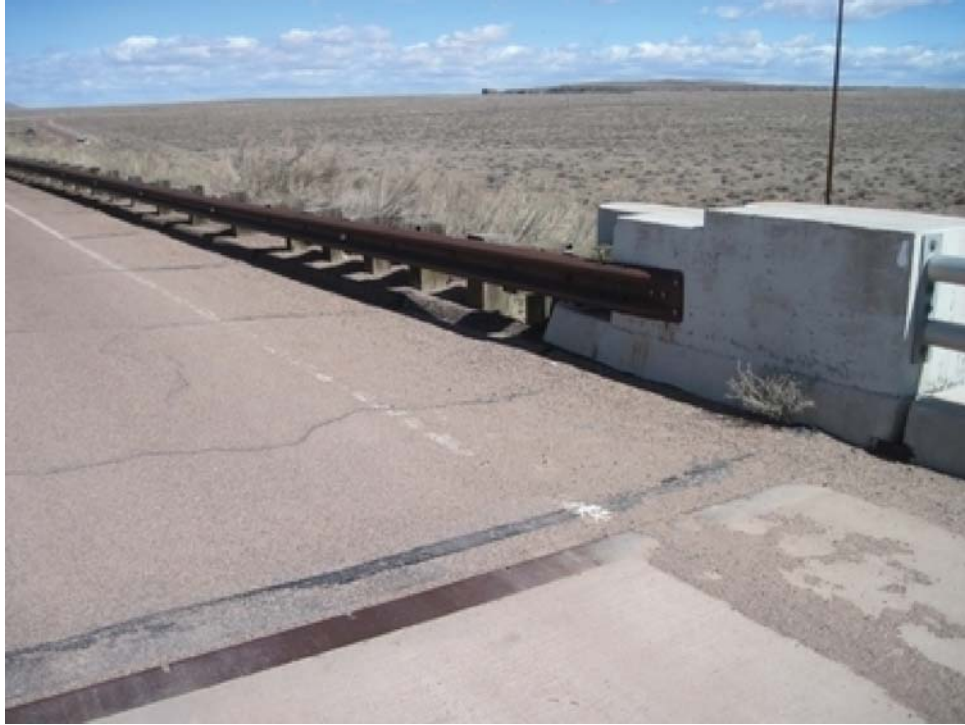
PEFO_0010_5.917_L_1.jpg

Barrier ID:	PEFO-0010-5.917-L				
Route Name:	NORTH-SOUTH HIGHWAY				
Inspection Date:	02/04/2010	Barrier Rating:	32.50		
Barrier Description					
Type:	W-BEAM STRONG POST	Barrier Function:	TRAFFIC		
Barrier Material:	WEATHERING STEEL/CORTEN	Post Material:	WOOD		
Blockout Type:	WOOD	Length (ft.):	706		
Speed Limit (MPH):	45	Placement with Respect to Road:	INSIDE OF CURVE		
Hazard Behind Barrier:	MEDIUM				
Barrier Crashworthiness					
Appropriate Test Level:	TL-2	Barrier Test Level:	TL-3	Is Barrier Crashworthy?:	YES
Beg. End Trtmt Type:	W-BEAM BCT	Is Beg. End Trtmt Crashworthy?:	NO	Approach Transition Type:	BRIDGE RAIL W-BEAM
Ending End Trtmt Type:	NONE	Ending End Trtmt Crashworthy?:	N/A		
Average Measurements					
Design Height (In.):	27	Width (In.):	0.0	Post Spacing (In.):	74.8
Height (In.):	25.3	Lateral Offset (In.):	66.0	Road Grade (%):	2.60
Physical Condition					
Barrier	Alignment and Height:	Alignment acceptable. 606-ft was between 1 and 3-in below the 27-in design height.

Breaking and Cracking:	Four posts and six blocks are cracked.			
	Missing Elements:	There were no missing elements observed.			
	Corrosion and Weathering:	There was no corrosion or weathering observed.			
End Treatments	Alignment and Height:	Alignment acceptable. 30-ft was between 1 and 3-in below the 27-in design height.			
	Breaking and Cracking:	There was no breaking or cracking observed.			
	Missing Elements:	There were no missing elements observed.			
	Corrosion and Weathering:	There was no corrosion or weathering observed.

Repair Action:	REPAIR	FMSS Work Type:	DEFERRED MAINTENANCE	Repair Cost:	\$12172
Brief Workorder:	Raise 606 L.F. of barrier to 27-in design height and replace 4 posts and 6 blocks.				
Workorder:	Adjust Guardrail at \$10- per -Lin. Ft. for 606 LF = \$6060. Raise 606-ft. of barrier up to 27-in design height. Replace Post at \$100- per -Each for 4 Post(s) = \$400. Replace the 4 damaged posts. Replace Block at \$30- per -Each for 6 Block(s) = \$180. Replace the 6 damaged blocks. Low Speed Traffic Control at \$1475- per -Day for 3 Day(s) = \$4425.

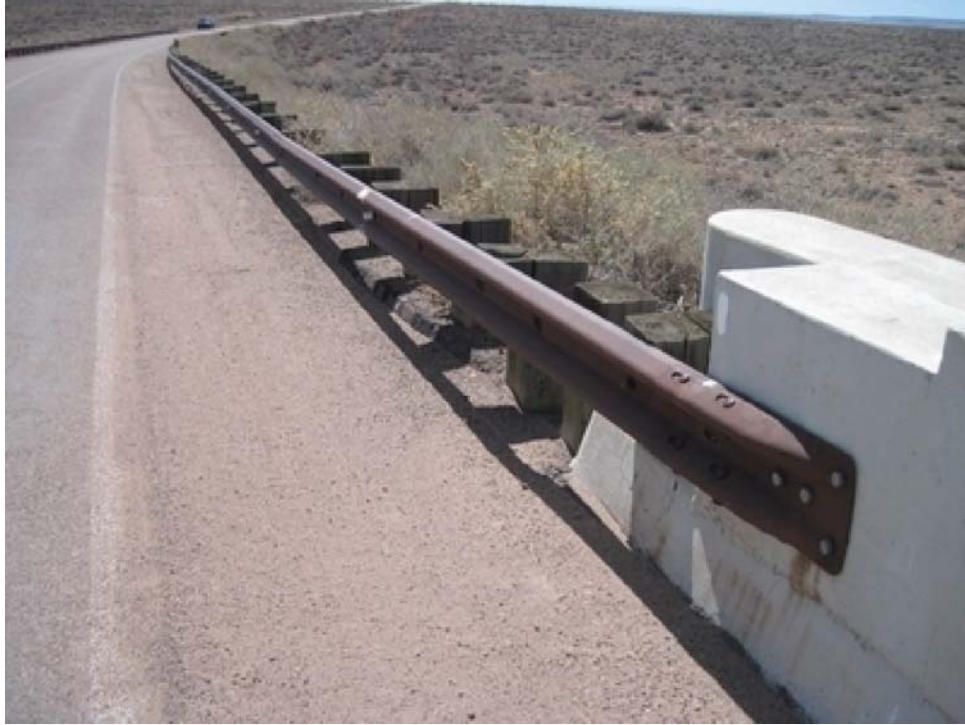
PEFO_0010_6.099_R_1.jpg

Barrier ID:	PEFO-0010-6.099-R				
Route Name:	NORTH-SOUTH HIGHWAY				
Inspection Date:	02/04/2010	Barrier Rating:	34.20		
Barrier Description					
Type:	W-BEAM STRONG POST	Barrier Function:	TRAFFIC		
Barrier Material:	WEATHERING STEEL/CORTEN	Post Material:	WOOD		
Blockout Type:	WOOD	Length (ft.):	505		
Speed Limit (MPH):	45	Placement with Respect to Road:	INSIDE OF CURVE		
Hazard Behind Barrier:	HIGH				
Barrier Crashworthiness					
Appropriate Test Level:	TL-2	Barrier Test Level:	TL-3	Is Barrier Crashworthy?:	YES
Beg. End Trtmt Type:	NONE	Is Beg. End Trtmt Crashworthy?:	N/A	Approach Transition Type:	BRIDGE RAIL W-BEAM
Ending End Trtmt Type:	W-BEAM BCT	Ending End Trtmt Crashworthy?:	NO		
Average Measurements					
Design Height (In.):	27	Width (In.):	0.0	Post Spacing (In.):	75.1
Height (In.):	25.5	Lateral Offset (In.):	77.3	Road Grade (%):	0.60
Physical Condition					
Barrier	Alignment and Height:	Alignment acceptable. 185-ft was between 1 and 3-in below the 27-in design height.

Breaking and Cracking:	There are 3 blocks and 4 posts that are severely cracked.			
	Missing Elements:	There were no missing elements observed.			
	Corrosion and Weathering:	There was no corrosion or weathering observed.			
End Treatments	Alignment and Height:	Alignment acceptable. 0-ft was between 1 and 3-in below the 27-in design height and 30-ft was more than 3-in below the design height.			
	Breaking and Cracking:	There is 1 post that is badly cracked.			
	Missing Elements:	There is 1 block that is missing.			
	Corrosion and Weathering:	There was no corrosion or weathering observed.

Repair Action:	REPAIR	FMSS Work Type:	DEFERRED MAINTENANCE	Repair Cost:	\$4373
Brief Workorder:	Raise 185 L.F. of barrier to the 27-in design height and replace 5 posts and 5 blocks.				
Workorder:	Adjust Guardrail at \$10- per -Lin. Ft. for 185 LF = \$1850. Raise 185-ft. of barrier up to 27-in design height. Replace Block at \$30- per -Each for 5 Block(s) = \$150. Replace the 5 missing / damaged blocks. Replace Post at \$100- per -Each for 5 Post(s) = \$500. Replace 5 damaged posts. Low Speed Traffic Control at \$1475- per -Day for 1 Day(s) = \$1475.

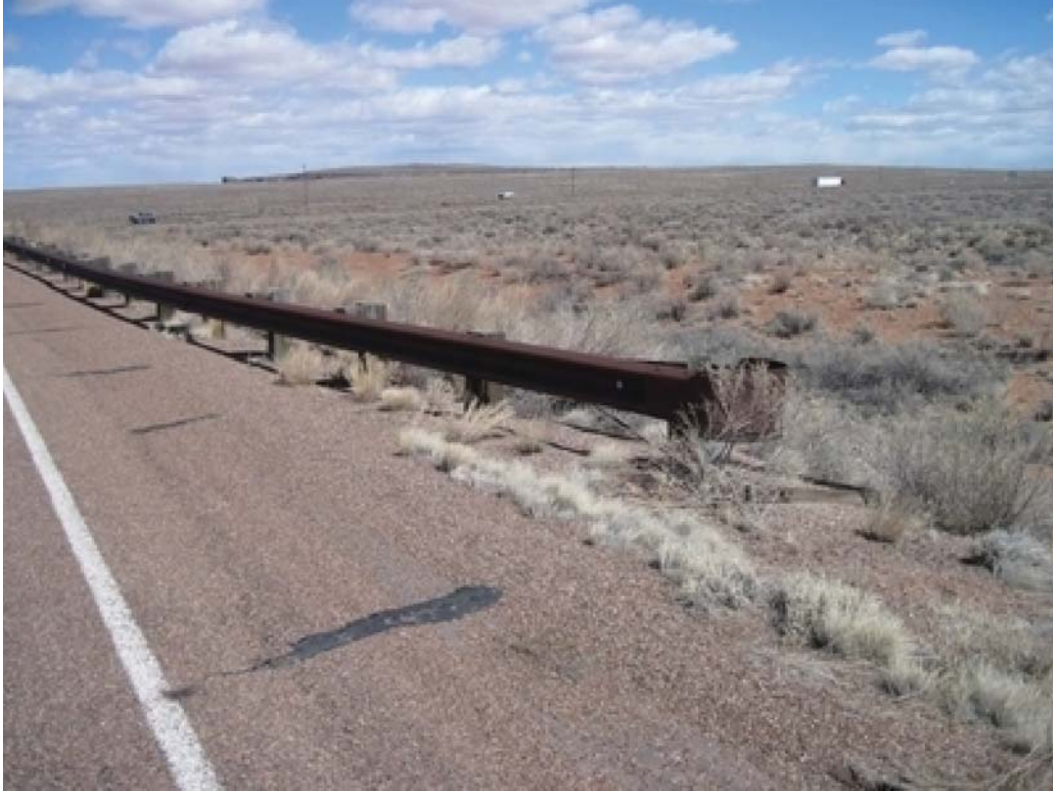
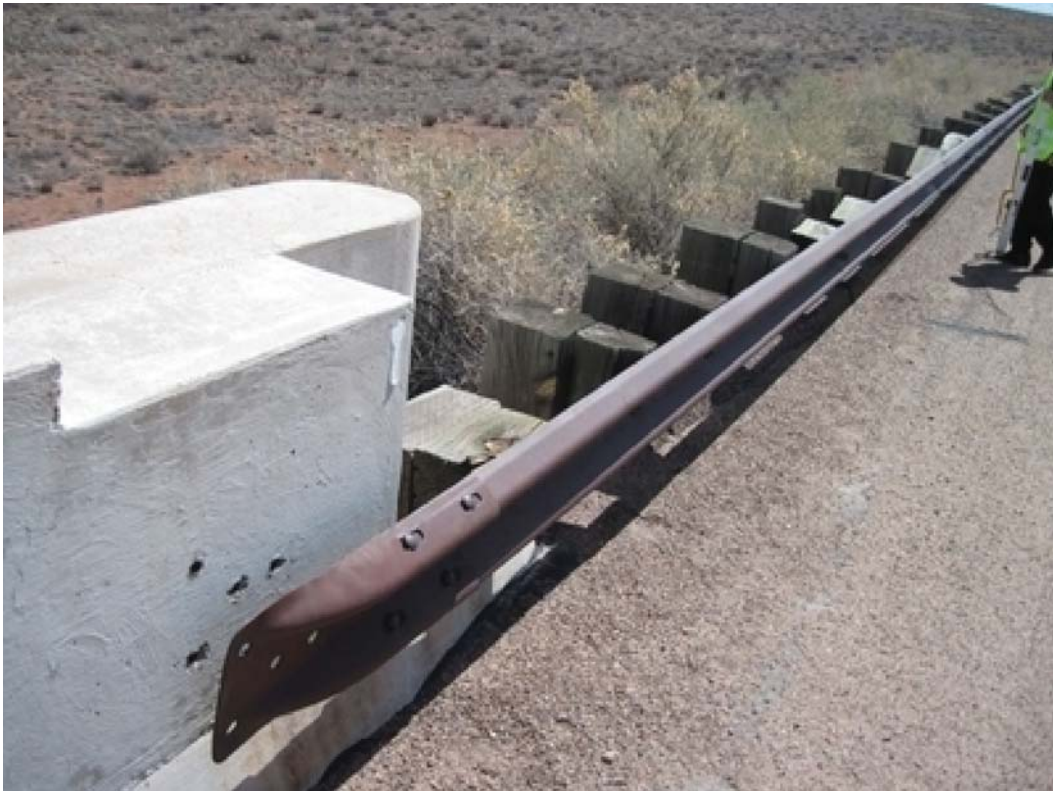
Barrier ID:	PEFO-0010-6.101-L				
Route Name:	NORTH-SOUTH HIGHWAY				
Inspection Date:	02/04/2010	Barrier Rating:	38.20		
Barrier Description					
Type:	W-BEAM STRONG POST	Barrier Function:	TRAFFIC		
Barrier Material:	WEATHERING STEEL/CORTEN	Post Material:	WOOD		
Blockout Type:	WOOD	Length (ft.):	530		
Speed Limit (MPH):	45	Placement with Respect to Road:	OUTSIDE OF CURVE		
Hazard Behind Barrier:	MEDIUM				
Barrier Crashworthiness					
Appropriate Test Level:	TL-2	Barrier Test Level:	TL-3	Is Barrier Crashworthy?:	YES
Beg. End Trtmt Type:	NONE	Is Beg. End Trtmt Crashworthy?:	N/A	Approach Transition Type:	BRIDGE RAIL W-BEAM
Ending End Trtmt Type:	W-BEAM BCT	Ending End Trtmt Crashworthy?:	NO		
Average Measurements					
Design Height (In.):	27	Width (In.):	0.0	Post Spacing (In.):	74.9
Height (In.):	25.6	Lateral Offset (In.):	67.3	Road Grade (%):	0.90
Physical Condition					
Barrier	Alignment and Height:	The alignment had less than 6in of deflection. 380ft. was 1-3 in below the 27-in. design height.

Breaking and Cracking:	5 blocks and 3 posts have large cracks and/or rotated sideways. There was no breaking or cracking to the rail.			
	Missing Elements:	There were no missing elements observed.			
	Corrosion and Weathering:	There was no corrosion or weathering observed.			
End Treatments	Alignment and Height:	Alignment acceptable. 30-ft was between 1 and 3-in below the 27-in design height.			
	Breaking and Cracking:	There were minor cracking present to the posts and blocks but they are still in good condition.			
	Missing Elements:	There were no missing elements observed.			
	Corrosion and Weathering:	There was no corrosion or weathering observed.

Repair Action:	REPAIR	FMSS Work Type:	DEFERRED MAINTENANCE	Repair Cost:	\$14344
Brief Workorder:	Raise 380 L.F. of guardrail up to 27-in design height replace transition section replace 8 blocks and 3 posts.				
Workorder:	<p>Adjust Guardrail at \$10- per -Lin. Ft. for 380 LF = \$3800. Raise 380-ft. of barrier up to 27-in design height.</p> <p>Replace Block at \$30- per -Each for 8 Block(s) = \$240. Replace 8 cracked/rotated blocks.</p> <p>Replace Post at \$100- per -Each for 3 Post(s) = \$300. Replace 3 cracked posts.</p> <p>Remove Guardrail at \$10- per -Lin. Ft. for 30 LF = \$300. Remove entire transition section.</p> <p>Bridge Rail - W-Beam at \$2500- per -Each for 1 = \$2500. Install new transition section.</p> <p>Low Speed Traffic Control at \$1475- per -Day for 4 Day(s) = \$5900. 2 days to raise guardrail 1 day for transition removal 1 day for transition installation.</p>

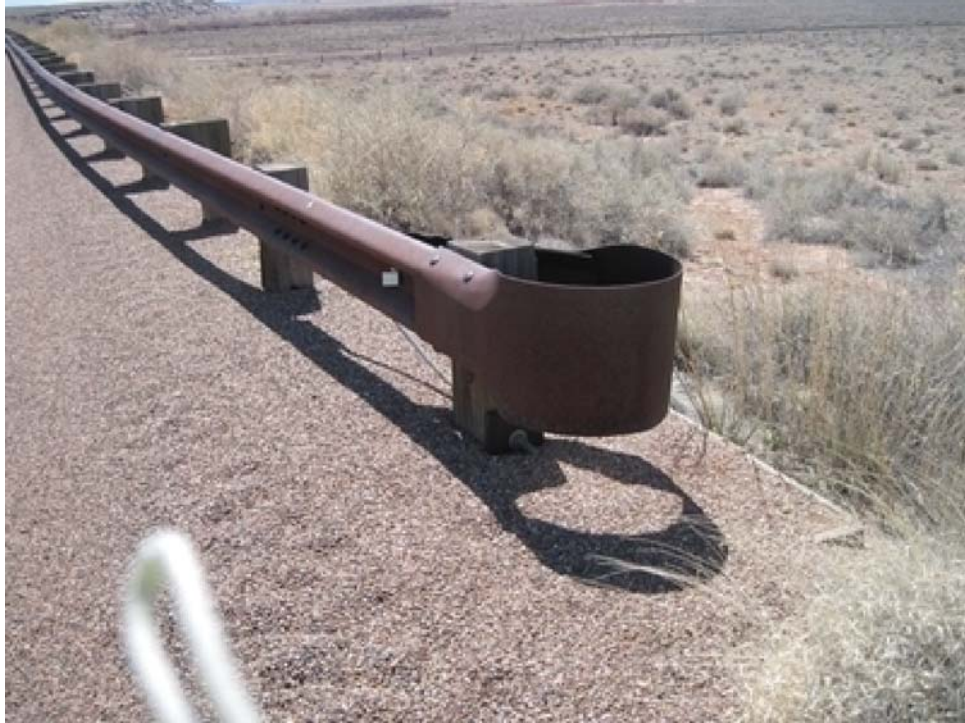
PEFO_0010_10.421_R_1.jpg

Barrier ID:	PEFO-0010-10.421-R				
Route Name:	NORTH-SOUTH HIGHWAY				
Inspection Date:	02/04/2010	Barrier Rating:	33.70		
Barrier Description					
Type:	W-BEAM STRONG POST	Barrier Function:	TRAFFIC		
Barrier Material:	WEATHERING STEEL/CORTEN	Post Material:	WOOD		
Blockout Type:	WOOD	Length (ft.):	505		
Speed Limit (MPH):	45	Placement with Respect to Road:	OUTSIDE OF CURVE		
Hazard Behind Barrier:	MEDIUM				
Barrier Crashworthiness					
Appropriate Test Level:	TL-2	Barrier Test Level:	TL-3	Is Barrier Crashworthy?:	YES
Beg. End Trtmt Type:	W-BEAM BCT	Is Beg. End Trtmt Crashworthy?:	NO	Approach Transition Type:	CONC/MASON W-BEAM
Ending End Trtmt Type:	NONE	Ending End Trtmt Crashworthy?:	N/A		
Average Measurements					
Design Height (In.):	27	Width (In.):	0.0	Post Spacing (In.):	75.3
Height (In.):	26.2	Lateral Offset (In.):	55.7	Road Grade (%):	0.40
Physical Condition					
Barrier	Alignment and Height:	Alignment acceptable. 300-ft was between 1 and 3-in below the 27-in design height.

Breaking and Cracking:	There was no breaking or cracking observed.			
	Missing Elements:	There were no missing elements observed.			
	Corrosion and Weathering:	There was no corrosion or weathering observed.			
End Treatments	Alignment and Height:	Alignment is acceptable. Height is within 1-in of 27-in design height.			
	Breaking and Cracking:	There was no breaking or cracking observed.			
	Missing Elements:	There were no missing elements observed.			
	Corrosion and Weathering:	There was no corrosion or weathering observed.

Repair Action:	REPAIR	FMSS Work Type:	DEFERRED MAINTENANCE	Repair Cost:	\$6545
Brief Workorder:	Raise the height of 300 L.F. of guardrail to 27 inch design height.				
Workorder:	Adjust Guardrail at \$10- per -Lin. Ft. for 300 LF = \$3000. Raise 300-ft. of barrier up to 27-in design height. Low Speed Traffic Control at \$1475- per -Day for 2 Day(s) = \$2950.

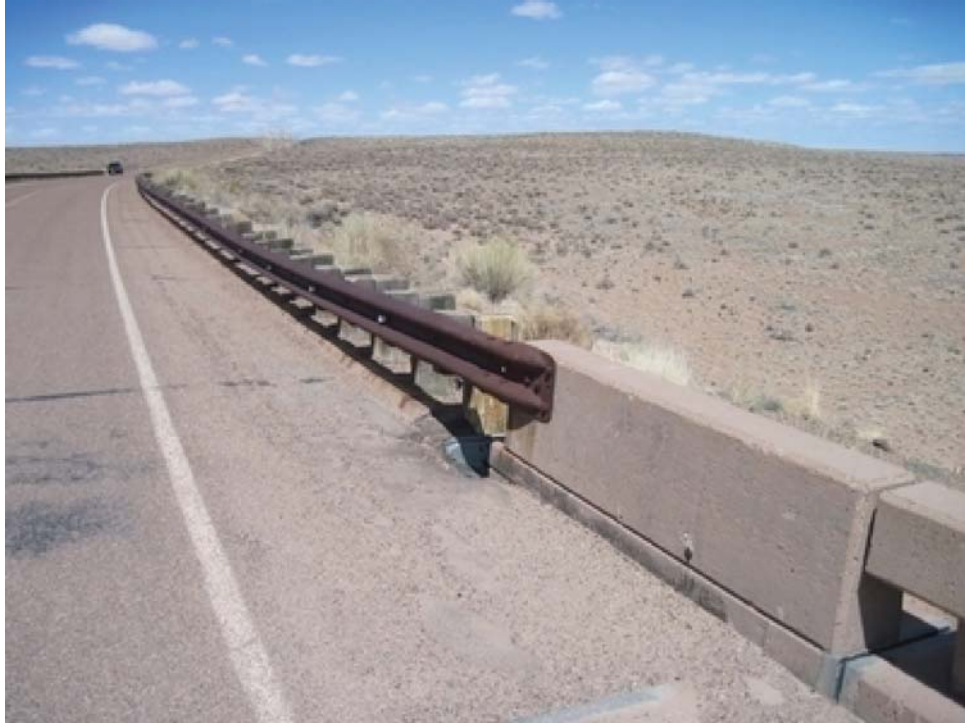
PEFO_0010_10.427_L_1.jpg

Barrier ID:	PEFO-0010-10.427-L				
Route Name:	NORTH-SOUTH HIGHWAY				
Inspection Date:	02/04/2010	Barrier Rating:	32.50		
Barrier Description					
Type:	W-BEAM STRONG POST	Barrier Function:	TRAFFIC		
Barrier Material:	WEATHERING STEEL/CORTEN	Post Material:	WOOD		
Blockout Type:	WOOD	Length (ft.):	472		
Speed Limit (MPH):	45	Placement with Respect to Road:	INSIDE OF CURVE		
Hazard Behind Barrier:	MEDIUM				
Barrier Crashworthiness					
Appropriate Test Level:	TL-2	Barrier Test Level:	TL-3	Is Barrier Crashworthy?:	YES
Beg. End Trtmt Type:	W-BEAM BCT	Is Beg. End Trtmt Crashworthy?:	NO	Approach Transition Type:	CONC/MASON W-BEAM
Ending End Trtmt Type:	NONE	Ending End Trtmt Crashworthy?:	N/A		
Average Measurements					
Design Height (In.):	27	Width (In.):	0.0	Post Spacing (In.):	74.6
Height (In.):	25.7	Lateral Offset (In.):	54.2	Road Grade (%):	0.80
Physical Condition					
Barrier	Alignment and Height:	The alignment had less than 6in of deflection. The height was within 1" of the 27-in design height for 72ft. and was between 24" and 26" for 400ft.

Breaking and Cracking:	5 blocks and 3 posts exhibit large cracking more than 1in through the cross-section. Just minor cracking to the remainder of the posts and blocks.			
	Missing Elements:	There were no missing elements observed.			
	Corrosion and Weathering:	There was no corrosion or weathering observed.			
End Treatments	Alignment and Height:	Alignment is acceptable. Height is within 1-in of 27-in design height.			
	Breaking and Cracking:	Minor cracking was present in the posts and blocks but they were still in good condition.			
	Missing Elements:	There were no missing elements observed.			
	Corrosion and Weathering:	There was no corrosion or weathering observed.

Repair Action:	REPAIR	FMSS Work Type:	DEFERRED MAINTENANCE	Repair Cost:	\$9763
Brief Workorder:	Raise 400 L.F. of guardrail to the 27-in. design height and replace 5 cracked blocks and 3 cracked posts.				
Workorder:	Adjust Guardrail at \$10- per -Lin. Ft. for 400 LF = \$4000. Raise 400-ft. of barrier up to 27-in design height. Replace Block at \$30- per -Each for 5 Block(s) = \$150. Replace 5 cracked blocks. Replace Post at \$100- per -Each for 3 Post(s) = \$300. Replace 3 cracked posts. Low Speed Traffic Control at \$1475- per -Day for 3 Day(s) = \$4425.

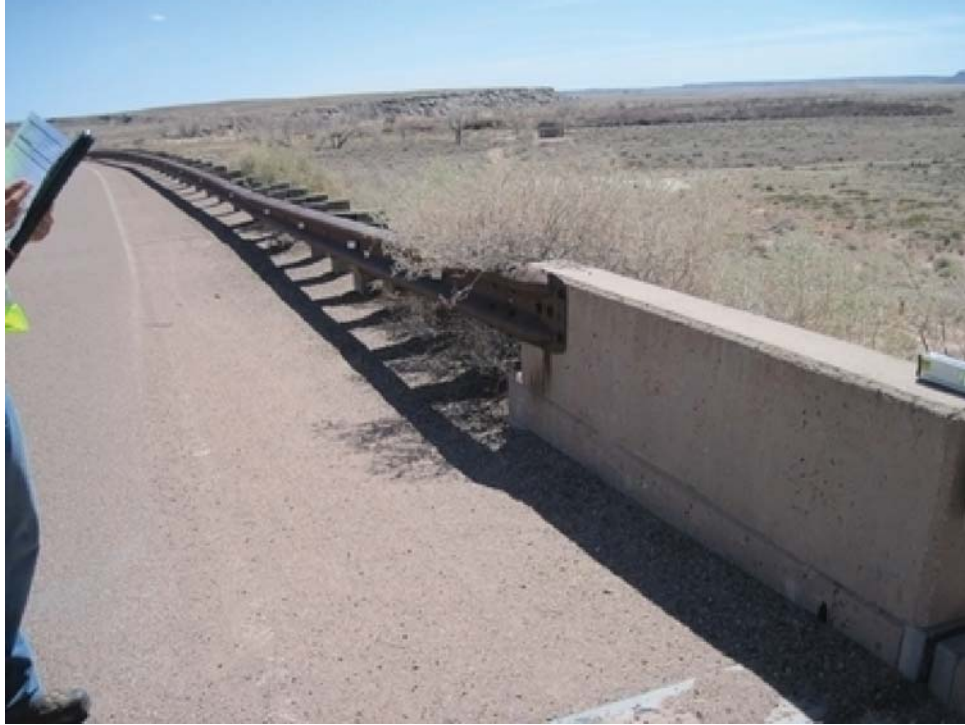
PEFO_0010_10.552_R_1.jpg

Barrier ID:	PEFO-0010-10.552-R				
Route Name:	NORTH-SOUTH HIGHWAY				
Inspection Date:	02/04/2010	Barrier Rating:	40.00		
Barrier Description					
Type:	W-BEAM STRONG POST	Barrier Function:	TRAFFIC		
Barrier Material:	WEATHERING STEEL/CORTEN	Post Material:	WOOD		
Blockout Type:	WOOD	Length (ft.):	838		
Speed Limit (MPH):	45	Placement with Respect to Road:	OUTSIDE OF CURVE		
Hazard Behind Barrier:	EXTREME				
Barrier Crashworthiness					
Appropriate Test Level:	TL-2	Barrier Test Level:	TL-3	Is Barrier Crashworthy?:	YES
Beg. End Trtmt Type:	NONE	Is Beg. End Trtmt Crashworthy?:	N/A	Approach Transition Type:	CONC/MASON W-BEAM
Ending End Trtmt Type:	W-BEAM BCT	Ending End Trtmt Crashworthy?:	NO		
Average Measurements					
Design Height (In.):	27	Width (In.):	0.0	Post Spacing (In.):	75.1
Height (In.):	27.0	Lateral Offset (In.):	52.5	Road Grade (%):	3.40
Physical Condition					
Barrier	Alignment and Height:	Alignment is acceptable. Height is within 1-in of 27-in design height.

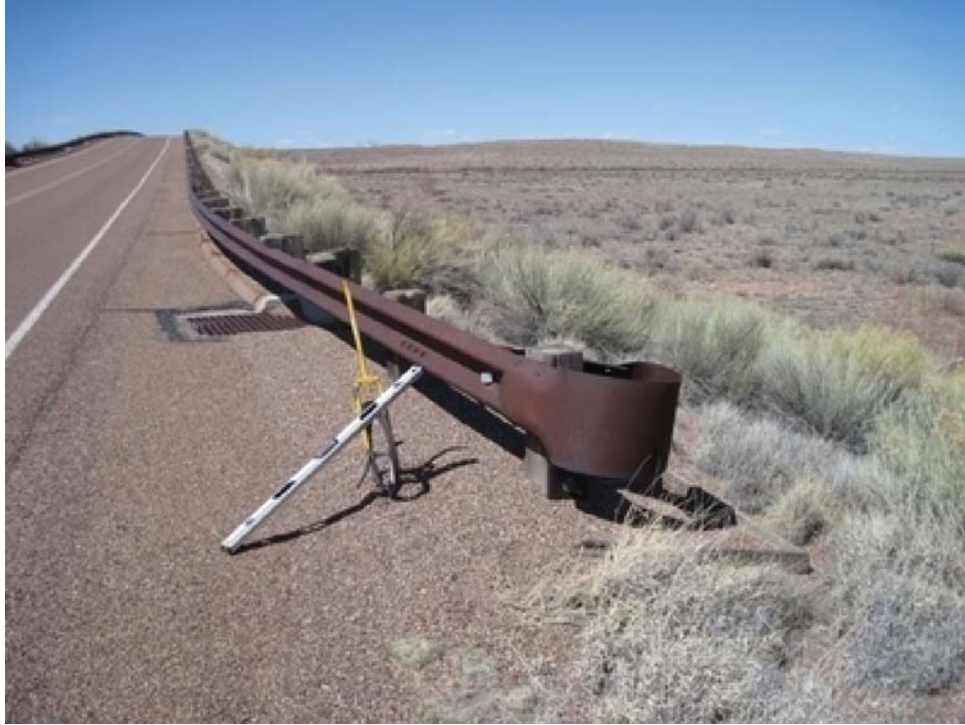
PEFO_0010_10.553_L_1.jpg

Barrier ID:	PEFO-0010-10.553-L				
Route Name:	NORTH-SOUTH HIGHWAY				
Inspection Date:	02/04/2010	Barrier Rating:	23.60		
Barrier Description					
Type:	W-BEAM STRONG POST	Barrier Function:	TRAFFIC		
Barrier Material:	WEATHERING STEEL/CORTEN	Post Material:	WOOD		
Blockout Type:	WOOD	Length (ft.):	865		
Speed Limit (MPH):	45	Placement with Respect to Road:	TANGENT		
Hazard Behind Barrier:	MEDIUM				
Barrier Crashworthiness					
Appropriate Test Level:	TL-2	Barrier Test Level:	TL-3	Is Barrier Crashworthy?:	YES
Beg. End Trtmt Type:	NONE	Is Beg. End Trtmt Crashworthy?:	N/A	Approach Transition Type:	CONC/MASON W-BEAM
Ending End Trtmt Type:	W-BEAM BCT	Ending End Trtmt Crashworthy?:	NO		
Average Measurements					
Design Height (In.):	27	Width (In.):	0.0	Post Spacing (In.):	74.9
Height (In.):	26.1	Lateral Offset (In.):	59.0	Road Grade (%):	3.40
Physical Condition					
Barrier	Alignment and Height:	Alignment acceptable. 100-ft was between 1 and 3-in below the 27-in design height.
