GIP Report

NPS Guardwall/Rail Inventory Program  
Rock Creek Park

Federal Lands Highway  
Road Inventory Program

Data Collection Date: November 2010  
Report Date: December 2015

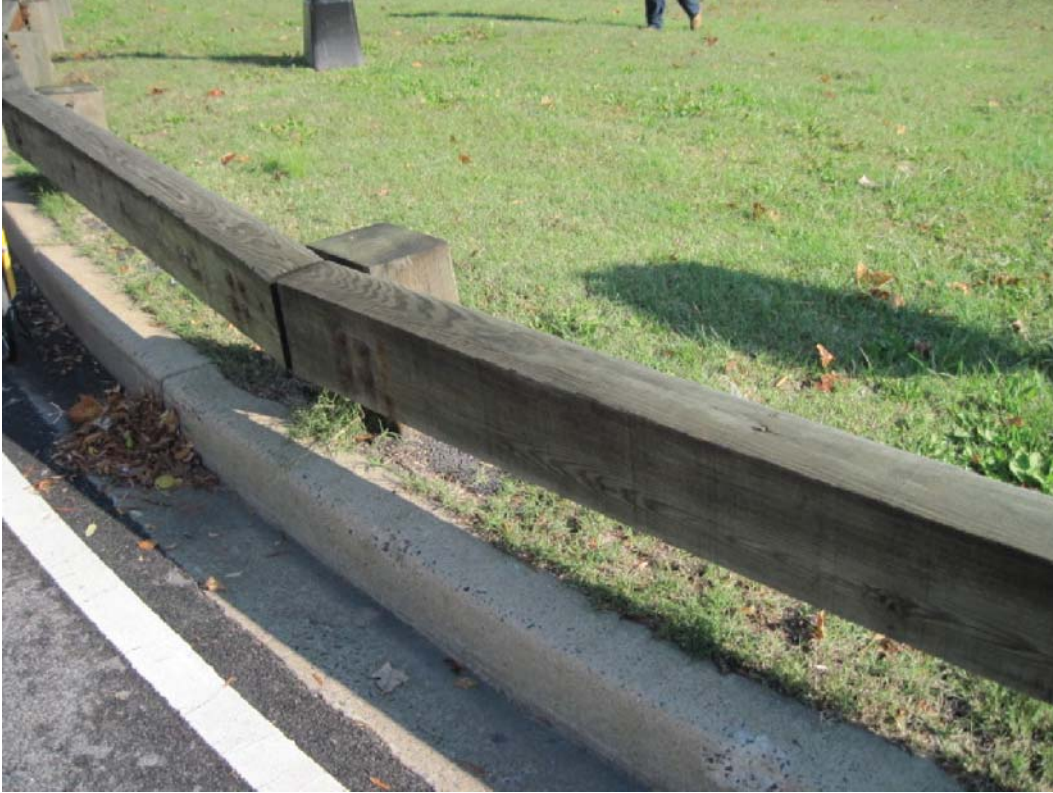
ROCR\_0001\_0.183\_R\_1.jpg

| <b>Barrier</b> | <b>Alignment and Height:</b> | No alignment deflection was observed. Height is 0.5 - 2 in above 27-in design height. | | | |
| | <b>Breaking and Cracking:</b> | 2 rails have been impacted and have breaks resulting in cross-section deformation. | | | |

**Repair Recommendations**
