# ROMO GIP Report

## NPS Guardwall/Rail Inventory Program Rocky Mountain National Park

**Federal Highway Administration  
Eastern Federal Lands Highway Division  
Road Inventory Program (RIP)**

**Data Collection Date: October 2009  
Report Date: November 2015**

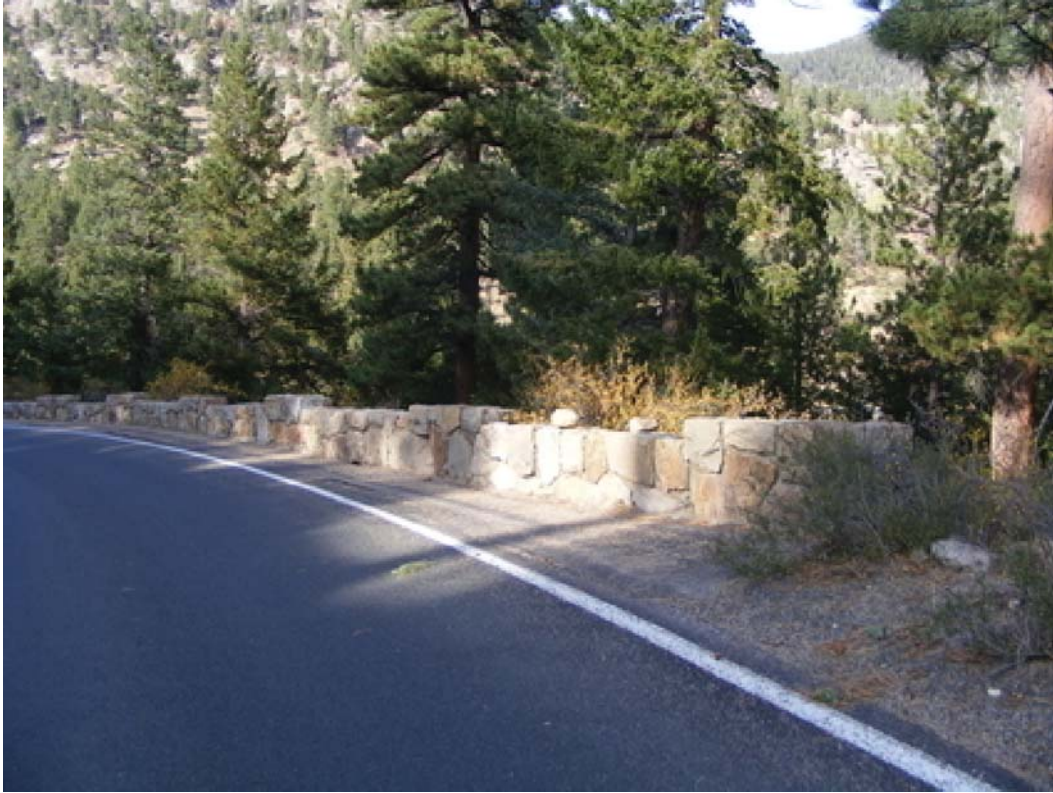
**ROMO\_0010\_0.726\_L\_1.jpg**

<b>Barrier ID:</b>	ROMO-0010-0.726-L				
<b>Route Name:</b>	TRAIL RIDGE ROAD				
<b>Inspection Date:</b>	10/01/2009	<b>Barrier Rating:</b>	42.40		
<b>Barrier Description</b>					
<b>Type:</b>	STONE MASONRY WITHOUT CONCRETE CORE WALL	<b>Barrier Function:</b>	TRAFFIC		
<b>Barrier Material:</b>	STONE	<b>Post Material:</b>	N/A		
<b>Blockout Type:</b>	N/A	<b>Length (ft.):</b>	240		
<b>Speed Limit (MPH):</b>	35	<b>Placement with Respect to Road:</b>	OUTSIDE OF CURVE		
<b>Hazard Behind Barrier:</b>	MEDIUM				
<b>Barrier Crashworthiness</b>					
<b>Appropriate Test Level:</b>	TL-2	<b>Barrier Test Level:</b>	NCW	<b>Is Barrier Crashworthy?:</b>	NO
<b>Beg. End Trtmt Type:</b>	NONE	<b>Is Beg. End Trtmt Crashworthy?:</b>	N/A	<b>Approach Transition Type:</b>	NONE
<b>Ending End Trtmt Type:</b>	NONE	<b>Ending End Trtmt Crashworthy?:</b>	N/A		
<b>Average Measurements</b>					
<b>Design Height (In.):</b>	24	<b>Width (In.):</b>	19.0	<b>Post Spacing (In.):</b>	0.0

<b>Height (In.):</b>	21.6	<b>Lateral Offset (In.):</b>	42.5	<b>Road Grade (%):</b>	3.20
<b>Physical Condition</b>					
<b>Barrier</b>	<b>Alignment and Height:</b>	Alignment acceptable. Height was within 3-in of the 18-in/24-in crenellated design height.			
	<b>Breaking and Cracking:</b>	No major cracking/no breaking.			
	<b>Missing Elements:</b>	No missing elements observed.			
	<b>Corrosion and Weathering:</b>	No corrosion or weathering observed.			
<b>End Treatments</b>	<b>Alignment and Height:</b>				
	<b>Breaking and Cracking:</b>				
	<b>Missing Elements:</b>				
	<b>Corrosion and Weathering:</b>

<b>Repair Action:</b>	NO ACTION	<b>FMSS Work Type:</b>	N/A	<b>Repair Cost:</b>	\$0
<b>Brief Workorder:</b>	N/A				
<b>Workorder:</b>

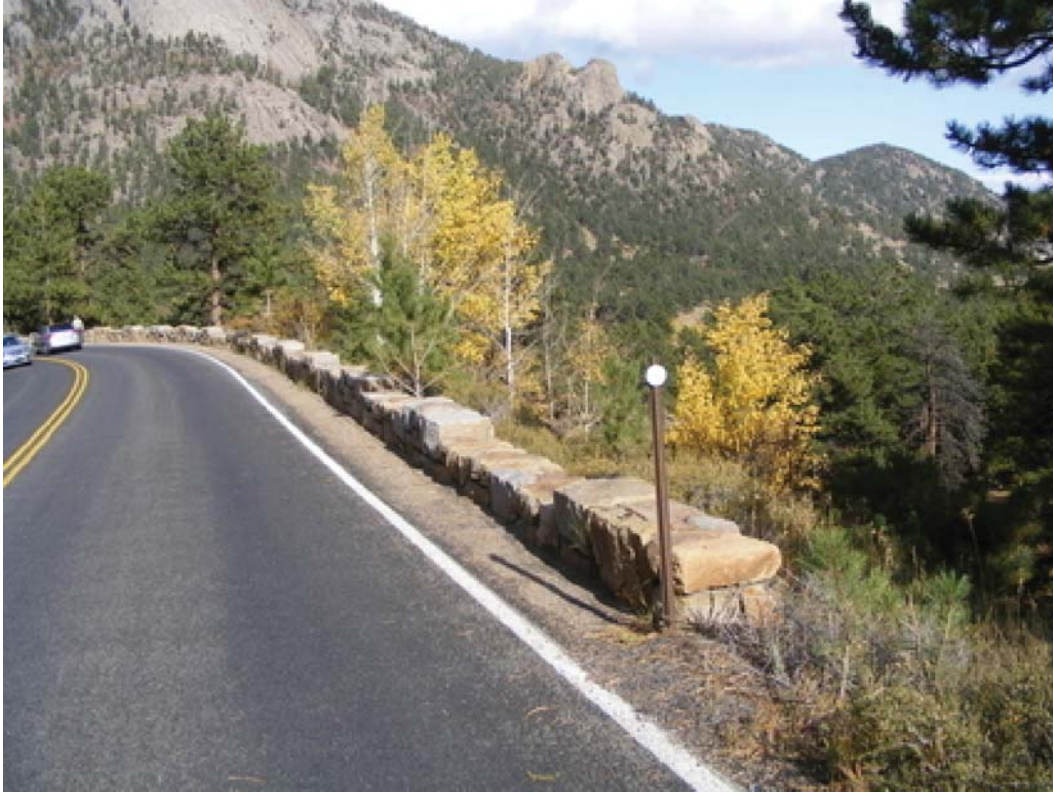
**ROMO\_0010\_0.787\_L\_1.jpg**

<b>Barrier ID:</b>	ROMO-0010-0.787-L				
<b>Route Name:</b>	TRAIL RIDGE ROAD				
<b>Inspection Date:</b>	10/01/2009	<b>Barrier Rating:</b>	41.00		
<b>Barrier Description</b>					
<b>Type:</b>	STONE MASONRY WITHOUT CONCRETE CORE WALL	<b>Barrier Function:</b>	TRAFFIC		
<b>Barrier Material:</b>	STONE	<b>Post Material:</b>	N/A		
<b>Blockout Type:</b>	N/A	<b>Length (ft.):</b>	311		
<b>Speed Limit (MPH):</b>	35	<b>Placement with Respect to Road:</b>	OUTSIDE OF CURVE		
<b>Hazard Behind Barrier:</b>	MEDIUM				
<b>Barrier Crashworthiness</b>					
<b>Appropriate Test Level:</b>	TL-2	<b>Barrier Test Level:</b>	NCW	<b>Is Barrier Crashworthy?:</b>	NO
<b>Beg. End Trtmt Type:</b>	NONE	<b>Is Beg. End Trtmt Crashworthy?:</b>	N/A	<b>Approach Transition Type:</b>	NONE
<b>Ending End Trtmt Type:</b>	NONE	<b>Ending End Trtmt Crashworthy?:</b>	N/A		
<b>Average Measurements</b>					
<b>Design Height (In.):</b>	24	<b>Width (In.):</b>	19.0	<b>Post Spacing (In.):</b>	0.0

<b>Height (In.):</b>	21.0	<b>Lateral Offset (In.):</b>	36.5	<b>Road Grade (%):</b>	2.20
<b>Physical Condition</b>					
<b>Barrier</b>	<b>Alignment and Height:</b>	Alignment acceptable. Height was within 3-in of the 18-in/24-in crenellated design height.			
	<b>Breaking and Cracking:</b>	No major cracking or breaking.			
	<b>Missing Elements:</b>	No missing elements observed.			
	<b>Corrosion and Weathering:</b>	No corrosion or weathering observed.			
<b>End Treatments</b>	<b>Alignment and Height:</b>				
	<b>Breaking and Cracking:</b>				
	<b>Missing Elements:</b>				
	<b>Corrosion and Weathering:</b>

<b>Repair Action:</b>	NO ACTION	<b>FMSS Work Type:</b>	N/A	<b>Repair Cost:</b>	\$0
<b>Brief Workorder:</b>	N/A				
<b>Workorder:</b>

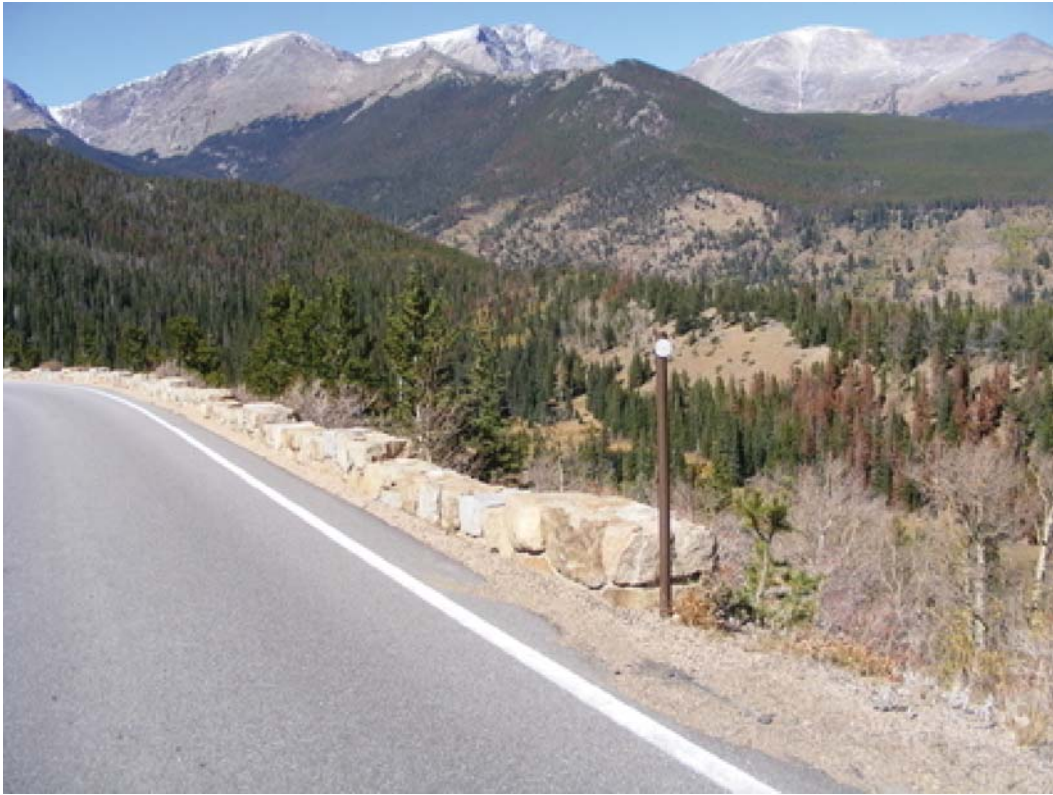
**ROMO\_0010\_6.875\_L\_1.jpg**

<b>Barrier ID:</b>	ROMO-0010-6.875-L				
<b>Route Name:</b>	TRAIL RIDGE ROAD				
<b>Inspection Date:</b>	10/02/2009	<b>Barrier Rating:</b>	76.60		
<b>Barrier Description</b>					
<b>Type:</b>	STONE MASONRY WITHOUT CONCRETE CORE WALL	<b>Barrier Function:</b>	TRAFFIC		
<b>Barrier Material:</b>	STONE	<b>Post Material:</b>	N/A		
<b>Blockout Type:</b>	N/A	<b>Length (ft.):</b>	587		
<b>Speed Limit (MPH):</b>	35	<b>Placement with Respect to Road:</b>	OUTSIDE OF CURVE		
<b>Hazard Behind Barrier:</b>	EXTREME				
<b>Barrier Crashworthiness</b>					
<b>Appropriate Test Level:</b>	TL-2	<b>Barrier Test Level:</b>	NCW	<b>Is Barrier Crashworthy?:</b>	NO
<b>Beg. End Trtmt Type:</b>	NONE	<b>Is Beg. End Trtmt Crashworthy?:</b>	N/A	<b>Approach Transition Type:</b>	NONE
<b>Ending End Trtmt Type:</b>	NONE	<b>Ending End Trtmt Crashworthy?:</b>	N/A		
<b>Average Measurements</b>					
<b>Design Height (In.):</b>	24	<b>Width (In.):</b>	19.0	<b>Post Spacing (In.):</b>	0.0

<b>Height (In.):</b>	14.3	<b>Lateral Offset (In.):</b>	30.2	<b>Road Grade (%):</b>	6.90
<b>Physical Condition</b>					
<b>Barrier</b>	<b>Alignment and Height:</b>	Alignment acceptable. 360-ft was 3-6-in below the 18-in/24-in crenellated design height and 90-ft was 7-in below.			
	<b>Breaking and Cracking:</b>	No breaking or cracking observed.			
	<b>Missing Elements:</b>	No missing elements were observed.			
	<b>Corrosion and Weathering:</b>	No corrosion or weathering observed.			
<b>End Treatments</b>	<b>Alignment and Height:</b>				
	<b>Breaking and Cracking:</b>				
	<b>Missing Elements:</b>				
	<b>Corrosion and Weathering:</b>

<b>Repair Action:</b>	REPAIR	<b>FMSS Work Type:</b>	DEFERRED MAINTENANCE	<b>Repair Cost:</b>	\$70813
<b>Brief Workorder:</b>	Raise guardwall 2-in. Remove and reset 90-ft of stone masonry guardwall on concrete footer to adjacent crenellated 12-in/18-in height.				
<b>Workorder:</b>	Remove & Reset Stone Masonry Guardwall at \$250- per -Cu. Ft. for 216 CF = \$54000. [(1.5ft)(1.6ft)(90ft)] = 216 CF. Structural Concrete at \$1000- per -Cu. Yd. for 3 CY = \$3000. [(1.6ft)(.5ft)(90ft)]/27 = 2.7 CY. Low Speed Traffic Control at \$1475- per -Day for 5 Day(s) = \$7375. 1 day removal 4 days installation.

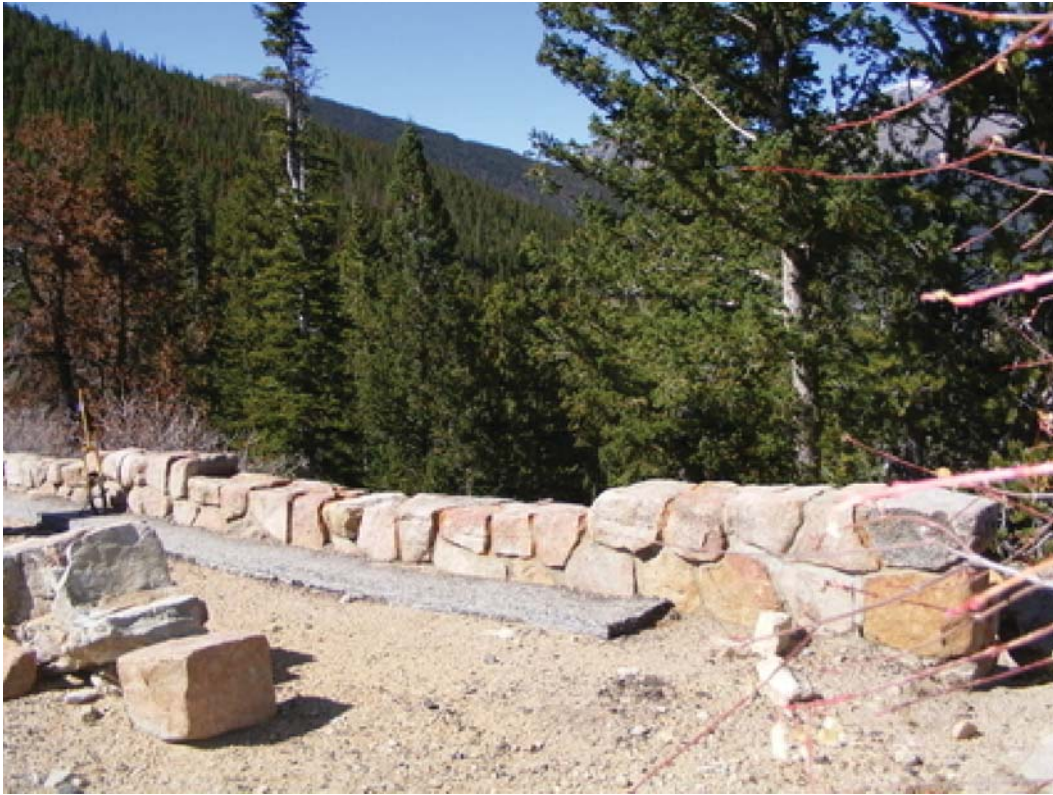
**ROMO\_0010\_7.506\_L\_1.jpg**

<b>Barrier ID:</b>	ROMO-0010-7.506-L				
<b>Route Name:</b>	TRAIL RIDGE ROAD				
<b>Inspection Date:</b>	10/02/2009	<b>Barrier Rating:</b>	60.70		
<b>Barrier Description</b>					
<b>Type:</b>	STONE MASONRY WITHOUT CONCRETE CORE WALL	<b>Barrier Function:</b>	TRAFFIC		
<b>Barrier Material:</b>	STONE	<b>Post Material:</b>	N/A		
<b>Blockout Type:</b>	N/A	<b>Length (ft.):</b>	104		
<b>Speed Limit (MPH):</b>	35	<b>Placement with Respect to Road:</b>	OUTSIDE OF CURVE		
<b>Hazard Behind Barrier:</b>	HIGH				
<b>Barrier Crashworthiness</b>					
<b>Appropriate Test Level:</b>	TL-2	<b>Barrier Test Level:</b>	NCW	<b>Is Barrier Crashworthy?:</b>	NO
<b>Beg. End Trtmt Type:</b>	NONE	<b>Is Beg. End Trtmt Crashworthy?:</b>	N/A	<b>Approach Transition Type:</b>	NONE
<b>Ending End Trtmt Type:</b>	NONE	<b>Ending End Trtmt Crashworthy?:</b>	N/A		
<b>Average Measurements</b>					
<b>Design Height (In.):</b>	24	<b>Width (In.):</b>	19.0	<b>Post Spacing (In.):</b>	0.0

<b>Height (In.):</b>	12.0	<b>Lateral Offset (In.):</b>	113.0	<b>Road Grade (%):</b>	4.80
<b>Physical Condition</b>					
<b>Barrier</b>	<b>Alignment and Height:</b>	Alignment is skewed off road way-wall leans away from road 6 in. 64-ft was 3-6-in below the 18-in/24-in crenellated design height and 40-ft was 7-in below.			
	<b>Breaking and Cracking:</b>	No breaking or cracking observed.			
	<b>Missing Elements:</b>	No missing elements.			
	<b>Corrosion and Weathering:</b>	No corrosion or weathering observed.			
<b>End Treatments</b>	<b>Alignment and Height:</b>				
	<b>Breaking and Cracking:</b>				
	<b>Missing Elements:</b>				
	<b>Corrosion and Weathering:</b>

<b>Repair Action:</b>	REPAIR	<b>FMSS Work Type:</b>	DEFERRED MAINTENANCE	<b>Repair Cost:</b>	\$33468
<b>Brief Workorder:</b>	Raise guardwall 2-in. Remove and reset 40-ft of stone masonry guardwall on concrete footer to adjacent crenellated 12-in/18-in height.				
<b>Workorder:</b>	Remove & Reset Stone Masonry Guardwall at \$250- per -Cu. Ft. for 96 CF = \$24000. [(1.5ft)(1.6ft)(40ft)] = 96 CF. Structural Concrete at \$1000- per -Cu. Yd. for 2 CY = \$2000. [(1.6ft)(0.5ft)(40ft)] /27 = 1.2 CY. Low Speed Traffic Control at \$1475- per -Day for 3 Day(s) = \$4425. 1 day removal and 2 days installation.

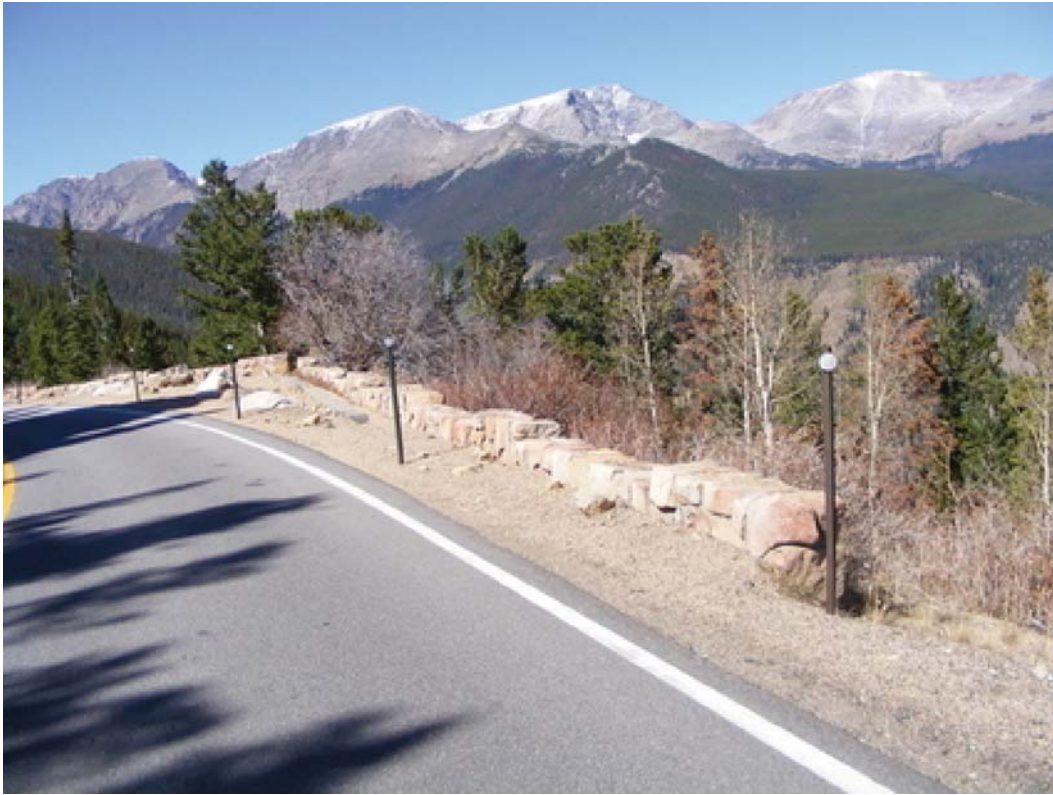
**ROMO\_0010\_7.527\_L\_1.jpg**

<b>Barrier ID:</b>	ROMO-0010-7.527-L				
<b>Route Name:</b>	TRAIL RIDGE ROAD				
<b>Inspection Date:</b>	10/02/2009	<b>Barrier Rating:</b>	58.50		
<b>Barrier Description</b>					
<b>Type:</b>	STONE MASONRY WITHOUT CONCRETE CORE WALL	<b>Barrier Function:</b>	TRAFFIC		
<b>Barrier Material:</b>	STONE	<b>Post Material:</b>	N/A		
<b>Blockout Type:</b>	N/A	<b>Length (ft.):</b>	97		
<b>Speed Limit (MPH):</b>	35	<b>Placement with Respect to Road:</b>	OUTSIDE OF CURVE		
<b>Hazard Behind Barrier:</b>	HIGH				
<b>Barrier Crashworthiness</b>					
<b>Appropriate Test Level:</b>	TL-2	<b>Barrier Test Level:</b>	NCW	<b>Is Barrier Crashworthy?:</b>	NO
<b>Beg. End Trtmt Type:</b>	NONE	<b>Is Beg. End Trtmt Crashworthy?:</b>	N/A	<b>Approach Transition Type:</b>	NONE
<b>Ending End Trtmt Type:</b>	NONE	<b>Ending End Trtmt Crashworthy?:</b>	N/A		
<b>Average Measurements</b>					
<b>Design Height (In.):</b>	24	<b>Width (In.):</b>	18.0	<b>Post Spacing (In.):</b>	0.0

<b>Height (In.):</b>	11.0	<b>Lateral Offset (In.):</b>	137.3	<b>Road Grade (%):</b>	1.60
<b>Physical Condition</b>					
<b>Barrier</b>	<b>Alignment and Height:</b>	Alignment acceptable. 61-ft was 3-6-in below the 18-in/24-in crenellated design height and 36-ft was 9-in below.			
	<b>Breaking and Cracking:</b>	No breaking or cracking observed.			
	<b>Missing Elements:</b>	No missing elements were observed.			
	<b>Corrosion and Weathering:</b>	No corrosion or weathering observed.			
<b>End Treatments</b>	<b>Alignment and Height:</b>				
	<b>Breaking and Cracking:</b>				
	<b>Missing Elements:</b>				
	<b>Corrosion and Weathering:</b>

<b>Repair Action:</b>	REPAIR	<b>FMSS Work Type:</b>	DEFERRED MAINTENANCE	<b>Repair Cost:</b>	\$28243
<b>Brief Workorder:</b>	Raise guardwall 3-in. Remove and reset 36-ft of stone masonry guardwall on concrete footer to adjacent crenellated 12-in/18-in height.				
<b>Workorder:</b>	Remove & Reset Stone Masonry Guardwall at \$250- per -Cu. Ft. for 81 CF = \$20250. [(1.5ft)(1.5ft)(36ft)] = 81 CF. Structural Concrete at \$1000- per -Cu. Yd. for 1 CY = \$1000. [(1.5ft)(.5ft)(36ft)] /27 = 1 CY. Low Speed Traffic Control at \$1475- per -Day for 3 Day(s) = \$4425. 1 day removal and 2 days installation.

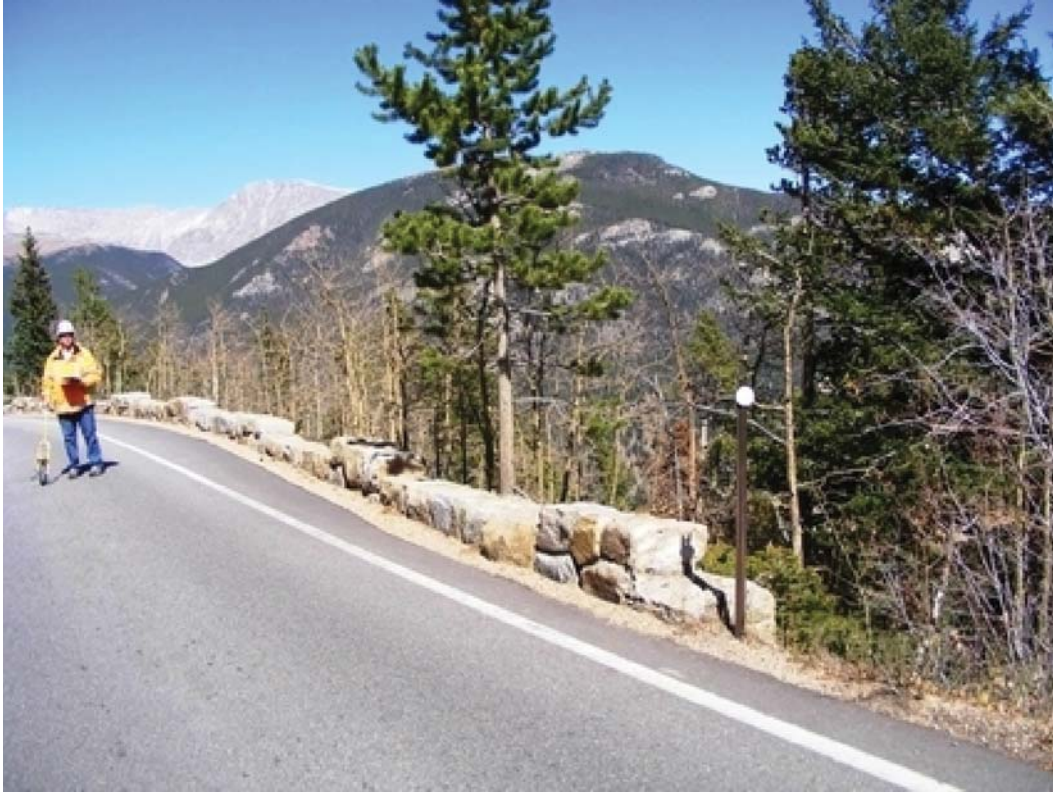
**ROMO\_0010\_7.642\_L\_1.jpg**

<b>Barrier ID:</b>	ROMO-0010-7.642-L				
<b>Route Name:</b>	TRAIL RIDGE ROAD				
<b>Inspection Date:</b>	10/02/2009	<b>Barrier Rating:</b>	66.50		
<b>Barrier Description</b>					
<b>Type:</b>	STONE MASONRY WITHOUT CONCRETE CORE WALL	<b>Barrier Function:</b>	TRAFFIC		
<b>Barrier Material:</b>	STONE	<b>Post Material:</b>	N/A		
<b>Blockout Type:</b>	N/A	<b>Length (ft.):</b>	308		
<b>Speed Limit (MPH):</b>	35	<b>Placement with Respect to Road:</b>	OUTSIDE OF CURVE		
<b>Hazard Behind Barrier:</b>	HIGH				
<b>Barrier Crashworthiness</b>					
<b>Appropriate Test Level:</b>	TL-2	<b>Barrier Test Level:</b>	NCW	<b>Is Barrier Crashworthy?:</b>	NO
<b>Beg. End Trtmt Type:</b>	NONE	<b>Is Beg. End Trtmt Crashworthy?:</b>	N/A	<b>Approach Transition Type:</b>	NONE
<b>Ending End Trtmt Type:</b>	NONE	<b>Ending End Trtmt Crashworthy?:</b>	N/A		
<b>Average Measurements</b>					
<b>Design Height (In.):</b>	24	<b>Width (In.):</b>	18.0	<b>Post Spacing (In.):</b>	0.0

<b>Height (In.):</b>	12.6	<b>Lateral Offset (In.):</b>	32.2	<b>Road Grade (%):</b>	3.90
<b>Physical Condition</b>					
<b>Barrier</b>	<b>Alignment and Height:</b>	Alignment acceptable. 153-ft was 3-6-in below the 18-in/24-in crenellated design height and 155-ft was 7-in below.			
	<b>Breaking and Cracking:</b>	No breaking or cracking observed.			
	<b>Missing Elements:</b>	No missing elements observed.			
	<b>Corrosion and Weathering:</b>	No corrosion or weathering observed.			
<b>End Treatments</b>	<b>Alignment and Height:</b>				
	<b>Breaking and Cracking:</b>				
	<b>Missing Elements:</b>				
	<b>Corrosion and Weathering:</b>

<b>Repair Action:</b>	REPAIR	<b>FMSS Work Type:</b>	DEFERRED MAINTENANCE	<b>Repair Cost:</b>	\$116078
<b>Brief Workorder:</b>	Raise guardwall 2-in. Remove and reset 155-ft of stone masonry guardwall on concrete footer to adjacent crenellated 12-in/18-in height.				
<b>Workorder:</b>	Remove & Reset Stone Masonry Guardwall at \$250- per -Cu. Ft. for 349 CF = \$87250. [(1.5ft)(1.5ft)(155ft)] = 348.8 CF. Structural Concrete at \$1000- per -Cu. Yd. for 5 CY = \$5000. [(1.5ft)(.5ft)(155ft)] /27 = 4.3 CY. Low Speed Traffic Control at \$1475- per -Day for 9 Day(s) = \$13275. 2 days removal and 7 days installation.

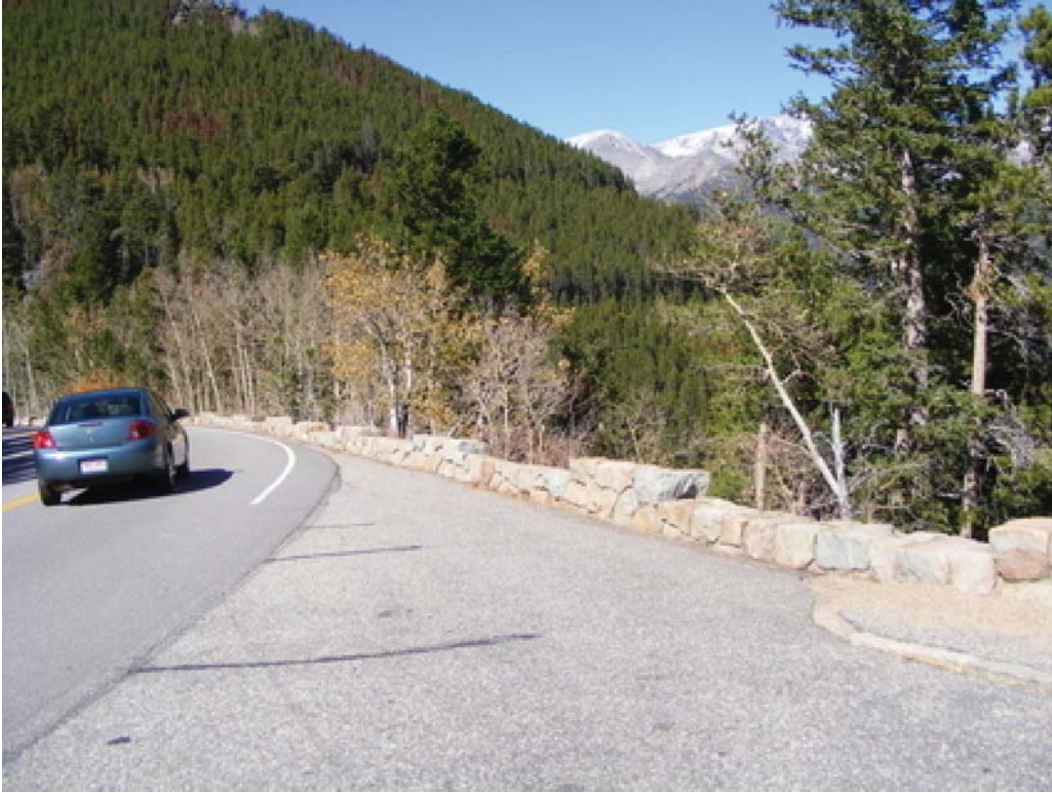
**ROMO\_0010\_7.941\_L\_1.jpg**

<b>Barrier ID:</b>	ROMO-0010-7.941-L				
<b>Route Name:</b>	TRAIL RIDGE ROAD				
<b>Inspection Date:</b>	10/02/2009	<b>Barrier Rating:</b>	72.80		
<b>Barrier Description</b>					
<b>Type:</b>	STONE MASONRY WITHOUT CONCRETE CORE WALL	<b>Barrier Function:</b>	TRAFFIC		
<b>Barrier Material:</b>	STONE	<b>Post Material:</b>	N/A		
<b>Blockout Type:</b>	N/A	<b>Length (ft.):</b>	288		
<b>Speed Limit (MPH):</b>	35	<b>Placement with Respect to Road:</b>	OUTSIDE OF CURVE		
<b>Hazard Behind Barrier:</b>	HIGH				
<b>Barrier Crashworthiness</b>					
<b>Appropriate Test Level:</b>	TL-2	<b>Barrier Test Level:</b>	NCW	<b>Is Barrier Crashworthy?:</b>	NO
<b>Beg. End Trtmt Type:</b>	NONE	<b>Is Beg. End Trtmt Crashworthy?:</b>	N/A	<b>Approach Transition Type:</b>	NONE
<b>Ending End Trtmt Type:</b>	NONE	<b>Ending End Trtmt Crashworthy?:</b>	N/A		
<b>Average Measurements</b>					
<b>Design Height (In.):</b>	24	<b>Width (In.):</b>	18.7	<b>Post Spacing (In.):</b>	0.0

<b>Height (In.):</b>	10.6	<b>Lateral Offset (In.):</b>	39.0	<b>Road Grade (%):</b>	5.10
<b>Physical Condition</b>					
<b>Barrier</b>	<b>Alignment and Height:</b>	Alignment acceptable. 288-ft was 7-in to 10-in below the 18-in/24-in crenellated design height.			
	<b>Breaking and Cracking:</b>	No breaking or cracking observed.			
	<b>Missing Elements:</b>	No missing elements observed.			
	<b>Corrosion and Weathering:</b>	No corrosion or weathering observed.			
<b>End Treatments</b>	<b>Alignment and Height:</b>				
	<b>Breaking and Cracking:</b>				
	<b>Missing Elements:</b>				
	<b>Corrosion and Weathering:</b>
