GIP Report

NPS Guardwall/Rail Inventory Program
Sequoia National Park

Federal Lands Highway
Road Inventory Program

Data Collection Date: October 2009
Report Date: November 2015

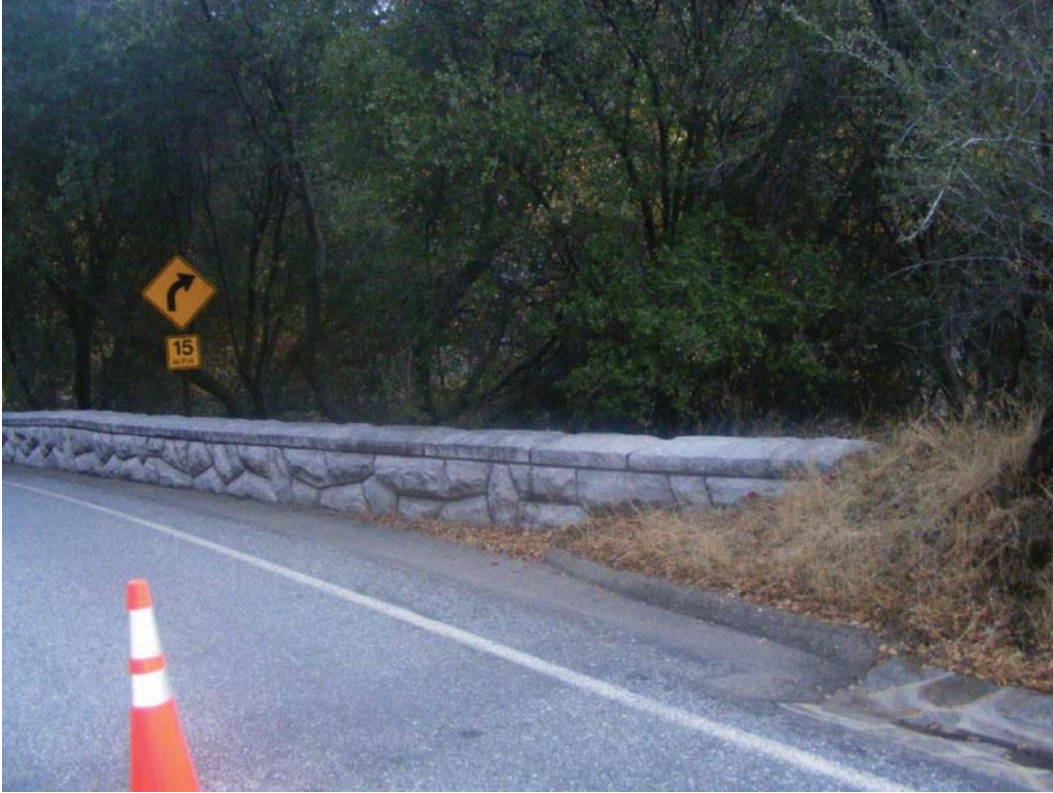
SEQU_0010_1.337_R_1.JPG

Barrier ID:	SEQU-0010-1.337-R				
Route Name:	GENERALS HIGHWAY HISTORIC				
Inspection Date:	10/21/2009	Barrier Rating:	34.40		
Barrier Description					
Type:	STONE MASONRY WITH CONCRETE CORE WALL	Barrier Function:	TRAFFIC		
Barrier Material:	CONCRETE	Post Material:	N/A		
Blockout Type:	N/A	Length (ft.):	597		
Speed Limit (MPH):	15	Placement with Respect to Road:	BOTH INSIDE AND OUTSIDE		
Hazard Behind Barrier:	EXTREME				
Barrier Crashworthiness					
Appropriate Test Level:	TL-1	Barrier Test Level:	TL-3	Is Barrier Crashworthy?:	YES
Beg. End Trtmt Type:	NONE	Is Beg. End Trtmt Crashworthy?:	N/A	Approach Transition Type:	NONE
Ending End Trtmt Type:	NONE	Ending End Trtmt Crashworthy?:	N/A		
Average Measurements					
Design Height (In.):	27	Width (In.):	26.0	Post Spacing (In.):	0.0
Height (In.):	29.2	Lateral Offset (In.):	41.5	Road Grade (%):	3.60
Physical Condition					
Barrier	Alignment and Height:	The alignment is off by less than 6 in. The height of the wall exceeds the design height of 27 in by 1-4 ins.

Breaking and Cracking:	No breaking or cracking.			
	Missing Elements:	No missing elements observed.			
	Corrosion and Weathering:	No corrosion or weathering observed.			
End Treatments	Alignment and Height:				
	Breaking and Cracking:				
	Missing Elements:				
	Corrosion and Weathering:

Repair Action:	NO ACTION	FMSS Work Type:	N/A	Repair Cost:	\$0
Brief Workorder:	N/A				
Workorder:

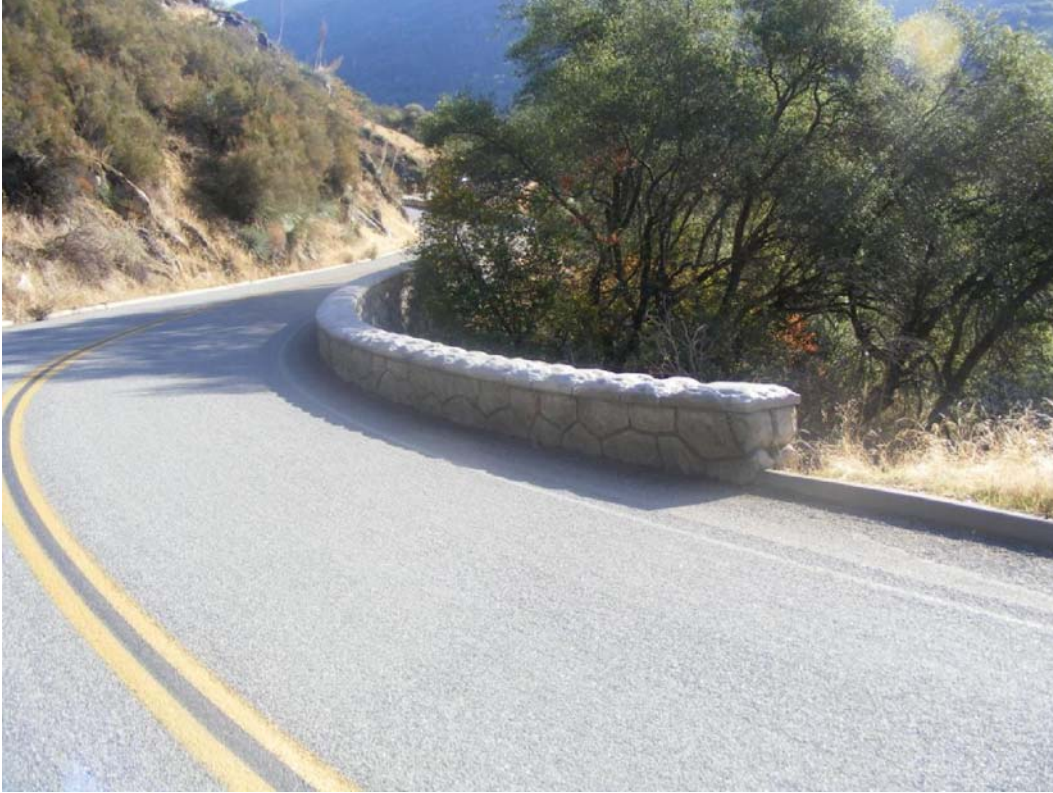
SEQU_0010_1.868_R_1.JPG

Barrier ID:	SEQU-0010-1.868-R				
Route Name:	GENERALS HIGHWAY HISTORIC				
Inspection Date:	10/21/2009	Barrier Rating:	32.90		
Barrier Description					
Type:	STONE MASONRY WITH CONCRETE CORE WALL	Barrier Function:	TRAFFIC		
Barrier Material:	CONCRETE	Post Material:	N/A		
Blockout Type:	N/A	Length (ft.):	707		
Speed Limit (MPH):	15	Placement with Respect to Road:	BOTH INSIDE AND OUTSIDE		
Hazard Behind Barrier:	EXTREME				
Barrier Crashworthiness					
Appropriate Test Level:	TL-1	Barrier Test Level:	TL-3	Is Barrier Crashworthy?:	YES
Beg. End Trtmt Type:	NONE	Is Beg. End Trtmt Crashworthy?:	N/A	Approach Transition Type:	NONE
Ending End Trtmt Type:	NONE	Ending End Trtmt Crashworthy?:	N/A		
Average Measurements					
Design Height (In.):	27	Width (In.):	25.5	Post Spacing (In.):	0.0
Height (In.):	28.0	Lateral Offset (In.):	20.0	Road Grade (%):	4.80
Physical Condition					
Barrier	Alignment and Height:	The alignment showed no deflection. The height of the wall is above the design height of 27 in by 0-2 in.
