GIP Report

NPS Guardwall/Rail Inventory Program
Suitland Parkway National Capital Parks - East

Federal Highway Administration
Eastern Federal Lands Highway Division
Road Inventory Program (RIP)

Data Collection Date: November 2010
Report Date: November 2015

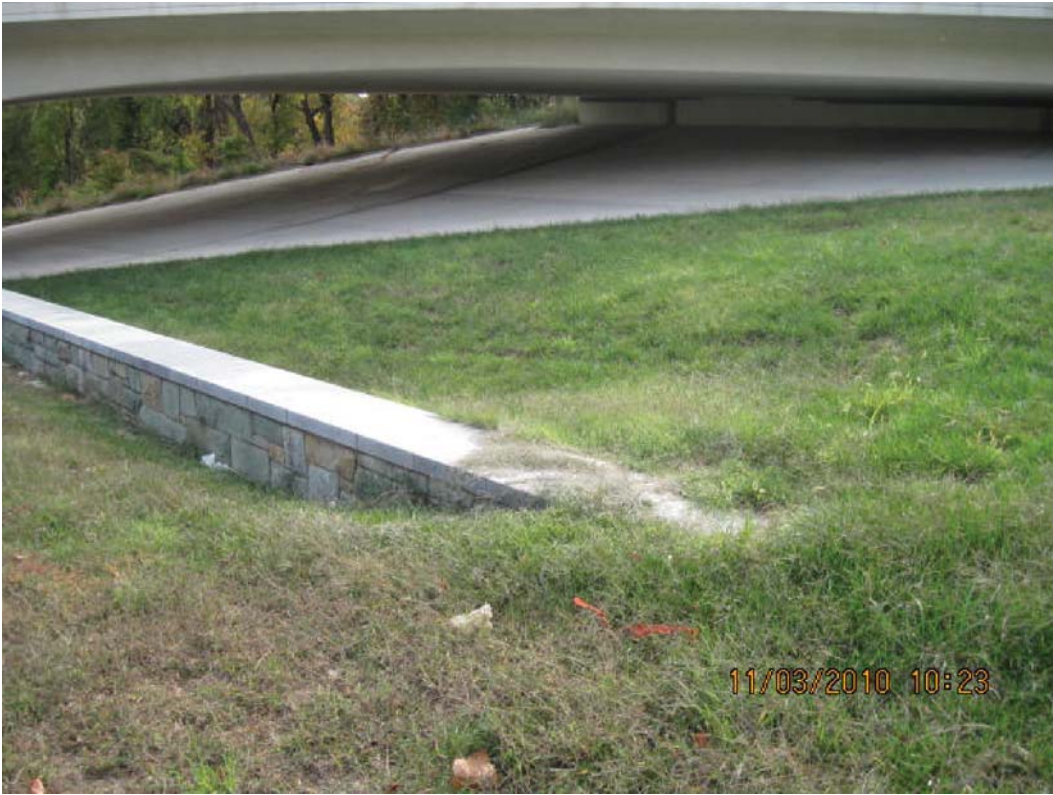
SUIT_0001_0.000_R_1.jpg

Barrier ID:	SUIT-0001-0.000-R				
Route Name:	EASTBOUND SUITLAND PARKWAY				
Inspection Date:	03/11/2010	Barrier Rating:	41.40		
Barrier Description					
Type:	CONCRETE WITH SIMULATED STONE FACE	Barrier Function:	TRAFFIC		
Barrier Material:	CONCRETE	Post Material:	N/A		
Blockout Type:	N/A	Length (ft.):	229		
Speed Limit (MPH):	45	Placement with Respect to Road:	OUTSIDE OF CURVE		
Hazard Behind Barrier:	LOW				
Barrier Crashworthiness					
Appropriate Test Level:	TL-2	Barrier Test Level:	TL-3	Is Barrier Crashworthy?:	YES
Beg. End Trtmt Type:	OTHER: CONCRETE WITH	Is Beg. End Trtmt Crashworthy?:	NO	Approach Transition Type:	NONE
Ending End Trtmt Type:	OTHER: STONE WITH CONCRETE	Ending End Trtmt Crashworthy?:	NO		
Average Measurements					
Design Height (In.):	27	Width (In.):	26.0	Post Spacing (In.):	0.0
Height (In.):	26.7	Lateral Offset (In.):	197.3	Road Grade (%):	5.40
Physical Condition					
Barrier	Alignment and Height:	Alignment deflection was less than 6 in. The entire barrier was within 1/2 in of design height (27 in).

Breaking and Cracking:	5 ft of the barrier has loose stones. Minor cracking of less than 1/4 in observed in the cap.			
	Missing Elements:	No elements appeared to be missing.			
	Corrosion and Weathering:	5 ft of the mortar joints were deteriorated resulting in loose stones.			
End Treatments	Alignment and Height:	Alignment acceptable. Height within 3-in of 27-in design height.			
	Breaking and Cracking:	No breaking or cracking observed.			
	Missing Elements:	No elements appeared to be missing.			
	Corrosion and Weathering:	No surface corrosion or erosion observed.

Repair Action:	REPAIR	FMSS Work Type:	DEFERRED MAINTENANCE	Repair Cost:	\$1777
Brief Workorder:	Repoint 1 SY of barrier.				
Workorder:	Re-Point Masonry Barrier at \$140- per -Sq. Yd. for 1 SY = \$140. [(2.5 sf + 1.1 sf)/9 = 0.4 sy Low Speed Traffic Control at \$1475- per -Day for 1 Day(s) = \$1475.

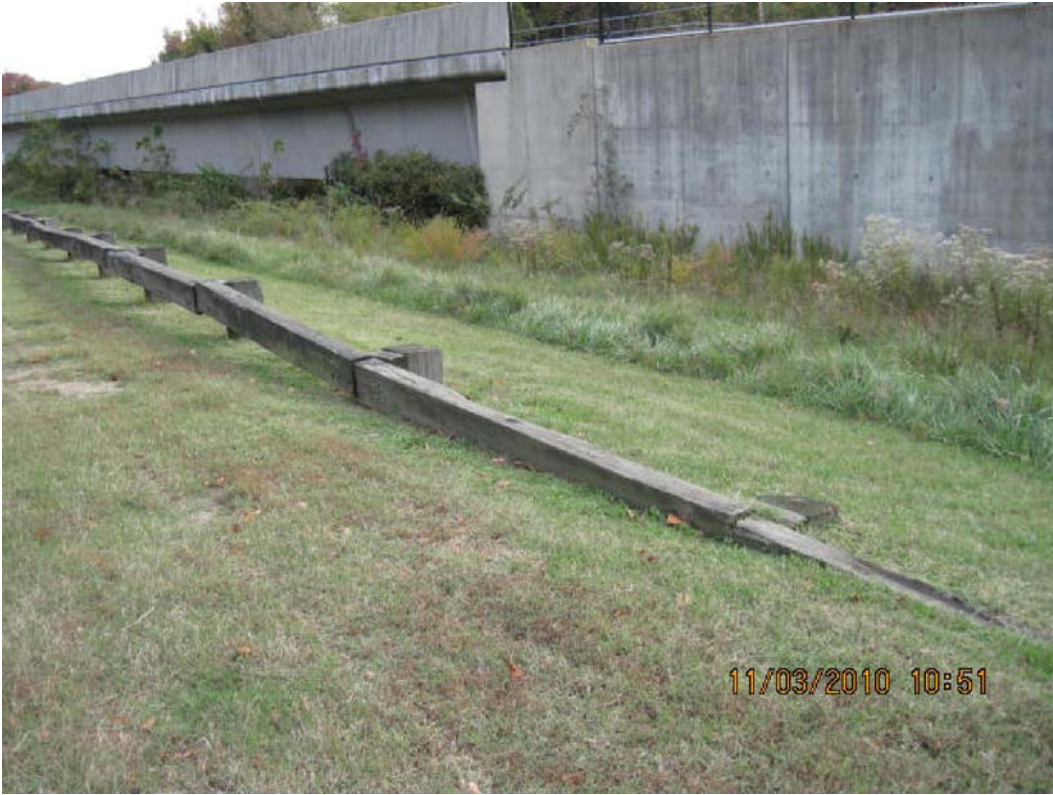
SUIT_0001_0.188_R_1.jpg

Barrier ID:	SUIT-0001-0.188-R				
Route Name:	EASTBOUND SUITLAND PARKWAY				
Inspection Date:	03/11/2010	Barrier Rating:	48.40		
Barrier Description					
Type:	STEEL-BACKED TIMBER WITH BLOCKOUT	Barrier Function:	TRAFFIC		
Barrier Material:	STEEL-BACKED TIMBER/LOG	Post Material:	WOOD		
Blockout Type:	WOOD	Length (ft.):	242		
Speed Limit (MPH):	45	Placement with Respect to Road:	OUTSIDE OF CURVE		
Hazard Behind Barrier:	MEDIUM				
Barrier Crashworthiness					
Appropriate Test Level:	TL-2	Barrier Test Level:	TL-3	Is Barrier Crashworthy?:	YES
Beg. End Trtmt Type:	SBT/LOG FLARED	Is Beg. End Trtmt Crashworthy?:	NO	Approach Transition Type:	NONE
Ending End Trtmt Type:	SBT/LOG FLARED	Ending End Trtmt Crashworthy?:	NO		
Average Measurements					
Design Height (In.):	27	Width (In.):	0.0	Post Spacing (In.):	120.3
Height (In.):	23.7	Lateral Offset (In.):	136.6	Road Grade (%):	1.70
Physical Condition					
Barrier	Alignment and Height:	Some deflections observed in alignment no greater than 4 in. 110 ft of barrier is 3-5 in below 27 in design height. 50 ft of barrier is 1 to 3 in below 27 in design height.

Breaking and Cracking:	20 ft. guardrail was observed to have impact related cracking. 3 blockouts had cracking that caused full breaking.			
	Missing Elements:	1 blockout was observed to be missing.			
	Corrosion and Weathering:	30 ft guardrail had a loss of at least 50% of cross section. No erosion around posts observed.			
End Treatments	Alignment and Height:	Alignment acceptable. Height within 1-in of 27-in design height.			
	Breaking and Cracking:	1 post was cracked through the center about 2 in width.			
	Missing Elements:	No elements were observed to be missing.			
	Corrosion and Weathering:	No erosion around posts observed. No loss of cross section greater than 5% observed.

Repair Action:	REPAIR	FMSS Work Type:	DEFERRED MAINTENANCE	Repair Cost:	\$5000
Brief Workorder:	Raise 160-ft of guardrail up to 27-in design height replace 50-ft of rail 1 post and 4 blocks.				
Workorder:	Replace Rail at \$25- per -Lin. Ft. for 50 LF = \$1250. Replace 50-ft of rail. Replace Block at \$30- per -Each for 4 Block(s) = \$120. Replace 3 cracked blockouts and 1 missing blockout. Replace Post at \$100- per -Each for 1 Post(s) = \$100. Replace 1 cracked post. Adjust Guardrail at \$10- per -Lin. Ft. for 160 LF = \$1600. Raise 160 ft of rail to 27 inch design height. Low Speed Traffic Control at \$1475- per -Day for 1 Day(s) = \$1475.

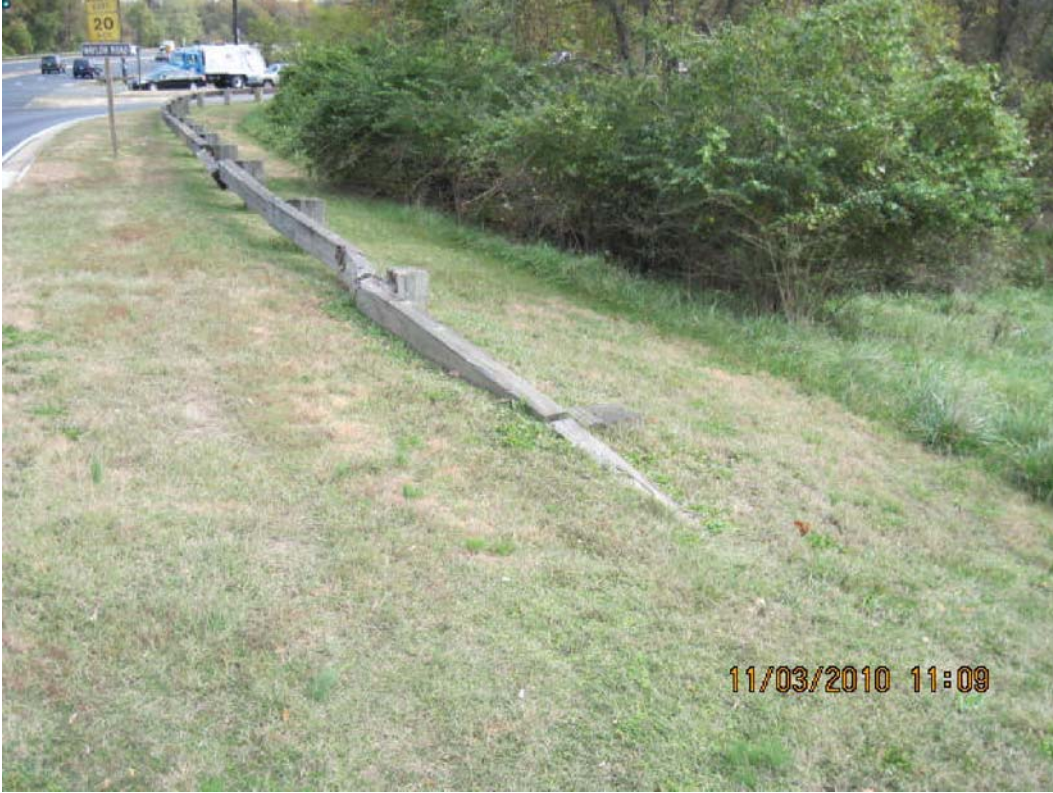
SUIT_0001_0.378_R_1.jpg

Barrier ID:	SUIT-0001-0.378-R				
Route Name:	EASTBOUND SUITLAND PARKWAY				
Inspection Date:	03/11/2010	Barrier Rating:	39.70		
Barrier Description					
Type:	STEEL-BACKED TIMBER WITH BLOCKOUT	Barrier Function:	TRAFFIC		
Barrier Material:	STEEL-BACKED TIMBER/LOG	Post Material:	WOOD		
Blockout Type:	WOOD	Length (ft.):	167		
Speed Limit (MPH):	45	Placement with Respect to Road:	TANGENT		
Hazard Behind Barrier:	MEDIUM				
Barrier Crashworthiness					
Appropriate Test Level:	TL-2	Barrier Test Level:	TL-3	Is Barrier Crashworthy?:	YES
Beg. End Trtmt Type:	SBT/LOG FLARED	Is Beg. End Trtmt Crashworthy?:	NO	Approach Transition Type:	NONE
Ending End Trtmt Type:	NONE	Ending End Trtmt Crashworthy?:	N/A		
Average Measurements					
Design Height (In.):	27	Width (In.):	0.0	Post Spacing (In.):	119.3
Height (In.):	24.7	Lateral Offset (In.):	124.6	Road Grade (%):	0.80
Physical Condition					
Barrier	Alignment and Height:	No deflections greater than 6 in were observed in the alignment. The barrier height was between 1 and 3 in below the 27 in design height for the entire length.

Breaking and Cracking:	10ft of rail and 3 blocks were cracked or broken due to impacts.			
	Missing Elements:	There were 10 bolts/washers/nuts missing and several of the bolts were loose.			
	Corrosion and Weathering:	Weathering was observed but less than 5 percent of the cross section has been lost. No erosion was observed.			
End Treatments	Alignment and Height:	Alignment acceptable. Height within 1-in of 27-in design height.			
	Breaking and Cracking:	10ft of rail was broken due to impact and 1 block was broken.			
	Missing Elements:	Several bolts were loose.			
	Corrosion and Weathering:	Less than 5 percent of the cross section has been lost.

Repair Action:	REPAIR	FMSS Work Type:	DEFERRED MAINTENANCE	Repair Cost:	\$4131
Brief Workorder:	Raise 137-ft of guardrail up to 27-in design height replace 20-ft of rail 4 blocks 10 bolt assemblies and tighten loose bolts.				
Workorder:	<p>Adjust Guardrail at \$10- per -Lin. Ft. for 137 LF = \$1370. Raise 137 feet of guardrail to the design height of 27 inches.</p> <p>Replace Rail at \$25- per -Lin. Ft. for 20 LF = \$500. Replace 20 ft of rail.</p> <p>Replace Block at \$30- per -Each for 4 Block(s) = \$120. Replace 4 blockouts.</p> <p>Bolt Assembly at \$5- per - for 10 = \$50. 10 bolt assemblies.</p> <p>Labor at \$60- per -Hour for 4 Hrs = \$240. Replace and tighten bolts.</p> <p>Low Speed Traffic Control at \$1475- per -Day for 1 Day(s) = \$1475.</p>

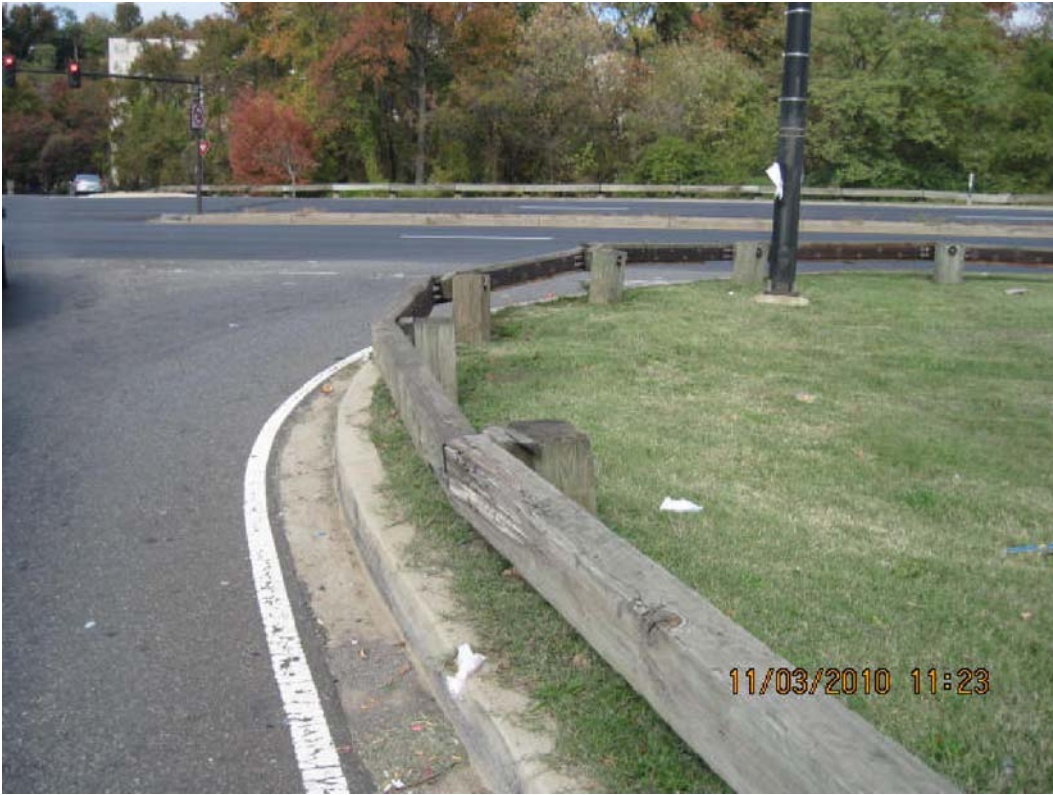
SUIT_0001_0.431_R_1.jpg

Barrier ID:	SUIT-0001-0.431-R				
Route Name:	EASTBOUND SUITLAND PARKWAY				
Inspection Date:	03/11/2010	Barrier Rating:	40.20		
Barrier Description					
Type:	STEEL-BACKED TIMBER WITH BLOCKOUT	Barrier Function:	TRAFFIC		
Barrier Material:	STEEL-BACKED TIMBER/LOG	Post Material:	WOOD		
Blockout Type:	WOOD	Length (ft.):	67		
Speed Limit (MPH):	45	Placement with Respect to Road:	INSIDE OF CURVE		
Hazard Behind Barrier:	LOW				
Barrier Crashworthiness					
Appropriate Test Level:	TL-2	Barrier Test Level:	TL-3	Is Barrier Crashworthy?:	YES
Beg. End Trtmt Type:	NONE	Is Beg. End Trtmt Crashworthy?:	N/A	Approach Transition Type:	NONE
Ending End Trtmt Type:	SBT/LOG FLARED	Ending End Trtmt Crashworthy?:	NO		
Average Measurements					
Design Height (In.):	27	Width (In.):	0.0	Post Spacing (In.):	111.3
Height (In.):	23.7	Lateral Offset (In.):	68.3	Road Grade (%):	3.50
Physical Condition					
Barrier	Alignment and Height:	Alignment deflection was less than 6 in. 10 ft of the barrier was 1 to 3 in below design height (27 ines). 42 ft of the barrier was 3-6 ines below design height (27 ines).
