GIP Report

**NPS Guardwall/Rail Inventory Program
Theodore Roosevelt National Park**

**Federal Lands Highway
Road Inventory Program**

**Data Collection Date: August 2010
Report Date: November 2015**

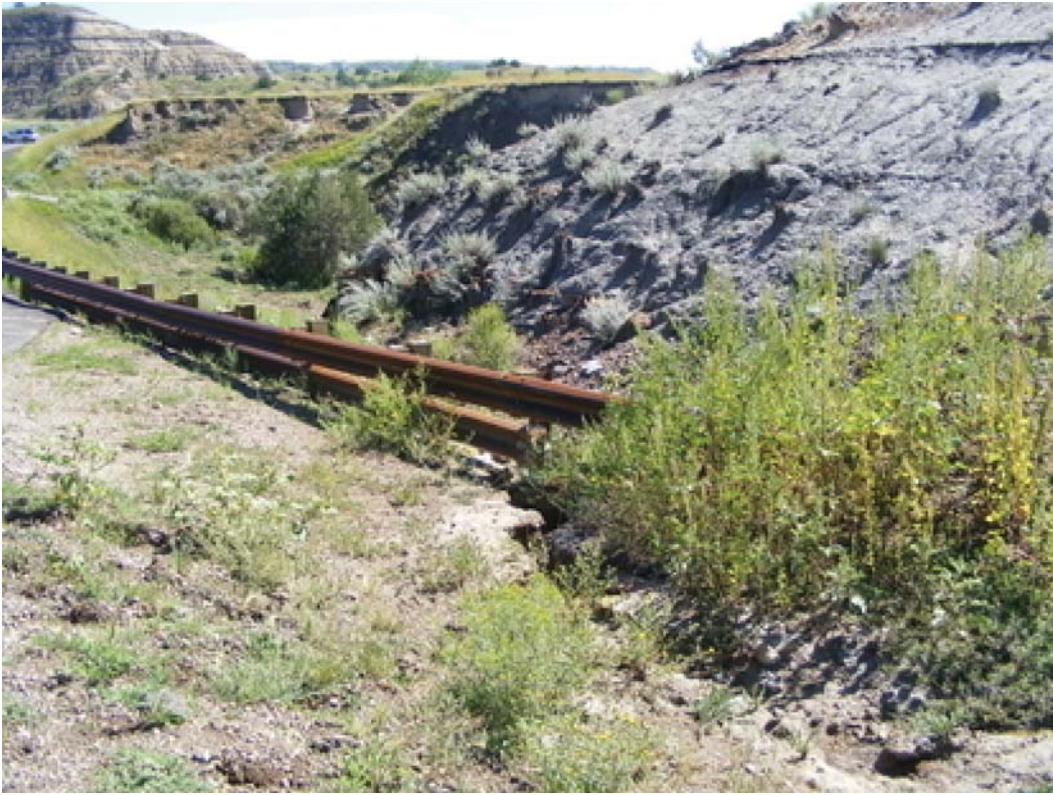
THRO_0010_1.232_L_1.JPG

Barrier ID:	THRO-0010-1.232-L				
Route Name:	SCENIC DRIVE				
Inspection Date:	10/08/2010	Barrier Rating:	14.00		
Barrier Description					
Type:	W-BEAM STRONG POST	Barrier Function:	TRAFFIC		
Barrier Material:	WEATHERING STEEL/CORTEN	Post Material:	WOOD		
Blockout Type:	WOOD	Length (ft.):	301		
Speed Limit (MPH):	25	Placement with Respect to Road:	TANGENT		
Hazard Behind Barrier:	HIGH				
Barrier Crashworthiness					
Appropriate Test Level:	TL-1	Barrier Test Level:	TL-3	Is Barrier Crashworthy?:	YES
Beg. End Trtmt Type:	W-BEAM FLARED 350 COMPLIANT	Is Beg. End Trtmt Crashworthy?:	YES	Approach Transition Type:	NONE
Ending End Trtmt Type:	W-BEAM FLARED 350 COMPLIANT	Ending End Trtmt Crashworthy?:	YES		
Average Measurements					
Design Height (In.):	27	Width (In.):	0.0	Post Spacing (In.):	75.0
Height (In.):	29.7	Lateral Offset (In.):	61.7	Road Grade (%):	2.00
Physical Condition					
Barrier	Alignment and Height:	Alignment acceptable. Height was 2 to 3-in above the 27-in design height.

Breaking and Cracking:	1 cracked block. No other cracked or broken barrier elements.			
	Missing Elements:	No missing barrier elements.			
	Corrosion and Weathering:	Minimal corrosion/weathering of barrier elements.			
End Treatments	Alignment and Height:	Alignment acceptable. Height was 2 to 3-in above the 27-in design height.			
	Breaking and Cracking:	No cracked or broken end treatment elements.			
	Missing Elements:	No missing end treatment elements.			
	Corrosion and Weathering:	Minimal corrosion/weathering of end treatment elements.

Repair Action:	REPAIR	FMSS Work Type:	DEFERRED MAINTENANCE	Repair Cost:	\$33
Brief Workorder:	Replace one cracked block.				
Workorder:	Replace Block at \$30- per -Each for 1 Block(s) = \$30. Replace one cracked block.

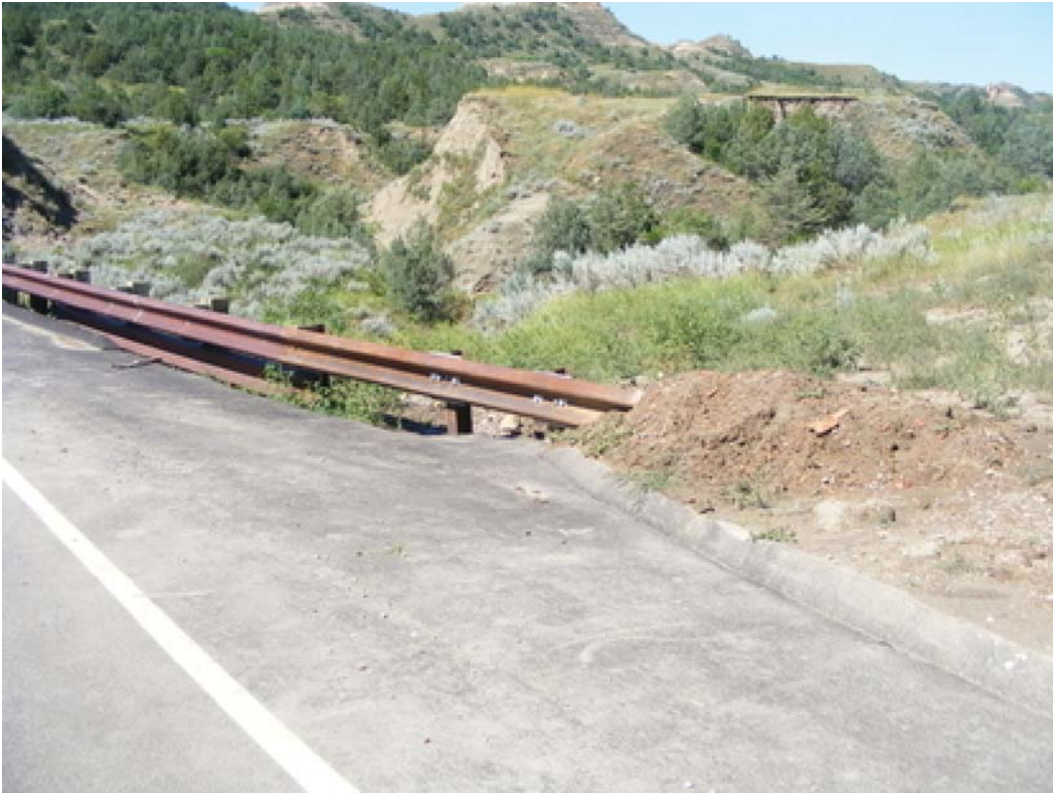
THRO_0010_1.246_R_1.JPG

Barrier ID:	THRO-0010-1.246-R				
Route Name:	SCENIC DRIVE				
Inspection Date:	10/08/2010	Barrier Rating:	11.10		
Barrier Description					
Type:	W-BEAM STRONG POST	Barrier Function:	TRAFFIC		
Barrier Material:	WEATHERING STEEL/CORTEN	Post Material:	WOOD		
Blockout Type:	WOOD	Length (ft.):	239		
Speed Limit (MPH):	25	Placement with Respect to Road:	TANGENT		
Hazard Behind Barrier:	HIGH				
Barrier Crashworthiness					
Appropriate Test Level:	TL-1	Barrier Test Level:	TL-3	Is Barrier Crashworthy?:	YES
Beg. End Trtmt Type:	W-BEAM BURIED END	Is Beg. End Trtmt Crashworthy?:	YES	Approach Transition Type:	NONE
Ending End Trtmt Type:	W-BEAM BURIED END	Ending End Trtmt Crashworthy?:	YES		
Average Measurements					
Design Height (In.):	27	Width (In.):	0.0	Post Spacing (In.):	73.6
Height (In.):	27.7	Lateral Offset (In.):	66.3	Road Grade (%):	2.20
Physical Condition					
Barrier	Alignment and Height:	Alignment acceptable. Height within 1-in of 27-in design height.

Breaking and Cracking:	No cracked or broken barrier elements.			
	Missing Elements:	No missing barrier elements.			
	Corrosion and Weathering:	Minimal corrosion/weathering of barrier elements.			
End Treatments	Alignment and Height:	Alignment acceptable. Height within 1-in of 27-in design height.			
	Breaking and Cracking:	No cracked or broken end treatment elements.			
	Missing Elements:	No missing end treatment elements.			
	Corrosion and Weathering:	Minimal corrosion/weathering of end treatment elements.

Barrier ID:	THRO-0010-1.246-R				
Route Name:	SCENIC DRIVE				
Inspection Date:	10/08/2010	Barrier Rating:		11.10	
Repair Recommendations					
Repair Action:	NO ACTION	FMSS Work Type:	N/A	Repair Cost:	\$0
Brief Workorder:	N/A				
Workorder:

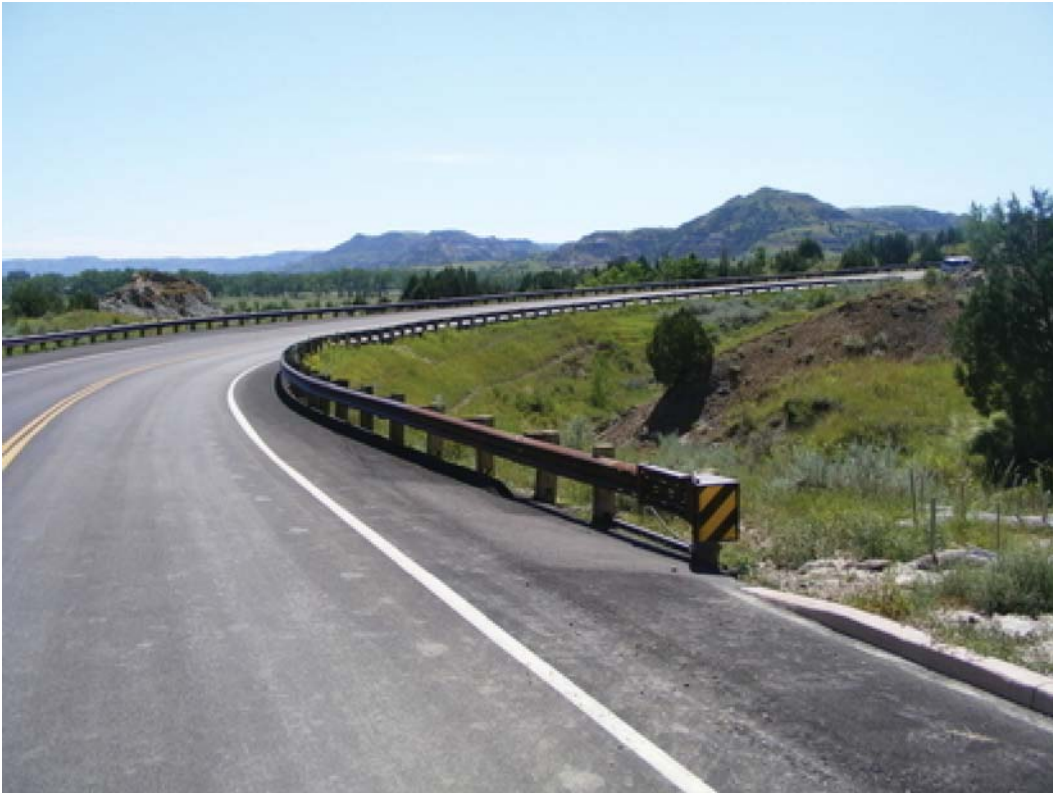
THRO_0010_1.411_R_1.JPG

Barrier ID:	THRO-0010-1.411-R				
Route Name:	SCENIC DRIVE				
Inspection Date:	10/08/2010	Barrier Rating:	18.00		
Barrier Description					
Type:	W-BEAM STRONG POST	Barrier Function:	TRAFFIC		
Barrier Material:	WEATHERING STEEL/CORTEN	Post Material:	WOOD		
Blockout Type:	WOOD	Length (ft.):	435		
Speed Limit (MPH):	25	Placement with Respect to Road:	INSIDE OF CURVE		
Hazard Behind Barrier:	MEDIUM				
Barrier Crashworthiness					
Appropriate Test Level:	TL-1	Barrier Test Level:	TL-3	Is Barrier Crashworthy?:	YES
Beg. End Trtmt Type:	W-BEAM FLARED 350 COMPLIANT	Is Beg. End Trtmt Crashworthy?:	YES	Approach Transition Type:	NONE
Ending End Trtmt Type:	W-BEAM FLARED 350 COMPLIANT	Ending End Trtmt Crashworthy?:	YES		
Average Measurements					
Design Height (In.):	27	Width (In.):	0.0	Post Spacing (In.):	73.5
Height (In.):	27.6	Lateral Offset (In.):	46.0	Road Grade (%):	3.20
Physical Condition					
Barrier	Alignment and Height:	Alignment acceptable. Height within 1-in of 27-in design height.

Breaking and Cracking:	No cracked or broken barrier elements.			
	Missing Elements:	No missing barrier elements.			
	Corrosion and Weathering:	No major weathering of the barrier.			
End Treatments	Alignment and Height:	Alignment acceptable. Height within 1-in of 27-in design height.			
	Breaking and Cracking:	No major cracking or breaking of the end treatments.			
	Missing Elements:	No missing end treatment elements.			
	Corrosion and Weathering:	No major weathering of the end treatments.

Repair Action:	NO ACTION	FMSS Work Type:	N/A	Repair Cost:	\$0
Brief Workorder:	N/A				
Workorder:

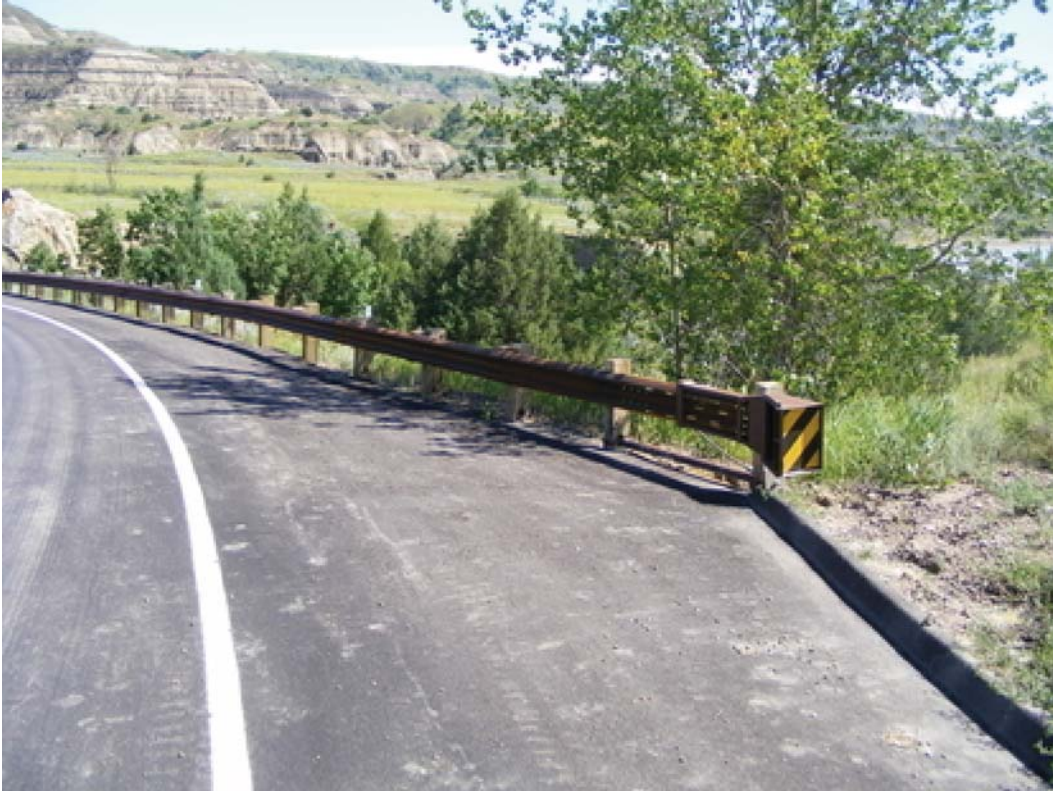
THRO_0010_1.421_L_1.JPG

Barrier ID:	THRO-0010-1.421-L				
Route Name:	SCENIC DRIVE				
Inspection Date:	10/08/2010	Barrier Rating:	26.80		
Barrier Description					
Type:	W-BEAM STRONG POST	Barrier Function:	TRAFFIC		
Barrier Material:	WEATHERING STEEL/CORTEN	Post Material:	WOOD		
Blockout Type:	WOOD	Length (ft.):	525		
Speed Limit (MPH):	25	Placement with Respect to Road:	OUTSIDE OF CURVE		
Hazard Behind Barrier:	HIGH				
Barrier Crashworthiness					
Appropriate Test Level:	TL-1	Barrier Test Level:	TL-3	Is Barrier Crashworthy?:	YES
Beg. End Trtmt Type:	W-BEAM FLARED 350 COMPLIANT	Is Beg. End Trtmt Crashworthy?:	YES	Approach Transition Type:	NONE
Ending End Trtmt Type:	W-BEAM FLARED 350 COMPLIANT	Ending End Trtmt Crashworthy?:	YES		
Average Measurements					
Design Height (In.):	27	Width (In.):	0.0	Post Spacing (In.):	75.0
Height (In.):	27.0	Lateral Offset (In.):	96.5	Road Grade (%):	5.70
Physical Condition					
Barrier	Alignment and Height:	Alignment acceptable. Height within 1-in of 27-in design height.

Breaking and Cracking:	No cracked or broken barrier elements.			
	Missing Elements:	No missing barrier elements.			
	Corrosion and Weathering:	No major weathering of the barrier.			
End Treatments	Alignment and Height:	Alignment acceptable. Height within 1-in of 27-in design height.			
	Breaking and Cracking:	No major cracking or breaking of the end treatments.			
	Missing Elements:	No missing end treatment elements.			
	Corrosion and Weathering:	No major weathering of the end treatments.

Barrier ID:	THRO-0010-1.421-L				
Route Name:	SCENIC DRIVE				
Inspection Date:	10/08/2010	Barrier Rating:		26.80	
Repair Recommendations					
Repair Action:	NO ACTION	FMSS Work Type:	N/A	Repair Cost:	\$0
Brief Workorder:	N/A				
Workorder:

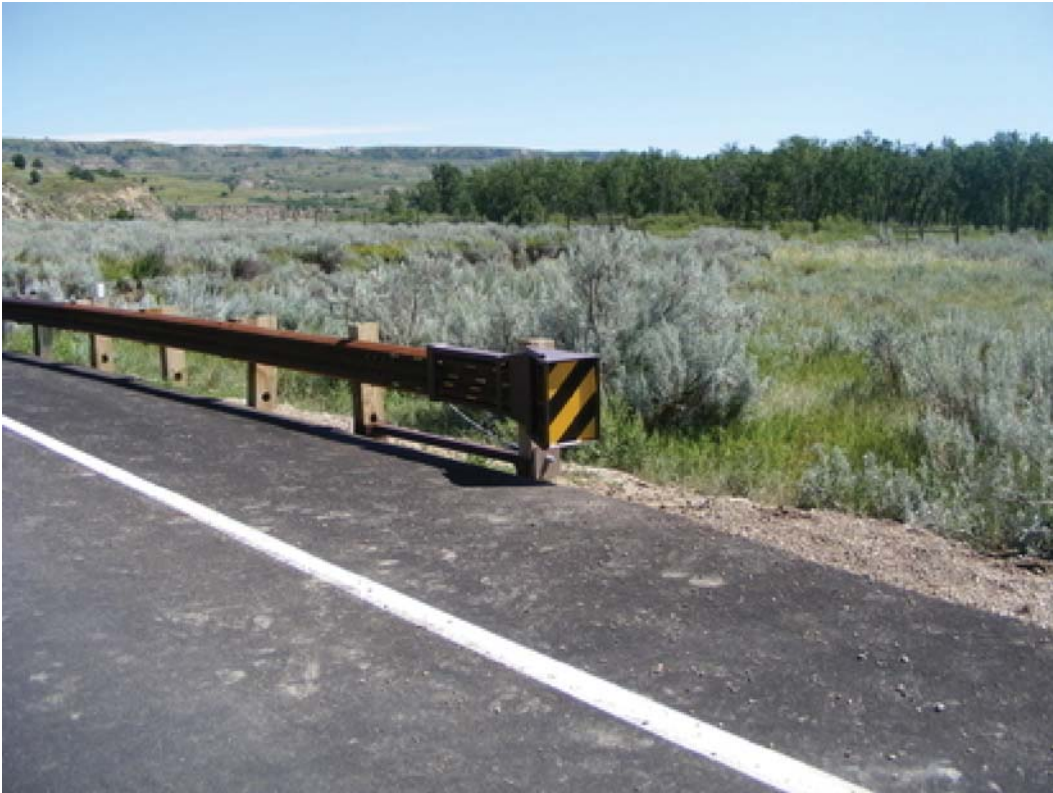
THRO_0010_1.857_L_1.JPG

Barrier ID:	THRO-0010-1.857-L				
Route Name:	SCENIC DRIVE				
Inspection Date:	10/08/2010	Barrier Rating:	11.10		
Barrier Description					
Type:	W-BEAM STRONG POST	Barrier Function:	TRAFFIC		
Barrier Material:	WEATHERING STEEL/CORTEN	Post Material:	WOOD		
Blockout Type:	WOOD	Length (ft.):	131		
Speed Limit (MPH):	25	Placement with Respect to Road:	TANGENT		
Hazard Behind Barrier:	HIGH				
Barrier Crashworthiness					
Appropriate Test Level:	TL-1	Barrier Test Level:	TL-3	Is Barrier Crashworthy?:	YES
Beg. End Trtmt Type:	W-BEAM FLARED 350 COMPLIANT	Is Beg. End Trtmt Crashworthy?:	YES	Approach Transition Type:	NONE
Ending End Trtmt Type:	W-BEAM TANGENT 350	Ending End Trtmt Crashworthy?:	YES		
Average Measurements					
Design Height (In.):	27	Width (In.):	0.0	Post Spacing (In.):	75.0
Height (In.):	27.0	Lateral Offset (In.):	62.2	Road Grade (%):	0.70
Physical Condition					
Barrier	Alignment and Height:	Alignment acceptable. Height within 1-in of 27-in design height.

Breaking and Cracking:	No cracked or broken barrier elements.			
	Missing Elements:	No missing barrier elements.			
	Corrosion and Weathering:	Minimal corrosion/weathering of barrier elements.			
End Treatments	Alignment and Height:	Alignment acceptable. Height within 1-in of 27-in design height.			
	Breaking and Cracking:	No cracked or broken end treatment elements.			
	Missing Elements:	No missing end treatment elements.			
	Corrosion and Weathering:	Minimal corrosion/weathering of end treatment elements.

Barrier ID:	THRO-0010-1.857-L				
Route Name:	SCENIC DRIVE				
Inspection Date:	10/08/2010	Barrier Rating:		11.10	
Repair Recommendations					
Repair Action:	NO ACTION	FMSS Work Type:	N/A	Repair Cost:	\$0
Brief Workorder:	N/A				
Workorder:

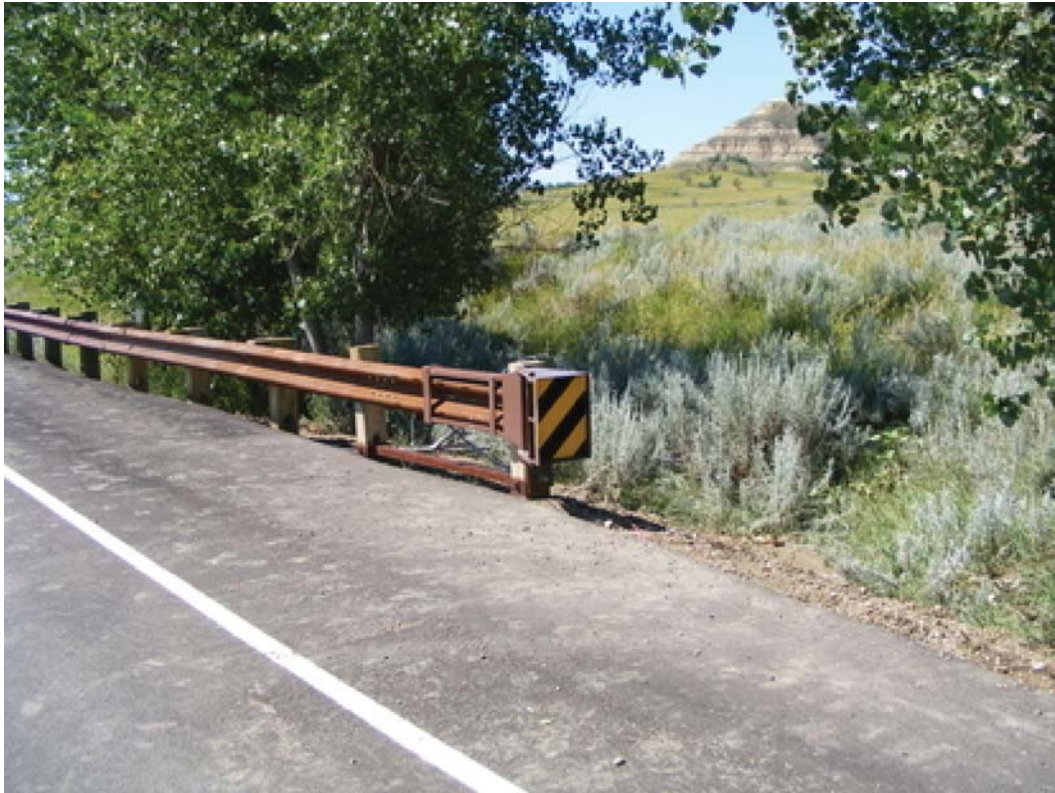
THRO_0010_1.857_R_1.JPG

Barrier ID:	THRO-0010-1.857-R				
Route Name:	SCENIC DRIVE				
Inspection Date:	10/08/2010	Barrier Rating:	9.30		
Barrier Description					
Type:	W-BEAM STRONG POST	Barrier Function:	TRAFFIC		
Barrier Material:	WEATHERING STEEL/CORTEN	Post Material:	WOOD		
Blockout Type:	WOOD	Length (ft.):	131		
Speed Limit (MPH):	25	Placement with Respect to Road:	TANGENT		
Hazard Behind Barrier:	MEDIUM				
Barrier Crashworthiness					
Appropriate Test Level:	TL-1	Barrier Test Level:	TL-3	Is Barrier Crashworthy?:	YES
Beg. End Trtmt Type:	W-BEAM FLARED 350 COMPLIANT	Is Beg. End Trtmt Crashworthy?:	YES	Approach Transition Type:	NONE
Ending End Trtmt Type:	W-BEAM FLARED 350 COMPLIANT	Ending End Trtmt Crashworthy?:	YES		
Average Measurements					
Design Height (In.):	27	Width (In.):	0.0	Post Spacing (In.):	75.6
Height (In.):	28.2	Lateral Offset (In.):	87.6	Road Grade (%):	0.40
Physical Condition					
Barrier	Alignment and Height:	Alignment acceptable. Height was 1 to 2-in above the 27-in design height.

Breaking and Cracking:	No cracked or broken barrier elements.			
	Missing Elements:	No missing barrier elements.			
	Corrosion and Weathering:	Minimal corrosion/weathering of barrier elements.			
End Treatments	Alignment and Height:	Alignment acceptable. Height was 1 to 2-in above the 27-in design height.			
	Breaking and Cracking:	No cracked or broken end treatment elements.			
	Missing Elements:	No missing end treatment elements.			
	Corrosion and Weathering:	Minimal corrosion/weathering of end treatment elements.

Repair Action:	NO ACTION	FMSS Work Type:	N/A	Repair Cost:	\$0
Brief Workorder:	N/A				
Workorder:

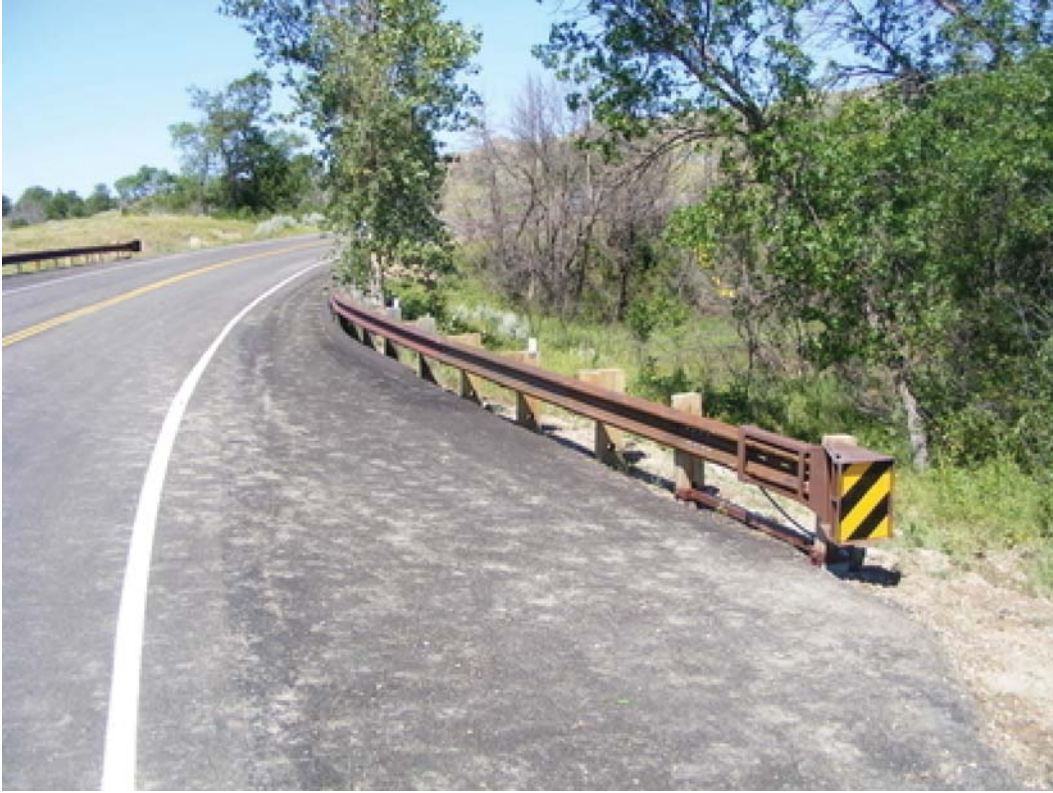
THRO_0010_3.313_R_1.JPG

Barrier ID:	THRO-0010-3.313-R				
Route Name:	SCENIC DRIVE				
Inspection Date:	10/08/2010	Barrier Rating:	12.10		
Barrier Description					
Type:	W-BEAM STRONG POST	Barrier Function:	TRAFFIC		
Barrier Material:	WEATHERING STEEL/CORTEN	Post Material:	WOOD		
Blockout Type:	WOOD	Length (ft.):	145		
Speed Limit (MPH):	25	Placement with Respect to Road:	INSIDE OF CURVE		
Hazard Behind Barrier:	MEDIUM				
Barrier Crashworthiness					
Appropriate Test Level:	TL-1	Barrier Test Level:	TL-3	Is Barrier Crashworthy?:	YES
Beg. End Trtmt Type:	W-BEAM FLARED 350 COMPLIANT	Is Beg. End Trtmt Crashworthy?:	YES	Approach Transition Type:	NONE
Ending End Trtmt Type:	W-BEAM TANGENT 350	Ending End Trtmt Crashworthy?:	YES		
Average Measurements					
Design Height (In.):	27	Width (In.):	0.0	Post Spacing (In.):	75.3
Height (In.):	26.2	Lateral Offset (In.):	75.0	Road Grade (%):	1.20
Physical Condition					
Barrier	Alignment and Height:	Alignment acceptable. Height within 1-in of 27-in design height.

Breaking and Cracking:	No cracked or broken barrier elements.			
	Missing Elements:	No missing barrier elements.			
	Corrosion and Weathering:	No major weathering of the barrier.			
End Treatments	Alignment and Height:	Alignment acceptable. Height within 1-in of 27-in design height.			
	Breaking and Cracking:	No major cracking or breaking of the end treatments.			
	Missing Elements:	No missing end treatment elements.			
	Corrosion and Weathering:	No major weathering of the end treatments.
