WICA GIP Report

NPS Guardwall/Rail Inventory Program Wind Cave National Park

**Federal Lands Highway
Road Inventory Program**

Data Collection Date: August 2010
Report Date: November 2015

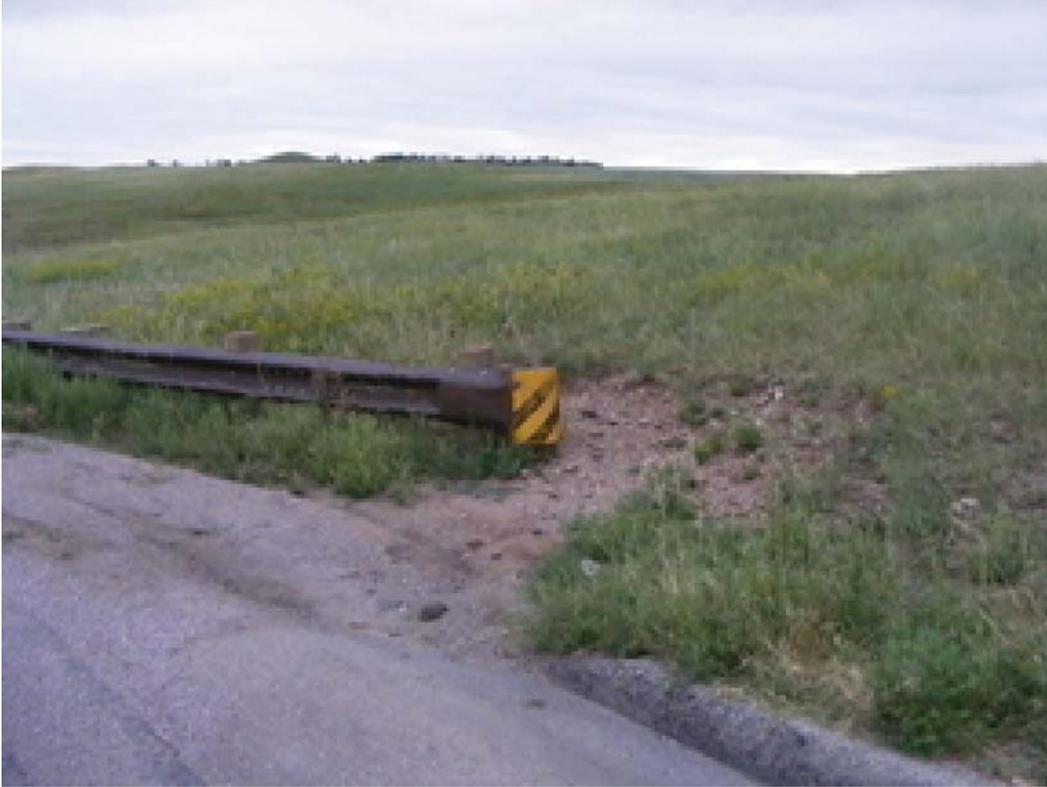
WICA_0010_3.544_R_1.JPG

Barrier ID:	WICA-0010-3.544-R				
Route Name:	WIND CAVE HIGHWAY (U.S. 385)				
Inspection Date:	08/14/2010	Barrier Rating:	43.90		
Barrier Description					
Type:	W-BEAM STRONG POST	Barrier Function:	TRAFFIC		
Barrier Material:	WEATHERING STEEL/CORTEN	Post Material:	WOOD		
Blockout Type:	WOOD	Length (ft.):	676		
Speed Limit (MPH):	45	Placement with Respect to Road:	OUTSIDE OF CURVE		
Hazard Behind Barrier:	MEDIUM				
Barrier Crashworthiness					
Appropriate Test Level:	TL-2	Barrier Test Level:	TL-3	Is Barrier Crashworthy?:	YES
Beg. End Trtmt Type:	W-BEAM FLARED 350 COMPLIANT	Is Beg. End Trtmt Crashworthy?:	YES	Approach Transition Type:	NONE
Ending End Trtmt Type:	W-BEAM FLARED 350 COMPLIANT	Ending End Trtmt Crashworthy?:	YES		
Average Measurements					
Design Height (In.):	27	Width (In.):	0.0	Post Spacing (In.):	74.5
Height (In.):	26.7	Lateral Offset (In.):	38.0	Road Grade (%):	3.90
Physical Condition

Barrier	Alignment and Height:	Alignment acceptable. 20-ft was between 1 and 3-in below the 27-in design height and 50-ft was more than 3-in below the design height.			
	Breaking and Cracking:	7 loose bolts. No cracked or broken barrier elements.			
	Missing Elements:	No missing barrier elements.			
	Corrosion and Weathering:	Minimal corrosion/weathering of barrier elements. No erosion around posts.			
End Treatments	Alignment and Height:	Alignment is acceptable. Height of trailing end treatment is within 1-in. of 27-in. design height. Height of approach end treatment is more than 3-in below 27-in. design height.			
	Breaking and Cracking:	No cracked or broken end treatment elements.			
	Missing Elements:	No missing end treatment elements.			
	Corrosion and Weathering:	Minimal corrosion/weathering of end treatment elements.

Repair Action:	REPAIR	FMSS Work Type:	DEFERRED MAINTENANCE	Repair Cost:	\$2459
Brief Workorder:	Raise 70 lf of guardrail to 27 inch design height and tighten loose bolts.				
Workorder:	Adjust Guardrail at \$10- per -Lin. Ft. for 70 LF = \$700. Raise 70 lf of guardrail to 27 inch design height. Labor at \$60- per -Hour for 1 Hrs = \$60. Tighten loose bolts. Low Speed Traffic Control at \$1475- per -Day for 1 Day(s) = \$1475.

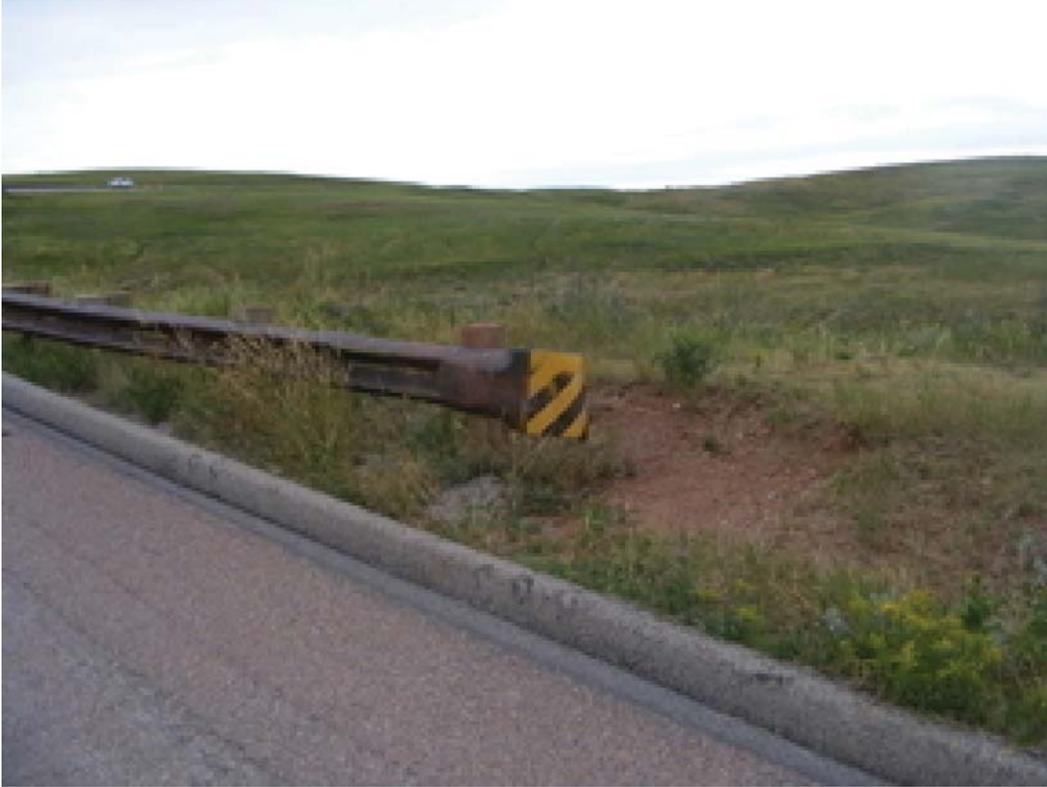
WICA_0010_3.574_L_1.JPG

Barrier ID:	WICA-0010-3.574-L				
Route Name:	WIND CAVE HIGHWAY (U.S. 385)				
Inspection Date:	08/14/2010	Barrier Rating:	26.60		
Barrier Description					
Type:	W-BEAM STRONG POST	Barrier Function:	TRAFFIC		
Barrier Material:	WEATHERING STEEL/CORTEN	Post Material:	WOOD		
Blockout Type:	WOOD	Length (ft.):	586		
Speed Limit (MPH):	45	Placement with Respect to Road:	INSIDE OF CURVE		
Hazard Behind Barrier:	MEDIUM				
Barrier Crashworthiness					
Appropriate Test Level:	TL-2	Barrier Test Level:	TL-3	Is Barrier Crashworthy?:	YES
Beg. End Trtmt Type:	W-BEAM FLARED 350 COMPLIANT	Is Beg. End Trtmt Crashworthy?:	YES	Approach Transition Type:	NONE
Ending End Trtmt Type:	W-BEAM FLARED 350 COMPLIANT	Ending End Trtmt Crashworthy?:	YES		
Average Measurements					
Design Height (In.):	27	Width (In.):	0.0	Post Spacing (In.):	74.5
Height (In.):	27.2	Lateral Offset (In.):	65.8	Road Grade (%):	3.90
Physical Condition

Barrier	Alignment and Height:	Alignment acceptable. Height within 1-in of 27-in design height.			
	Breaking and Cracking:	No cracked or broken barrier elements.			
	Missing Elements:	No missing barrier elements.			
	Corrosion and Weathering:	Minimal corrosion/weathering of barrier elements.			
End Treatments	Alignment and Height:	Alignment acceptable. Height within 1-in of 27-in design height.			
	Breaking and Cracking:	No cracked or broken end treatment elements.			
	Missing Elements:	No missing end treatment elements.			
	Corrosion and Weathering:	Minimal corrosion/weathering of end treatment elements.

Barrier ID:	WICA-0010-3.574-L				
Route Name:	WIND CAVE HIGHWAY (U.S. 385)				
Inspection Date:	08/14/2010		Barrier Rating:	26.60	
Repair Recommendations					
Repair Action:	NO ACTION	FMSS Work Type:	N/A	Repair Cost:	\$0
Brief Workorder:	N/A				
Workorder:

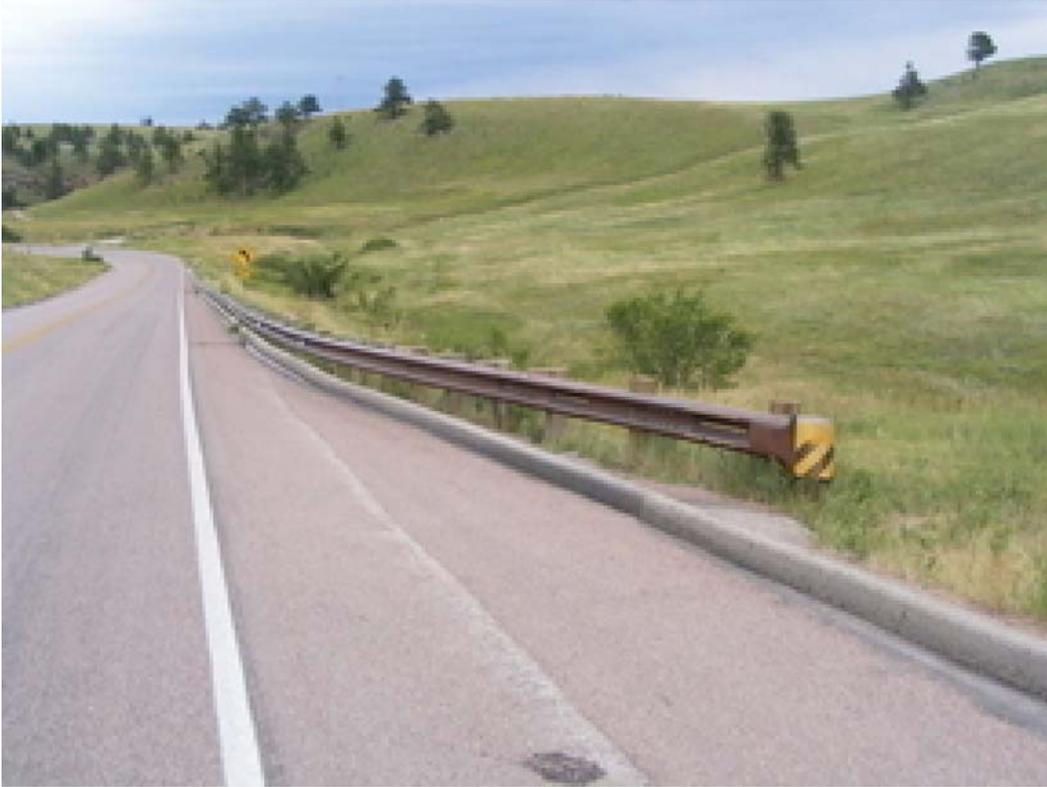
WICA_0010_3.825_R_1.JPG

Barrier ID:	WICA-0010-3.825-R				
Route Name:	WIND CAVE HIGHWAY (U.S. 385)				
Inspection Date:	08/14/2010	Barrier Rating:	34.00		
Barrier Description					
Type:	W-BEAM STRONG POST	Barrier Function:	TRAFFIC		
Barrier Material:	WEATHERING STEEL/CORTEN	Post Material:	WOOD		
Blockout Type:	WOOD	Length (ft.):	580		
Speed Limit (MPH):	45	Placement with Respect to Road:	TANGENT		
Hazard Behind Barrier:	HIGH				
Barrier Crashworthiness					
Appropriate Test Level:	TL-2	Barrier Test Level:	TL-3	Is Barrier Crashworthy?:	YES
Beg. End Trtmt Type:	W-BEAM FLARED 350 COMPLIANT	Is Beg. End Trtmt Crashworthy?:	YES	Approach Transition Type:	NONE
Ending End Trtmt Type:	W-BEAM FLARED 350 COMPLIANT	Ending End Trtmt Crashworthy?:	YES		
Average Measurements					
Design Height (In.):	27	Width (In.):	0.0	Post Spacing (In.):	74.5
Height (In.):	26.2	Lateral Offset (In.):	52.5	Road Grade (%):	6.90
Physical Condition					
Barrier	Alignment and Height:	Alignment acceptable. Height within 1-in of 27-in design height.

Breaking and Cracking:	No breaking with minor cracking of the barrier posts and blocks.			
	Missing Elements:	No missing barrier elements.			
	Corrosion and Weathering:	No major weathering or corrosion of the barrier.			
End Treatments	Alignment and Height:	Alignment acceptable. Height within 1-in of 27-in design height.			
	Breaking and Cracking:	No breaking with minor cracking of the end treatment posts and blocks.			
	Missing Elements:	No missing end treatment elements.			
	Corrosion and Weathering:	No major weathering of the end treatments.

Barrier ID:	WICA-0010-3.825-R				
Route Name:	WIND CAVE HIGHWAY (U.S. 385)				
Inspection Date:	08/14/2010	Barrier Rating:		34.00	
Repair Recommendations					
Repair Action:	NO ACTION	FMSS Work Type:	N/A	Repair Cost:	\$0
Brief Workorder:	N/A				
Workorder:

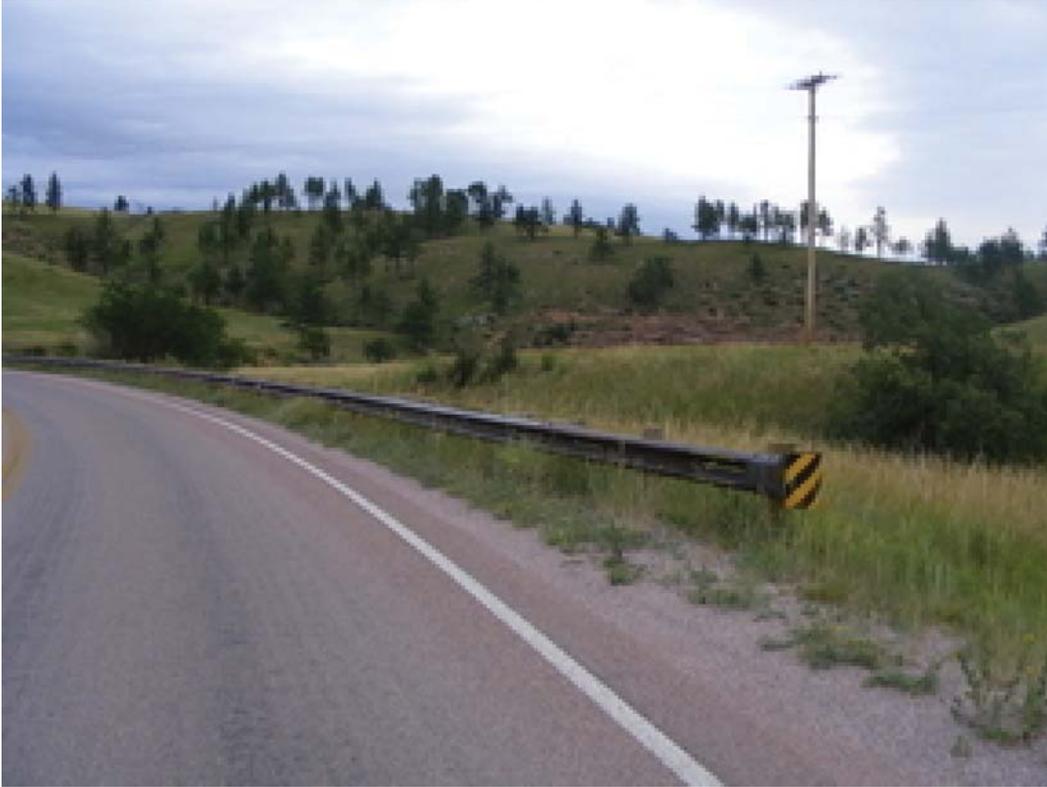
WICA_0010_4.020_R_1.JPG

Barrier ID:	WICA-0010-4.020-R				
Route Name:	WIND CAVE HIGHWAY (U.S. 385)				
Inspection Date:	08/14/2010	Barrier Rating:	39.50		
Barrier Description					
Type:	W-BEAM STRONG POST	Barrier Function:	TRAFFIC		
Barrier Material:	WEATHERING STEEL/CORTEN	Post Material:	WOOD		
Blockout Type:	WOOD	Length (ft.):	472		
Speed Limit (MPH):	45	Placement with Respect to Road:	OUTSIDE OF CURVE		
Hazard Behind Barrier:	MEDIUM				
Barrier Crashworthiness					
Appropriate Test Level:	TL-2	Barrier Test Level:	TL-3	Is Barrier Crashworthy?:	YES
Beg. End Trtmt Type:	W-BEAM FLARED 350 COMPLIANT	Is Beg. End Trtmt Crashworthy?:	YES	Approach Transition Type:	NONE
Ending End Trtmt Type:	W-BEAM FLARED 350 COMPLIANT	Ending End Trtmt Crashworthy?:	YES		
Average Measurements					
Design Height (In.):	27	Width (In.):	0.0	Post Spacing (In.):	75.0
Height (In.):	25.0	Lateral Offset (In.):	45.0	Road Grade (%):	1.60
Physical Condition

Barrier	Alignment and Height:	Alignment acceptable. Height within 1-in of 27-in design height.			
	Breaking and Cracking:	No breaking with minor cracking of the barrier posts and blocks.			
	Missing Elements:	No missing barrier elements.			
	Corrosion and Weathering:	No major weathering or corrosion of the barrier.			
End Treatments	Alignment and Height:	Alignment acceptable. Height within 1-in of 27-in design height.			
	Breaking and Cracking:	No breaking with minor cracking of the end treatment posts and blocks.			
	Missing Elements:	No missing end treatment elements.			
	Corrosion and Weathering:	No major weathering of the end treatment.

Barrier ID:	WICA-0010-4.020-R				
Route Name:	WIND CAVE HIGHWAY (U.S. 385)				
Inspection Date:	08/14/2010	Barrier Rating:		39.50	
Repair Recommendations					
Repair Action:	NO ACTION	FMSS Work Type:	N/A	Repair Cost:	\$0
Brief Workorder:	N/A				
Workorder:

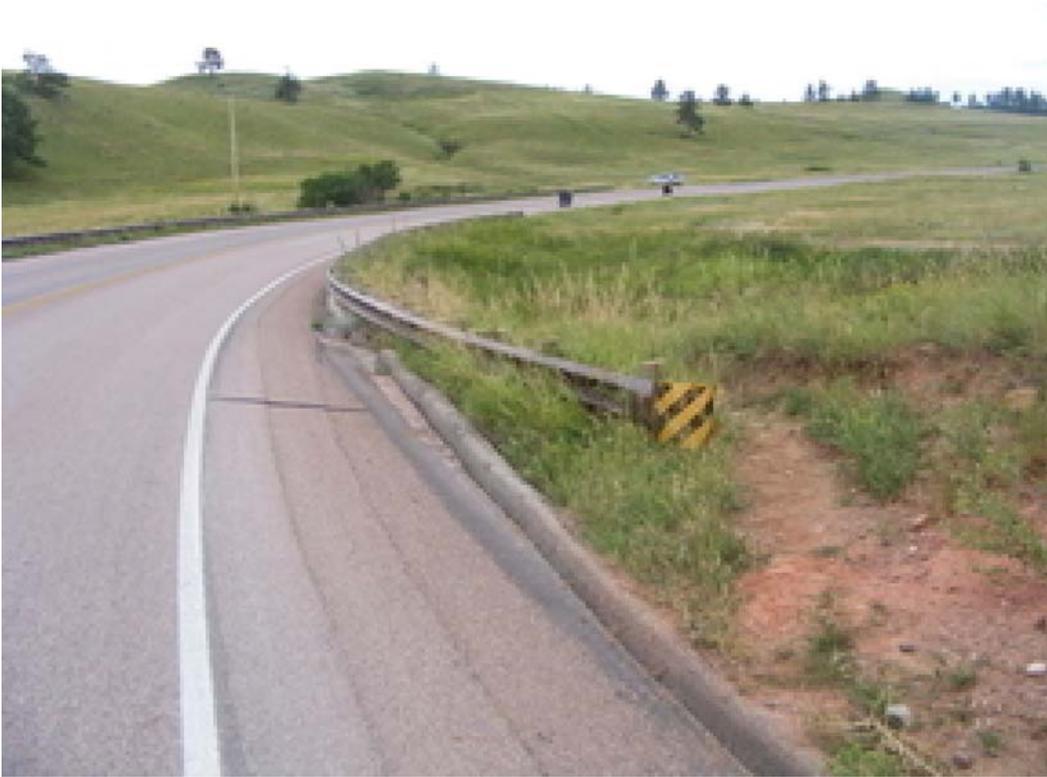
WICA_0010_4.058_L_1.JPG

Barrier ID:	WICA-0010-4.058-L				
Route Name:	WIND CAVE HIGHWAY (U.S. 385)				
Inspection Date:	08/14/2010	Barrier Rating:	26.60		
Barrier Description					
Type:	W-BEAM STRONG POST	Barrier Function:	TRAFFIC		
Barrier Material:	WEATHERING STEEL/CORTEN	Post Material:	WOOD		
Blockout Type:	WOOD	Length (ft.):	270		
Speed Limit (MPH):	45	Placement with Respect to Road:	INSIDE OF CURVE		
Hazard Behind Barrier:	MEDIUM				
Barrier Crashworthiness					
Appropriate Test Level:	TL-2	Barrier Test Level:	TL-3	Is Barrier Crashworthy?:	YES
Beg. End Trtmt Type:	W-BEAM FLARED 350 COMPLIANT	Is Beg. End Trtmt Crashworthy?:	YES	Approach Transition Type:	NONE
Ending End Trtmt Type:	W-BEAM FLARED 350 COMPLIANT	Ending End Trtmt Crashworthy?:	YES		
Average Measurements					
Design Height (In.):	27	Width (In.):	0.0	Post Spacing (In.):	74.5
Height (In.):	26.6	Lateral Offset (In.):	55.5	Road Grade (%):	2.10
Physical Condition

Barrier	Alignment and Height:	Alignment acceptable. Height within 1-in of 27-in design height.			
	Breaking and Cracking:	No breaking with minor cracking of the barrier posts and blocks.			
	Missing Elements:	No missing barrier elements.			
	Corrosion and Weathering:	No major weathering or corrosion of the barrier.			
End Treatments	Alignment and Height:	Alignment acceptable. Height within 1-in of 27-in design height.			
	Breaking and Cracking:	No breaking with minor cracking of the end treatment posts and blocks.			
	Missing Elements:	No missing end treatment elements.			
	Corrosion and Weathering:	Soil has eroded from the bank on to the beginning end treatment.

Repair Action:	REPAIR	FMSS Work Type:	DEFERRED MAINTENANCE	Repair Cost:	\$2437
Brief Workorder:	Remove the soil that has eroded onto the beginning end treatment to correct the approach height.				
Workorder:	<p>Loader at \$125- per -Hour for 4 Hrs = \$500. Remove the soil that has eroded onto the beginning end treatment.</p> <p>Labor at \$60- per -Hour for 4 Hrs = \$240. Remove the soil that has eroded onto the beginning end treatment.</p> <p>Low Speed Traffic Control at \$1475- per -Day for 1 Day(s) = \$1475.</p>

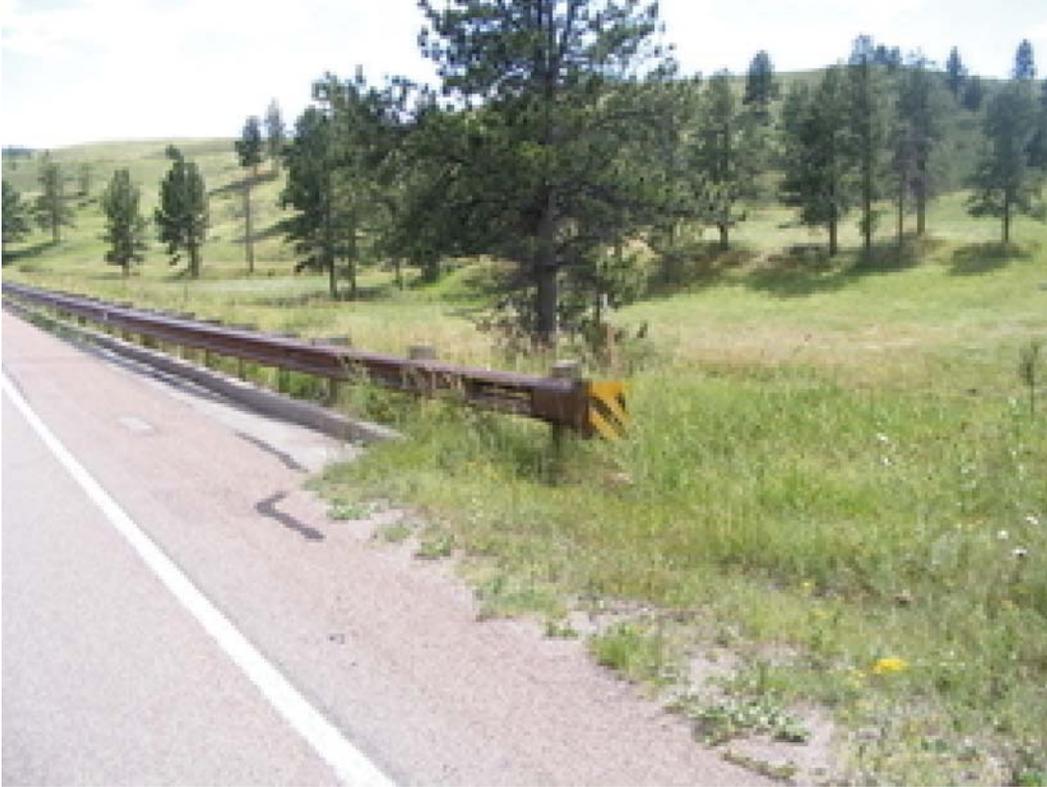
WICA_0010_4.335_L_1.JPG

Barrier ID:	WICA-0010-4.335-L				
Route Name:	WIND CAVE HIGHWAY (U.S. 385)				
Inspection Date:	08/13/2010	Barrier Rating:	31.20		
Barrier Description					
Type:	W-BEAM STRONG POST	Barrier Function:	TRAFFIC		
Barrier Material:	WEATHERING STEEL/CORTEN	Post Material:	WOOD		
Blockout Type:	WOOD	Length (ft.):	230		
Speed Limit (MPH):	45	Placement with Respect to Road:	TANGENT		
Hazard Behind Barrier:	HIGH				
Barrier Crashworthiness					
Appropriate Test Level:	TL-2	Barrier Test Level:	TL-3	Is Barrier Crashworthy?:	YES
Beg. End Trtmt Type:	W-BEAM FLARED 350 COMPLIANT	Is Beg. End Trtmt Crashworthy?:	YES	Approach Transition Type:	NONE
Ending End Trtmt Type:	W-BEAM FLARED 350 COMPLIANT	Ending End Trtmt Crashworthy?:	YES		
Average Measurements					
Design Height (In.):	27	Width (In.):	0.0	Post Spacing (In.):	75.3
Height (In.):	27.7	Lateral Offset (In.):	72.0	Road Grade (%):	6.70
Physical Condition					
Barrier	Alignment and Height:	Alignment acceptable. Height within 1-in of 27-in design height. No evidence of impact.

Breaking and Cracking:	No cracked or broken barrier elements.			
	Missing Elements:	No missing barrier elements.			
	Corrosion and Weathering:	Minimal corrosion/weathering of barrier elements. No erosion around posts.			
End Treatments	Alignment and Height:	Alignment acceptable. Height within 1-in of 27-in design height.			
	Breaking and Cracking:	No cracked or broken end treatment elements.			
	Missing Elements:	No missing end treatment elements.			
	Corrosion and Weathering:	Minimal corrosion/weathering of end treatment elements.

Repair Action:	NO ACTION	FMSS Work Type:	N/A	Repair Cost:	\$0
Brief Workorder:	N/A				
Workorder:

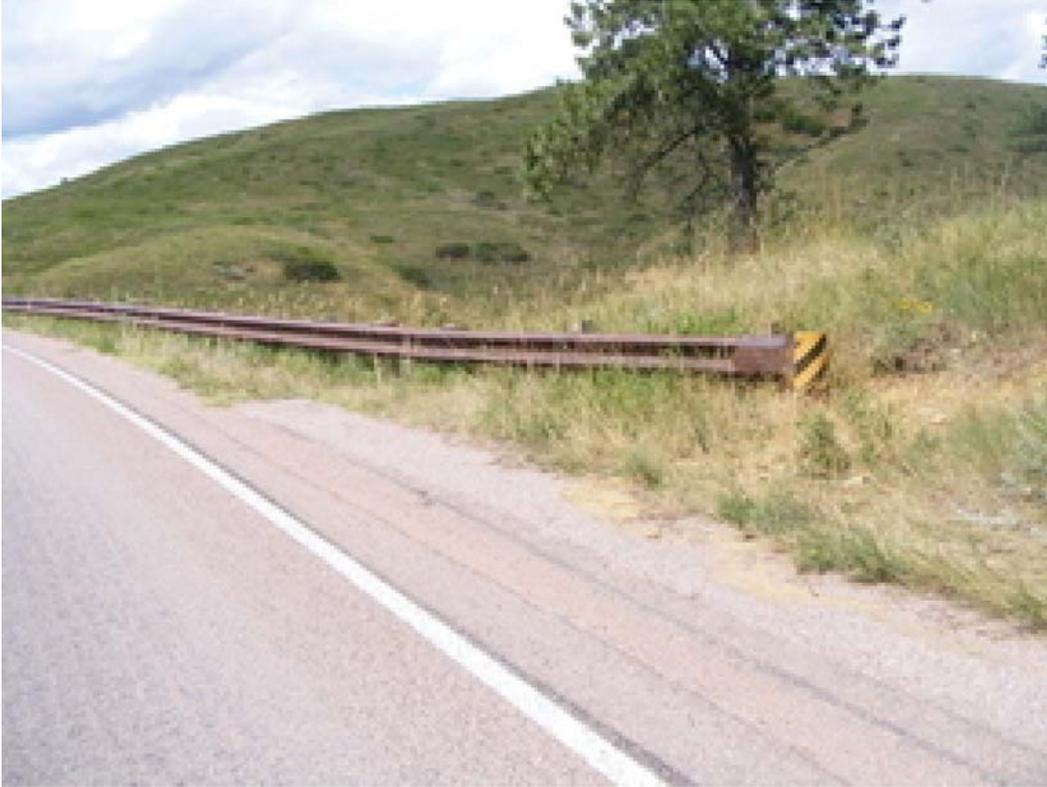
WICA_0010_4.412_R_1.JPG

Barrier ID:	WICA-0010-4.412-R				
Route Name:	WIND CAVE HIGHWAY (U.S. 385)				
Inspection Date:	08/13/2010	Barrier Rating:	38.20		
Barrier Description					
Type:	W-BEAM STRONG POST	Barrier Function:	TRAFFIC		
Barrier Material:	WEATHERING STEEL/CORTEN	Post Material:	WOOD		
Blockout Type:	WOOD	Length (ft.):	230		
Speed Limit (MPH):	45	Placement with Respect to Road:	OUTSIDE OF CURVE		
Hazard Behind Barrier:	MEDIUM				
Barrier Crashworthiness					
Appropriate Test Level:	TL-2	Barrier Test Level:	TL-3	Is Barrier Crashworthy?:	YES
Beg. End Trtmt Type:	W-BEAM FLARED 350 COMPLIANT	Is Beg. End Trtmt Crashworthy?:	YES	Approach Transition Type:	NONE
Ending End Trtmt Type:	W-BEAM FLARED 350 COMPLIANT	Ending End Trtmt Crashworthy?:	YES		
Average Measurements					
Design Height (In.):	27	Width (In.):	0.0	Post Spacing (In.):	75.0
Height (In.):	25.0	Lateral Offset (In.):	54.2	Road Grade (%):	3.70
Physical Condition

Barrier	Alignment and Height:	Alignment acceptable. The barrier height is low by 2 in from the design height of 27 in.			
	Breaking and Cracking:	No cracked or broken barrier elements.			
	Missing Elements:	No missing barrier elements.			
	Corrosion and Weathering:	No major weathering or corrosion of the barrier.			
End Treatments	Alignment and Height:	The end treatment alignment is acceptable. The height is low by 2 in from the design height of 27 in.			
	Breaking and Cracking:	No major breaking or cracking of the end treatments.			
	Missing Elements:	No missing end treatment elements.			
	Corrosion and Weathering:	No major weathering of the end treatments.

Repair Action:	REPAIR	FMSS Work Type:	DEFERRED MAINTENANCE	Repair Cost:	\$4153
Brief Workorder:	Raise entire barrier and end treatments up to 27 inch design height.				
Workorder:	Adjust Guardrail at \$10- per -Lin. Ft. for 230 LF = \$2300. Raise entire barrier and end treatments up to 27 inch design height. Low Speed Traffic Control at \$1475- per -Day for 1 Day(s) = \$1475.

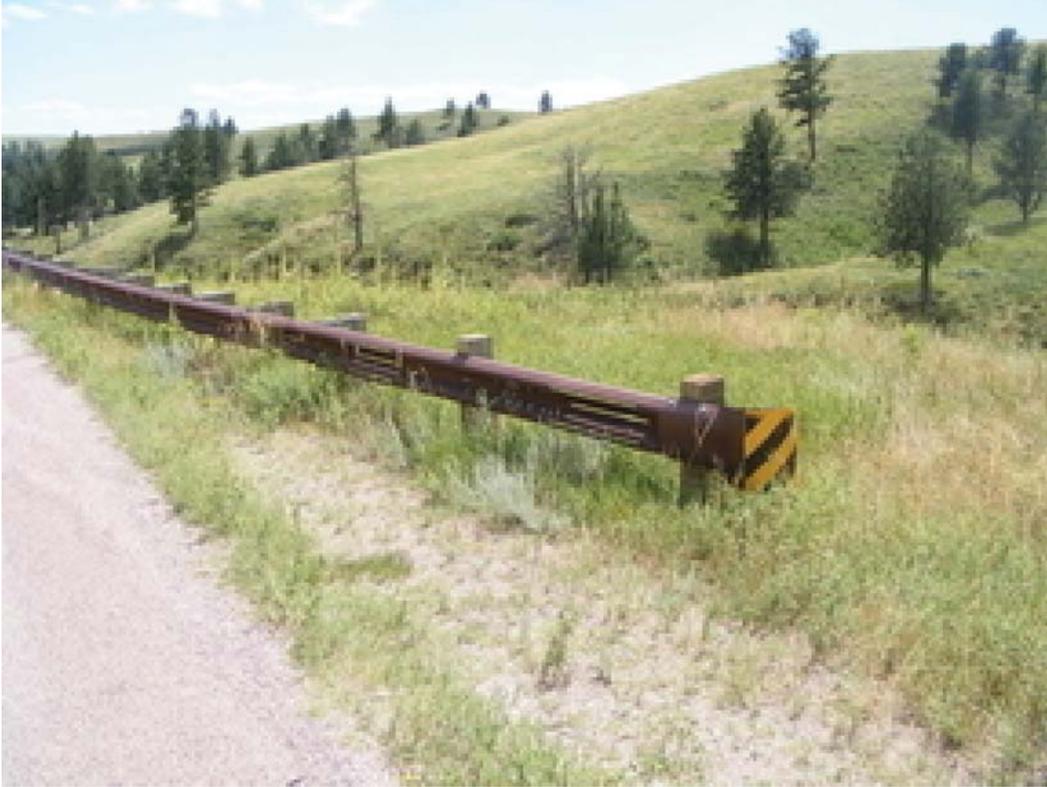
WICA_0010_4.423_L_1.JPG

Barrier ID:	WICA-0010-4.423-L				
Route Name:	WIND CAVE HIGHWAY (U.S. 385)				
Inspection Date:	08/13/2010	Barrier Rating:	36.50		
Barrier Description					
Type:	W-BEAM STRONG POST	Barrier Function:	TRAFFIC		
Barrier Material:	WEATHERING STEEL/CORTEN	Post Material:	WOOD		
Blockout Type:	WOOD	Length (ft.):	525		
Speed Limit (MPH):	45	Placement with Respect to Road:	BOTH INSIDE AND OUTSIDE		
Hazard Behind Barrier:	MEDIUM				
Barrier Crashworthiness					
Appropriate Test Level:	TL-2	Barrier Test Level:	TL-3	Is Barrier Crashworthy?:	YES
Beg. End Trtmt Type:	W-BEAM FLARED 350 COMPLIANT	Is Beg. End Trtmt Crashworthy?:	YES	Approach Transition Type:	NONE
Ending End Trtmt Type:	W-BEAM FLARED 350 COMPLIANT	Ending End Trtmt Crashworthy?:	YES		
Average Measurements					
Design Height (In.):	27	Width (In.):	0.0	Post Spacing (In.):	74.5
Height (In.):	26.2	Lateral Offset (In.):	67.3	Road Grade (%):	5.30
Physical Condition

Barrier	Alignment and Height:	Alignment acceptable. Height within 1-in of 27-in design height.			
	Breaking and Cracking:	No cracked or broken barrier elements.			
	Missing Elements:	No missing barrier elements.			
	Corrosion and Weathering:	No major weathering or corrosion of the barrier.			
End Treatments	Alignment and Height:	The end treatment alignment is acceptable. The height on both ends is low by 3 in from the design height of 27 ins.			
	Breaking and Cracking:	No major breaking or cracking of the end treatments.			
	Missing Elements:	No missing end treatment elements.			
	Corrosion and Weathering:	No major weathering of the end treatments.

Repair Action:	REPAIR	FMSS Work Type:	DEFERRED MAINTENANCE	Repair Cost:	\$2503
Brief Workorder:	Raise both end treatments to the design height of 27 inches.				
Workorder:	Adjust Guardrail at \$10- per -Lin. Ft. for 80 LF = \$800. Raise both end treatments to the design height of 27 inches. Low Speed Traffic Control at \$1475- per -Day for 1 Day(s) = \$1475.

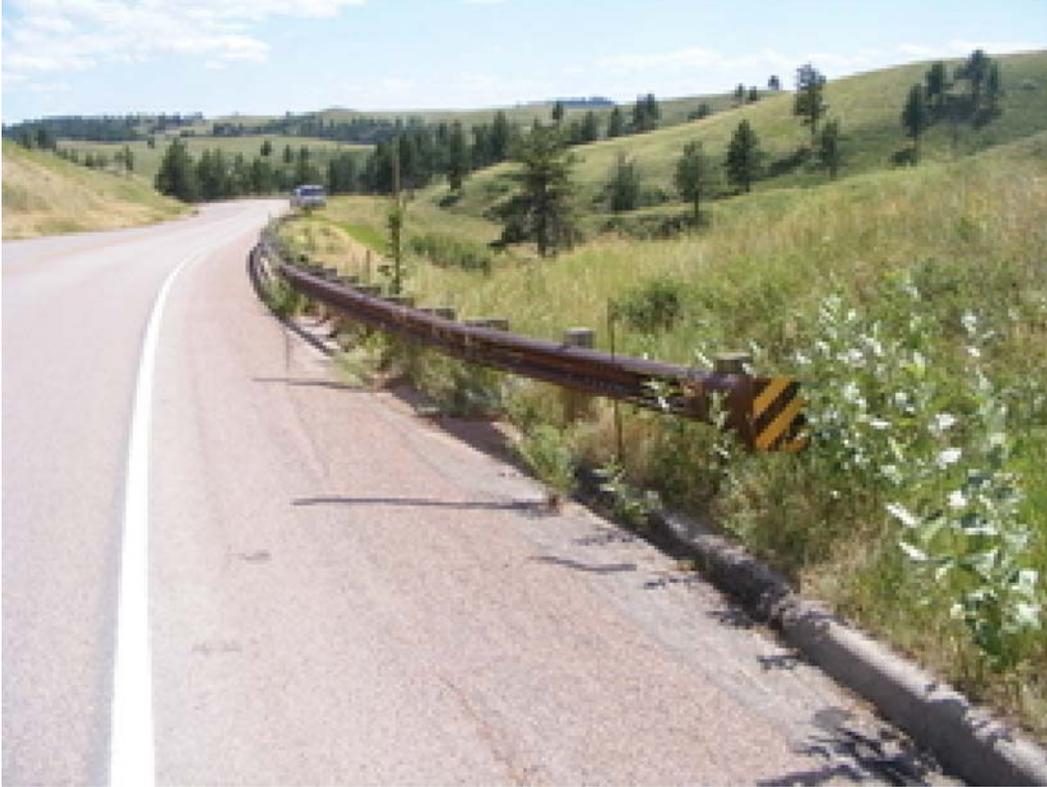
WICA_0010_4.537_L_1.JPG

Barrier ID:	WICA-0010-4.537-L				
Route Name:	WIND CAVE HIGHWAY (U.S. 385)				
Inspection Date:	08/13/2010	Barrier Rating:	29.70		
Barrier Description					
Type:	W-BEAM STRONG POST	Barrier Function:	TRAFFIC		
Barrier Material:	WEATHERING STEEL/CORTEN	Post Material:	WOOD		
Blockout Type:	WOOD	Length (ft.):	230		
Speed Limit (MPH):	45	Placement with Respect to Road:	INSIDE OF CURVE		
Hazard Behind Barrier:	HIGH				
Barrier Crashworthiness					
Appropriate Test Level:	TL-2	Barrier Test Level:	TL-3	Is Barrier Crashworthy?:	YES
Beg. End Trtmt Type:	W-BEAM FLARED 350 COMPLIANT	Is Beg. End Trtmt Crashworthy?:	YES	Approach Transition Type:	NONE
Ending End Trtmt Type:	W-BEAM FLARED 350 COMPLIANT	Ending End Trtmt Crashworthy?:	YES		
Average Measurements					
Design Height (In.):	27	Width (In.):	0.0	Post Spacing (In.):	75.3
Height (In.):	27.0	Lateral Offset (In.):	69.5	Road Grade (%):	5.70
Physical Condition					
Barrier	Alignment and Height:	Alignment acceptable. Height within 1-in of 27-in design height.

Breaking and Cracking:	No cracked or broken barrier elements.			
	Missing Elements:	No missing barrier elements.			
	Corrosion and Weathering:	No major weathering or corrosion of the barrier.			
End Treatments	Alignment and Height:	The end treatment alignment is acceptable. The ending end height is low by 3 in from the design height of 27 ins.			
	Breaking and Cracking:	No major breaking or cracking of the end treatments.			
	Missing Elements:	No missing end treatment elements.			
	Corrosion and Weathering:	No major weathering of the end treatments.

Repair Action:	REPAIR	FMSS Work Type:	DEFERRED MAINTENANCE	Repair Cost:	\$1953
Brief Workorder:	Raise ending end treatment to the design height of 27 inches.				
Workorder:	Adjust Guardrail at \$10- per -Lin. Ft. for 30 LF = \$300. Raise ending end treatment to the design height of 27 inches. Low Speed Traffic Control at \$1475- per -Day for 1 Day(s) = \$1475.

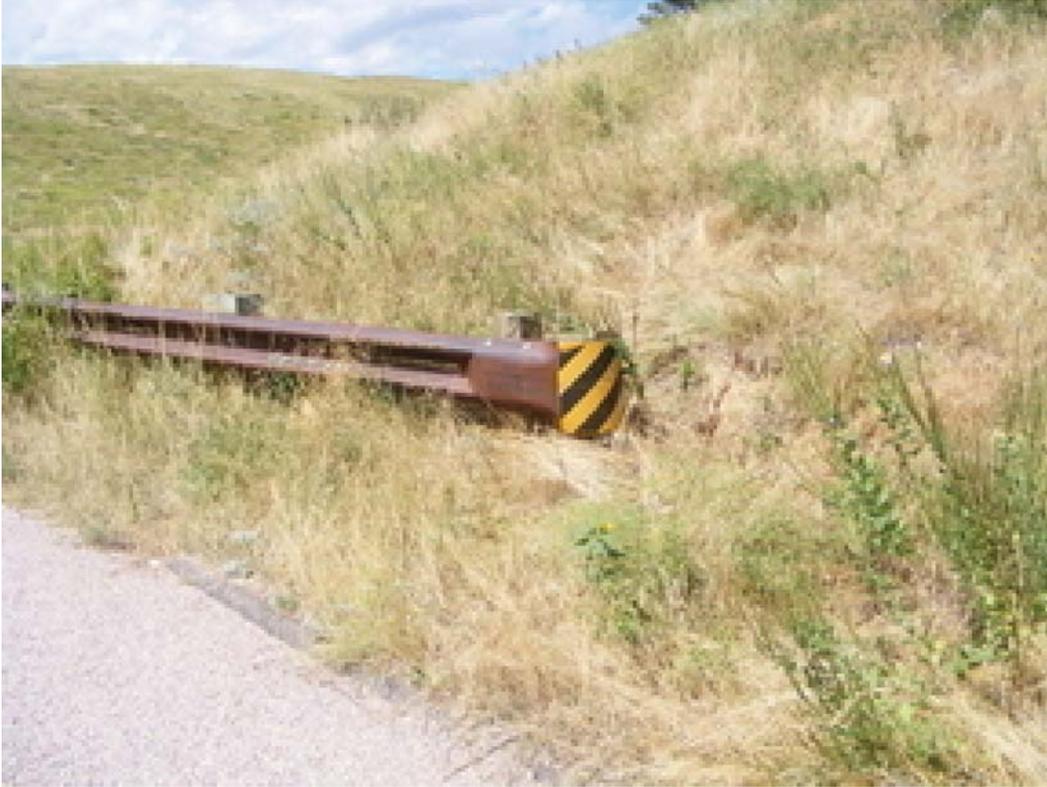
WICA_0010_4.655_R_1.JPG

Barrier ID:	WICA-0010-4.655-R				
Route Name:	WIND CAVE HIGHWAY (U.S. 385)				
Inspection Date:	08/13/2010	Barrier Rating:	34.00		
Barrier Description					
Type:	W-BEAM STRONG POST	Barrier Function:	TRAFFIC		
Barrier Material:	WEATHERING STEEL/CORTEN	Post Material:	WOOD		
Blockout Type:	WOOD	Length (ft.):	279		
Speed Limit (MPH):	45	Placement with Respect to Road:	OUTSIDE OF CURVE		
Hazard Behind Barrier:	HIGH				
Barrier Crashworthiness					
Appropriate Test Level:	TL-2	Barrier Test Level:	TL-3	Is Barrier Crashworthy?:	YES
Beg. End Trtmt Type:	W-BEAM FLARED 350 COMPLIANT	Is Beg. End Trtmt Crashworthy?:	YES	Approach Transition Type:	NONE
Ending End Trtmt Type:	W-BEAM FLARED 350 COMPLIANT	Ending End Trtmt Crashworthy?:	YES		
Average Measurements					
Design Height (In.):	27	Width (In.):	0.0	Post Spacing (In.):	75.0
Height (In.):	26.2	Lateral Offset (In.):	70.3	Road Grade (%):	6.00
Physical Condition					
Barrier	Alignment and Height:	Alignment acceptable. Height within 1-in of 27-in design height. No evidence of impact.

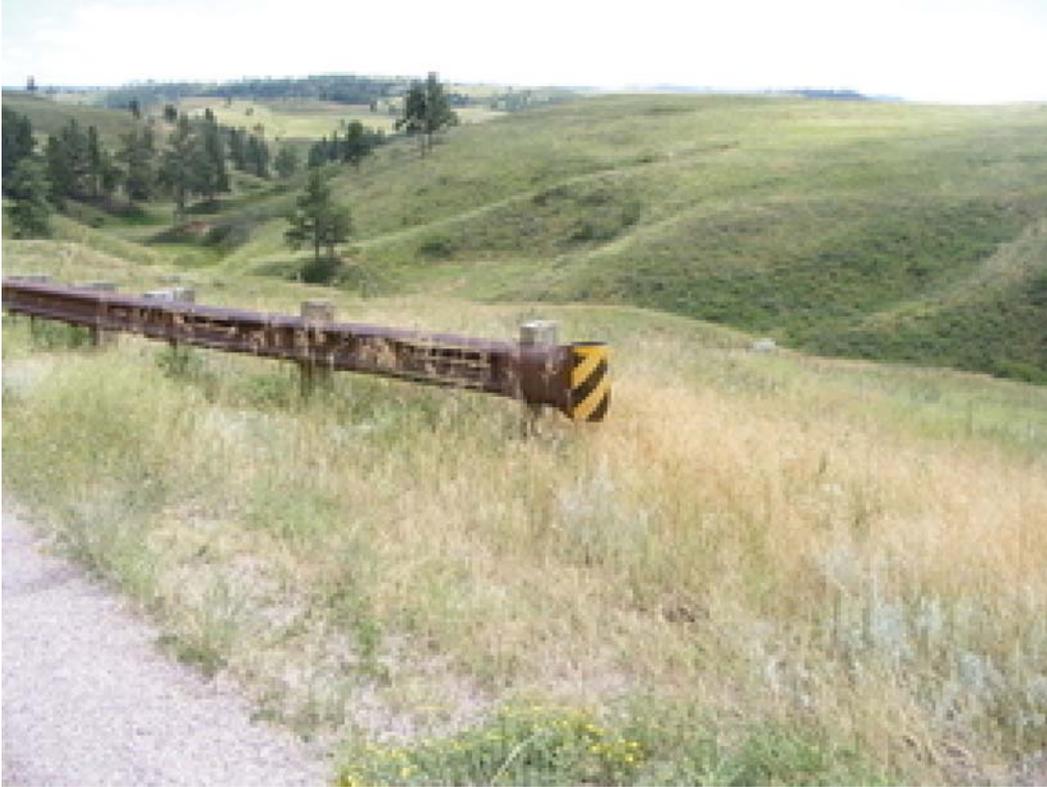
WICA_0010_4.669_L_1.JPG

Barrier ID:	WICA-0010-4.669-L				
Route Name:	WIND CAVE HIGHWAY (U.S. 385)				
Inspection Date:	08/13/2010	Barrier Rating:	37.00		
Barrier Description					
Type:	W-BEAM STRONG POST	Barrier Function:	TRAFFIC		
Barrier Material:	WEATHERING STEEL/CORTEN	Post Material:	WOOD		
Blockout Type:	WOOD	Length (ft.):	509		
Speed Limit (MPH):	45	Placement with Respect to Road:	INSIDE OF CURVE		
Hazard Behind Barrier:	HIGH				
Barrier Crashworthiness					
Appropriate Test Level:	TL-2	Barrier Test Level:	TL-3	Is Barrier Crashworthy?:	YES
Beg. End Trtmt Type:	W-BEAM FLARED 350 COMPLIANT	Is Beg. End Trtmt Crashworthy?:	YES	Approach Transition Type:	NONE
Ending End Trtmt Type:	W-BEAM FLARED 350 COMPLIANT	Ending End Trtmt Crashworthy?:	YES		
Average Measurements					
Design Height (In.):	27	Width (In.):	0.0	Post Spacing (In.):	74.6
Height (In.):	28.0	Lateral Offset (In.):	70.3	Road Grade (%):	6.90
Physical Condition					
Barrier	Alignment and Height:	Alignment acceptable. Height within 1-in of 27-in design height. No evidence of impact.

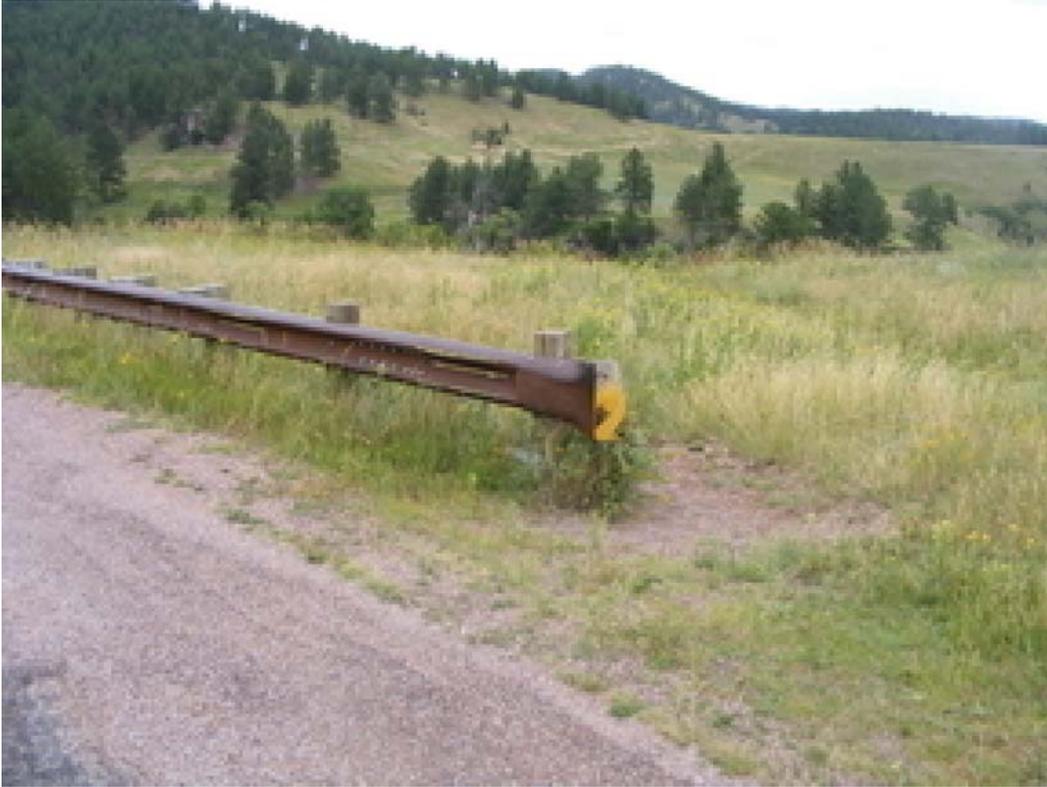
WICA_0010_5.966_R_1.JPG

Barrier ID:	WICA-0010-5.966-R				
Route Name:	WIND CAVE HIGHWAY (U.S. 385)				
Inspection Date:	08/14/2010	Barrier Rating:	34.00		
Barrier Description					
Type:	W-BEAM STRONG POST	Barrier Function:	TRAFFIC		
Barrier Material:	WEATHERING STEEL/CORTEN	Post Material:	WOOD		
Blockout Type:	WOOD	Length (ft.):	633		
Speed Limit (MPH):	45	Placement with Respect to Road:	OUTSIDE OF CURVE		
Hazard Behind Barrier:	HIGH				
Barrier Crashworthiness					
Appropriate Test Level:	TL-2	Barrier Test Level:	TL-3	Is Barrier Crashworthy?:	YES
Beg. End Trtmt Type:	W-BEAM FLARED 350 COMPLIANT	Is Beg. End Trtmt Crashworthy?:	YES	Approach Transition Type:	NONE
Ending End Trtmt Type:	W-BEAM FLARED 350 COMPLIANT	Ending End Trtmt Crashworthy?:	YES		
Average Measurements					
Design Height (In.):	27	Width (In.):	0.0	Post Spacing (In.):	74.3
Height (In.):	27.5	Lateral Offset (In.):	65.0	Road Grade (%):	2.00
Physical Condition					
Barrier	Alignment and Height:	Alignment acceptable. Height within 1-in of 27-in design height. Minor impact to one rail.

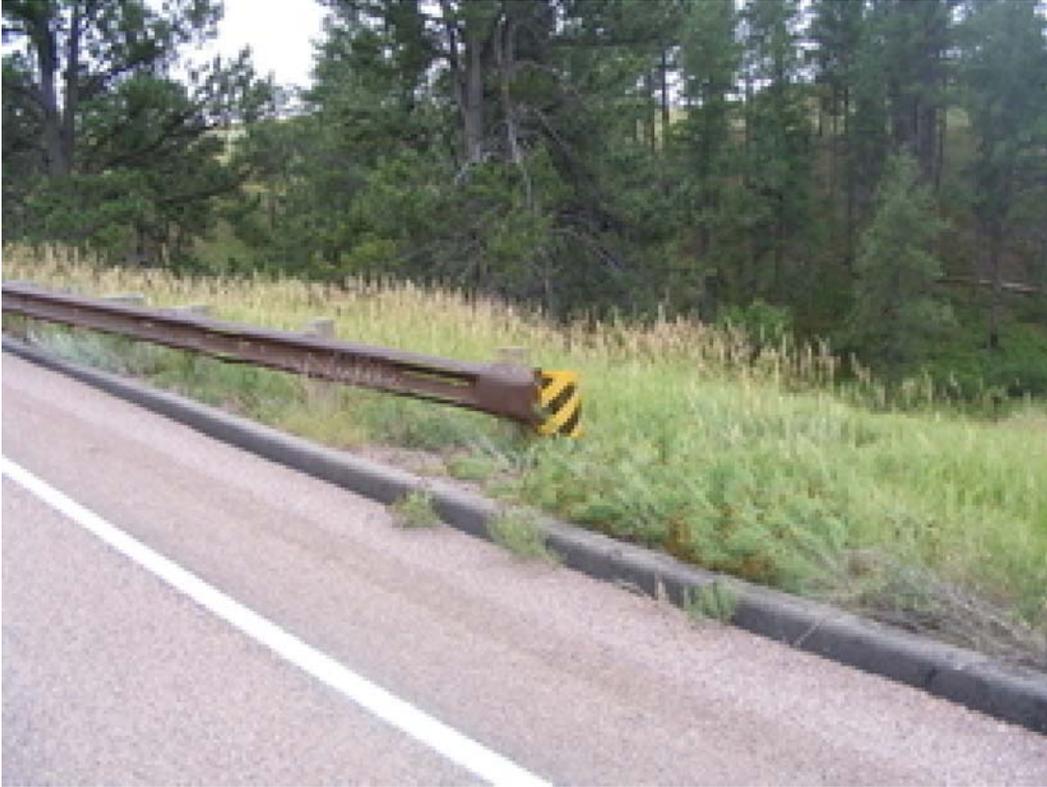
WICA_0010_6.016_L_1.JPG

Barrier ID:	WICA-0010-6.016-L				
Route Name:	WIND CAVE HIGHWAY (U.S. 385)				
Inspection Date:	08/14/2010	Barrier Rating:	28.30		
Barrier Description					
Type:	W-BEAM STRONG POST	Barrier Function:	TRAFFIC		
Barrier Material:	WEATHERING STEEL/CORTEN	Post Material:	WOOD		
Blockout Type:	WOOD	Length (ft.):	431		
Speed Limit (MPH):	45	Placement with Respect to Road:	INSIDE OF CURVE		
Hazard Behind Barrier:	HIGH				
Barrier Crashworthiness					
Appropriate Test Level:	TL-2	Barrier Test Level:	TL-3	Is Barrier Crashworthy?:	YES
Beg. End Trtmt Type:	W-BEAM FLARED 350 COMPLIANT	Is Beg. End Trtmt Crashworthy?:	YES	Approach Transition Type:	NONE
Ending End Trtmt Type:	W-BEAM FLARED 350 COMPLIANT	Ending End Trtmt Crashworthy?:	YES		
Average Measurements					
Design Height (In.):	27	Width (In.):	0.0	Post Spacing (In.):	75.6
Height (In.):	27.0	Lateral Offset (In.):	52.2	Road Grade (%):	1.50
Physical Condition					
Barrier	Alignment and Height:	Alignment acceptable. Height within 1-in of 27-in design height. No evidence of impact.

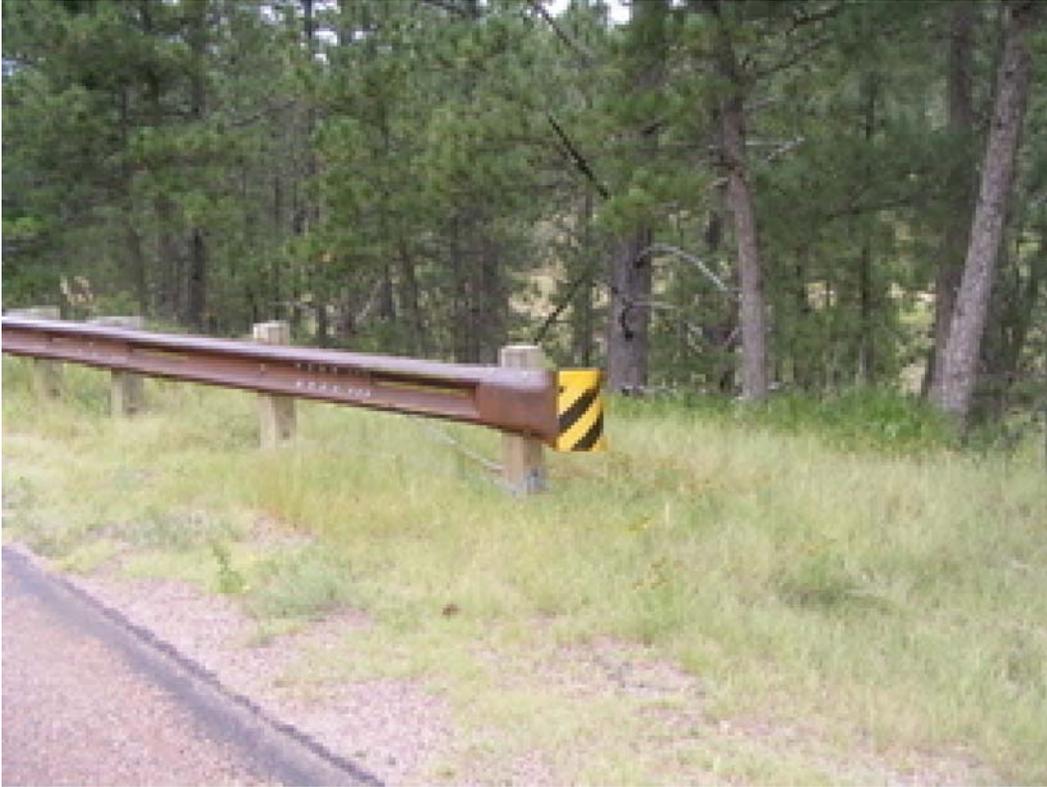
WICA_0010_6.222_R_1.JPG

Barrier ID:	WICA-0010-6.222-R				
Route Name:	WIND CAVE HIGHWAY (U.S. 385)				
Inspection Date:	08/14/2010	Barrier Rating:	31.20		
Barrier Description					
Type:	W-BEAM STRONG POST	Barrier Function:	TRAFFIC		
Barrier Material:	WEATHERING STEEL/CORTEN	Post Material:	WOOD		
Blockout Type:	WOOD	Length (ft.):	179		
Speed Limit (MPH):	45	Placement with Respect to Road:	OUTSIDE OF CURVE		
Hazard Behind Barrier:	HIGH				
Barrier Crashworthiness					
Appropriate Test Level:	TL-2	Barrier Test Level:	TL-3	Is Barrier Crashworthy?:	YES
Beg. End Trtmt Type:	W-BEAM FLARED 350 COMPLIANT	Is Beg. End Trtmt Crashworthy?:	YES	Approach Transition Type:	NONE
Ending End Trtmt Type:	W-BEAM FLARED 350 COMPLIANT	Ending End Trtmt Crashworthy?:	YES		
Average Measurements					
Design Height (In.):	27	Width (In.):	0.0	Post Spacing (In.):	74.6
Height (In.):	27.2	Lateral Offset (In.):	71.0	Road Grade (%):	0.50
Physical Condition					
Barrier	Alignment and Height:	Alignment acceptable. Entire barrier is between 1-in below to 2-in above the 27-in design height.

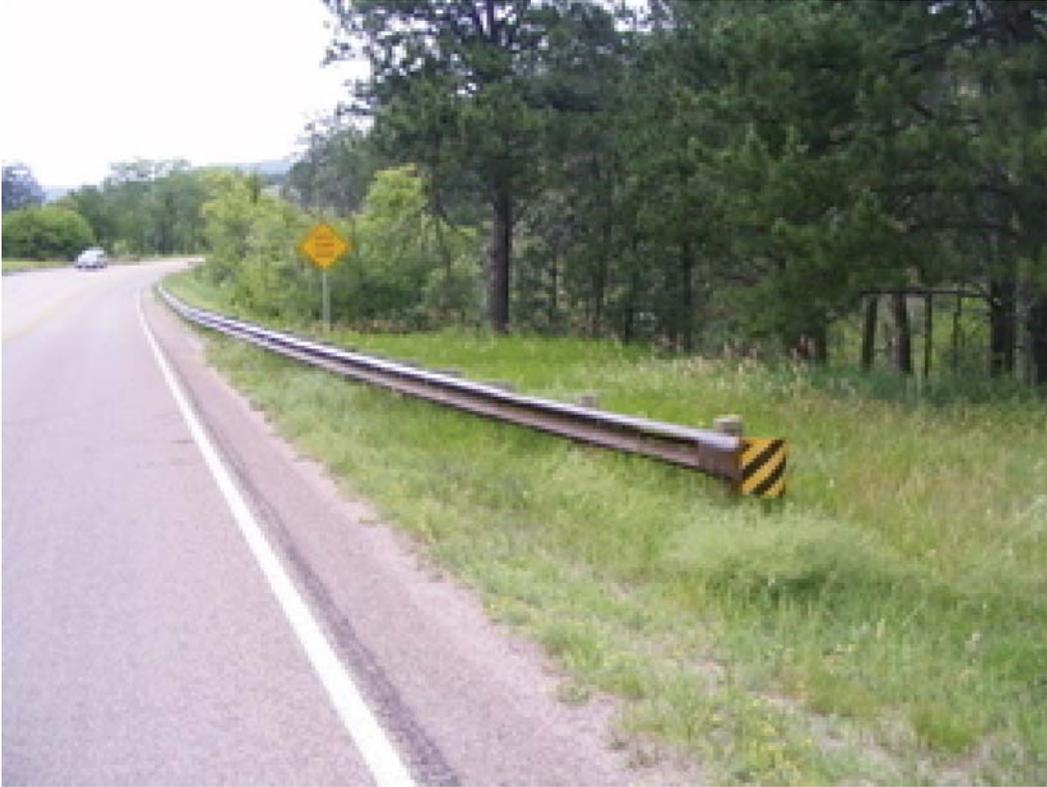
WICA_0010_6.367_R_1.JPG

Barrier ID:	WICA-0010-6.367-R				
Route Name:	WIND CAVE HIGHWAY (U.S. 385)				
Inspection Date:	08/14/2010	Barrier Rating:	28.30		
Barrier Description					
Type:	W-BEAM STRONG POST	Barrier Function:	TRAFFIC		
Barrier Material:	WEATHERING STEEL/CORTEN	Post Material:	WOOD		
Blockout Type:	WOOD	Length (ft.):	385		
Speed Limit (MPH):	45	Placement with Respect to Road:	INSIDE OF CURVE		
Hazard Behind Barrier:	HIGH				
Barrier Crashworthiness					
Appropriate Test Level:	TL-2	Barrier Test Level:	TL-3	Is Barrier Crashworthy?:	YES
Beg. End Trtmt Type:	W-BEAM FLARED 350 COMPLIANT	Is Beg. End Trtmt Crashworthy?:	YES	Approach Transition Type:	NONE
Ending End Trtmt Type:	W-BEAM FLARED 350 COMPLIANT	Ending End Trtmt Crashworthy?:	YES		
Average Measurements					
Design Height (In.):	27	Width (In.):	0.0	Post Spacing (In.):	74.3
Height (In.):	29.0	Lateral Offset (In.):	52.2	Road Grade (%):	1.30
Physical Condition					
Barrier	Alignment and Height:	Alignment acceptable. Height is 1-3in. above 27-in. design height.

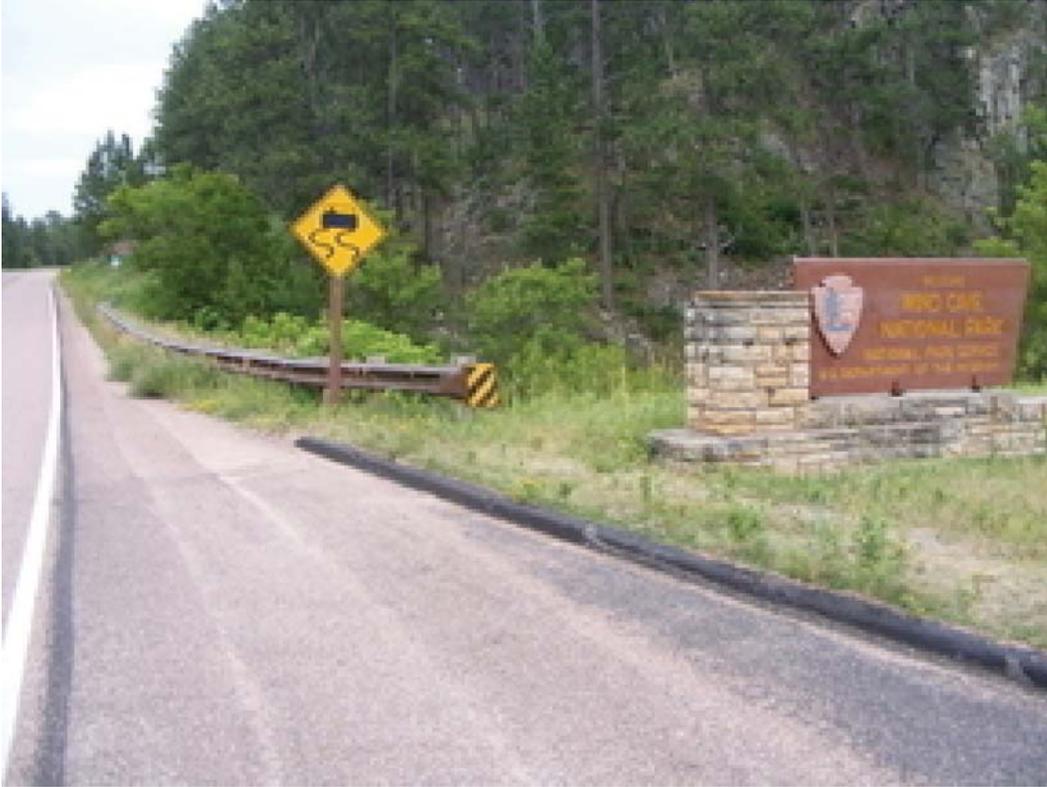
WICA_0010_6.383_L_1.JPG

Barrier ID:	WICA-0010-6.383-L				
Route Name:	WIND CAVE HIGHWAY (U.S. 385)				
Inspection Date:	08/14/2010	Barrier Rating:	22.60		
Barrier Description					
Type:	W-BEAM STRONG POST	Barrier Function:	TRAFFIC		
Barrier Material:	WEATHERING STEEL/CORTEN	Post Material:	WOOD		
Blockout Type:	WOOD	Length (ft.):	170		
Speed Limit (MPH):	45	Placement with Respect to Road:	TANGENT		
Hazard Behind Barrier:	HIGH				
Barrier Crashworthiness					
Appropriate Test Level:	TL-2	Barrier Test Level:	TL-3	Is Barrier Crashworthy?:	YES
Beg. End Trtmt Type:	W-BEAM FLARED 350 COMPLIANT	Is Beg. End Trtmt Crashworthy?:	YES	Approach Transition Type:	NONE
Ending End Trtmt Type:	W-BEAM FLARED 350 COMPLIANT	Ending End Trtmt Crashworthy?:	YES		
Average Measurements					
Design Height (In.):	27	Width (In.):	0.0	Post Spacing (In.):	75.0
Height (In.):	29.2	Lateral Offset (In.):	70.5	Road Grade (%):	0.60
Physical Condition					
Barrier	Alignment and Height:	Alignment acceptable. Height is 2-3in. above 27-in. design height.

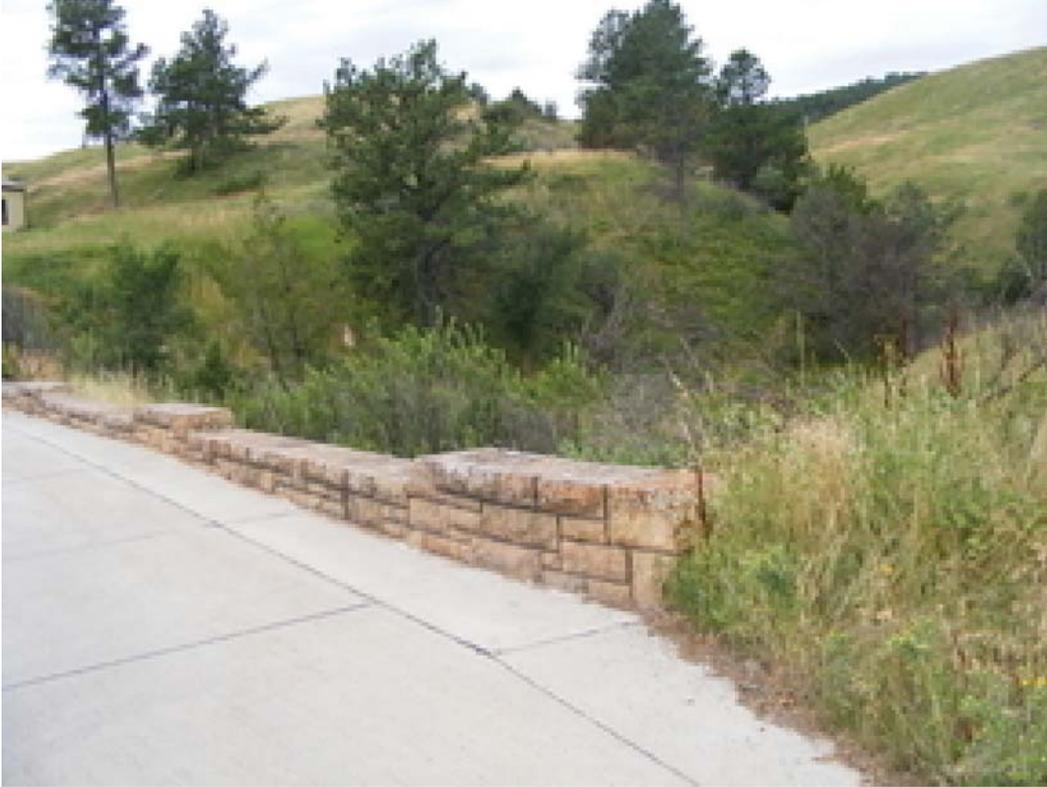
WICA_0011ZZ_0.003_R_1.JPG

Barrier ID:	WICA-0011ZZ-0.003-R				
Route Name:	VISITOR CENTER/CAVE ACCESS ROADS				
Inspection Date:	08/14/2010	Barrier Rating:	40.00		
Barrier Description					
Type:	STONE MASONRY CRENELLATED WITHOUT	Barrier Function:	TRAFFIC		
Barrier Material:	STONE	Post Material:	N/A		
Blockout Type:	N/A	Length (ft.):	111		
Speed Limit (MPH):	15	Placement with Respect to Road:	OUTSIDE OF CURVE		
Hazard Behind Barrier:	HIGH				
Barrier Crashworthiness					
Appropriate Test Level:	TL-1	Barrier Test Level:	NCW	Is Barrier Crashworthy?:	NO
Beg. End Trtmt Type:	NONE	Is Beg. End Trtmt Crashworthy?:	N/A	Approach Transition Type:	NONE
Ending End Trtmt Type:	NONE	Ending End Trtmt Crashworthy?:	N/A		
Average Measurements					
Design Height (In.):	18	Width (In.):	18.0	Post Spacing (In.):	0.0
Height (In.):	15.6	Lateral Offset (In.):	37.0	Road Grade (%):	0.80
Physical Condition					
Barrier	Alignment and Height:	Alignment of barrier is acceptable. 49ft. of barrier was 0-3in. below 18-in design height 14ft. was 3-6in. below and 48ft. was more than 6in. below design height.

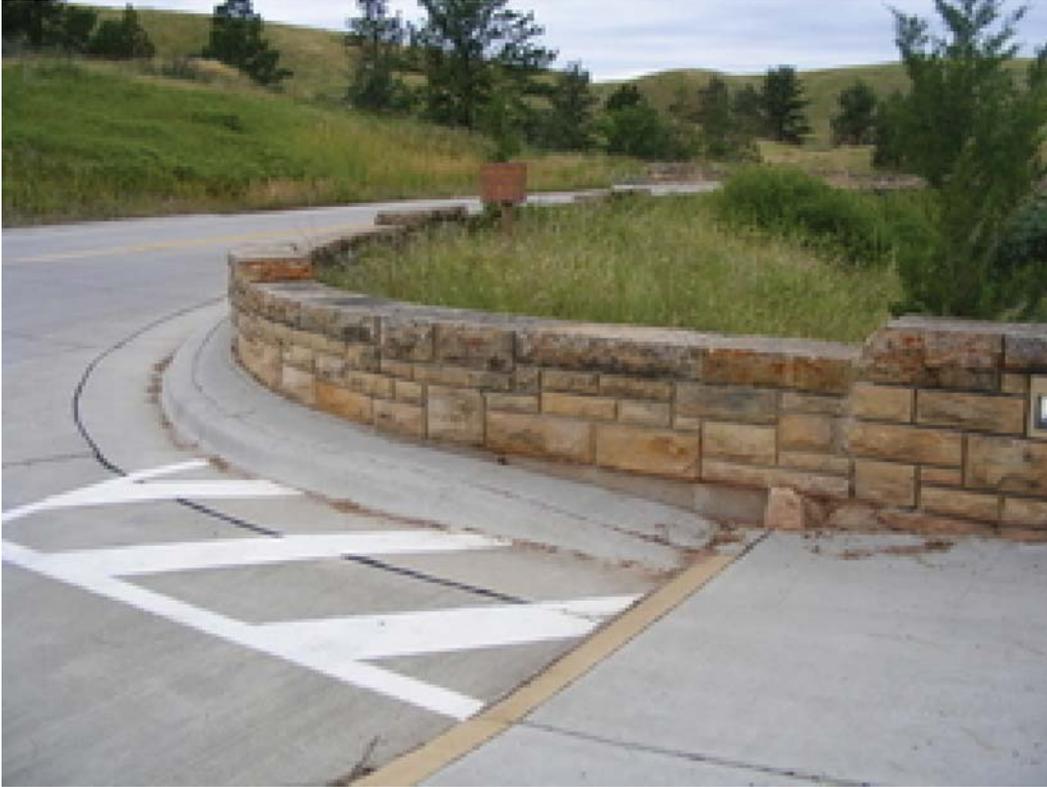
WICA_0011ZZ_0.017_L_1.JPG

Barrier ID:	WICA-0011ZZ-0.017-L				
Route Name:	VISITOR CENTER/CAVE ACCESS ROADS				
Inspection Date:	08/14/2010	Barrier Rating:	36.50		
Barrier Description					
Type:	STONE MASONRY CRENELLATED WITHOUT	Barrier Function:	TRAFFIC		
Barrier Material:	STONE	Post Material:	N/A		
Blockout Type:	N/A	Length (ft.):	318		
Speed Limit (MPH):	15	Placement with Respect to Road:	INSIDE OF CURVE		
Hazard Behind Barrier:	MEDIUM				
Barrier Crashworthiness					
Appropriate Test Level:	TL-1	Barrier Test Level:	NCW	Is Barrier Crashworthy?:	NO
Beg. End Trtmt Type:	NONE	Is Beg. End Trtmt Crashworthy?:	N/A	Approach Transition Type:	NONE
Ending End Trtmt Type:	NONE	Ending End Trtmt Crashworthy?:	N/A		
Average Measurements					
Design Height (In.):	18	Width (In.):	18.0	Post Spacing (In.):	0.0
Height (In.):	19.0	Lateral Offset (In.):	51.0	Road Grade (%):	1.10
Physical Condition					
Barrier	Alignment and Height:	Alignment acceptable. Height within 3-in of 18-in design height. No evidence of impact.
