**GIP Report**

**NPS Guardwall/Rail Inventory Program  
Yosemite National Park**

**Federal Lands Highway  
Road Inventory Program**

**Data Collection Date: October 2009  
Report Date: December 2015**

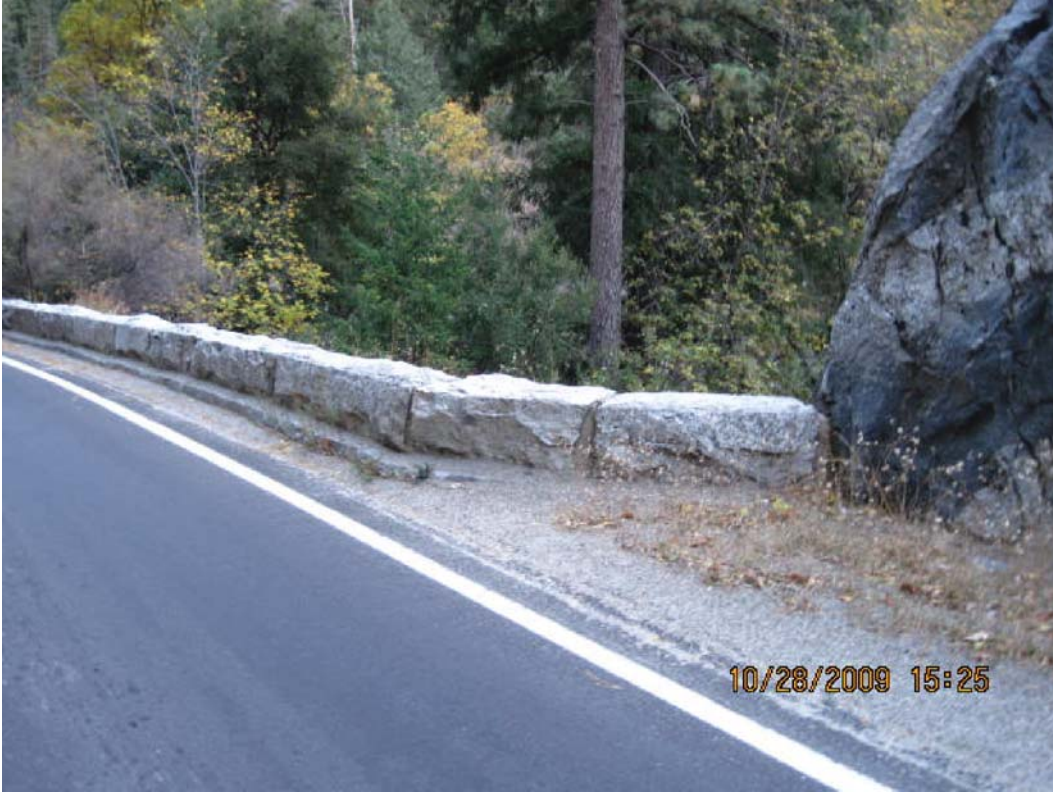
**YOSE\_0013\_0.058\_L\_1.jpg**

<b>Barrier ID:</b>	YOSE-0013-0.058-L				
<b>Route Name:</b>	BIG OAK FLAT ROAD				
<b>Inspection Date:</b>	10/28/2009	<b>Barrier Rating:</b>	40.70		
<b>Barrier Description</b>					
<b>Type:</b>	STONE MASONRY WITHOUT CONCRETE CORE WALL	<b>Barrier Function:</b>	TRAFFIC		
<b>Barrier Material:</b>	STONE	<b>Post Material:</b>	N/A		
<b>Blockout Type:</b>	N/A	<b>Length (ft.):</b>	166		
<b>Speed Limit (MPH):</b>	35	<b>Placement with Respect to Road:</b>	OUTSIDE OF CURVE		
<b>Hazard Behind Barrier:</b>	MEDIUM				
<b>Barrier Crashworthiness</b>					
<b>Appropriate Test Level:</b>	TL-2	<b>Barrier Test Level:</b>	NCW	<b>Is Barrier Crashworthy?:</b>	NO
<b>Beg. End Trtmt Type:</b>	OTHER: STONE FLARED	<b>Is Beg. End Trtmt Crashworthy?:</b>	NO	<b>Approach Transition Type:</b>	NONE
<b>Ending End Trtmt Type:</b>	NONE	<b>Ending End Trtmt Crashworthy?:</b>	N/A		
<b>Average Measurements</b>					
<b>Design Height (In.):</b>	24	<b>Width (In.):</b>	18.7	<b>Post Spacing (In.):</b>	0.0

<b>Height (In.):</b>	25.7	<b>Lateral Offset (In.):</b>	23.2	<b>Road Grade (%):</b>	5.10
<b>Physical Condition</b>					
<b>Barrier</b>	<b>Alignment and Height:</b>	Alignment is acceptable. The height of the wall exceeds the 24in design height.			
	<b>Breaking and Cracking:</b>	No breaking or cracking was observed.			
	<b>Missing Elements:</b>	No missing elements.			
	<b>Corrosion and Weathering:</b>	Some lichen growing on stone.			
<b>End Treatments</b>	<b>Alignment and Height:</b>				
	<b>Breaking and Cracking:</b>				
	<b>Missing Elements:</b>				
	<b>Corrosion and Weathering:</b>

<b>Barrier ID:</b>	YOSE-0013-0.058-L				
<b>Route Name:</b>	BIG OAK FLAT ROAD				
<b>Inspection Date:</b>	10/28/2009	<b>Barrier Rating:</b>		40.70	
<b>Repair Recommendations</b>					
<b>Repair Action:</b>	NO ACTION	<b>FMSS Work Type:</b>	N/A	<b>Repair Cost:</b>	\$0
<b>Brief Workorder:</b>	N/A				
<b>Workorder:</b>

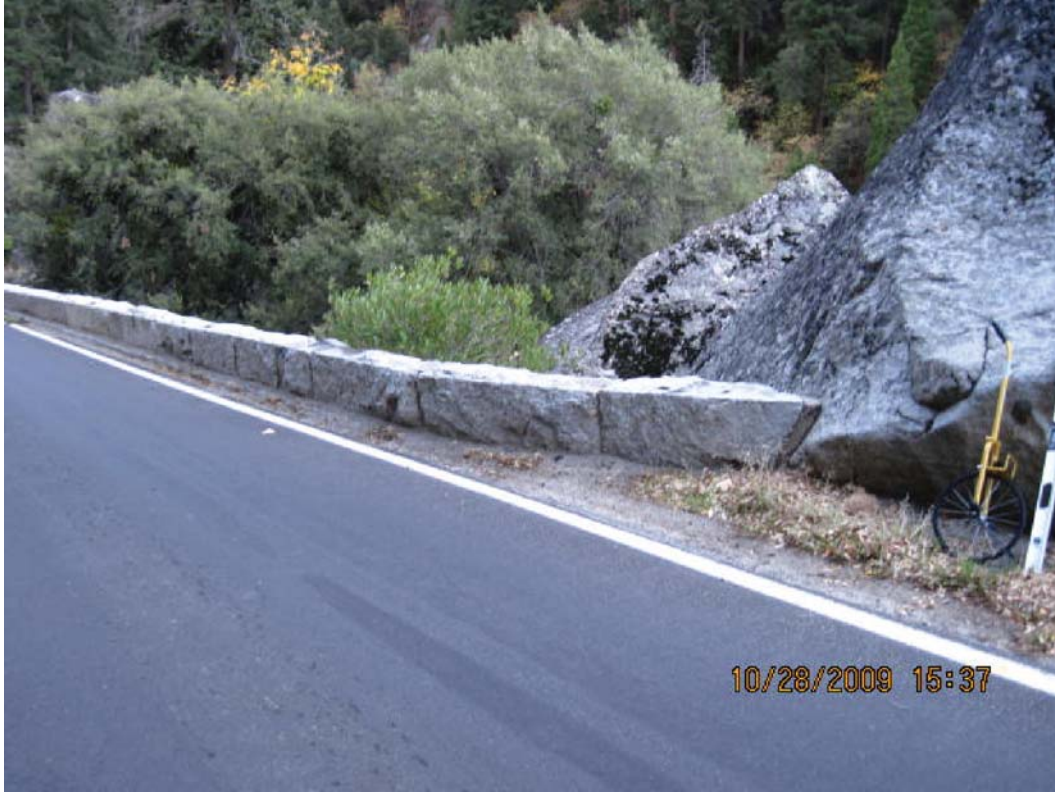
**YOSE\_0013\_0.107\_L\_1.jpg**

<b>Barrier ID:</b>	YOSE-0013-0.107-L				
<b>Route Name:</b>	BIG OAK FLAT ROAD				
<b>Inspection Date:</b>	10/28/2009	<b>Barrier Rating:</b>	32.20		
<b>Barrier Description</b>					
<b>Type:</b>	STONE MASONRY WITHOUT CONCRETE CORE WALL	<b>Barrier Function:</b>	TRAFFIC		
<b>Barrier Material:</b>	STONE	<b>Post Material:</b>	N/A		
<b>Blockout Type:</b>	N/A	<b>Length (ft.):</b>	161		
<b>Speed Limit (MPH):</b>	35	<b>Placement with Respect to Road:</b>	TANGENT		
<b>Hazard Behind Barrier:</b>	MEDIUM				
<b>Barrier Crashworthiness</b>					
<b>Appropriate Test Level:</b>	TL-2	<b>Barrier Test Level:</b>	NCW	<b>Is Barrier Crashworthy?:</b>	NO
<b>Beg. End Trtmt Type:</b>	OTHER: STONE FLARED	<b>Is Beg. End Trtmt Crashworthy?:</b>	NO	<b>Approach Transition Type:</b>	NONE
<b>Ending End Trtmt Type:</b>	OTHER: STONE FLARED	<b>Ending End Trtmt Crashworthy?:</b>	NO		
<b>Average Measurements</b>					
<b>Design Height (In.):</b>	24	<b>Width (In.):</b>	18.0	<b>Post Spacing (In.):</b>	0.0

<b>Height (In.):</b>	23.2	<b>Lateral Offset (In.):</b>	15.6	<b>Road Grade (%):</b>	6.00
<b>Physical Condition</b>					
<b>Barrier</b>	<b>Alignment and Height:</b>	Alignment has no deflection. Height is above 21 in the entire length so barrier is within 3-in of 24-in. design height.			
	<b>Breaking and Cracking:</b>	No breaking or cracking was observed.			
	<b>Missing Elements:</b>	No missing elements.			
	<b>Corrosion and Weathering:</b>	No corrosion or weathering.			
<b>End Treatments</b>	<b>Alignment and Height:</b>				
	<b>Breaking and Cracking:</b>				
	<b>Missing Elements:</b>				
	<b>Corrosion and Weathering:</b>

<b>Barrier ID:</b>	YOSE-0013-0.107-L				
<b>Route Name:</b>	BIG OAK FLAT ROAD				
<b>Inspection Date:</b>	10/28/2009	<b>Barrier Rating:</b>		32.20	
<b>Repair Recommendations</b>					
<b>Repair Action:</b>	NO ACTION	<b>FMSS Work Type:</b>	N/A	<b>Repair Cost:</b>	\$0
<b>Brief Workorder:</b>	N/A				
<b>Workorder:</b>
