GIP Report

NPS Guardwall/Rail Inventory Program Zion National Park

**Federal Lands Highway
Road Inventory Program**

**Data Collection Date: April 2010
Report Date: November 2015**

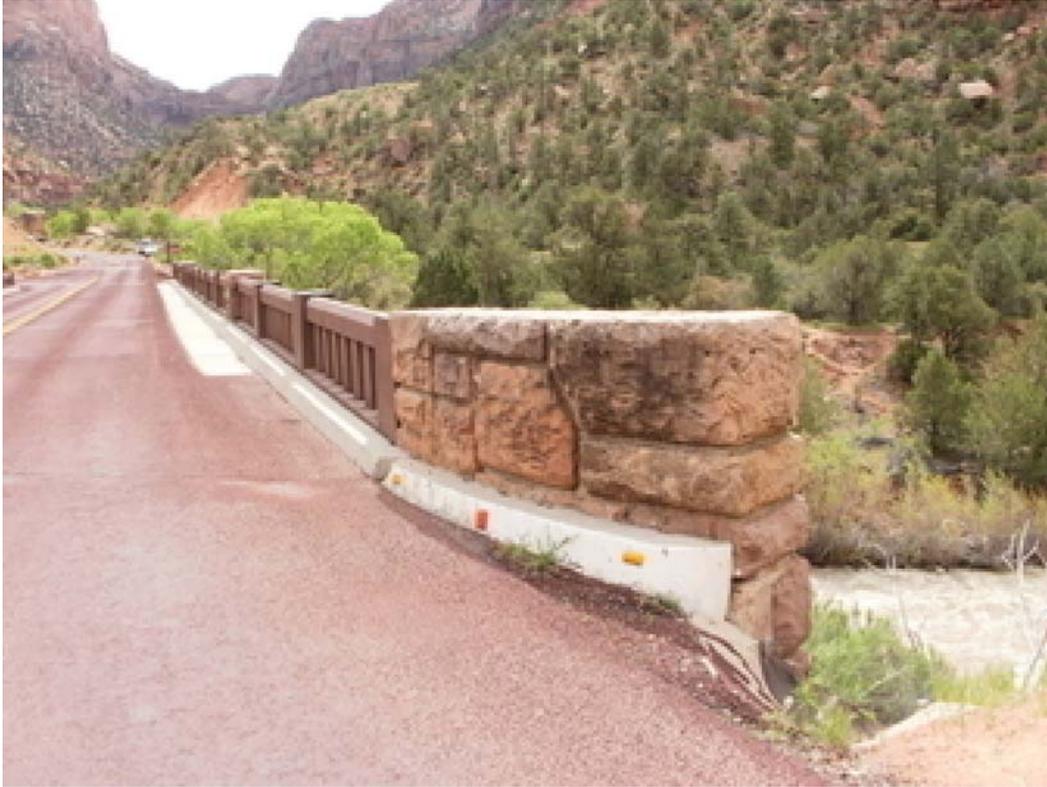
ZION_0010_1.476_R_1.JPG

Barrier ID:	ZION-0010-1.476-R				
Route Name:	ZION-MT CARMEL HIGHWAY				
Inspection Date:	04/29/2010	Barrier Rating:	25.10		
Barrier Description					
Type:	STONE MASONRY WITHOUT CONCRETE CORE WALL	Barrier Function:	TRAFFIC		
Barrier Material:	STONE	Post Material:	N/A		
Blockout Type:	N/A	Length (ft.):	10		
Speed Limit (MPH):	35	Placement with Respect to Road:	INSIDE OF CURVE		
Hazard Behind Barrier:	MEDIUM				
Barrier Crashworthiness					
Appropriate Test Level:	TL-2	Barrier Test Level:	NCW	Is Barrier Crashworthy?:	NO
Beg. End Trtmt Type:	NONE	Is Beg. End Trtmt Crashworthy?:	N/A	Approach Transition Type:	NONE
Ending End Trtmt Type:	NONE	Ending End Trtmt Crashworthy?:	N/A		
Average Measurements					
Design Height (In.):	24	Width (In.):	27.0	Post Spacing (In.):	0.0
Height (In.):	42.0	Lateral Offset (In.):	57.5	Road Grade (%):	0.40
Physical Condition					
Barrier	Alignment and Height:	The alignment of abutment was correct. Height of abutment was 41 to 47 in.

Breaking and Cracking:	No breaking or cracking of abutment.			
	Missing Elements:	No missing elements in abutment.			
	Corrosion and Weathering:	No major weathering on abutment.			
End Treatments	Alignment and Height:	N/A			
	Breaking and Cracking:	N/A			
	Missing Elements:	N/A			
	Corrosion and Weathering:	N/A

Barrier ID:	ZION-0010-1.476-R				
Route Name:	ZION-MT CARMEL HIGHWAY				
Inspection Date:	04/29/2010	Barrier Rating:		25.10	
Repair Recommendations					
Repair Action:	NO ACTION	FMSS Work Type:	N/A	Repair Cost:	\$0
Brief Workorder:	N/A				
Workorder:

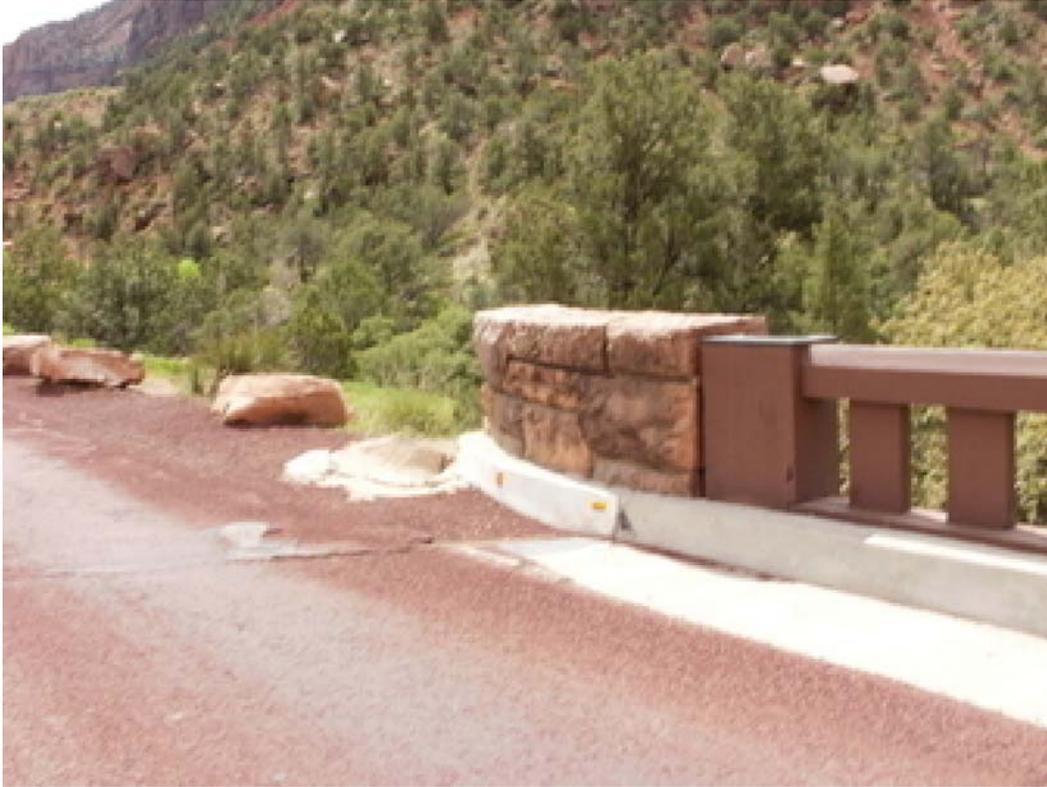
ZION_0010_1.513_R_1.JPG

Barrier ID:	ZION-0010-1.513-R				
Route Name:	ZION-MT CARMEL HIGHWAY				
Inspection Date:	04/29/2010	Barrier Rating:	24.00		
Barrier Description					
Type:	STONE MASONRY WITHOUT CONCRETE CORE WALL	Barrier Function:	TRAFFIC		
Barrier Material:	STONE	Post Material:	N/A		
Blockout Type:	N/A	Length (ft.):	11		
Speed Limit (MPH):	35	Placement with Respect to Road:	TANGENT		
Hazard Behind Barrier:	HIGH				
Barrier Crashworthiness					
Appropriate Test Level:	TL-2	Barrier Test Level:	NCW	Is Barrier Crashworthy?:	NO
Beg. End Trtmt Type:	NONE	Is Beg. End Trtmt Crashworthy?:	N/A	Approach Transition Type:	NONE
Ending End Trtmt Type:	NONE	Ending End Trtmt Crashworthy?:	N/A		
Average Measurements					
Design Height (In.):	24	Width (In.):	26.0	Post Spacing (In.):	0.0
Height (In.):	42.0	Lateral Offset (In.):	50.2	Road Grade (%):	1.20
Physical Condition					
Barrier	Alignment and Height:	Barrier was in alignment and was greater than the 24-in design height by 21 in. Appeared to be bridge abutment.

Breaking and Cracking:	No breaking or cracking in barrier.			
	Missing Elements:	No missing elements in barrier.			
	Corrosion and Weathering:	No weathering observed in barrier.			
End Treatments	Alignment and Height:	N/A			
	Breaking and Cracking:	N/A			
	Missing Elements:	N/A			
	Corrosion and Weathering:	N/A

Barrier ID:	ZION-0010-1.513-R				
Route Name:	ZION-MT CARMEL HIGHWAY				
Inspection Date:	04/29/2010	Barrier Rating:		24.00	
Repair Recommendations					
Repair Action:	NO ACTION	FMSS Work Type:	N/A	Repair Cost:	\$0
Brief Workorder:	N/A				
Workorder:
