**The Road Inventory
of
Santa Monica Mountains National
Recreation Area
SAMO - 8540**

Road Inventory Program

Prepared By:
Federal Highway Administration
Eastern Federal Lands Highway Division
Cycle 3

Santa Monica Mountains National in California

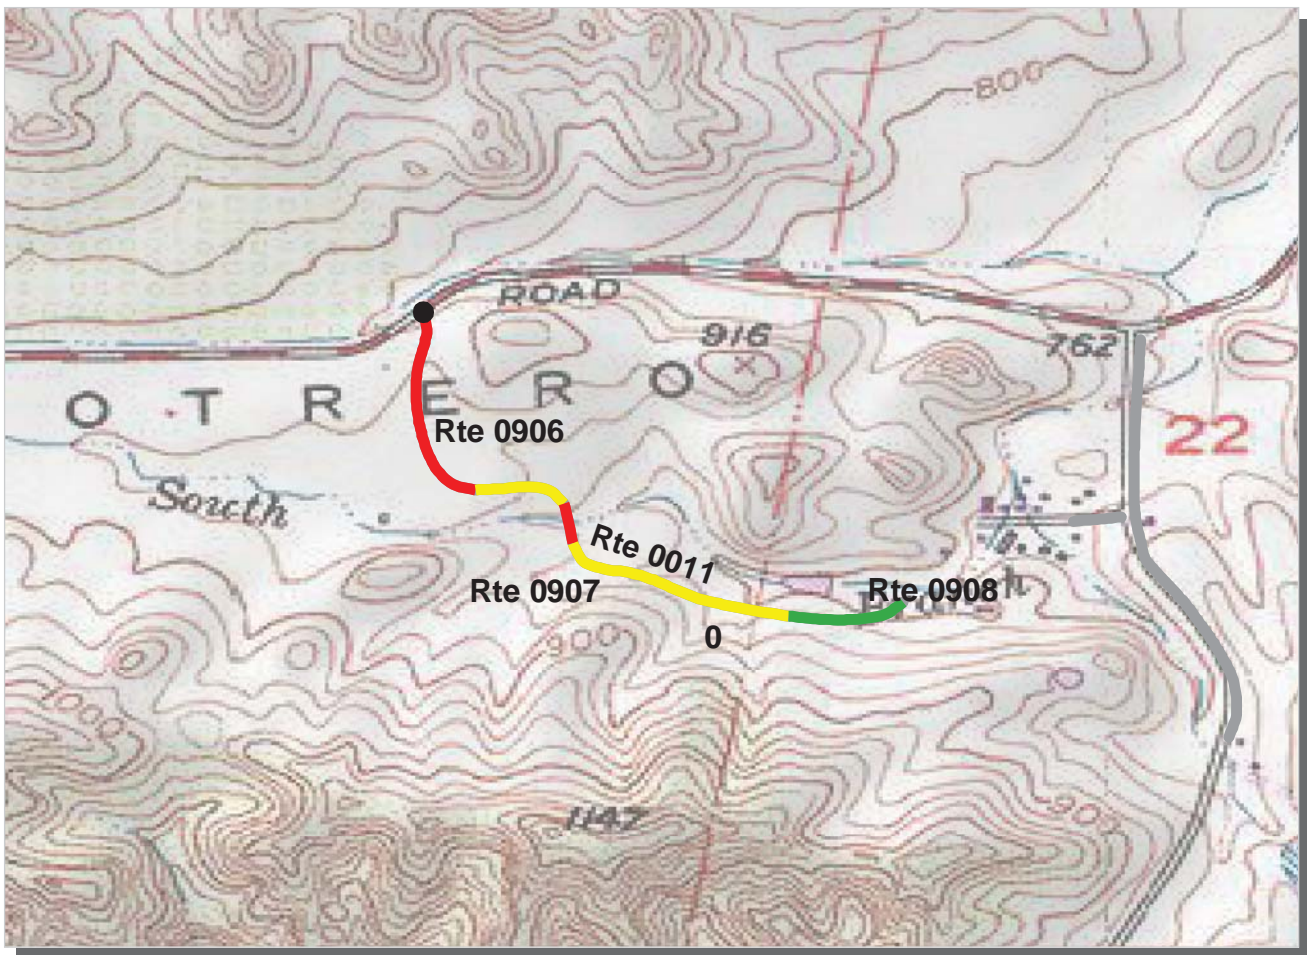
ROUTE: 0011 Rancho Sierra Vista/Satwiwa Entrance Road **TOTAL LENGTH: 0.64 Miles**

Section Number	0				
Section Length (mi)	0.64				
AADT	**				
SADT	**				
ADT Date	**				
Cross Section Information					
Number of Lanes	2				
Paved Width (ft)	19				
Lane Width (ft)	10				
Shoulder Width (ft)	3				
Roadway Condition Information					
PCR (Pavement Condition Rating)	65				
RCI (Roughness Condition Index)	65				
SCR (Surface Condition Rating)	66				
Alligator Cracking Index	99				
Rutting Index	70				
Patching Index	98				
Transverse Cracking Index	100				
Longitudinal Cracking Index	97				
Shoulder Condition Rating	GOOD				
Drainage Condition Rating	GOOD

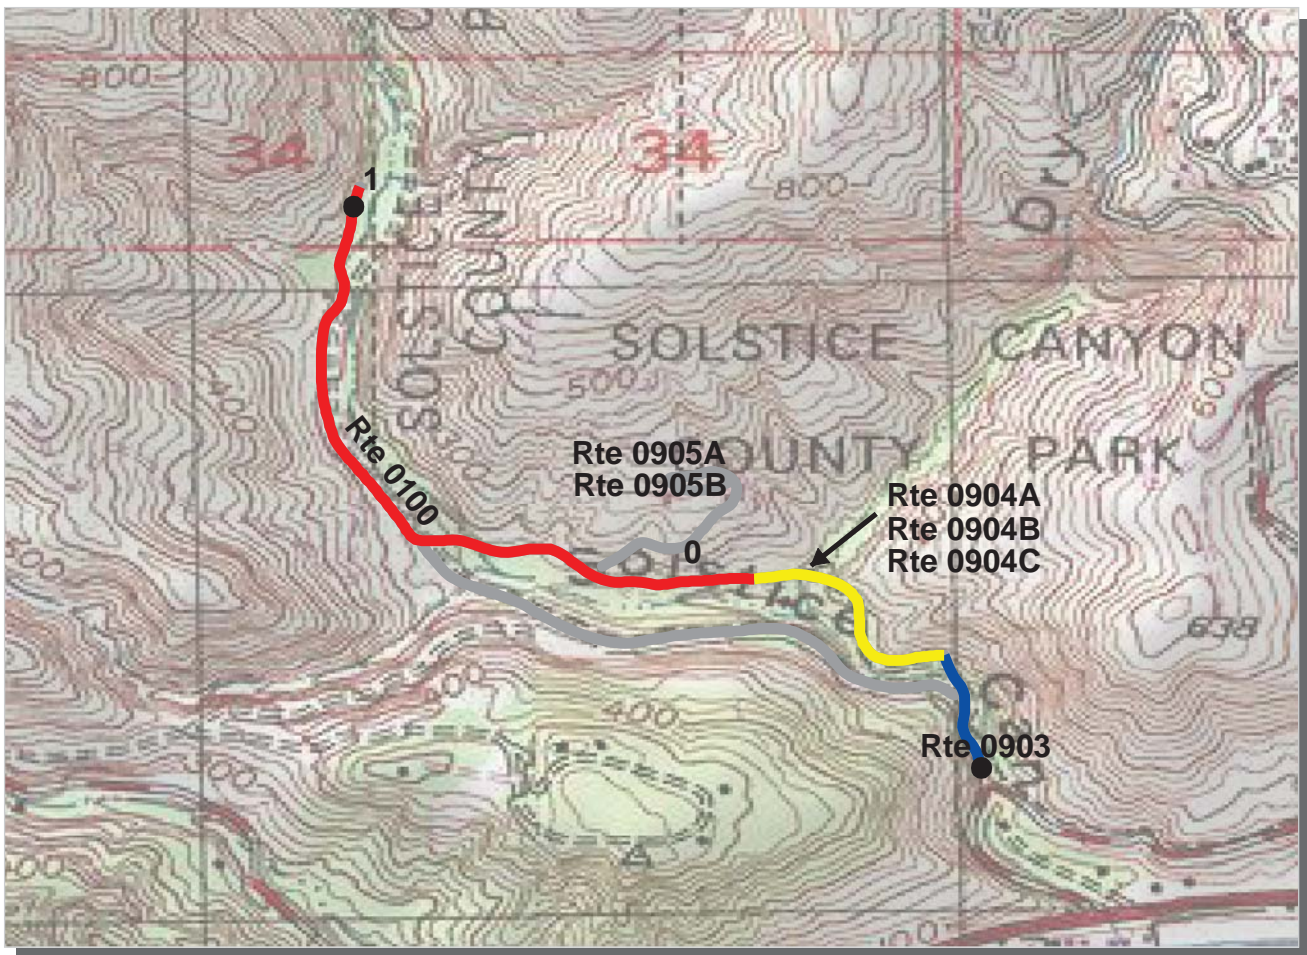
ROUTE: 0100 Solstice Canyon Access Road **TOTAL LENGTH: 1.04 Miles**

Section Number	0	1			
Section Length (mi)	1.00	0.04			
AADT	**				
SADT	**				
ADT Date	**				
Cross Section Information					
Number of Lanes	2	1			
Paved Width (ft)	14	9			
Lane Width (ft)	14	9			
Shoulder Width (ft)	0	0			
Roadway Condition Information					
PCR (Pavement Condition Rating)	44	17			
RCI (Roughness Condition Index)	NC	-1			
SCR (Surface Condition Rating)	44	17			
Alligator Cracking Index	100	100			
Rutting Index	45	17			
Patching Index	100	100			
Transverse Cracking Index	100	100			
Longitudinal Cracking Index	100	100			
Shoulder Condition Rating	N/A	N/A			
Drainage Condition Rating	GOOD	GOOD

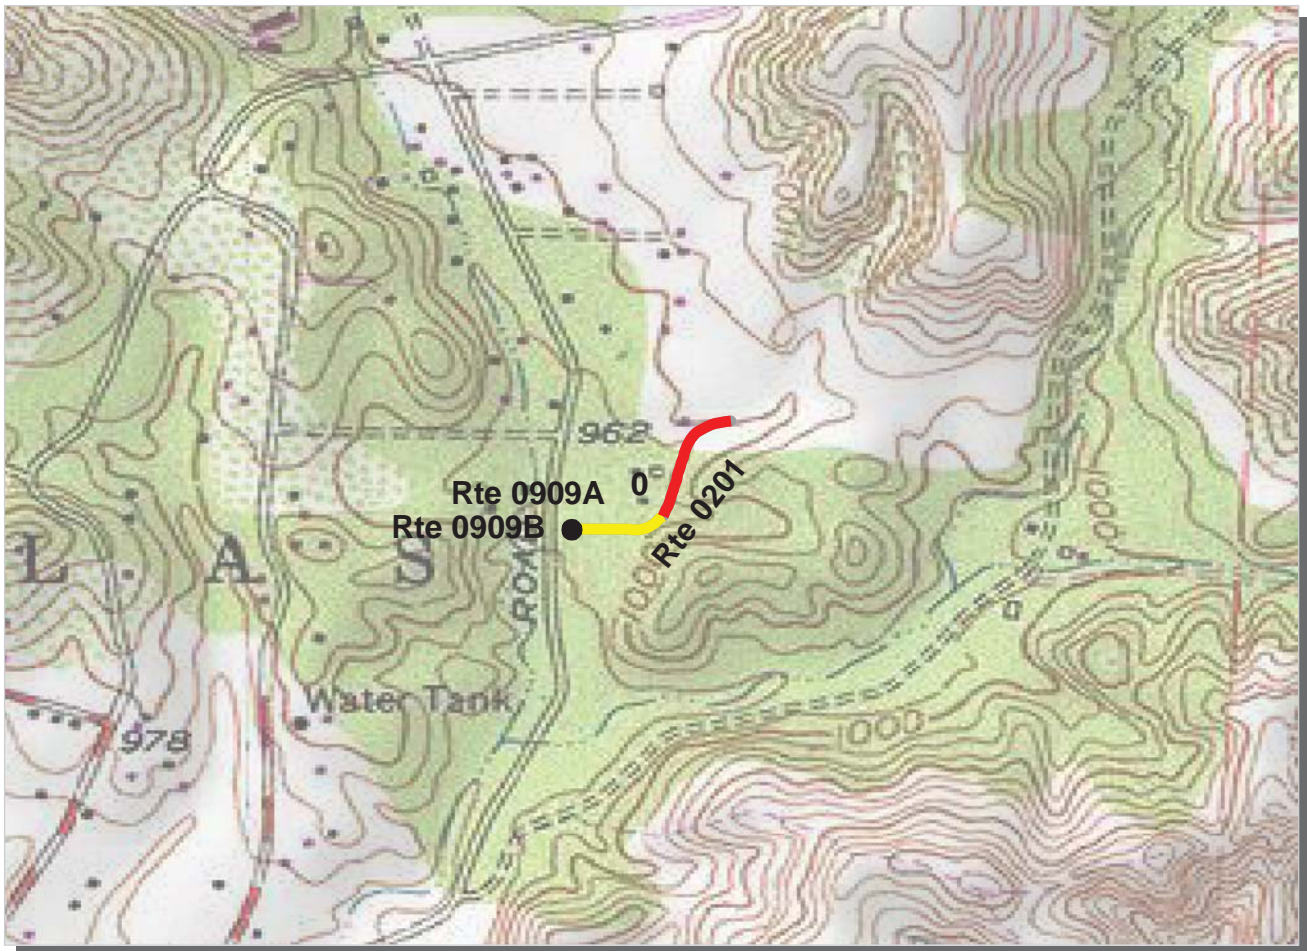
ROUTE: 0201 Cheeseboro Canyon Entrance Road **TOTAL LENGTH: 0.22 Miles**

Section Number	0			
Section Length (mi)	0.22			
AADT	**			
SADT	**			
ADT Date	**			
Cross Section Information				
Number of Lanes	2			
Paved Width (ft)	16			
Lane Width (ft)	8			
Shoulder Width (ft)	0			
Roadway Condition Information				
PCR (Pavement Condition Rating)	60			
RCI (Roughness Condition Index)	45			
SCR (Surface Condition Rating)	65			
Alligator Cracking Index	100			
Rutting Index	70			
Patching Index	100			
Transverse Cracking Index	99			
Longitudinal Cracking Index	95			
Shoulder Condition Rating	N/A			
Drainage Condition Rating	GOOD

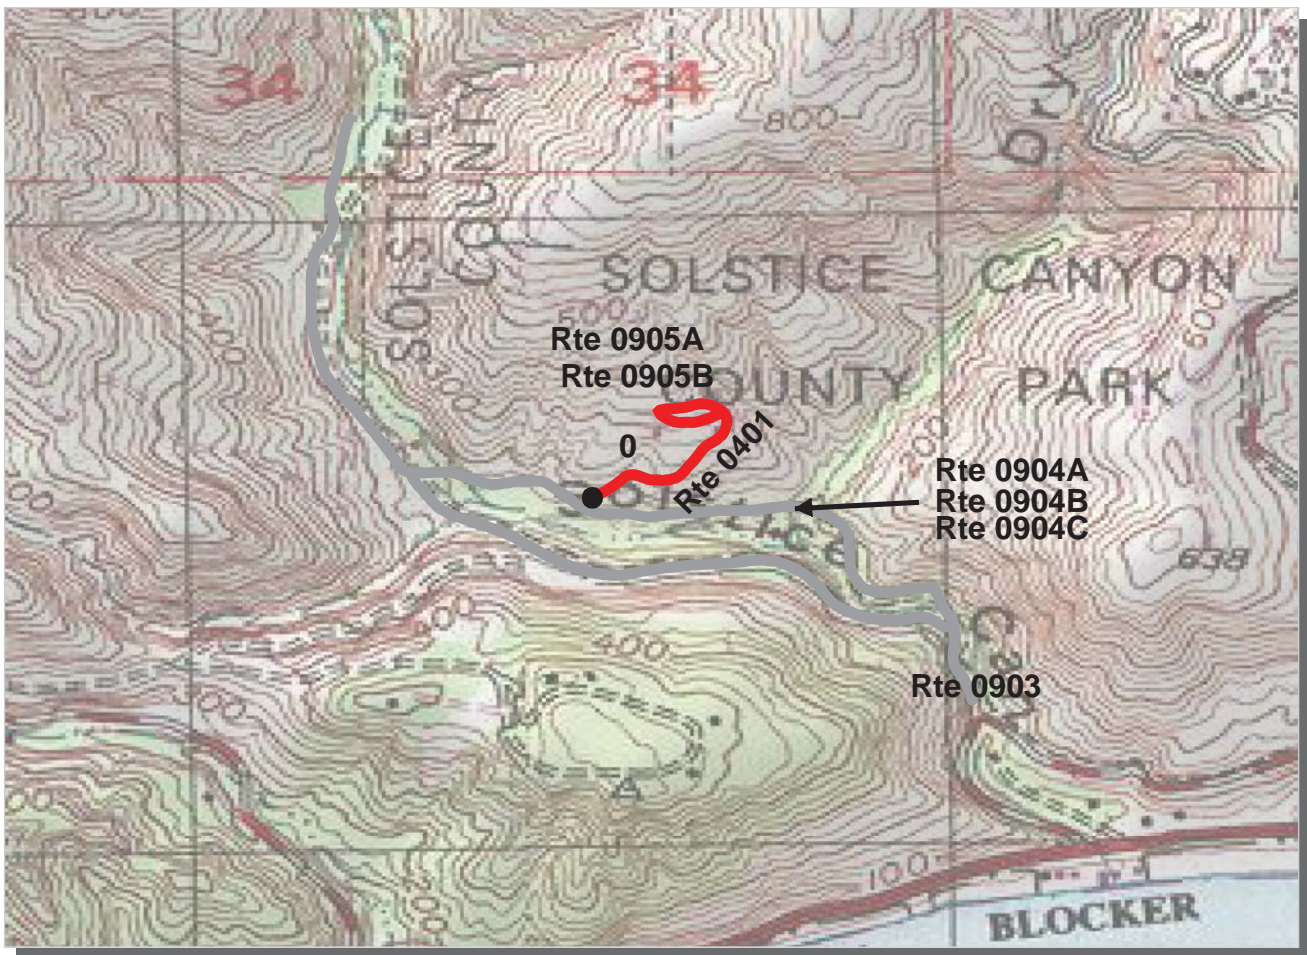
ROUTE: 0401 Trw Buildings Access Road **TOTAL LENGTH: 0.29 Miles**

Section Number	0				
Section Length (mi)	0.29				
AADT	**				
SADT	**				
ADT Date	**				
Cross Section Information					
Number of Lanes	1				
Paved Width (ft)	14				
Lane Width (ft)	14				
Shoulder Width (ft)	0				
Roadway Condition Information					
PCR (Pavement Condition Rating)	8				
RCI (Roughness Condition Index)	NC				
SCR (Surface Condition Rating)	8				
Alligator Cracking Index	41				
Rutting Index	23				
Patching Index	91				
Transverse Cracking Index	94				
Longitudinal Cracking Index	96				
Shoulder Condition Rating	N/A				
Drainage Condition Rating	GOOD

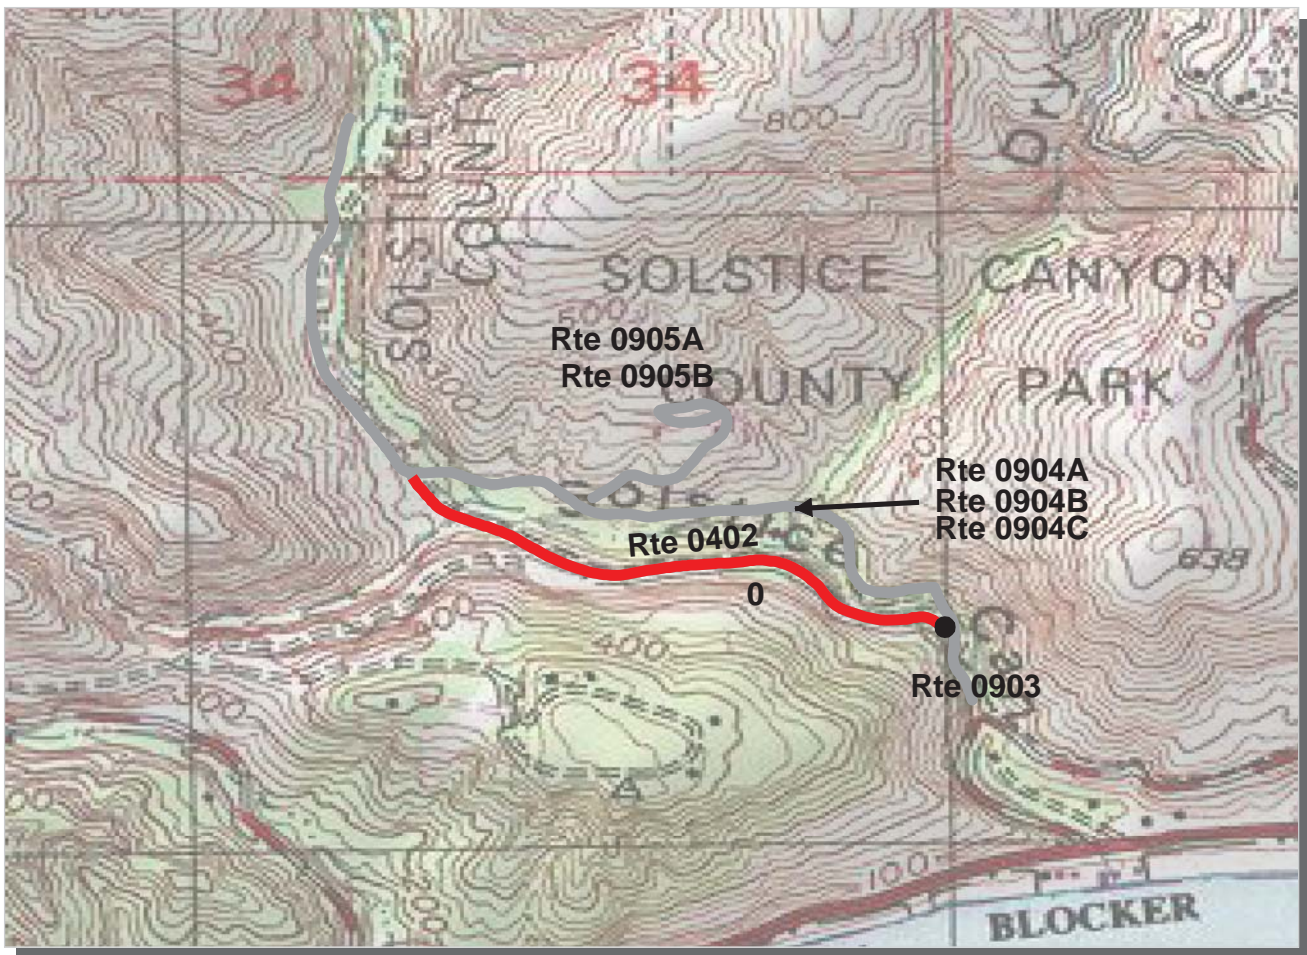
ROUTE: 0402 Solstice Canyon Upper Road **TOTAL LENGTH: 0.51 Miles**

Section Number	0			
Section Length (mi)	0.51			
AADT	**			
SADT	**			
ADT Date	**			
Cross Section Information				
Number of Lanes	1			
Paved Width (ft)	14			
Lane Width (ft)	14			
Shoulder Width (ft)	0			
Roadway Condition Information				
PCR (Pavement Condition Rating)	6			
RCI (Roughness Condition Index)	NC			
SCR (Surface Condition Rating)	6			
Alligator Cracking Index	53			
Rutting Index	27			
Patching Index	96			
Transverse Cracking Index	99			
Longitudinal Cracking Index	97			
Shoulder Condition Rating	N/A			
Drainage Condition Rating	GOOD

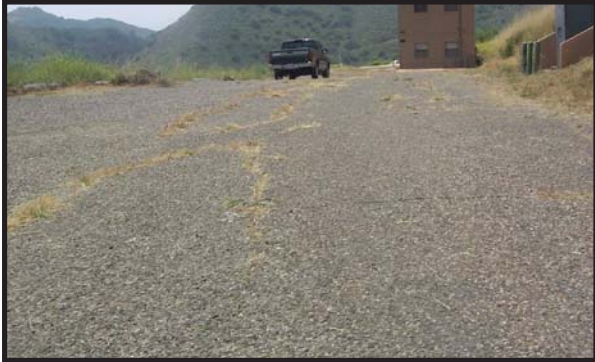
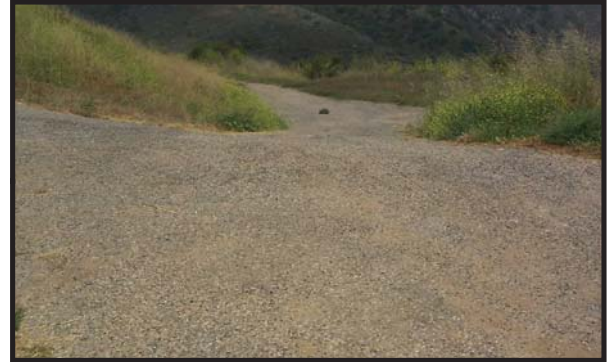
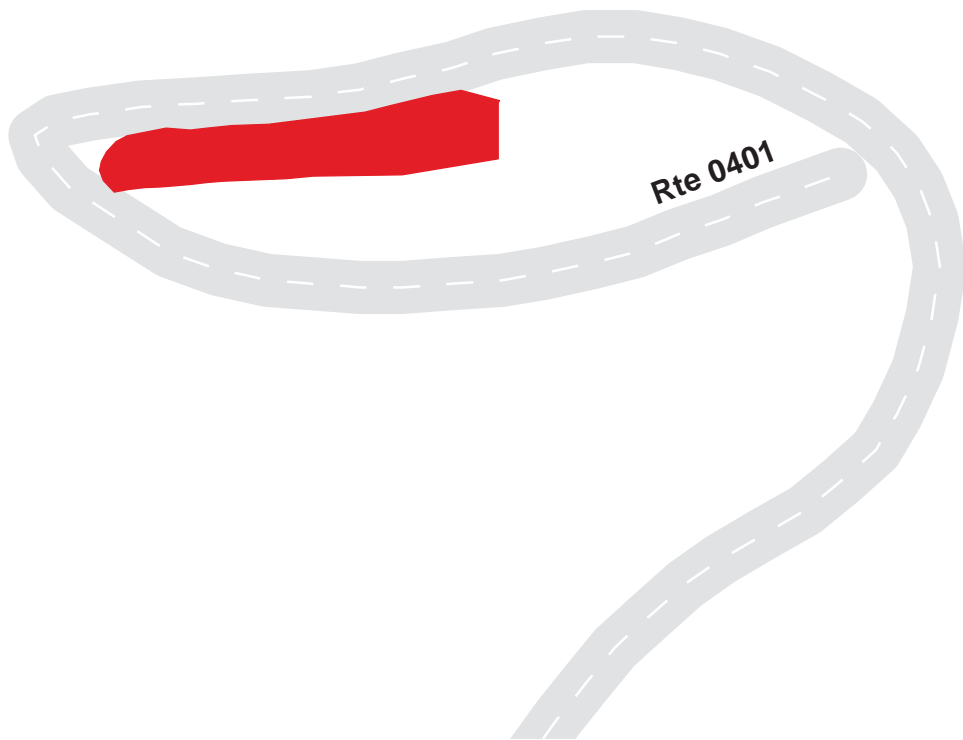
Route 0905A

Route	Public / NonPublic	Date Visited	Area (sq ft)	Lane Miles *	Surface Type	Condition / PCR
0905A	NonPublic	6/9/2001	3081	0.05	AS	POOR / 45

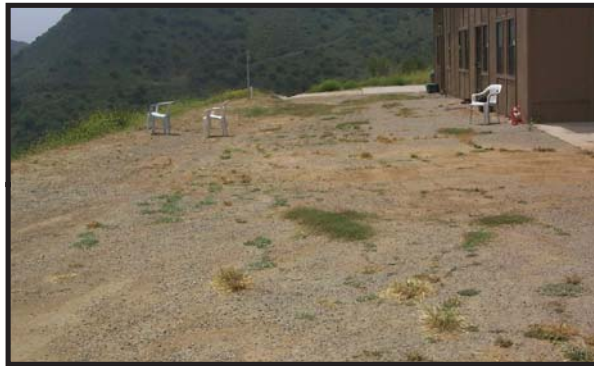
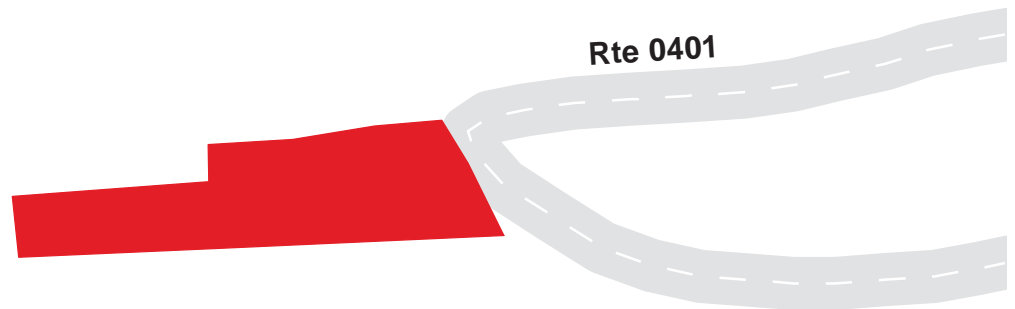
Route 0905B

Route	Public / NonPublic	Date Visited	Area (sq ft)	Lane Miles *	Surface Type	Condition / PCR
0905B	NonPublic	6/9/2001	5405	0.09	AS	POOR / 45

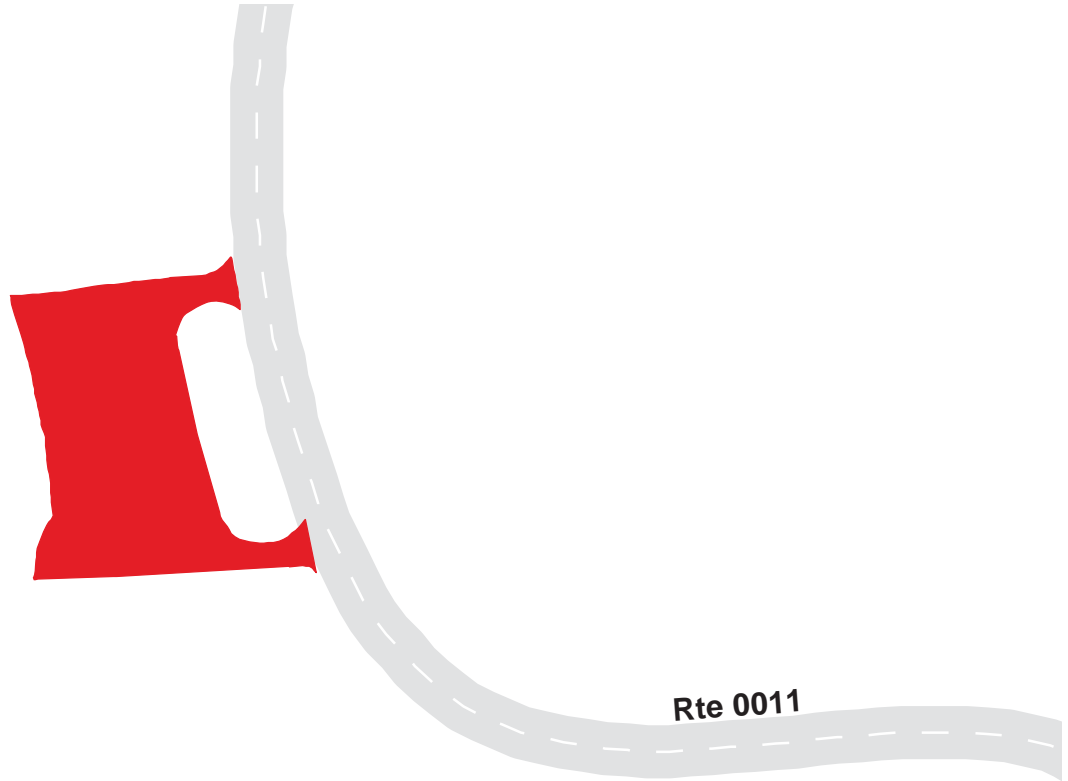
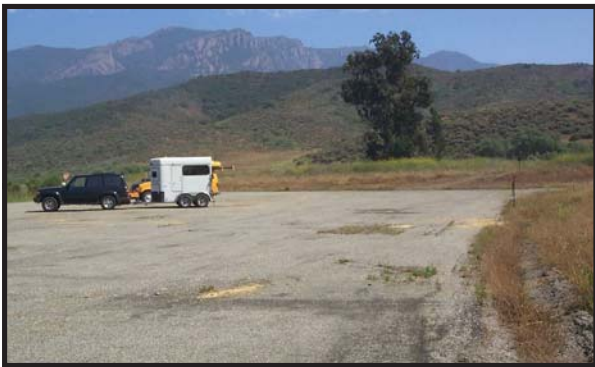
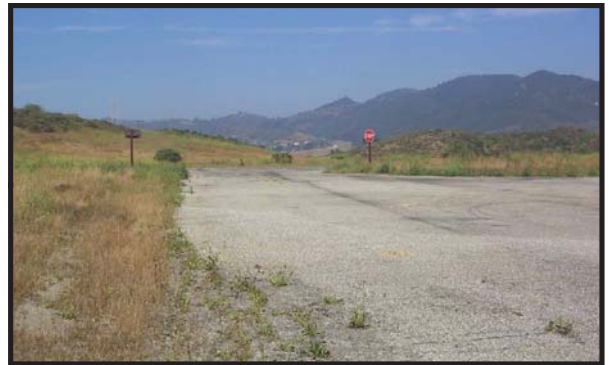
Route 0906

Route	Public / NonPublic	Date Visited	Area (sq ft)	Lane Miles *	Surface Type	Condition / PCR
0906	Public	6/8/2001	31902	0.55	OC	FAIR / 73

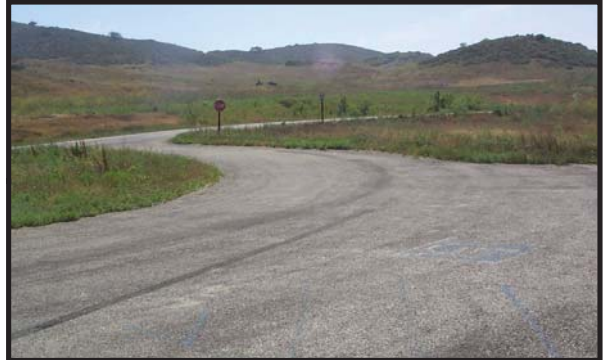
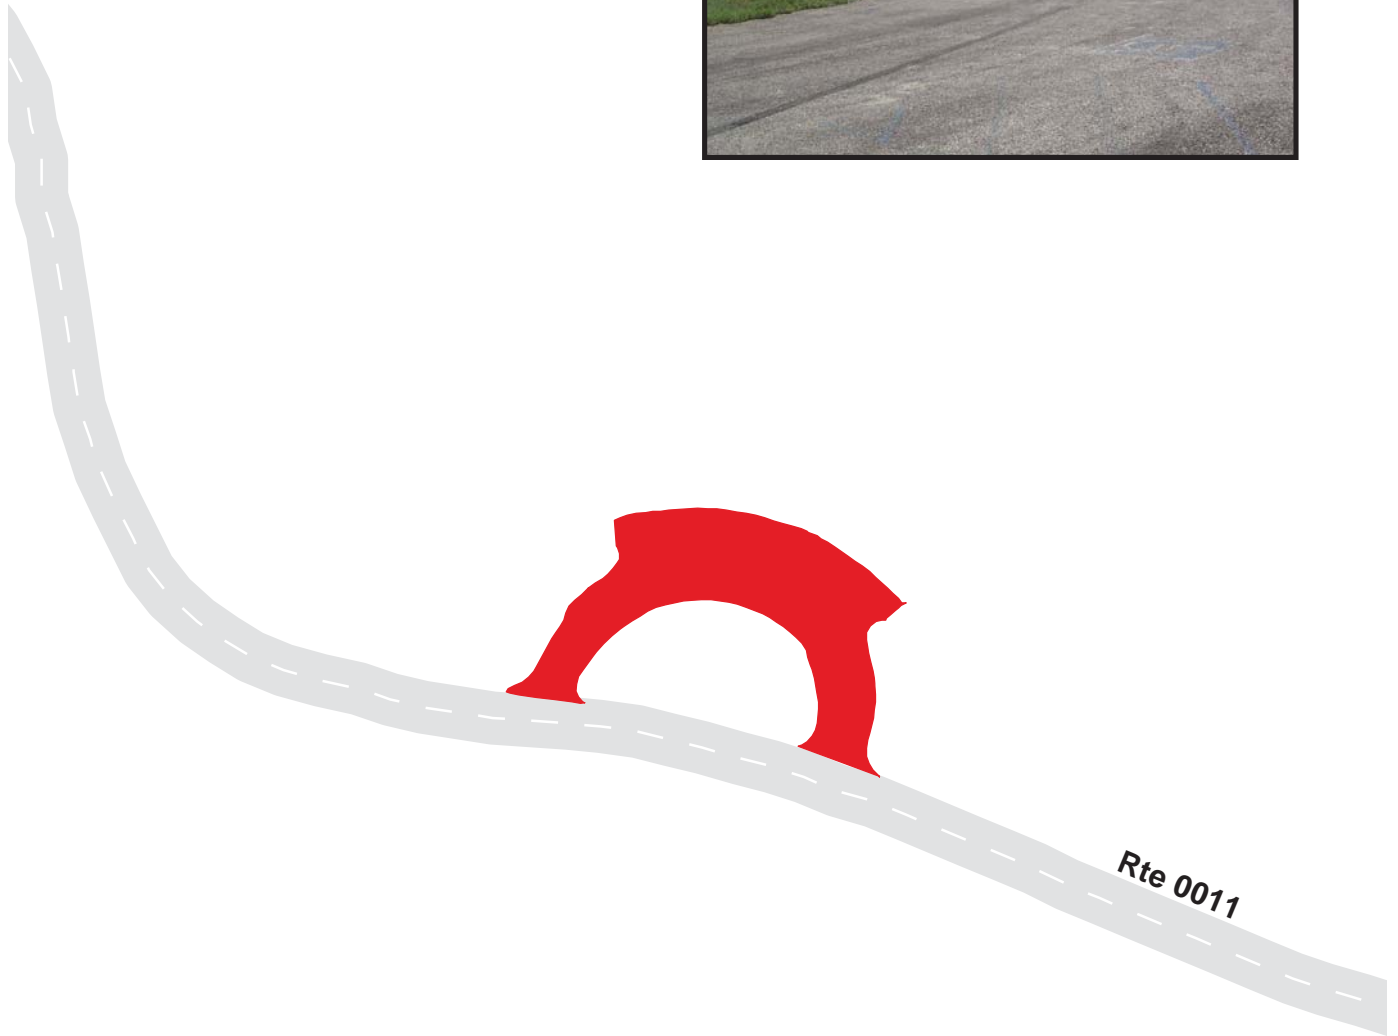
Route 0907

Route	Public / NonPublic	Date Visited	Area (sq ft)	Lane Miles *	Surface Type	Condition / PCR
0907	Public	6/8/2001	8569	0.15	OC	FAIR / 73

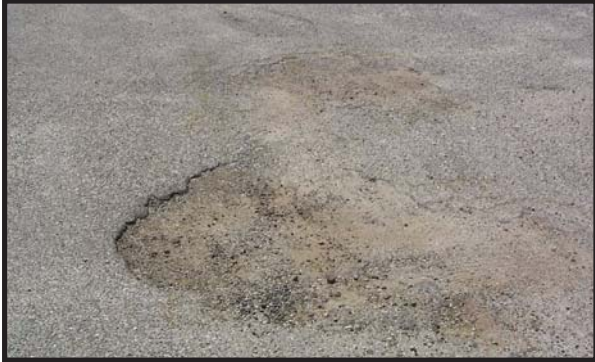
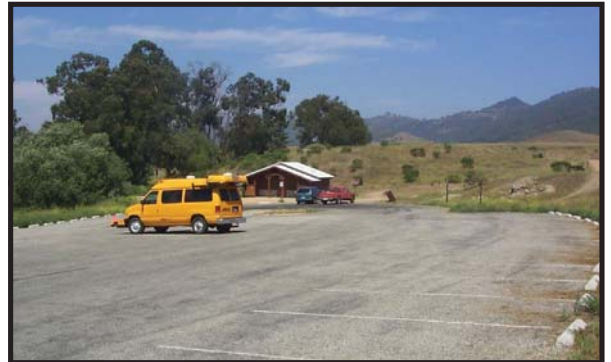
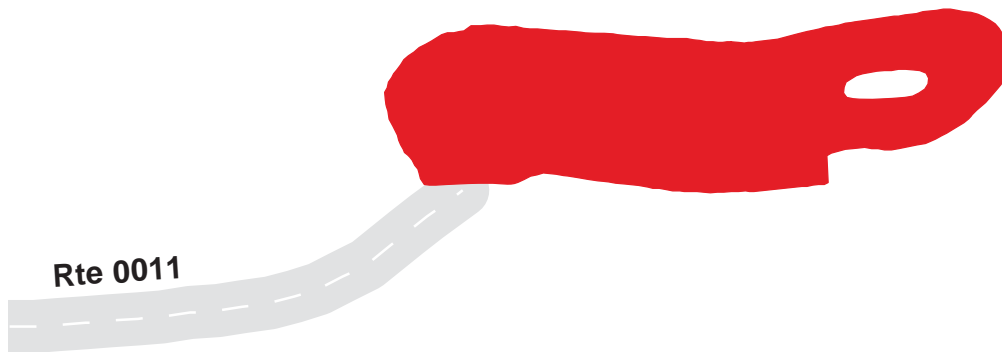
Route 0908

Route	Public / NonPublic	Date Visited	Area (sq ft)	Lane Miles *	Surface Type	Condition / PCR
0908	Public	6/8/2001	33071	0.57	AS	FAIR / 73
