Federal Lands Highway Road Inventory Program

Road Inventory and Condition Assessment

Aztec Ruins National Monument AZRU

Cycle 5 Report

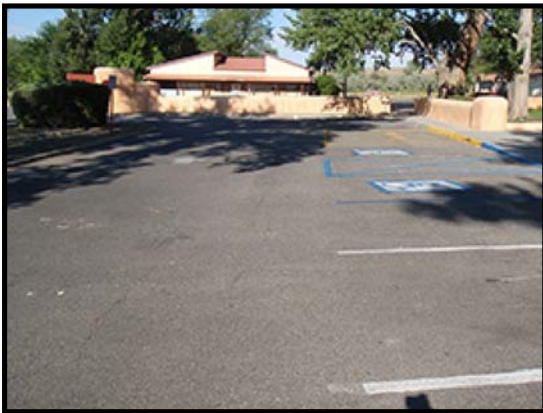
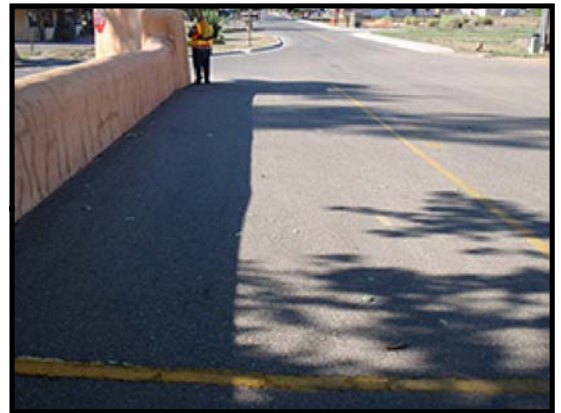
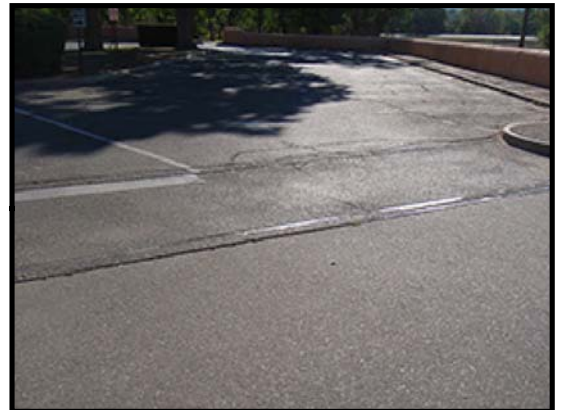
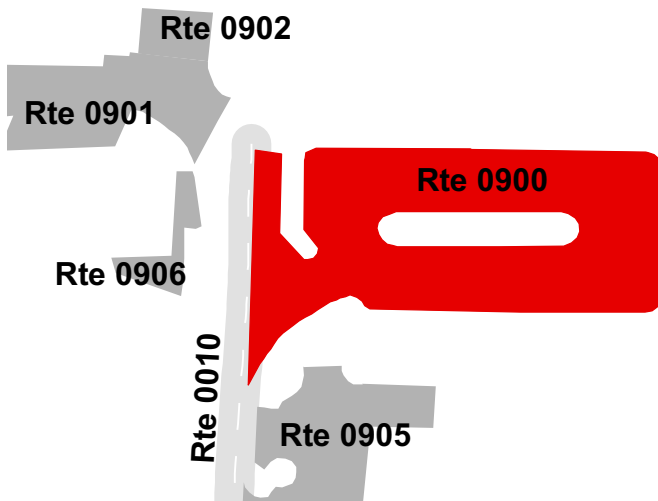
Route 0900

Route Number	Public / NonPublic	Date Visited	Area (sq ft)	Lane Miles *	Surface Type
0900	PUBLIC	9/3/2011	17,718	0.31	AS
Culverts	Drop Inlets	Gates	Curb & Gutter	Curb	PCR
0	1	1	CONCRETE CURB AND GUTTER	CONCRETE CURB	POOR/45

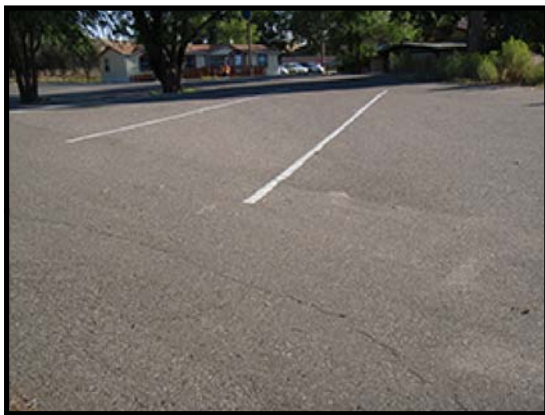
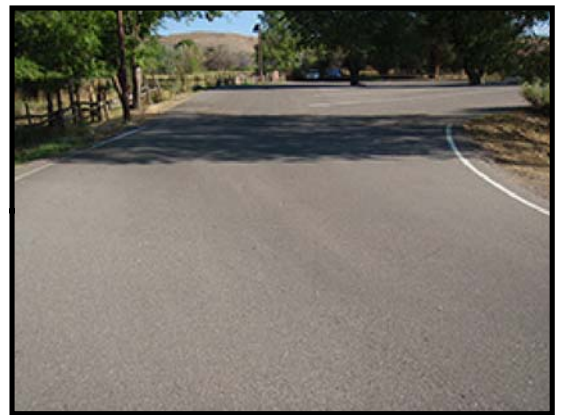
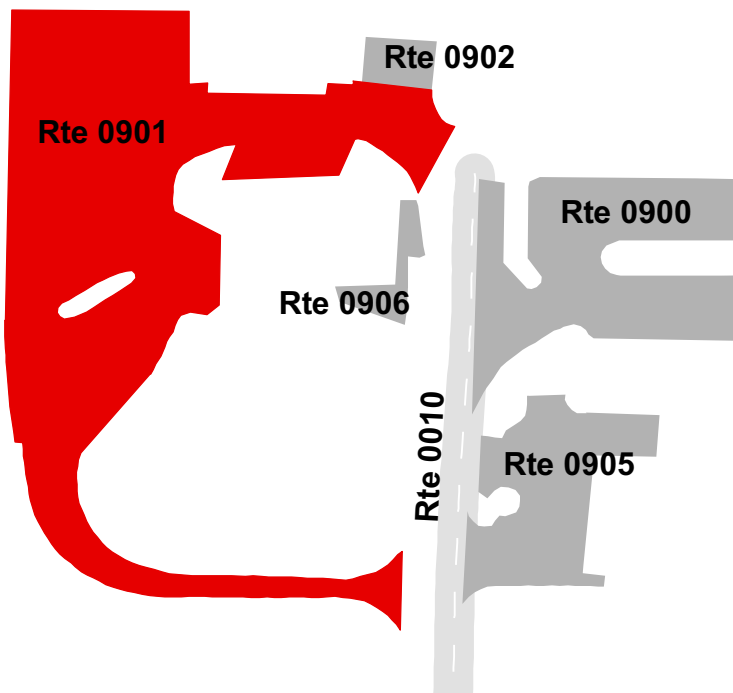
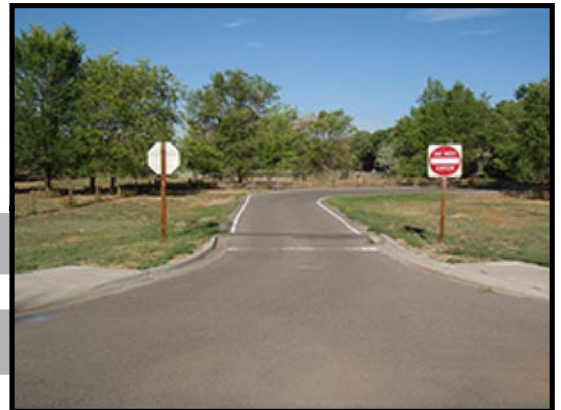
Route 0901

Route Number	Public / NonPublic	Date Visited	Area (sq ft)	Lane Miles *	Surface Type
0901	PUBLIC	9/3/2011	32,411	0.56	AS
Culverts	Drop Inlets	Gates	Curb & Gutter	Curb	PCR
2	0	0	CONCRETE CURB AND GUTTER	NO CURB	FAIR/73

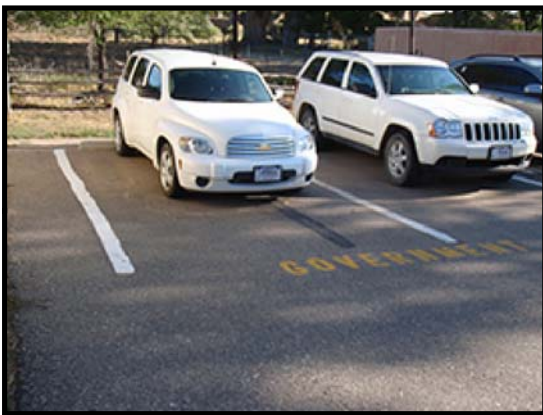
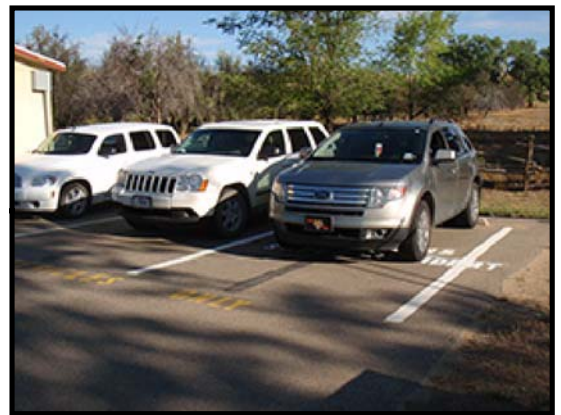
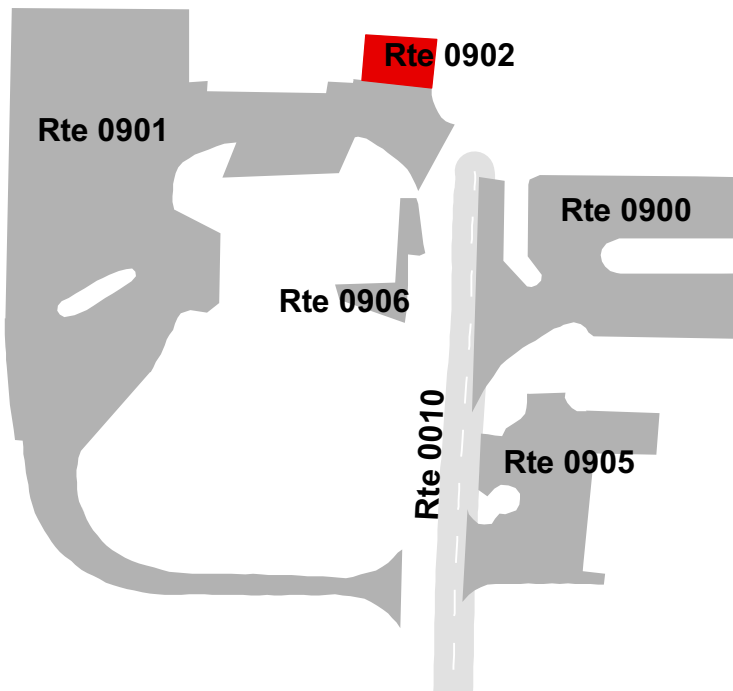
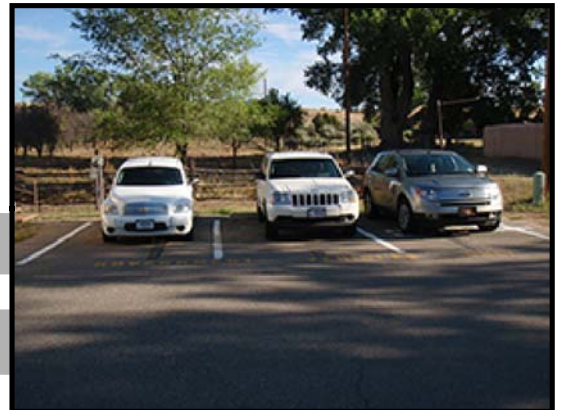
AZTEC RUINS NATIONAL MONUMENT
Route 0902
 GOVERNMENT PARKING
 ADJACENT TO ROUTE 0901 (WESTERN PARKING LOT)

Route Number	Public / NonPublic	Date Visited	Area (sq ft)	Lane Miles *	Surface Type
0902	NONPUBLIC	9/3/2011	1,034	0.02	AS
Culverts	Drop Inlets	Gates	Curb & Gutter	Curb	PCR
0	0	0	NO CURB AND GUTTER	NO CURB	FAIR/73

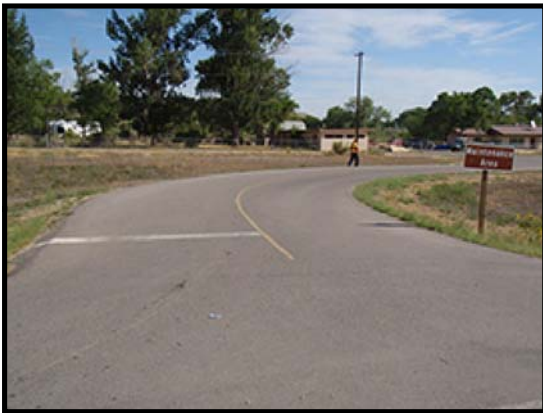
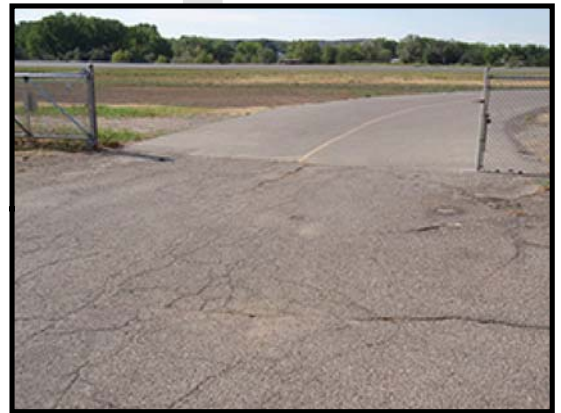
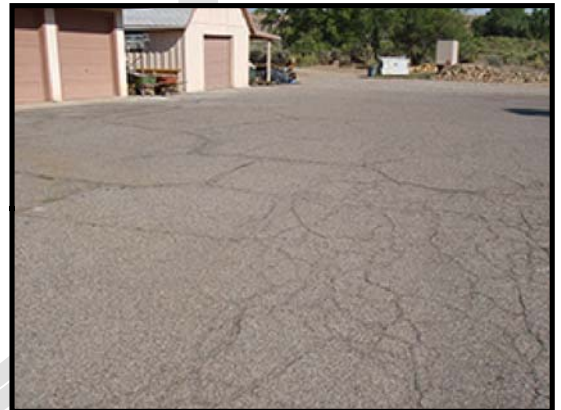
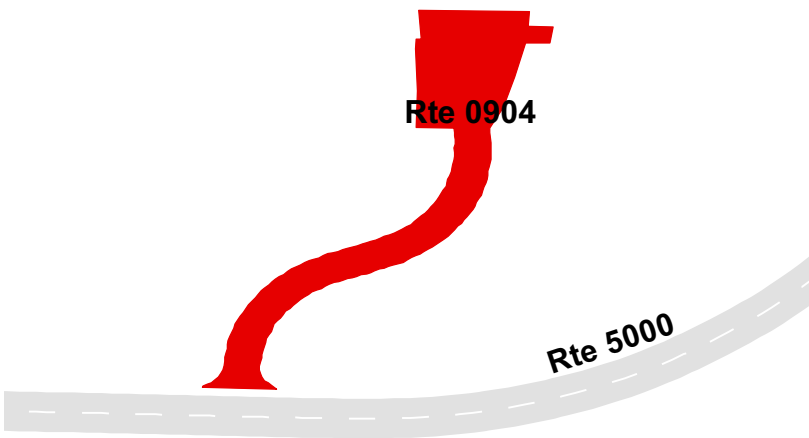
Route 0904

Route Number	Public / NonPublic	Date Visited	Area (sq ft)	Lane Miles *	Surface Type
0904	NONPUBLIC	9/3/2011	15,353	0.26	AS
Culverts	Drop Inlets	Gates	Curb & Gutter	Curb	PCR
0	0	1	NO CURB AND GUTTER	NO CURB	FAIR/73

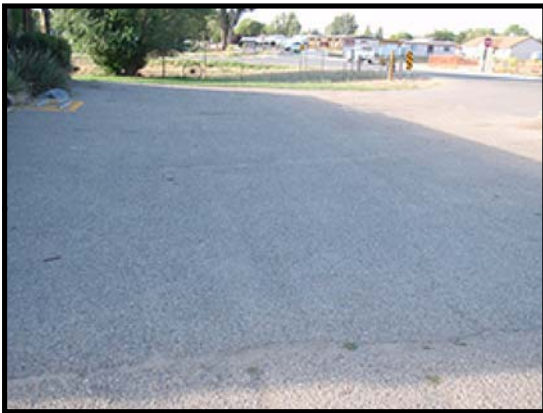
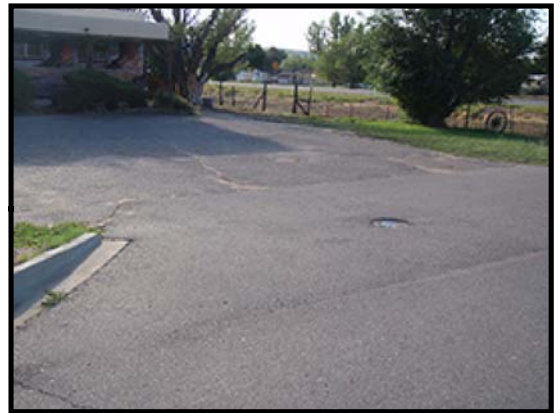
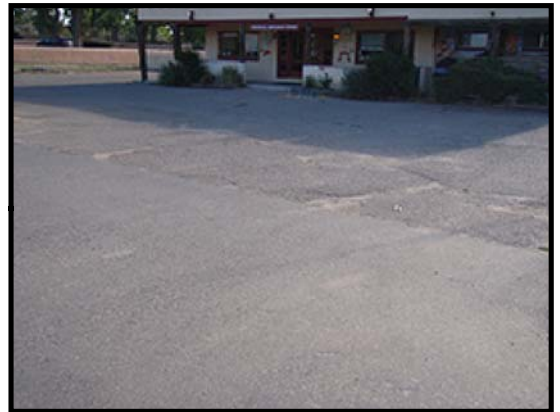
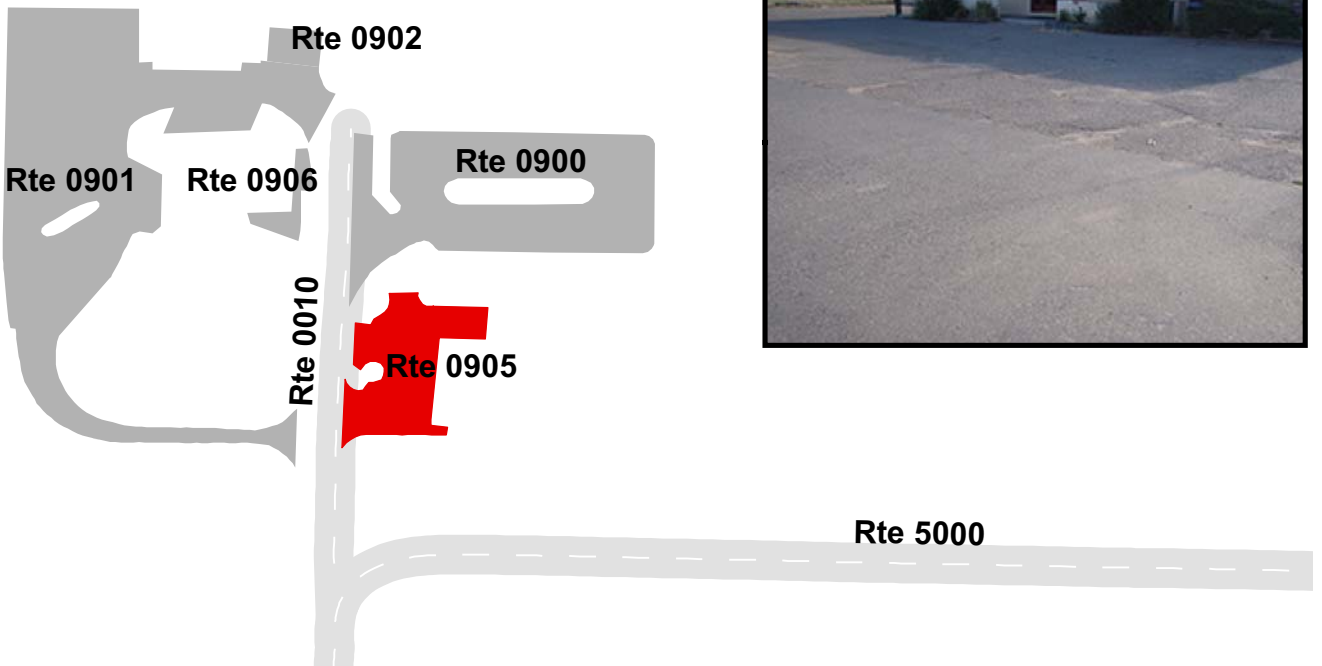
Route 0905

Route Number	Public / NonPublic	Date Visited	Area (sq ft)	Lane Miles *	Surface Type
0905	NONPUBLIC	9/3/2011	6,710	0.12	AS
Culverts	Drop Inlets	Gates	Curb & Gutter	Curb	PCR
0	0	0	CONCRETE CURB AND GUTTER	NO CURB	POOR/45

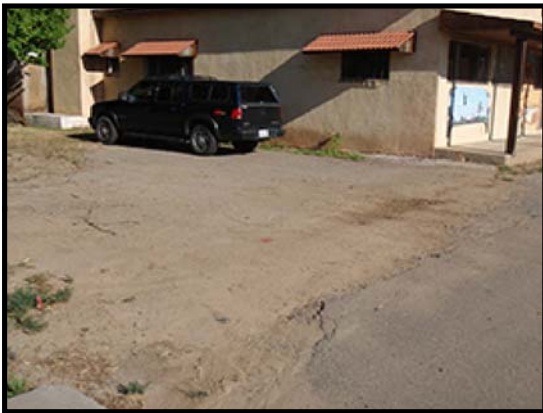
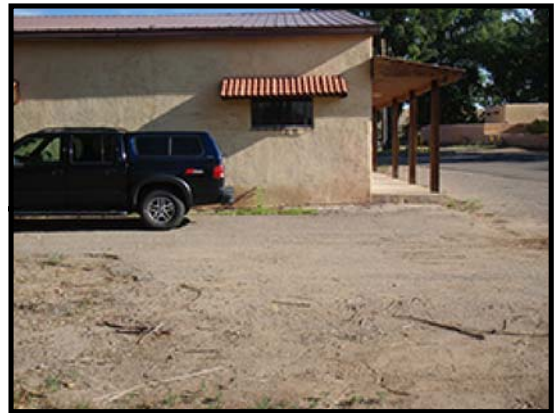
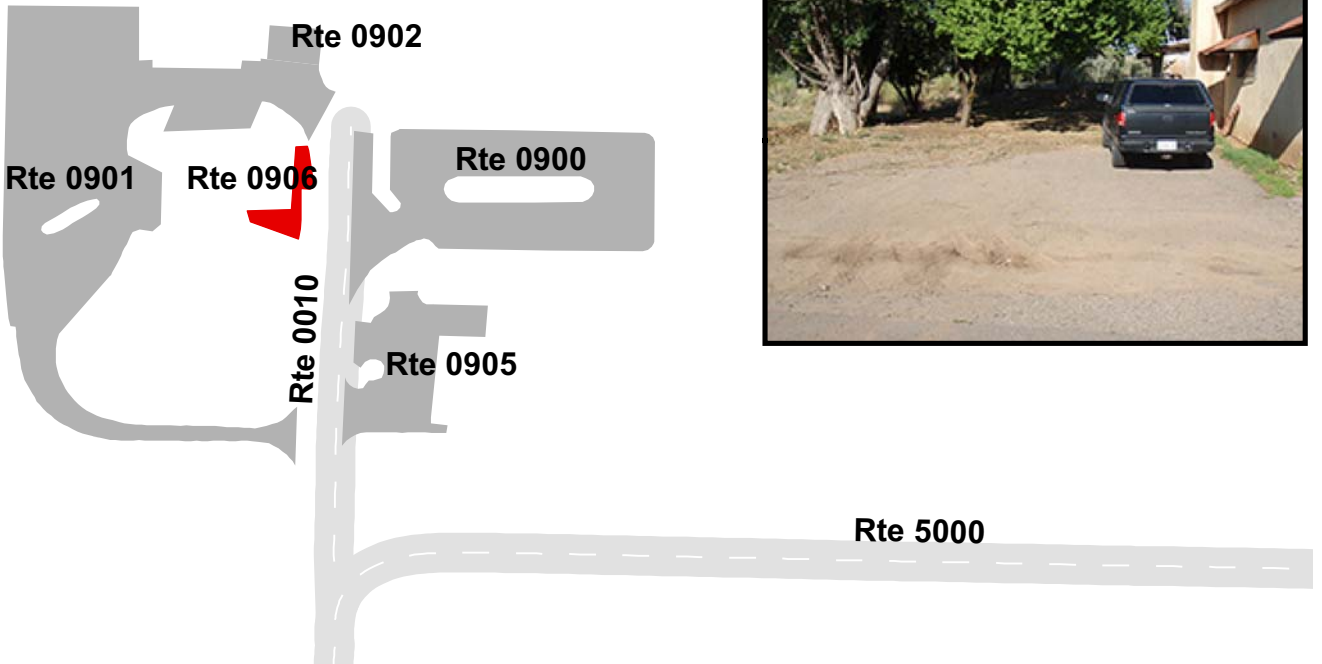
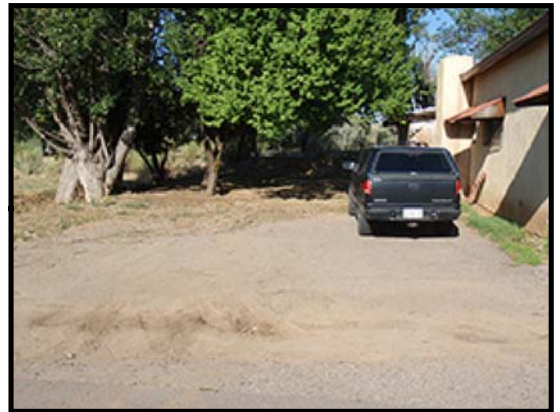
Route 0906

Route Number	Public / NonPublic	Date Visited	Area (sq ft)	Lane Miles *	Surface Type
0906	PUBLIC	9/3/2011	1,090	0.02	AS
Culverts	Drop Inlets	Gates	Curb & Gutter	Curb	PCR
0	0	0	NO CURB AND GUTTER	NO CURB	POOR/45
