Federal Lands Highway Road Inventory Program

Road Inventory and Condition Assessment

Bandelier National Monument BAND

Cycle 5 Report

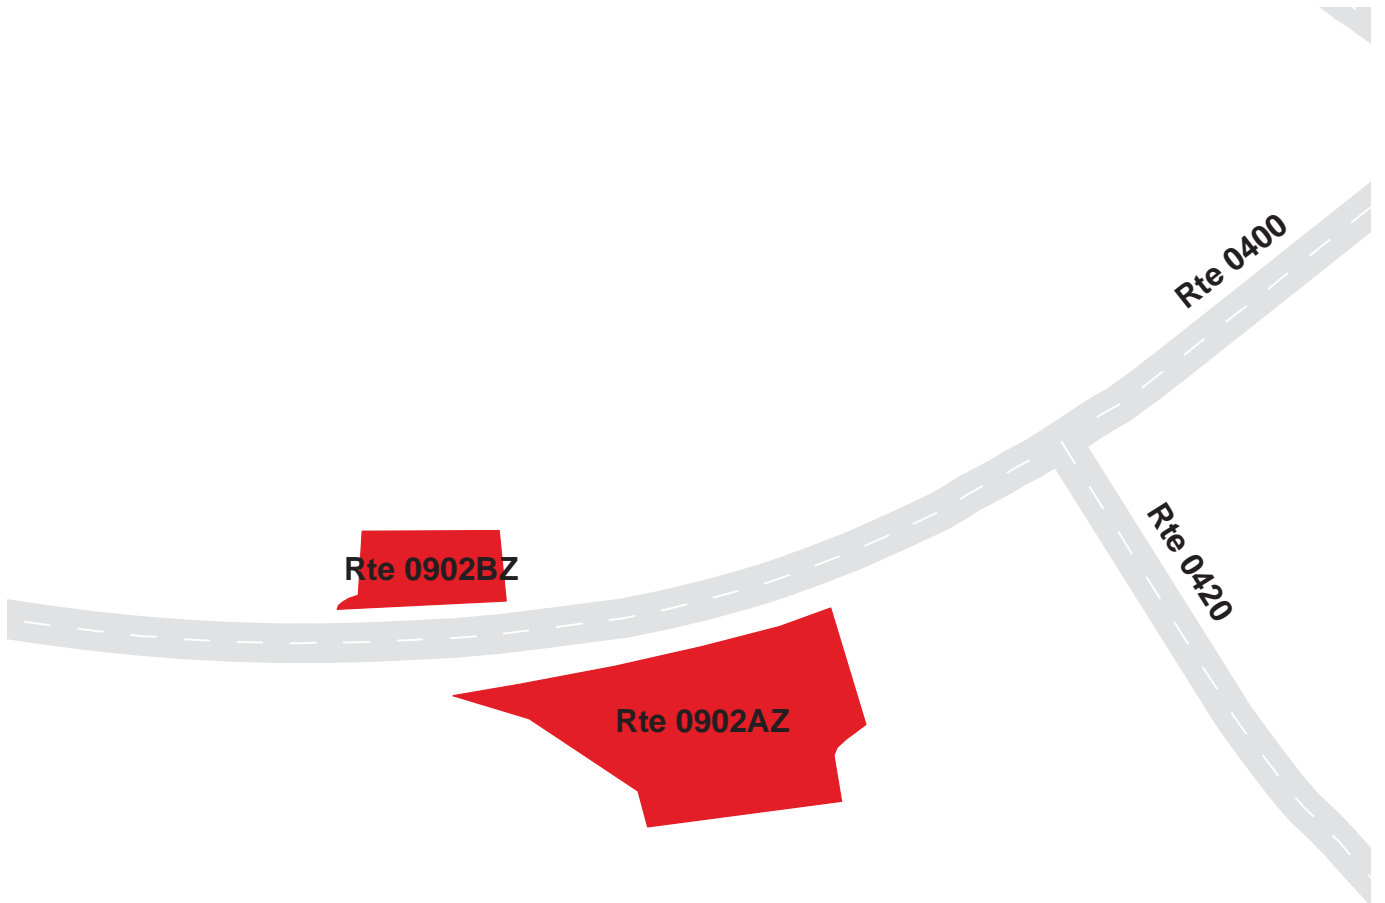
Route 0902AZ

Route Number	Public / NonPublic	Date Visited	Area (sq ft)	Lane Miles *	Surface Type
0902AZ	NONPUBLIC	9/6/2011	2,640	0.05	AS
Culverts	Drop Inlets	Gates	Curb & Gutter	Curb	PCR
0	0	0	NO CURB AND GUTTER	NO CURB	EXCELLENT/97
