Federal Lands Highway Road Inventory Program

Road Inventory and Condition Assessment

Bighorn Canyon National Recreation Area BICA - 1320

Cycle 5 Report

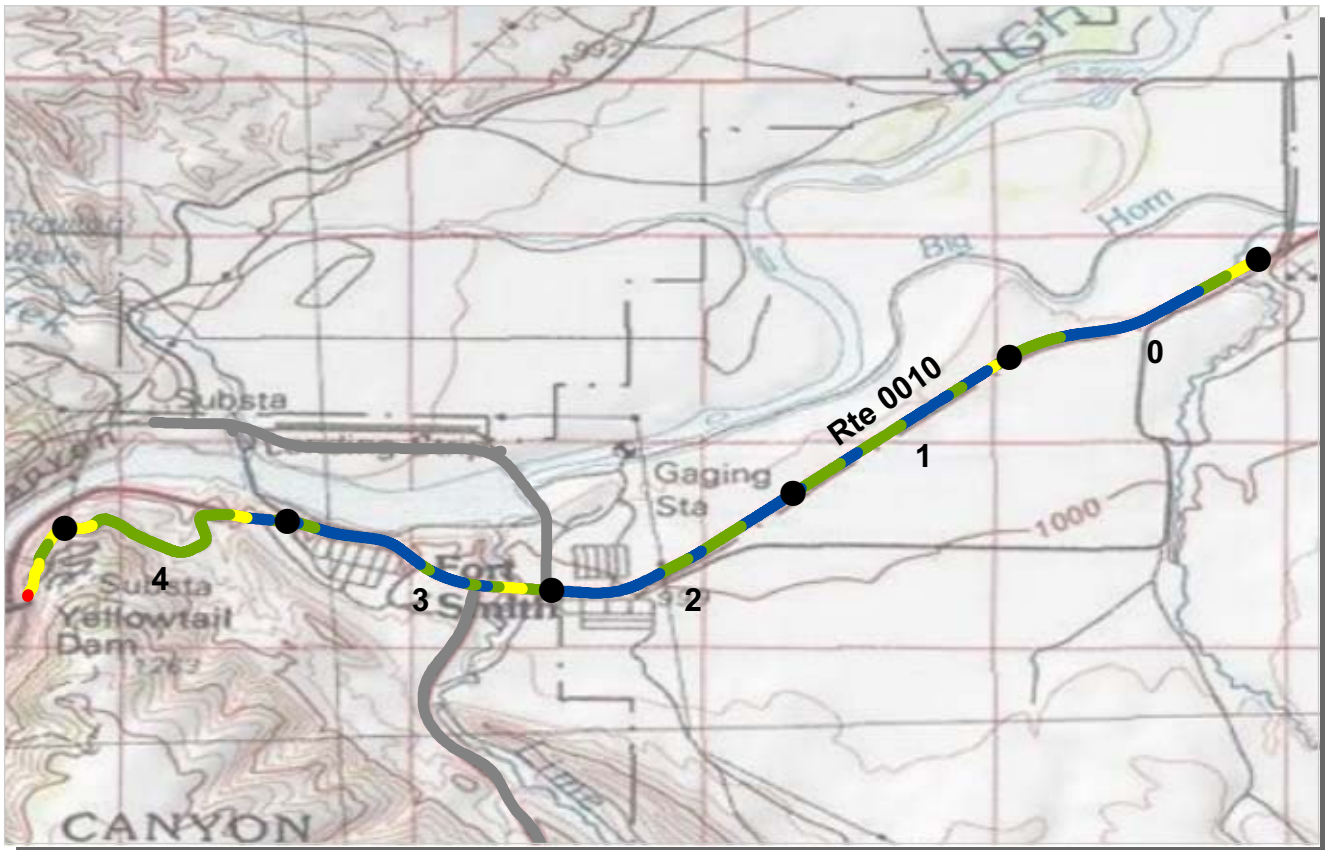
ROUTE: 0010 FORT SMITH ACCESS ROAD

<i>Section Number</i>	0	1	2	3	4
<i>Section Length (mi)</i>	1.00	1.00	1.00	1.00	1.00
<i>Cross Section Information</i>					
Number of Lanes	2	2	2	2	2
Paved Width (ft)	24	25	25	25	26
Lane Width (ft)	11	11	11	10	10
<i>Roadway Condition Information</i>					
SCR (Surface Condition Rating)	93	92	92	94	93
PCR (Pavement Condition Rating)	96	95	95	96	86
<i>Distress Index Values</i>					
Structural Crack Index	98	100	100	95	98
Transverse Cracking Index	93	92	96	94	95
Patching Index	100	100	100	100	100
Rutting Index	96	94	92	99	93
Roughness Condition Index (RCI)	100	100	100	100	75

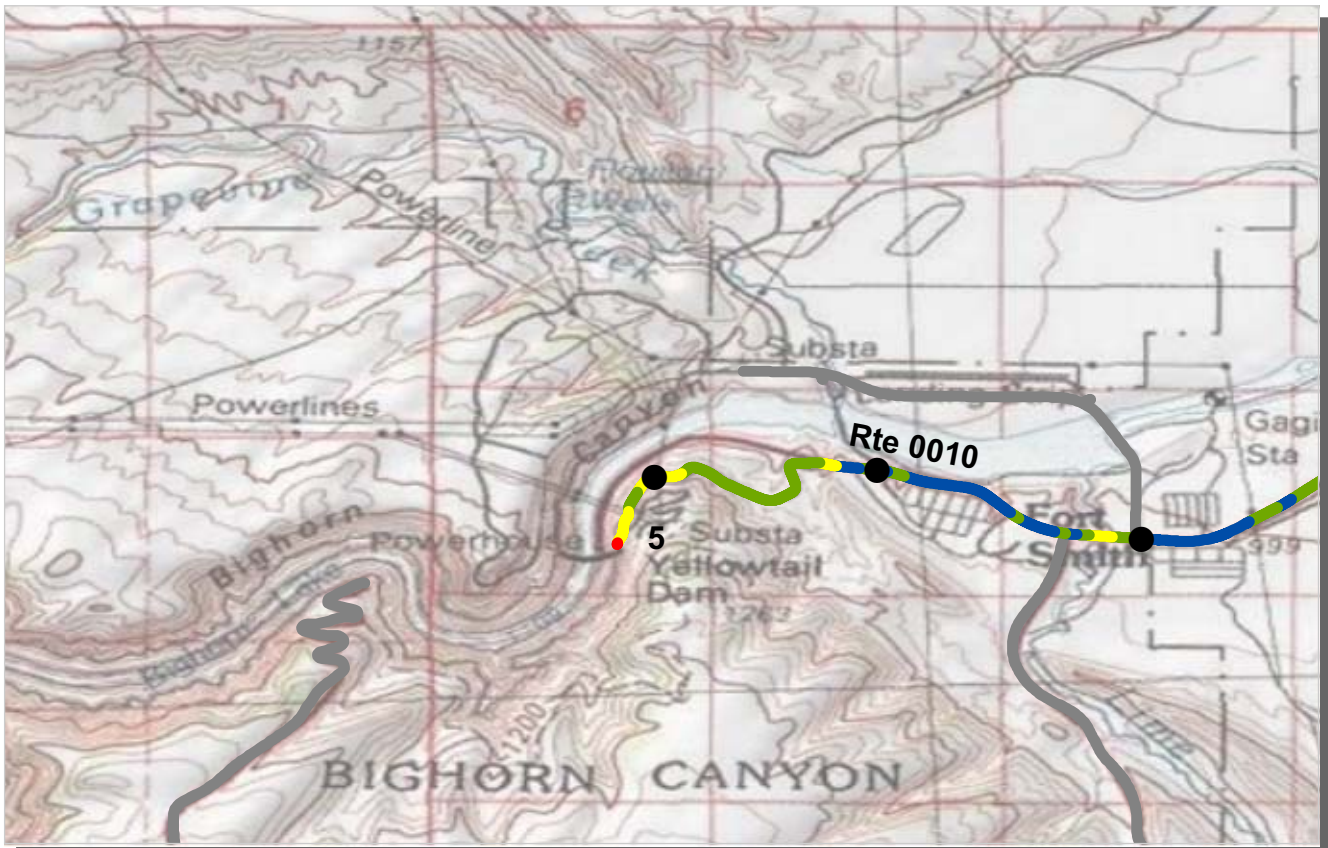
ROUTE: 0010 FORT SMITH ACCESS ROAD

Section Number	5				
Section Length (mi)	0.37				
Cross Section Information					
Number of Lanes	2				
Paved Width (ft)	26				
Lane Width (ft)	11				
Roadway Condition Information					
SCR (Surface Condition Rating)	88				
PCR (Pavement Condition Rating)	74				
Distress Index Values					
Structural Crack Index	98				
Transverse Cracking Index	97				
Patching Index	100				
Rutting Index	88				
Roughness Condition Index (RCI)	53

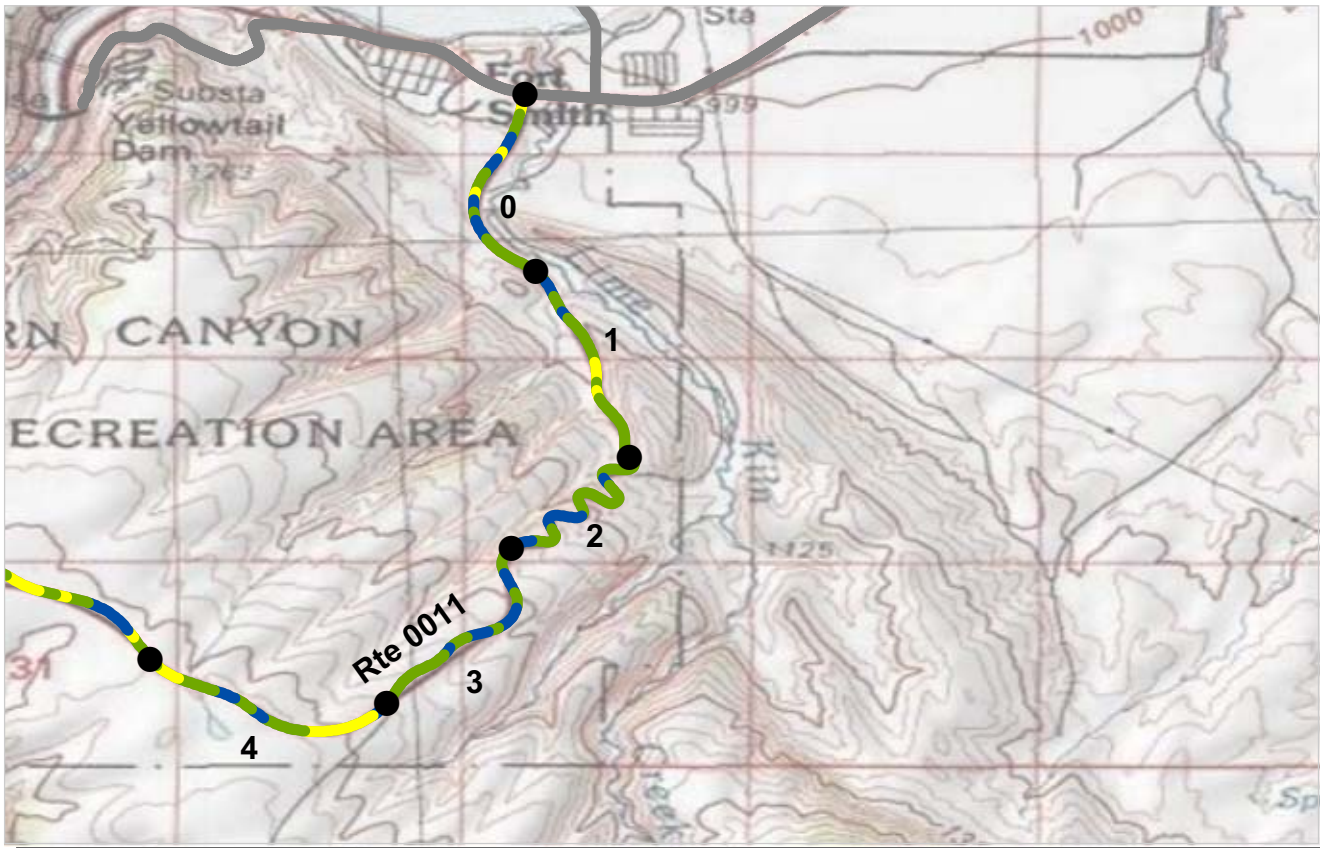
ROUTE: 0011 OK-A-BEH ROAD

<i>Section Number</i>	0	1	2	3	4
<i>Section Length (mi)</i>	1.00	1.00	1.00	1.00	1.00
<i>Cross Section Information</i>					
Number of Lanes	2	2	2	2	2
Paved Width (ft)	23	23	29	29	27
Lane Width (ft)	10	10	10	10	10
<i>Roadway Condition Information</i>					
SCR (Surface Condition Rating)	92	89	93	91	89
PCR (Pavement Condition Rating)	86	90	91	92	87
<i>Distress Index Values</i>					
Structural Crack Index	98	98	100	100	97
Transverse Cracking Index	98	98	100	100	99
Patching Index	100	100	100	100	100
Rutting Index	92	89	93	91	89
Roughness Condition Index (RCI)	78	92	89	93	85

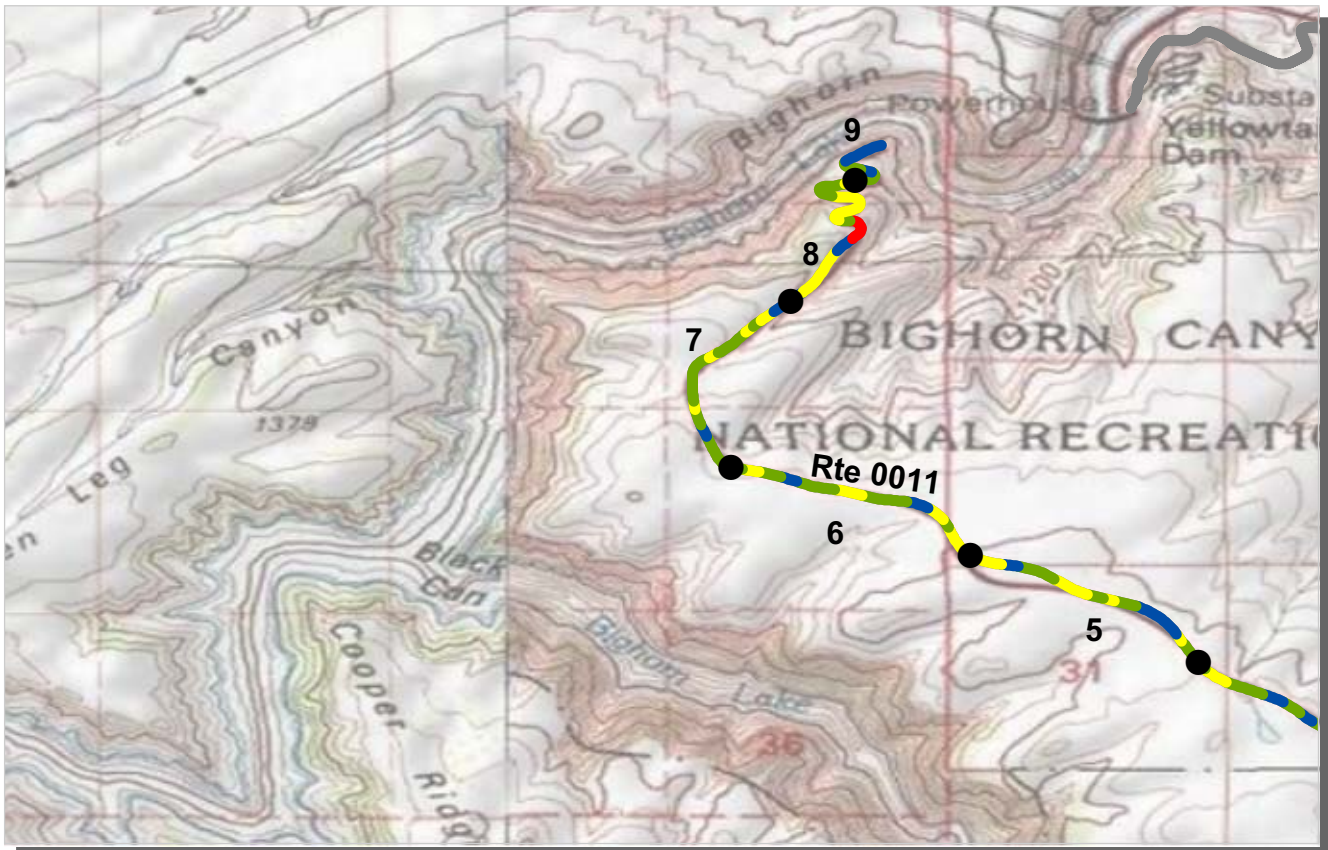
ROUTE: 0011 OK-A-BEH ROAD

<i>Section Number</i>	5	6	7	8	9
<i>Section Length (mi)</i>	1.00	1.00	1.00	1.00	0.37
<i>Cross Section Information</i>					
Number of Lanes	2	2	2	2	2
Paved Width (ft)	24	26	27	27	29
Lane Width (ft)	10	10	10	10	10
<i>Roadway Condition Information</i>					
SCR (Surface Condition Rating)	89	89	90	92	96
PCR (Pavement Condition Rating)	86	85	88	81	89
<i>Distress Index Values</i>					
Structural Crack Index	97	99	100	100	100
Transverse Cracking Index	98	98	99	99	100
Patching Index	100	100	100	95	100
Rutting Index	89	89	90	92	96
Roughness Condition Index (RCI)	82	79	84	64	79

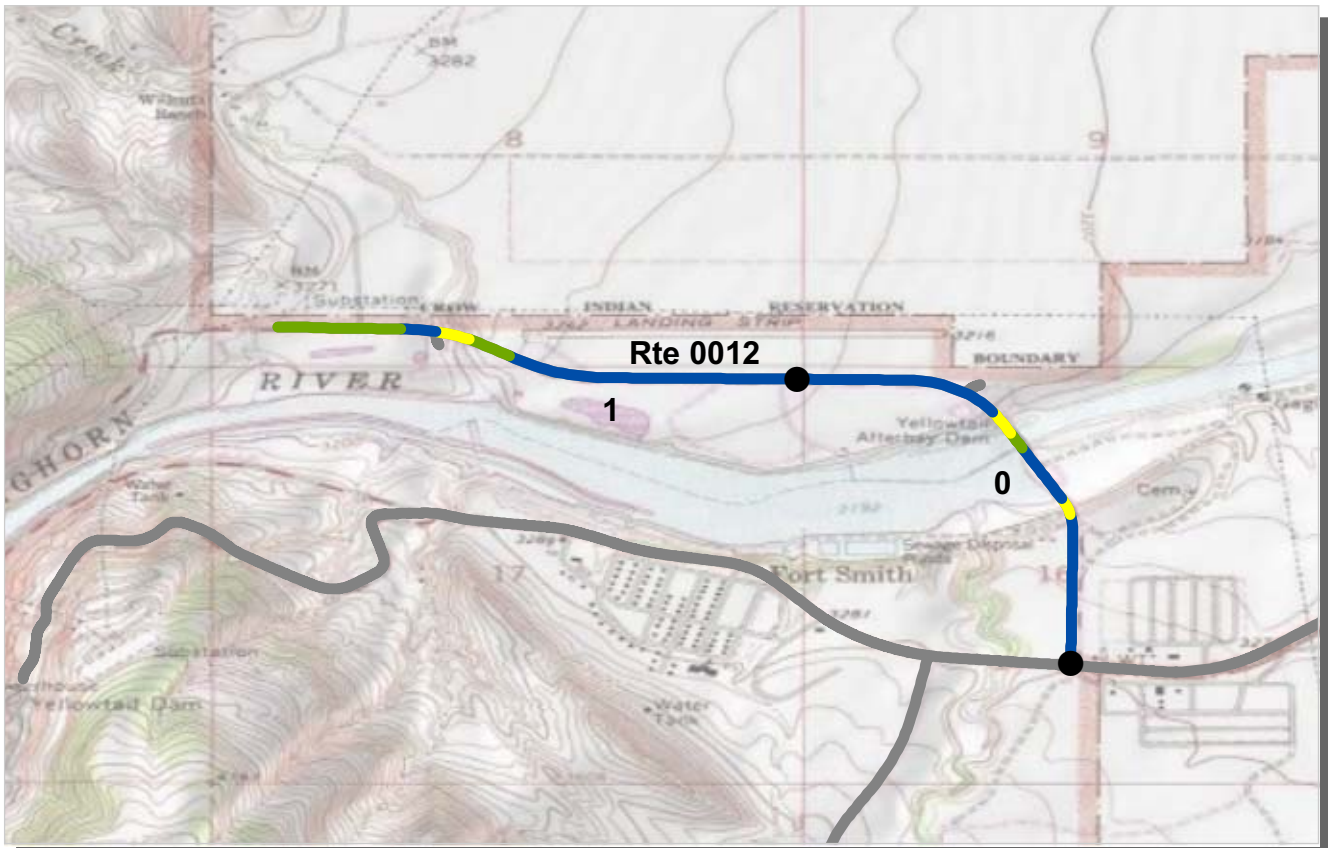
ROUTE: 0012 AFTERBAY ROAD

<i>Section Number</i>	0	1			
<i>Section Length (mi)</i>	1.00	0.91			
<i>Cross Section Information</i>					
Number of Lanes	2	2			
Paved Width (ft)	34	32			
Lane Width (ft)	11	11			
<i>Roadway Condition Information</i>					
SCR (Surface Condition Rating)	97	95			
PCR (Pavement Condition Rating)	97	94			
<i>Distress Index Values</i>					
Structural Crack Index	98	97			
Transverse Cracking Index	97	96			
Patching Index	100	100			
Rutting Index	98	95			
Roughness Condition Index (RCI)	96	92

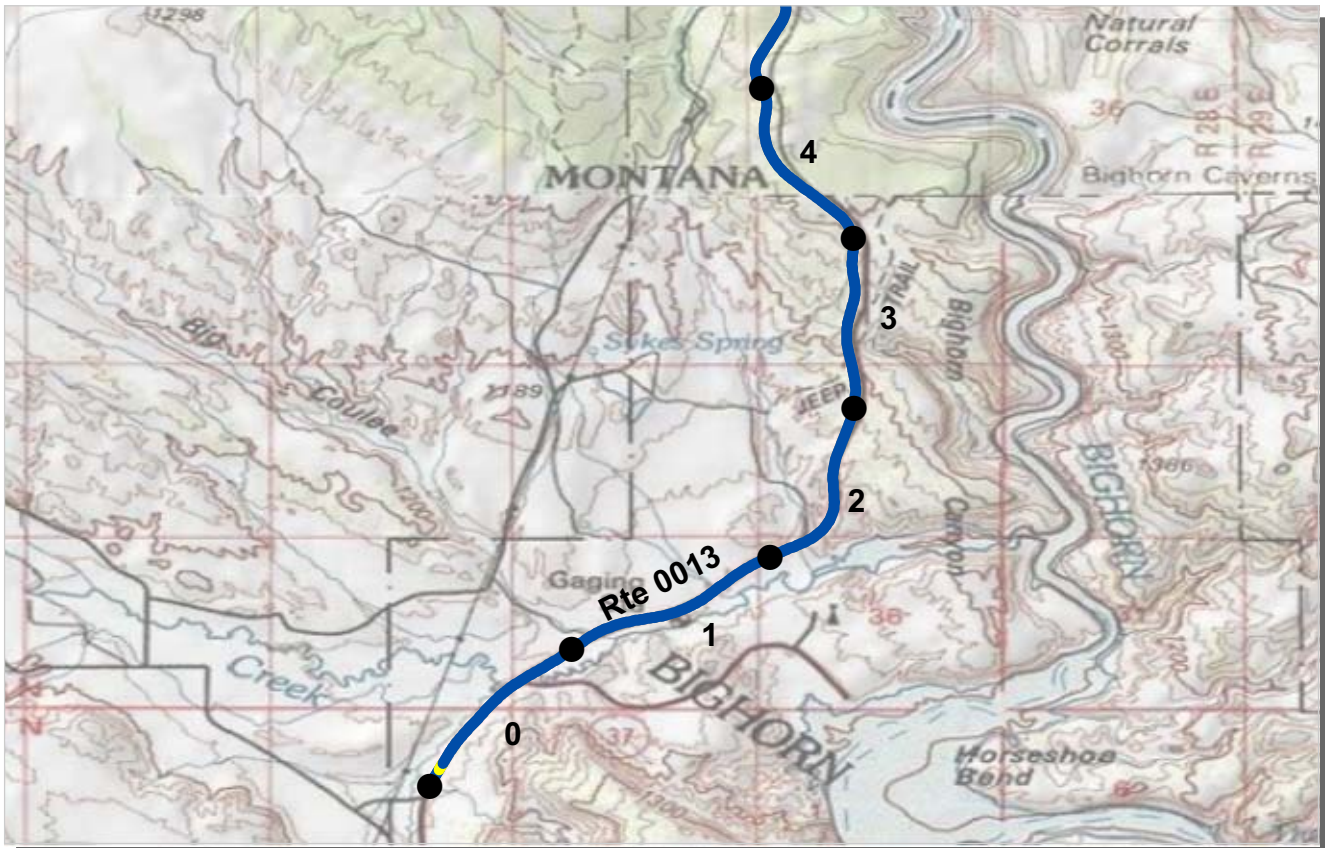
ROUTE: 0013 BAD PASS ROAD

<i>Section Number</i>	0	1	2	3	4
<i>Section Length (mi)</i>	1.00	1.00	1.00	1.00	1.00
<i>Cross Section Information</i>					
Number of Lanes	2	2	2	2	2
Paved Width (ft)	37	31	31	31	31
Lane Width (ft)	13	12	12	11	11
<i>Roadway Condition Information</i>					
SCR (Surface Condition Rating)	100	100	100	100	100
PCR (Pavement Condition Rating)	100	100	100	100	100
<i>Distress Index Values</i>					
Structural Crack Index	100	100	100	100	100
Transverse Cracking Index	100	100	100	100	100
Patching Index	100	100	100	100	100
Rutting Index	100	100	100	100	100
Roughness Condition Index (RCI)	100	100	100	100	100

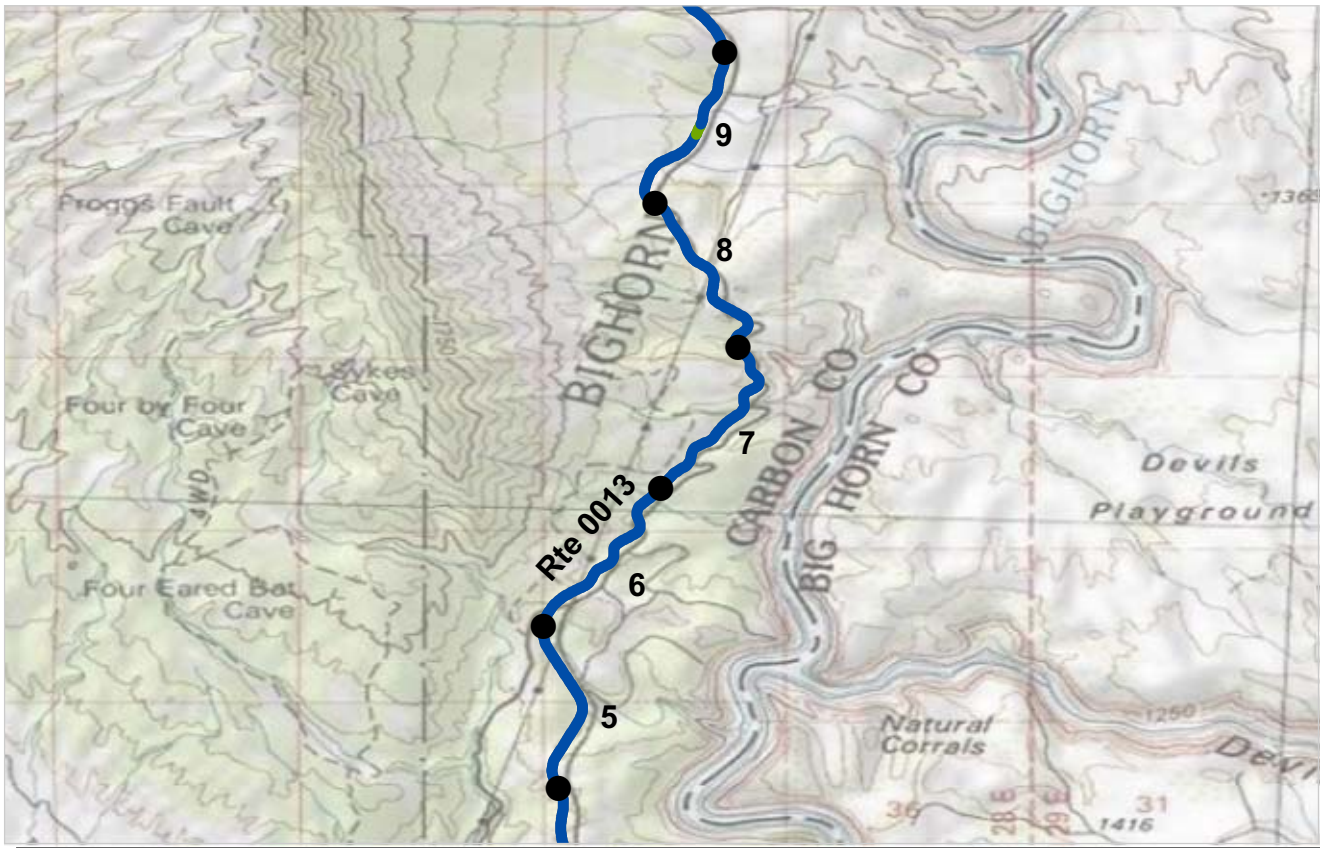
ROUTE: 0013 BAD PASS ROAD

<i>Section Number</i>	5	6	7	8	9
<i>Section Length (mi)</i>	1.00	1.00	1.00	1.00	1.00
<i>Cross Section Information</i>					
Number of Lanes	2	2	2	2	2
Paved Width (ft)	31	37	36	34	32
Lane Width (ft)	12	13	12	11	11
<i>Roadway Condition Information</i>					
SCR (Surface Condition Rating)	100	100	96	100	98
PCR (Pavement Condition Rating)	100	100	98	100	99
<i>Distress Index Values</i>					
Structural Crack Index	100	100	100	100	98
Transverse Cracking Index	100	100	100	100	100
Patching Index	100	100	100	100	100
Rutting Index	100	100	96	100	99
Roughness Condition Index (RCI)	100	100	100	100	100

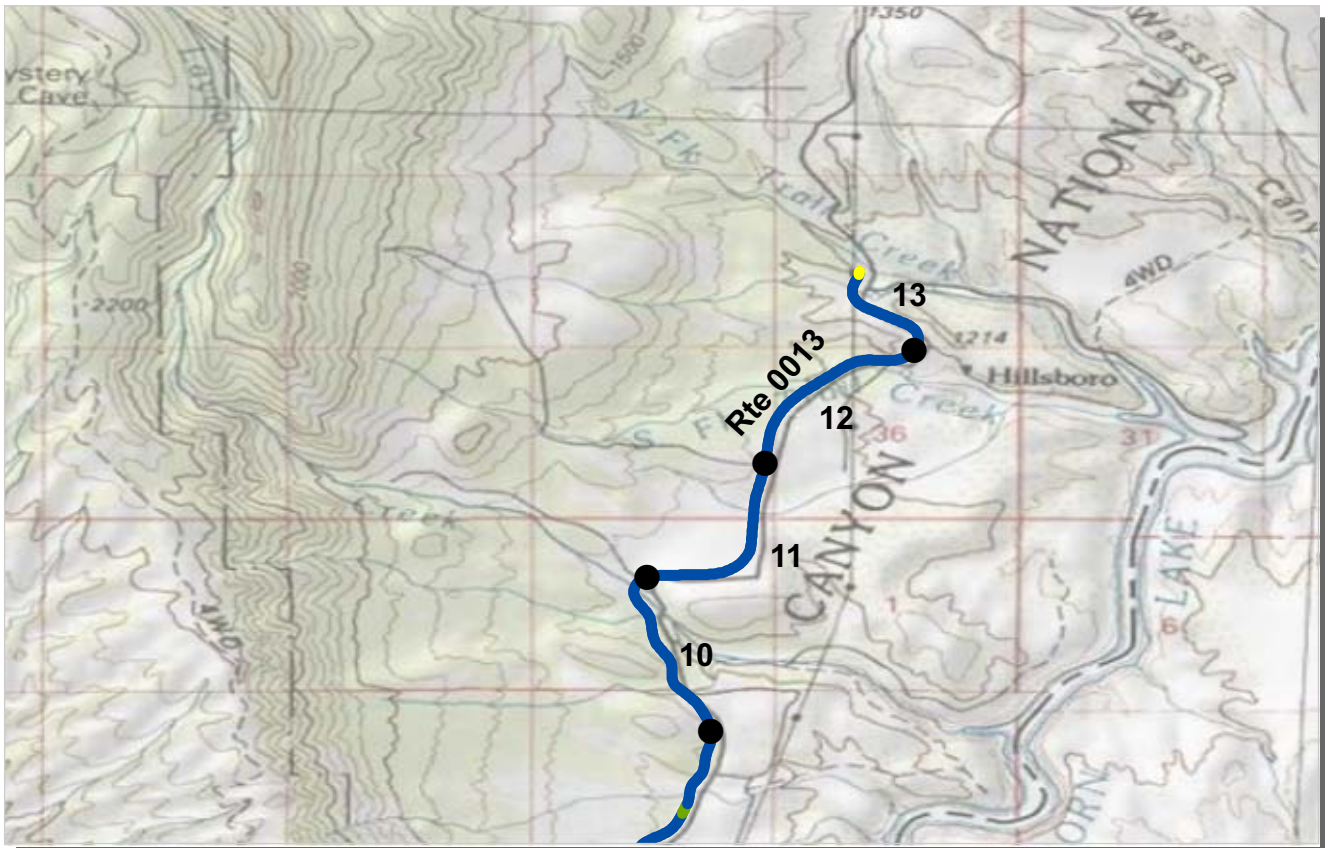
ROUTE: 0013 BAD PASS ROAD

<i>Section Number</i>	10	11	12	13
<i>Section Length (mi)</i>	1.00	1.00	1.00	0.60
<i>Cross Section Information</i>				
Number of Lanes	2	2	2	2
Paved Width (ft)	33	32	33	38
Lane Width (ft)	11	11	11	12
<i>Roadway Condition Information</i>				
SCR (Surface Condition Rating)	99	99	99	98
PCR (Pavement Condition Rating)	99	99	99	99
<i>Distress Index Values</i>				
Structural Crack Index	99	99	99	100
Transverse Cracking Index	100	100	100	100
Patching Index	100	100	100	100
Rutting Index	99	100	99	98
Roughness Condition Index (RCI)	100	100	100	100

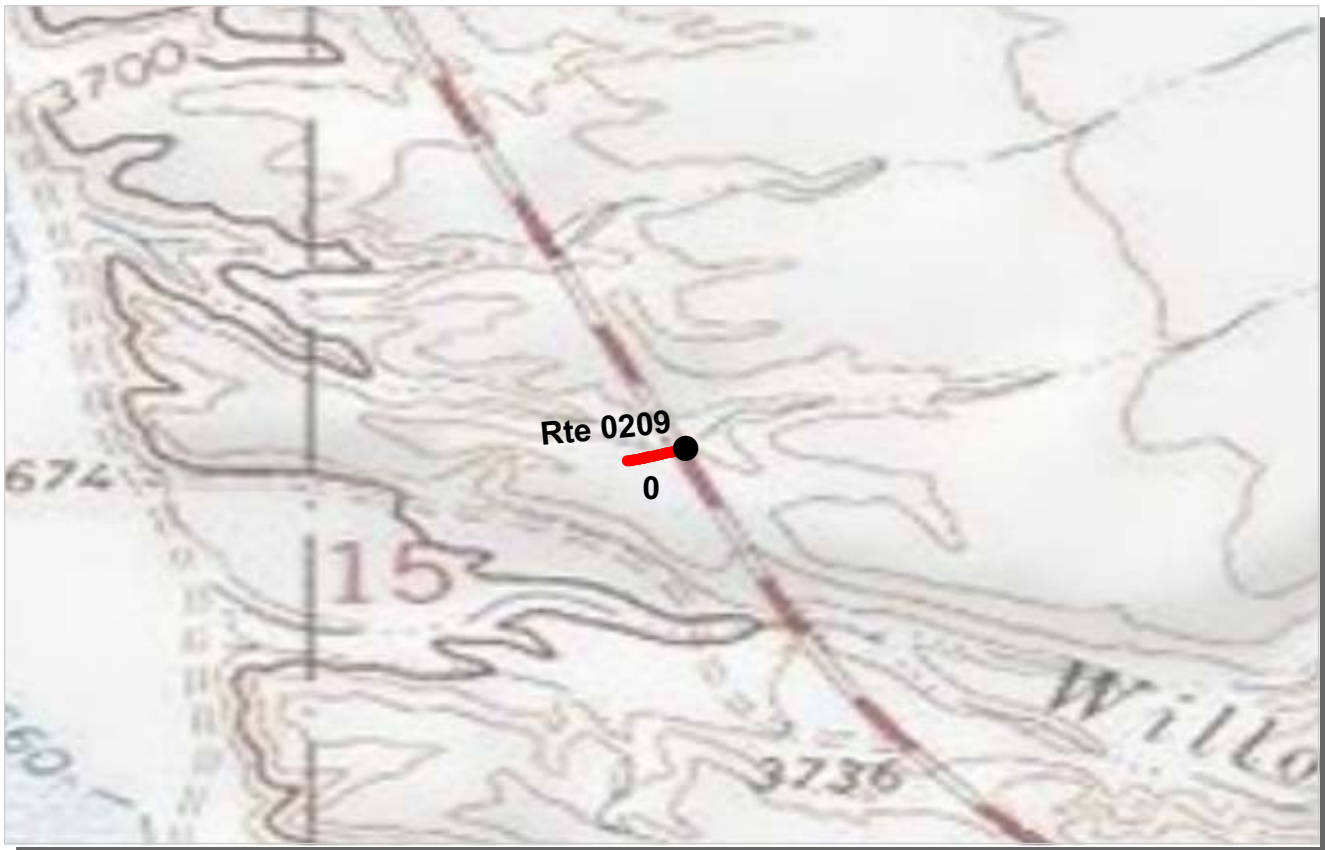
ROUTE: 0209 M. L. RANCH ROAD SOUTH UNIT

Section Number	0				
Section Length (mi)	0.03				
Cross Section Information					
Number of Lanes	2				
Paved Width (ft)	18				
Lane Width (ft)	9				
Roadway Condition Information					
SCR (Surface Condition Rating)	60				
PCR (Pavement Condition Rating)	60				
Distress Index Values					
Structural Crack Index	81				
Transverse Cracking Index	60				
Patching Index	100				
Rutting Index	94				
Roughness Condition Index (RCI)	NC

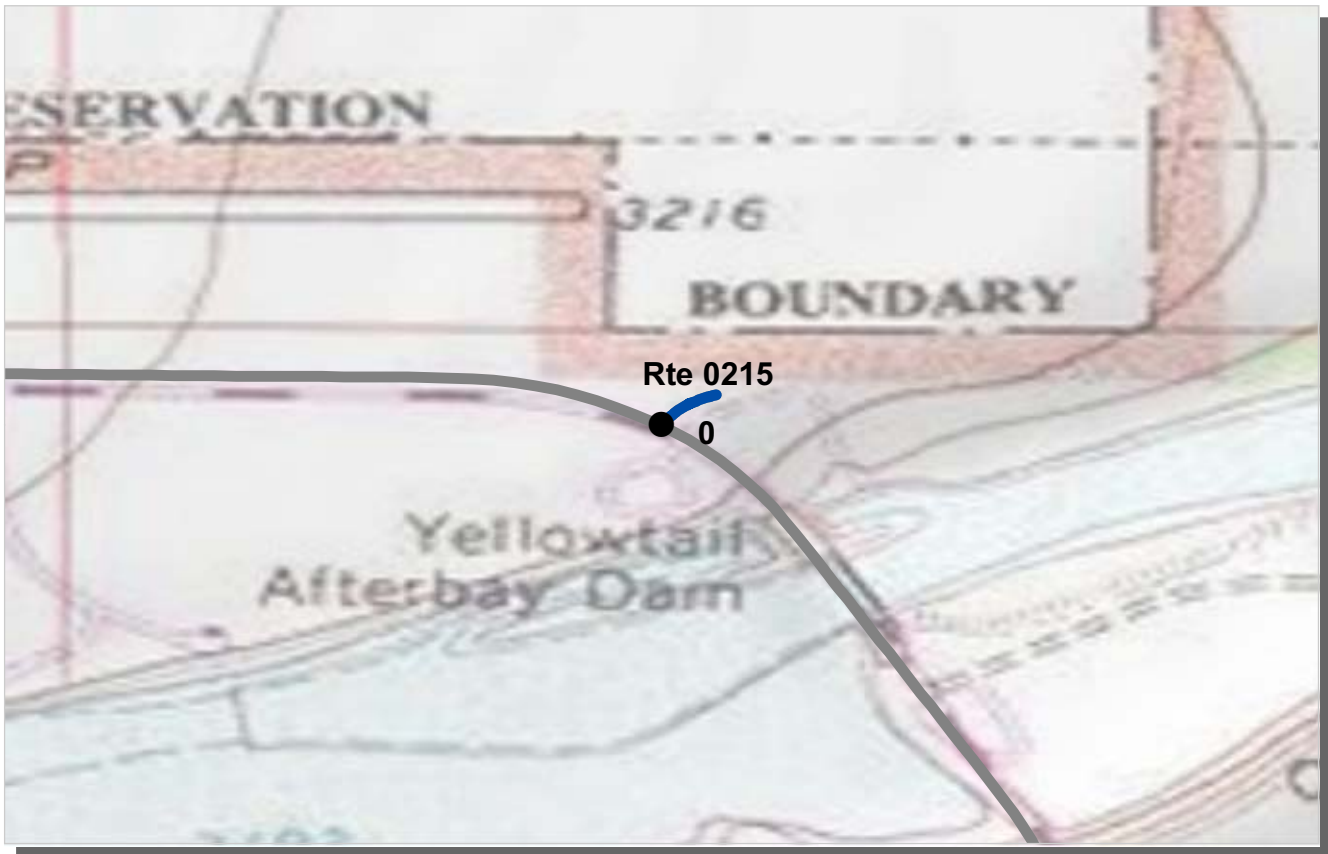
ROUTE: 0215 AFTERBAY RIVER LAUNCH ROAD

Section Number	0				
Section Length (mi)	0.03				
Cross Section Information					
Number of Lanes	2				
Paved Width (ft)	20				
Lane Width (ft)	9				
Roadway Condition Information					
SCR (Surface Condition Rating)	98				
PCR (Pavement Condition Rating)	98				
Distress Index Values					
Structural Crack Index	99				
Transverse Cracking Index	98				
Patching Index	100				
Rutting Index	98				
Roughness Condition Index (RCI)	NC

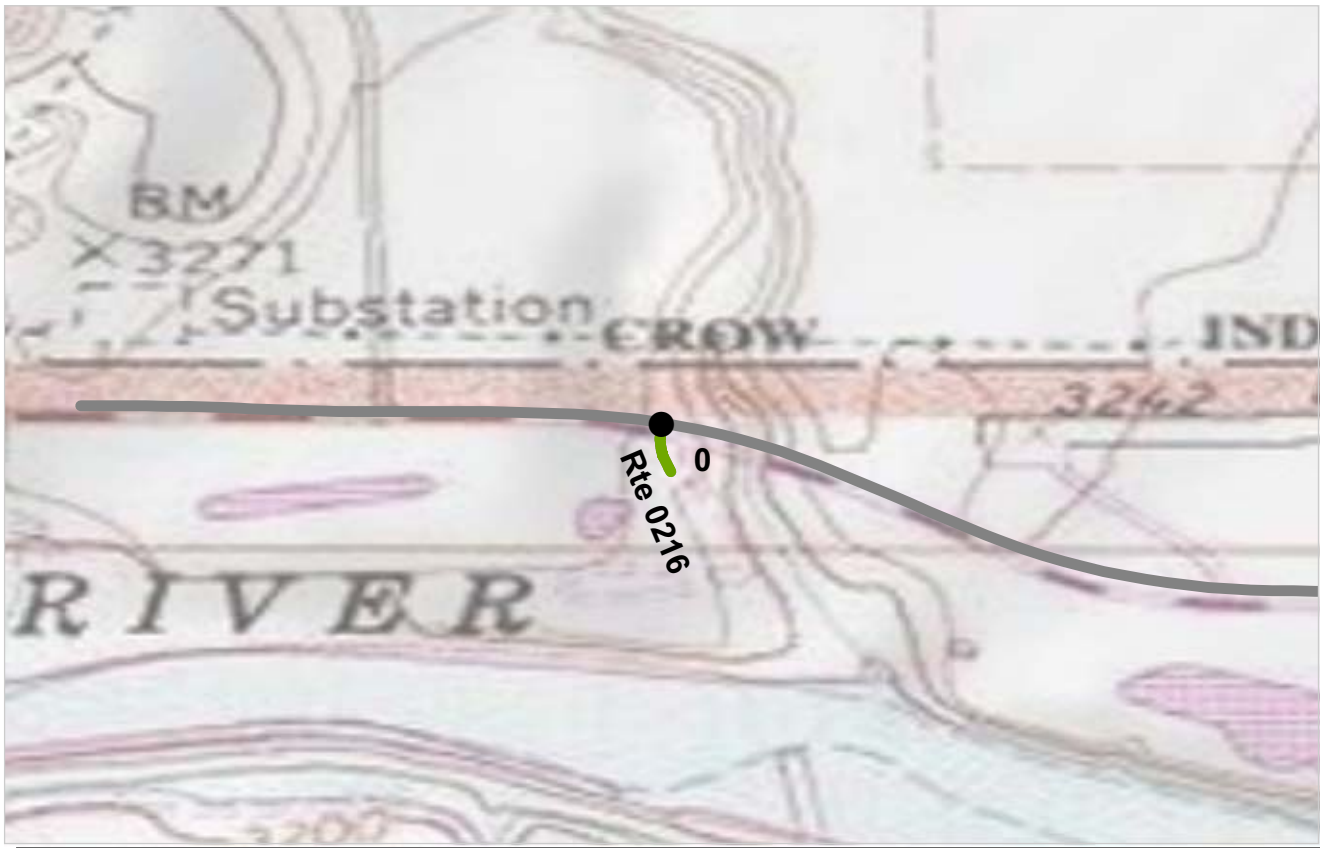
ROUTE: 0216 GRAPEVINE CAMPGROUND ROAD

Section Number	0				
Section Length (mi)	0.03				
Cross Section Information					
Number of Lanes	2				
Paved Width (ft)	21				
Lane Width (ft)	13				
Roadway Condition Information					
SCR (Surface Condition Rating)	89				
PCR (Pavement Condition Rating)	89				
Distress Index Values					
Structural Crack Index	100				
Transverse Cracking Index	100				
Patching Index	100				
Rutting Index	89				
Roughness Condition Index (RCI)	NC

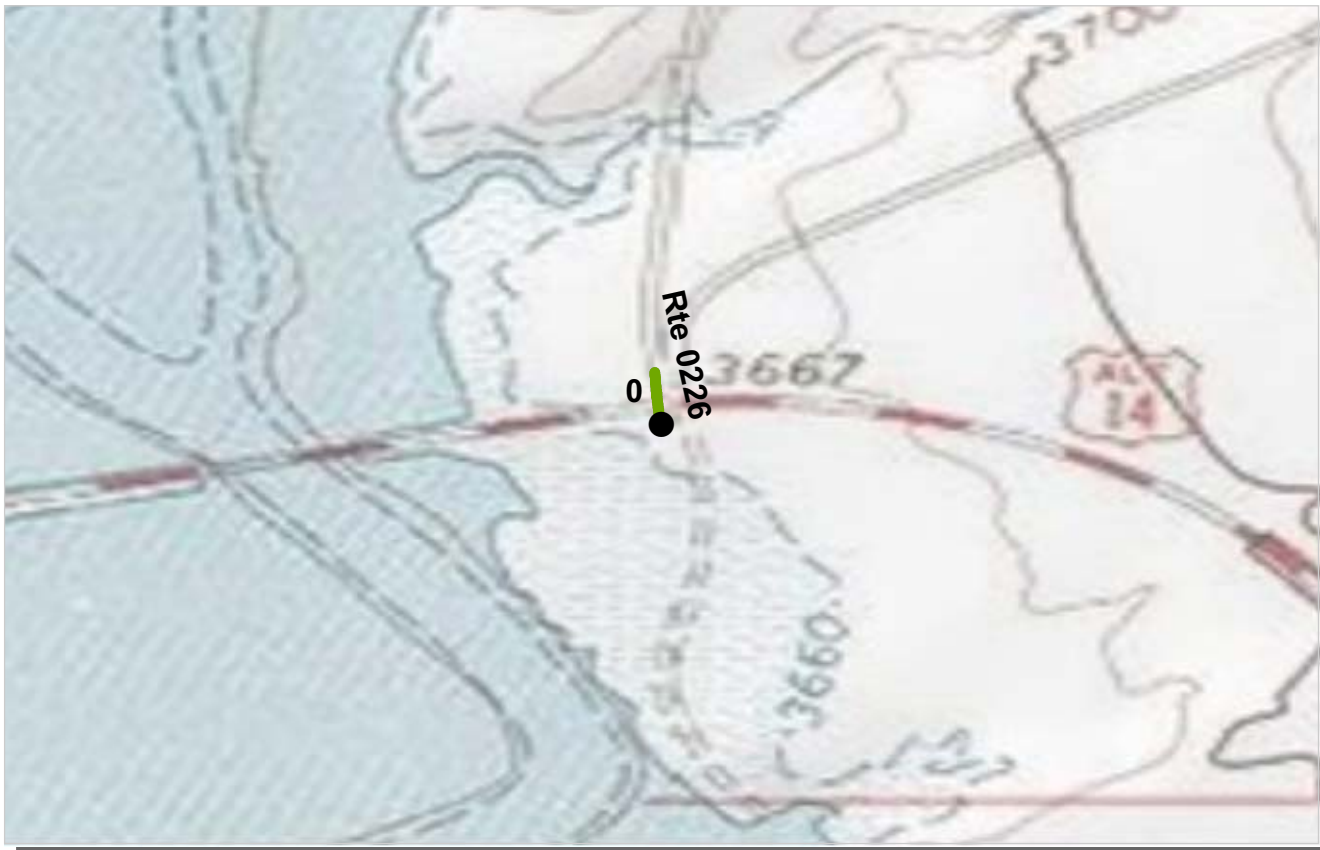
ROUTE: 0226 JOHN BLUE CANYON ROAD

Section Number	0				
Section Length (mi)	0.04				
Cross Section Information					
Number of Lanes	2				
Paved Width (ft)	25				
Lane Width (ft)	13				
Roadway Condition Information					
SCR (Surface Condition Rating)	91				
PCR (Pavement Condition Rating)	91				
Distress Index Values					
Structural Crack Index	98				
Transverse Cracking Index	99				
Patching Index	100				
Rutting Index	91				
Roughness Condition Index (RCI)	NC
