Federal Lands Highway Road Inventory Program

Road Inventory and Condition Assessment

Buffalo National River BUFF - 7150

Cycle 5 Report

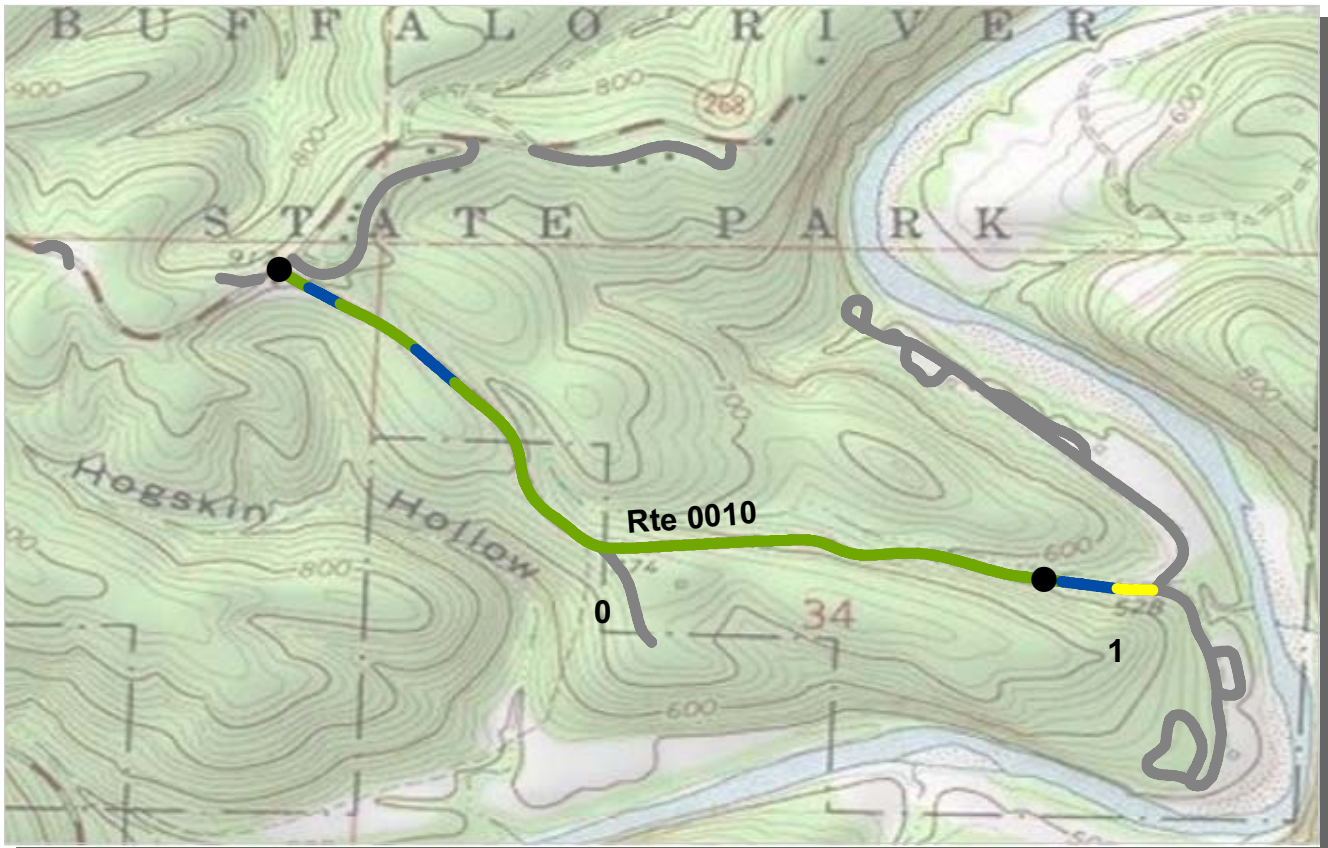
<i>Section Number</i>	0	1			
<i>Section Length (mi)</i>	1.00	0.12			
<i>Cross Section Information</i>					
Number of Lanes	2	2			
Paved Width (ft)	22	22			
Lane Width (ft)	10	9			
<i>Roadway Condition Information</i>					
SCR (Surface Condition Rating)	97	98			
PCR (Pavement Condition Rating)	90	82			
<i>Distress Index Values</i>					
Structural Crack Index	100	100			
Transverse Cracking Index	100	100			
Patching Index	100	100			
Rutting Index	97	98			
Roughness Condition Index (RCI)	80	57

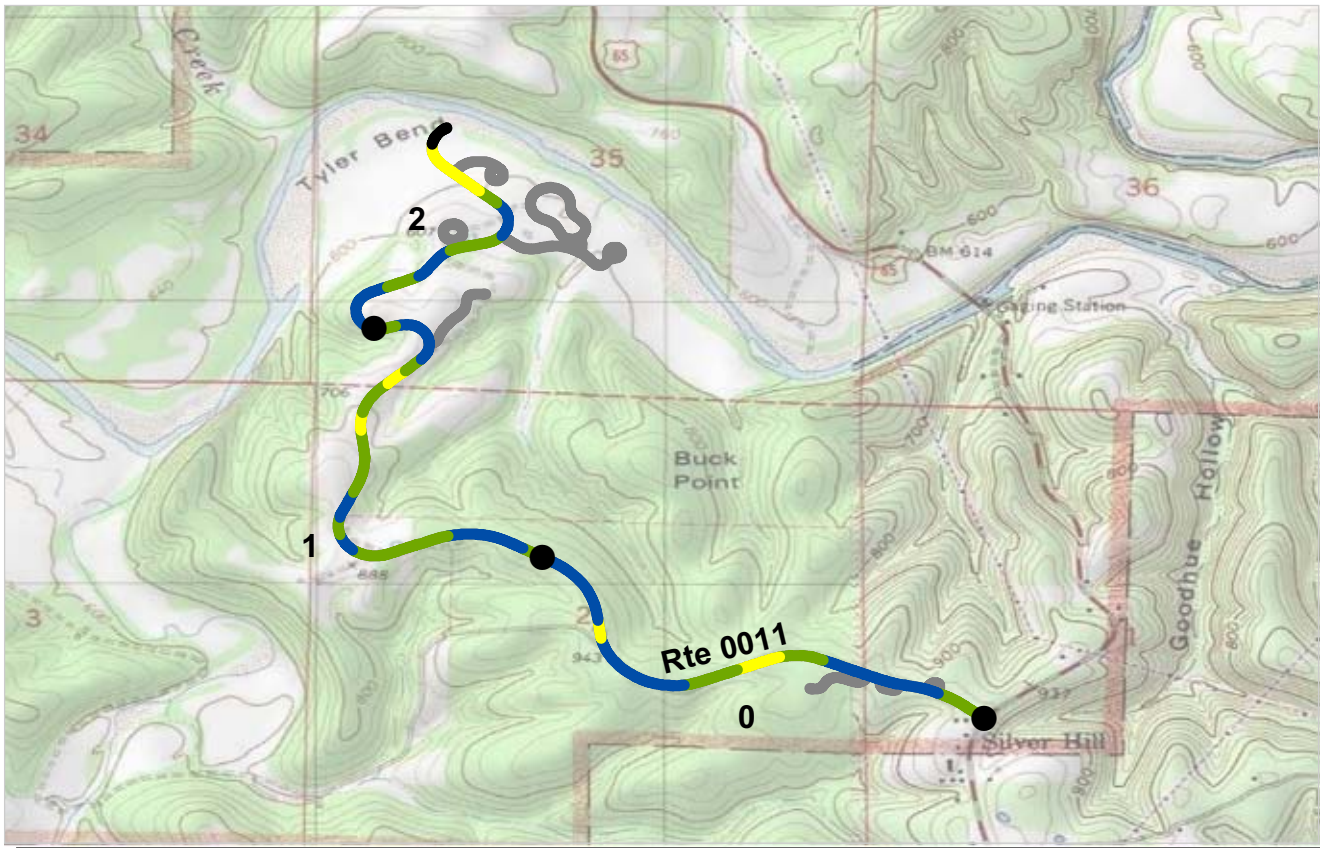
ROUTE: 0010 BUFFALO POINT ROAD

<i>Section Number</i>	0	1	2		
<i>Section Length (mi)</i>	1.00	1.00	0.69		
<i>Cross Section Information</i>					
Number of Lanes	2	2	2		
Paved Width (ft)	21	22	25		
Lane Width (ft)	10	10	11		
<i>Roadway Condition Information</i>					
SCR (Surface Condition Rating)	93	91	90		
PCR (Pavement Condition Rating)	91	91	89		
<i>Distress Index Values</i>					
Structural Crack Index	100	100	100		
Transverse Cracking Index	100	100	100		
Patching Index	100	100	100		
Rutting Index	93	91	90		
Roughness Condition Index (RCI)	88	91	87

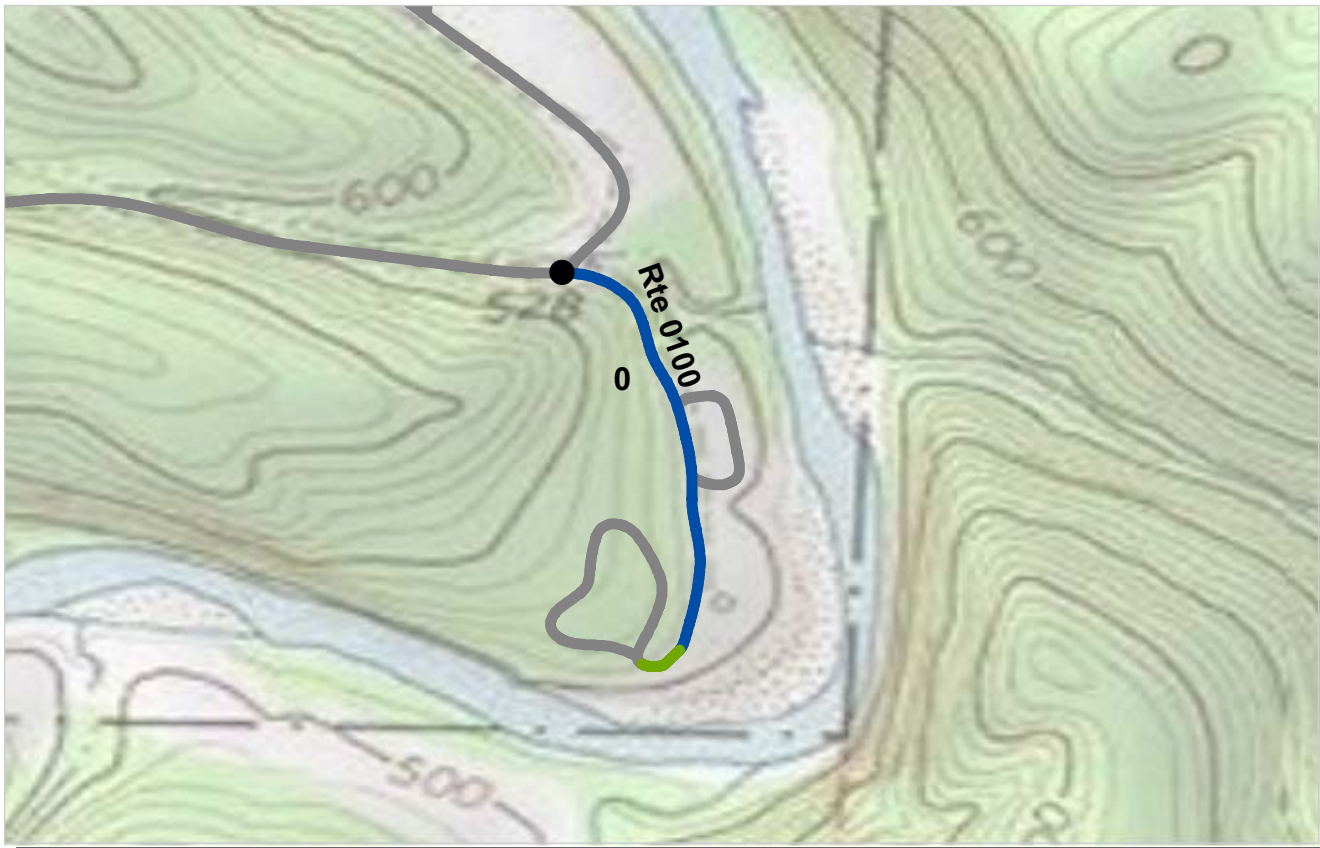
ROUTE: 0011 TYLER BEND ROAD

Section Number	0				
Section Length (mi)	0.30				
Cross Section Information					
Number of Lanes	2				
Paved Width (ft)	22				
Lane Width (ft)	10				
Roadway Condition Information					
SCR (Surface Condition Rating)	98				
PCR (Pavement Condition Rating)	98				
Distress Index Values					
Structural Crack Index	99				
Transverse Cracking Index	100				
Patching Index	100				
Rutting Index	98				
Roughness Condition Index (RCI)	NC

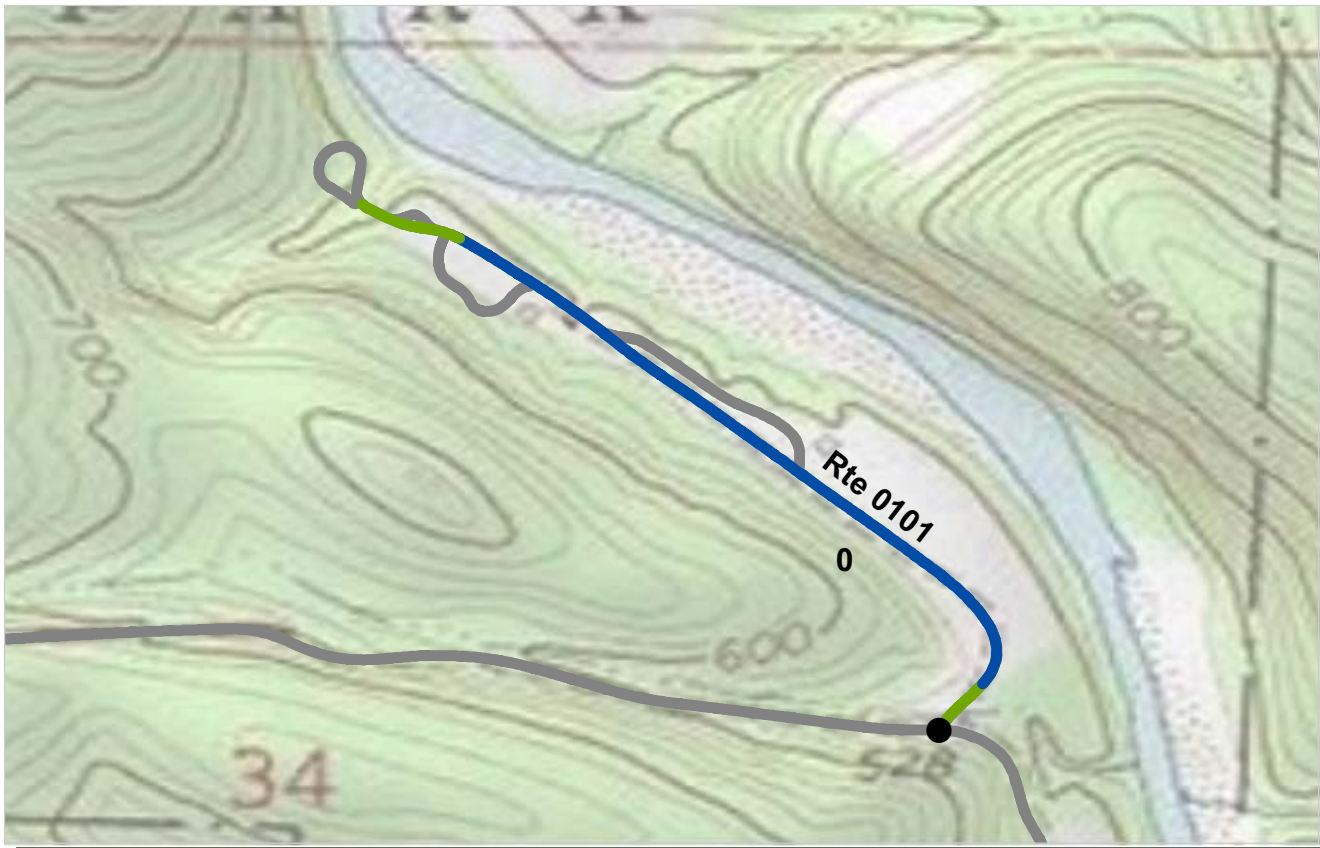
ROUTE: 0100 BUFFALO POINT RIVER ACCESS ROAD

Section Number	0				
Section Length (mi)	0.51				
Cross Section Information					
Number of Lanes	2				
Paved Width (ft)	19				
Lane Width (ft)	9				
Roadway Condition Information					
SCR (Surface Condition Rating)	95				
PCR (Pavement Condition Rating)	95				
Distress Index Values					
Structural Crack Index	100				
Transverse Cracking Index	99				
Patching Index	100				
Rutting Index	95				
Roughness Condition Index (RCI)	NC

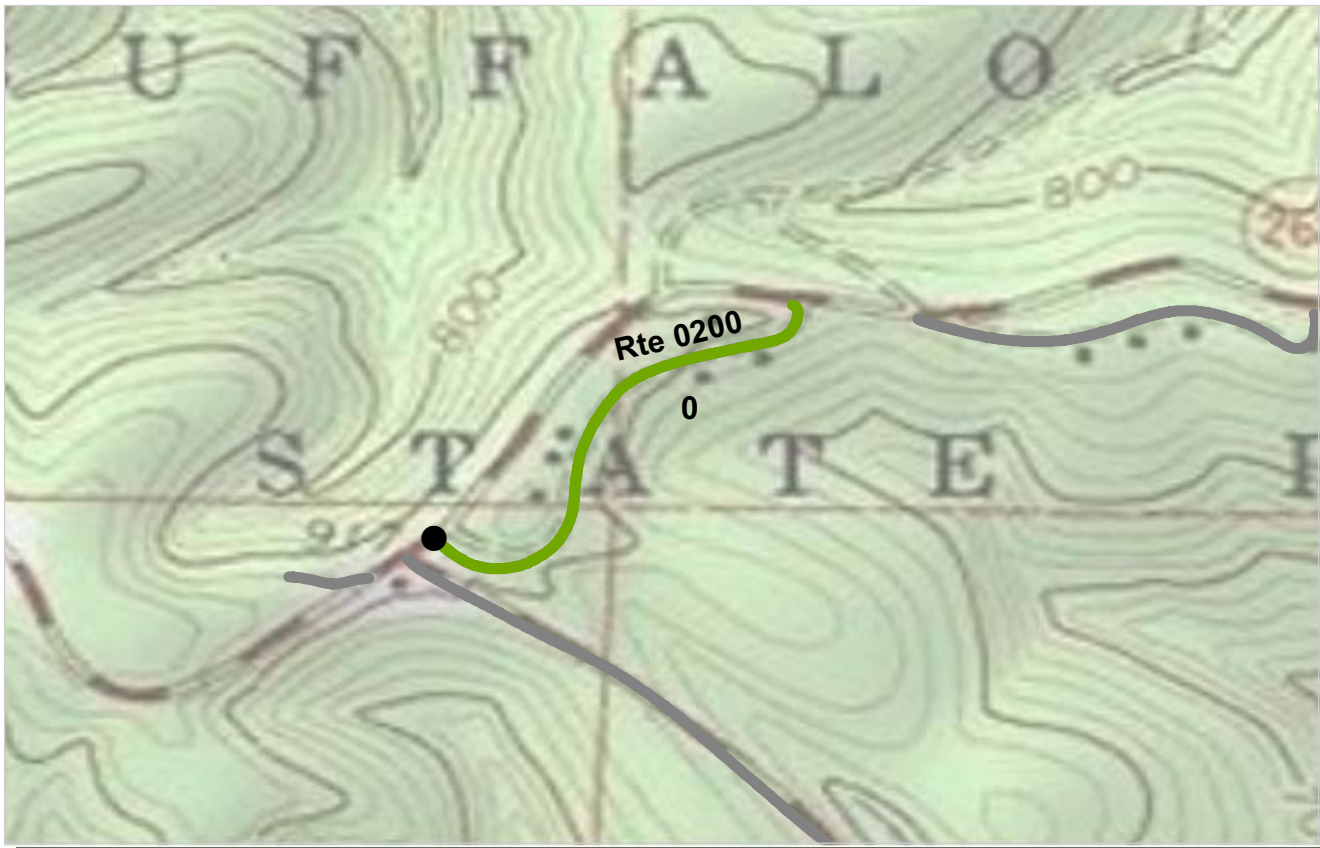
ROUTE: 0200 RUSTIC CABIN LOOP
BUFF : BUFFALO NATIONAL RIVER

Section Number	0				
Section Length (mi)	0.30				
Cross Section Information					
Number of Lanes	1				
Paved Width (ft)	13				
Lane Width (ft)	12				
Roadway Condition Information					
SCR (Surface Condition Rating)	90				
PCR (Pavement Condition Rating)	90				
Distress Index Values					
Structural Crack Index	100				
Transverse Cracking Index	100				
Patching Index	100				
Rutting Index	90				
Roughness Condition Index (RCI)	NC
