Federal Lands Highway Road Inventory Program

Road Inventory and Condition Assessment

Canyon de Chelly National Monument CACH

Cycle 5 Report

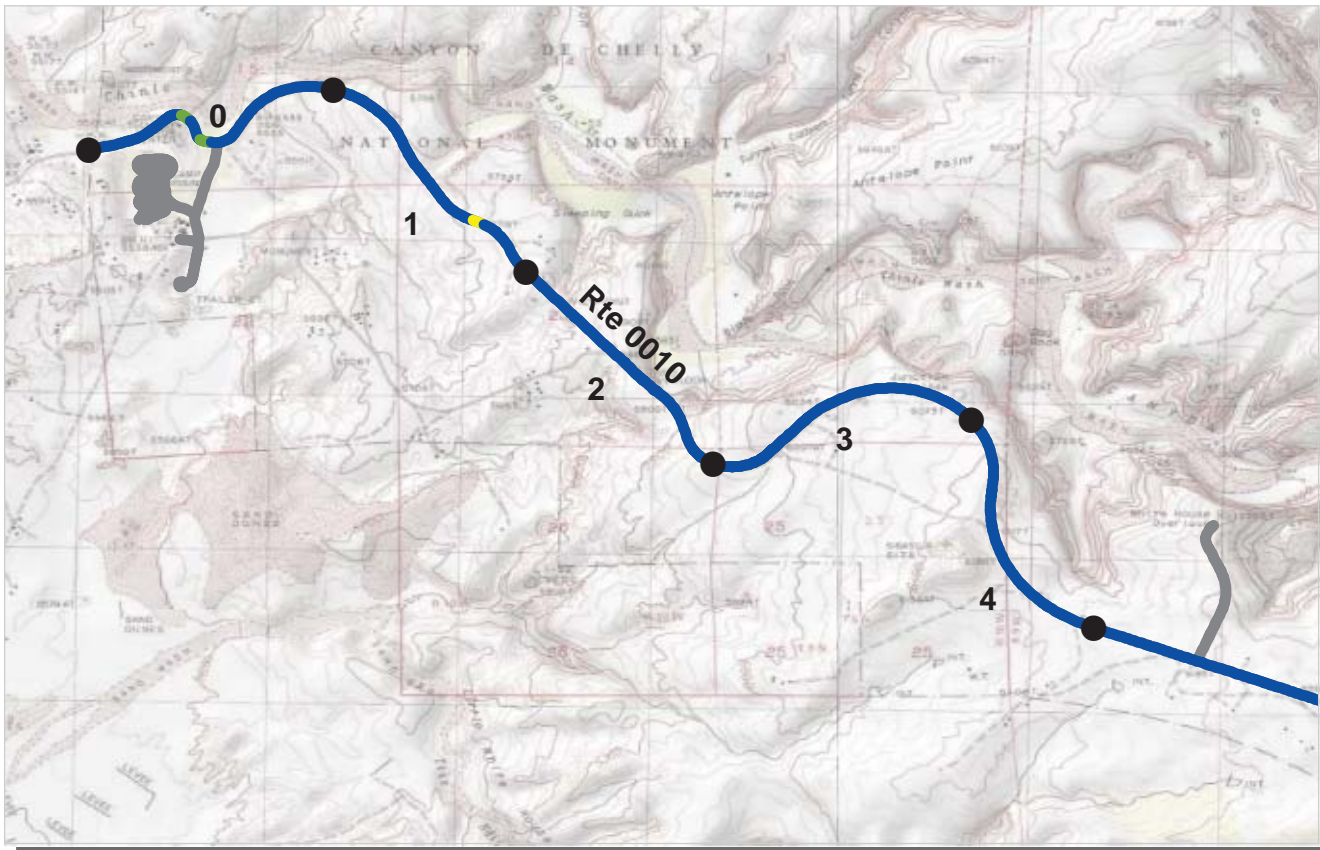
ROUTE: 0010 INDIAN ROUTE 7 (SOUTH RIM DRIVE)

<i>Section Number</i>	0	1	2	3	4
<i>Section Length (mi)</i>	1.00	1.00	1.00	1.00	1.00
<i>Cross Section Information</i>					
Number of Lanes	2	2	2	2	2
Paved Width (ft)	27	24	24	23	25
Lane Width (ft)	11	11	11	11	12
<i>Roadway Condition Information</i>					
SCR (Surface Condition Rating)	100	99	100	100	100
PCR (Pavement Condition Rating)	100	99	100	100	100
<i>Distress Index Values</i>					
Structural Crack Index	100	100	100	100	100
Transverse Cracking Index	100	100	100	100	100
Patching Index	100	99	100	100	100
Rutting Index	100	100	100	100	100
Roughness Condition Index (RCI)	100	100	100	100	100

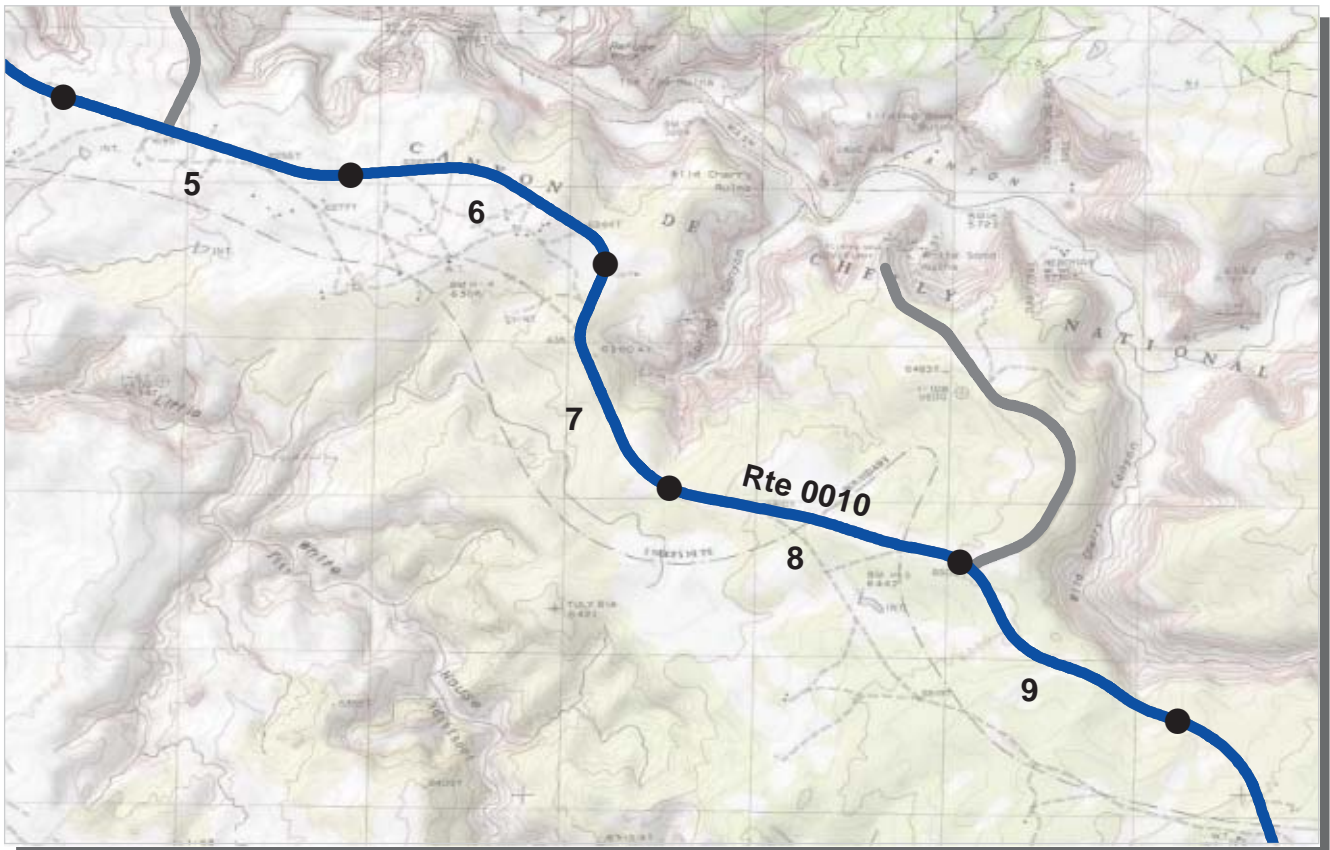
ROUTE: 0010 INDIAN ROUTE 7 (SOUTH RIM DRIVE)

<i>Section Number</i>	5	6	7	8	9
<i>Section Length (mi)</i>	1.00	1.00	1.00	1.00	1.00
<i>Cross Section Information</i>					
Number of Lanes	2	2	2	2	2
Paved Width (ft)	23	22	23	23	24
Lane Width (ft)	11	11	11	11	12
<i>Roadway Condition Information</i>					
SCR (Surface Condition Rating)	100	100	100	100	100
PCR (Pavement Condition Rating)	100	100	100	100	100
<i>Distress Index Values</i>					
Structural Crack Index	100	100	100	100	100
Transverse Cracking Index	100	100	100	100	100
Patching Index	100	100	100	100	100
Rutting Index	100	100	100	100	100
Roughness Condition Index (RCI)	100	100	100	100	100

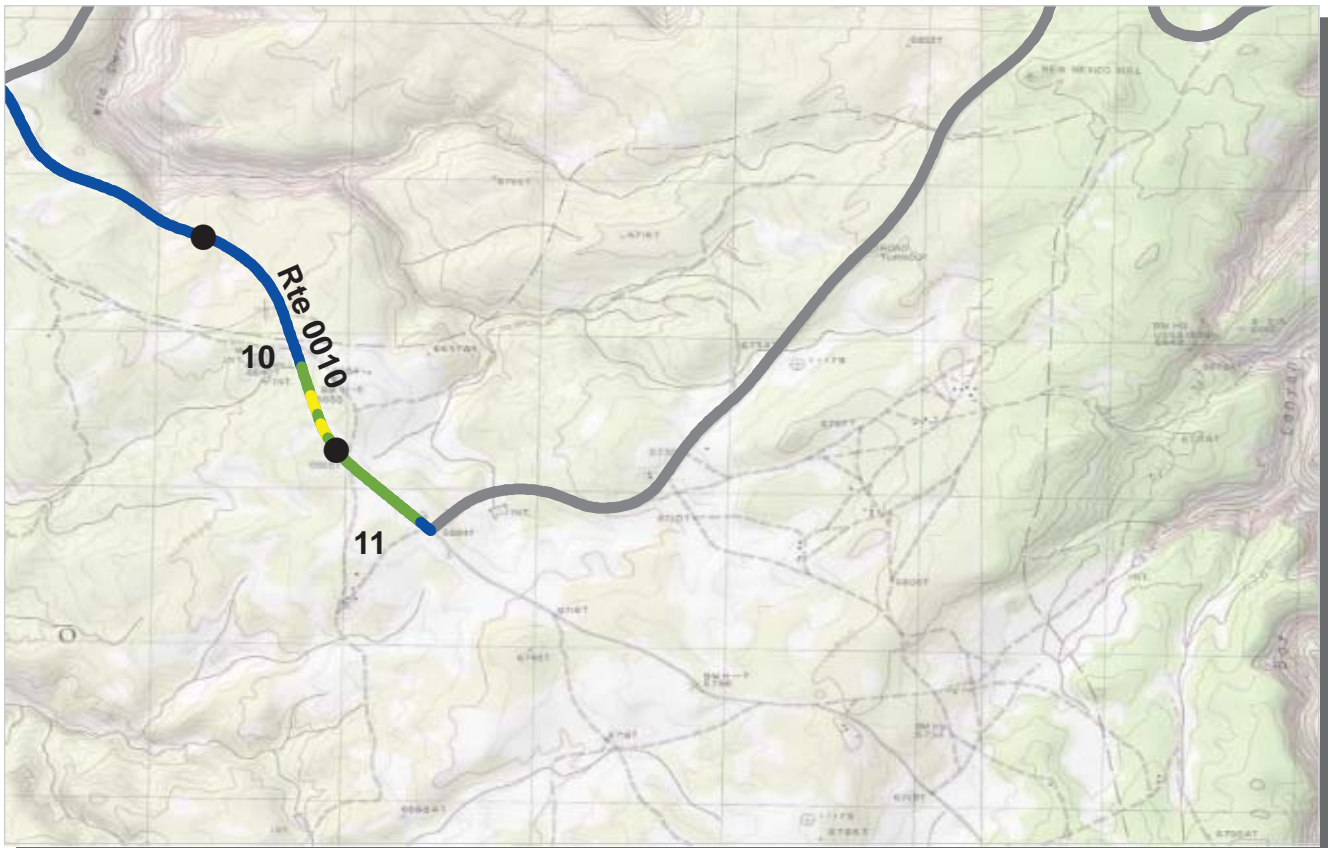
ROUTE: 0010 INDIAN ROUTE 7 (SOUTH RIM DRIVE)

<i>Section Number</i>	10	11			
<i>Section Length (mi)</i>	1.00	0.46			
<i>Cross Section Information</i>					
Number of Lanes	2	2			
Paved Width (ft)	26	27			
Lane Width (ft)	12	11			
<i>Roadway Condition Information</i>					
SCR (Surface Condition Rating)	94	90			
PCR (Pavement Condition Rating)	96	94			
<i>Distress Index Values</i>					
Structural Crack Index	94	90			
Transverse Cracking Index	97	90			
Patching Index	100	100			
Rutting Index	99	96			
Roughness Condition Index (RCI)	100	99

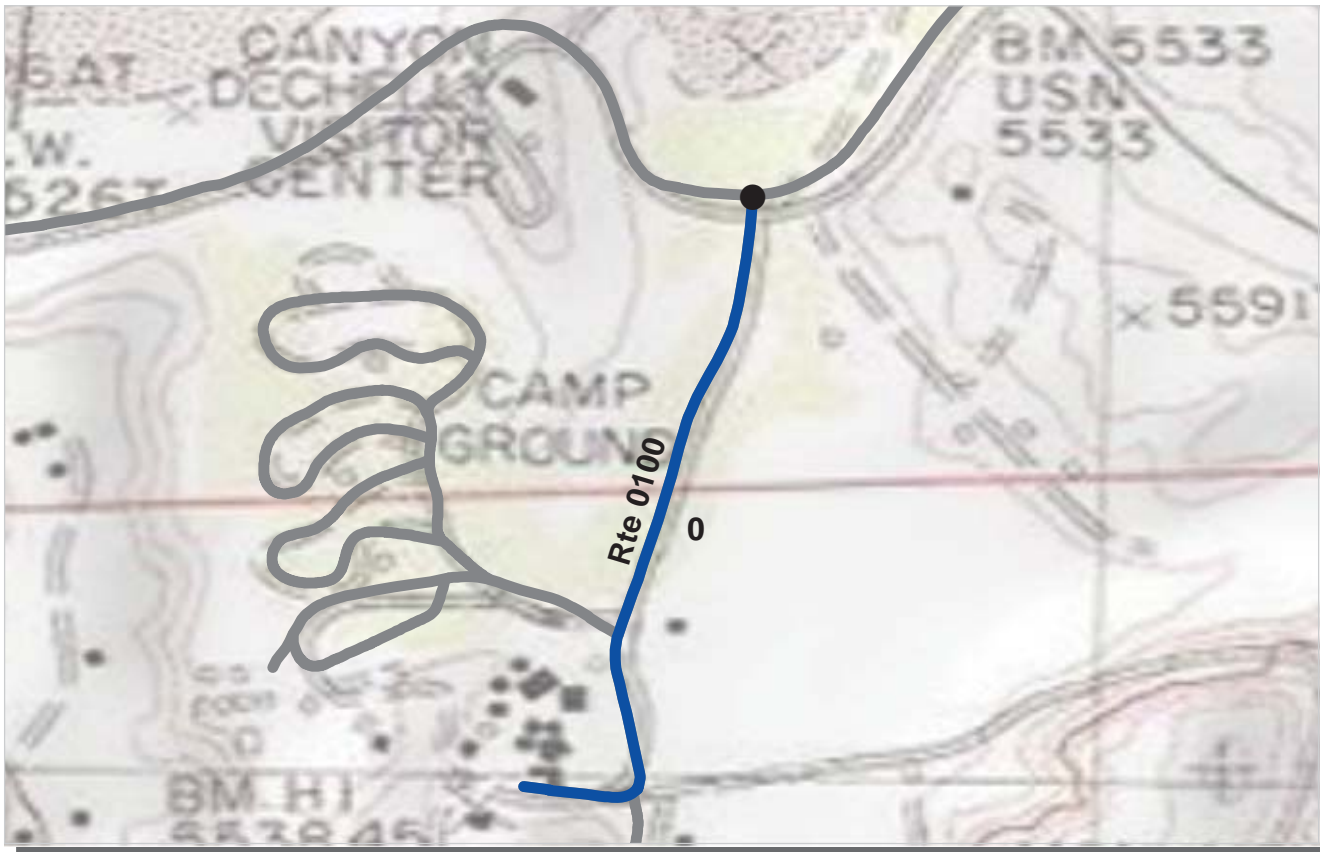
ROUTE: 0100 LODGE CAMPGROUND ACCESS ROAD

Section Number	0				
Section Length (mi)	0.46				
Cross Section Information					
Number of Lanes	2				
Paved Width (ft)	28				
Lane Width (ft)	14				
Roadway Condition Information					
SCR (Surface Condition Rating)	99				
PCR (Pavement Condition Rating)	99				
Distress Index Values					
Structural Crack Index	100				
Transverse Cracking Index	100				
Patching Index	100				
Rutting Index	99				
Roughness Condition Index (RCI)	NC

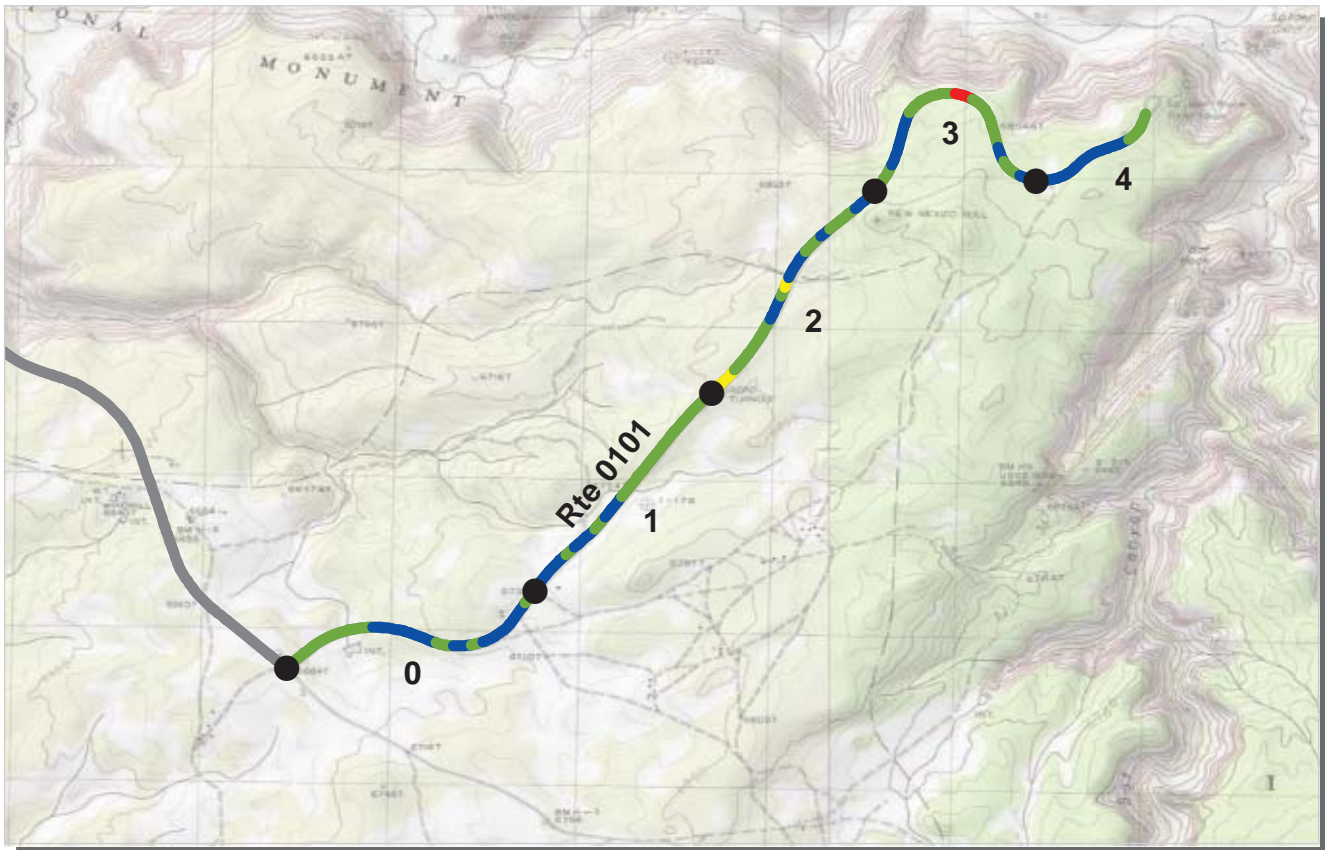
ROUTE: 0101 SPIDER ROCK ROAD

<i>Section Number</i>	0	1	2	3	4
<i>Section Length (mi)</i>	1.00	1.00	1.00	1.00	0.48
<i>Cross Section Information</i>					
Number of Lanes	2	2	2	2	2
Paved Width (ft)	31	29	30	32	30
Lane Width (ft)	12	11	12	12	11
<i>Roadway Condition Information</i>					
SCR (Surface Condition Rating)	94	94	96	93	97
PCR (Pavement Condition Rating)	96	95	94	91	95
<i>Distress Index Values</i>					
Structural Crack Index	94	94	96	93	97
Transverse Cracking Index	94	96	97	97	97
Patching Index	100	100	100	100	100
Rutting Index	98	97	96	96	98
Roughness Condition Index (RCI)	100	96	90	89	93

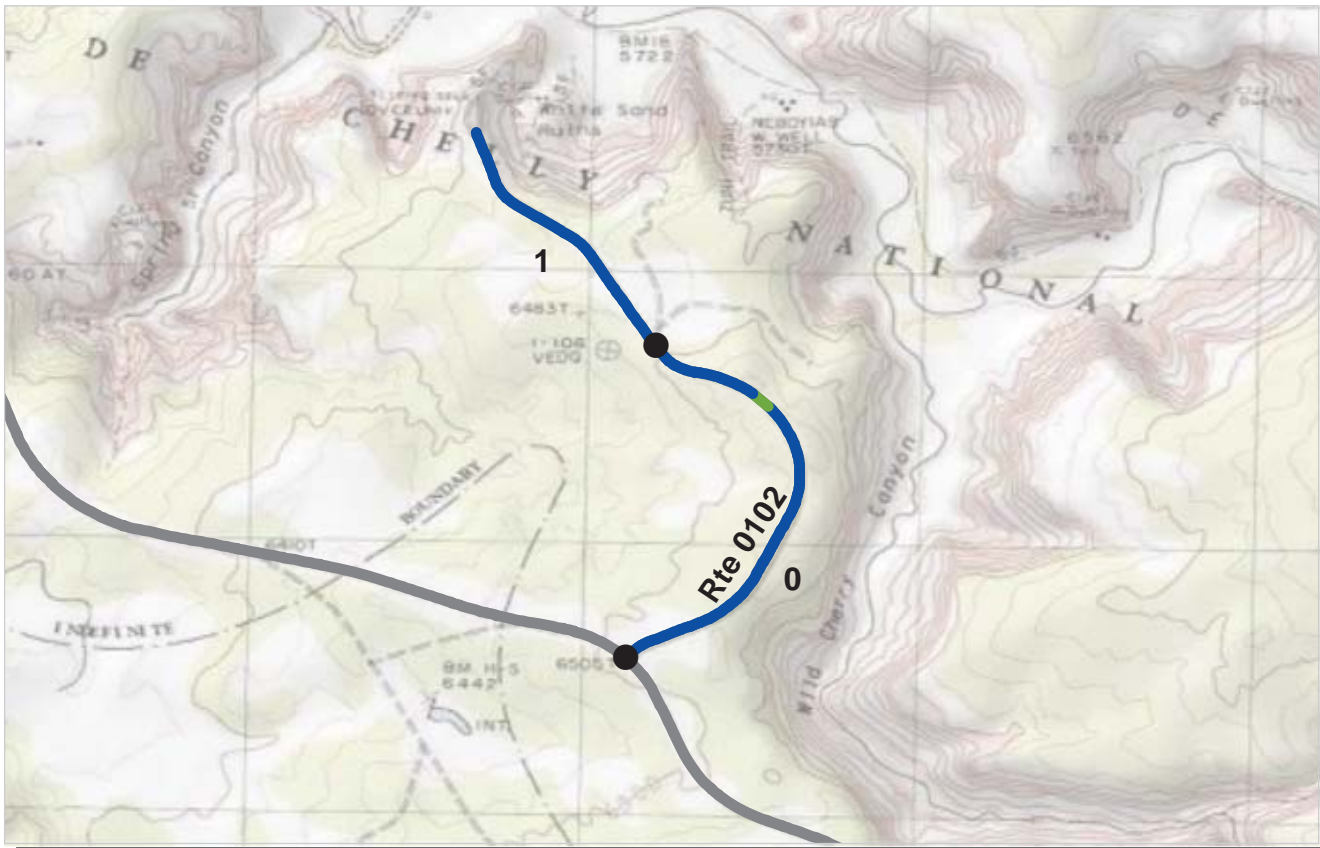
ROUTE: 0102 SLIDING HOUSE OVERLOOK ROAD

Section Number	0	1			
Section Length (mi)	1.00	0.61			
Cross Section Information					
Number of Lanes	2	2			
Paved Width (ft)	25	26			
Lane Width (ft)	12	12			
Roadway Condition Information					
SCR (Surface Condition Rating)	97	99			
PCR (Pavement Condition Rating)	98	99			
Distress Index Values					
Structural Crack Index	99	99			
Transverse Cracking Index	97	99			
Patching Index	100	100			
Rutting Index	98	99			
Roughness Condition Index (RCI)	100	100

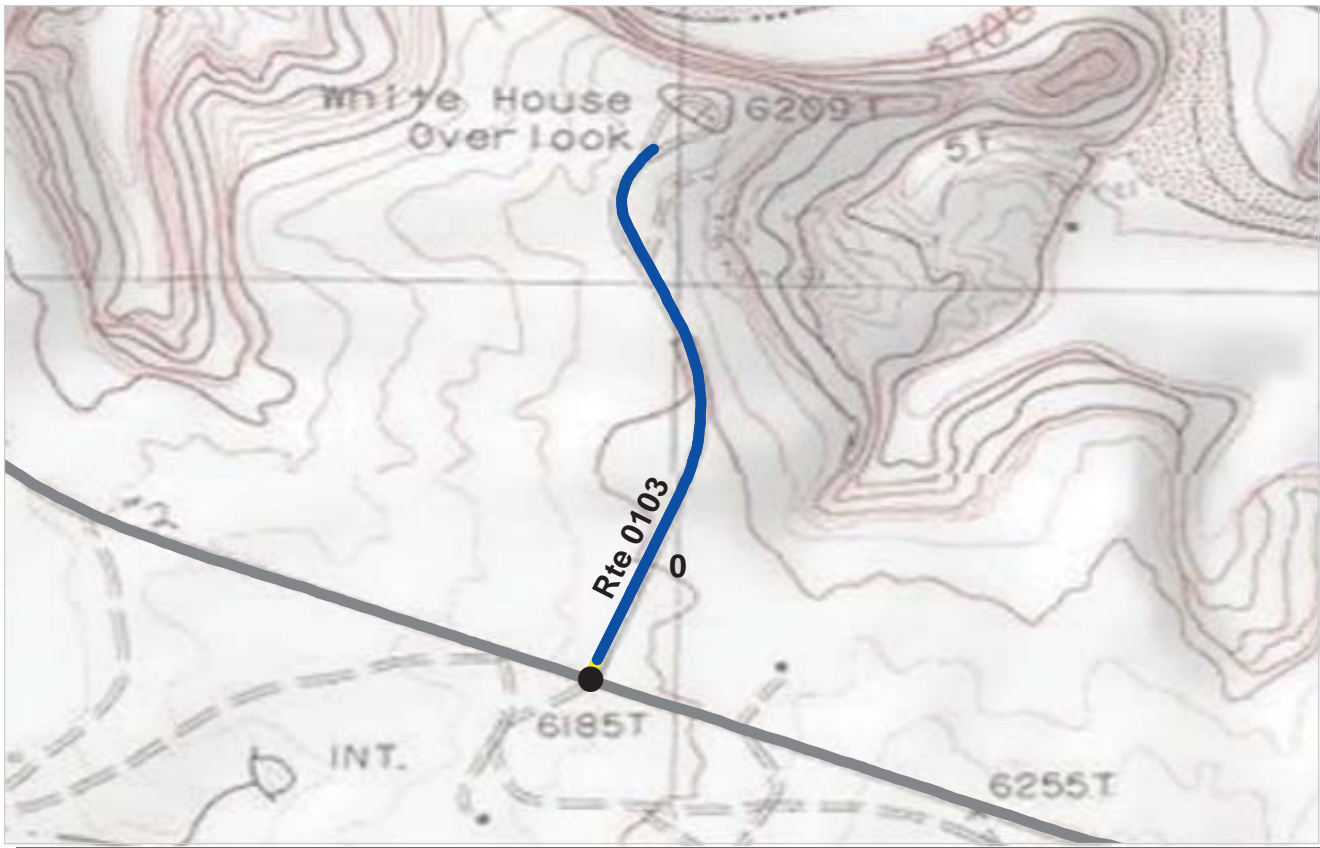
ROUTE: 0103 WHITE HOUSE OVERLOOK ROAD

Section Number	0				
Section Length (mi)	0.58				
Cross Section Information					
Number of Lanes	2				
Paved Width (ft)	21				
Lane Width (ft)	10				
Roadway Condition Information					
SCR (Surface Condition Rating)	100				
PCR (Pavement Condition Rating)	100				
Distress Index Values					
Structural Crack Index	100				
Transverse Cracking Index	100				
Patching Index	100				
Rutting Index	100				
Roughness Condition Index (RCI)	100

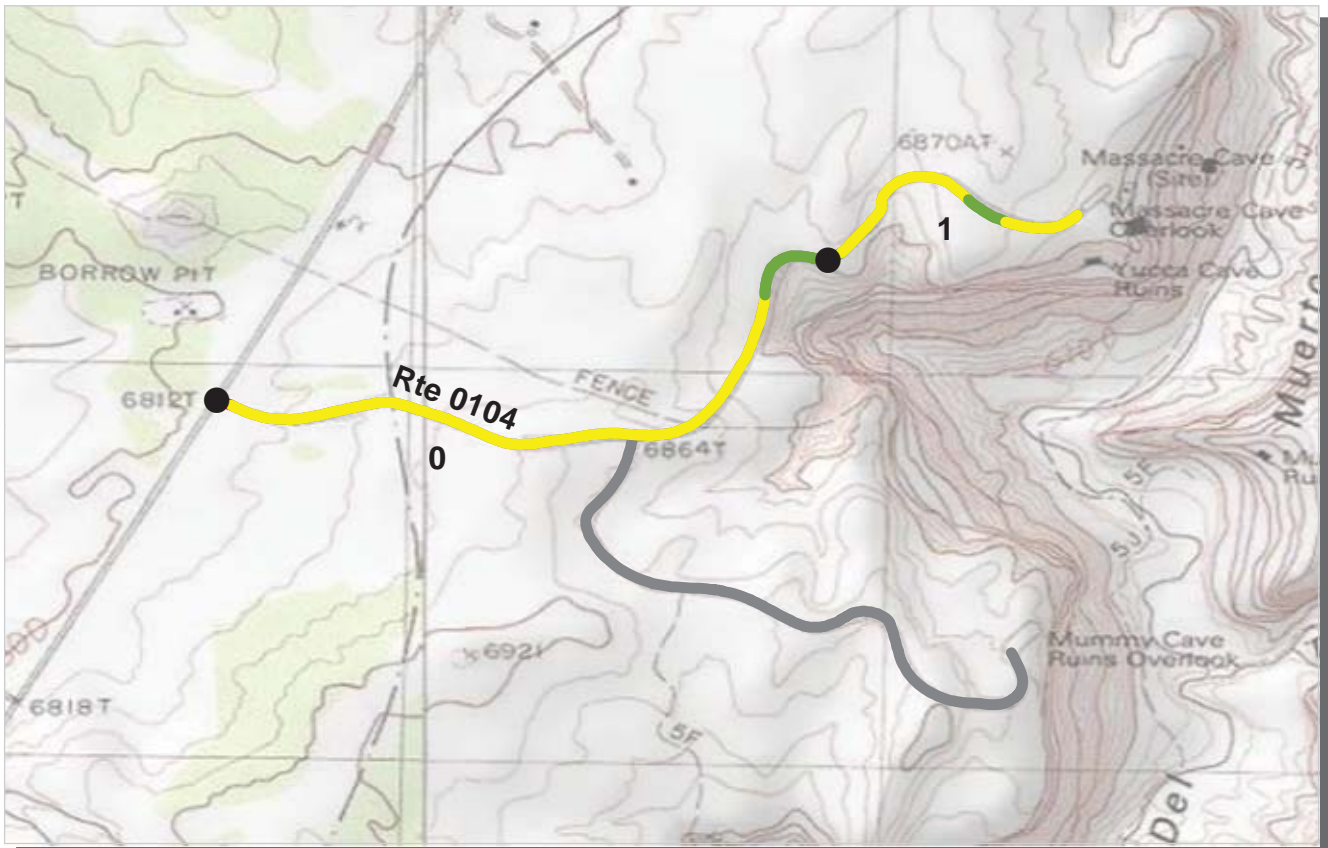
ROUTE: 0104 MASSACRE CAVE OVERLOOK ROAD

Section Number	0	1			
Section Length (mi)	1.00	0.42			
Cross Section Information					
Number of Lanes	2	2			
Paved Width (ft)	25	27			
Lane Width (ft)	11	12			
Roadway Condition Information					
SCR (Surface Condition Rating)	90	90			
PCR (Pavement Condition Rating)	75	78			
Distress Index Values					
Structural Crack Index	99	99			
Transverse Cracking Index	100	99			
Patching Index	100	100			
Rutting Index	90	90			
Roughness Condition Index (RCI)	52	61

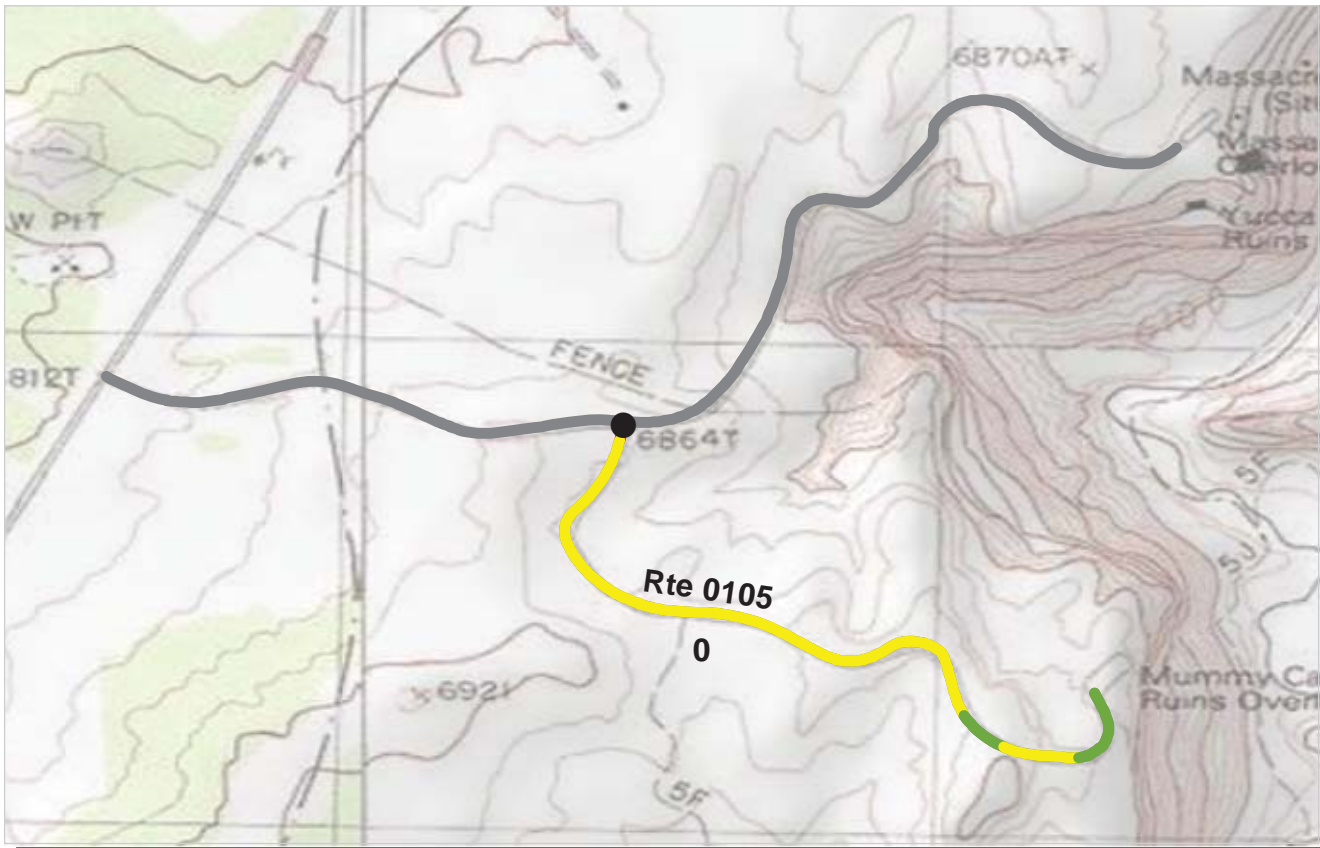
ROUTE: 0105 MUMMY CAVE OVERLOOK ROAD

Section Number	0				
Section Length (mi)	0.94				
Cross Section Information					
Number of Lanes	2				
Paved Width (ft)	27				
Lane Width (ft)	11				
Roadway Condition Information					
SCR (Surface Condition Rating)	91				
PCR (Pavement Condition Rating)	79				
Distress Index Values					
Structural Crack Index	99				
Transverse Cracking Index	99				
Patching Index	100				
Rutting Index	91				
Roughness Condition Index (RCI)	62

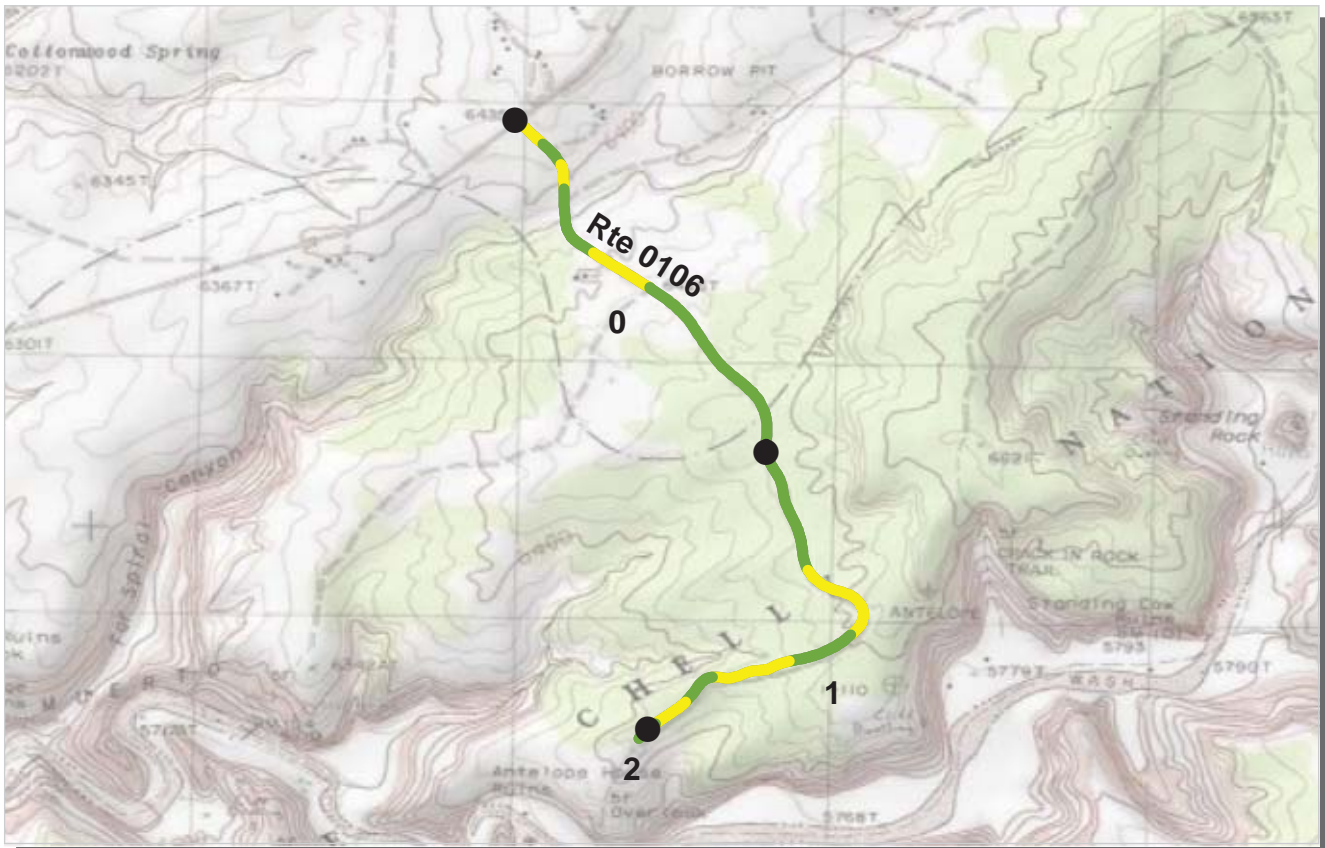
ROUTE: 0106 ANTELOPE HOUSE OVERLOOK ROAD

<i>Section Number</i>	0	1	2		
<i>Section Length (mi)</i>	1.00	1.00	0.03		
<i>Cross Section Information</i>					
Number of Lanes	2	2	2		
Paved Width (ft)	26	25	25		
Lane Width (ft)	13	12	12		
<i>Roadway Condition Information</i>					
SCR (Surface Condition Rating)	92	92	91		
PCR (Pavement Condition Rating)	84	85	82		
<i>Distress Index Values</i>					
Structural Crack Index	99	99	100		
Transverse Cracking Index	97	98	98		
Patching Index	100	100	100		
Rutting Index	92	92	91		
Roughness Condition Index (RCI)	73	75	68

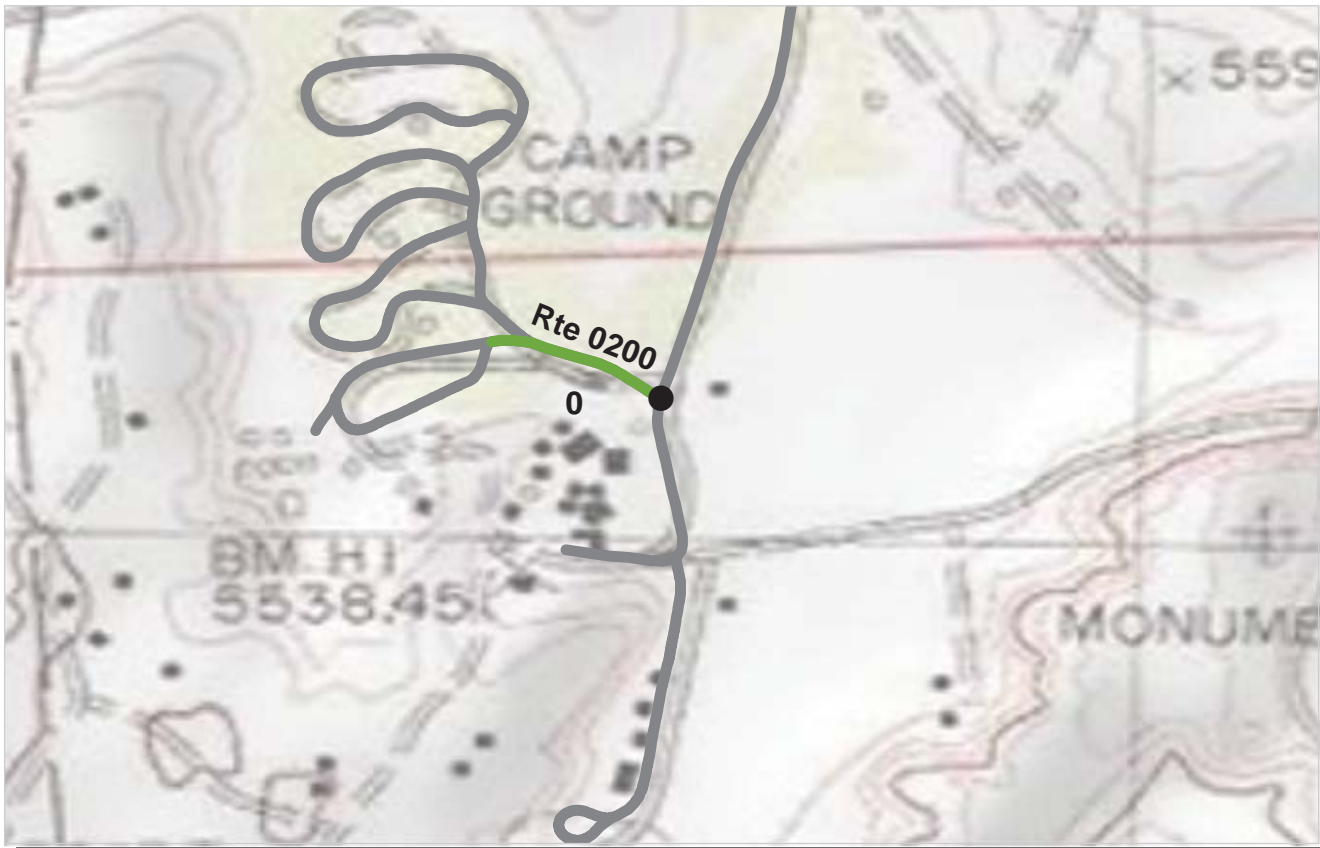
ROUTE: 0200 CAMPGROUND / MAINTENANCE ACCESS ROAD

Section Number	0				
Section Length (mi)	0.10				
Cross Section Information					
Number of Lanes	2				
Paved Width (ft)	21				
Lane Width (ft)	11				
Roadway Condition Information					
SCR (Surface Condition Rating)	88				
PCR (Pavement Condition Rating)	88				
Distress Index Values					
Structural Crack Index	90				
Transverse Cracking Index	88				
Patching Index	100				
Rutting Index	98				
Roughness Condition Index (RCI)	NC

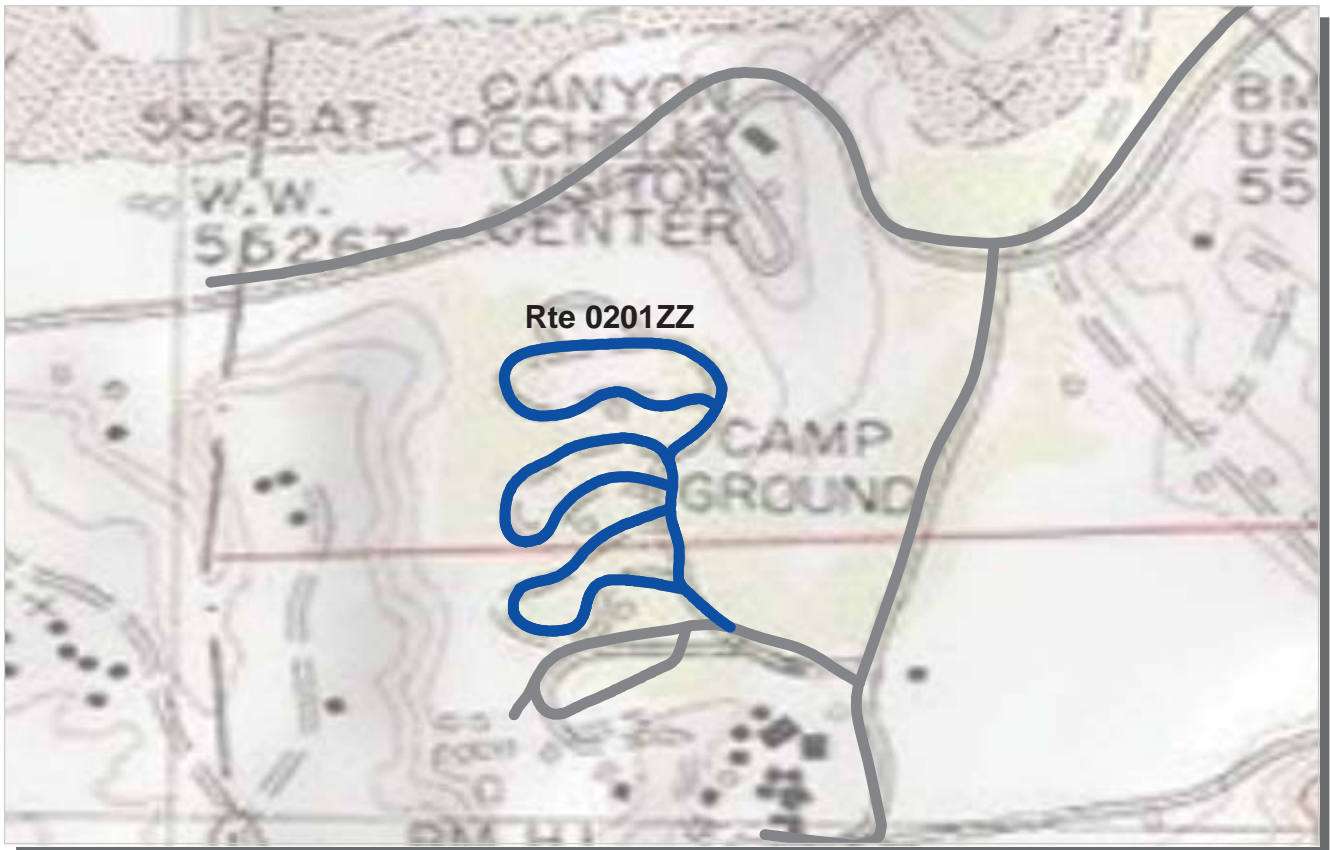
ROUTE: 0201ZZ COTTONWOOD CAMPGROUND LOOPS

Section Number					
Section Length (mi)					
Cross Section Information					
Number of Lanes	N/A				
Paved Width (ft)	N/A				
Lane Width (ft)	N/A				
Roadway Condition Information					
SCR (Surface Condition Rating)	99				
PCR (Pavement Condition Rating)	99				
Distress Index Values					
Structural Crack Index	N/A				
Transverse Cracking Index	N/A				
Patching Index	N/A				
Rutting Index	N/A				
Roughness Condition Index (RCI)	N/A

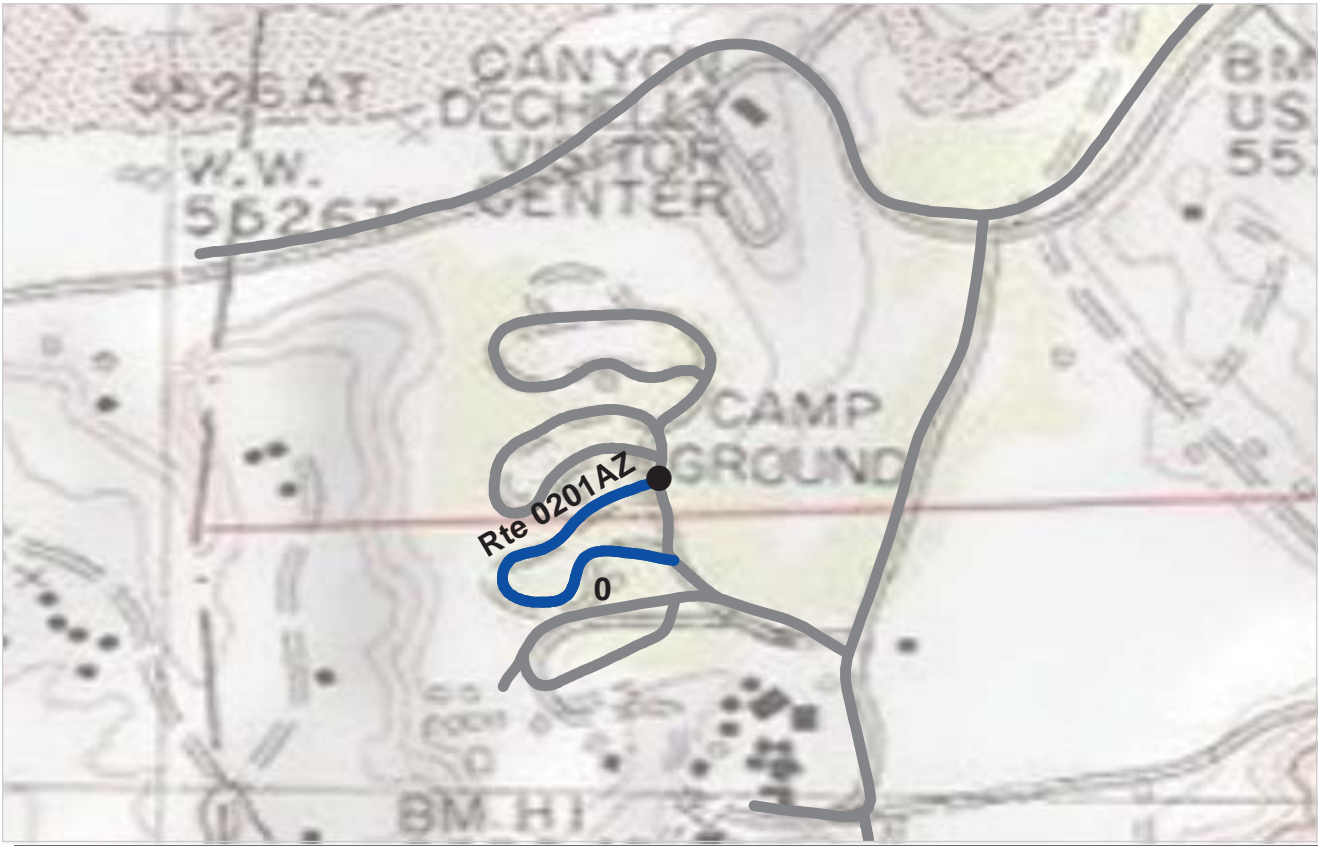
ROUTE: 0201AZ COTTONWOOD CAMPGROUND LOOP A

Section Number	0				
Section Length (mi)	0.22				
Cross Section Information					
Number of Lanes	1				
Paved Width (ft)	17				
Lane Width (ft)	17				
Roadway Condition Information					
SCR (Surface Condition Rating)	99				
PCR (Pavement Condition Rating)	99				
Distress Index Values					
Structural Crack Index	100				
Transverse Cracking Index	100				
Patching Index	100				
Rutting Index	99				
Roughness Condition Index (RCI)	NC

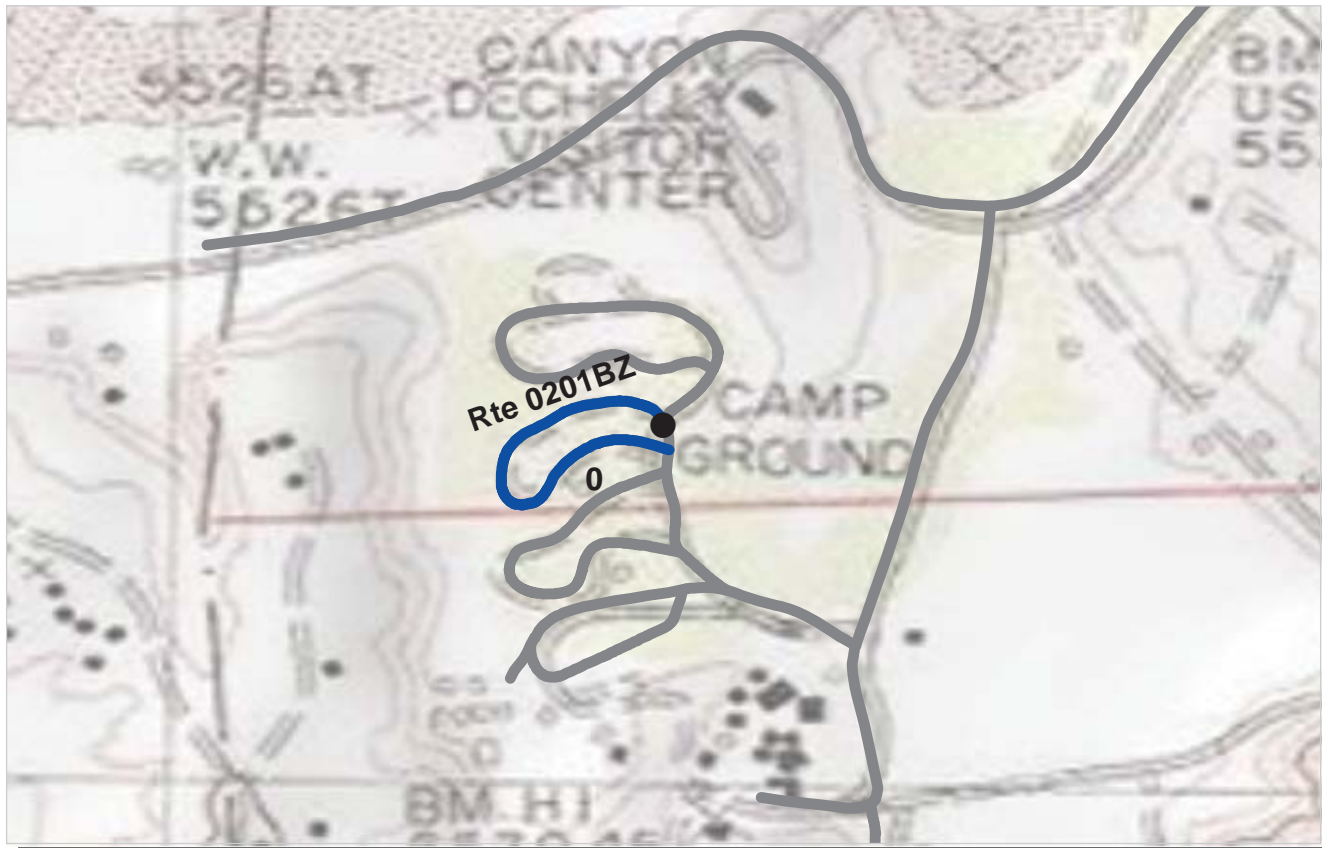
ROUTE: 0201BZ COTTONWOOD CAMPGROUND LOOP B
CACH : CANYON DE CHELLEY NATIONAL MONUMENT

Section Number	0				
Section Length (mi)	0.24				
Cross Section Information					
Number of Lanes	1				
Paved Width (ft)	14				
Lane Width (ft)	14				
Roadway Condition Information					
SCR (Surface Condition Rating)	99				
PCR (Pavement Condition Rating)	99				
Distress Index Values					
Structural Crack Index	100				
Transverse Cracking Index	100				
Patching Index	100				
Rutting Index	99				
Roughness Condition Index (RCI)	NC

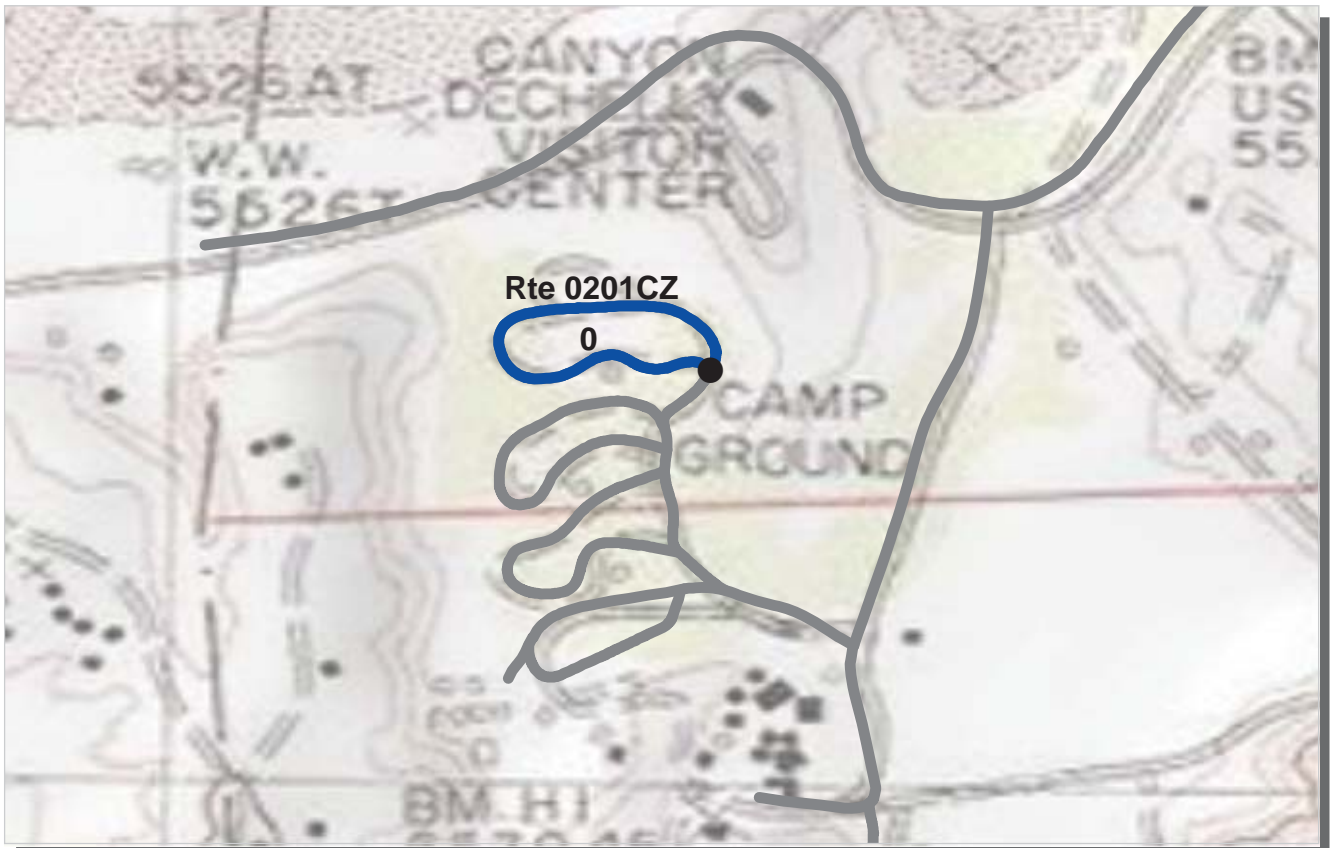
ROUTE: 0201CZ COTTONWOOD CAMPGROUND LOOP C

Section Number	0				
Section Length (mi)	0.28				
Cross Section Information					
Number of Lanes	1				
Paved Width (ft)	17				
Lane Width (ft)	17				
Roadway Condition Information					
SCR (Surface Condition Rating)	99				
PCR (Pavement Condition Rating)	99				
Distress Index Values					
Structural Crack Index	100				
Transverse Cracking Index	100				
Patching Index	100				
Rutting Index	99				
Roughness Condition Index (RCI)	NC
