# Federal Lands Highway Road Inventory Program

Road Inventory and Condition Assessment

## Castillo de San Marcos National Monument CASA

### Cycle 5 Report

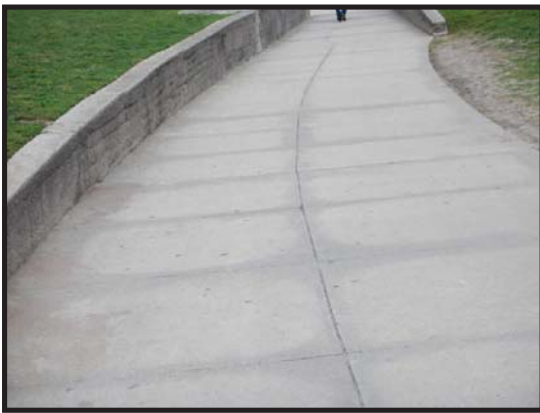
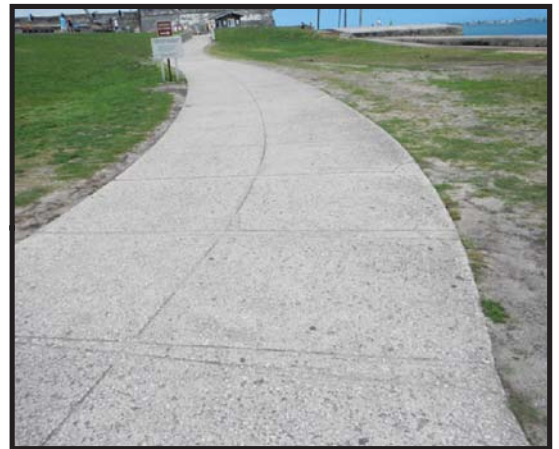
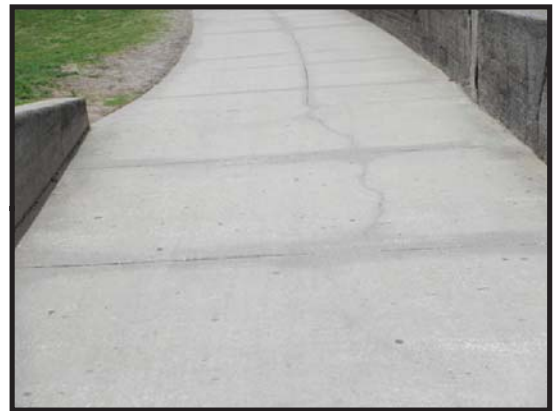
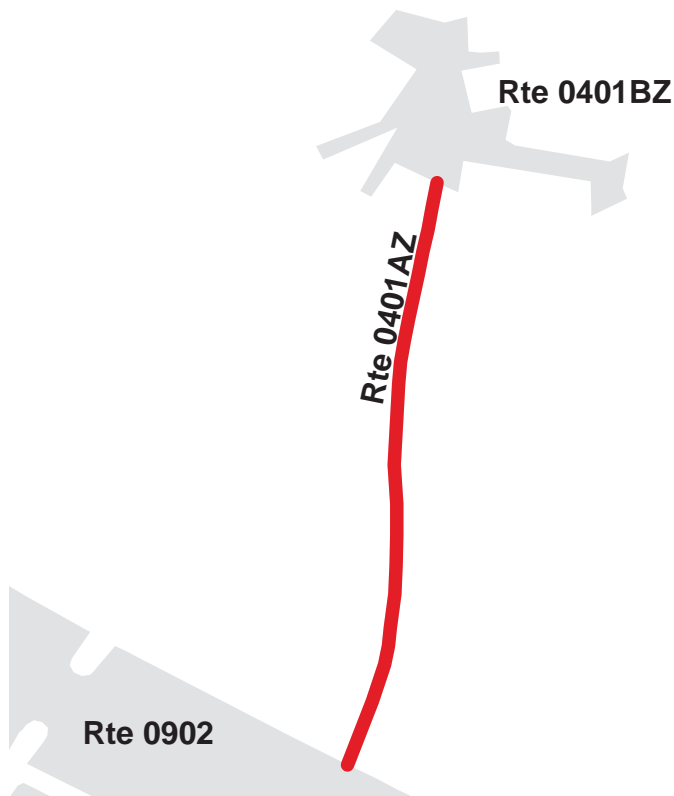
## Route 0401BZ

Route Number	Public / NonPublic	Date Visited	Area (sq ft)	Lane Miles *	Surface Type
0401BZ	PUBLIC	4/16/2013	3,254	0.06	CO
Culverts	Drop Inlets	Gates	Curb & Gutter	Curb	PCR
0	0	1	NO CURB AND GUTTER	NO CURB	GOOD/90

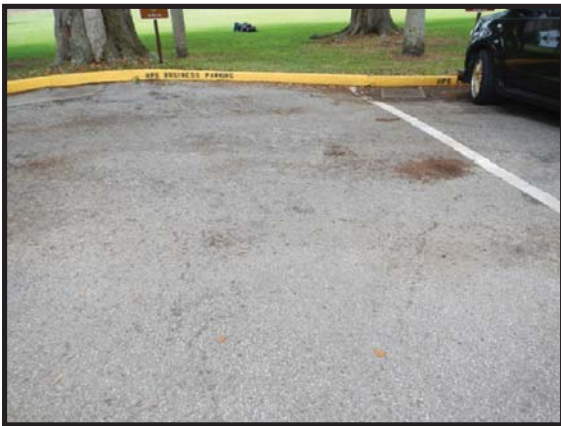
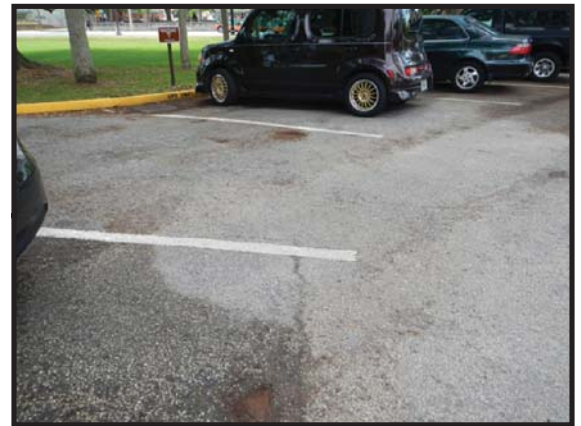
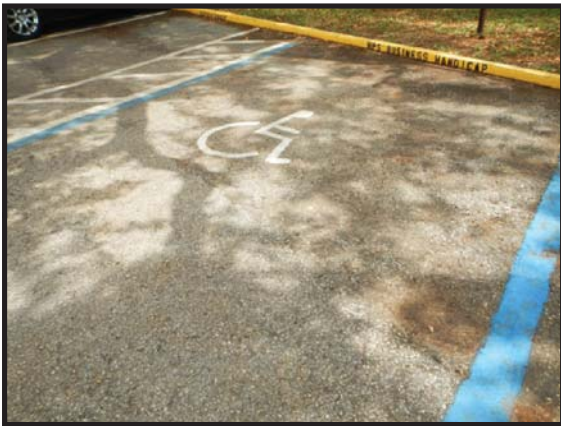
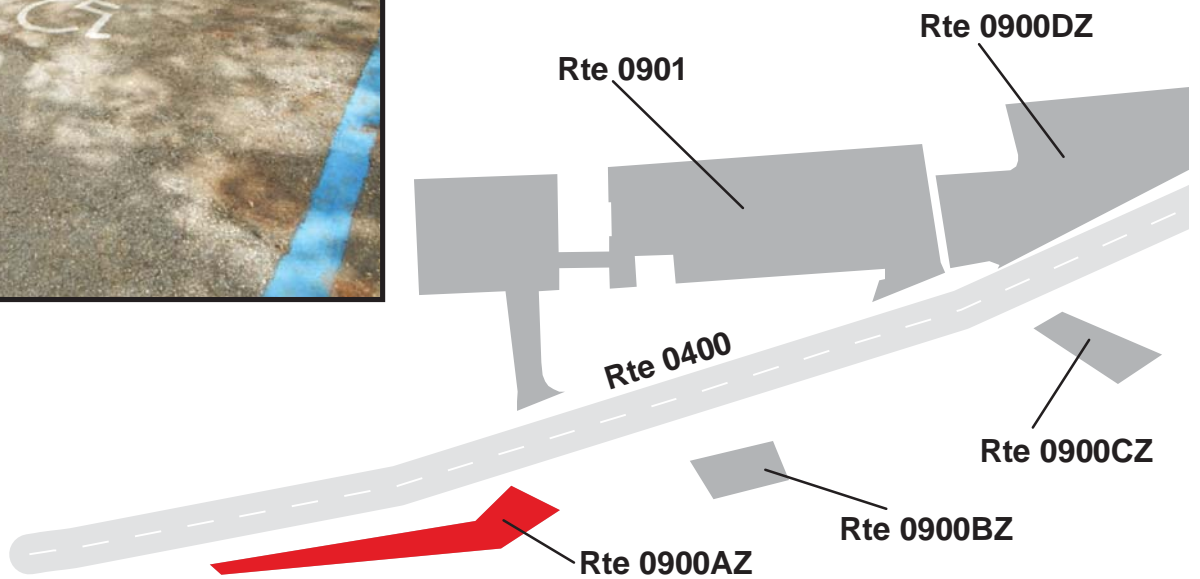
## Route 0900BZ

Route Number	Public / NonPublic	Date Visited	Area (sq ft)	Lane Miles *	Surface Type
0900BZ	NONPUBLIC	4/16/2013	361	0.01	AS
Culverts	Drop Inlets	Gates	Curb & Gutter	Curb	PCR
0	0	0	NO CURB AND GUTTER	CONCRETE CURB	GOOD/90

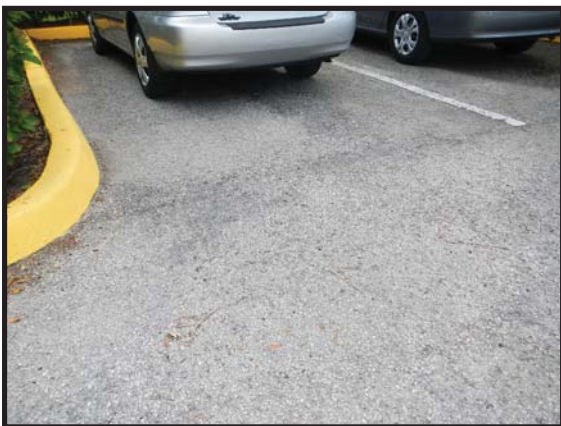
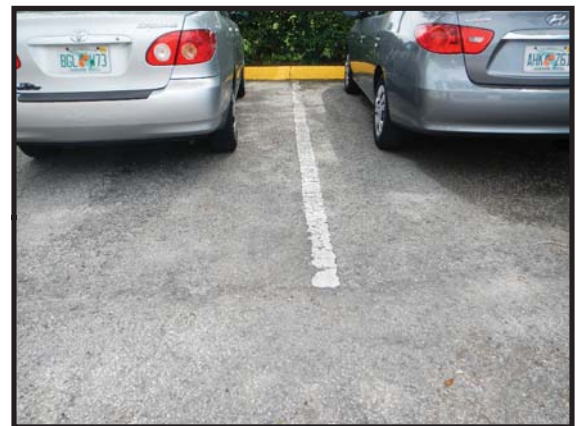
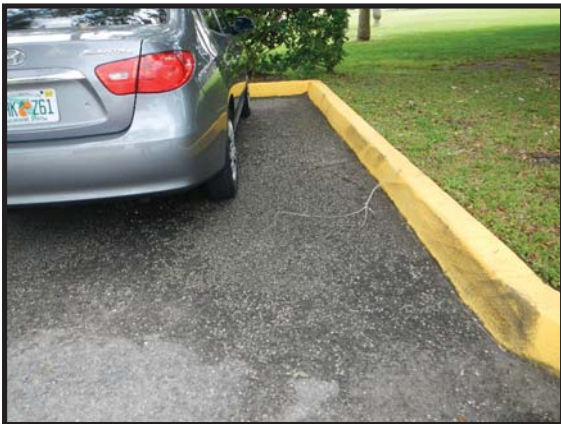
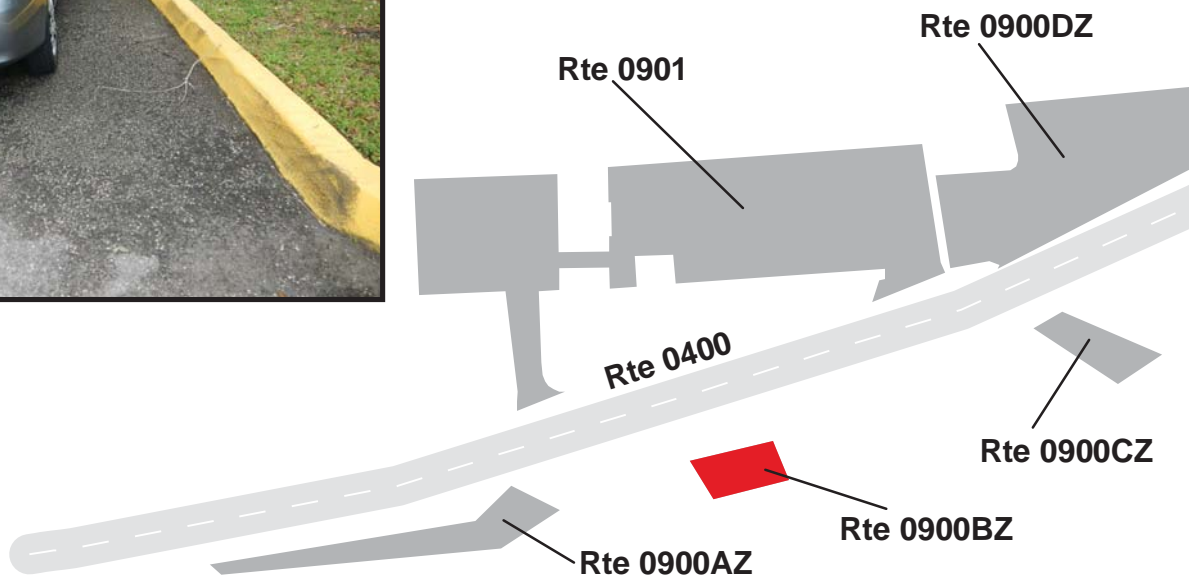
## Route 0900CZ

Route Number	Public / NonPublic	Date Visited	Area (sq ft)	Lane Miles *	Surface Type
0900CZ	NONPUBLIC	4/16/2013	407	0.01	AS
Culverts	Drop Inlets	Gates	Curb & Gutter	Curb	PCR
0	0	0	NO CURB AND GUTTER	NO CURB	FAIR/73

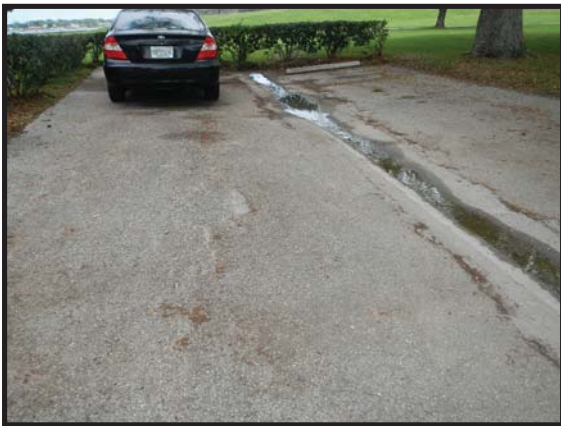
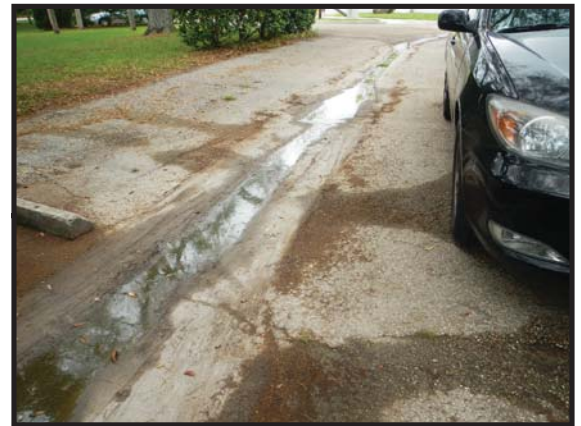
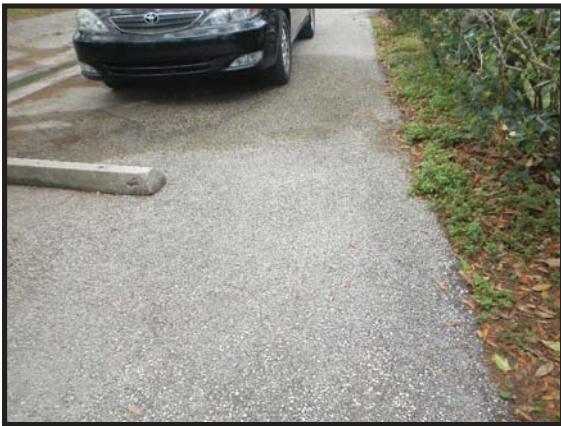
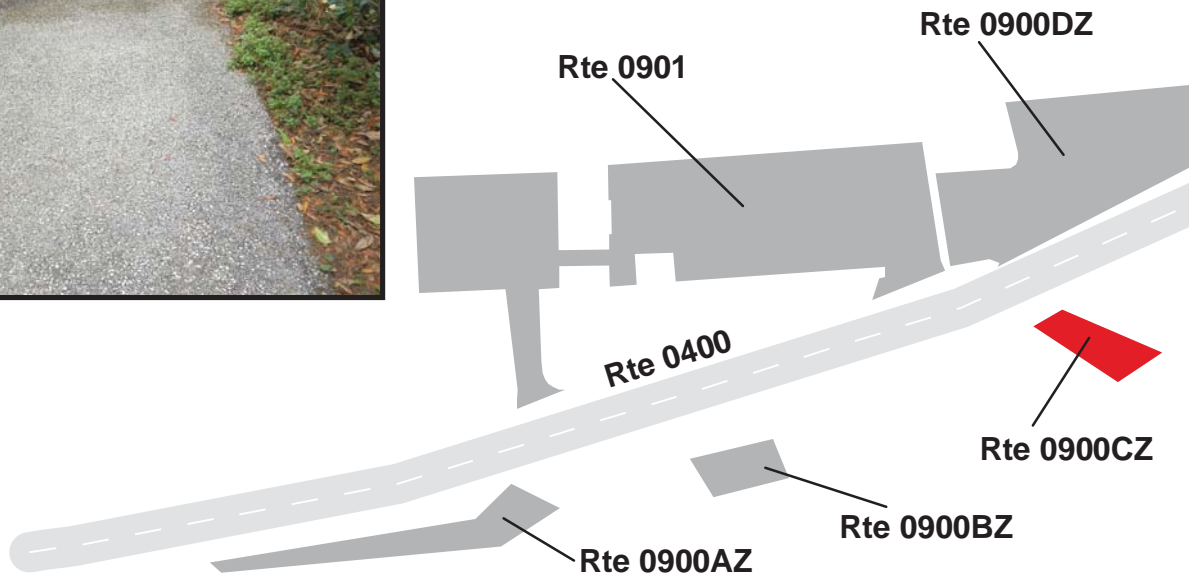
## Route 0900DZ

Route Number	Public / NonPublic	Date Visited	Area (sq ft)	Lane Miles *	Surface Type
0900DZ	NONPUBLIC	4/16/2013	3,466	0.06	AS
Culverts	Drop Inlets	Gates	Curb & Gutter	Curb	PCR
0	1	0	NO CURB AND GUTTER	CONCRETE CURB	GOOD/90

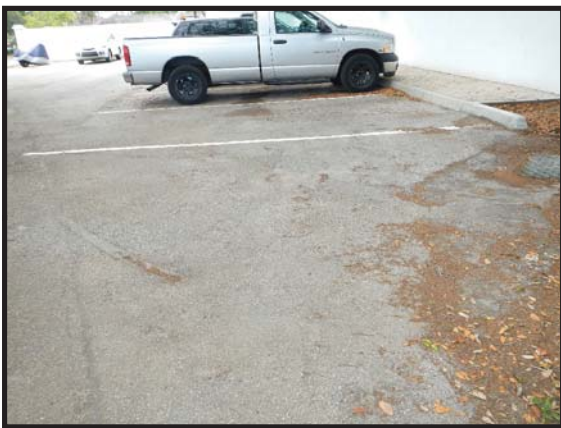
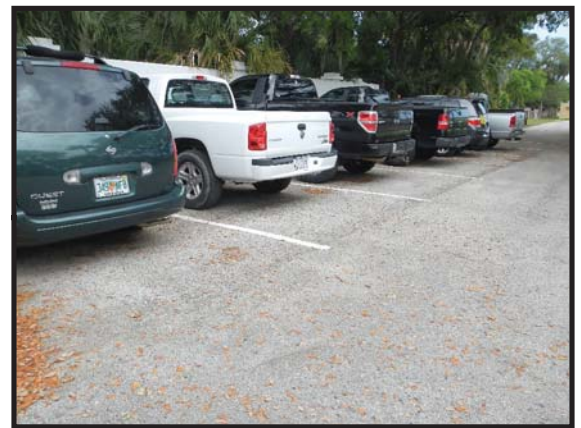
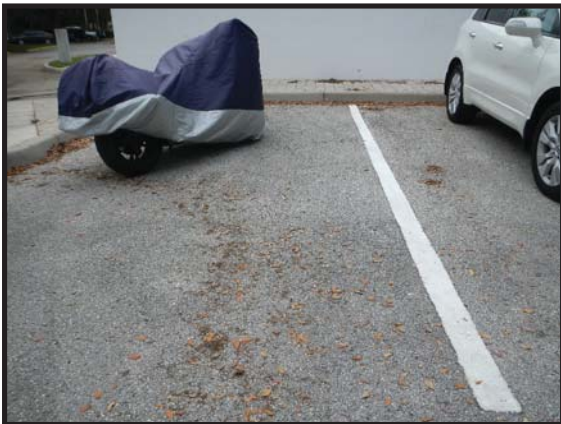
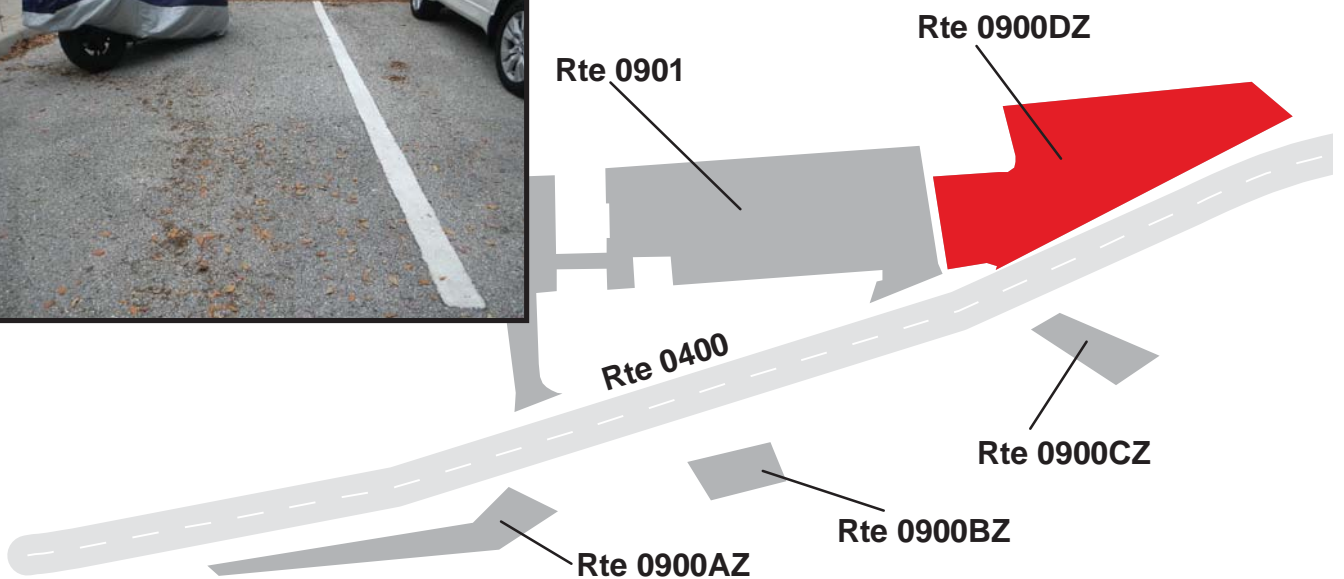
## Route 0901

Route Number	Public / NonPublic	Date Visited	Area (sq ft)	Lane Miles *	Surface Type
0901	NONPUBLIC	4/16/2013	6,253	0.11	AS
Culverts	Drop Inlets	Gates	Curb & Gutter	Curb	PCR
0	0	2	NO CURB AND GUTTER	CONCRETE CURB	FAIR/73

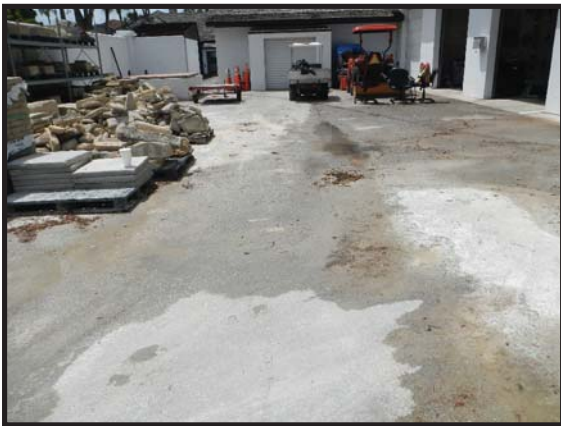
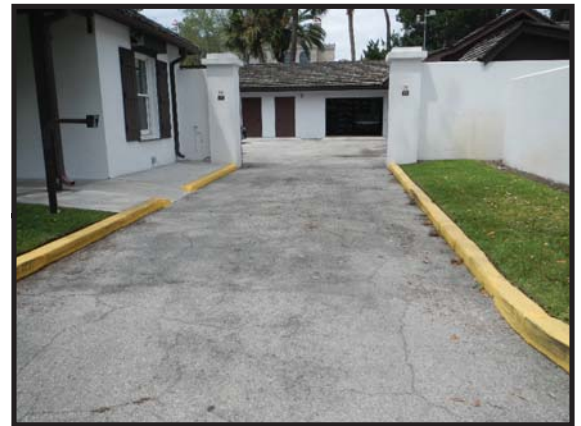
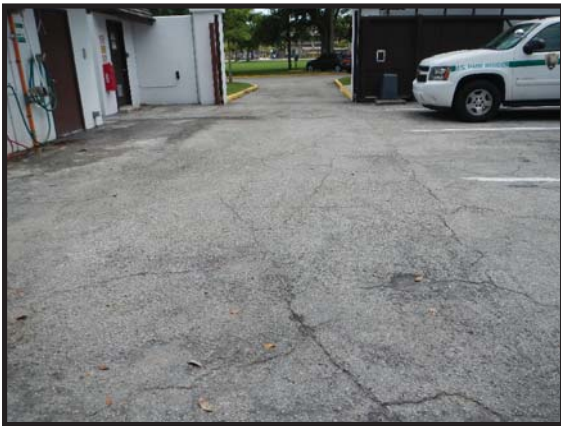
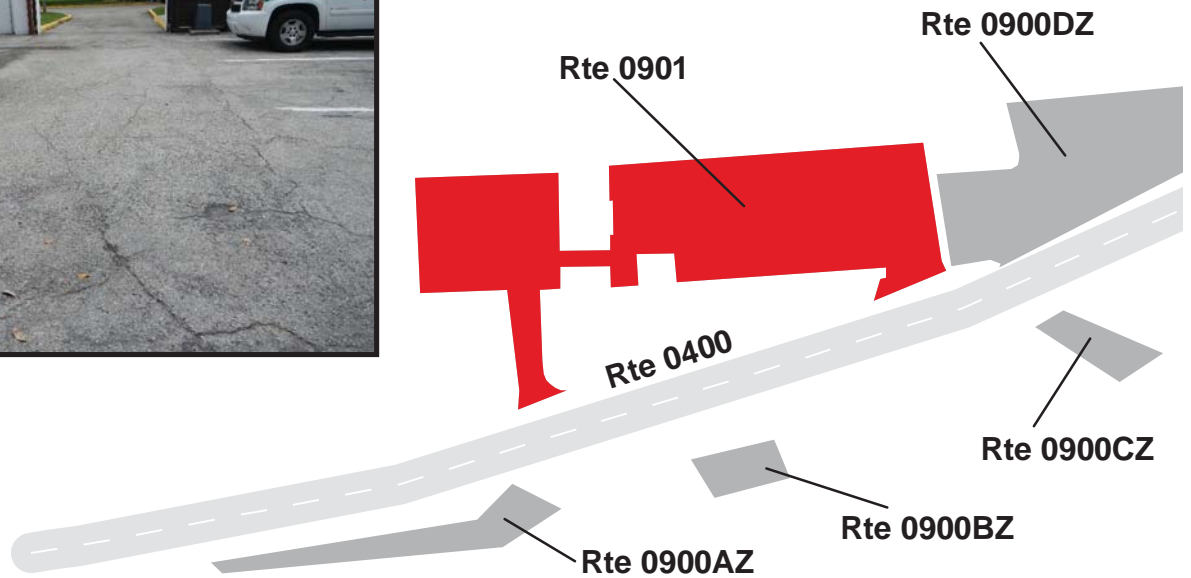
## Route 0902

Route Number	Public / NonPublic	Date Visited	Area (sq ft)	Lane Miles *	Surface Type
0902	PUBLIC	4/16/2013	54,412	0.94	AS
Culverts	Drop Inlets	Gates	Curb & Gutter	Curb	PCR
0	6	4	CONCRETE CURB AND GUTTER	CONCRETE CURB	FAIR/73
