Federal Lands Highway Road Inventory Program

Road Inventory and Condition Assessment

Cedar Breaks National Monument CEBR

Cycle 5 Report

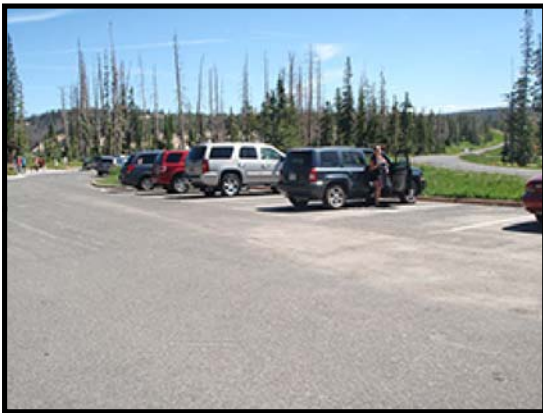
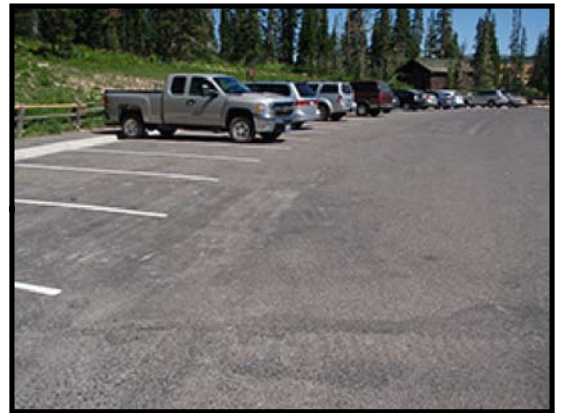
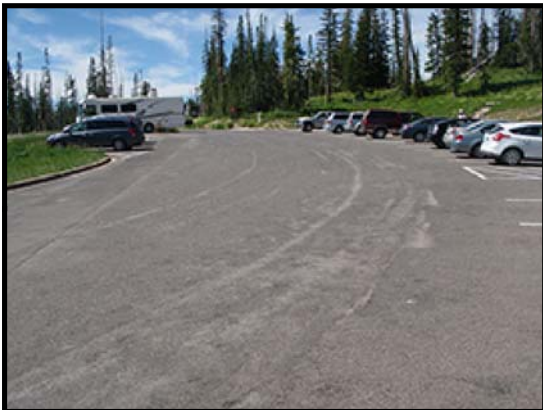
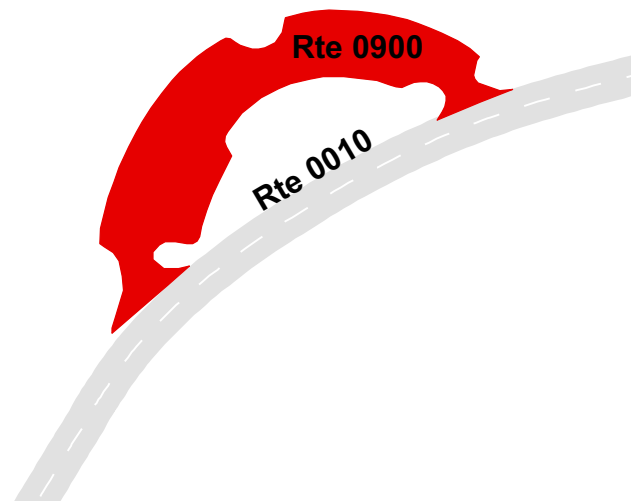
Route Number	Public / NonPublic	Date Visited	Area (sq ft)	Lane Miles *	Surface Type
0900	PUBLIC	8/12/2011	27,740	0.48	AS
Culverts	Drop Inlets	Gates	Curb & Gutter	Curb	PCR
0	0	0	CONCRETE CURB AND GUTTER	NO CURB	FAIR/73

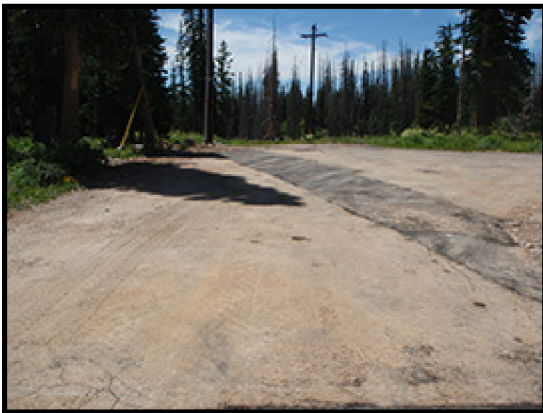
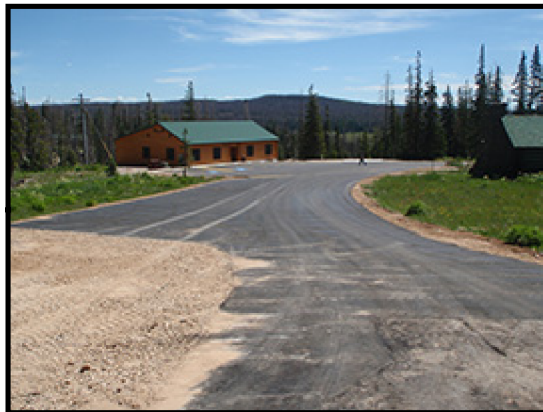
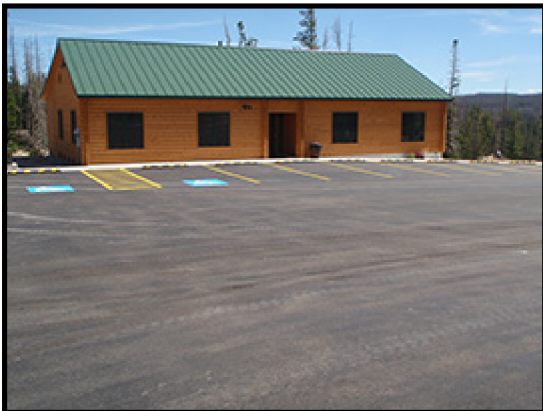
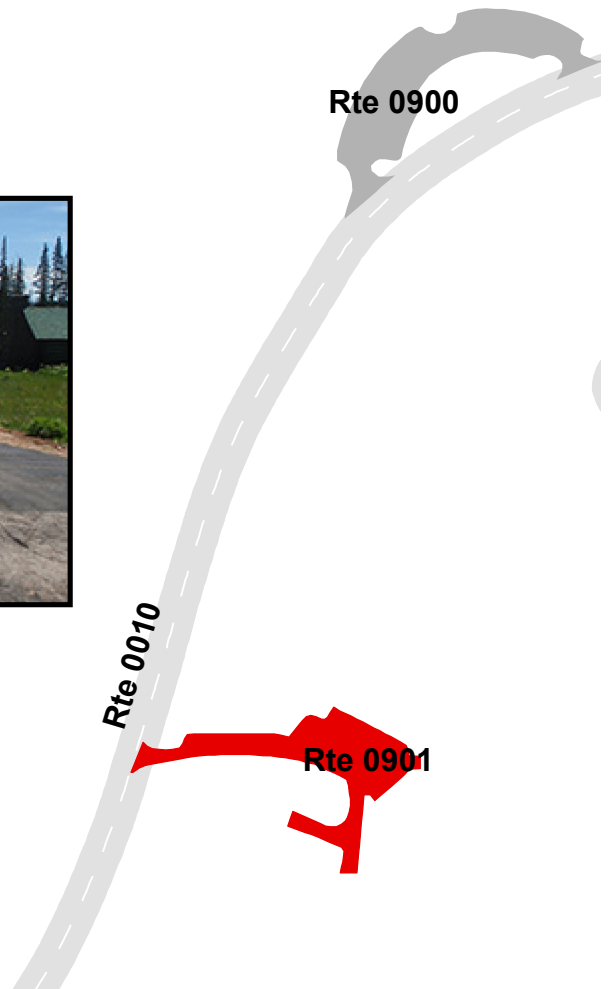
Route 0901

Route Number	Public / NonPublic	Date Visited	Area (sq ft)	Lane Miles *	Surface Type
0901	NONPUBLIC	8/12/2011	21,330	0.37	AS
Culverts	Drop Inlets	Gates	Curb & Gutter	Curb	PCR
0	0	0	NO CURB AND GUTTER	NO CURB	FAIR/73

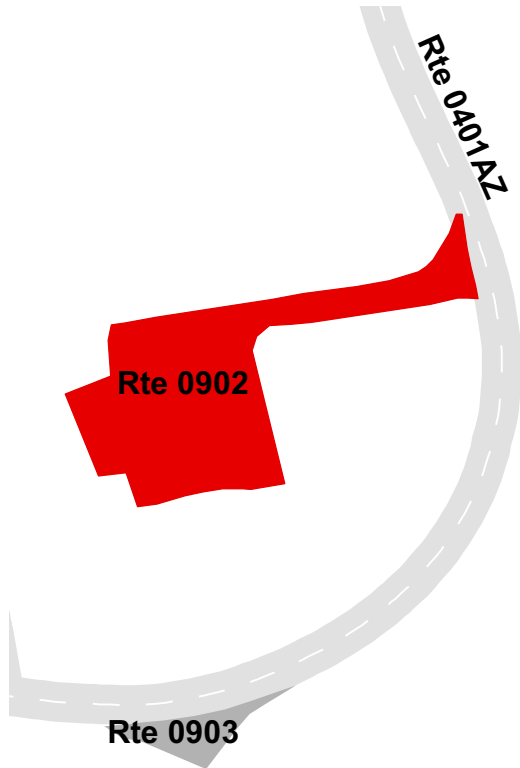
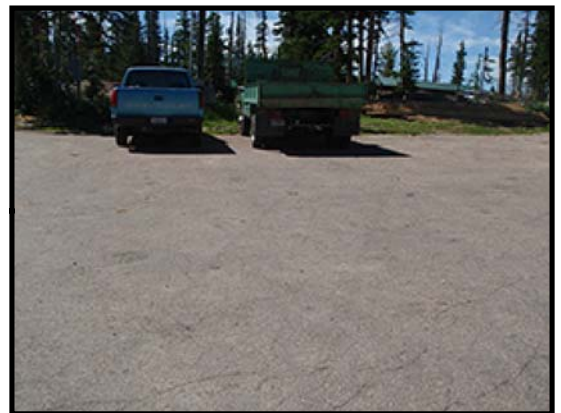
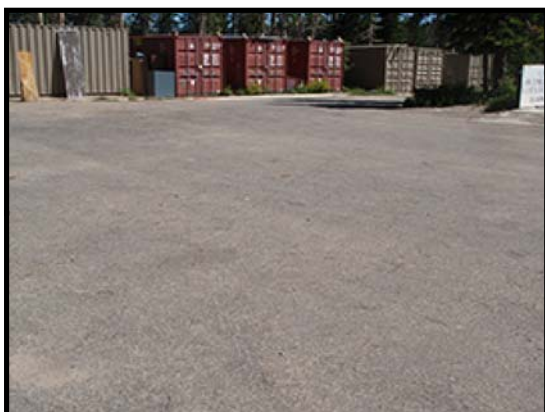
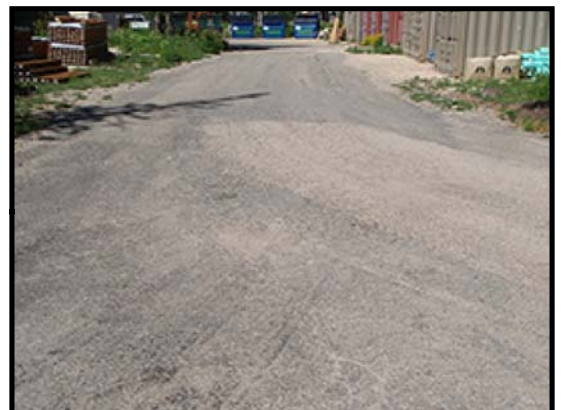
Route 0902

Route Number	Public / NonPublic	Date Visited	Area (sq ft)	Lane Miles *	Surface Type
0902	NONPUBLIC	8/12/2011	10,546	0.18	AS
Culverts	Drop Inlets	Gates	Curb & Gutter	Curb	PCR
0	0	0	NO CURB AND GUTTER	NO CURB	POOR/45

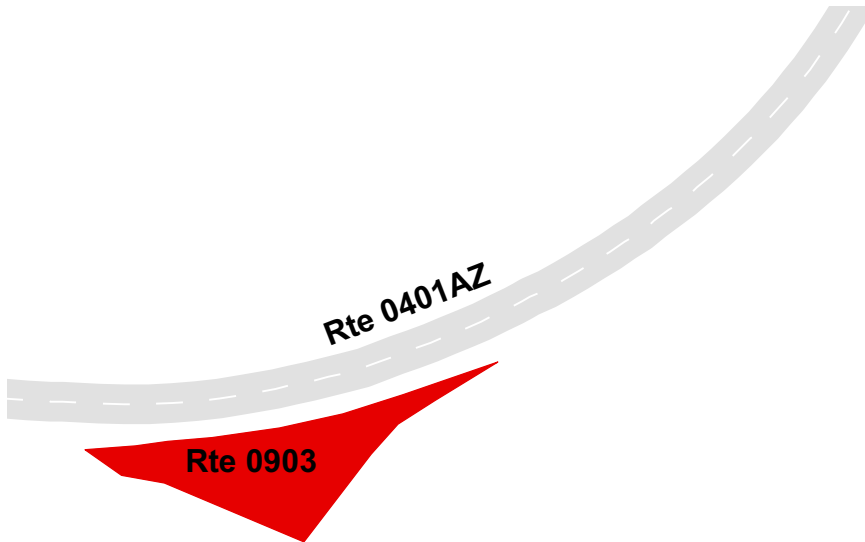
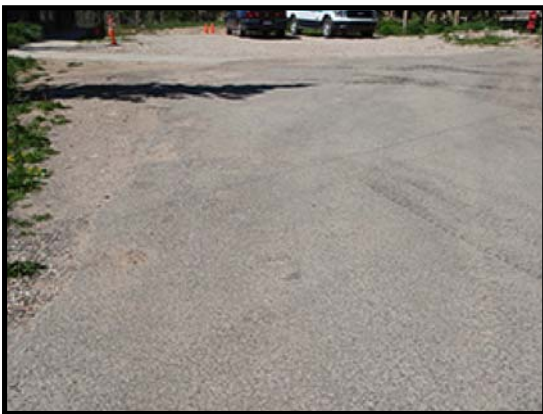
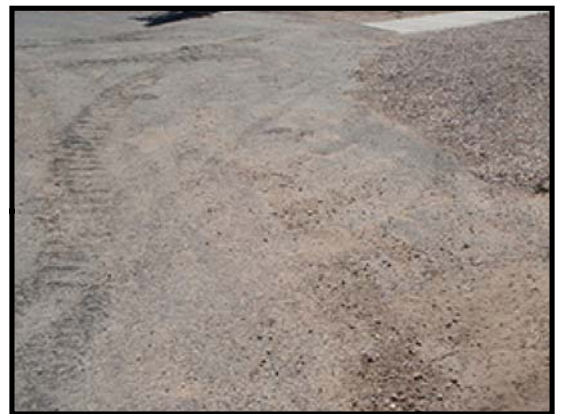
Route 0903

Route Number	Public / NonPublic	Date Visited	Area (sq ft)	Lane Miles *	Surface Type
0903	NONPUBLIC	8/12/2011	1,246	0.02	AS
Culverts	Drop Inlets	Gates	Curb & Gutter	Curb	PCR
0	0	0	NO CURB AND GUTTER	NO CURB	POOR/45

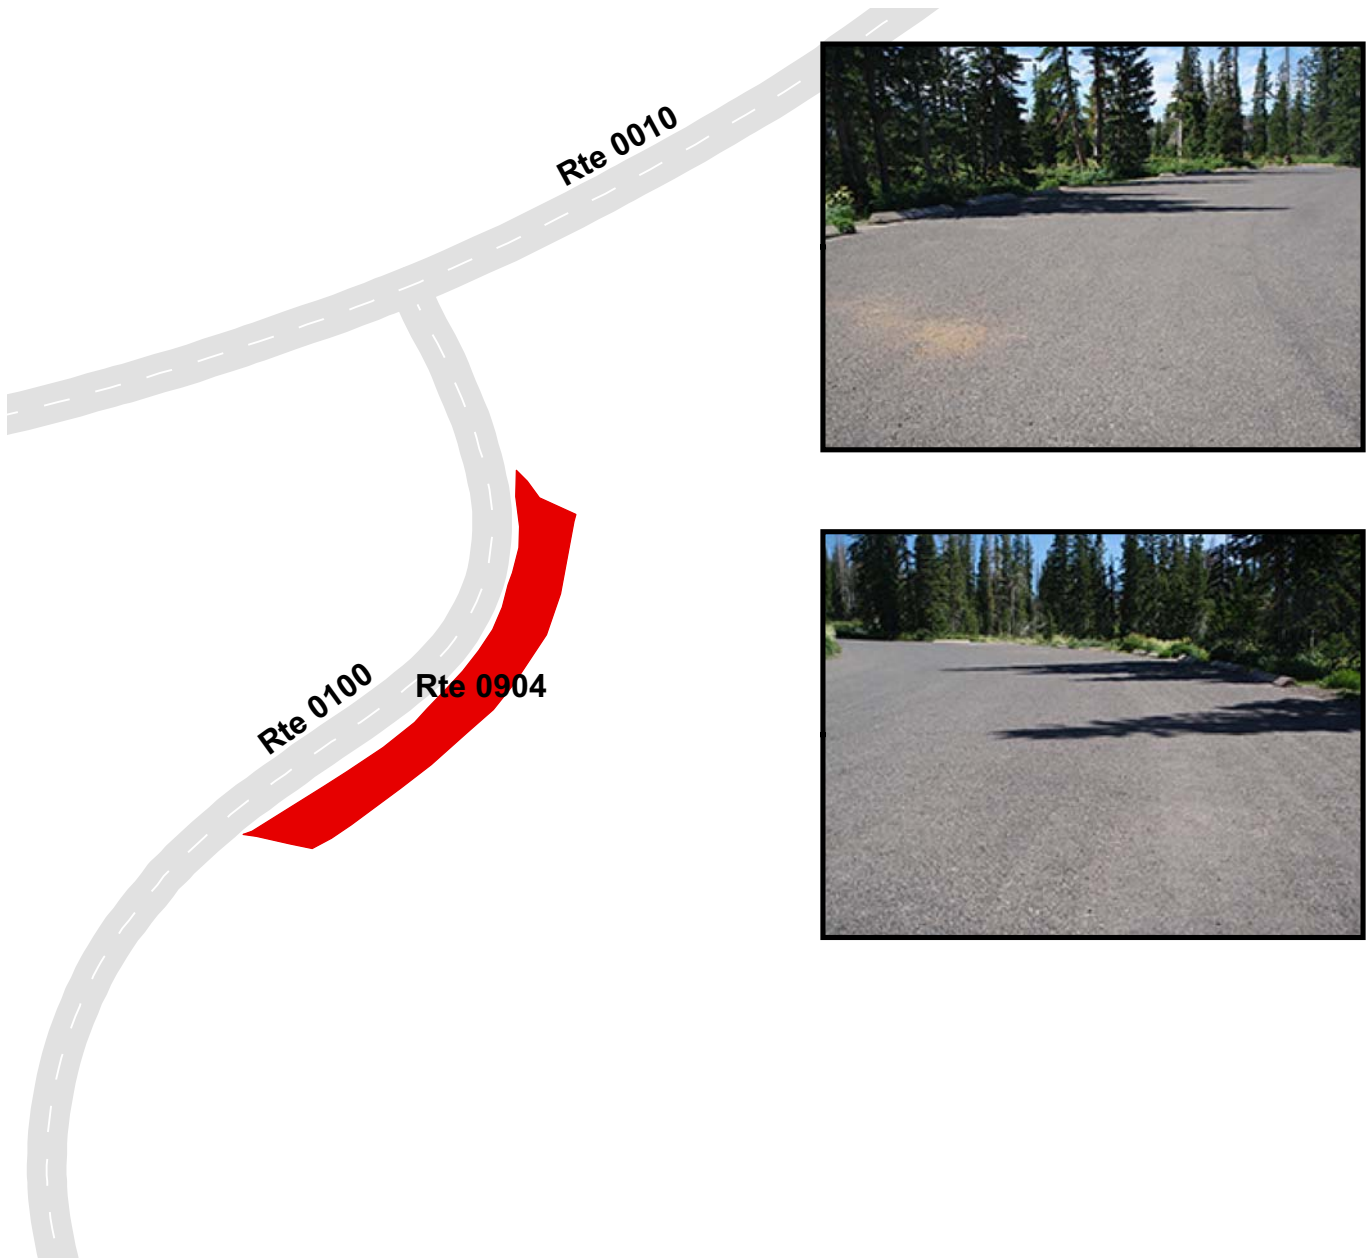
Route 0904

Route Number	Public / NonPublic	Date Visited	Area (sq ft)	Lane Miles *	Surface Type
0904	PUBLIC	8/12/2011	3,785	0.07	AS
Culverts	Drop Inlets	Gates	Curb & Gutter	Curb	PCR
0	0	0	NO CURB AND GUTTER	NO CURB	FAIR/73

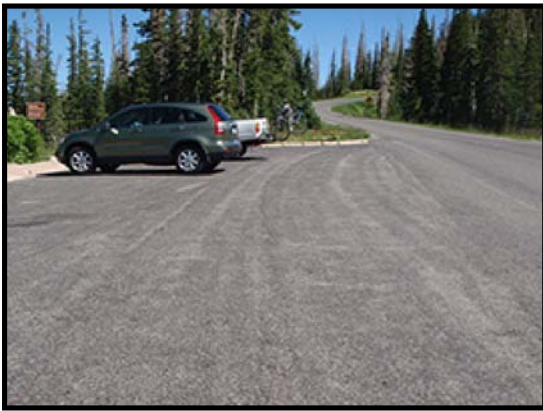
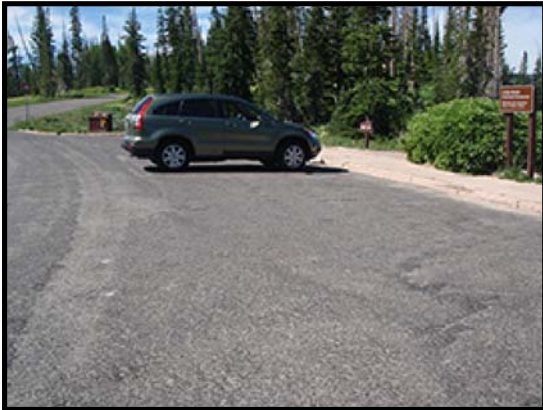
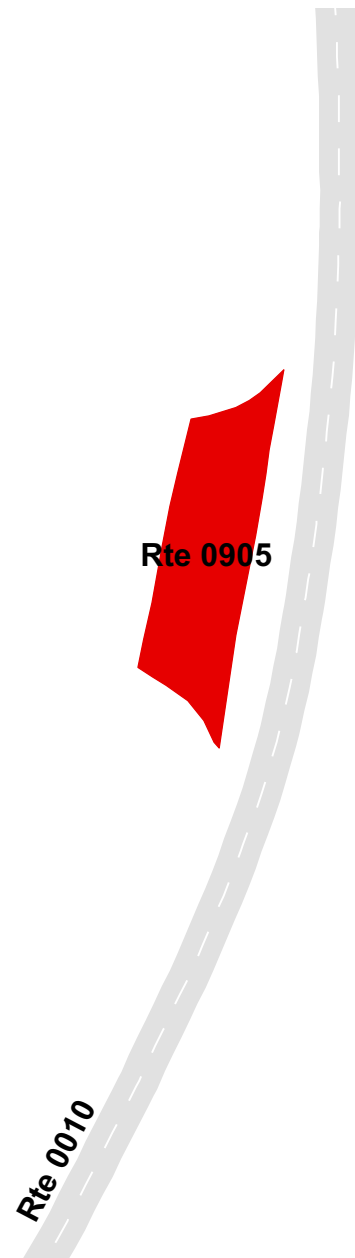
Route 0905

Route Number	Public / NonPublic	Date Visited	Area (sq ft)	Lane Miles *	Surface Type
0905	PUBLIC	8/12/2011	3,759	0.07	AS
Culverts	Drop Inlets	Gates	Curb & Gutter	Curb	PCR
0	0	0	CONCRETE CURB AND GUTTER	NO CURB	FAIR/73

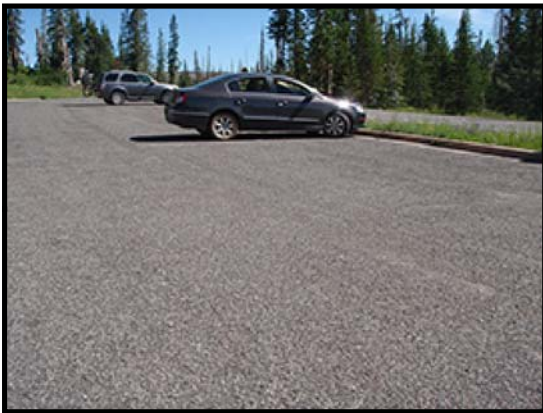
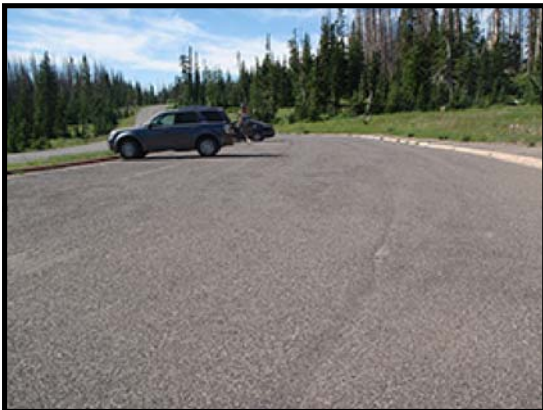
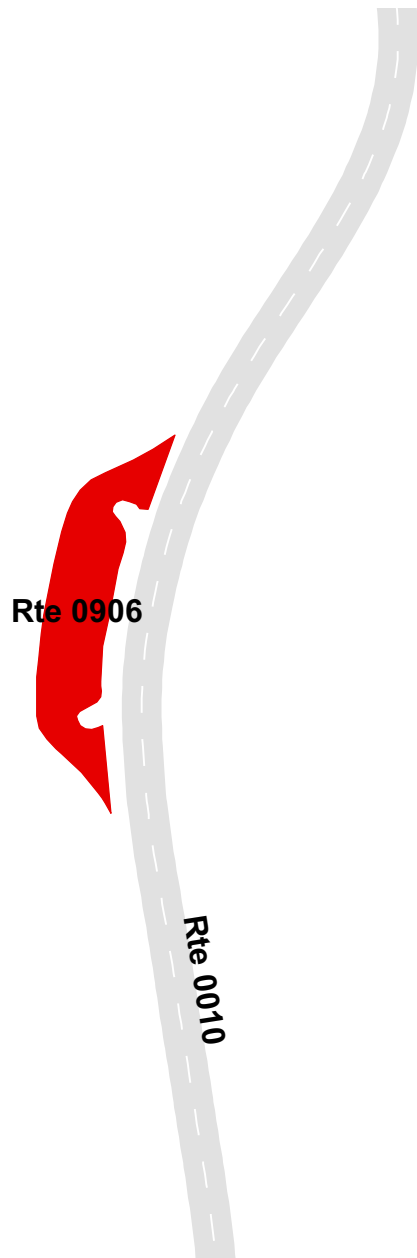
Route 0906

Route Number	Public / NonPublic	Date Visited	Area (sq ft)	Lane Miles *	Surface Type
0906	PUBLIC	8/12/2011	11,555	0.20	AS
Culverts	Drop Inlets	Gates	Curb & Gutter	Curb	PCR
0	1	0	CONCRETE CURB AND GUTTER	NO CURB	FAIR/73

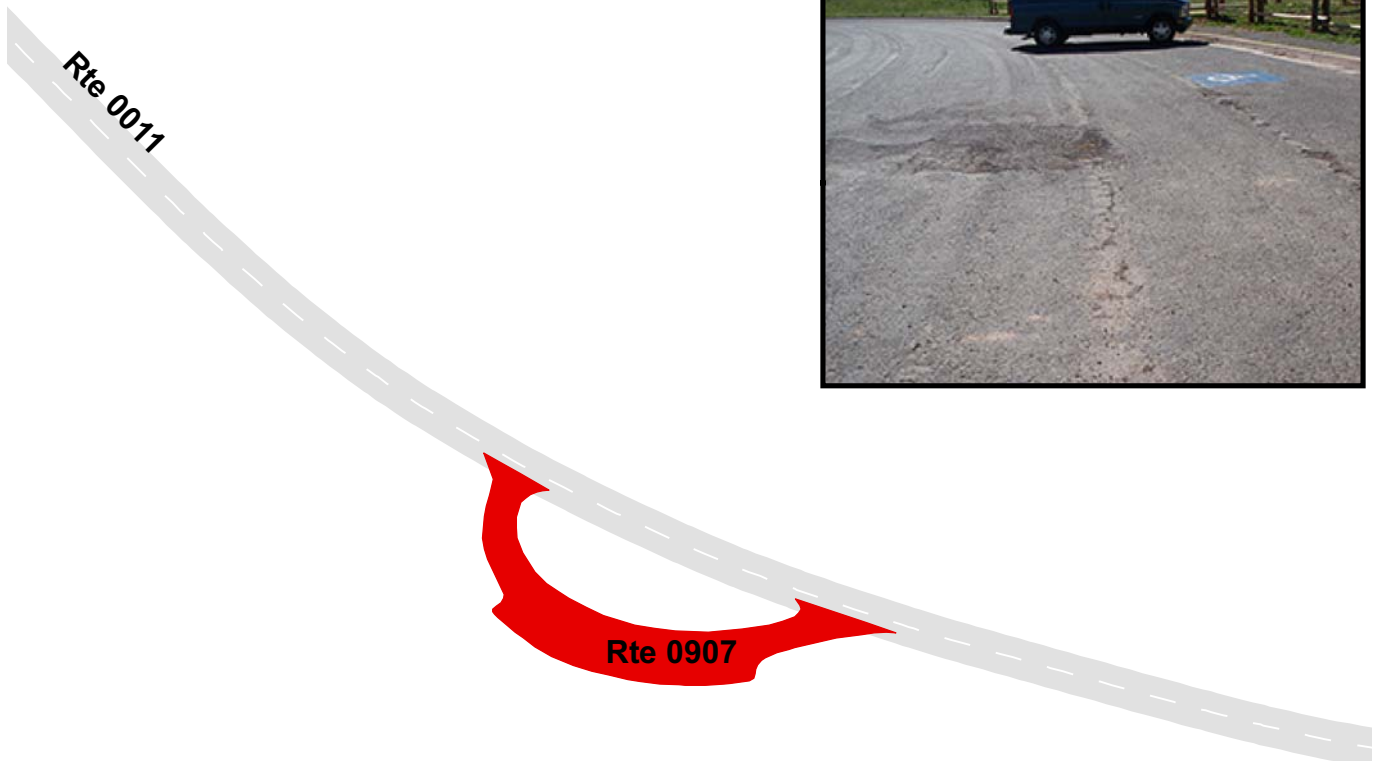
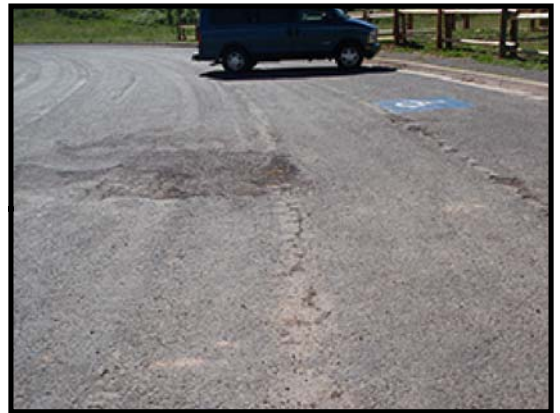
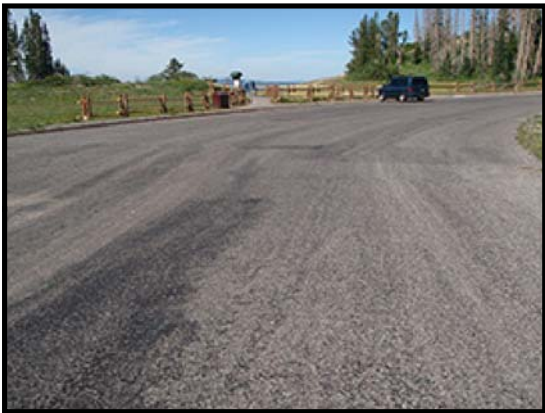
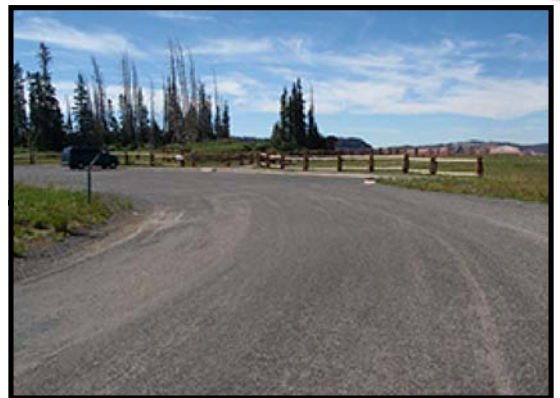
Route 0907

Route Number	Public / NonPublic	Date Visited	Area (sq ft)	Lane Miles *	Surface Type
0907	PUBLIC	8/12/2011	19,750	0.34	AS
Culverts	Drop Inlets	Gates	Curb & Gutter	Curb	PCR
0	0	0	CONCRETE CURB AND GUTTER	NO CURB	FAIR/73

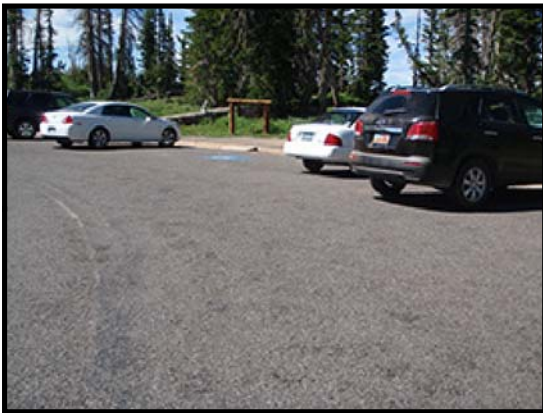
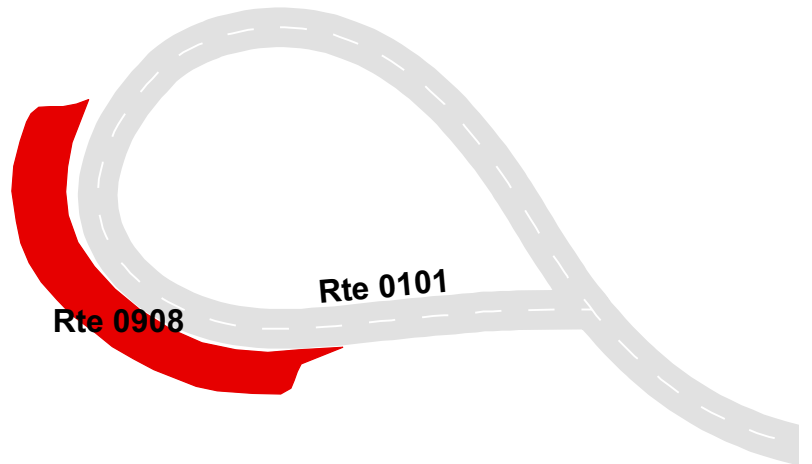
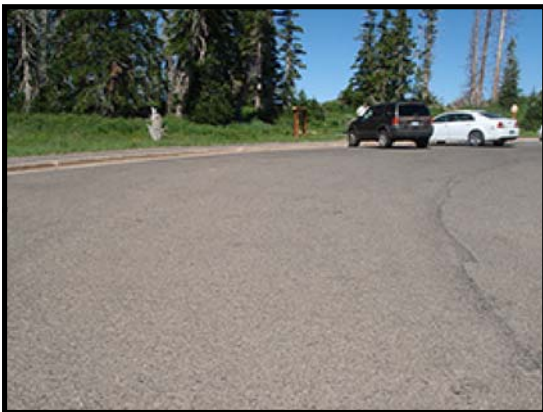
Route 0908

Route Number	Public / NonPublic	Date Visited	Area (sq ft)	Lane Miles *	Surface Type
0908	PUBLIC	8/12/2011	4,608	0.08	AS
Culverts	Drop Inlets	Gates	Curb & Gutter	Curb	PCR
0	0	0	CONCRETE CURB AND GUTTER	NO CURB	FAIR/73
