Federal Lands Highway Road Inventory Program

Road Inventory and Condition Assessment

Everglades National Park EVER

Cycle 5 Report

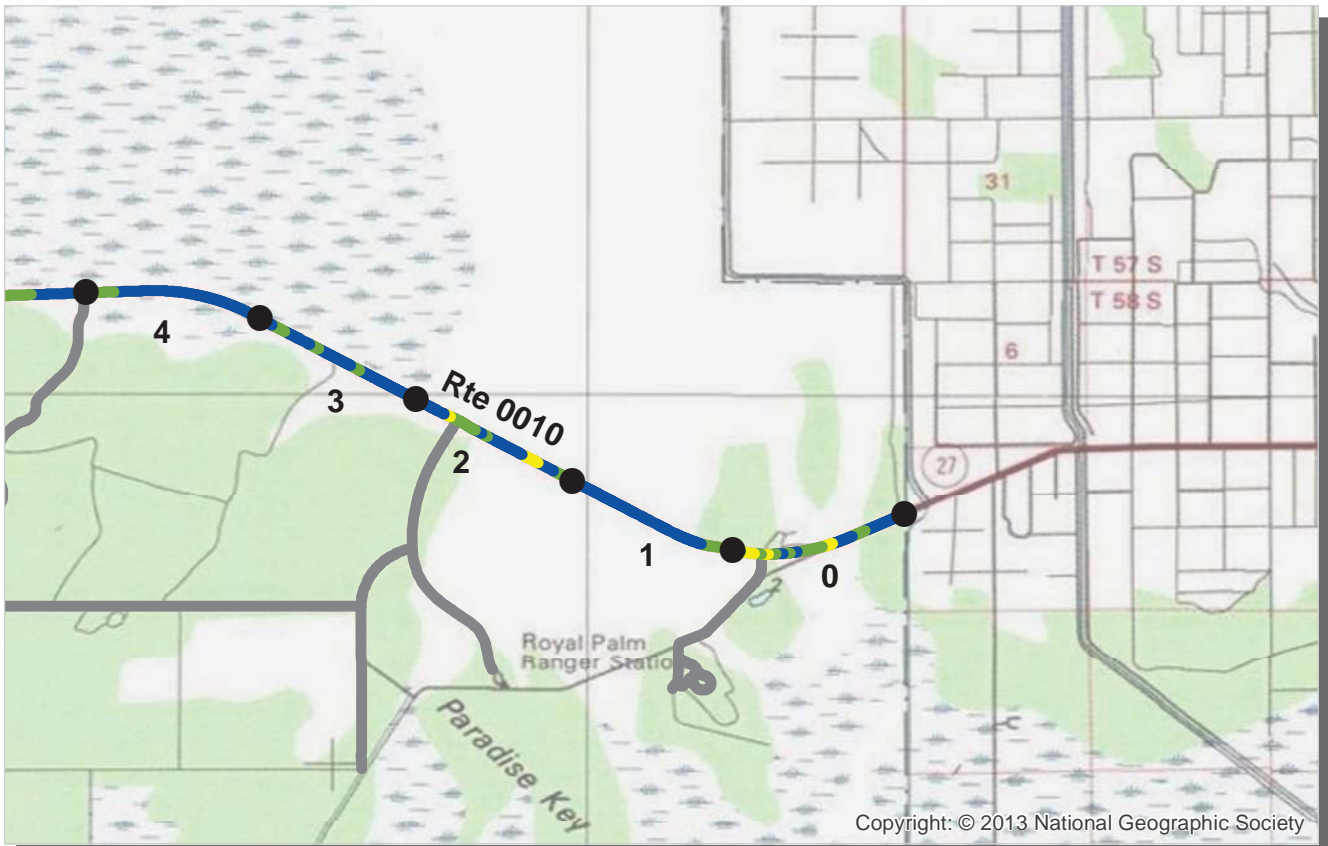
<i>Section Number</i>	0	1	2	3	4
<i>Section Length (mi)</i>	1.00	1.00	1.00	1.00	1.00
<i>Cross Section Information</i>					
Number of Lanes	2	2	2	2	2
Paved Width (ft)	22	19	21	21	22
Lane Width (ft)	10	12	11	11	10
<i>Roadway Condition Information</i>					
SCR (Surface Condition Rating)	93	98	98	97	94
PCR (Pavement Condition Rating)	89	99	97	98	96
<i>Distress Index Values</i>					
Structural Crack Index	96	98	98	98	99
Transverse Cracking Index	93	98	99	99	100
Patching Index	99	99	100	100	100
Rutting Index	95	98	98	97	94
Roughness Condition Index (RCI)	84	100	95	100	100

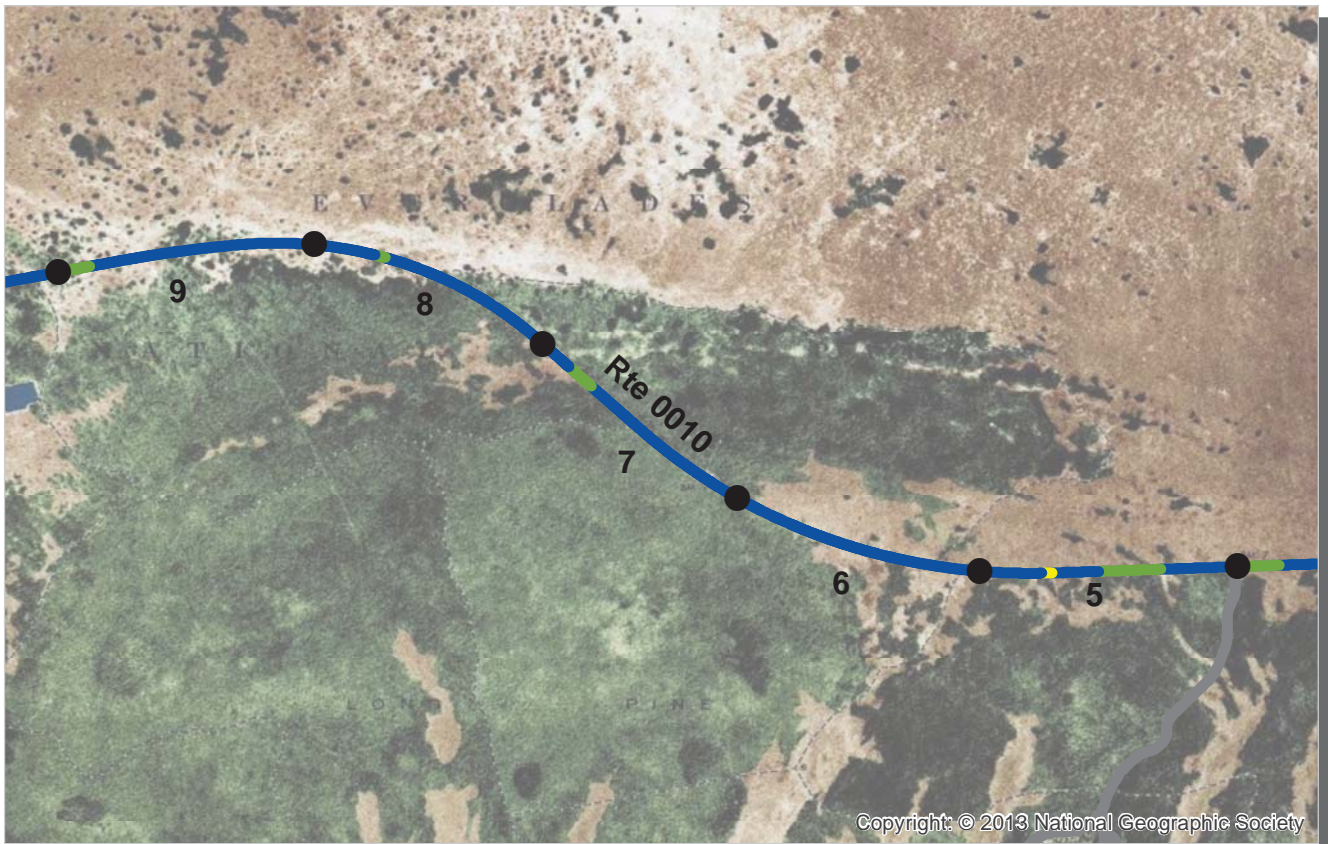
ROUTE: 0010 MAIN PARK ROAD

<i>Section Number</i>	5	6	7	8	9
<i>Section Length (mi)</i>	1.00	1.00	1.00	1.00	1.00
<i>Cross Section Information</i>					
Number of Lanes	2	2	2	2	2
Paved Width (ft)	21	22	22	22	22
Lane Width (ft)	11	11	11	11	10
<i>Roadway Condition Information</i>					
SCR (Surface Condition Rating)	94	97	97	97	96
PCR (Pavement Condition Rating)	96	98	98	98	98
<i>Distress Index Values</i>					
Structural Crack Index	97	100	97	99	97
Transverse Cracking Index	100	100	99	100	99
Patching Index	100	100	99	100	100
Rutting Index	94	97	97	97	96
Roughness Condition Index (RCI)	100	100	100	100	100

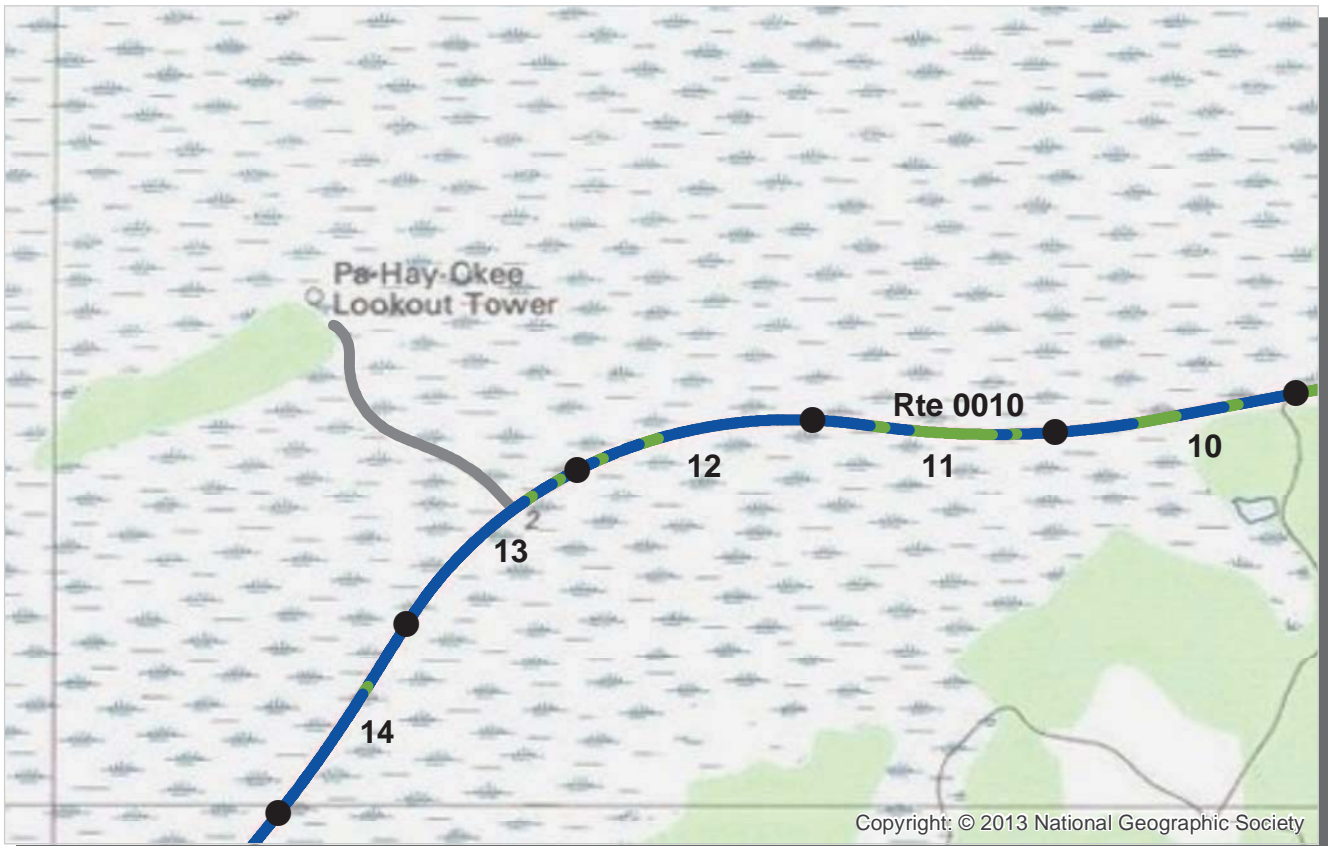
ROUTE: 0010 MAIN PARK ROAD

<i>Section Number</i>	10	11	12	13	14
<i>Section Length (mi)</i>	1.00	1.00	1.00	1.00	1.00
<i>Cross Section Information</i>					
Number of Lanes	2	2	2	2	2
Paved Width (ft)	22	22	22	22	22
Lane Width (ft)	11	11	11	11	11
<i>Roadway Condition Information</i>					
SCR (Surface Condition Rating)	94	93	95	94	94
PCR (Pavement Condition Rating)	96	96	97	96	96
<i>Distress Index Values</i>					
Structural Crack Index	96	99	100	100	99
Transverse Cracking Index	99	98	100	100	100
Patching Index	100	100	100	100	100
Rutting Index	94	93	95	94	94
Roughness Condition Index (RCI)	100	100	100	100	100

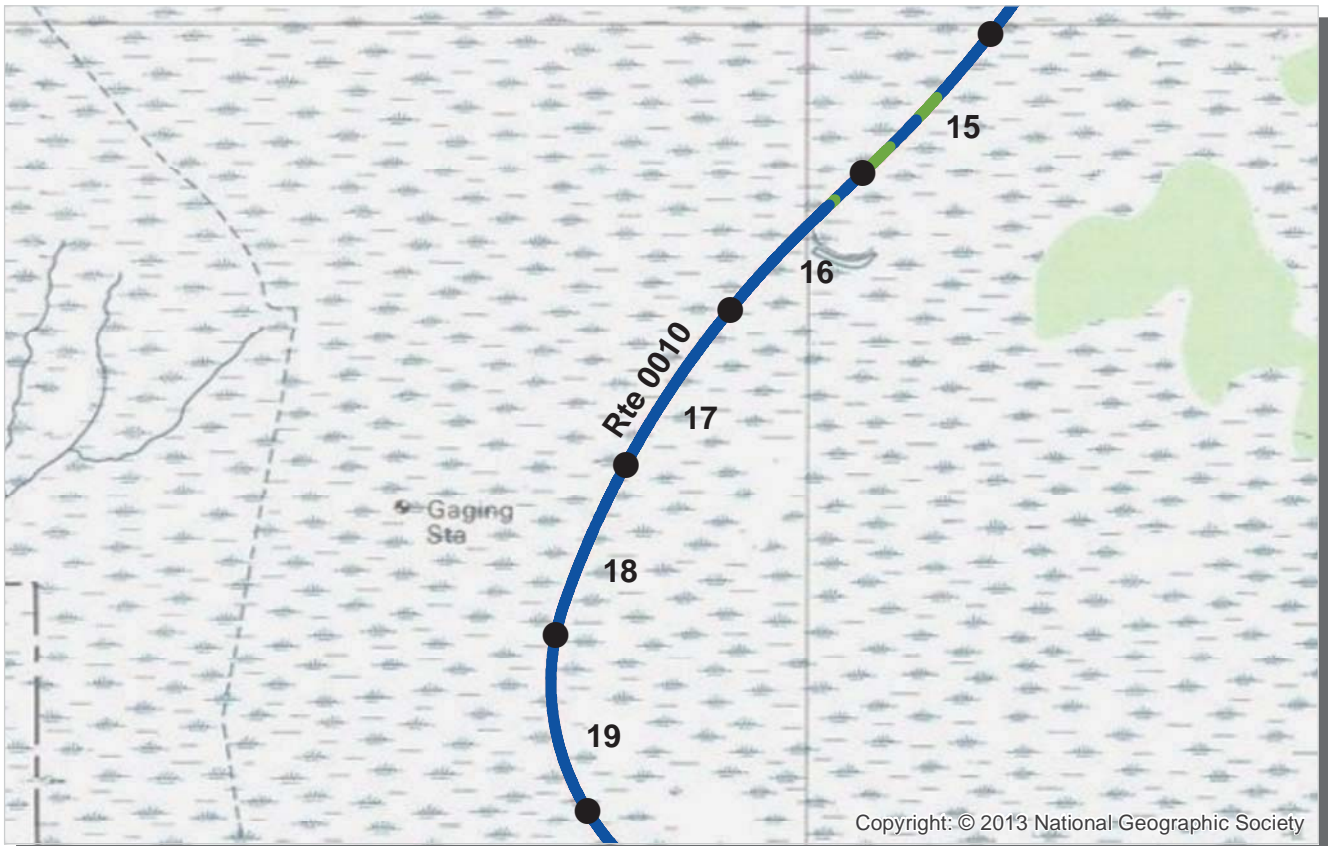
ROUTE: 0010 MAIN PARK ROAD

<i>Section Number</i>	15	16	17	18	19
<i>Section Length (mi)</i>	1.00	1.00	1.00	1.00	1.00
<i>Cross Section Information</i>					
Number of Lanes	2	2	2	2	2
Paved Width (ft)	23	22	23	23	23
Lane Width (ft)	11	11	11	11	11
<i>Roadway Condition Information</i>					
SCR (Surface Condition Rating)	92	96	98	100	100
PCR (Pavement Condition Rating)	95	98	99	100	100
<i>Distress Index Values</i>					
Structural Crack Index	99	100	100	100	100
Transverse Cracking Index	100	100	100	100	100
Patching Index	100	100	100	100	100
Rutting Index	92	96	98	100	100
Roughness Condition Index (RCI)	100	100	100	100	100

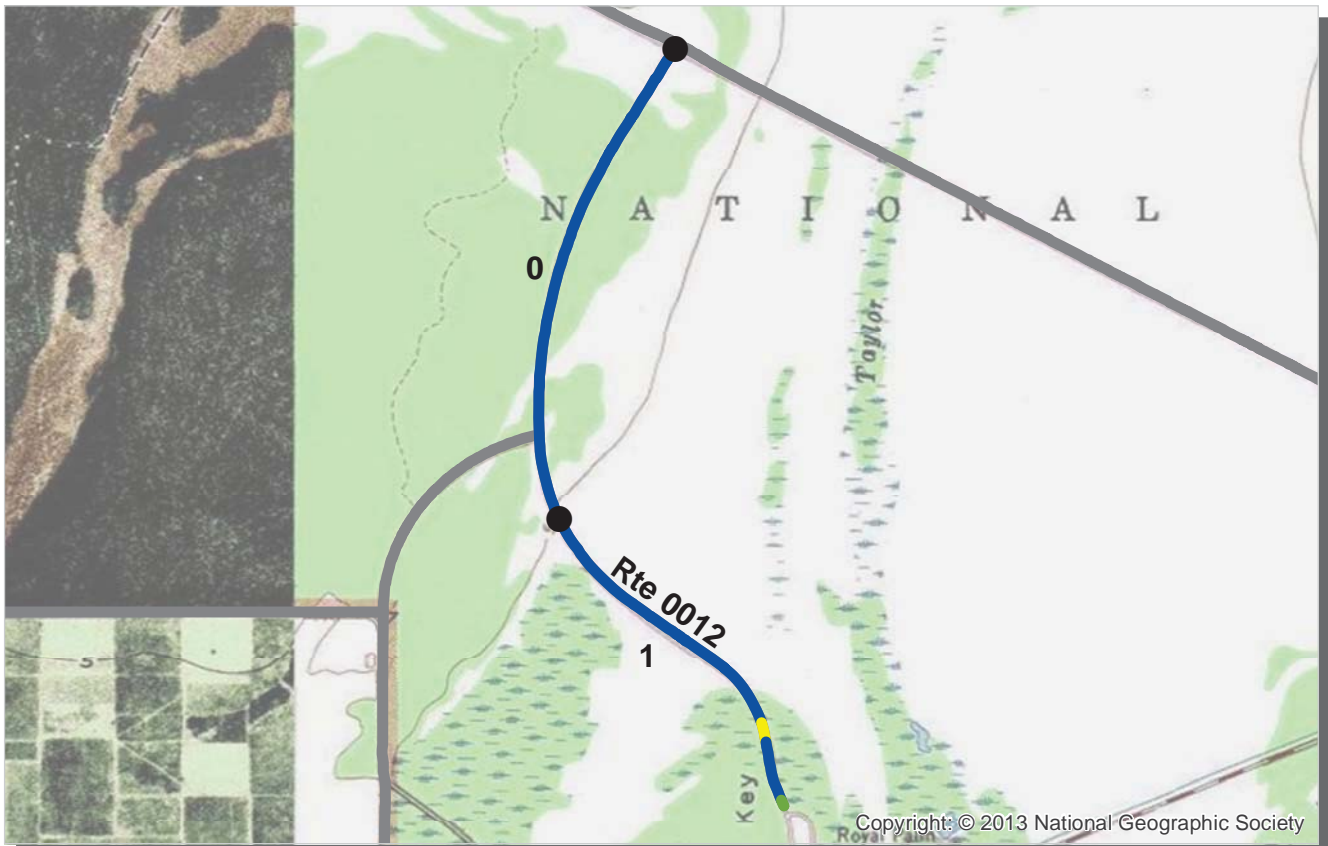
ROUTE: 0010 MAIN PARK ROAD

<i>Section Number</i>	0	1			
<i>Section Length (mi)</i>	1.00	0.74			
<i>Cross Section Information</i>					
Number of Lanes	2	2			
Paved Width (ft)	24	23			
Lane Width (ft)	11	11			
<i>Roadway Condition Information</i>					
SCR (Surface Condition Rating)	99	98			
PCR (Pavement Condition Rating)	99	99			
<i>Distress Index Values</i>					
Structural Crack Index	100	100			
Transverse Cracking Index	100	99			
Patching Index	100	100			
Rutting Index	99	98			
Roughness Condition Index (RCI)	100	100

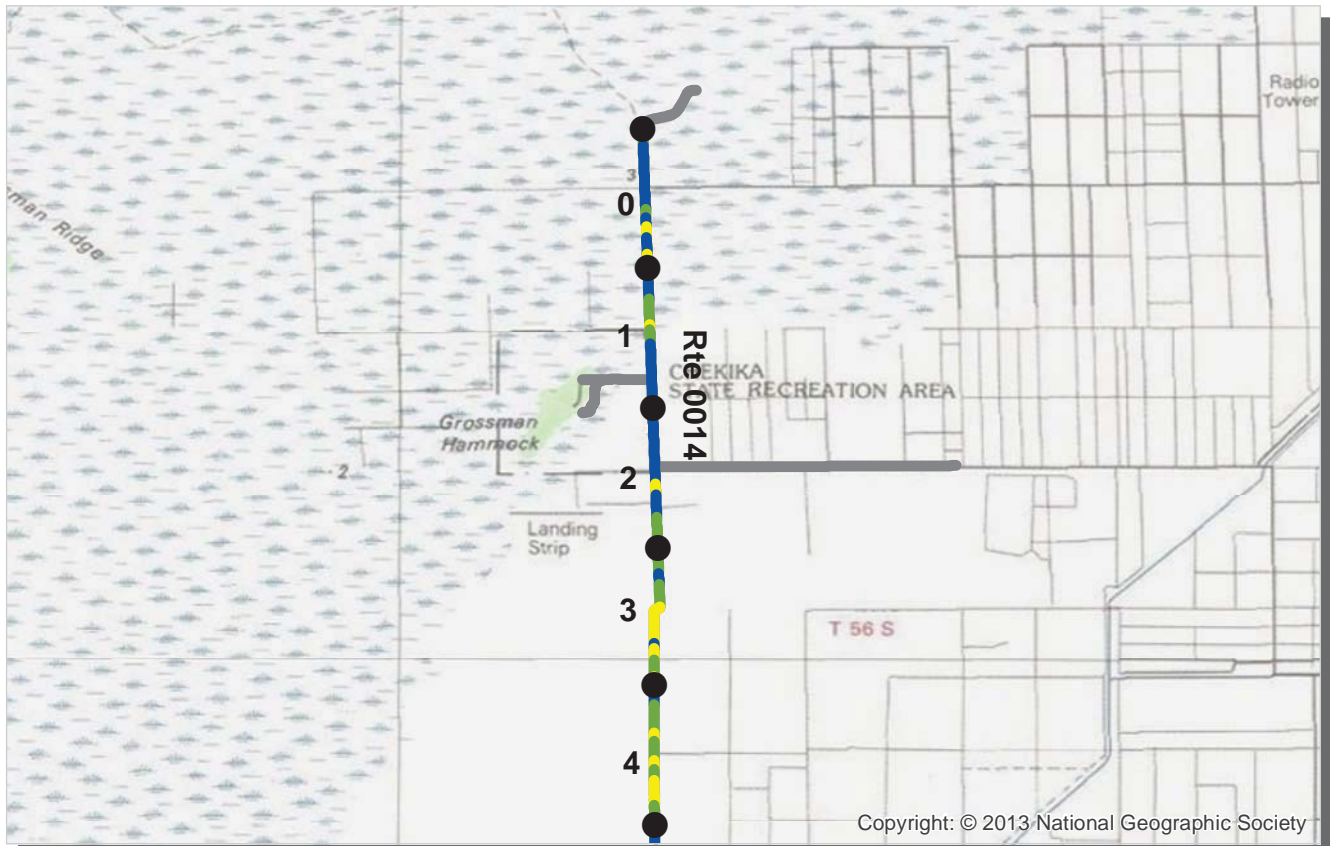
ROUTE: 0012 ROYAL PALM ACCESS ROAD

<i>Section Number</i>	0	1	2	3	4
<i>Section Length (mi)</i>	1.00	1.00	1.00	1.00	1.00
<i>Cross Section Information</i>					
Number of Lanes	2	2	2	2	2
Paved Width (ft)	16	18	18	17	17
Lane Width (ft)	9	9	9	8	9
<i>Roadway Condition Information</i>					
SCR (Surface Condition Rating)	93	98	96	93	92
PCR (Pavement Condition Rating)	91	96	98	87	85
<i>Distress Index Values</i>					
Structural Crack Index	99	98	96	96	100
Transverse Cracking Index	100	99	100	100	99
Patching Index	99	99	100	99	100
Rutting Index	93	98	97	93	92
Roughness Condition Index (RCI)	89	93	100	77	75
