Federal Lands Highway Road Inventory Program

Road Inventory and Condition Assessment

Fort Matanzas National Monument FOMA

Cycle 5 Report

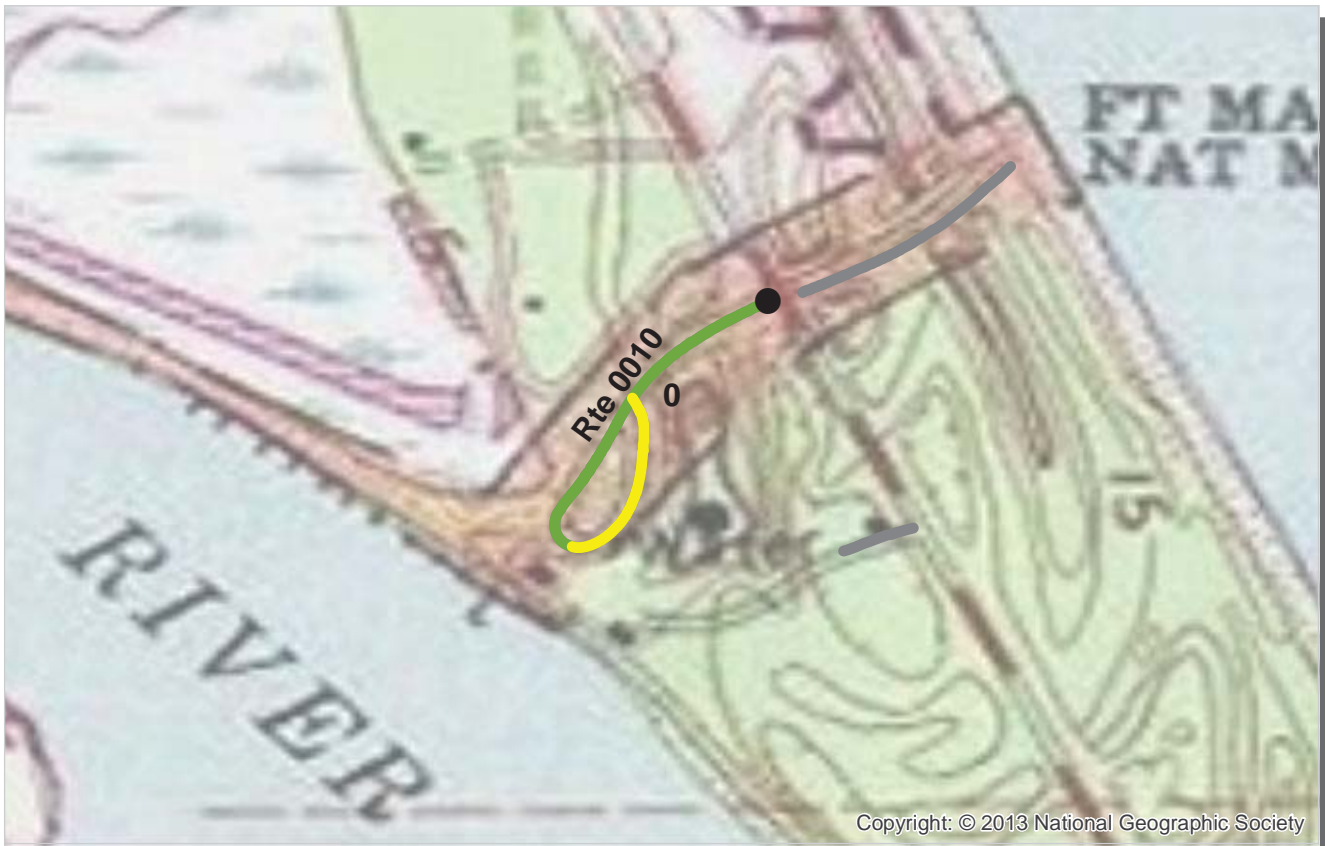
ROUTE: 0010 VISITOR CENTER ACCESS ROAD

Section Number	0				
Section Length (mi)	0.24				
Cross Section Information					
Number of Lanes	1				
Paved Width (ft)	22				
Lane Width (ft)	17				
Roadway Condition Information					
SCR (Surface Condition Rating)	89				
PCR (Pavement Condition Rating)	89				
Distress Index Values					
Structural Crack Index	89				
Transverse Cracking Index	89				
Patching Index	100				
Rutting Index	94				
Roughness Condition Index (RCI)	NC

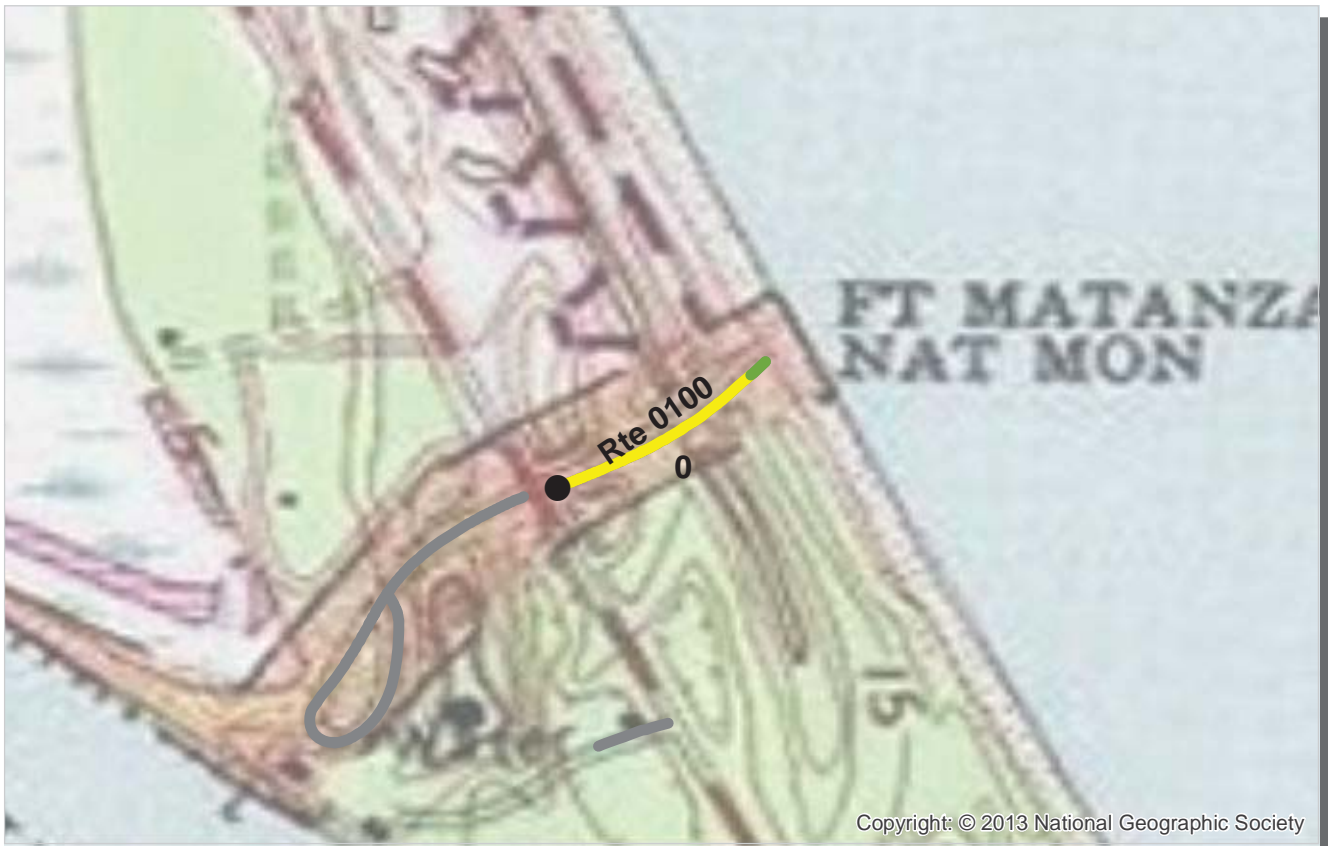
ROUTE: 0100 BEACH ACCESS ROAD

Section Number	0				
Section Length (mi)	0.11				
Cross Section Information					
Number of Lanes	2				
Paved Width (ft)	23				
Lane Width (ft)	11				
Roadway Condition Information					
SCR (Surface Condition Rating)	71				
PCR (Pavement Condition Rating)	71				
Distress Index Values					
Structural Crack Index	93				
Transverse Cracking Index	71				
Patching Index	100				
Rutting Index	99				
Roughness Condition Index (RCI)	NC

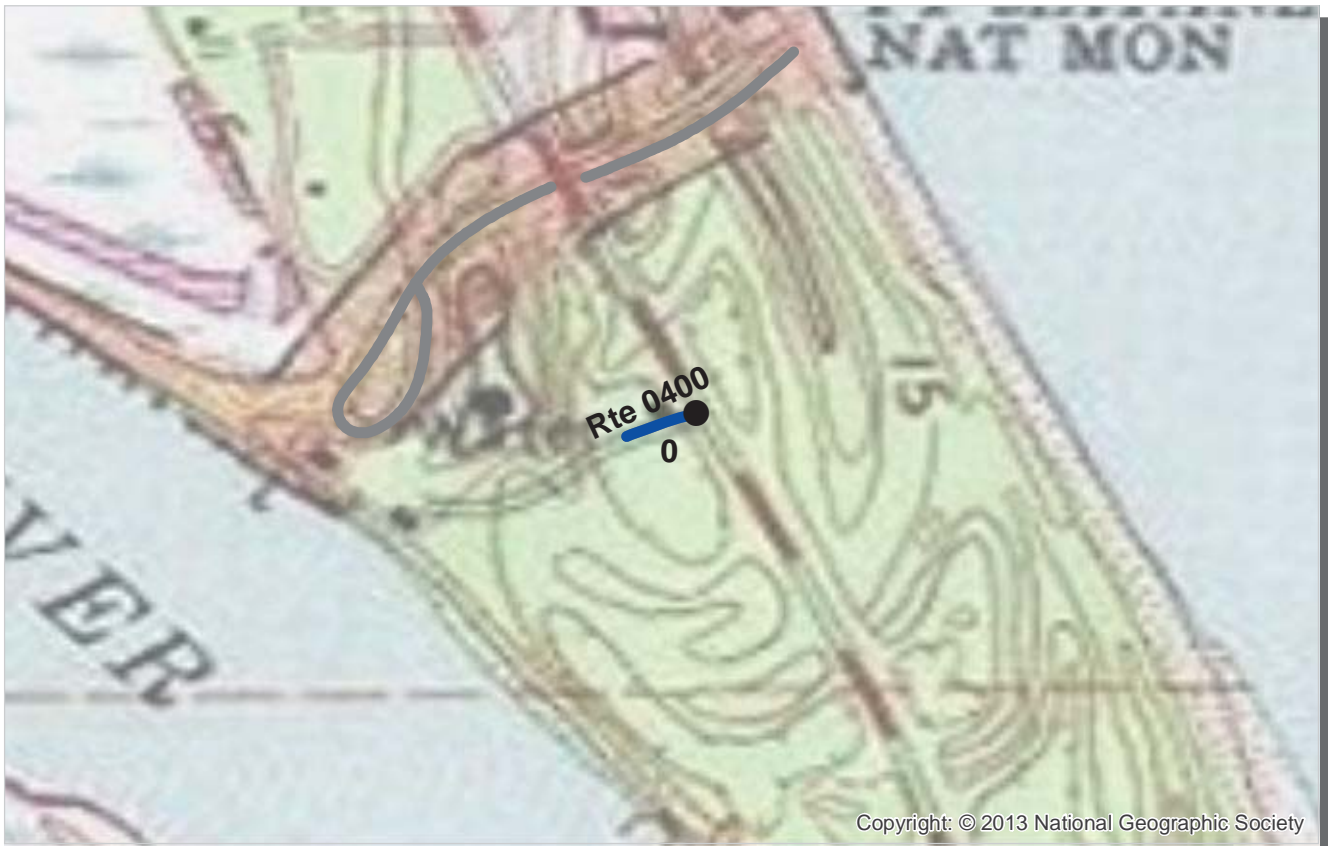
ROUTE: 0400 FOMA MAINTENANCE ACCESS ROAD

Section Number	0				
Section Length (mi)	0.03				
Cross Section Information					
Number of Lanes	1				
Paved Width (ft)	14				
Lane Width (ft)	14				
Roadway Condition Information					
SCR (Surface Condition Rating)	95				
PCR (Pavement Condition Rating)	95				
Distress Index Values					
Structural Crack Index	96				
Transverse Cracking Index	98				
Patching Index	100				
Rutting Index	95				
Roughness Condition Index (RCI)	NC

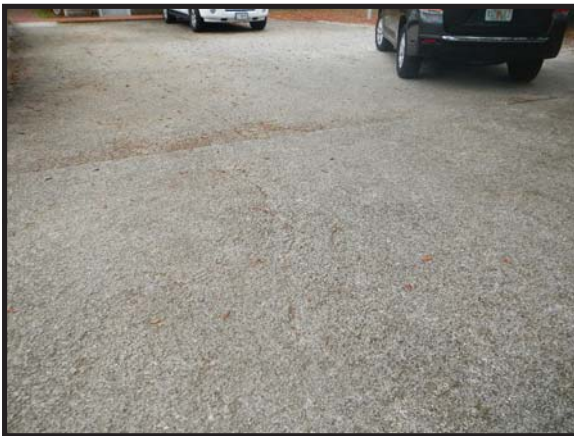
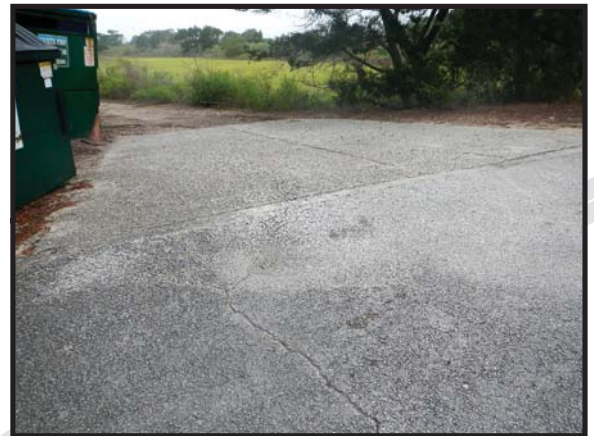
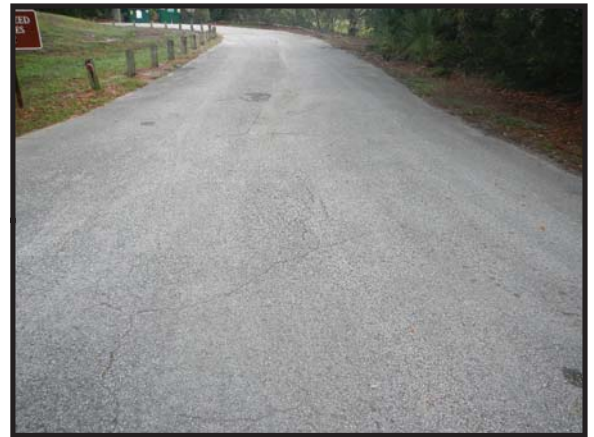
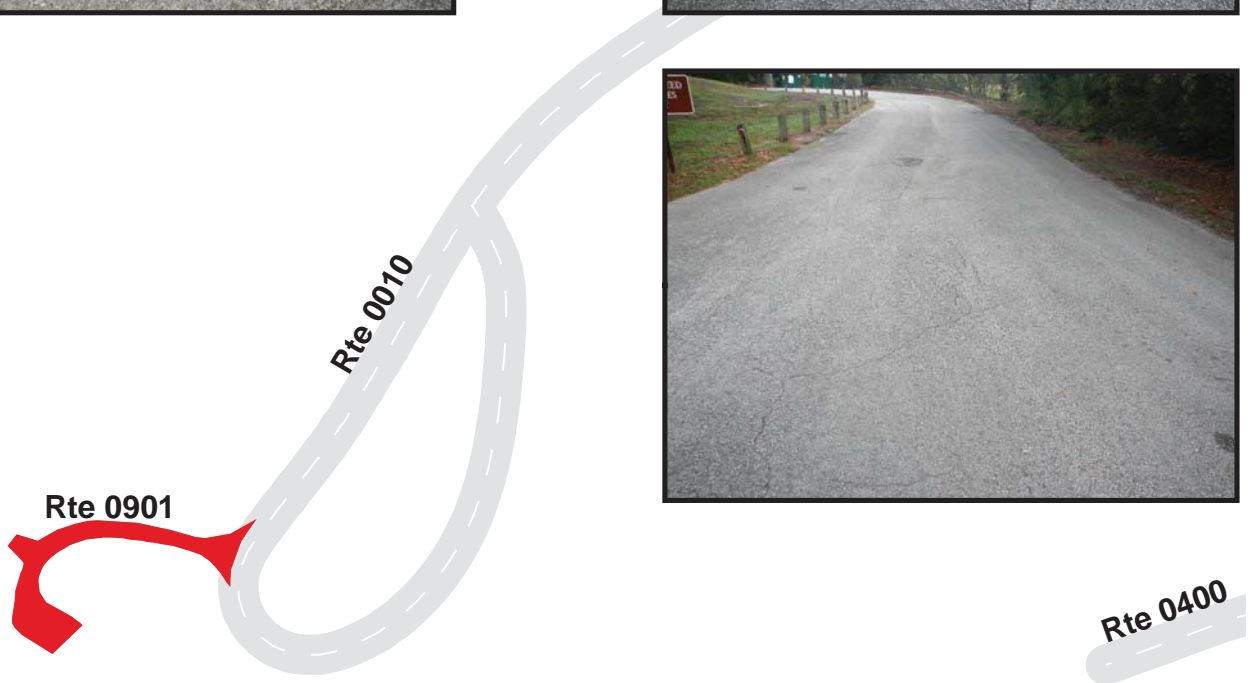
Route Number	Public / NonPublic	Date Visited	Area (sq ft)	Lane Miles *	Surface Type
0901	NONPUBLIC	4/17/2013	5,276	0.09	AS
Culverts	Drop Inlets	Gates	Curb & Gutter	Curb	PCR
0	0	0	NO CURB AND GUTTER	NO CURB	FAIR/73

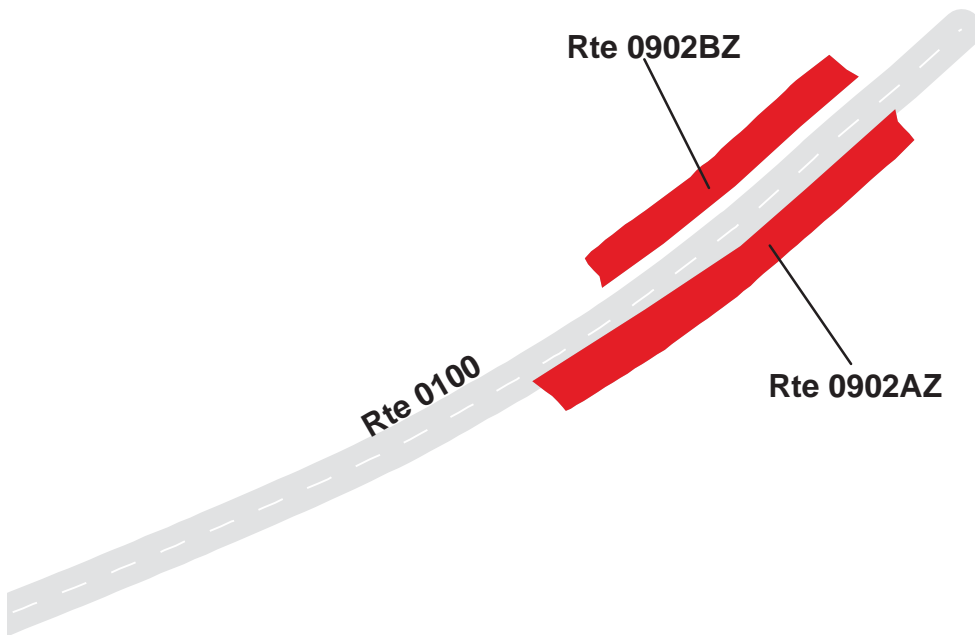
Route 0902ZZ

Route Number	Public / NonPublic	Date Visited	Area (sq ft)	Lane Miles *	Surface Type
0902ZZ	PUBLIC	4/17/2013	7,568	0.13	AS
Culverts	Drop Inlets	Gates	Curb & Gutter	Curb	PCR
0	0	0	NO CURB AND GUTTER	NO CURB	SUMMARY/73

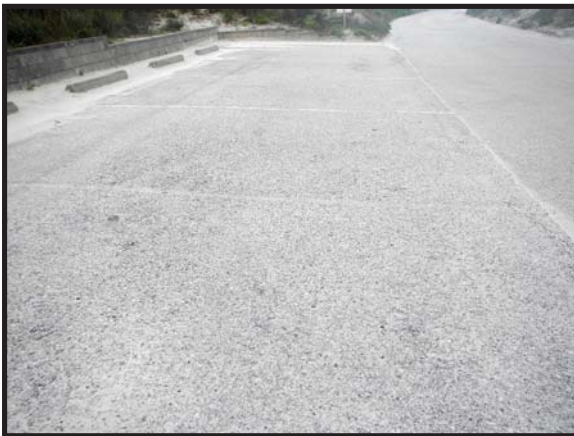
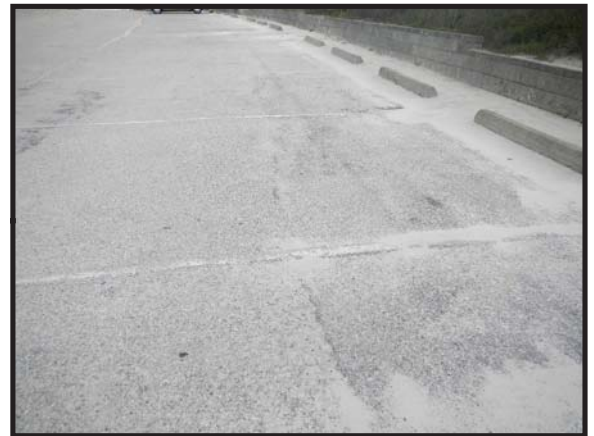
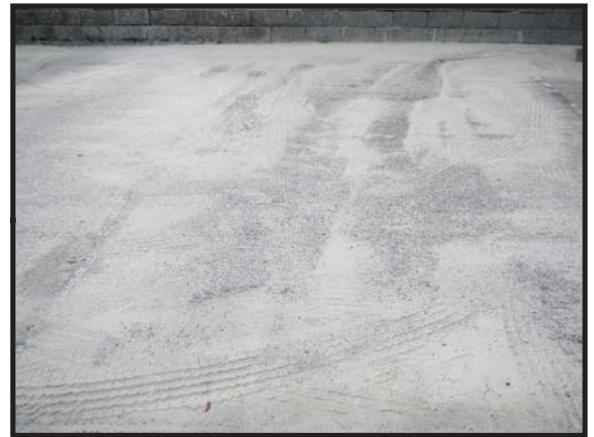
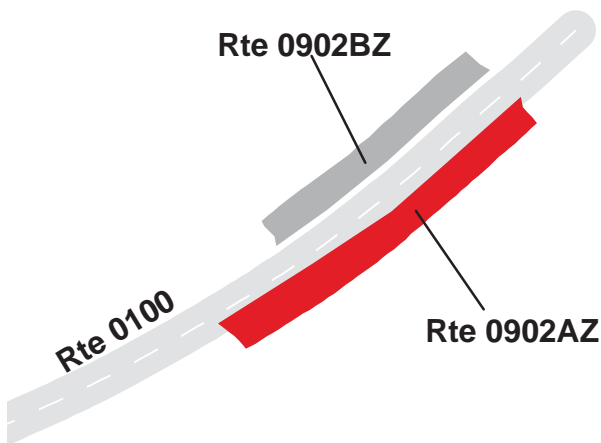
Route 0902AZ

Route Number	Public / NonPublic	Date Visited	Area (sq ft)	Lane Miles *	Surface Type
0902AZ	PUBLIC	4/17/2013	4,543	0.08	AS
Culverts	Drop Inlets	Gates	Curb & Gutter	Curb	PCR
0	0	0	NO CURB AND GUTTER	NO CURB	FAIR/73

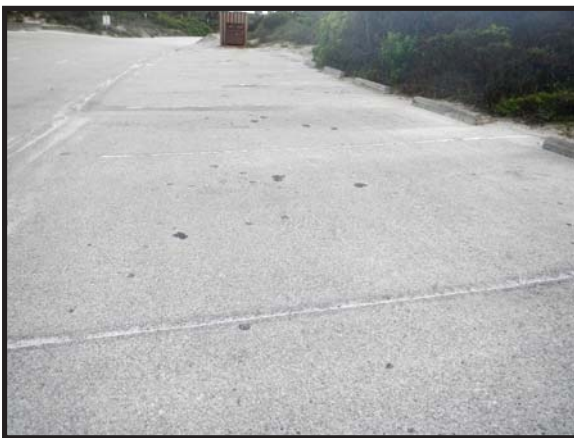
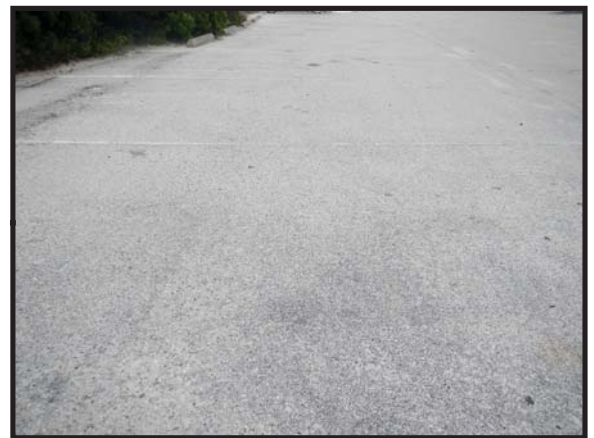
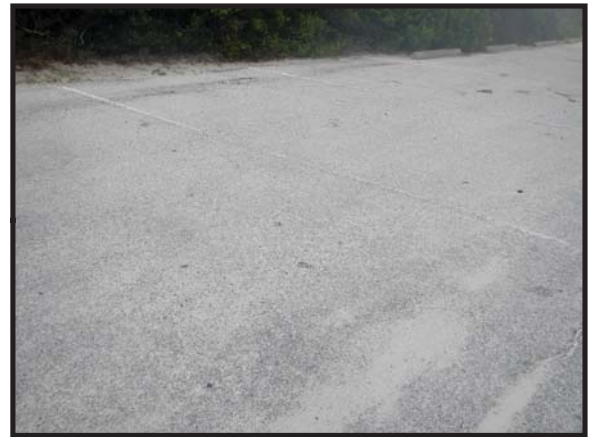
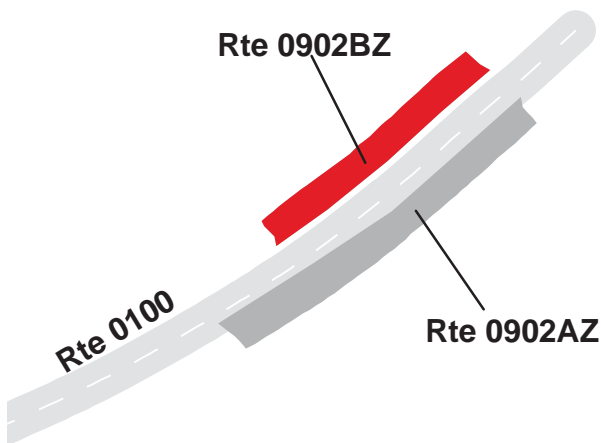
Route 0902BZ

Route Number	Public / NonPublic	Date Visited	Area (sq ft)	Lane Miles *	Surface Type
0902BZ	PUBLIC	4/17/2013	3,025	0.05	AS
Culverts	Drop Inlets	Gates	Curb & Gutter	Curb	PCR
0	0	0	NO CURB AND GUTTER	NO CURB	FAIR/73

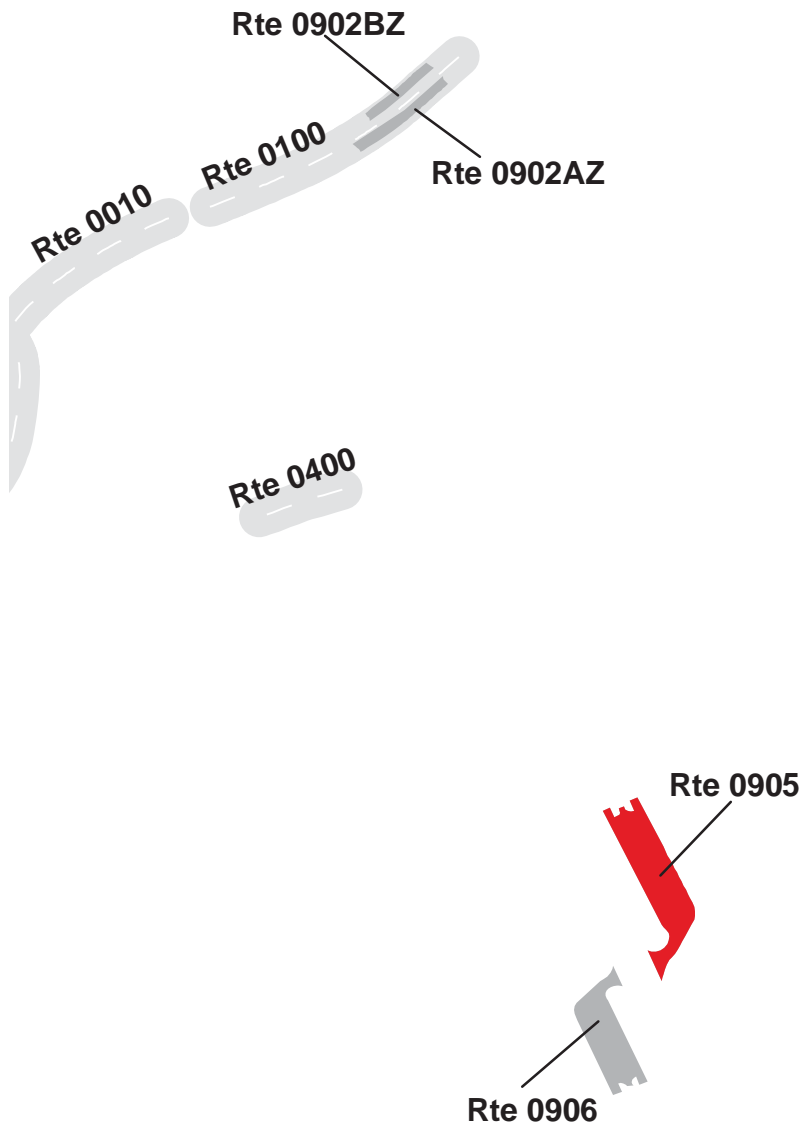
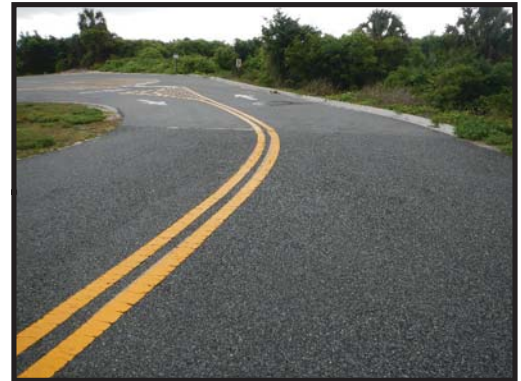
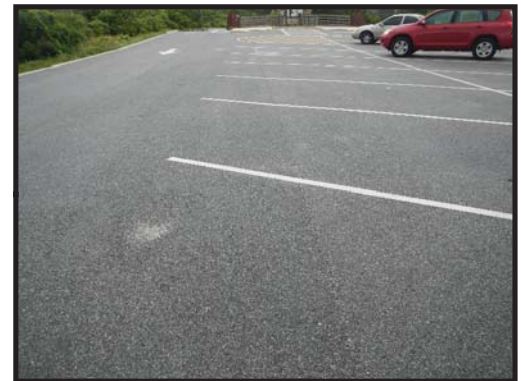
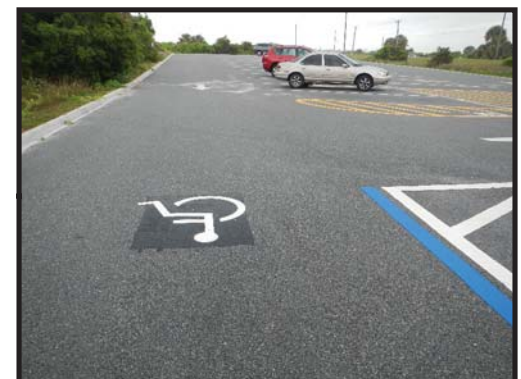
Route 0905

Route Number	Public / NonPublic	Date Visited	Area (sq ft)	Lane Miles *	Surface Type
0905	PUBLIC	4/17/2013	23,110	0.40	AS
Culverts	Drop Inlets	Gates	Curb & Gutter	Curb	PCR
0	0	0	CONCRETE CURB AND GUTTER	CONCRETE CURB	GOOD/90

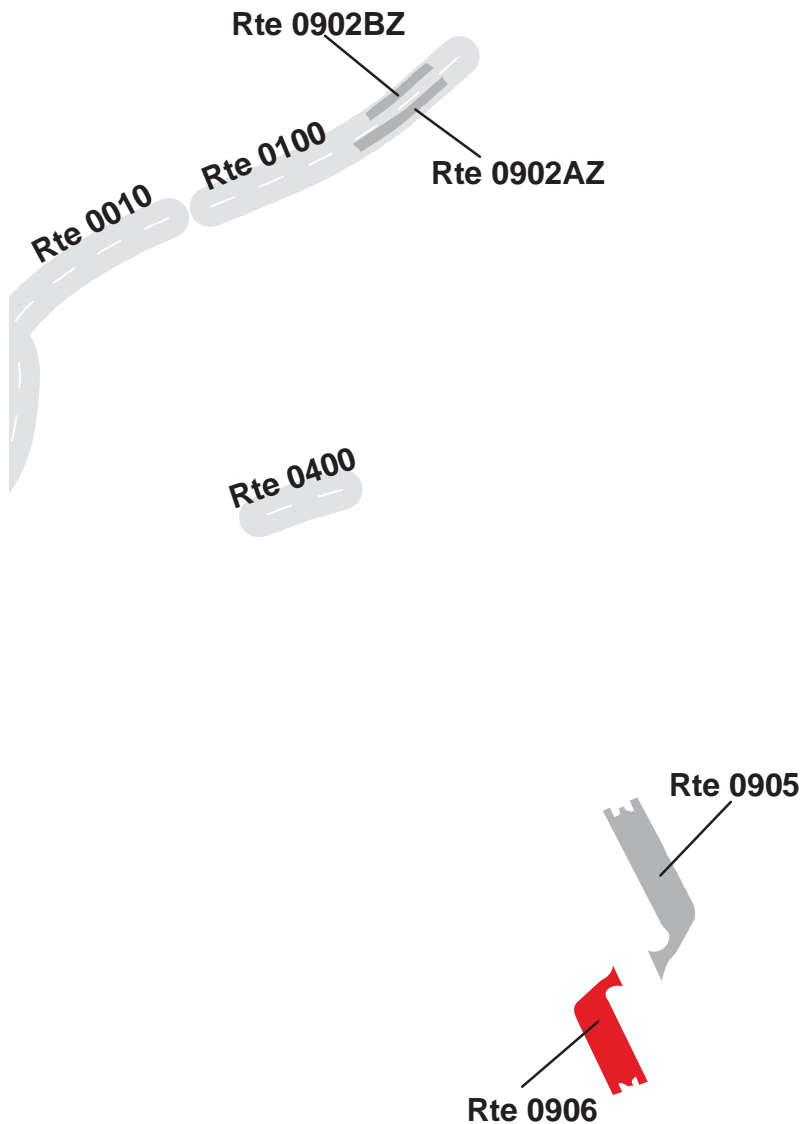
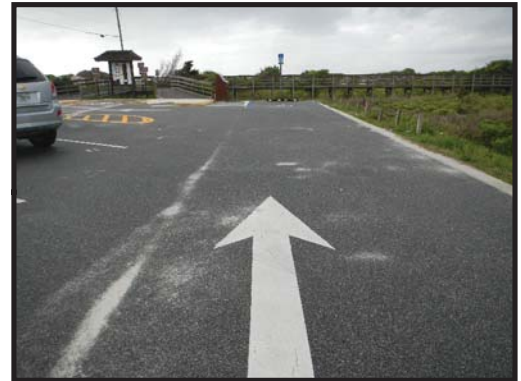
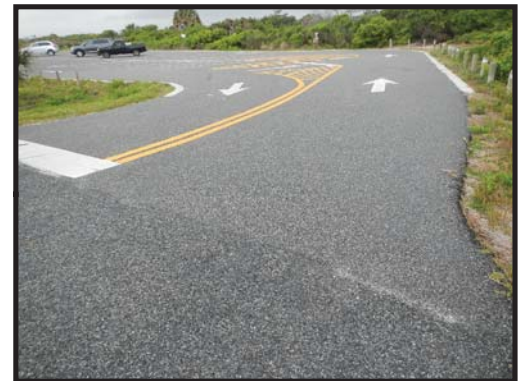
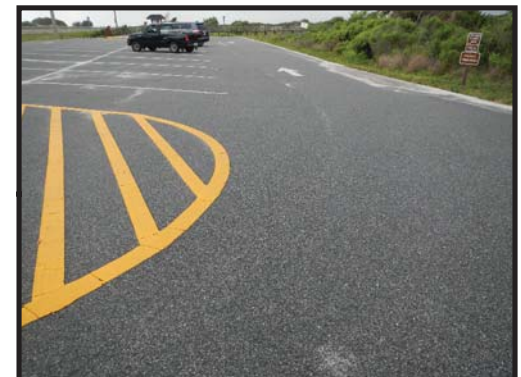
Route 0906

Route Number	Public / NonPublic	Date Visited	Area (sq ft)	Lane Miles *	Surface Type
0906	PUBLIC	4/17/2013	16,003	0.28	AS
Culverts	Drop Inlets	Gates	Curb & Gutter	Curb	PCR
0	0	0	NO CURB AND GUTTER	CONCRETE CURB	GOOD/90
