Federal Lands Highway Road Inventory Program

Road Inventory and Condition Assessment

Herbert Hoover National Historic Site HEHO

Cycle 5 Report

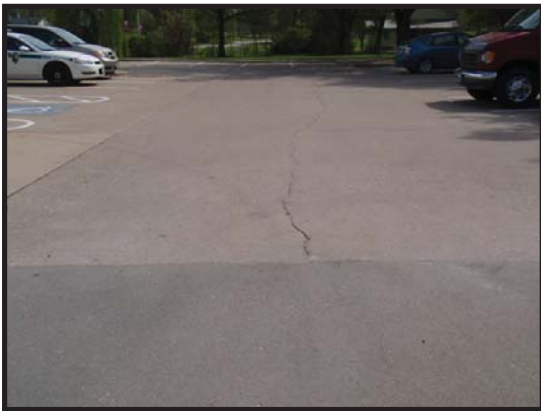
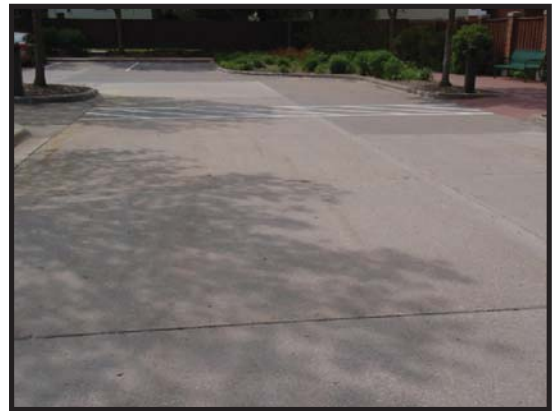
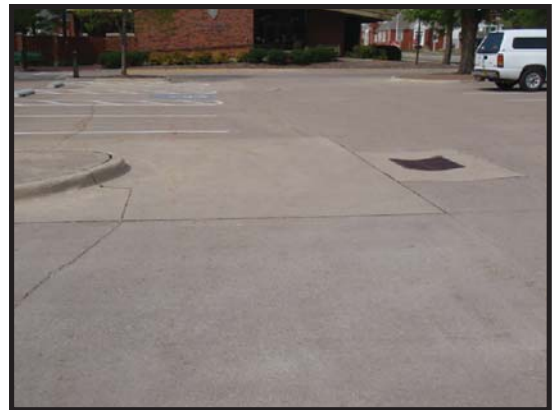
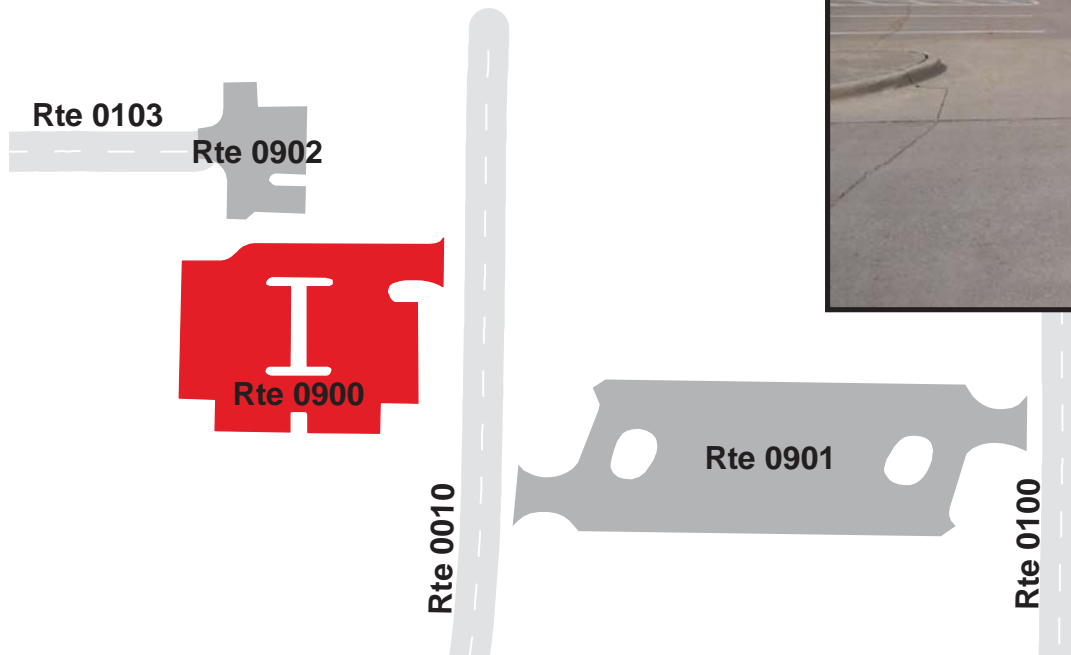
Route 0901

Route Number	Public / NonPublic	Date Visited	Area (sq ft)	Lane Miles *	Surface Type
0901	PUBLIC	4/25/2012	28,288	0.49	CO
Culverts	Drop Inlets	Gates	Curb & Gutter	Curb	PCR
0	0	0	NO CURB AND GUTTER	CONCRETE CURB	POOR/45

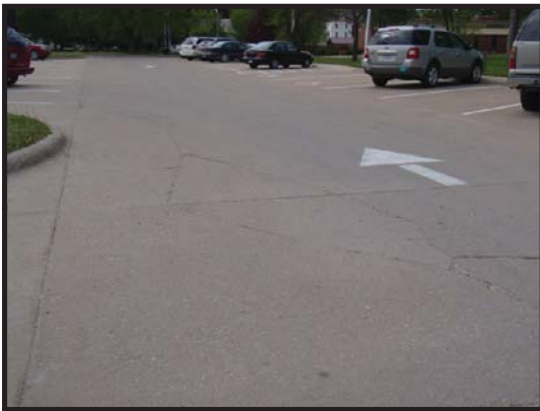
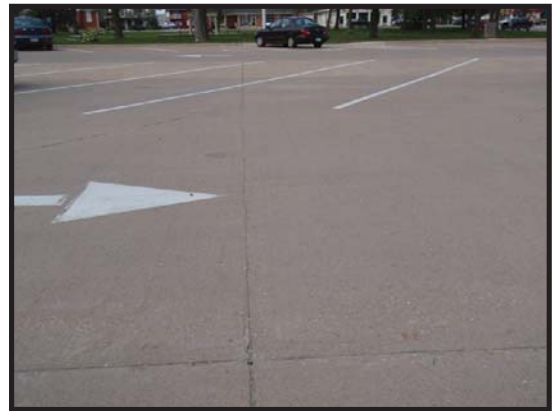
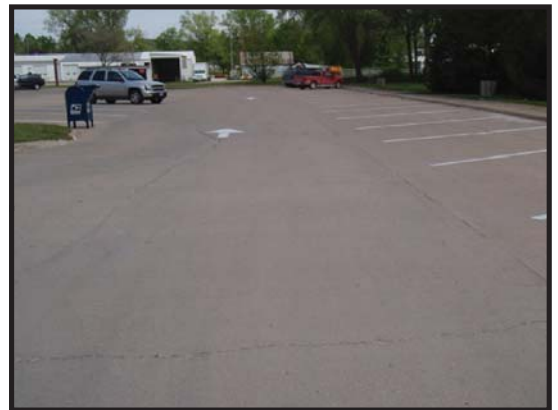
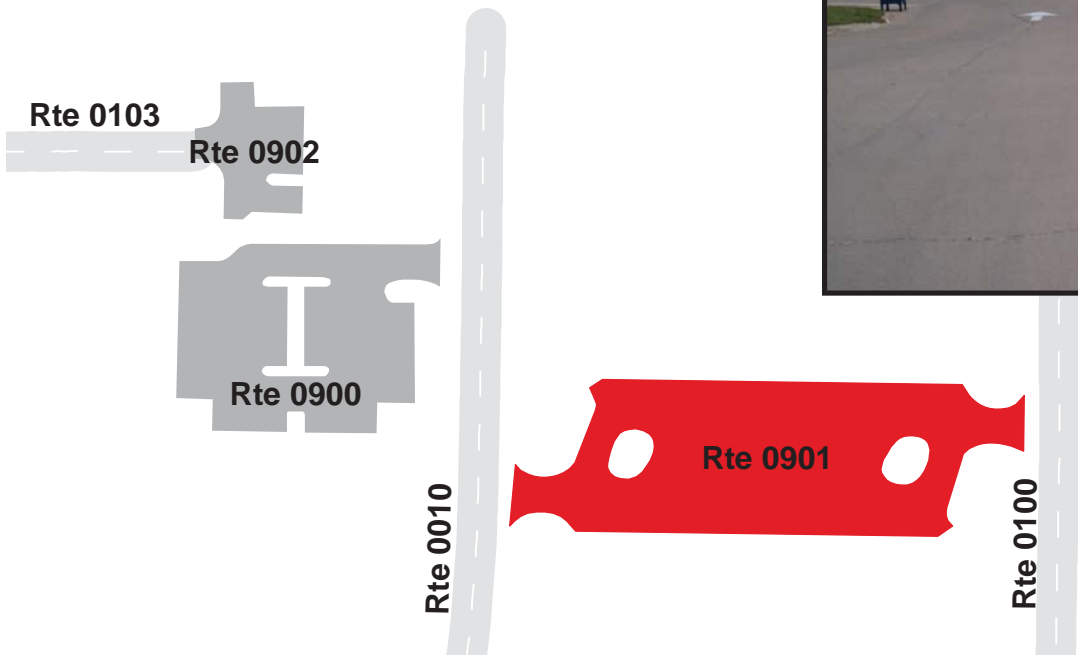
Route 0902

Route Number	Public / NonPublic	Date Visited	Area (sq ft)	Lane Miles *	Surface Type
0902	NONPUBLIC	4/25/2012	4,908	0.09	CO
Culverts	Drop Inlets	Gates	Curb & Gutter	Curb	PCR
0	2	0	NO CURB AND GUTTER	CONCRETE CURB	FAIR/73

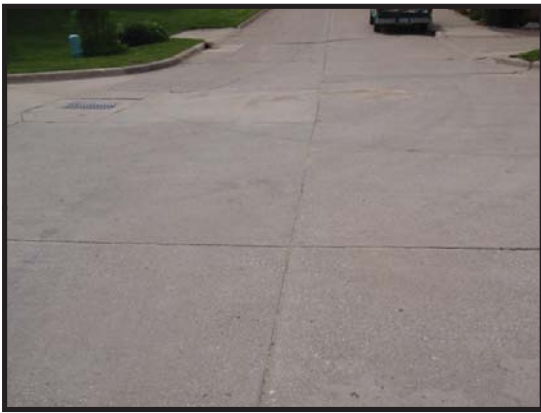
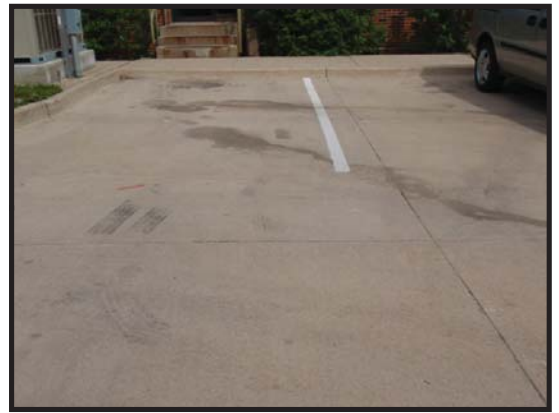
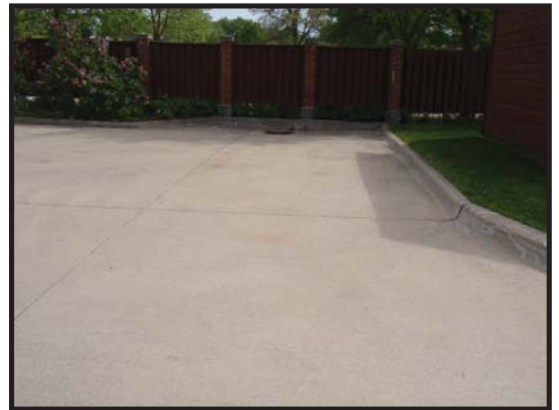
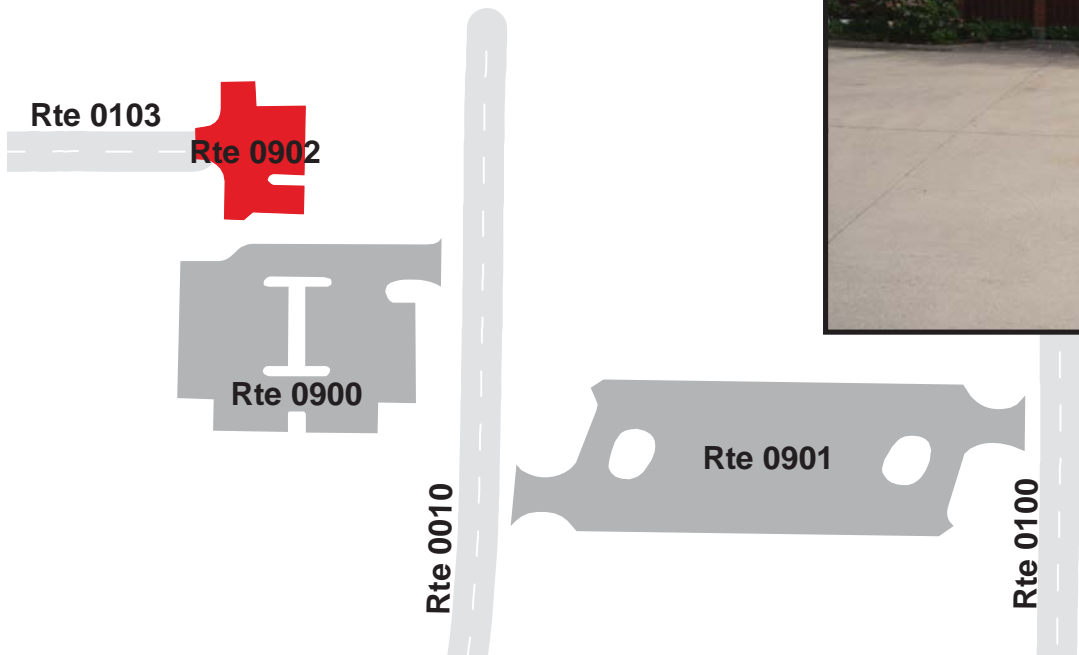
Route 0903

Route Number	Public / NonPublic	Date Visited	Area (sq ft)	Lane Miles *	Surface Type
0903	PUBLIC	4/25/2012	3,853	0.07	CO
Culverts	Drop Inlets	Gates	Curb & Gutter	Curb	PCR
0	0	0	NO CURB AND GUTTER	CONCRETE CURB	POOR/45

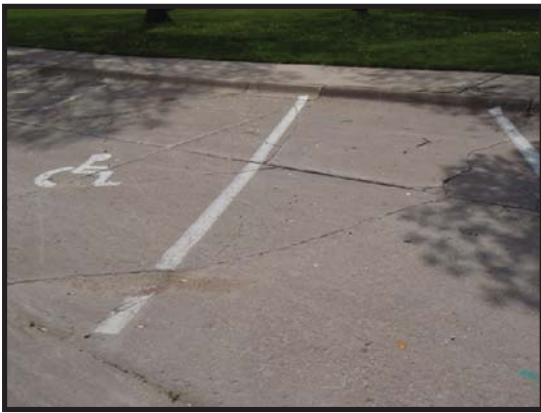
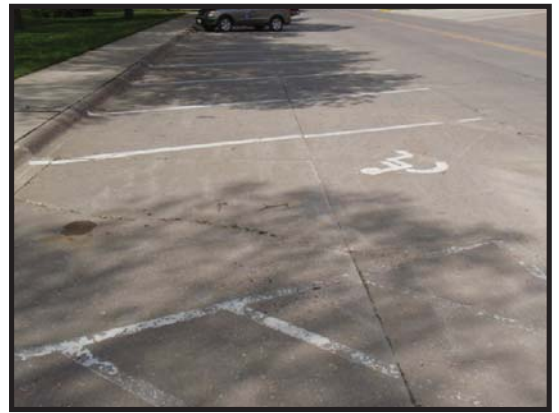
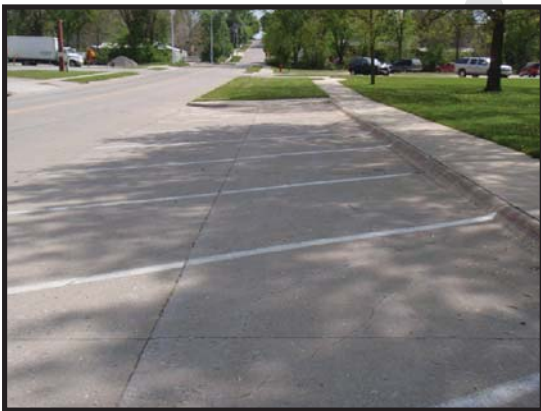
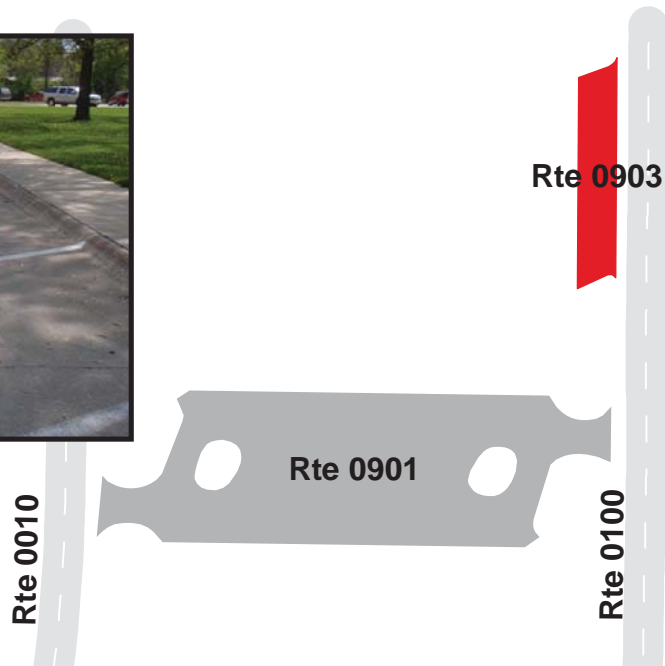
Route 0904

Route Number	Public / NonPublic	Date Visited	Area (sq ft)	Lane Miles *	Surface Type
0904	PUBLIC	4/25/2012	18,771	0.32	AS
Culverts	Drop Inlets	Gates	Curb & Gutter	Curb	PCR
0	3	0	CONCRETE CURB AND GUTTER	NO CURB	GOOD/90
