Federal Lands Highway Road Inventory Program

Road Inventory and Condition Assessment

Lassen Volcanic National Park

Cycle 5 Report

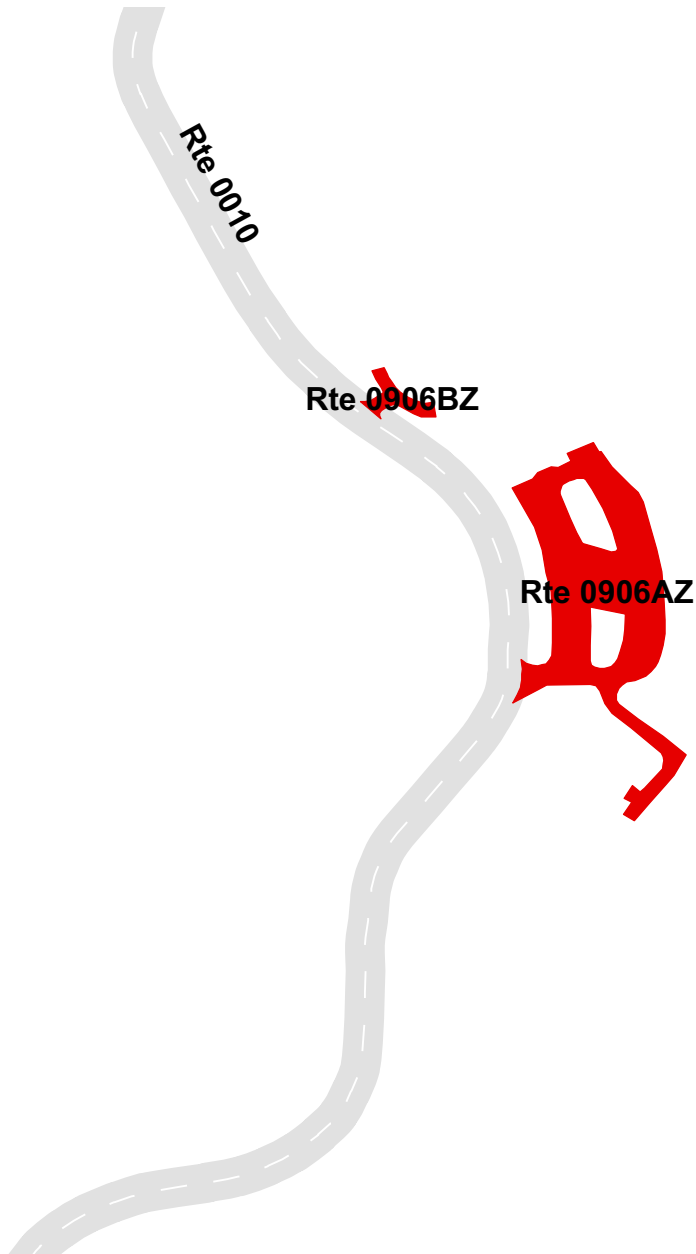
Route 0906AZ

Route Number	Public / NonPublic	Date Visited	Area (sq ft)	Lane Miles *	Surface Type
0906AZ	PUBLIC	8/15/2010	83,118	1.43	AS
Culverts	Drop Inlets	Gates	Curb & Gutter	Curb	PCR
2	2	0	CONCRETE CURB AND GUTTER	NO CURB	GOOD/90
