Federal Lands Highway Road Inventory Program

Road Inventory and Condition Assessment

Padre Island National Seashore
PAIS - 7490

Cycle 5 Report

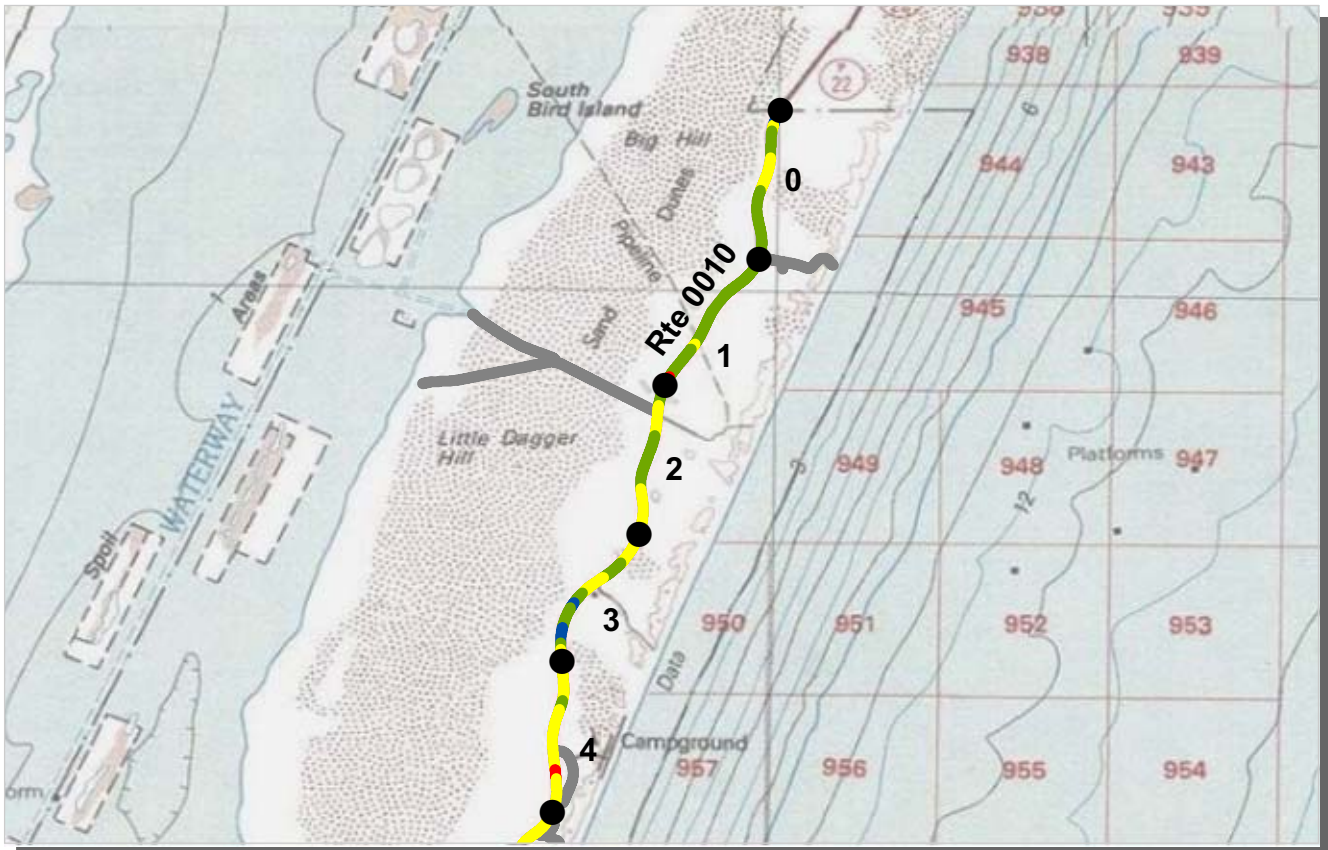
ROUTE: 0010 PADRE ISLAND ENTRANCE ROAD

<i>Section Number</i>	0	1	2	3	4
<i>Section Length (mi)</i>	1.00	1.00	1.00	1.00	1.00
<i>Cross Section Information</i>					
Number of Lanes	2	2	2	2	2
Paved Width (ft)	26	26	26	26	32
Lane Width (ft)	12	12	12	12	12
<i>Roadway Condition Information</i>					
SCR (Surface Condition Rating)	90	89	90	92	90
PCR (Pavement Condition Rating)	82	85	76	82	73
<i>Distress Index Values</i>					
Structural Crack Index	100	100	100	100	99
Transverse Cracking Index	100	100	100	100	100
Patching Index	100	100	100	100	100
Rutting Index	90	89	90	92	90
Roughness Condition Index (RCI)	70	80	56	68	47

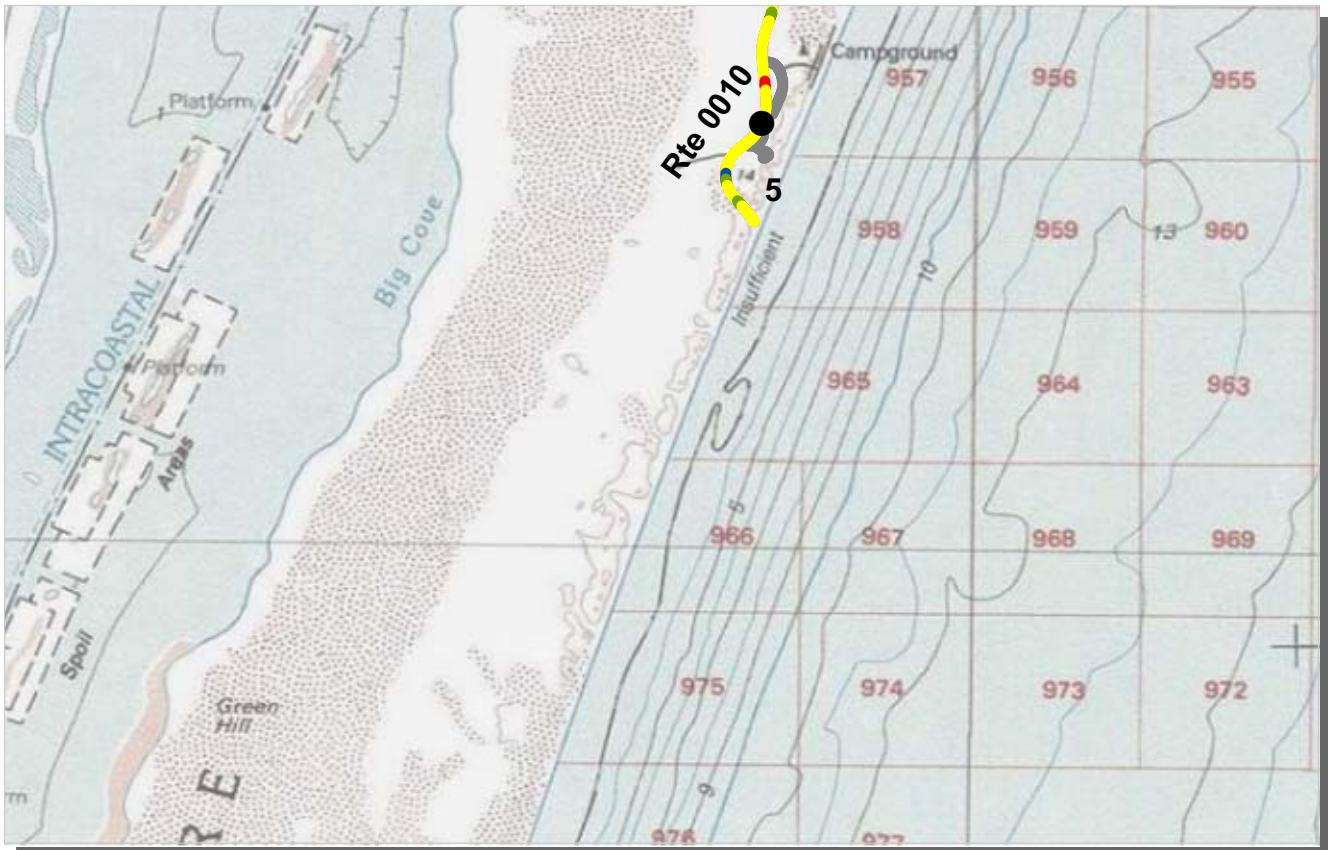
ROUTE: 0010 PADRE ISLAND ENTRANCE ROAD

Section Number	5				
Section Length (mi)	0.77				
Cross Section Information					
Number of Lanes	2				
Paved Width (ft)	26				
Lane Width (ft)	12				
Roadway Condition Information					
SCR (Surface Condition Rating)	92				
PCR (Pavement Condition Rating)	75				
Distress Index Values					
Structural Crack Index	96				
Transverse Cracking Index	98				
Patching Index	100				
Rutting Index	92				
Roughness Condition Index (RCI)	49

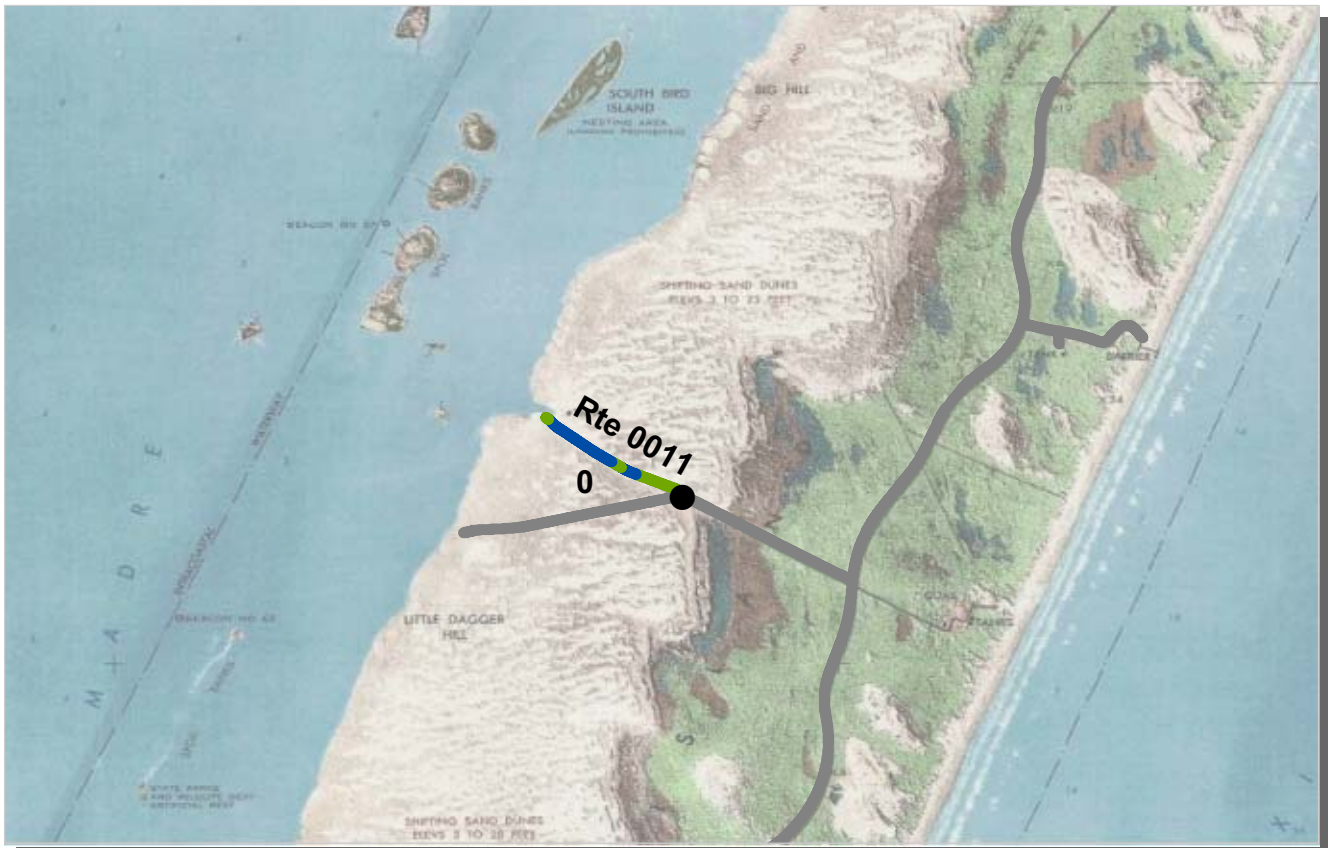
ROUTE: 0011 BOAT RAMP ROAD

Section Number	0				
Section Length (mi)	0.59				
Cross Section Information					
Number of Lanes	2				
Paved Width (ft)	21				
Lane Width (ft)	10				
Roadway Condition Information					
SCR (Surface Condition Rating)	99				
PCR (Pavement Condition Rating)	94				
Distress Index Values					
Structural Crack Index	99				
Transverse Cracking Index	100				
Patching Index	100				
Rutting Index	99				
Roughness Condition Index (RCI)	86

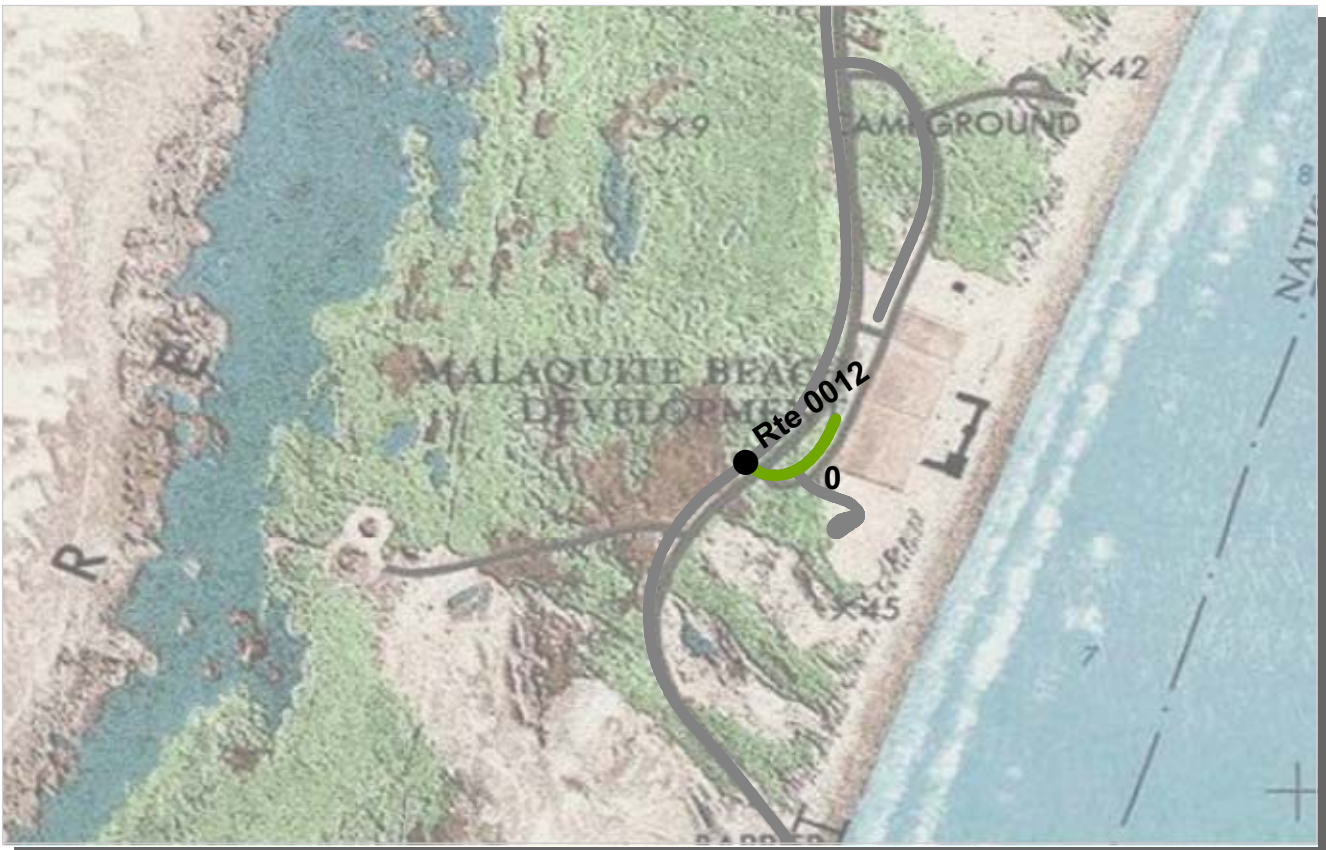
ROUTE: 0012 SOUTH MALAQUITE VISITOR CENTER ROAD

Section Number	0				
Section Length (mi)	0.15				
Cross Section Information					
Number of Lanes	2				
Paved Width (ft)	25				
Lane Width (ft)	12				
Roadway Condition Information					
SCR (Surface Condition Rating)	90				
PCR (Pavement Condition Rating)	90				
Distress Index Values					
Structural Crack Index	99				
Transverse Cracking Index	100				
Patching Index	99				
Rutting Index	90				
Roughness Condition Index (RCI)	NC

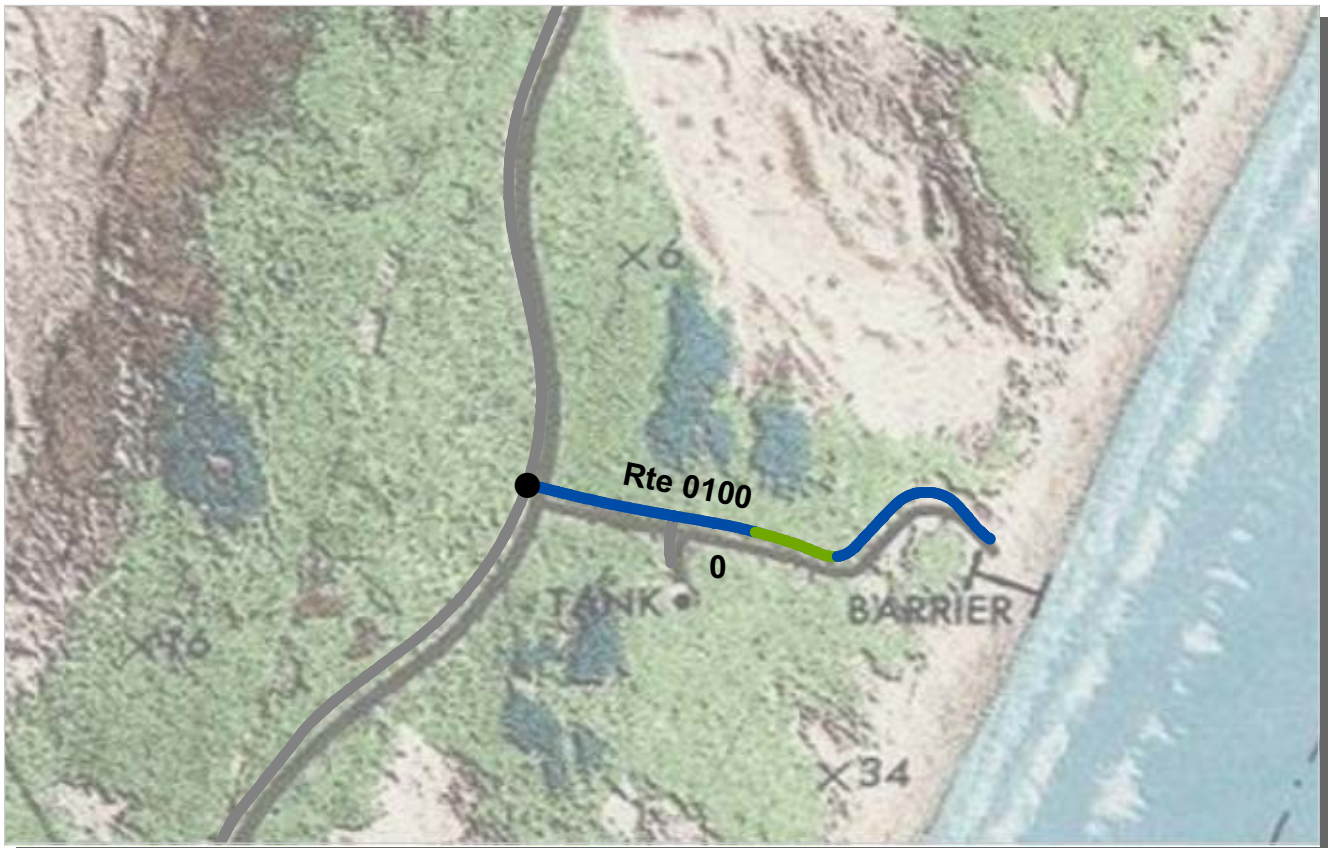
ROUTE: 0100 NORTH BEACH ACCESS ROAD

Section Number	0				
Section Length (mi)	0.49				
Cross Section Information					
Number of Lanes	2				
Paved Width (ft)	24				
Lane Width (ft)	11				
Roadway Condition Information					
SCR (Surface Condition Rating)	96				
PCR (Pavement Condition Rating)	96				
Distress Index Values					
Structural Crack Index	99				
Transverse Cracking Index	99				
Patching Index	100				
Rutting Index	96				
Roughness Condition Index (RCI)	NC

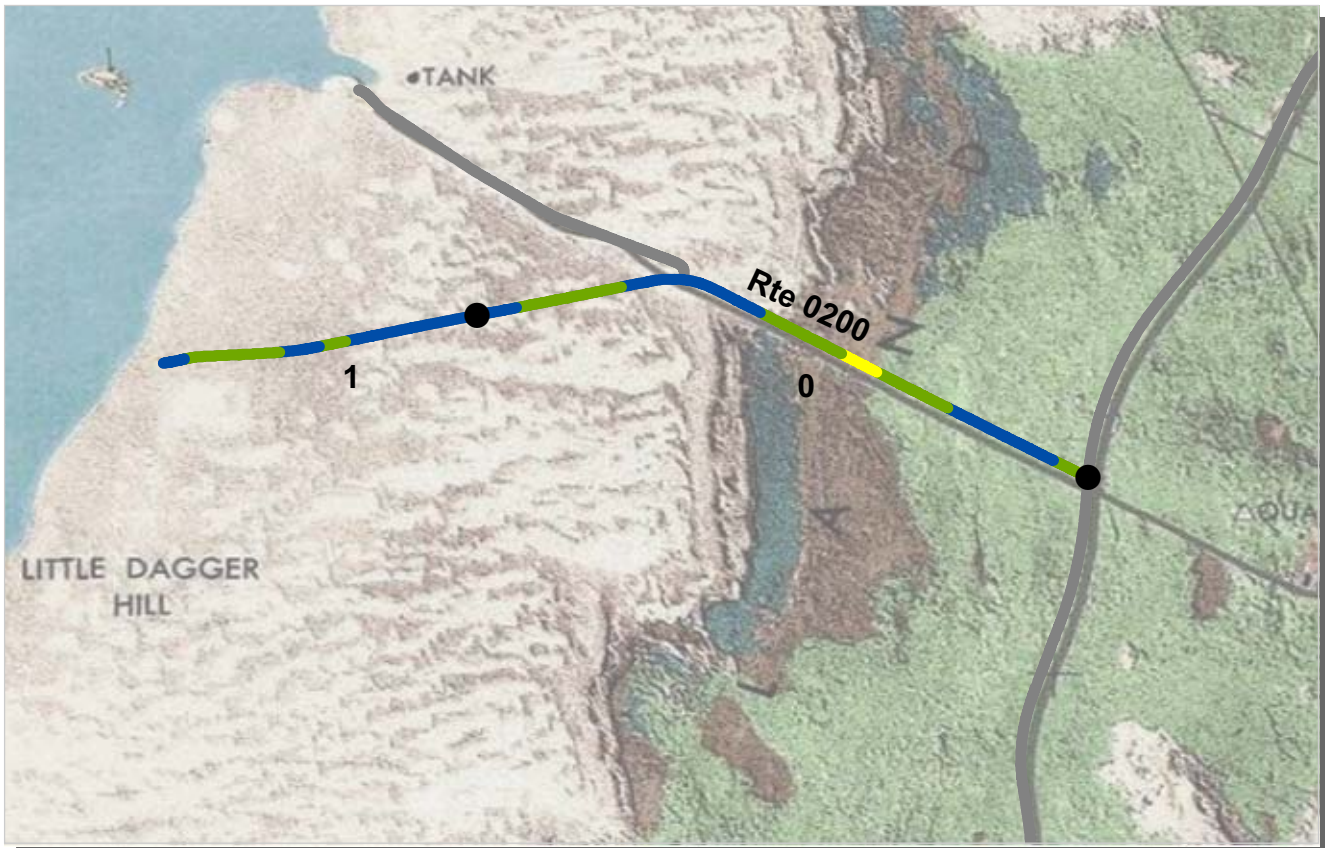
ROUTE: 0200 BIRD ISLAND BASIN ROAD

<i>Section Number</i>	0	1			
<i>Section Length (mi)</i>	1.00	0.47			
<i>Cross Section Information</i>					
Number of Lanes	2	2			
Paved Width (ft)	21	20			
Lane Width (ft)	9	9			
<i>Roadway Condition Information</i>					
SCR (Surface Condition Rating)	98	99			
PCR (Pavement Condition Rating)	93	92			
<i>Distress Index Values</i>					
Structural Crack Index	99	100			
Transverse Cracking Index	100	100			
Patching Index	100	100			
Rutting Index	98	99			
Roughness Condition Index (RCI)	85	82

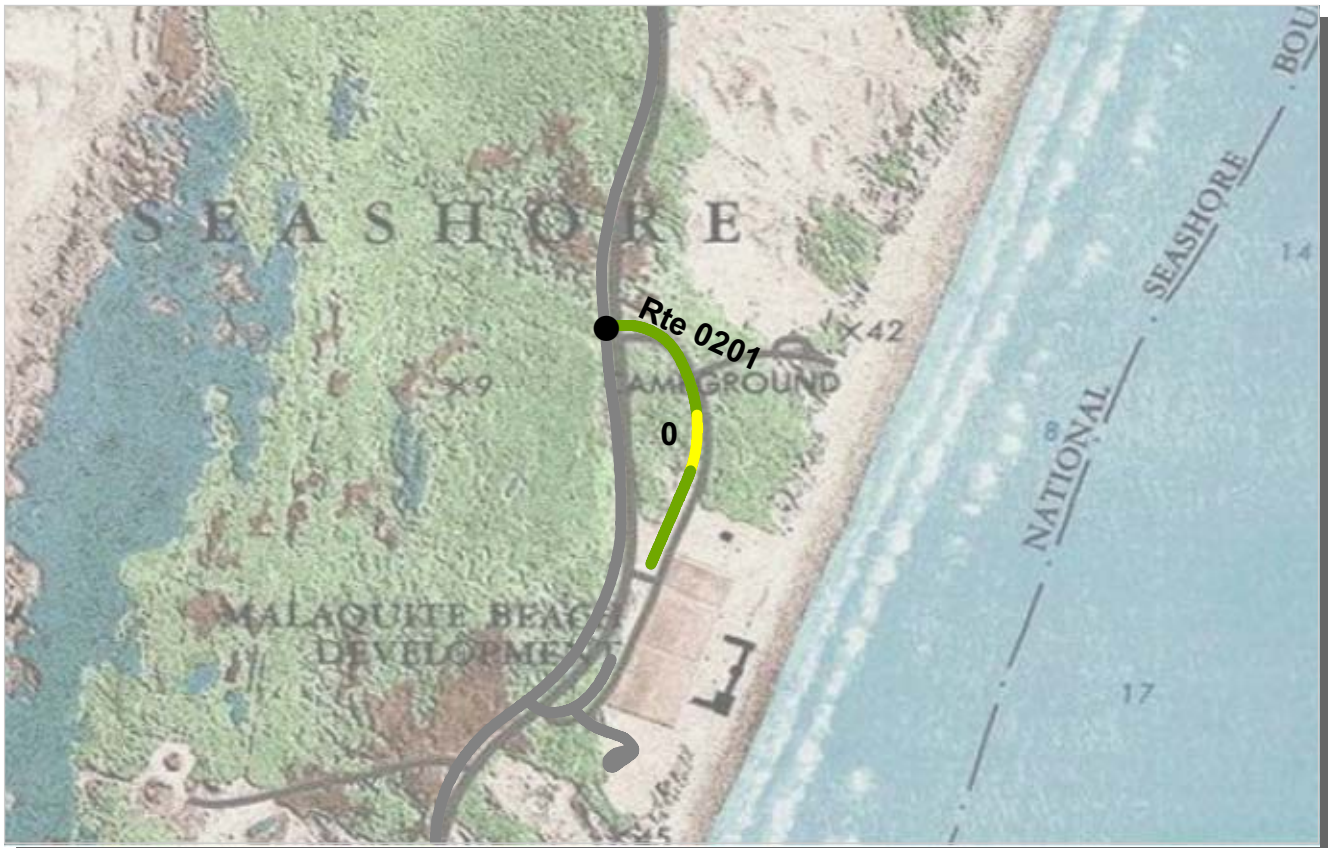
ROUTE: 0201 NORTH MALAQUITE VISITOR CENTER ROAD

Section Number	0				
Section Length (mi)	0.42				
Cross Section Information					
Number of Lanes	2				
Paved Width (ft)	31				
Lane Width (ft)	13				
Roadway Condition Information					
SCR (Surface Condition Rating)	87				
PCR (Pavement Condition Rating)	87				
Distress Index Values					
Structural Crack Index	95				
Transverse Cracking Index	100				
Patching Index	100				
Rutting Index	87				
Roughness Condition Index (RCI)	NC

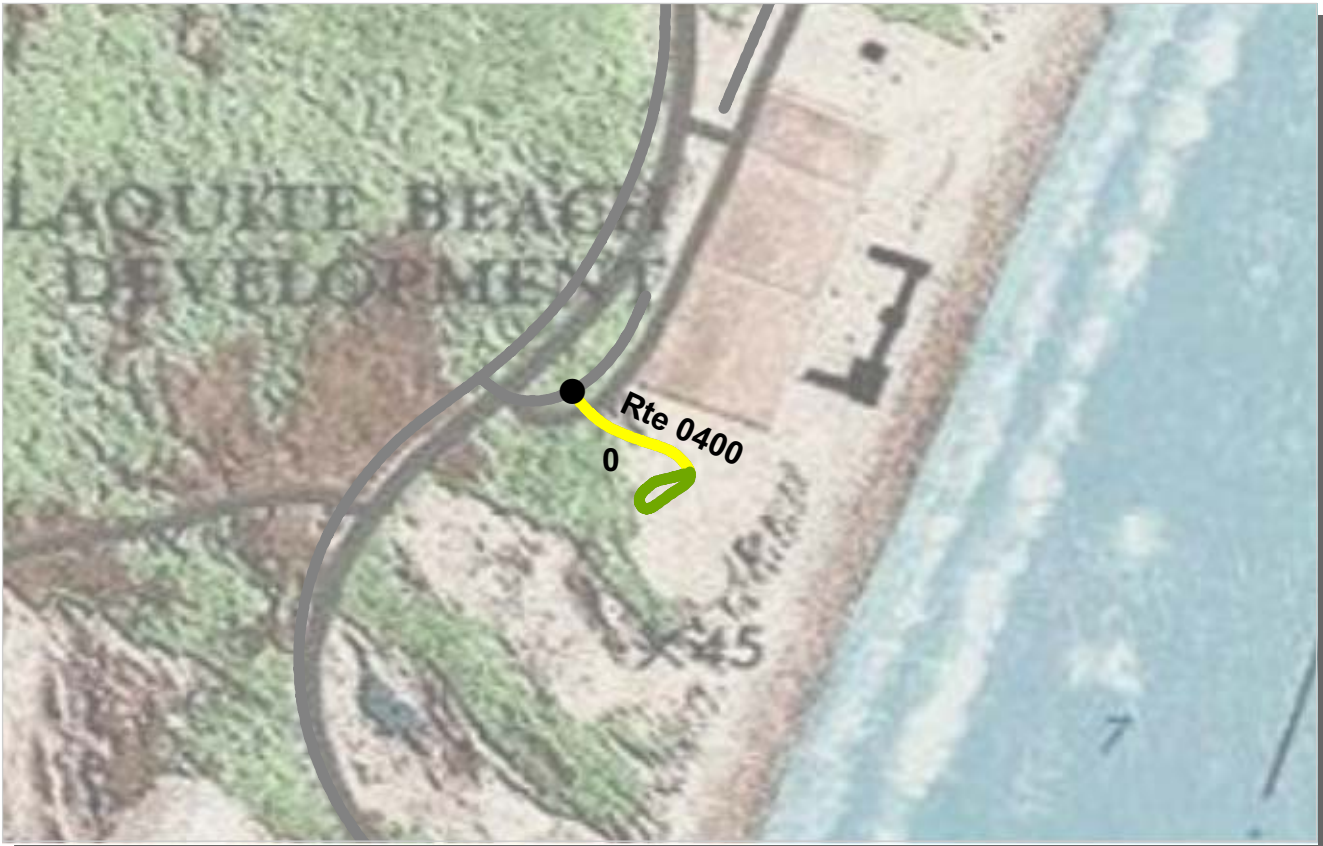
ROUTE: 0400 VIP CAMPGROUND ROAD

Section Number	0				
Section Length (mi)	0.19				
Cross Section Information					
Number of Lanes	2				
Paved Width (ft)	17				
Lane Width (ft)	10				
Roadway Condition Information					
SCR (Surface Condition Rating)	90				
PCR (Pavement Condition Rating)	90				
Distress Index Values					
Structural Crack Index	93				
Transverse Cracking Index	100				
Patching Index	96				
Rutting Index	90				
Roughness Condition Index (RCI)	NC

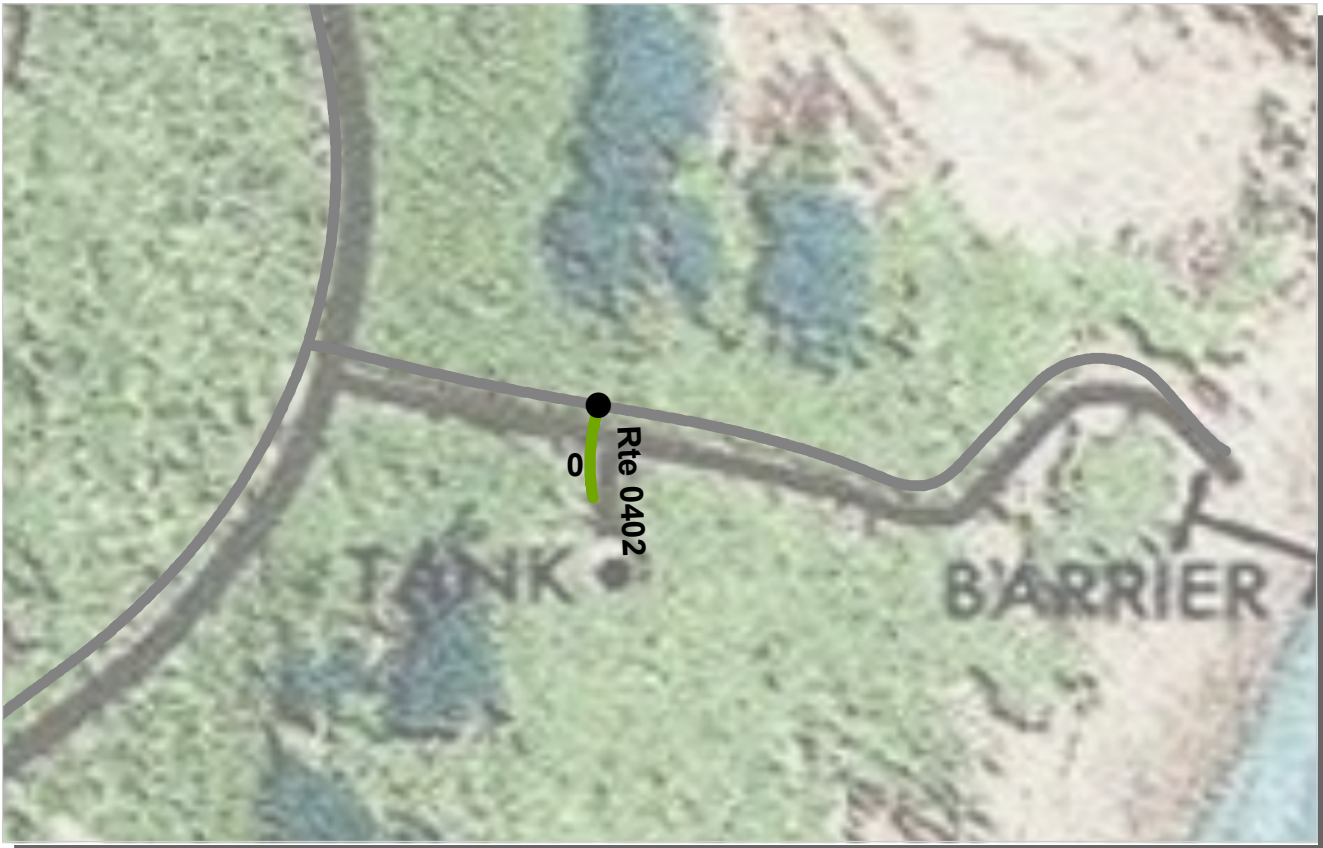
ROUTE: 0402 WATER TANK ROAD

Section Number	0				
Section Length (mi)	0.05				
Cross Section Information					
Number of Lanes	2				
Paved Width (ft)	19				
Lane Width (ft)	9				
Roadway Condition Information					
SCR (Surface Condition Rating)	89				
PCR (Pavement Condition Rating)	89				
Distress Index Values					
Structural Crack Index	89				
Transverse Cracking Index	99				
Patching Index	99				
Rutting Index	94				
Roughness Condition Index (RCI)	NC

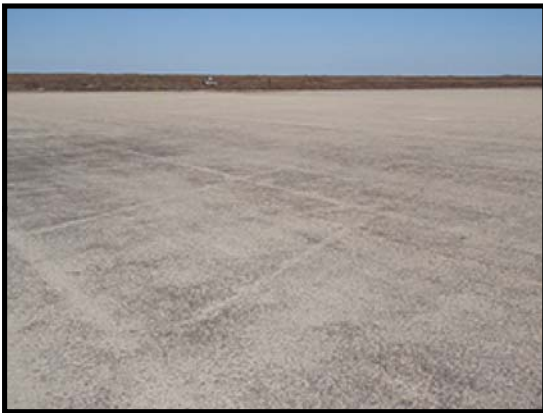
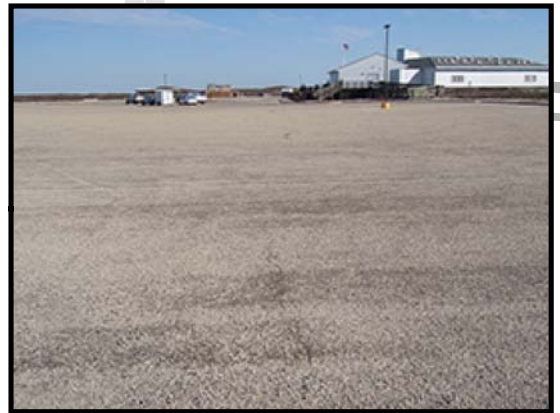
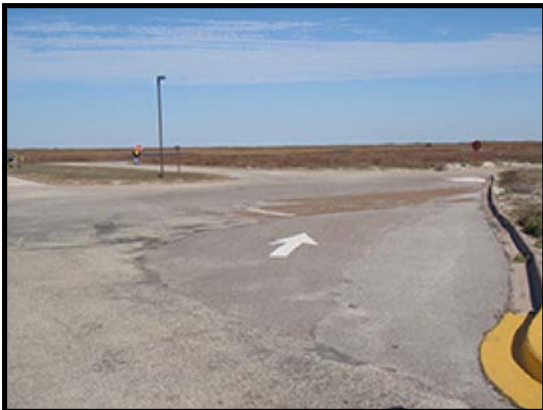
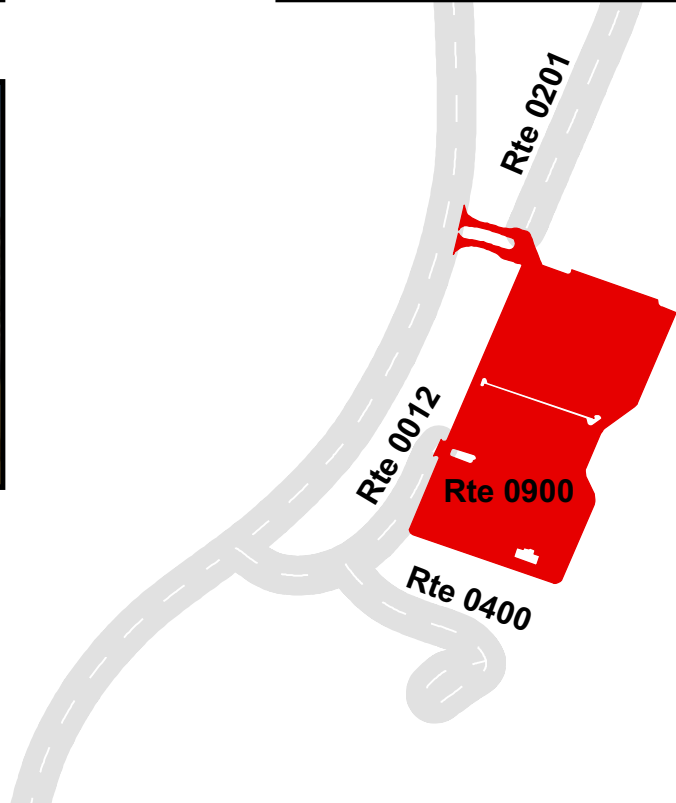
Route 0901

Route Number	Public / NonPublic	Date Visited	Area (sq ft)	Lane Miles *	Surface Type
0901	PUBLIC	2/10/2011	134,762	2.32	AS
Culverts	Drop Inlets	Gates	Curb & Gutter	Curb	PCR
0	0	0	NO CURB AND GUTTER	NO CURB	FAIR/73

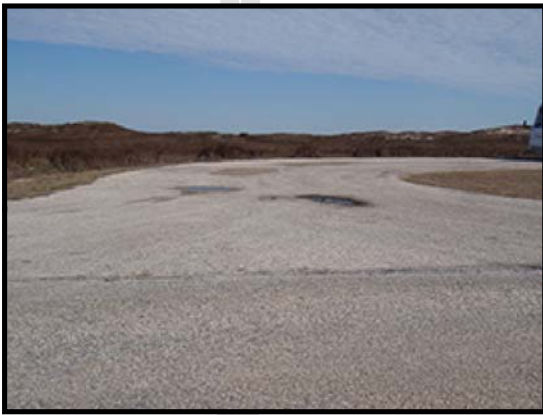
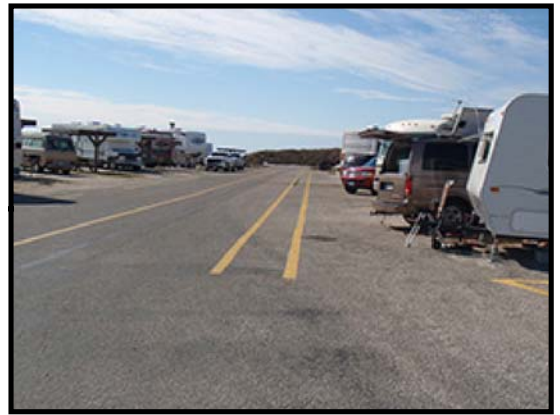
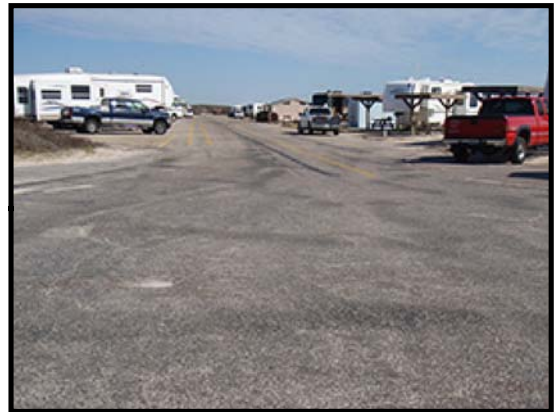
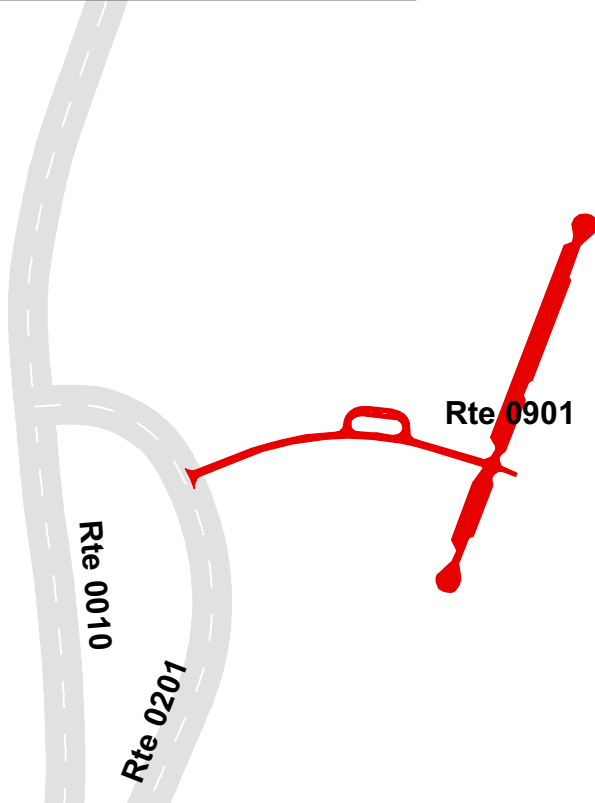
Route 0902

Route Number	Public / NonPublic	Date Visited	Area (sq ft)	Lane Miles *	Surface Type
0902	PUBLIC	2/10/2011	14,058	0.24	AS
Culverts	Drop Inlets	Gates	Curb & Gutter	Curb	PCR
0	0	1	NO CURB AND GUTTER	CONCRETE CURB	FAIR/73
