# Federal Lands Highway Road Inventory Program

Road Inventory and Condition Assessment

**Presidio of San Francisco**  
**PRES - 8150**

**Cycle 5 Report**

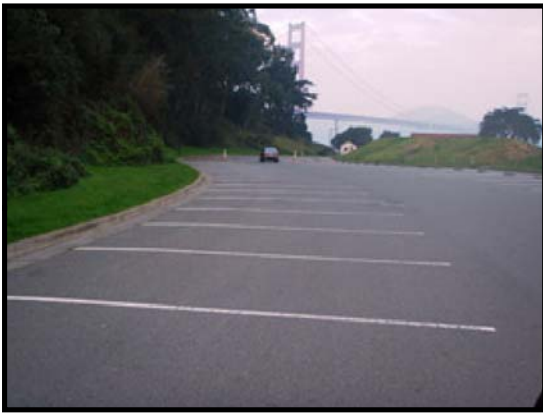
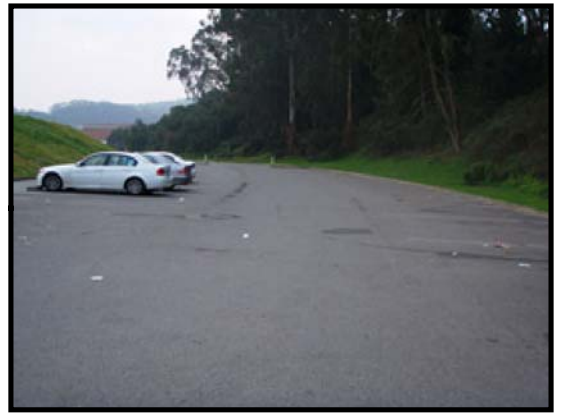
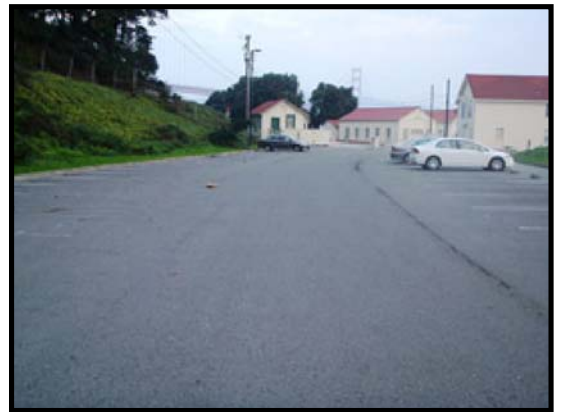
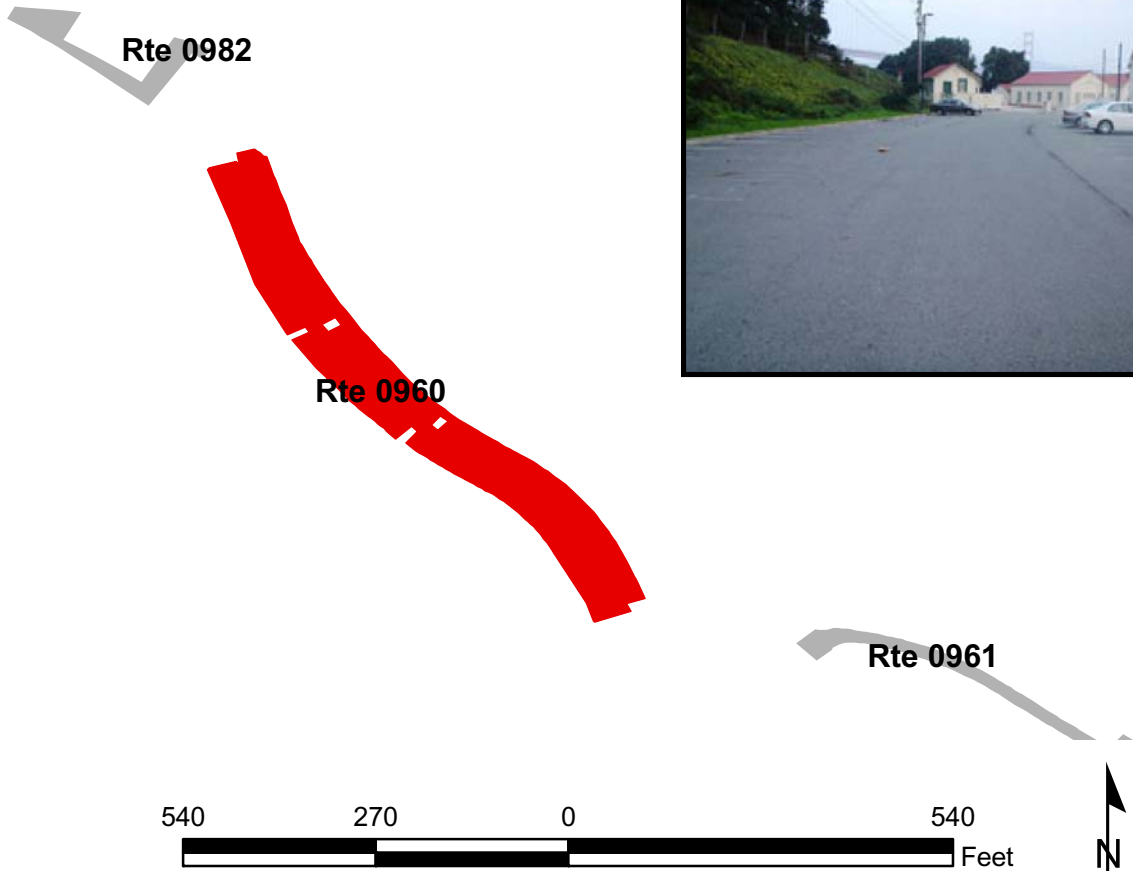
## Route 0960

Route Number	Public / NonPublic	Date Visited	Area (sq ft)	Lane Miles *	Surface Type
0960	PUBLIC	1/29/2010	51,558	0.89	AS
Culverts	Drop Inlets	Gates	Curb & Gutter	Curb	PCR
0	5	2	CONCRETE CURB AND GUTTER	ASPHALT CURB	GOOD/90

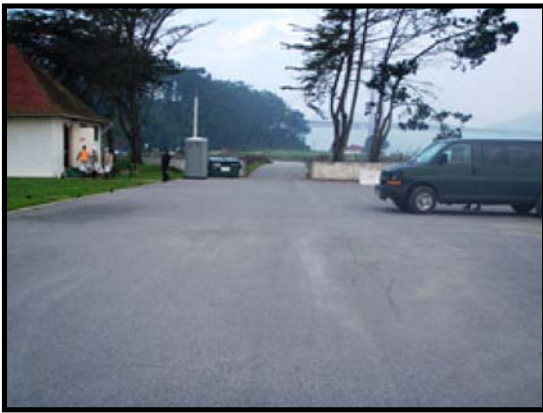
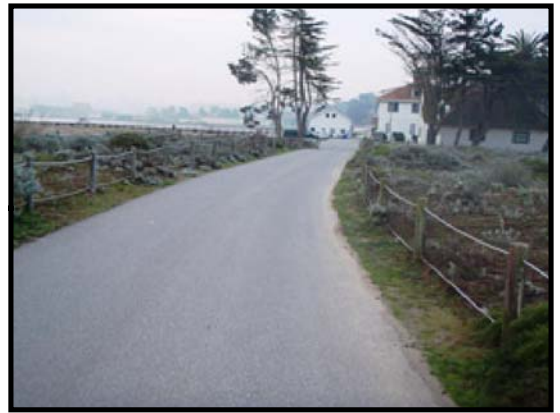
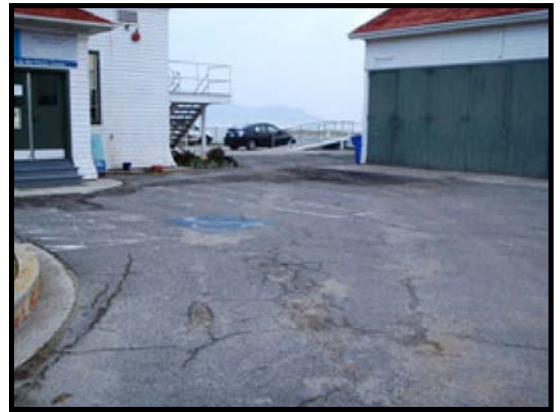
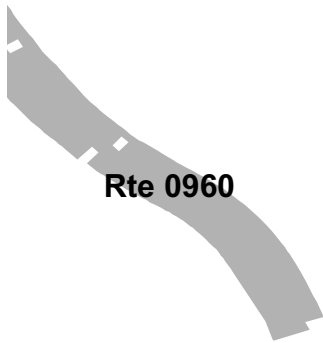
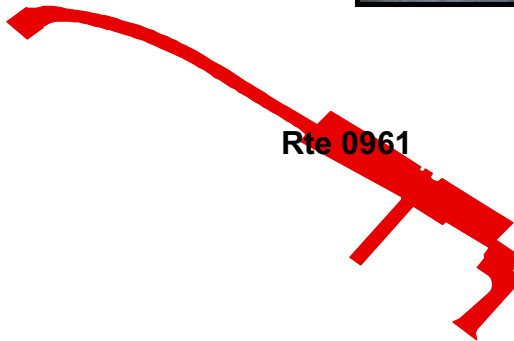
**PRESIDIO OF SAN FRANCISCO**  
**Route 0961**  
 CRISSY FIELD OLD COAST GUARD PARKING  
 FROM MASON STREET  
 THROUGH PARKING AREA TO PROMENADE

Route Number	Public / NonPublic	Date Visited	Area (sq ft)	Lane Miles *	Surface Type
0961	NONPUBLIC	1/29/2010	24,937	0.43	AS
Culverts	Drop Inlets	Gates	Curb & Gutter	Curb	PCR
0	1	0	CONCRETE CURB AND GUTTER	CONCRETE CURB	FAIR/73

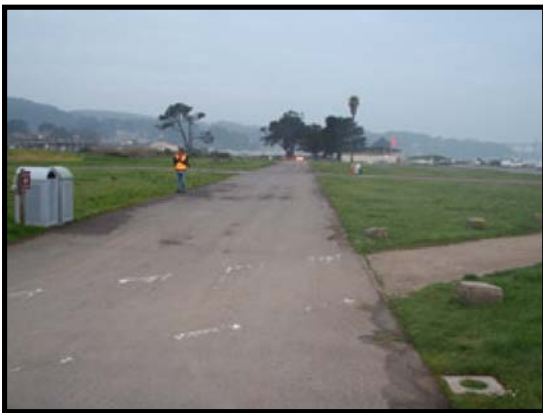
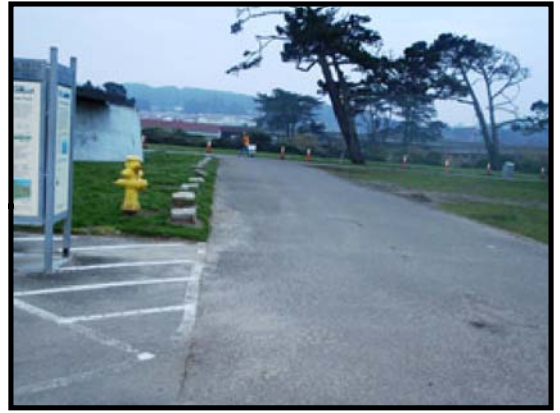
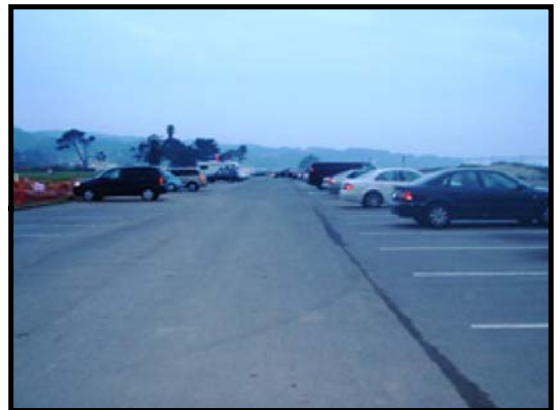
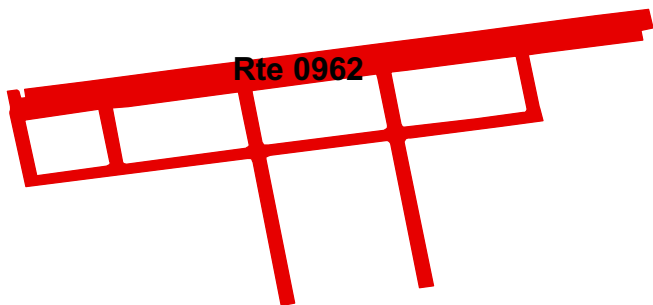
## Route 0962

Route Number	Public / NonPublic	Date Visited	Area (sq ft)	Lane Miles *	Surface Type
0962	PUBLIC	1/29/2010	106,786	1.84	AS
Culverts	Drop Inlets	Gates	Curb & Gutter	Curb	PCR
0	21	0	NO CURB AND GUTTER	CONCRETE CURB	FAIR/73

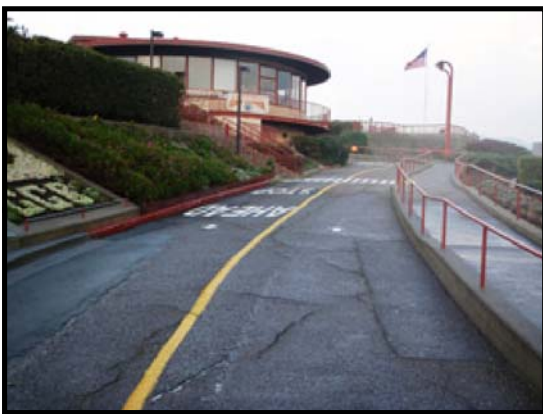
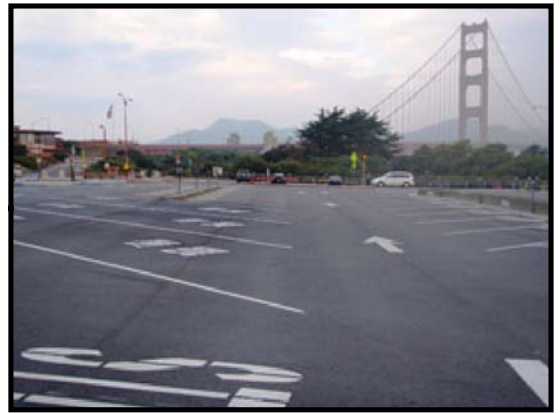
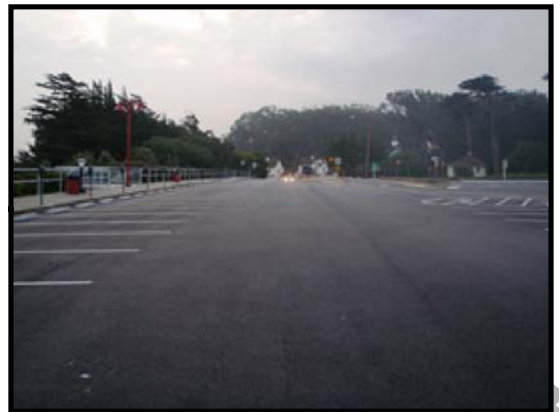
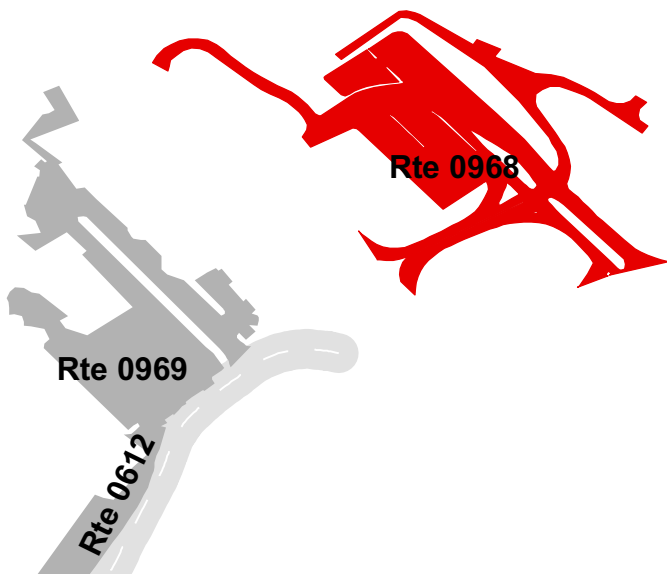
## Route 0968

Route Number	Public / NonPublic	Date Visited	Area (sq ft)	Lane Miles *	Surface Type
0968	PUBLIC	1/29/2010	96,048	1.65	AS
Culverts	Drop Inlets	Gates	Curb & Gutter	Curb	PCR
0	3	2	CONCRETE CURB AND GUTTER	CONCRETE CURB	GOOD/90

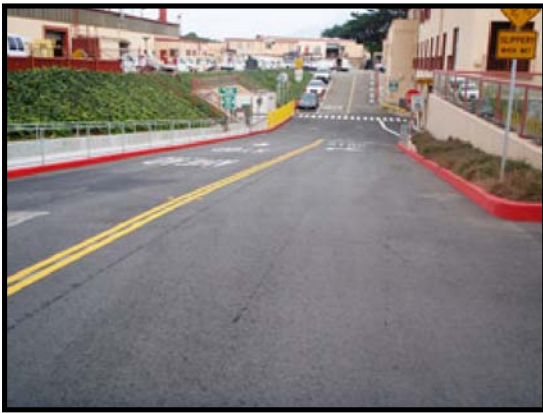
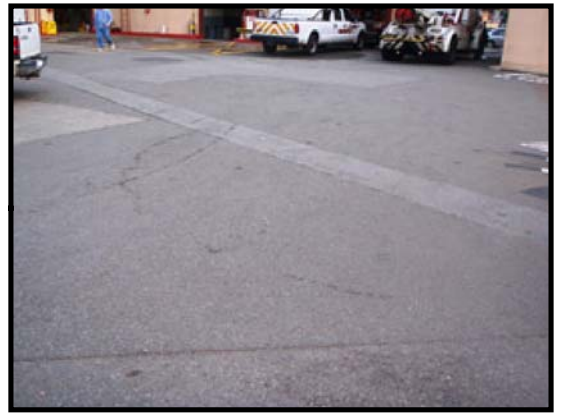
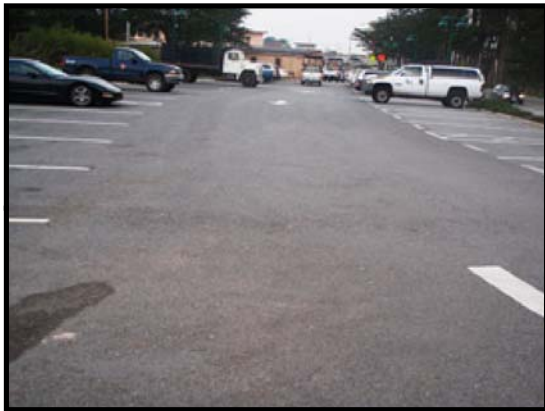
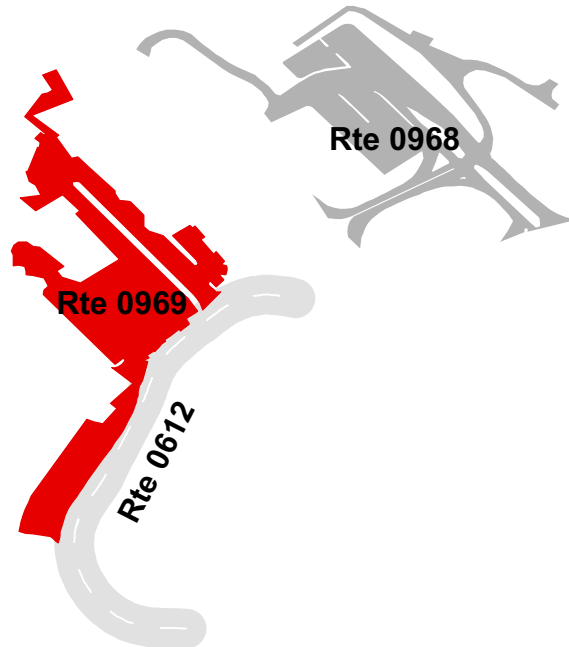
## Route 0969

Route Number	Public / NonPublic	Date Visited	Area (sq ft)	Lane Miles *	Surface Type
0969	PUBLIC	1/29/2010	96,133	1.66	AS
Culverts	Drop Inlets	Gates	Curb & Gutter	Curb	PCR
0	7	4	NO CURB AND GUTTER	CONCRETE CURB	GOOD/90

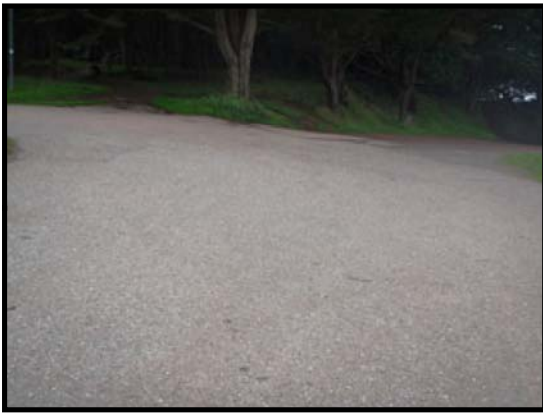
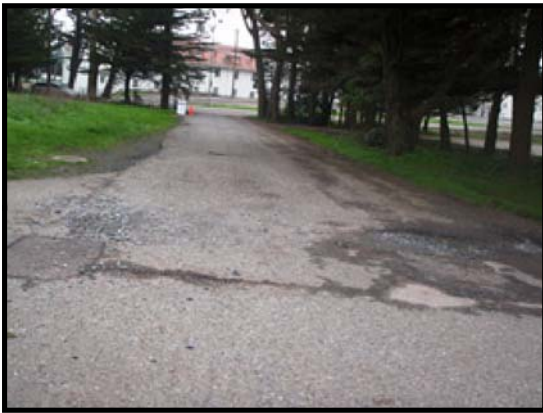
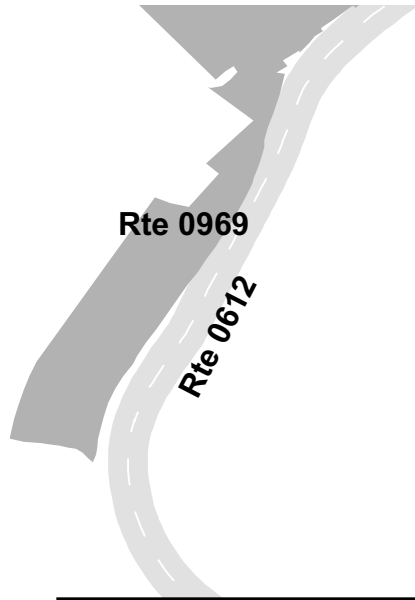
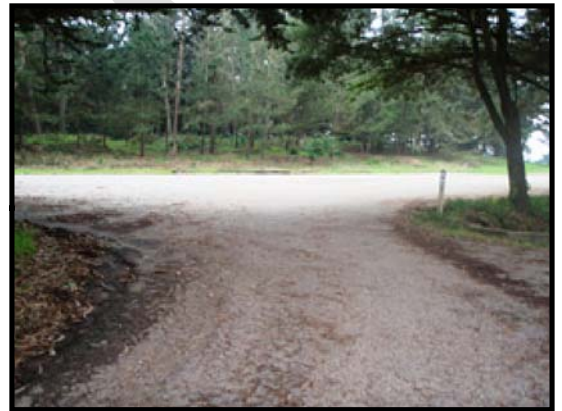
## Route 0970

Route Number	Public / NonPublic	Date Visited	Area (sq ft)	Lane Miles *	Surface Type
0970	PUBLIC	1/29/2010	19,879	0.34	AS
Culverts	Drop Inlets	Gates	Curb & Gutter	Curb	PCR
3	0	0	NO CURB AND GUTTER	WOOD CURB	POOR/45

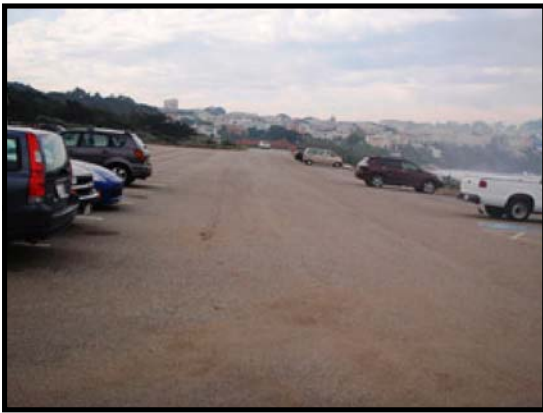
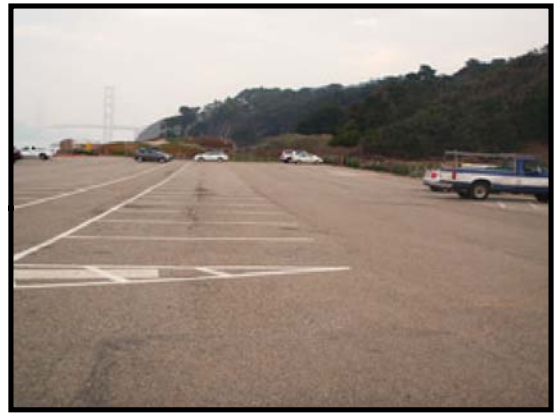
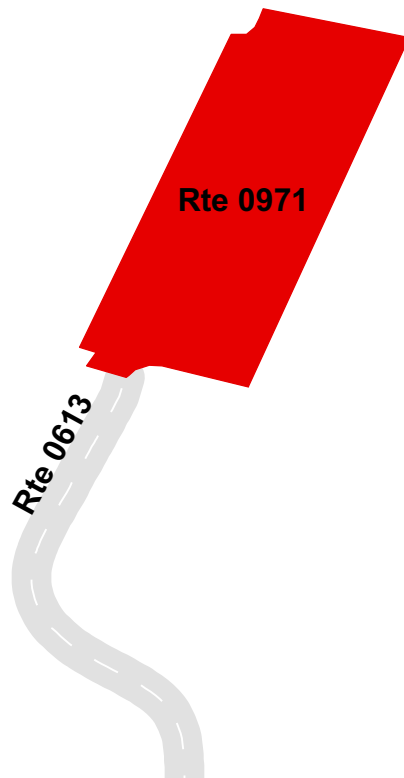
## Route 0971

Route Number	Public / NonPublic	Date Visited	Area (sq ft)	Lane Miles *	Surface Type
0971	PUBLIC	1/29/2010	42,999	0.74	AS
Culverts	Drop Inlets	Gates	Curb & Gutter	Curb	PCR
0	0	1	NO CURB AND GUTTER	NO CURB	FAIR/73

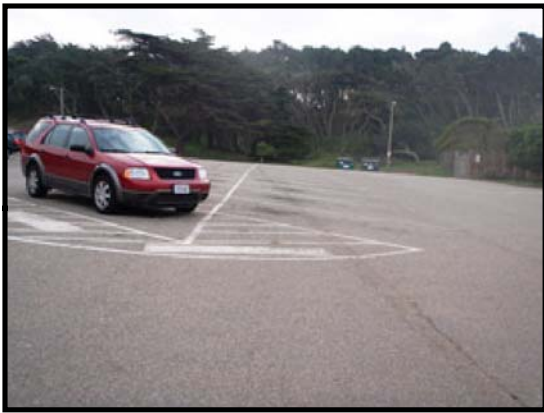
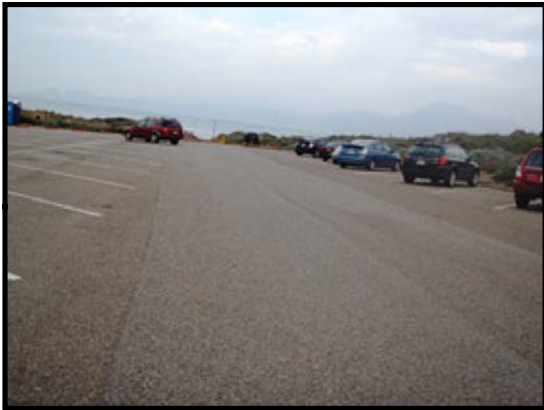
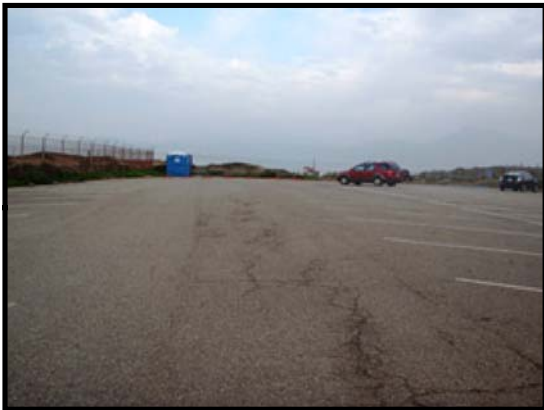
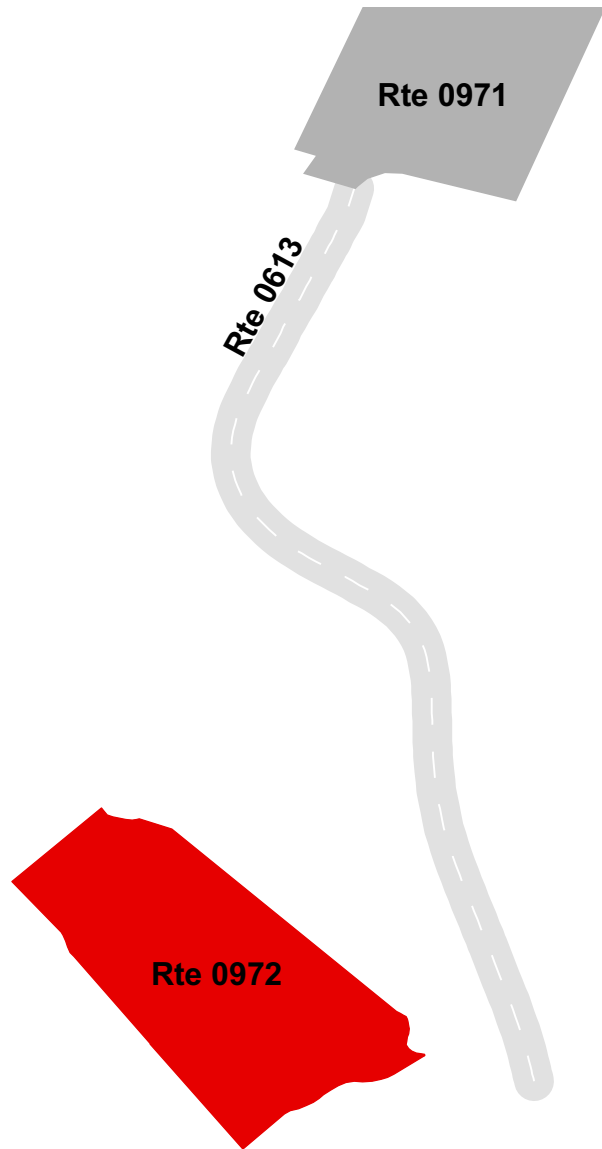
## Route 0972

Route Number	Public / NonPublic	Date Visited	Area (sq ft)	Lane Miles *	Surface Type
0972	PUBLIC	1/29/2010	25,195	0.43	AS
Culverts	Drop Inlets	Gates	Curb & Gutter	Curb	PCR
0	0	0	NO CURB AND GUTTER	NO CURB	FAIR/73

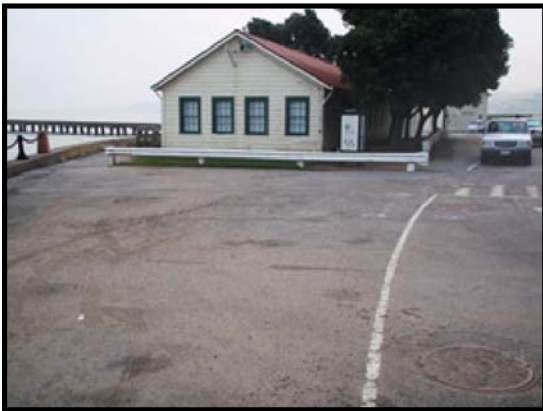
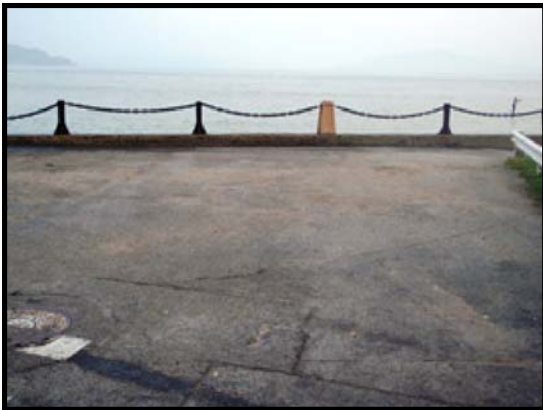
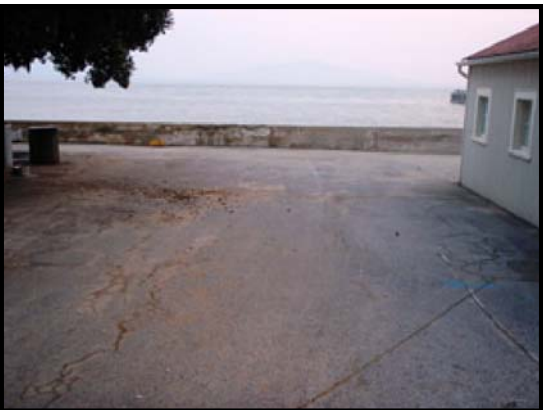
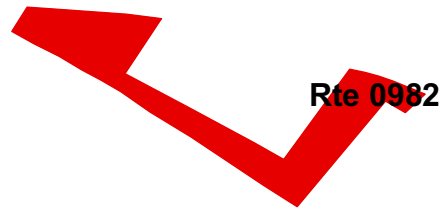
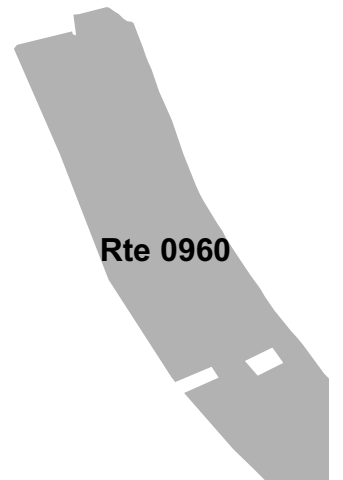
## Route 0982

Route Number	Public / NonPublic	Date Visited	Area (sq ft)	Lane Miles *	Surface Type
0982	PUBLIC	1/29/2010	4,277	0.07	AS
Culverts	Drop Inlets	Gates	Curb & Gutter	Curb	PCR
0	1	0	NO CURB AND GUTTER	NO CURB	POOR/45
