Federal Lands Highway Road Inventory Program

Road Inventory and Condition Assessment

Roosevelt Campobello International Park ROCA

Cycle 5 Report

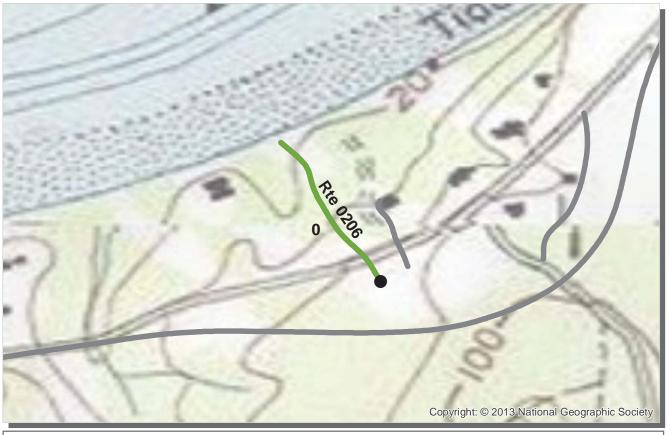
ROUTE: 0206 DOCK ACCESS ROAD ROCA : ROOSEVELT CAMPOBELLO INTERNATIONAL PARK

CO	LLECTED:	8/22/2013
NORTHEAST REGION		TOTAL	LENGTH:	0.16 Miles
Section Number	0			
Section Length (mi)	0.16			
Cross Section Information				
Number of Lanes	1			
Paved Width (ft)	13			
Lane Width (ft)	13			
Roadway Condition Information				
SCR (Surface Condition Rating)	87			
PCR (Pavement Condition Rating)	87			
Distress Index Values				
Structural Crack Index	100			
Transverse Cracking Index	100			
Patching Index	100			
Rutting Index	87			
Roughness Condition Index (RCI)	NC

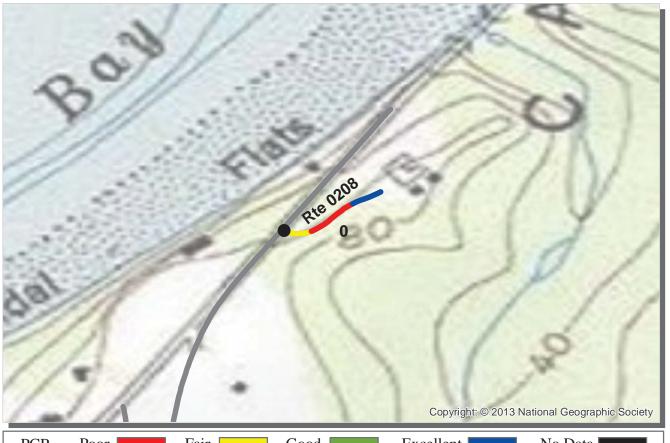
ROUTE: 0208 ADAMS LODGE ACCESS ROAD ROCA : ROOSEVELT CAMPOBELLO INTERNATIONAL PARK

CO	LLECTED:	8/22/2013
NORTHEAST REGION		TOTAL	LENGTH:	0.08 Miles
Section Number	0			
Section Length (mi)	0.08			
Cross Section Information				
Number of Lanes	1			
Paved Width (ft)	12			
Lane Width (ft)	12			
Roadway Condition Information				
SCR (Surface Condition Rating)	67			
PCR (Pavement Condition Rating)	67			
Distress Index Values				
Structural Crack Index	97			
Transverse Cracking Index	100			
Patching Index	99			
Rutting Index	67			
Roughness Condition Index (RCI)	NC

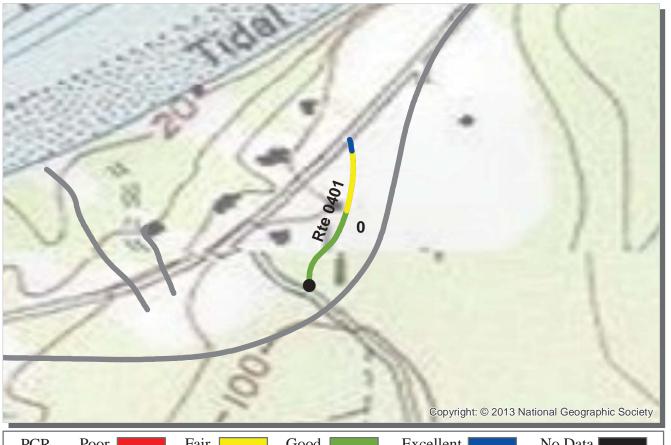
ROUTE: 0401 STAFF PARKING ROAD ROCA : ROOSEVELT CAMPOBELLO INTERNATIONAL PARK

CO	LLECTED:	8/22/2013
NORTHEAST REGION		TOTAL	LENGTH:	0.15 Miles
Section Number	0			
Section Length (mi)	0.15			
Cross Section Information				
Number of Lanes	1			
Paved Width (ft)	13			
Lane Width (ft)	13			
Roadway Condition Information				
SCR (Surface Condition Rating)	84			
PCR (Pavement Condition Rating)	84			
Distress Index Values				
Structural Crack Index	99			
Transverse Cracking Index	99			
Patching Index	100			
Rutting Index	84			
Roughness Condition Index (RCI)	NC

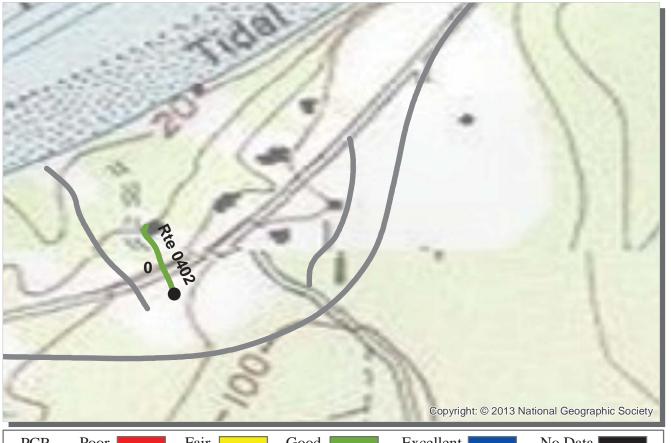
ROUTE: 0402 PRINCE COTTAGE ROAD ROCA : ROOSEVELT CAMPOBELLO INTERNATIONAL PARK

CO	LLECTED:	8/22/2013
NORTHEAST REGION		TOTAL	LENGTH:	0.07 Miles
Section Number	0			
Section Length (mi)	0.07			
Cross Section Information				
Number of Lanes	1			
Paved Width (ft)	11			
Lane Width (ft)	11			
Roadway Condition Information				
SCR (Surface Condition Rating)	94			
PCR (Pavement Condition Rating)	94			
Distress Index Values				
Structural Crack Index	100			
Transverse Cracking Index	98			
Patching Index	100			
Rutting Index	94			
Roughness Condition Index (RCI)	NC

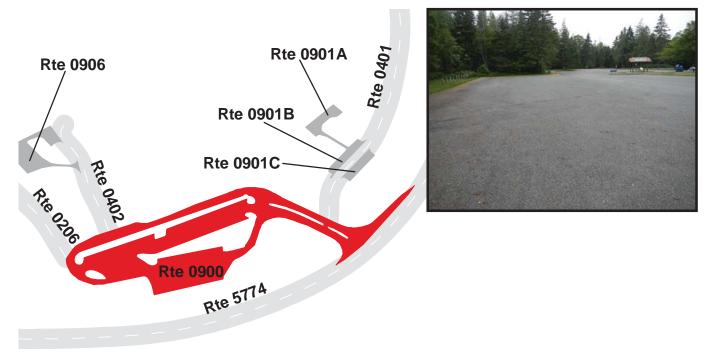
ROOSEVELT CAMPOBELLO INTERNATIONAL PARK Route 0900

Route	Public /				
Number	NonPublic	Date Visited	Area (sq ft)	Lane Miles *	Surface Type
0900	PUBLIC	6/26/2013	82,060	1.41	AS
Culverts	Drop Inlets	Gates	Curb & Gutter	Curb	PCR
			NO CURB AND		
0	4	1	GUTTER	STONE CURB	FAIR/73

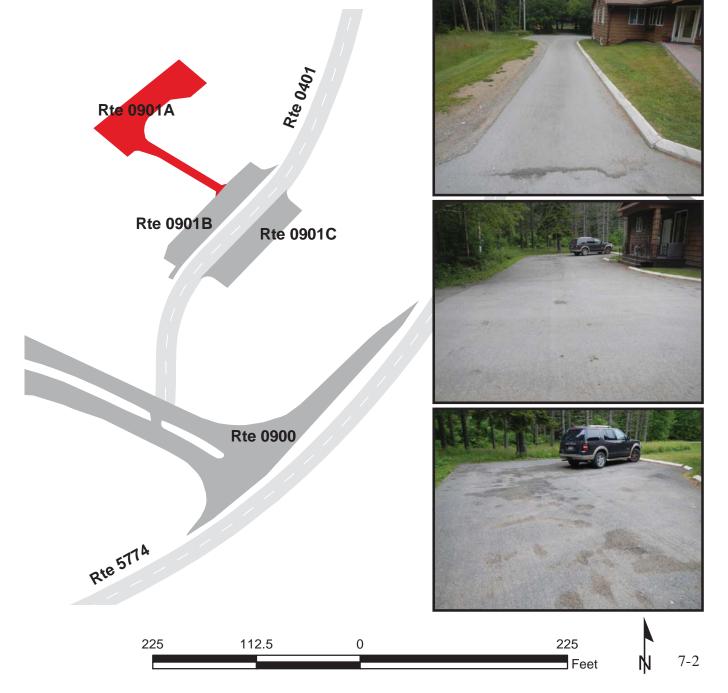
ROOSEVELT CAMPOBELLO INTERNATIONAL PARK Route 0901A

Route	Public /				
Number	NonPublic	Date Visited	Area (sq ft)	Lane Miles *	Surface Type
0901A	NONPUBLIC	6/26/2013	3,674	0.06	AS
Culverts	Drop Inlets	Gates	Curb & Gutter	Curb	PCR
			NO CURB AND	CONCRETE	
0	0	0	GUTTER	CURB	FAIR/73

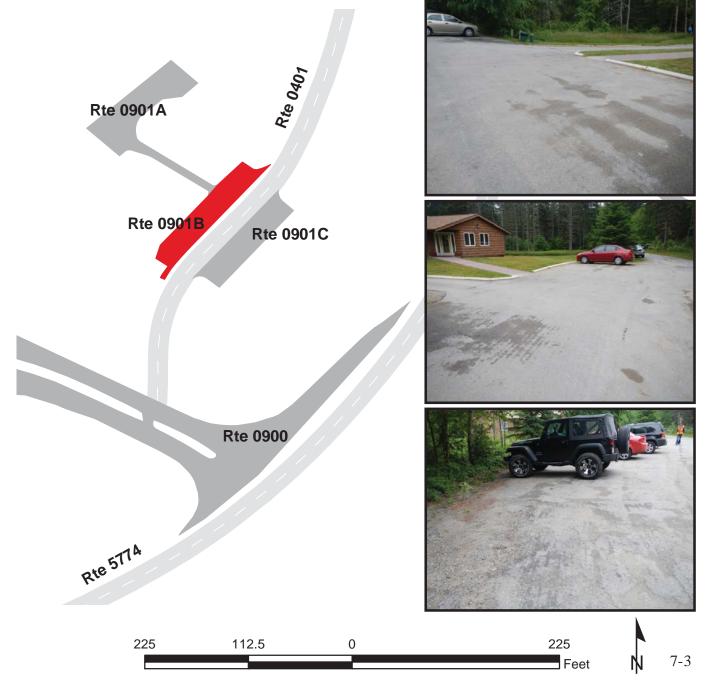
ROOSEVELT CAMPOBELLO INTERNATIONAL PARK Route 0901B

Route	Public /				
Number	NonPublic	Date Visited	Area (sq ft)	Lane Miles *	Surface Type
0901B	NONPUBLIC	6/26/2013	2,607	0.05	AS
Culverts	Drop Inlets	Gates	Curb & Gutter	Curb	PCR
			NO CURB AND	CONCRETE	
0	0	0	GUTTER	CURB	POOR/45

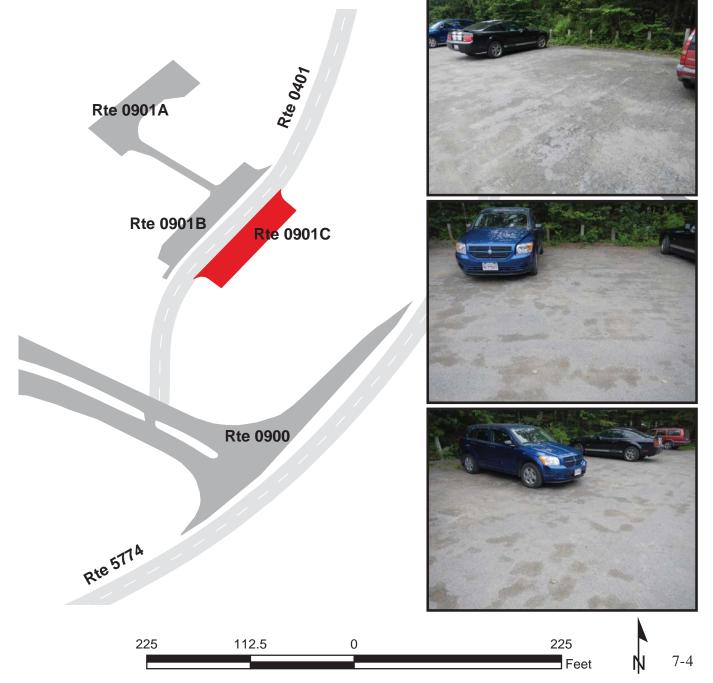
STAFF PARKING C ADJACENT TO ROUTE 0401 (STAFF PARKING ROAD)

Route	Public /				
Number	NonPublic	Date Visited	Area (sq ft)	Lane Miles *	Surface Type
0901C	NONPUBLIC	6/26/2013	2,391	0.04	AS
Culverts	Drop Inlets	Gates	Curb & Gutter	Curb	PCR
			NO CURB AND		
0	0	0	GUTTER	NO CURB	POOR/45

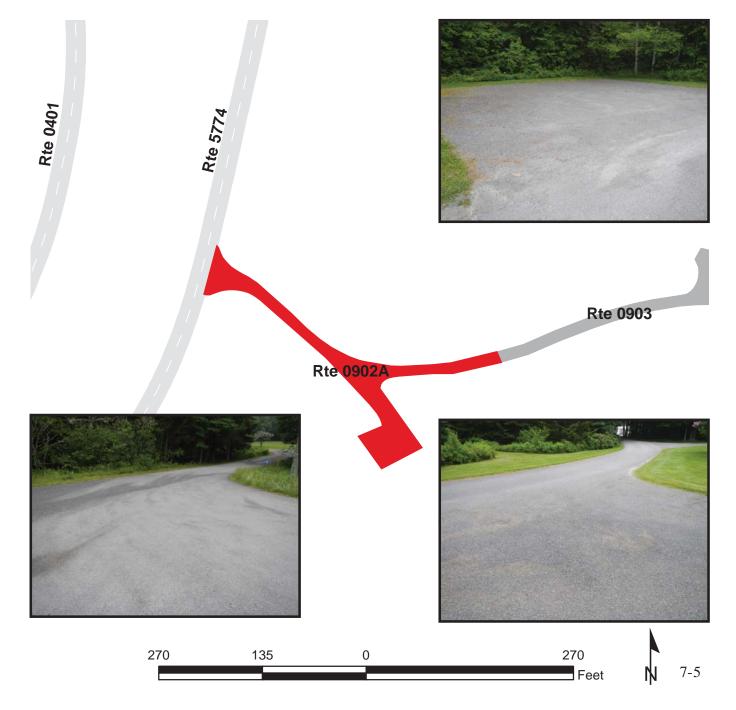
JOHNSTON COTTAGE PARKING

Route	Public /				
Number	NonPublic	Date Visited	Area (sq ft)	Lane Miles *	Surface Type
0902A	PUBLIC	6/26/2013	8,937	0.15	AS
Culverts	Drop Inlets	Gates	Curb & Gutter	Curb	PCR
			NO CURB AND		
0	0	0	GUTTER	NO CURB	FAIR/73

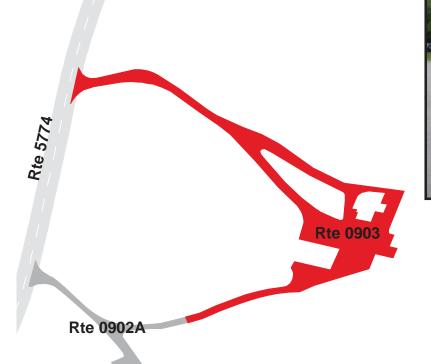
MAINTENANCE AREA PARKING FROM ROUTE 5774 (PROVINCIAL ROUTE 774) TO ROUTE 0902A (JOHNSTON COTTAGE PARKING)

Route	Public /				
Number	NonPublic	Date Visited	Area (sq ft)	Lane Miles *	Surface Type
0903	NONPUBLIC	6/26/2013	42,922	0.74	AS
Culverts	Drop Inlets	Gates	Curb & Gutter	Curb	PCR
			NO CURB AND		
0	0	0	GUTTER	NO CURB	GOOD/90
