Road Inventory and Condition Assessment

San Antonio Missions National Historical Park SAAN - 7600

Cycle 5 Report

Prepared By: Federal Highway Administration

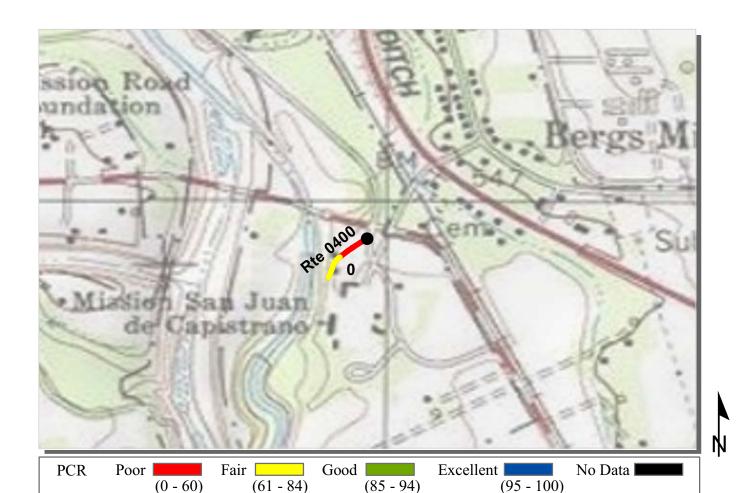
ROUTE: 0400 PARISH ROAD

INTERMOUNTAIN REGION		TOTAL	LENGTH:	0.07 Miles
Section Number	0			
Section Length (mi)	0.07			
Cross Section Information				
Number of Lanes	2			
Paved Width (ft)	22			
Lane Width (ft)	11			
Roadway Condition Information				
SCR (Surface Condition Rating)	45			
PCR (Pavement Condition Rating)	45			
Distress Index Values				
Structural Crack Index	45			
Transverse Cracking Index	91			
Patching Index	99			
Rutting Index	93			
Roughness Condition Index (RCI)	NC

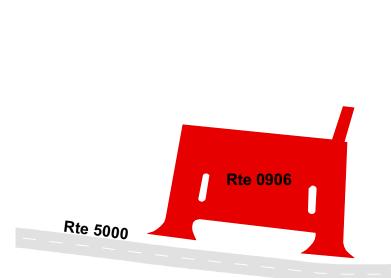
ESPADA AQUEDUCT PARKING FROM ROUTE 5000 (MISSION TRAIL) / ASHLEY ROAD AND ESPADA ROAD
