## Federal Lands Highway Road Inventory Program

Road Inventory and Condition Assessment

### Salinas Pueblo Missions National Monument SAPU

Cycle 5 Report

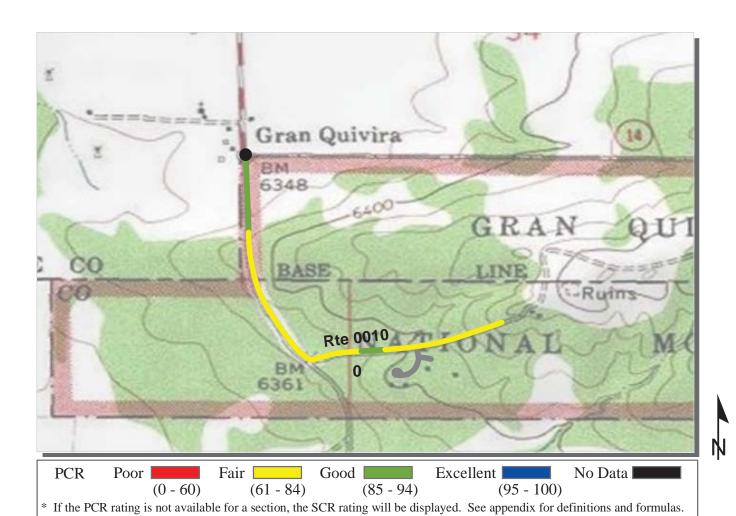
**ROUTE: 0010 GRAN QUIVIRA ROAD**

#### **COLLECTED:** 8/13/2012 INTERMOUNTAIN REGION **TOTAL LENGTH: 0.79 Miles** Section Number 0.79 Section Length (mi) **Cross Section Information** Number of Lanes Paved Width (ft) 21 Lane Width (ft) 9 Roadway Condition Information 92 SCR (Surface Condition Rating) PCR (Pavement Condition Rating) 77 Distress Index Values 97 Structural Crack Index 93 Transverse Cracking Index Patching Index 100 92 **Rutting Index** Roughness Condition Index (RCI) 54

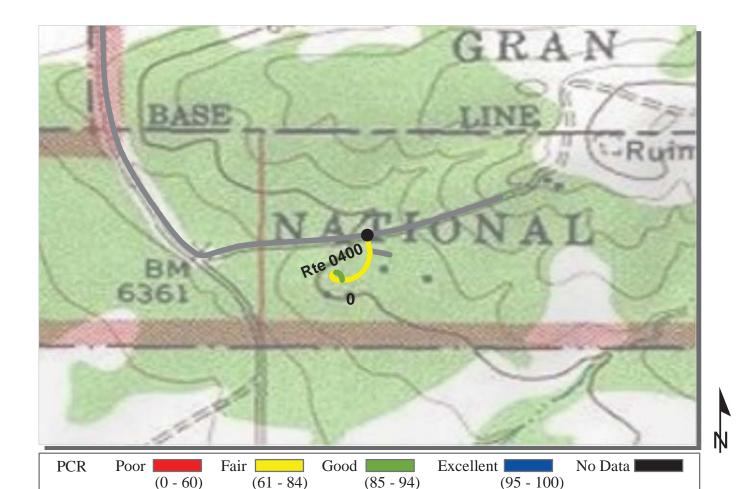
**ROUTE: 0400 RESIDENCE ROAD**

| INTERMOUNTAIN REGION | | TOTAL LEN | GIII. | 0.11 Milles |
|---|---|---|---|---|
| SCR (Surface Condition Rating) | 71 | | | |
| PCR (Pavement Condition Rating) | 71 | | | |
| Structural Crack Index | 71 | | | |
| Transverse Cracking Index | 84 | | | |

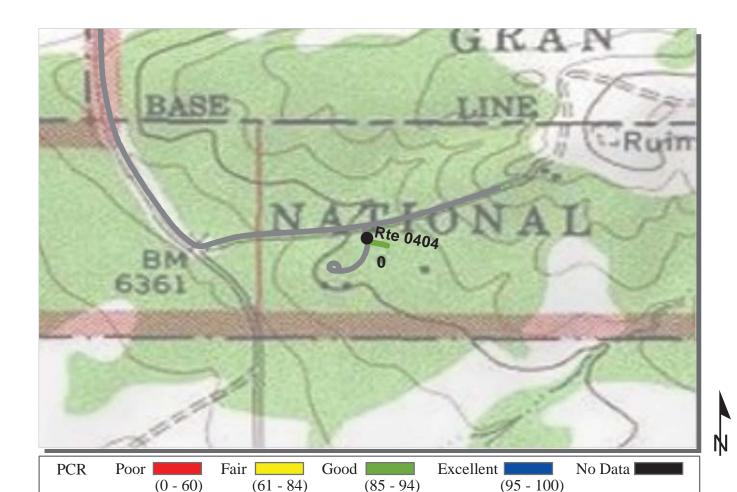
ROUTE: 0404 GRAN QUIVIRA MAINTENANCE AREA ROAD SAPU: SALINAS PUEBLO MISSIONS NATIONAL MONUMENT

| INTERMOUNTAIN REGION | | TOTAL | LENGTH: | 0.03 Miles |
|---|---|---|---|---|
| SCR (Surface Condition Rating) | 84 | | | |
| PCR (Pavement Condition Rating) | 84 | | | |
| Structural Crack Index | 91 | | | |
| Transverse Cracking Index | 84 | | | |
